Pipeline Safety Seminar

2020 NC's Incidents and Investigations

**Pennsylvania PUC - Pipeline Safety
September 9th, 2021**

Reportable Incidents

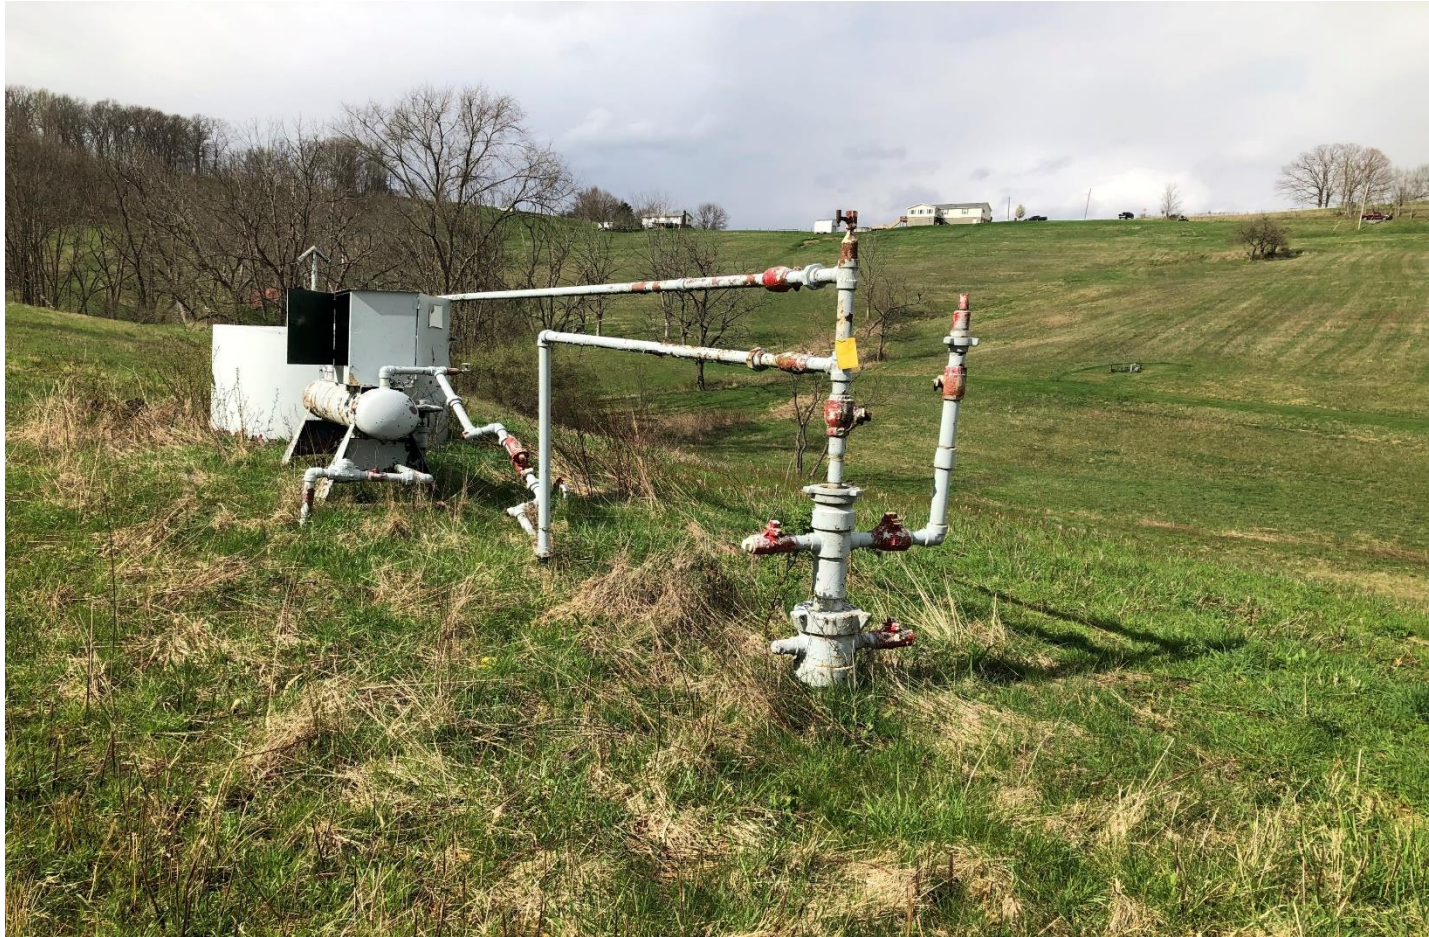
Farm Tap leak

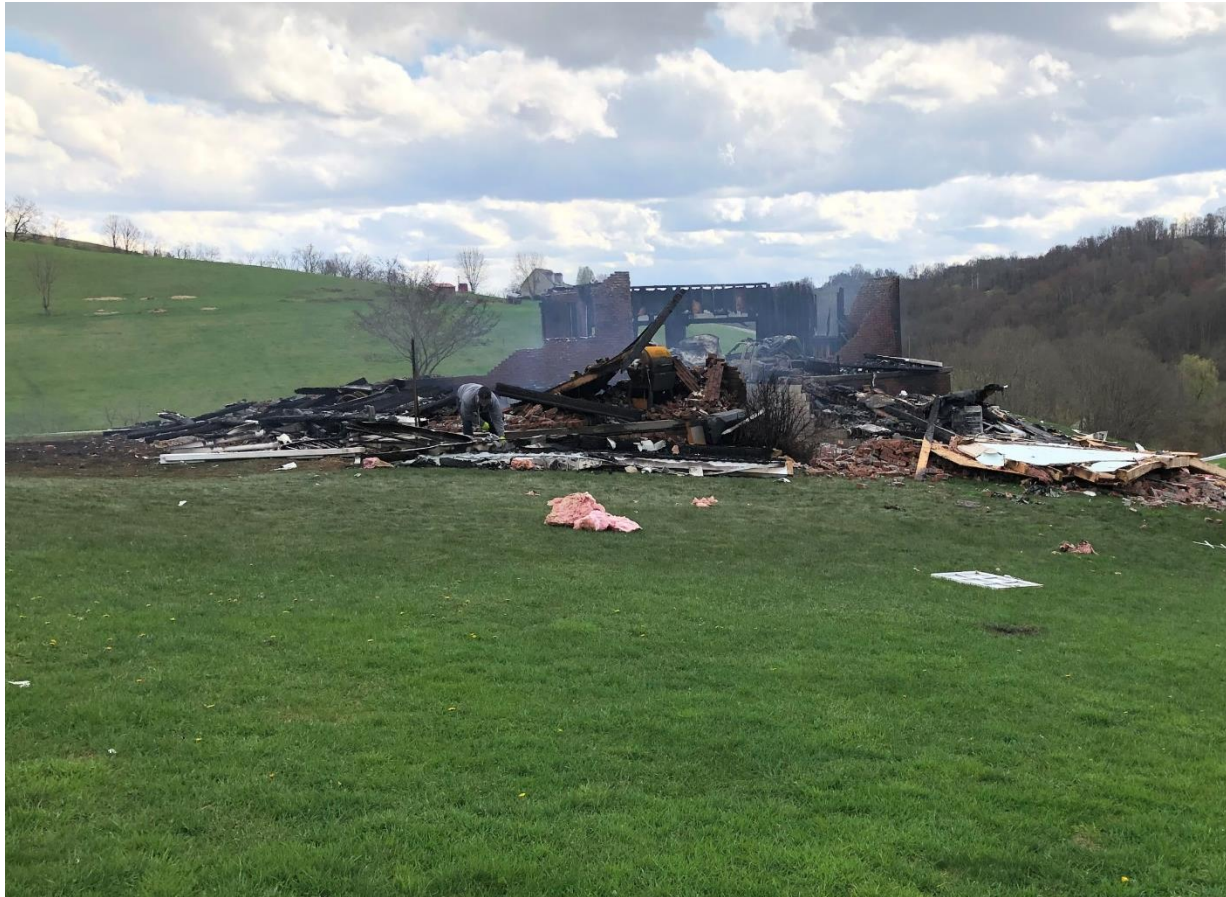
Thankfully no injuries

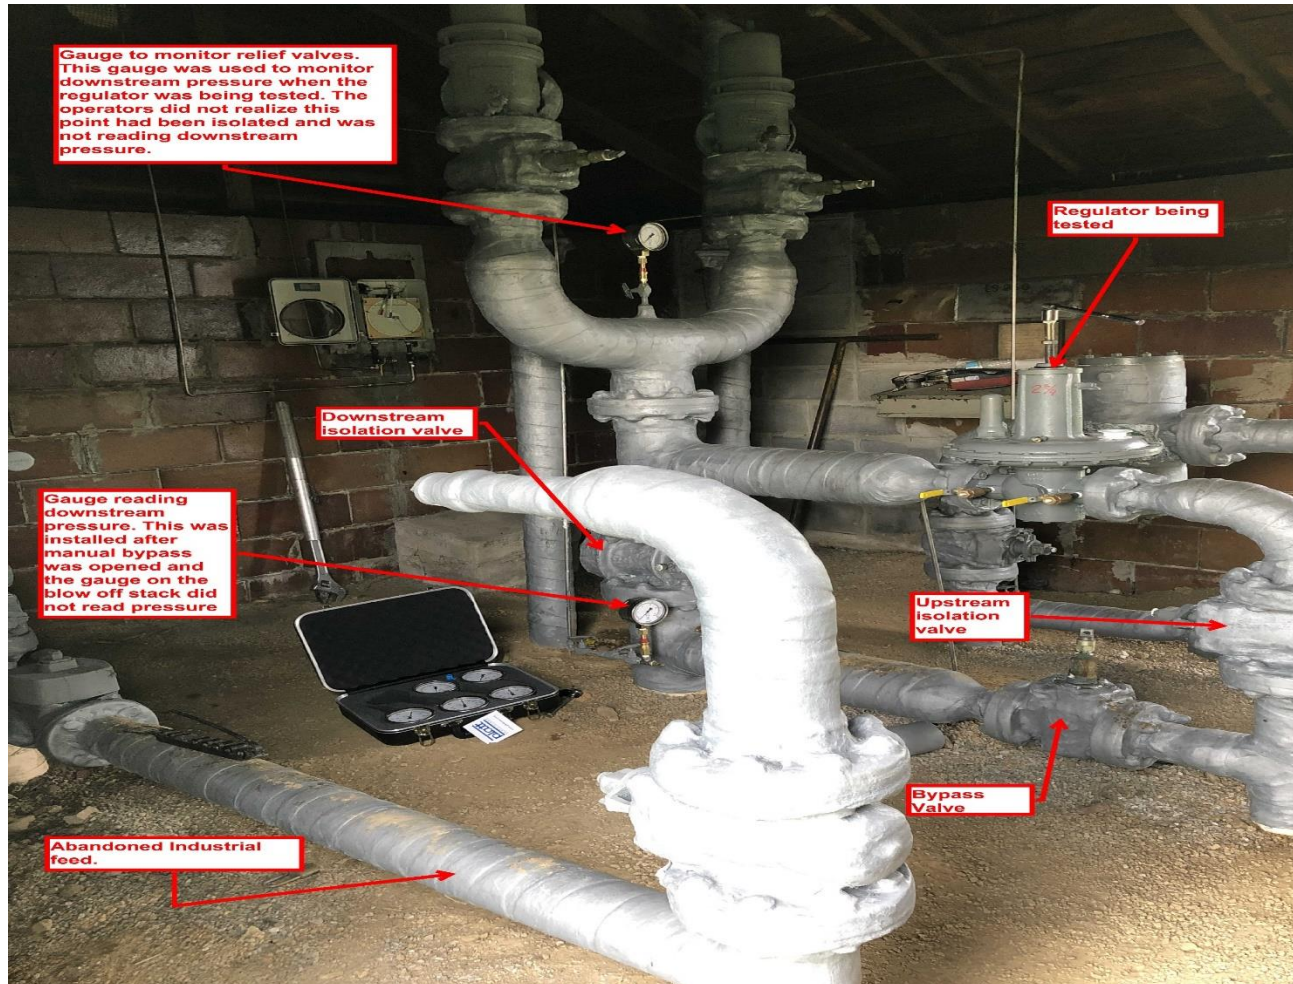
Incorrect gauge placement

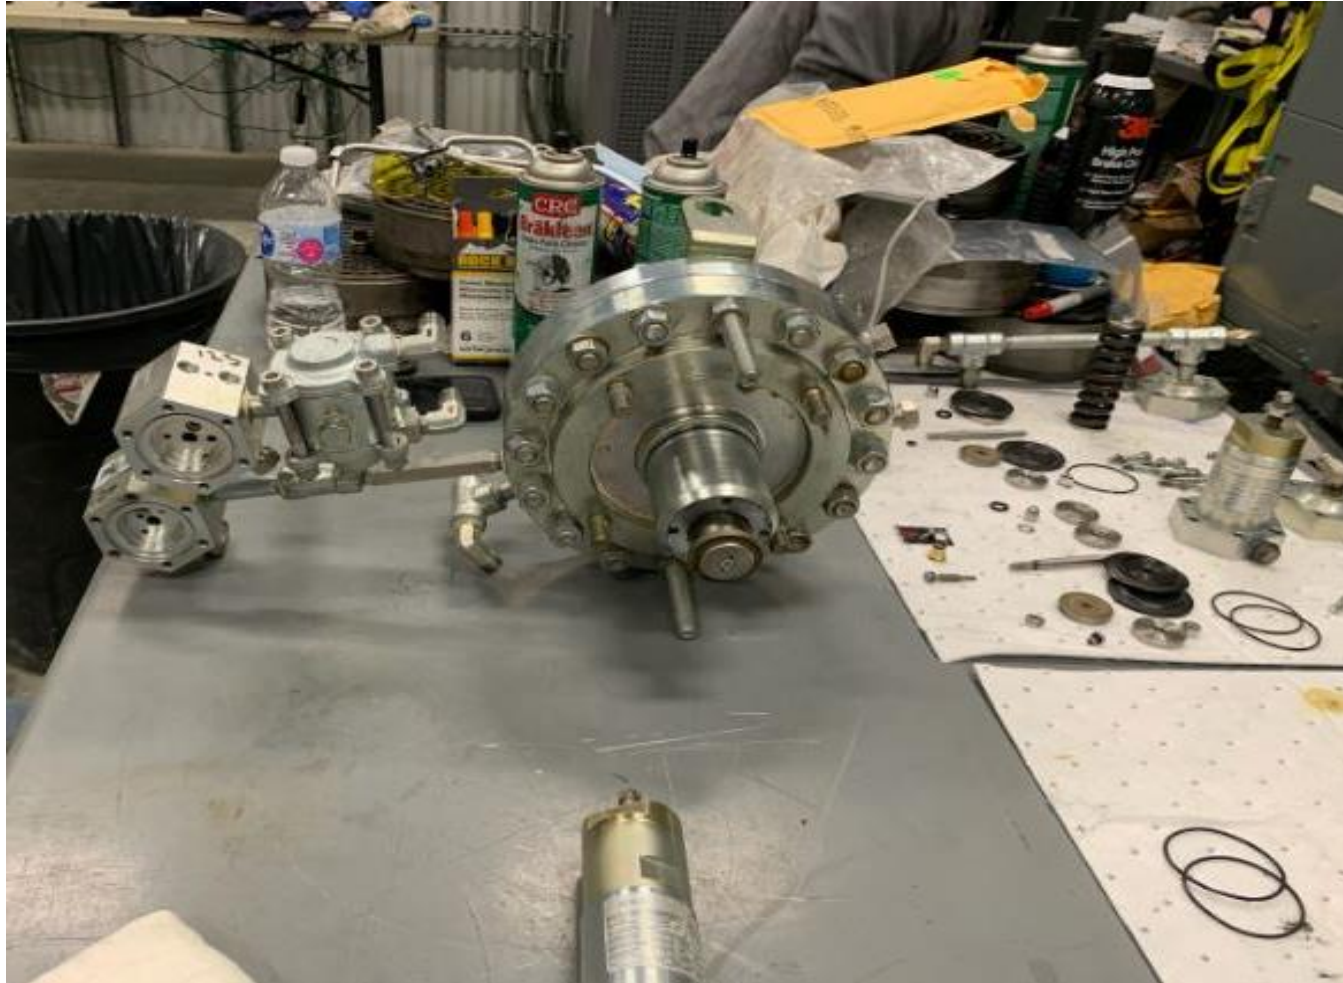
Gas loss thru relief

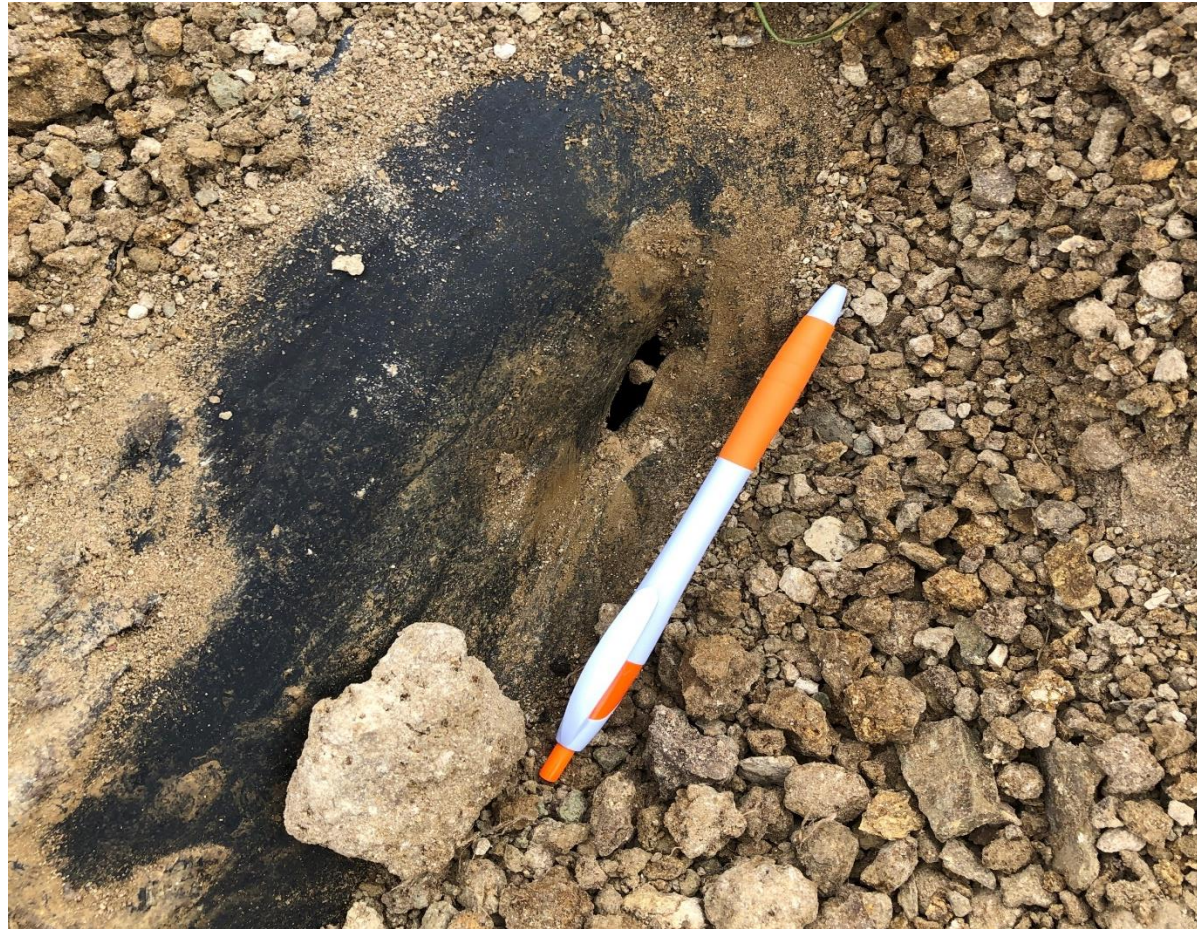
No One Call

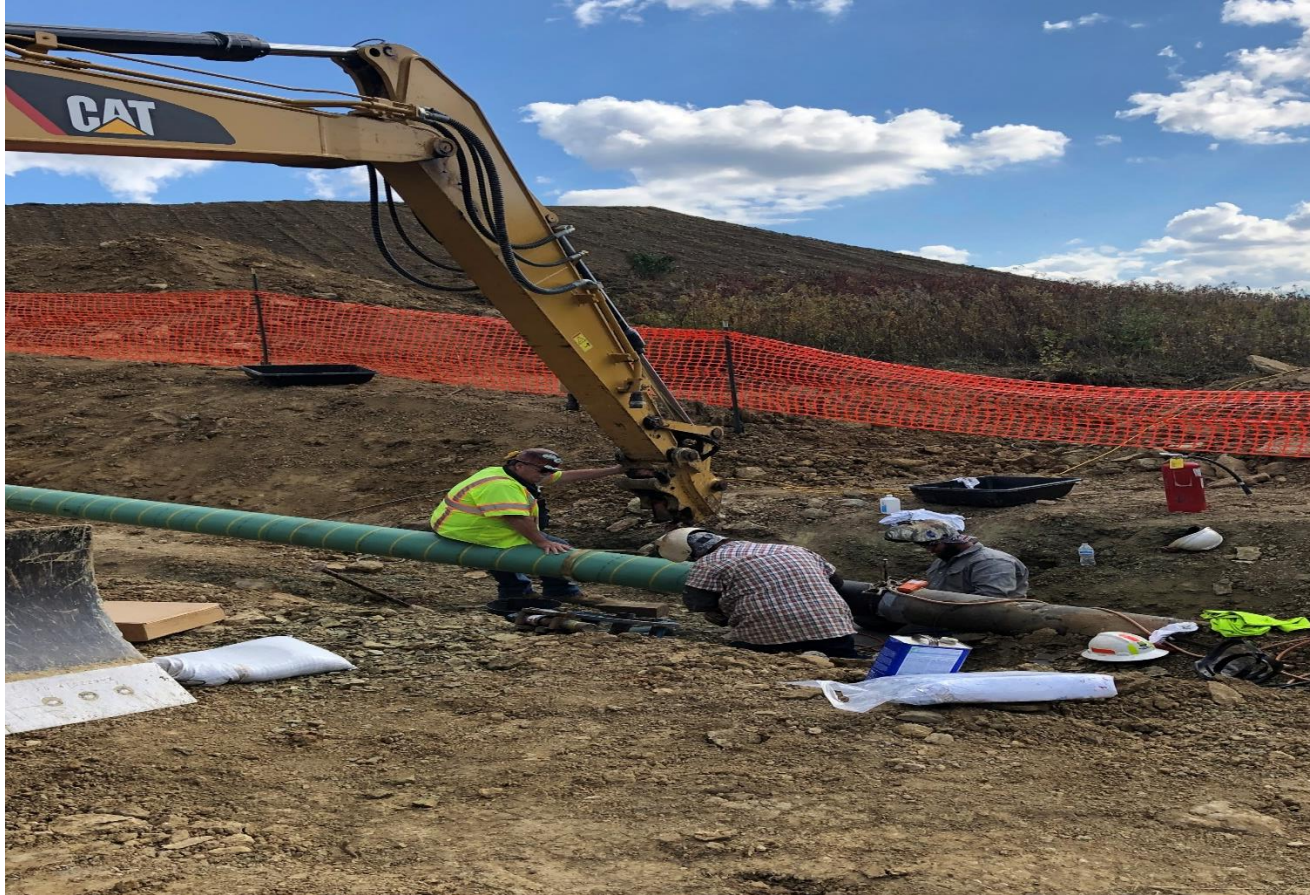
Bulldozer damaged 10" Steel main

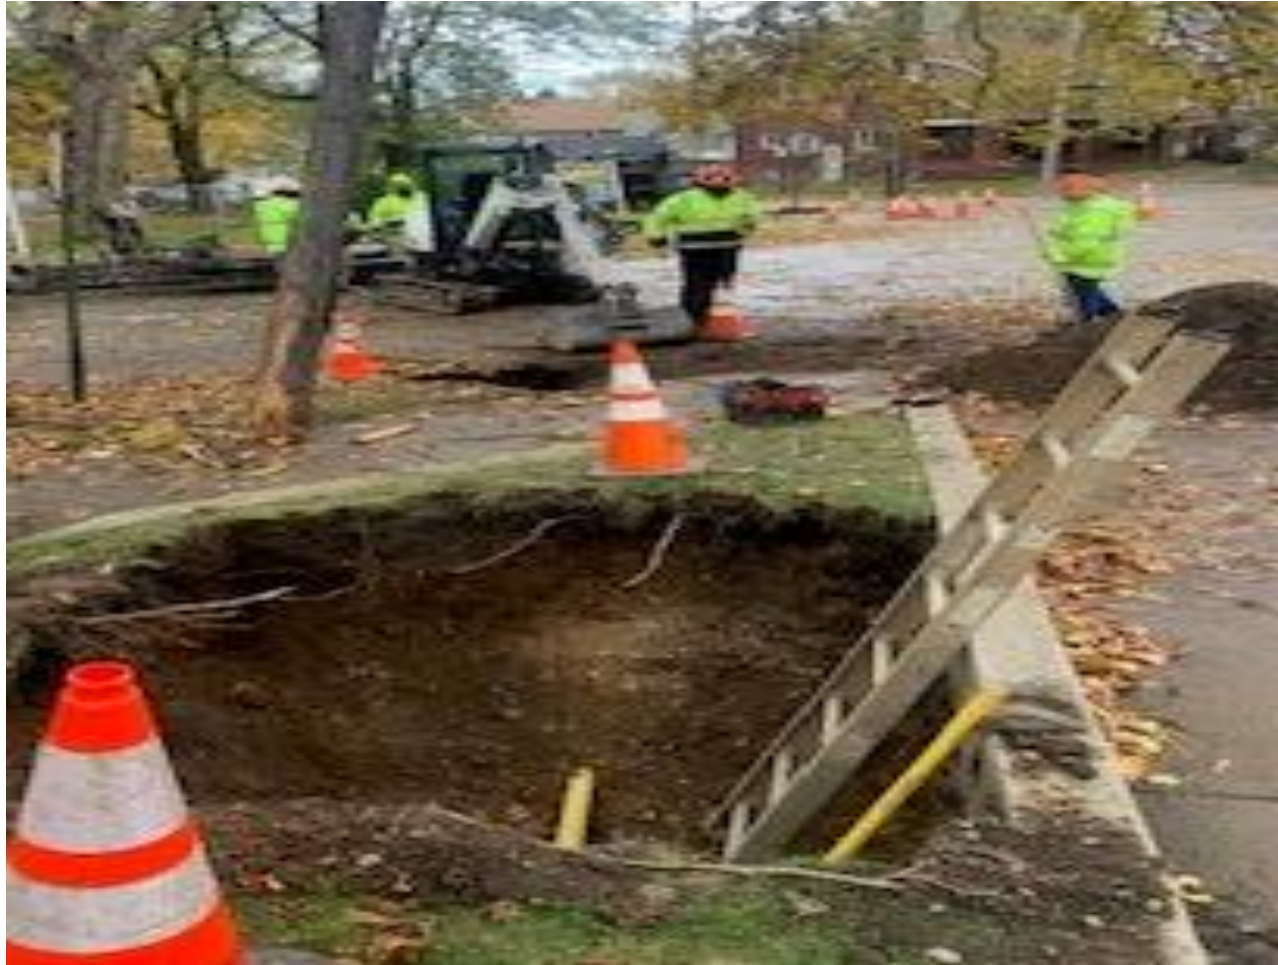
Main not marked

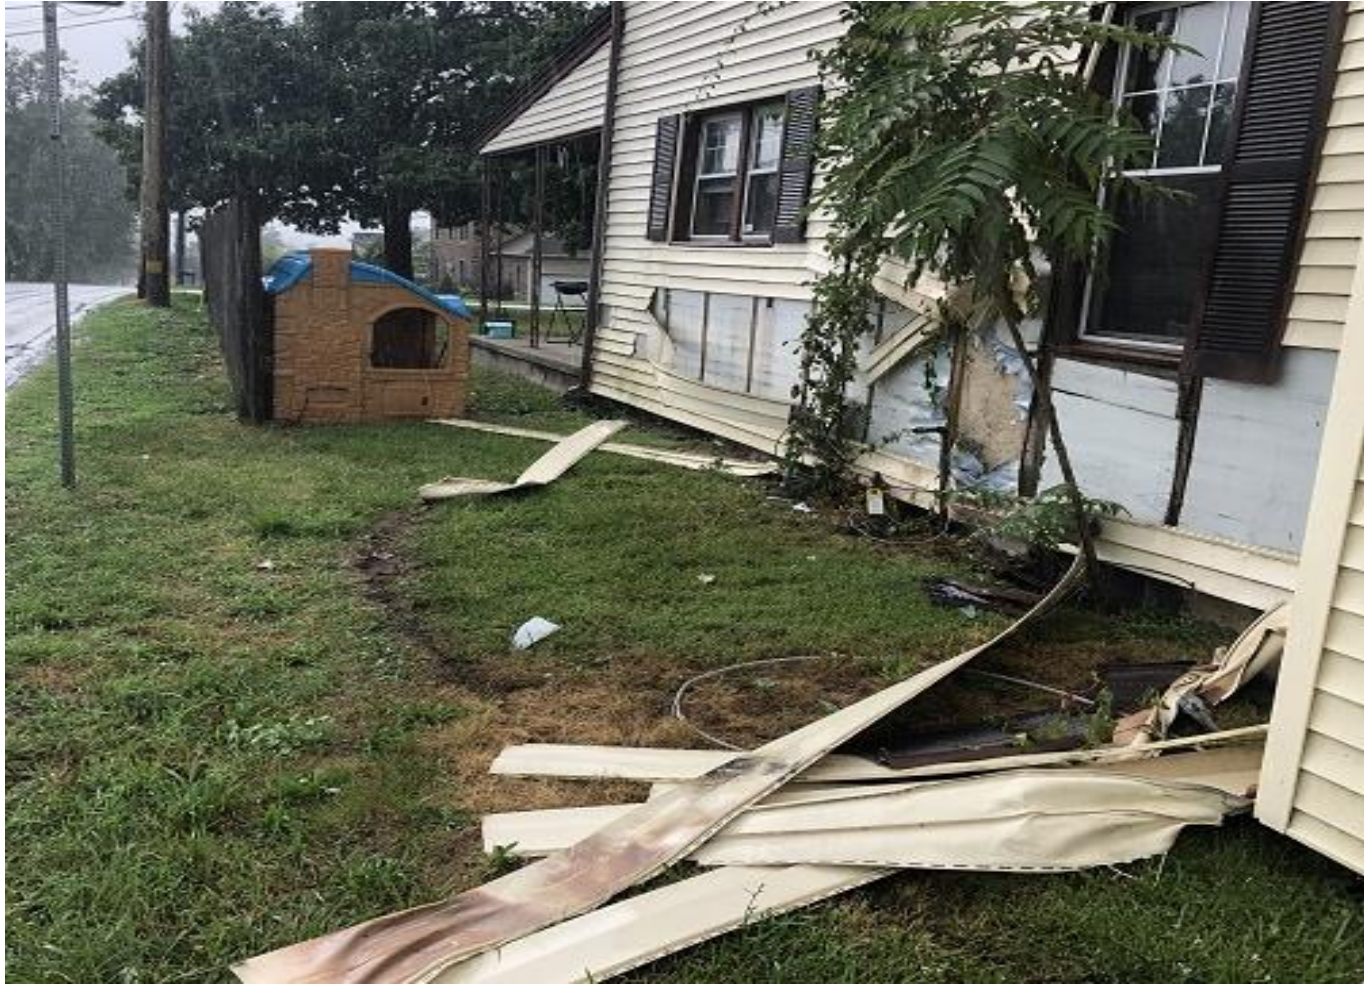
Downed electric wire

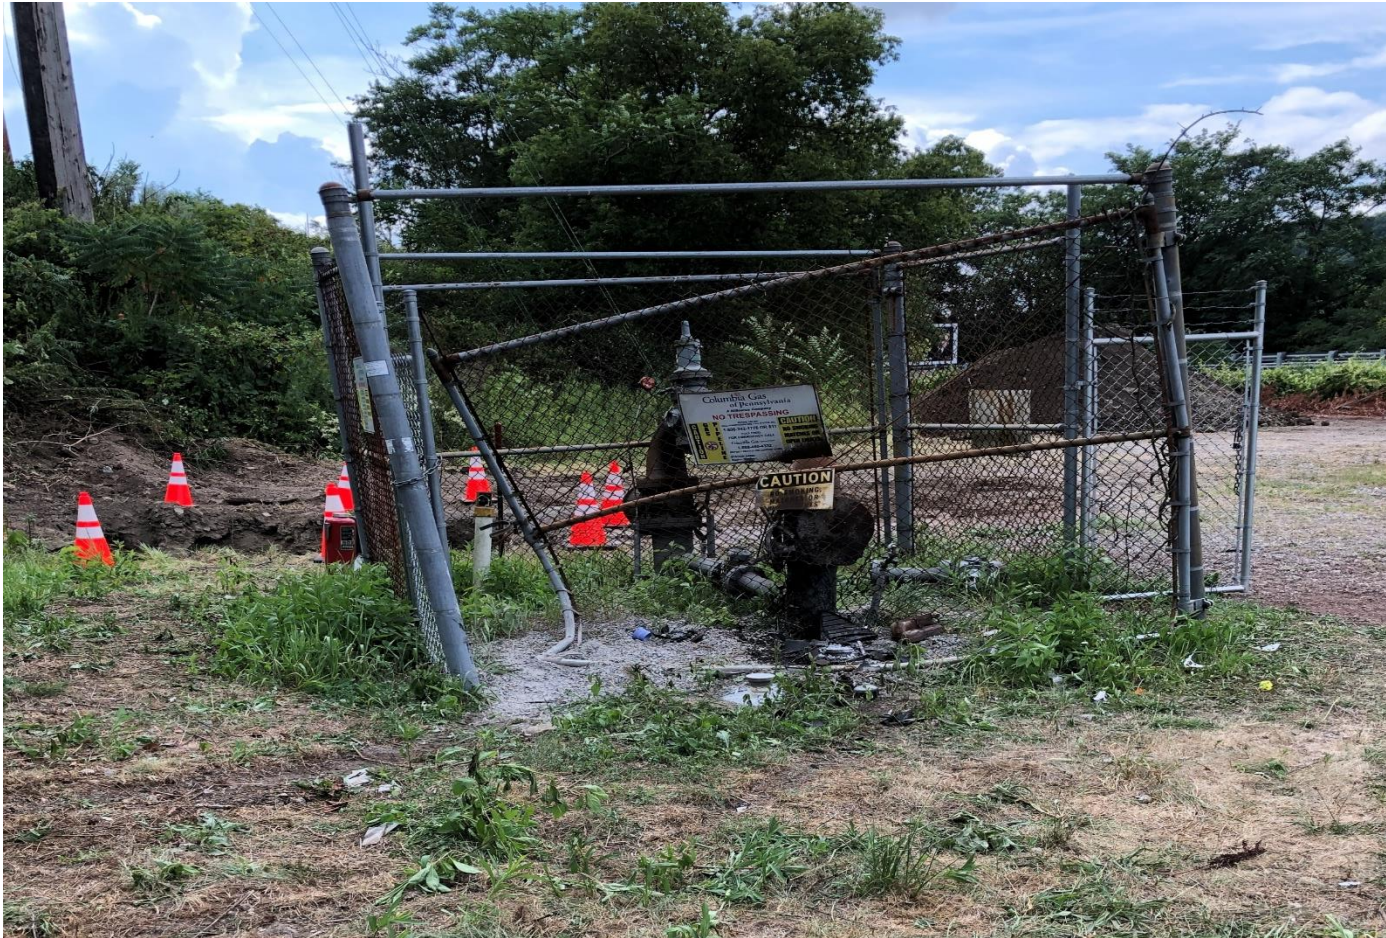
Vehicle damage

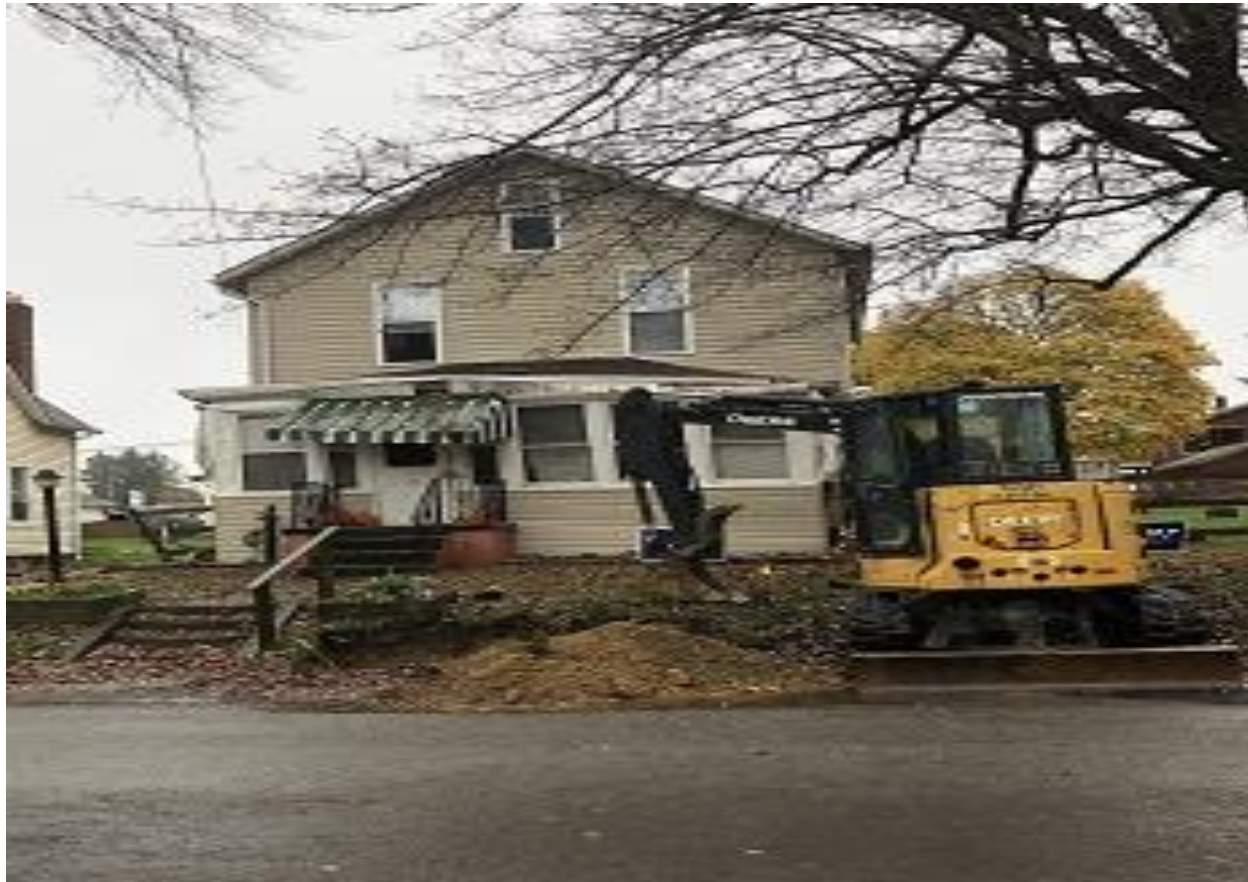
Leaking Butt Fusion

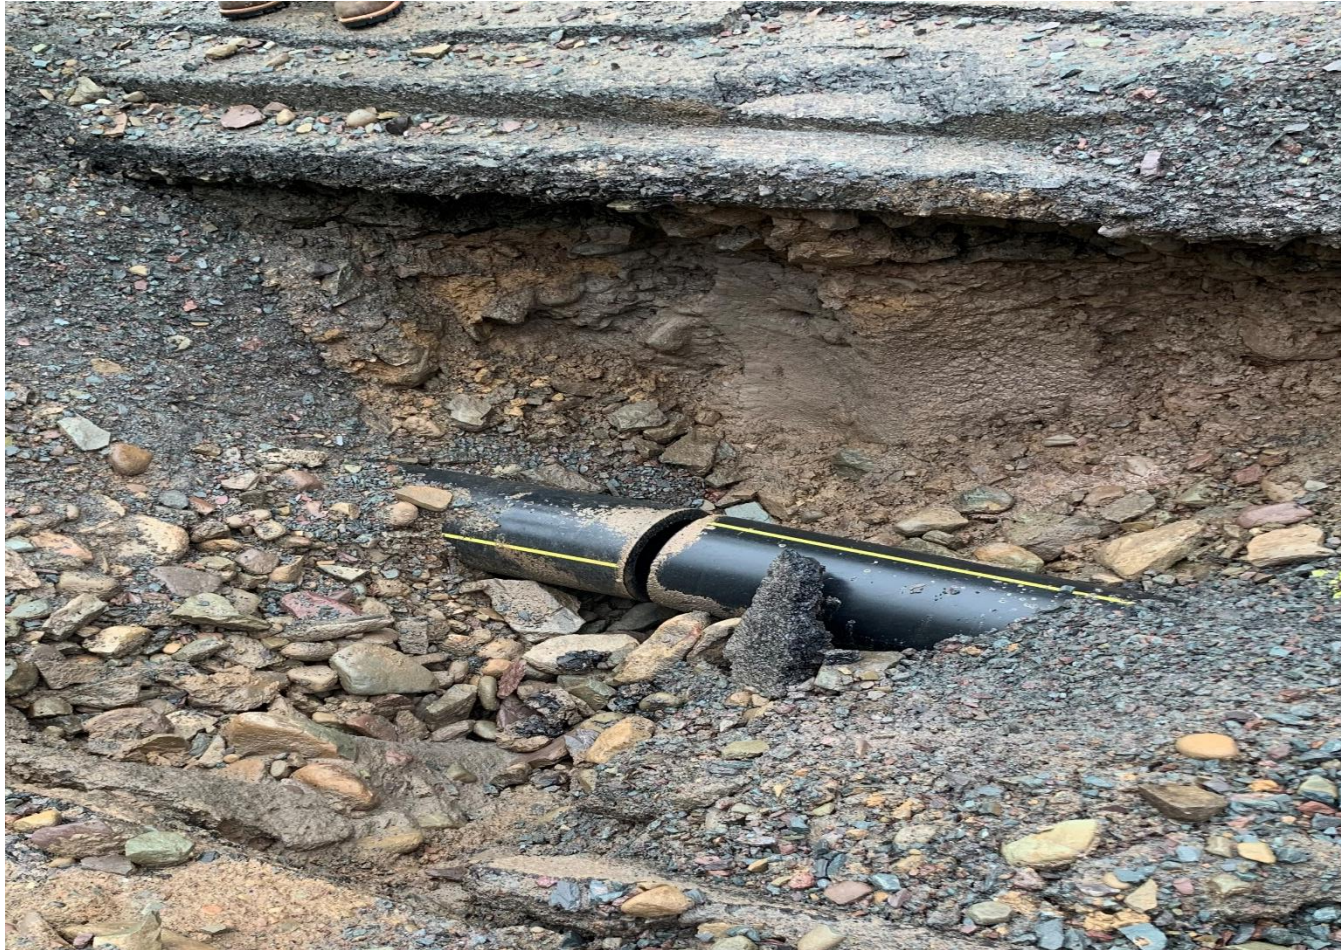
Failed Butt Fusion

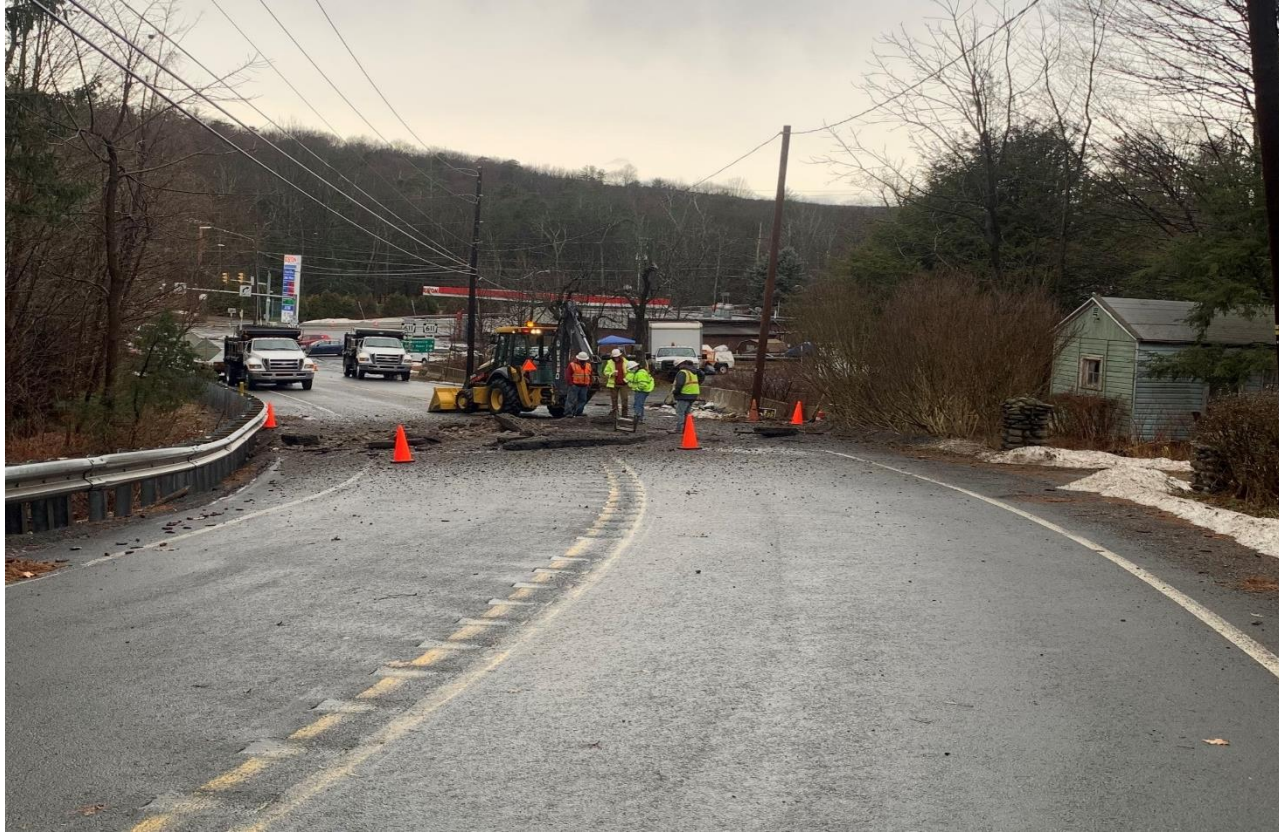
Failed Butt Fusion
