NOTICE OF VIOLATION (MANHOLES)

NOTICE OF VIOLATION

Re: Clean Water/Operations/Sewage
General Sewage
Manholes 1317 and 249
East Norriton Township
Montgomery County

GENERAL INSPECTION REPORT (Non-NPDES)

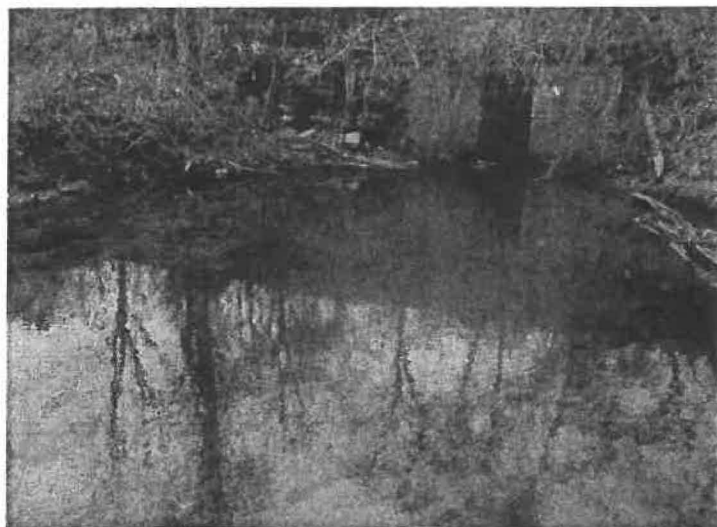
1. Branch of the Stoney Creek near manholes 1317 and 249, and with green material on the Substrate indicating the presence of sewage.

Item 1 of the NOV Letter noted erosion around the base of Manhole 1317 (actually Manhole 372). We believe this to be simply a lack of vegetation around the base of the manhole. Our inspections have found no evidence of erosion. Item 1 also detailed a “green material” in the creek. We believe that any SSO from either MH 372 or MH 371 would not have directly entered the creek due to the existing grades at this location. Both manholes are downhill from the banks of the creek, and therefore we believe that the “green material” observed in the creek did not (and could not have) resulted from any SSO from MH 372 or MH 371. Item 1 also referenced manhole 1318. We believe this was intended to refer to MH 372.

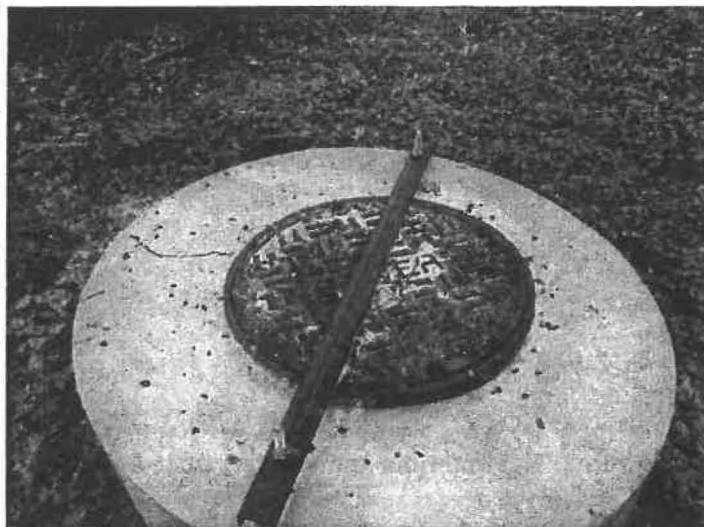
1. There were sewage solids such as bath tissue and debris on the manhole cover and around the base of manhole 1317. Lime was also on the lid and on the ground around the manhole. There was erosion around the base of manhole 1317. There was green material on the substrate of Stoney Creek located down gradient and approximately less than 10 yards from manhole 1318. These conditions indicate a Sanitary Sewer Overflow occurred from manhole 1317 which is an unpermitted discharge of sewage and a violation of Section 201 and 202 of the Clean Streams Law.

2. Manhole 1317 with solids and lime indicating an SSO Occurred, 04/18/2014

- Manholes in the vicinity of, and including, MH 372 and MH 371 have been raised and encased in concrete to preserve the integrity of the structures and to minimize the potential for SSOs.

- Raising manholes so that SSOs do not occur at this location.
 - Implementation of traditional soil and erosion control measures to ensure that, in the event of SSO, discharge would be diverted away from pond.

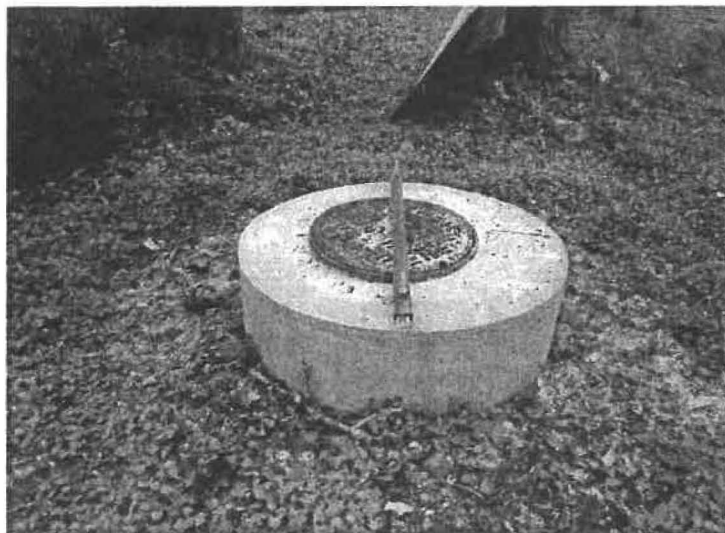
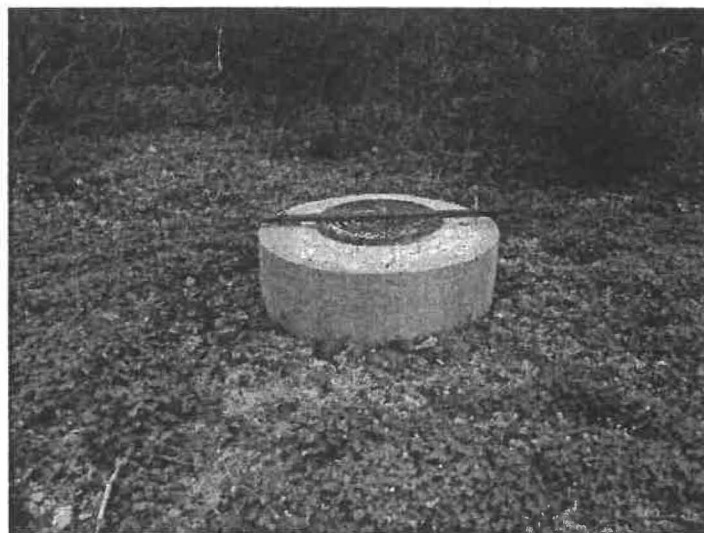
3. And 4. Manhole 1317 with sewage solids and lime on the ground around it, and erosion indicating SSOs occur at this location.

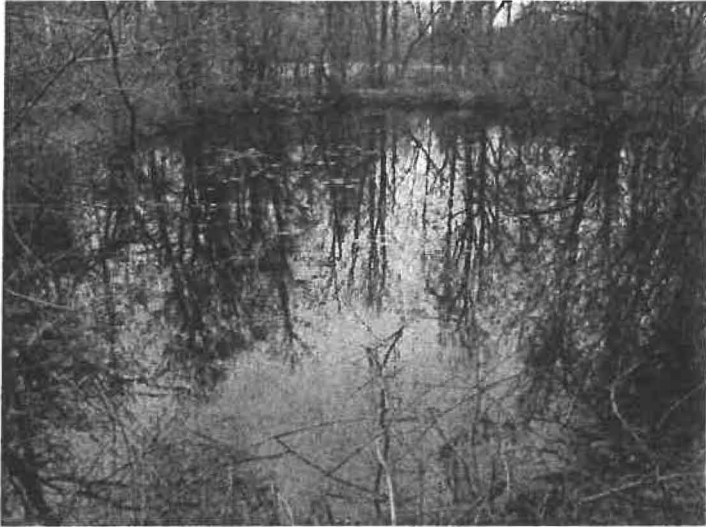
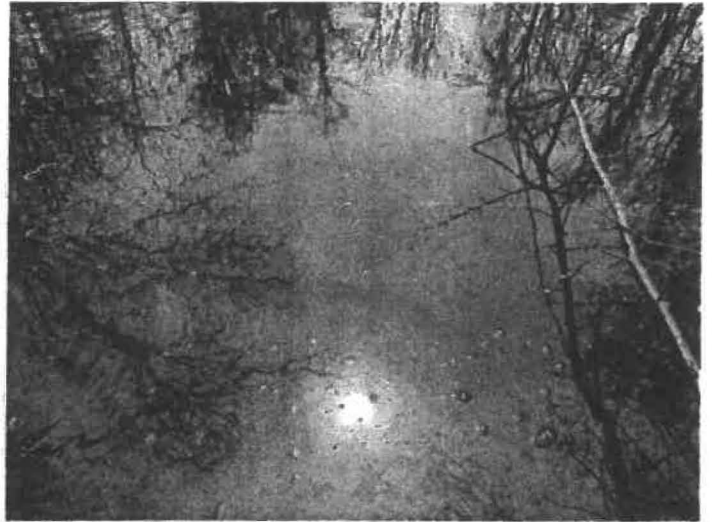
5. The Pond adjacent to the manhole 1317.

6. Sheen and emulsified oil on the surface of the Pond caused by an SSO on April 6, 2014.

Additionally, Item 3 on page 2 of the Inspection Report indicates that the Department observed a “petroleum based sheen” on the pond. A follow up inspection of this area was performed by Township personnel on Monday, May 5th, and while some type of substance was noted on the surface of the pond, no evidence of any sanitary sewer fats, oils or grease were observed on the surface of the pond or in the immediate vicinity of either MH 372 or MH 371.

- Installation of earthen berm and/or swale to redirect any SSO.
 - Perform manhole inspections of Timberlake PS service area. Specifically, areas bounded by Whitehall Road, Township Line Road, Swede Road and Germantown Pike. The work would include the inspection of in excess of 250 manholes.

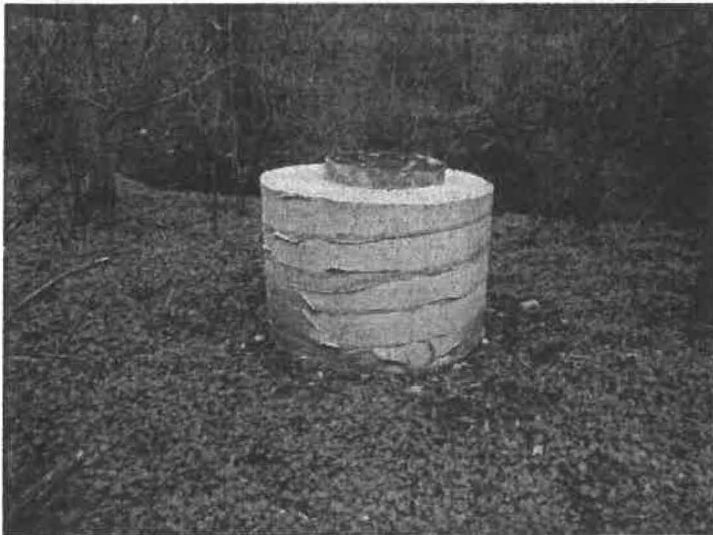
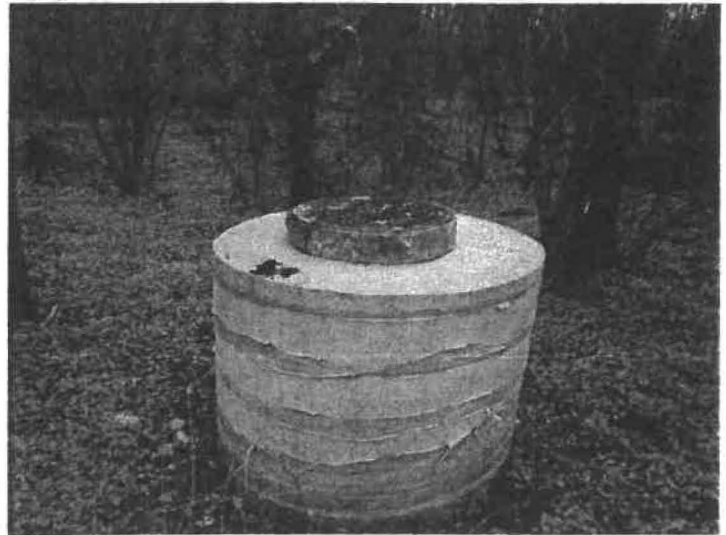
↑
MH 374

7. and 8. The manhole immediately upstream of manhole 1317 with erosion around the base, 04/18/14.

Item 4 on page 2 of the Inspection Report also raises concerns with MH 373 and MH 374 immediately upstream of the area in question. The Township personnel recently encased both of these manholes in concrete to prevent deterioration of these structures. We believe the “erosion” noted in the report is simply a lack of vegetation due to the recent encasement process. We also investigated the possibility of SSOs at these manholes and found no physical evidence that an SSO occurred at either location.

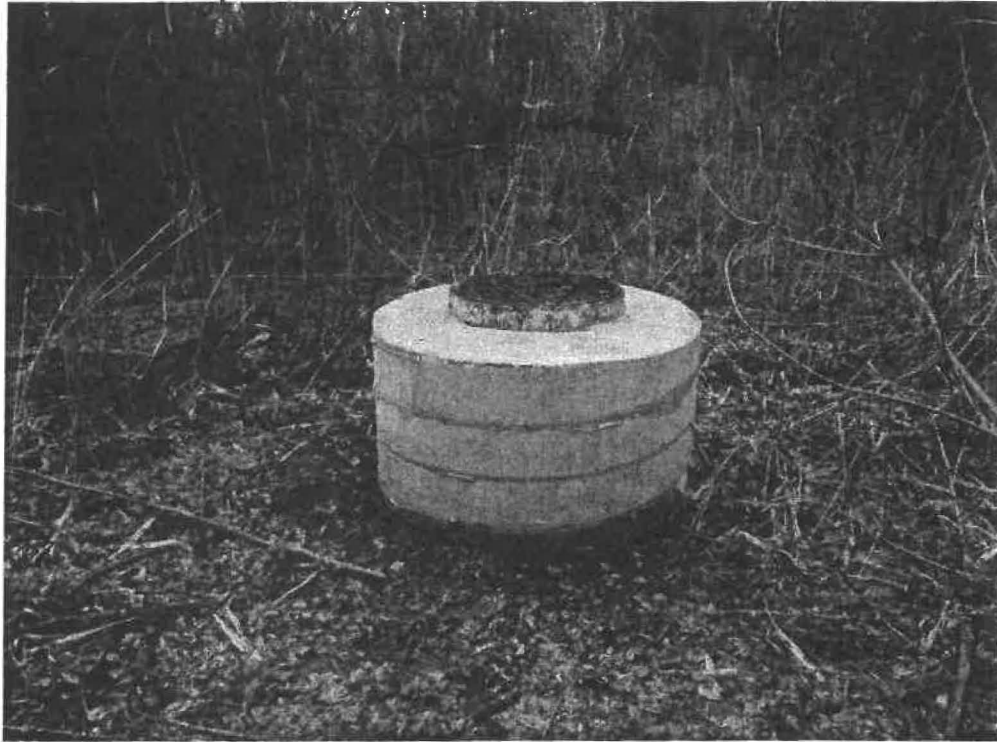
MH 373

9. An upstream manhole with erosion around the base, 04/18/14.

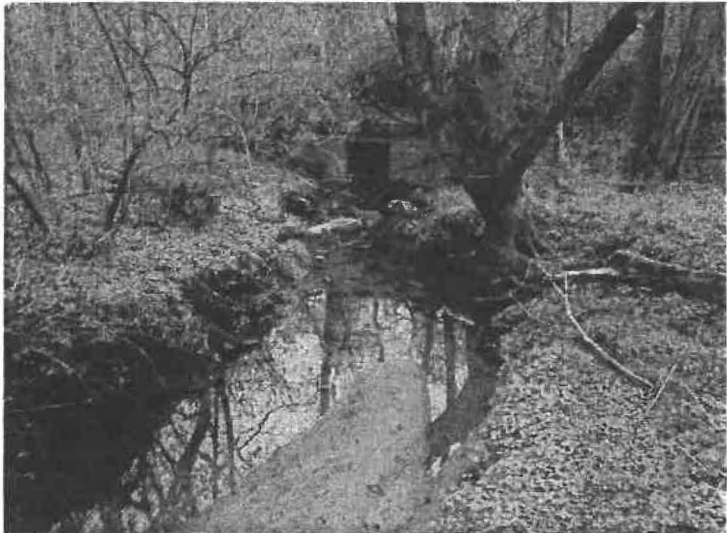
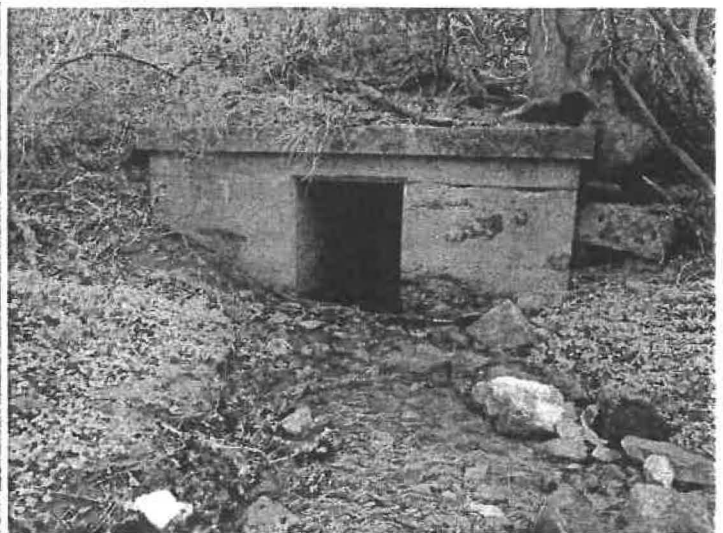
10. And 11. The section of Stoney Creek upstream of manhole 1317 and with no dark green material on the substrate or in the water column, 04/18/14.
