NOTICE OF VIOLATION (NORRIS CITY PUMP STATION)

**NOTICE OF VIOLATION**

Re: Clean Water/Operations/Sewage  
Norris City Avenue Pumping Station  
East Norriton Township  
Montgomery County

**GENERAL INSPECTION REPORT (Non-NPDES)**

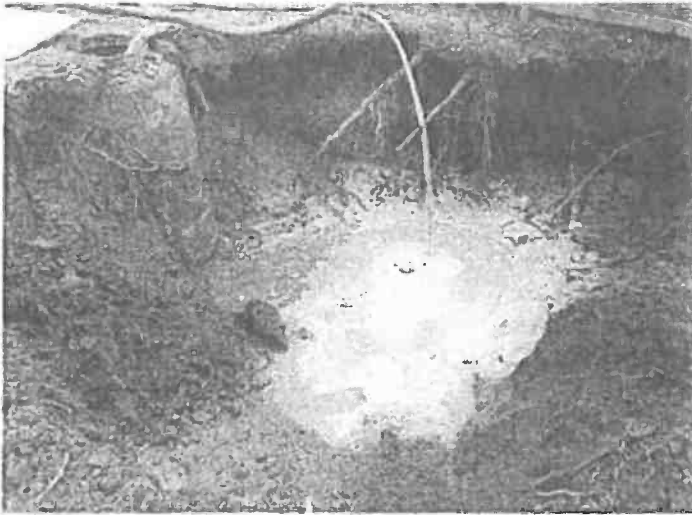
**1. The beginning of the excavation near manhole #2 on the 24 inch Section of the Stoney Creek 2. Interceptor, 02/25/16.**

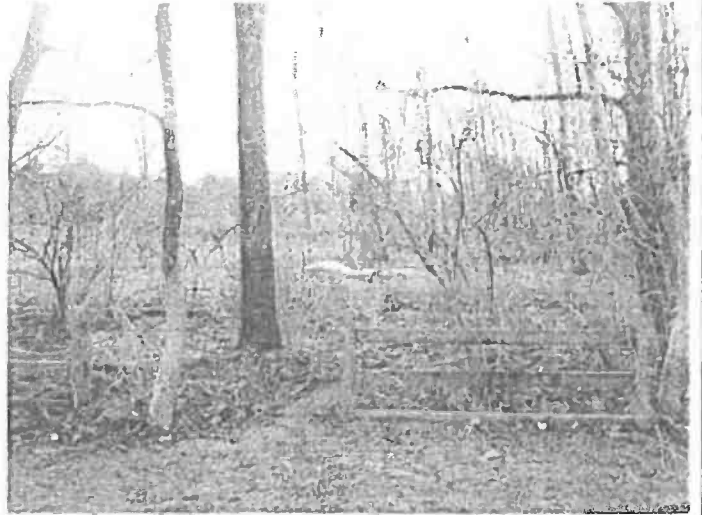
**2. Portable Pumps pumping water out of the hole to the wood, 02/25/16.**

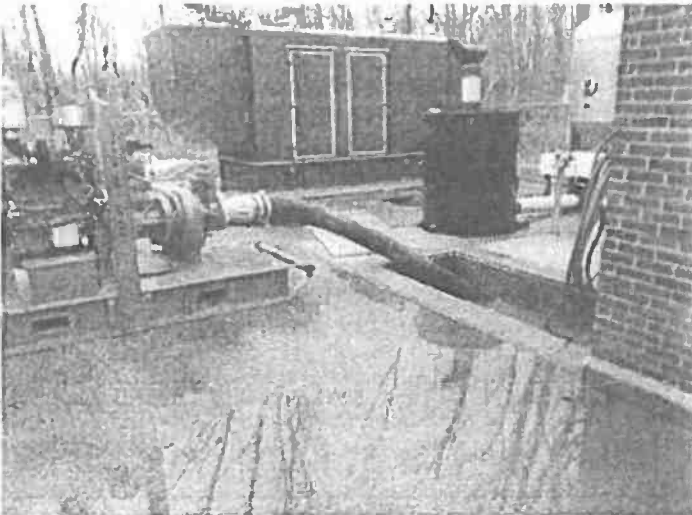
**3. One of the 8 inch Xylem Pumps pumping raw sewage out of the wet well to the ground and creek, 02/25/16.**

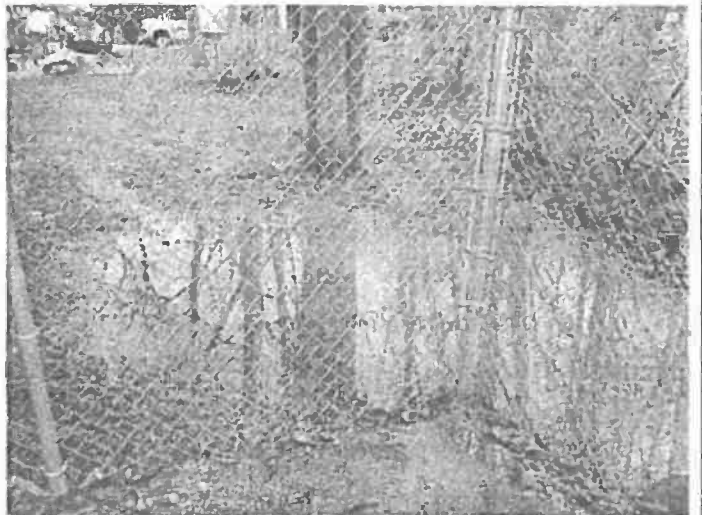
**4. Sewage on the ground due to the manhole located in driveway of the pump station overflowing.**

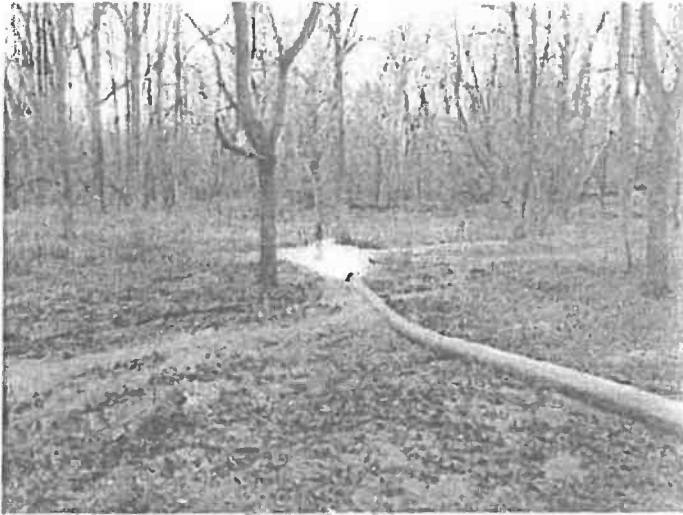
**5. One of the Xylem pumps discharging to the wooded area behind the pump station and flowing into Stoney Creek, 02/25/16.**

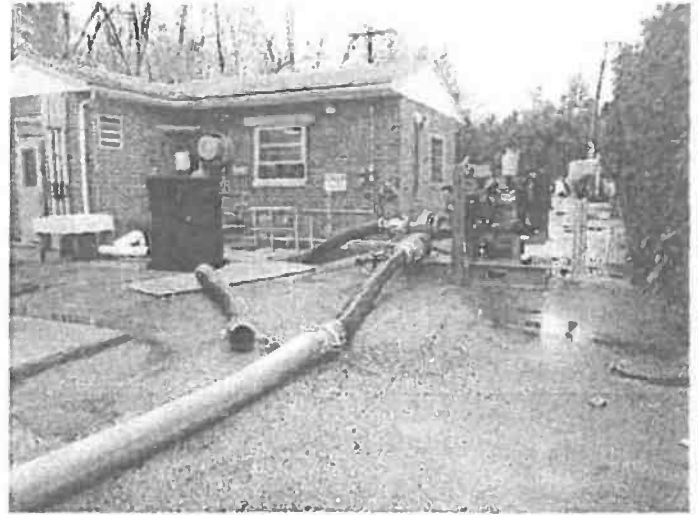
**6. The Xylem Pump set up and discharging from the wet well, 02/25/16.**

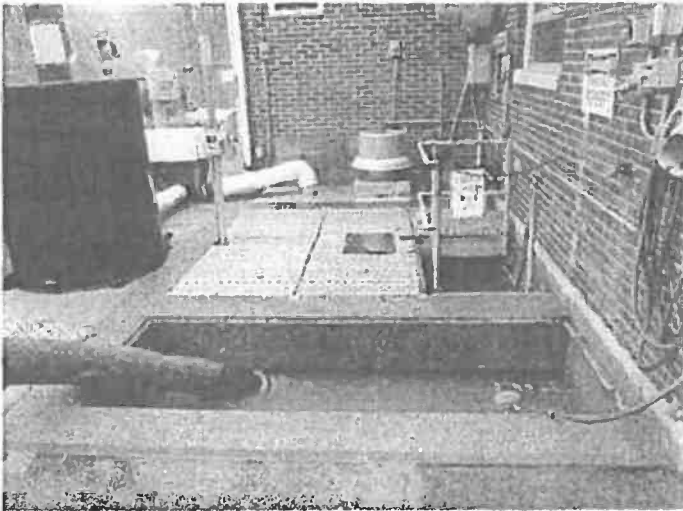
**7. The sewage level in the pumping station at the top of the wet well.**

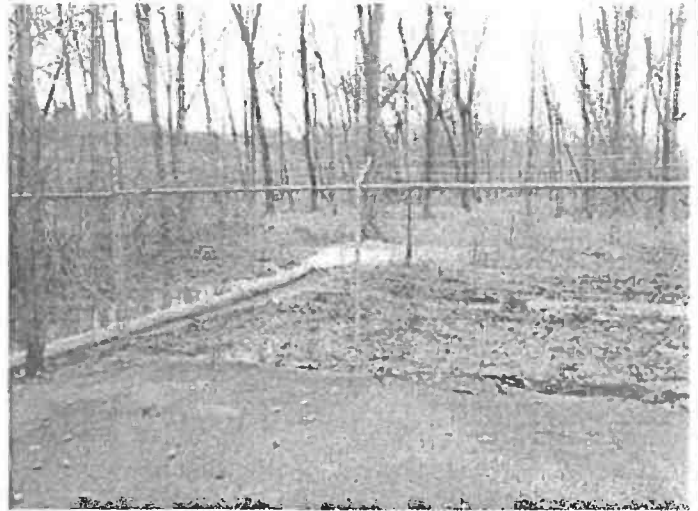
**8. The second Xylem Pump discharging to the woods and creek from the manhole on the Stoney Creek Interceptor immediately upstream of the wet well.**

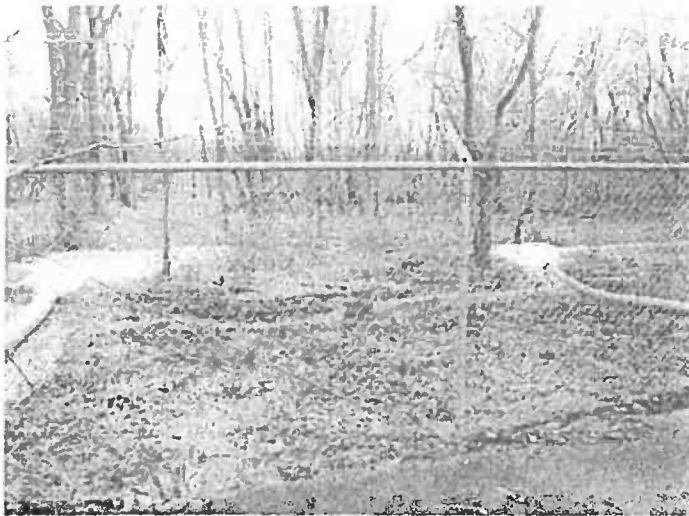
**9. The two 8 inch Xylem Pumps discharging to the ground and Stoney Creek, 02/25/16.**

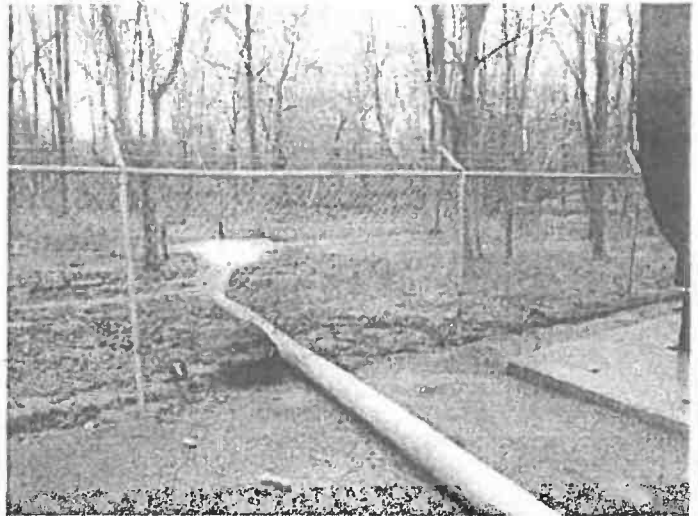
**10. One of the Xylem Pumps discharging to the ground and Stoney Creek, 02/25/16.**

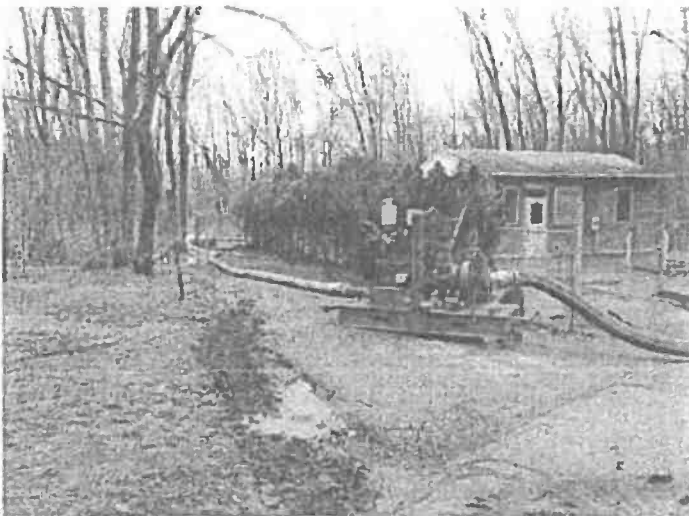
**11. The Second Xylem Pump discharging from manhole on the Stoney Creek Interceptor in the pump station driveway.**

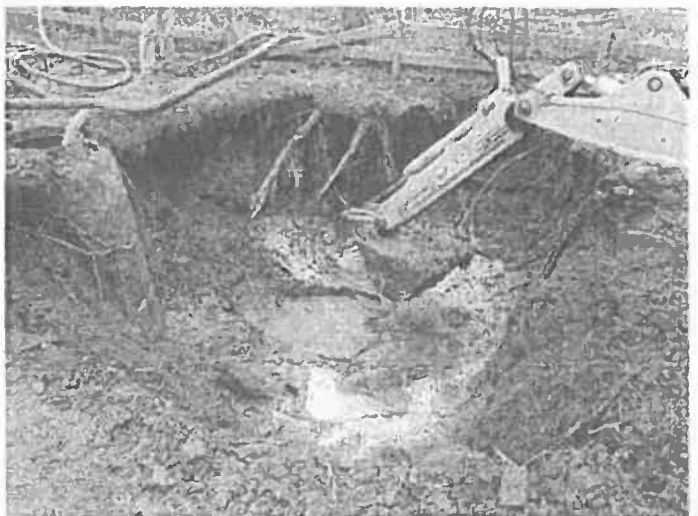
**12. The excavation of the 16 inch force main with a back-hoe.**

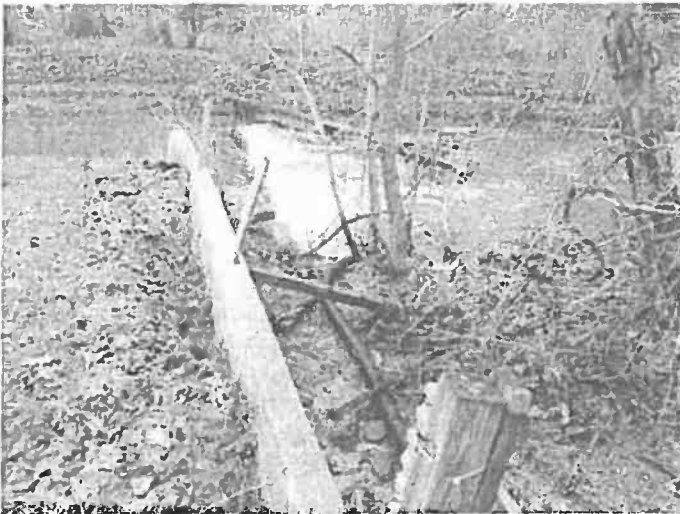
**13. Manhole 2A overflowing to Stoney Creek, 02/25/15.**

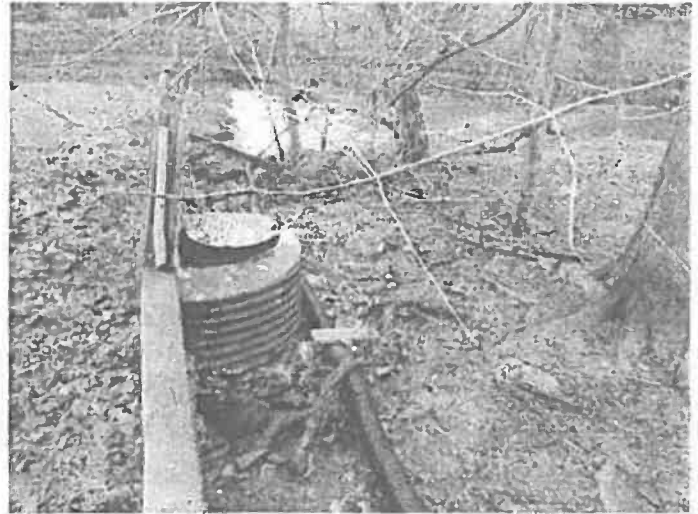
**14. Some sewage solids around the manhole.**

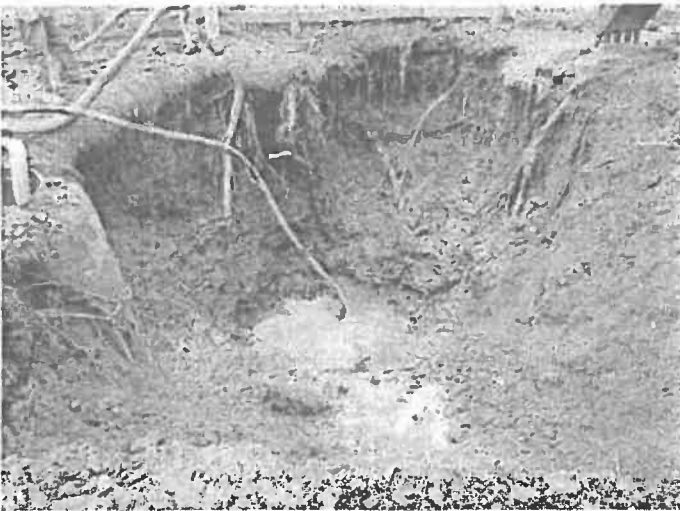
**15. One of the portable pumps in the excavation, 02/25/16.**

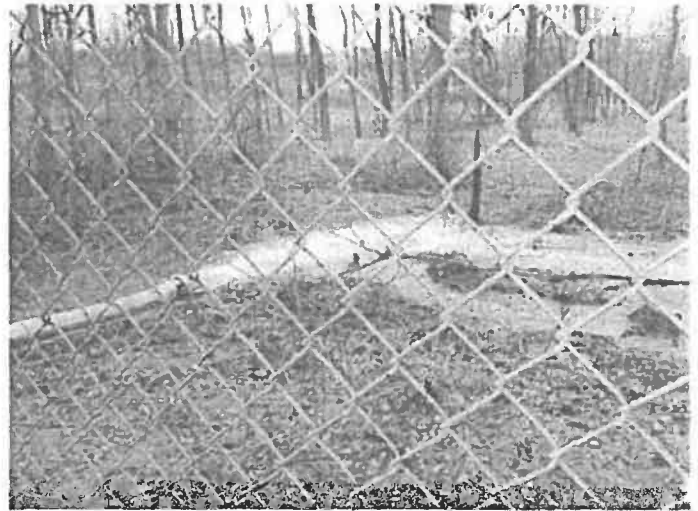
**16. The stream of sewage flowing out of the Xylem Pumps onto the ground and to Stoney Creek.**

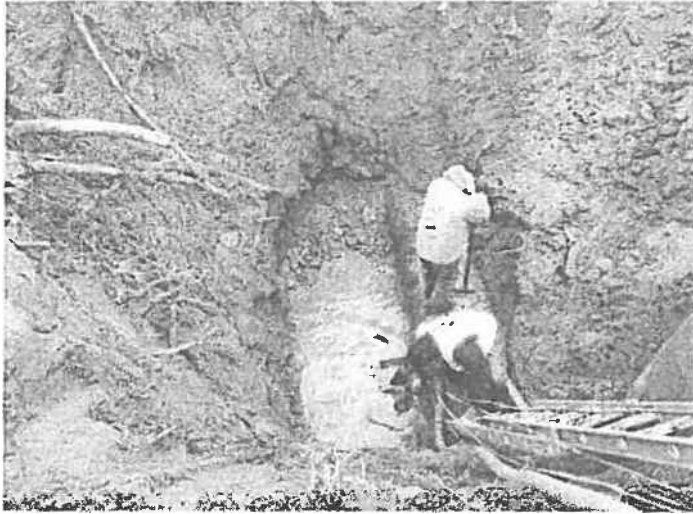
**17. The excavation of the 16 inch force main, 02/25/16.**

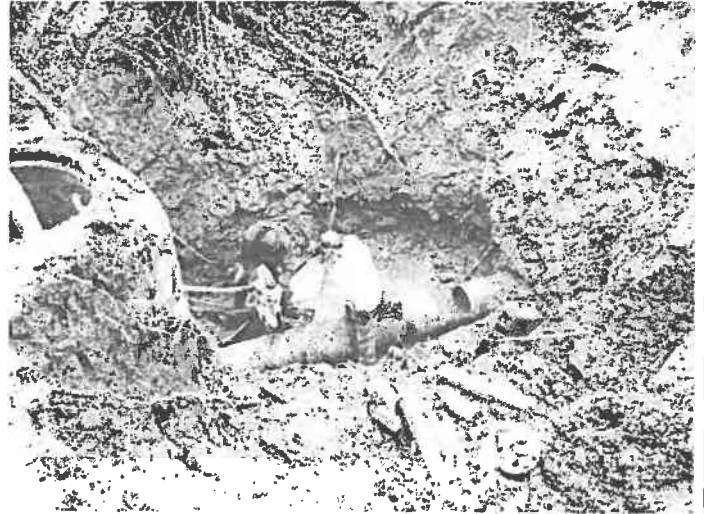
**18. The excavation of the 16 inch force main and the contractor cutting the pipe.**

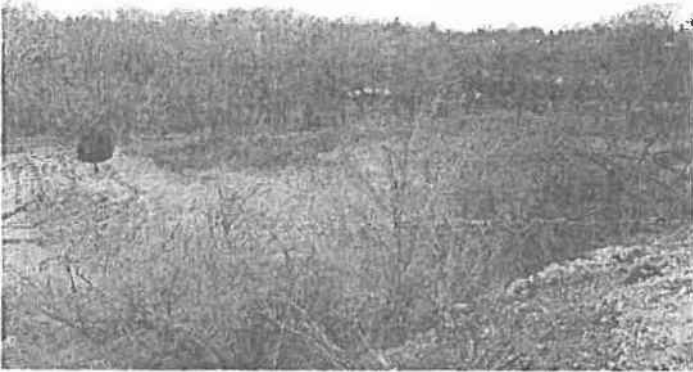
**19. The field below the Penn DOT building and the path the sewer line bypass would have needed to take to discharge to the Municipality of Norristown's manholes near Chain Street and Johnson Highway.**

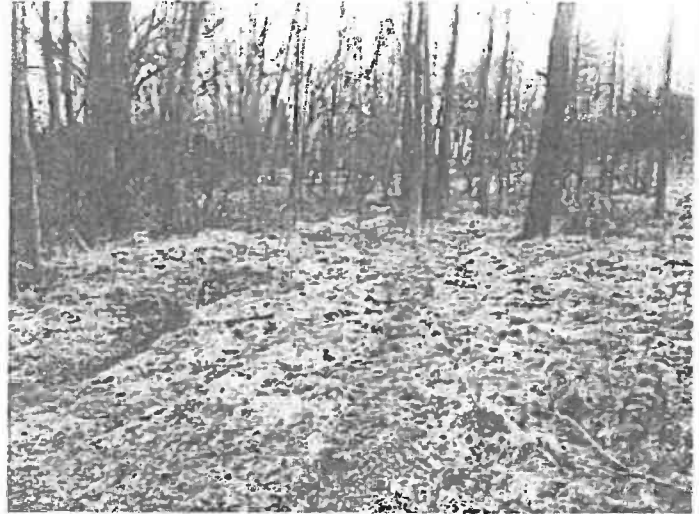
**2. The erosion channel from the portable pumps used to pump sewage and water out of the hole dug for the 16 inch Force Main, 02/26/16.**

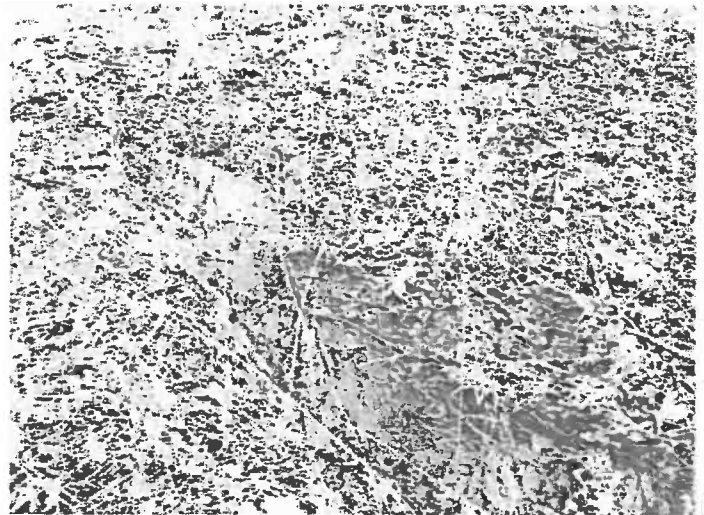
**4. The erosion channel and some remaining sewage from the Xylem 8 in. Portable Pumps, 02/26/16.**

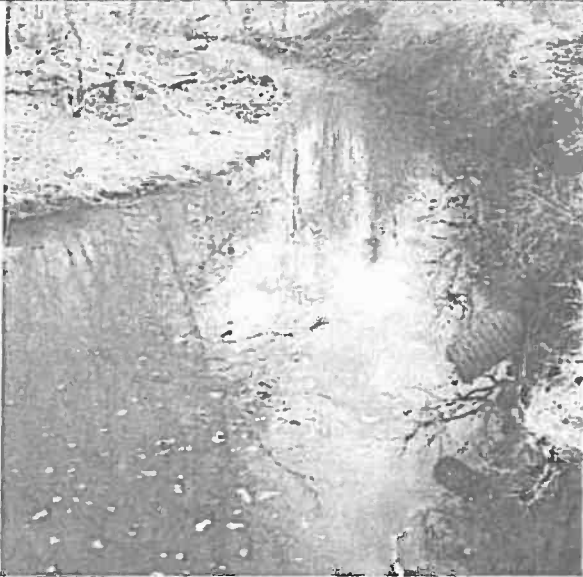
**5. Turbid water in a pool approximately 200 yards downstream from the Xylem pumps erosion channel, 02/26/16.**

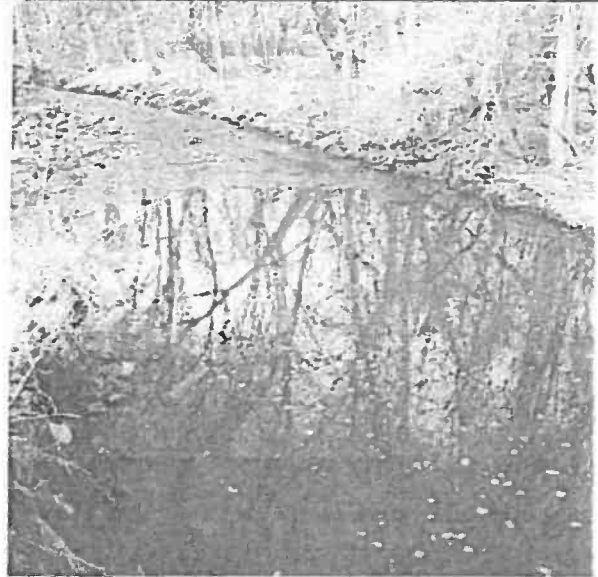
**6. Turbid and green colored water in a slow moving pool upstream from a riffle.**

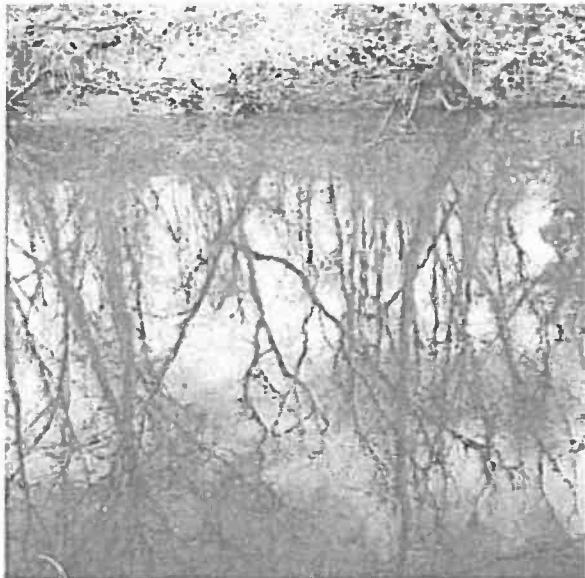
**7. Turbid green water in another slow moving area making Stoney Creek's bottom impossible to see.**

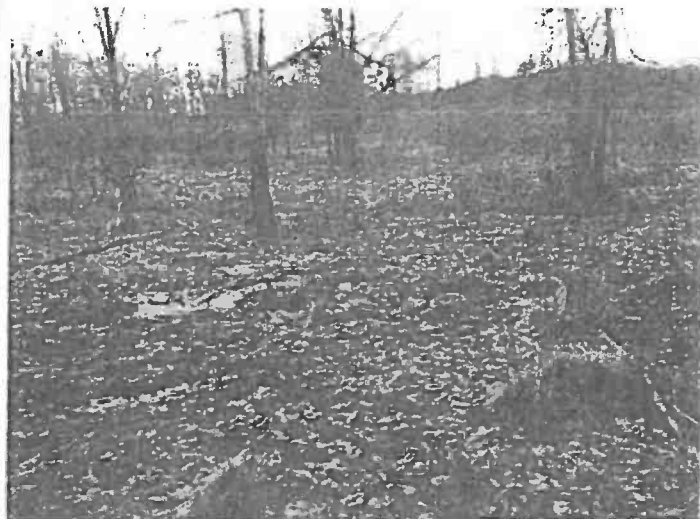
**9. Sewage and wet ground on Stoney Creek's flood plain located behind the Norris City Ave PS.**

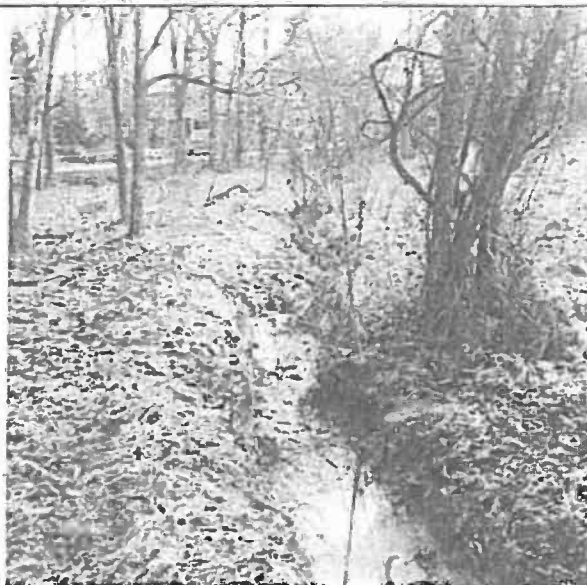
**10. The large erosion channel from the portable pumps used to dewater the excavation, 02/26/16.**

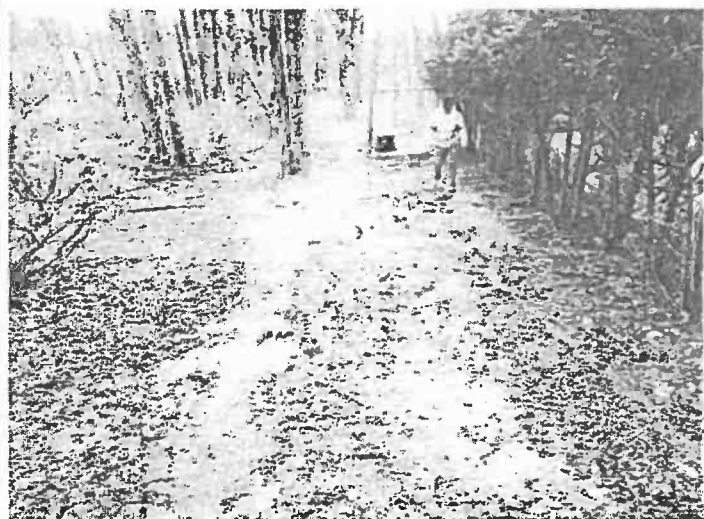
**11. Lime put down on the ground near the Xylem portable pump used to pump out of the last manhole on the Stoney Creek No. 2 Interceptor.**

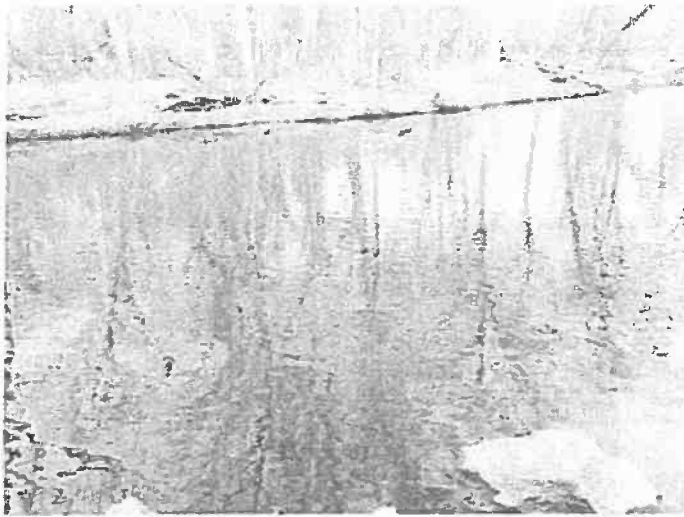
**13. Stoney Creek upstream of the Elmwood Zoo with very green and turbid water obscuring visibility of the creek substrate, 02/26/16.**

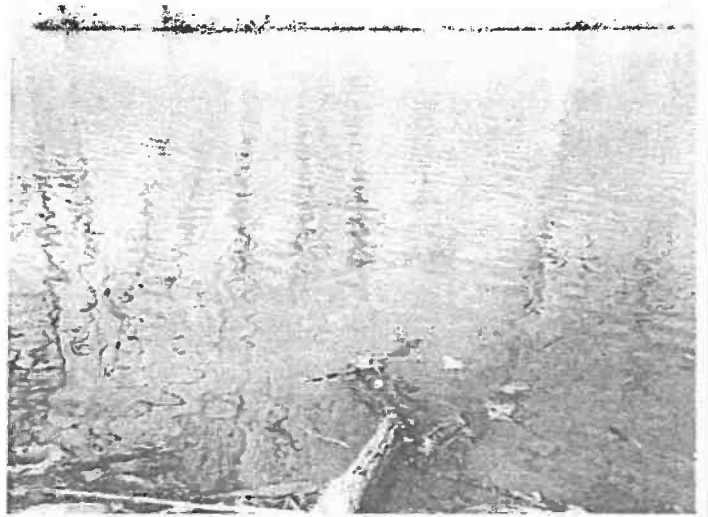
**14. Stoney Creek filled with turbid water approximately 100 yards upstream from the Elmwood Zoo parking lot.**

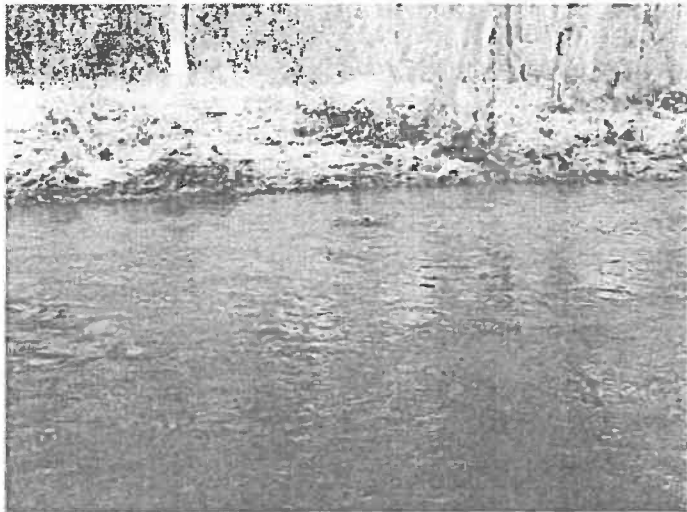
**15. A fast moving area adjacent to the Elmwood Zoo with green turbid water, 02/26/16**

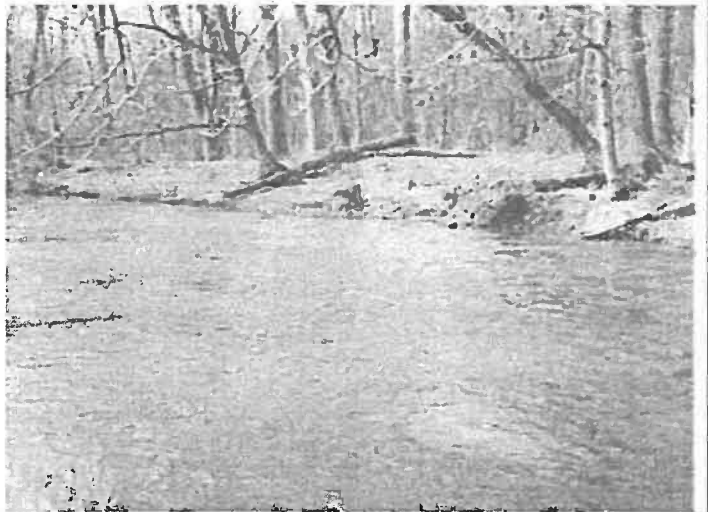
**16. More green turbid water in Stoney Creek downstream from the Elmwood Zoo, 02/26/16.**

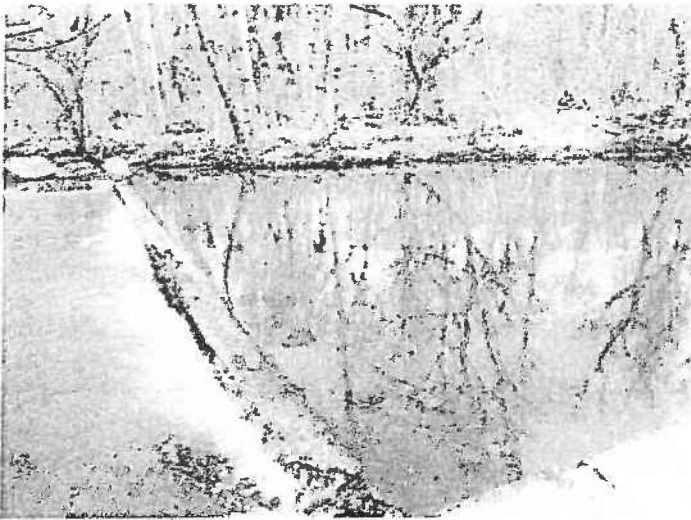
**17. Cloudy Green water upstream and downstream of the Norristown Dam approximately 300 yards downstream of the Elmwood Zoo, 02/26/16.**

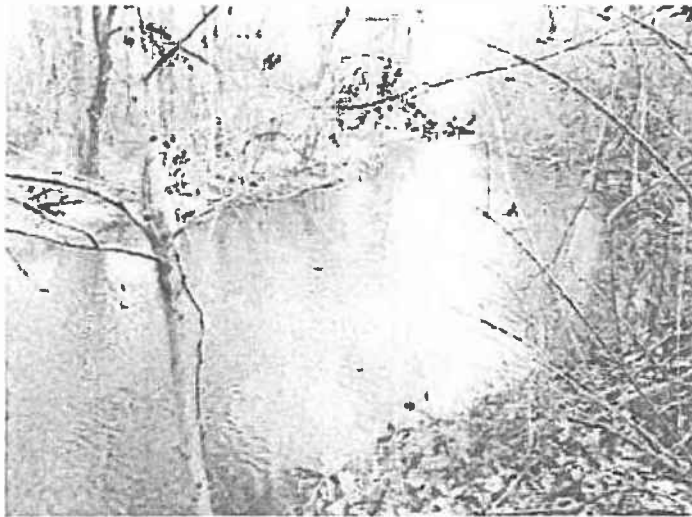
**19. Stoney Creek filled with green turbid water from a location approximately 200-300 yards downstream of the Elmwood Zoo.**

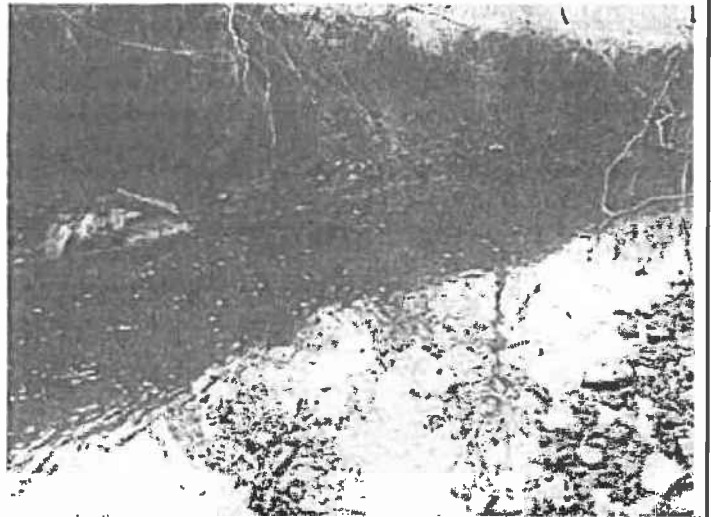
**20. A slow moving pool approximately 300 yards downstream from Norris City Avenue from the opposite bank with very green turbid water.**

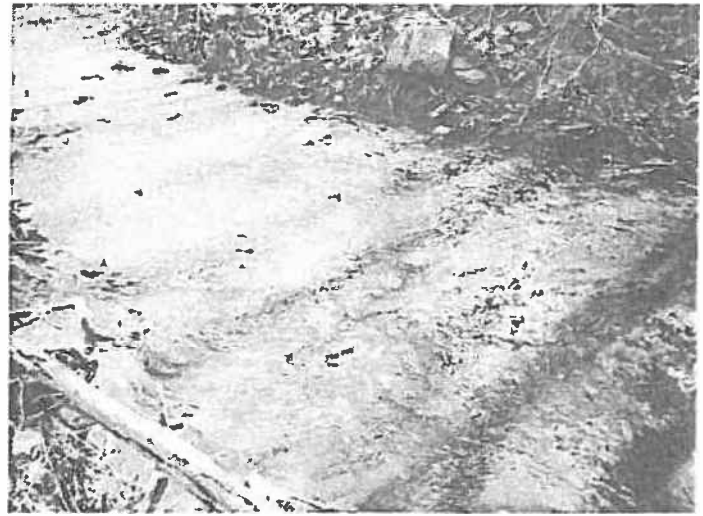
**22. A fast moving riffle on Stoney Creek approximately 50-100 yards downstream of the Norris City Avenue PS but filled with green water that obscures the bottom in pooled areas.**
