RE: Armstrong County NBIS Bridge Inspection Report
 South Buffalo Township Bridge #3

STRUCTURE B.M.S. NUMBER: 03 7223 0881 0003 (NORTH CLINTON Bridge)
BRIDGE NAME: T-881 Clinton Road over Buffalo and Pittsburgh Railroad
LOCATION: South Buffalo Township
Armstrong County
INSPECTION DATE: April 27, 2011
INSPECTION BY: Senate Engineering Company
Nathan Guntrum, C.B.I.
Mathew Pitsch, E.I.T.
PREPARED FOR: Armstrong County
Via
Pennsylvania Department
of Transportation District 10-0
PREPARED BY: Senate Engineering Company
Written by: N. Guntrum, CBI
Reviewed by: W.F.Braun, P.E.
Phone no. (412) 826-5454
OWNER OF BRIDGE: BUFFALO AND PITTSBURGH RAILROAD/SOUTH BUFFALO
TOWNSHIP
BRIDGE POSTING: 10 TONS

SOUTH BUFFALO TOWNSHIP BRIDGE #3 OVER BUFFALO AND
PITTSBURGH RAILROAD NORTH CLINTON

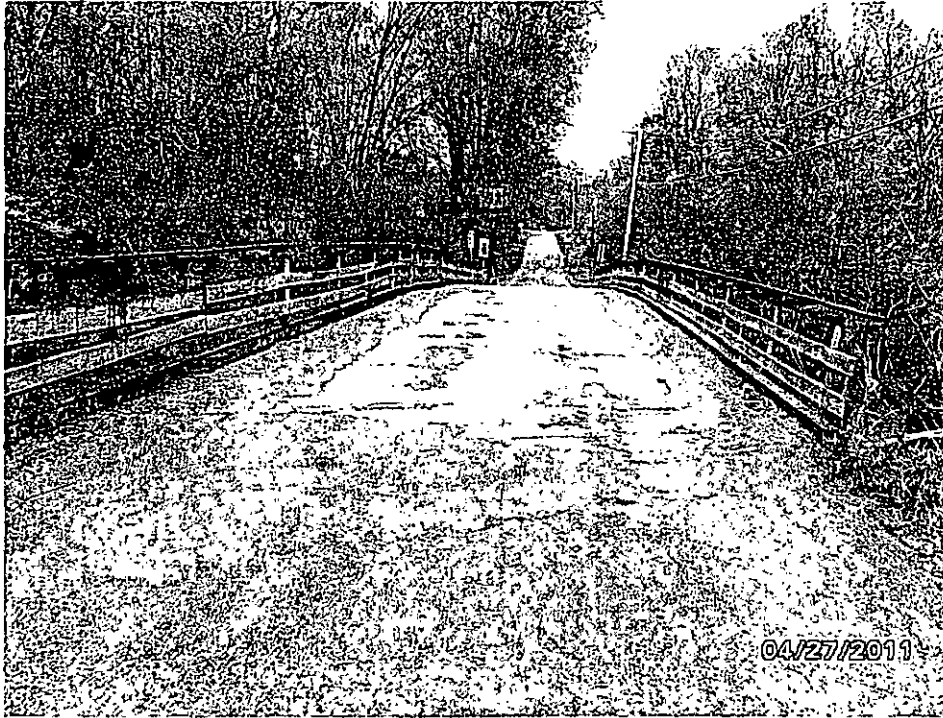
The bituminous approach roadway has medium tire abrasion and wheel rutting, randomly with random longitudinal and transverse cracking. The near and far approaches are sunken slightly at the abutments. There is a large bituminous cold patch area at the near abutment right and center. The deck consists of a 3" thick bituminous overlay on top of a 2 x 4 laminated timber deck. There are medium sized bumps above the piers, several areas of heavy transverse and map cracking (w/potholes starting.) There are random longitudinal cracks, a 2' diameter cold patch area @ midspan #3 right side. There is moderate to heavy water leakage and staining with random splitting and cracking.

PHOTO 1 NEAR APPROACH/TYPICAL WEARING SURFACE

REPAIR BIT. WEARING SURFACE

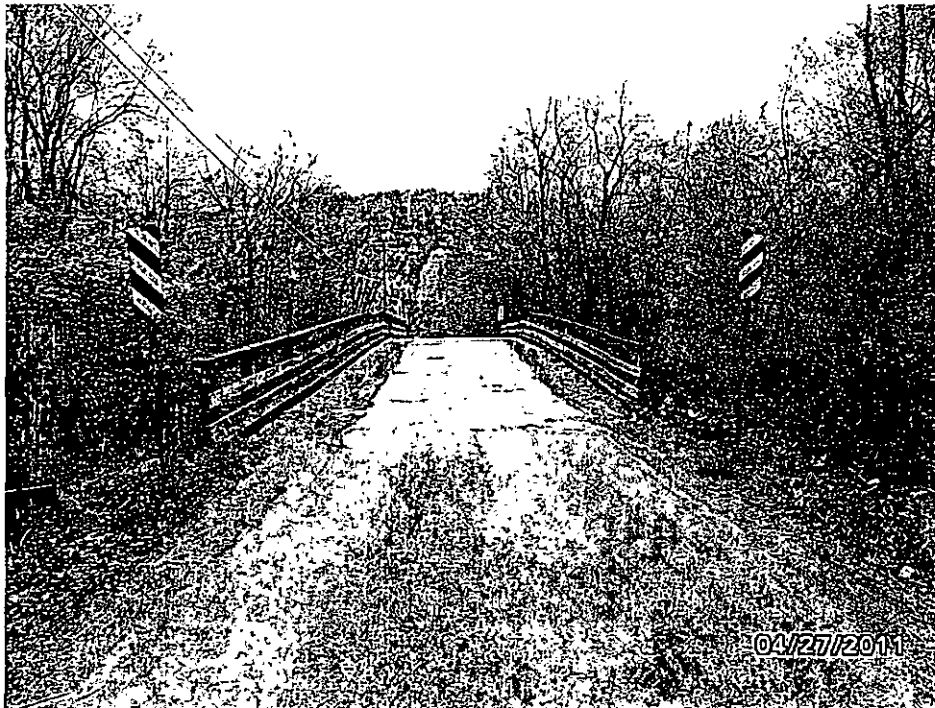
PHOTO 2 FAR APPROACH

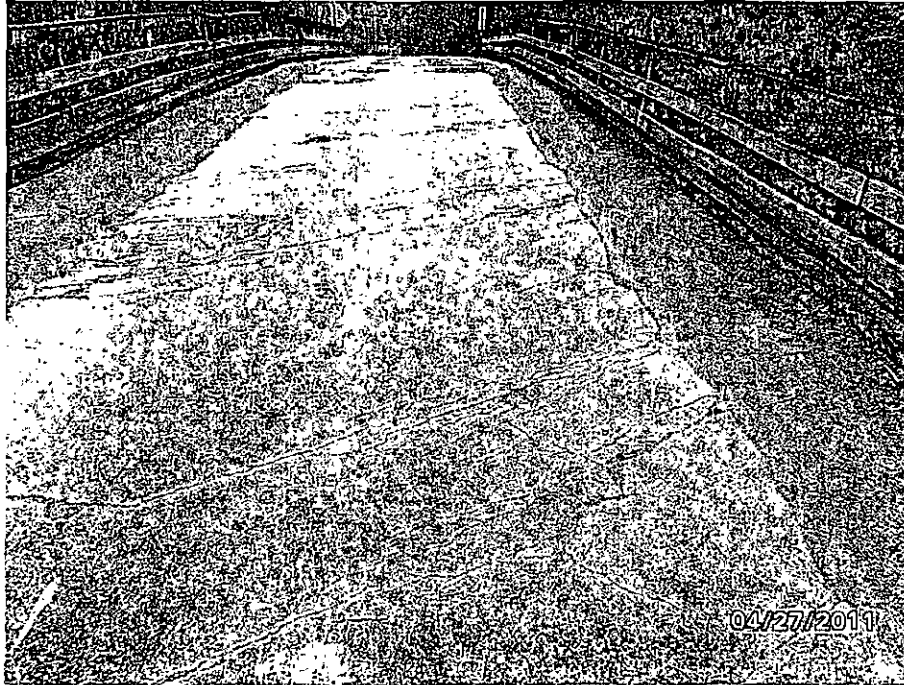
PHOTO 3 TYPICAL WEARING SURFACE LOOKING TOWARDS NEAR

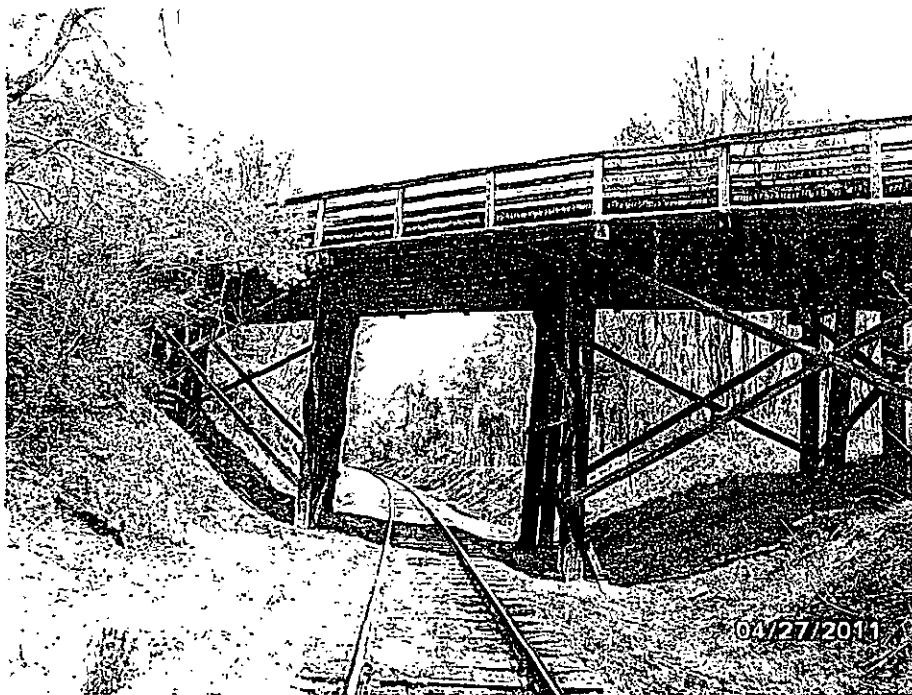
PHOTO 4 LEFT ELEVATION

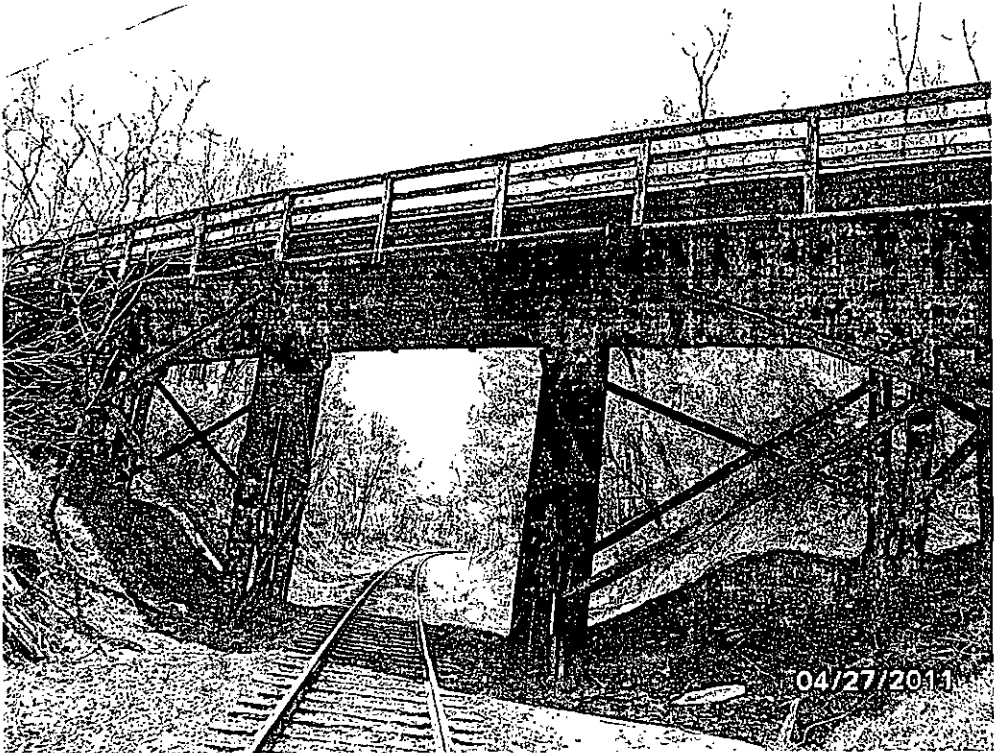
PHOTO 5 RIGHT ELEVATION

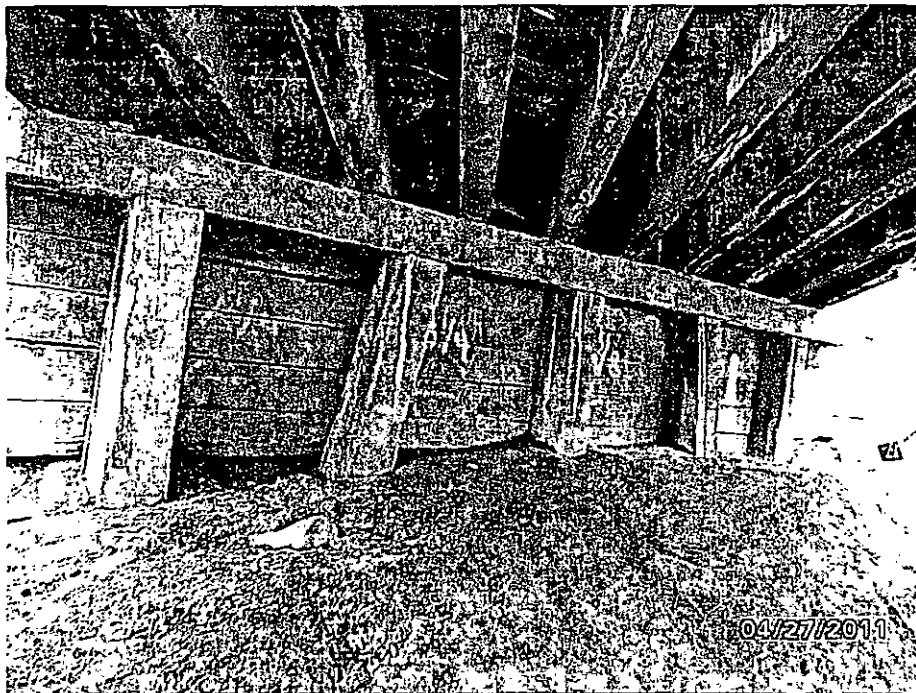
The near timber abutment back wall has random splitting and cracking with deterioration and decay with the top 2 timbers on the right side are loose. The far timber abutment back wall has random splitting and cracking with deterioration and decay with the top 2 timbers on the left side are loose.

PHOTO 8 NEAR ABUTMENT

Backwall: TIMBER = RANDOM SPLITTING & CRACKING W/ DETERIORATION & DECAY, TOP (2) TIMBERS IN BACK WALL ARE LOOSE @ TOP RT SIDE

REPAIR ABUTMENT/BACKWALL

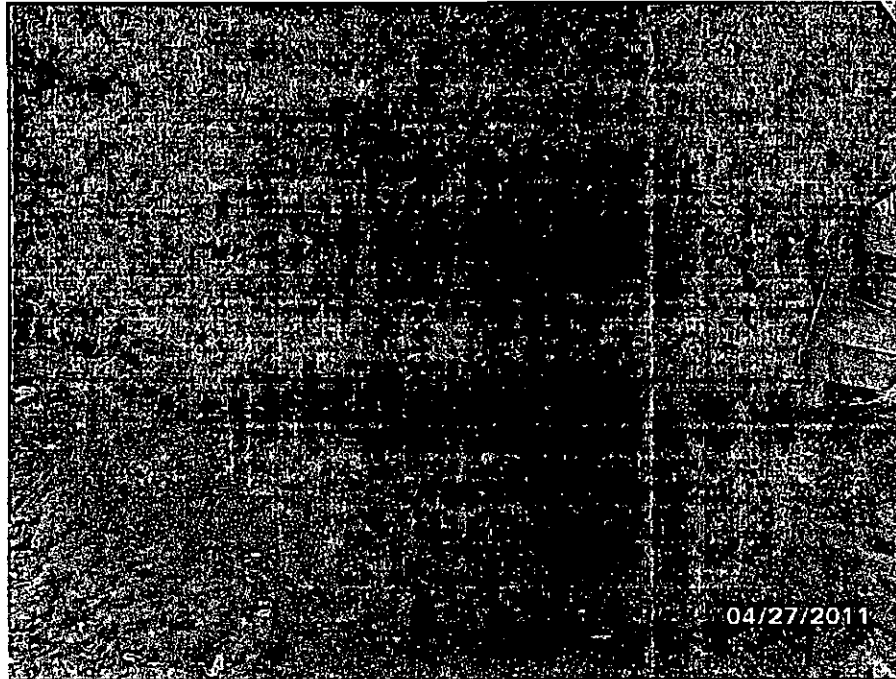
PHOTO 9 FAR ABUTMENT

Backwall: TIMBER = BEAMS FROM SUPER STR. ARE PUSHING DIRECTLY BACK ON THE BACK WALL, TOP (2) TIMBERS IN BACK WALL ARE LOOSE @ TOP LT SIDE, RANDOM SPLITTING & CRACKING W/ DETERIORATION & DECAY,

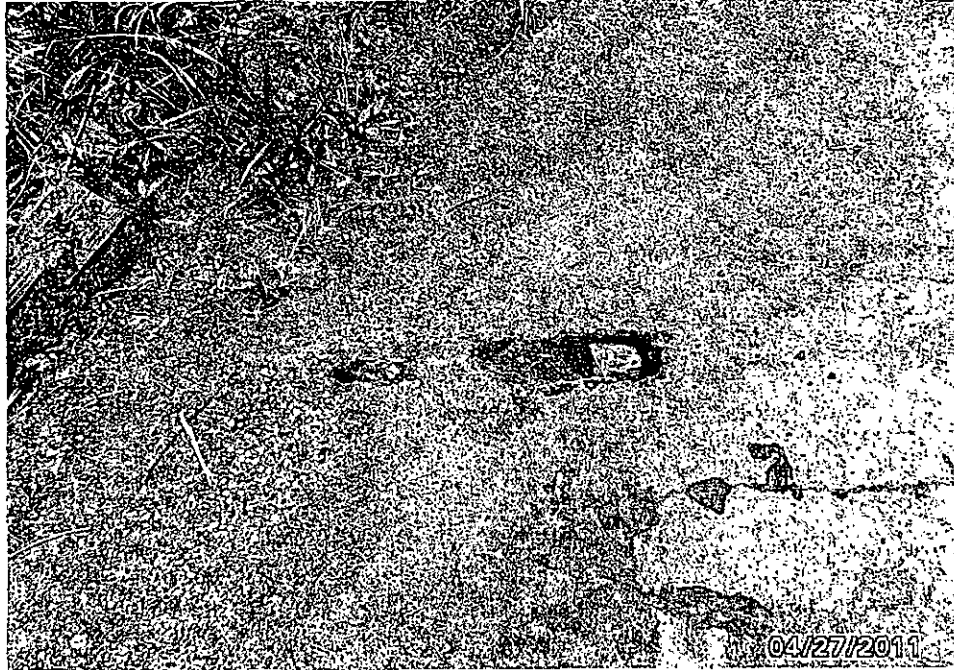
PHOTO 11 HOLE AT NEAR RIGHT

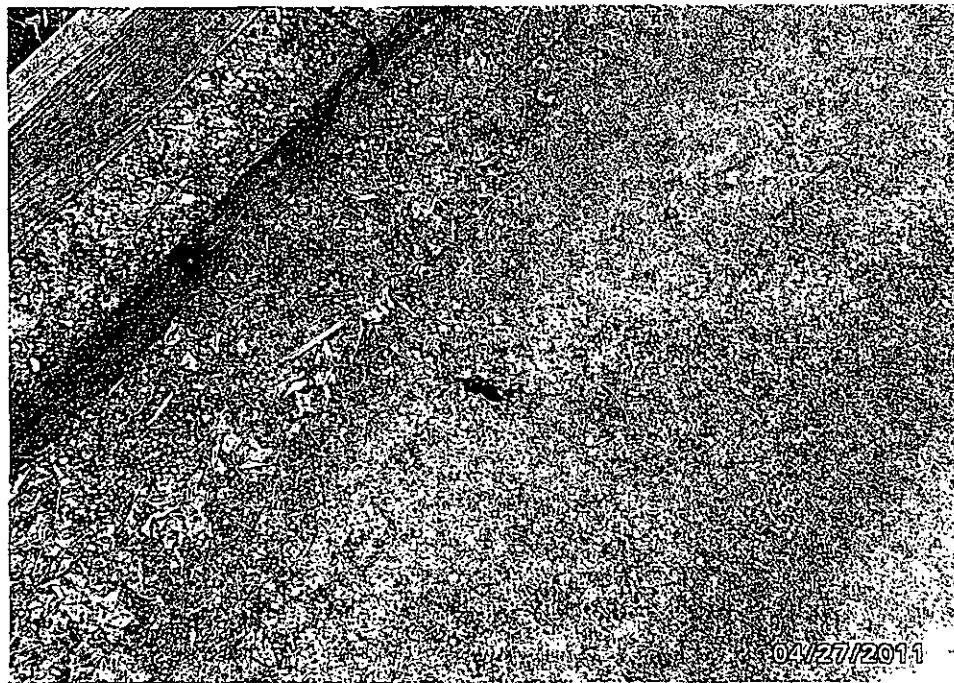
PHOTO 12 HOLE IN FAR RIGHT WEARING SURFACE
