PENNSYLVANIA PUBLIC UTILITY COMMISSION

STAFF'S STATEMENT #1

Crossing #1
AAR No. 518 184M
L.R. 36009
Noble Road
Sadsbury Township
Below Grade
Mile Post 4.03

TESTIMONY OF DAVID A. OLIVER

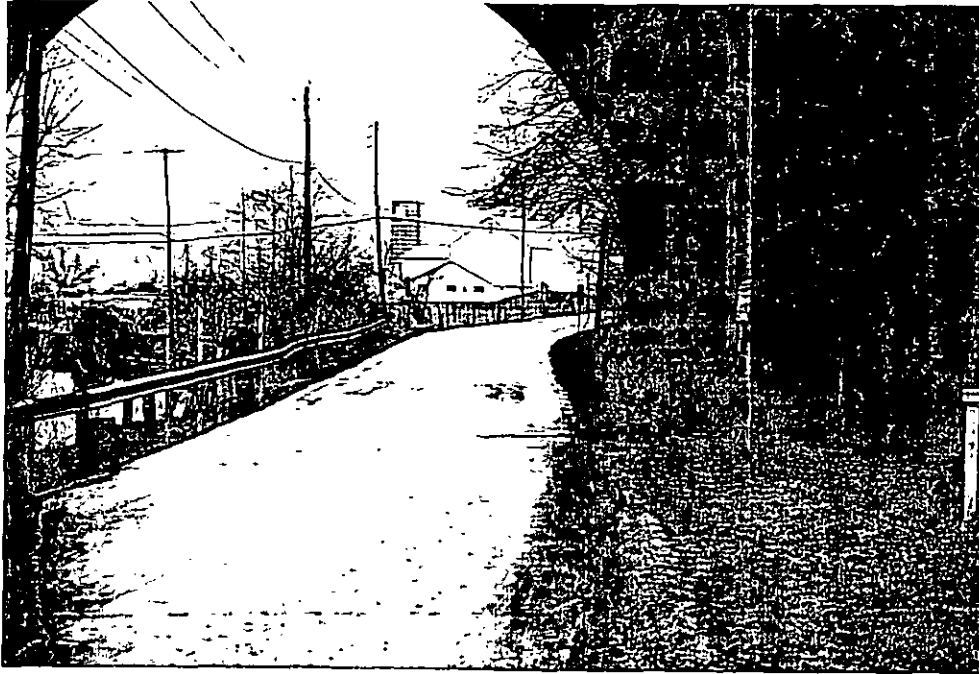
PUC STAFF EXHIBIT #1

3 A: Exhibit No. 1 is the northerly approach roadway looking
4 south. Note the close proximity of the structure to the
5 roadway on the right. This also shows the lack of sight
6 distance for vehicles going south. The creek is on the left
7 of the picture. Exhibit No. 2 is the southerly approach
8 roadway looking north. This shows the descending curve
9 which vehicles proceeding north must negotiate. Exhibit No.
10 3 is a general view of the bridge looking south.

2 A: According to current Department of Transportation design
3 criteria, the roadway at Crossing No. 1 has substandard
4 pavement width, shoulder width, and passing sight distance.
5 In addition, the proximity of the structure to the roadway
6 creates a roadside hazard which vehicles traveling south can
7 hit.

11 A: Remove the structure and grade back the embankment to a 2:1
12 slope.

13 A: Install protective fencing atop the bridge parapets and
14 install guide rail at the approaches to the westerly
15 abutment.

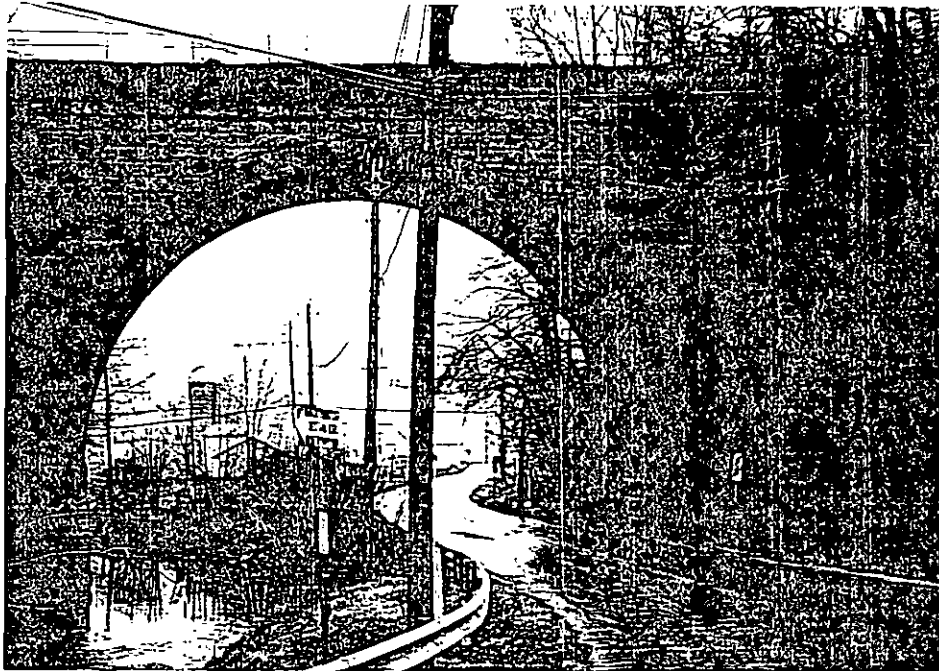
PUC STAFF EXHIBIT #3

14 A: The structure at Crossing No. 1 is a stone arch bridge which
15 is in fair condition.

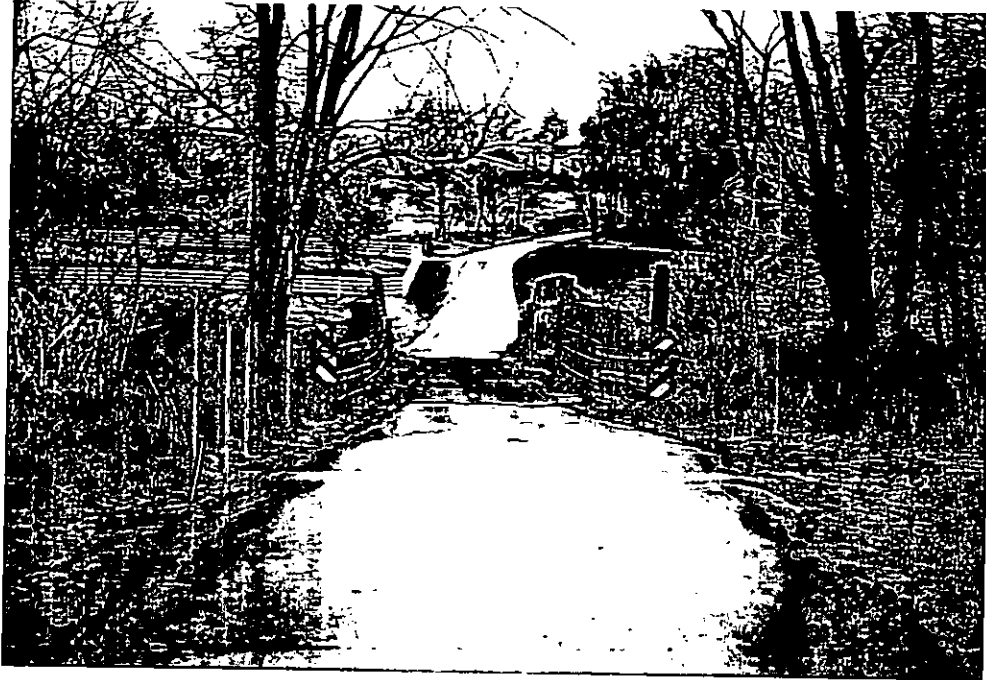
PUC STAFF EXHIBIT #4

7 A: Exhibit No. 4 is the southerly approach to the bridge
8 looking north. Note that the bridge is one lane only.
9 Exhibit No. 5 is the northerly approach to the bridge
10 looking south. The sign to the right of the bridge
11 indicates a ten ton weight limit.

2 A: According to current Department of Transportation design
3 criteria, the bridge has substandard pavement width, and
4 shoulder width. In addition, there is no speed limit posted
5 and vehicular traffic is limited to a maximum allowable load
6 of ten tons.

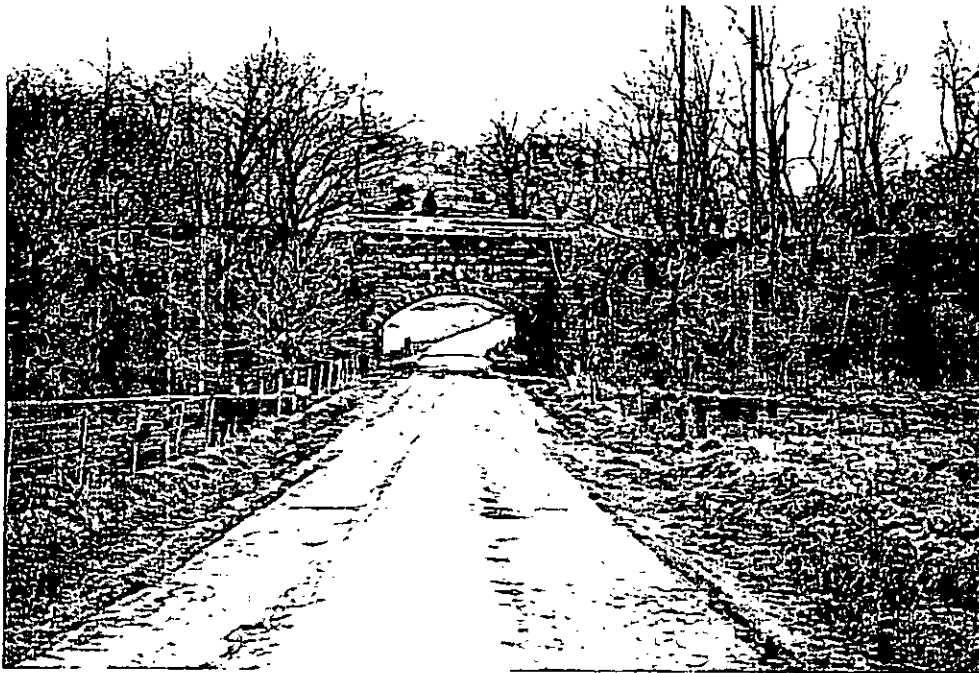
PUC STAFF EXHIBIT #12

1 Q: Is the photograph marked as PUC Staff Exhibit 12 a fair and
2 accurate depiction of Crossing No. 6?
3 A: Yes.
4
5 Q: Please describe what is depicted in PUC Staff Exhibit 12.
6 A: Exhibit No. 12 shows the southerly approach roadway looking
7 north. Note the low vertical clearance.
8
9 Q: Please describe the type of structure at Crossing No. 6 and
10 describe its condition.
11 A: The structure at Crossing No. 6 is a stone arch in fair
12 condition.
13
14 Q: Are there any conditions at this crossing which are unsafe
15 or substandard?
16 A: Yes.
17
18 Q: What are they?
19 A: According to Department of Transportation design criteria,
20 the pavement width and vertical clearance are substandard.
21
22 Q: What work do you believe should be performed at Crossing No.
23 6 in order to promote safety and prevent accidents?
24 A: Remove the structure and grade back the embankment to a 2:1
25 slope.
26

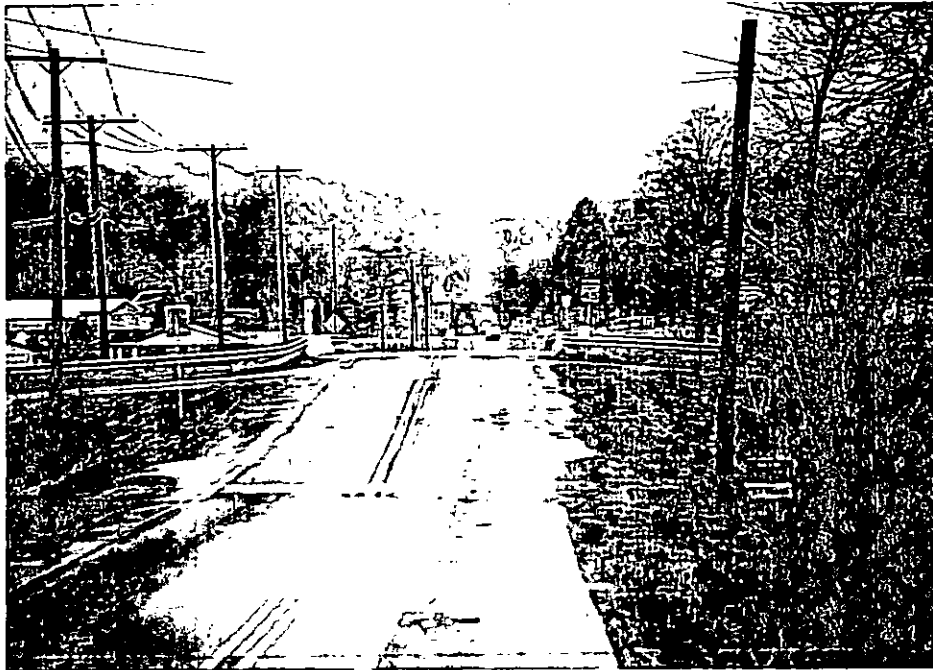
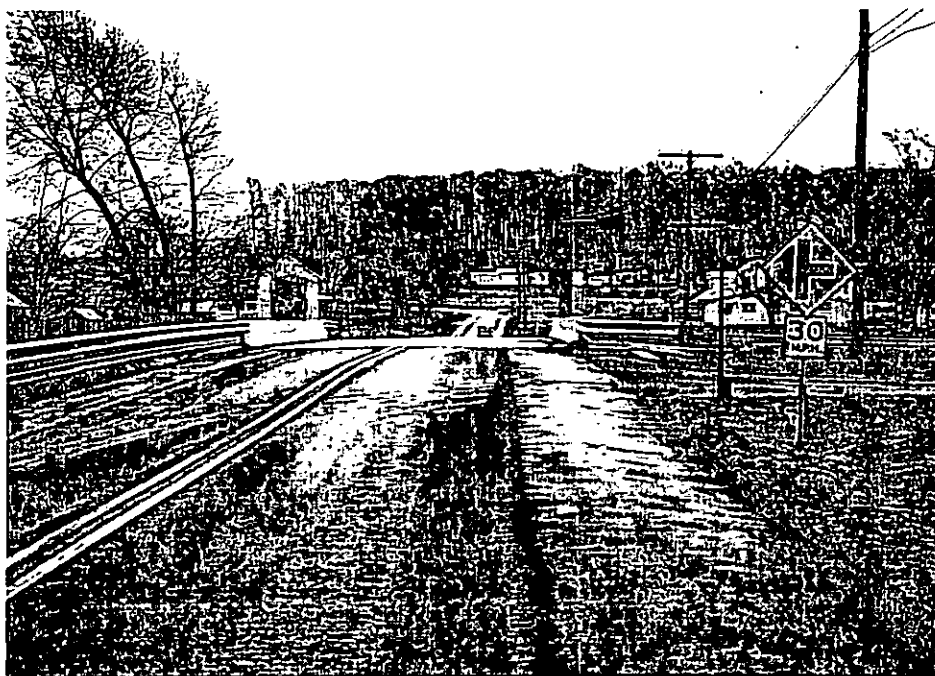
1 Q: Are the photographs marked as PUC Staff Exhibits 13 and 14 a
2 fair and accurate depiction of Crossing No. 7?
3 A: Yes.
4
5 Q: Please describe what is depicted in PUC Staff Exhibits 13
6 and 14.
7 A: Exhibit No. 13 is the southerly approach roadway looking
8 north. Exhibit No. 14 is the northerly approach roadway
9 looking south.
10
11 Q: Please describe the type of structure at Crossing No. 7 and
12 describe its condition.
13 A: The structure at Crossing No. 7 is a prestressed box beam
14 supported by masonry abutments.
15
16 Q: Are there any conditions at this crossing which are unsafe
17 or substandard?
18 A: No.
19
20 Q: Are you aware of any Commission orders which assign
21 maintenance responsibilities for this structure?
22 A: Yes. There is a Commission order entered June 21, 1990, at
23 Docket No. A-00105671 which directs the Department of
24 Transportation to maintain the bridge and directs Conrail to

3 A: The bridge constructed in approximately 1985 generally is in
4 good condition and meets current roadway construction
5 criteria. The bridge should remain in place. Future
6 disposition should be determined at a time when it is no
7 longer economically practical to repair the structure.

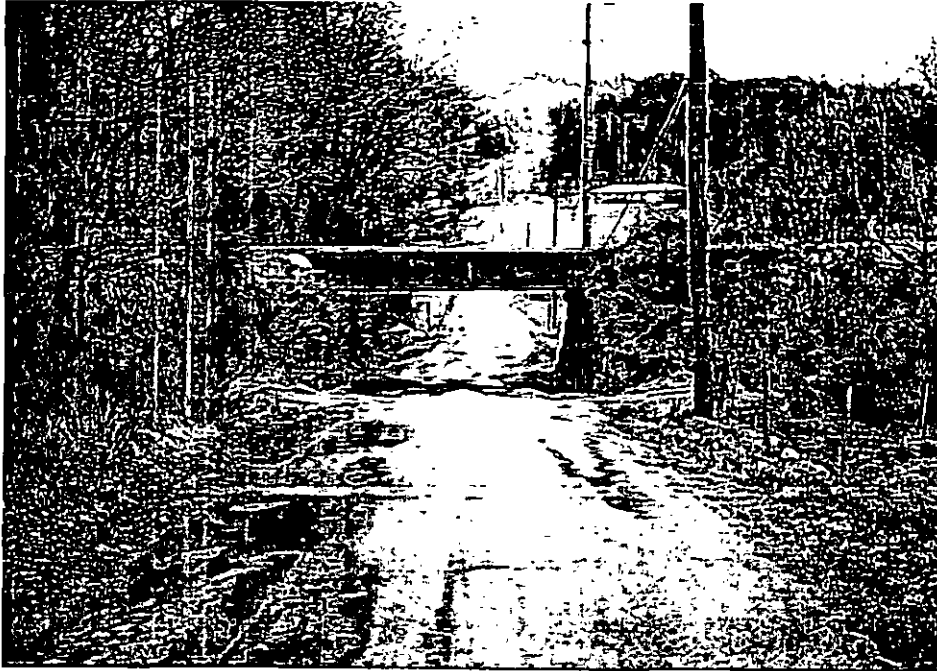
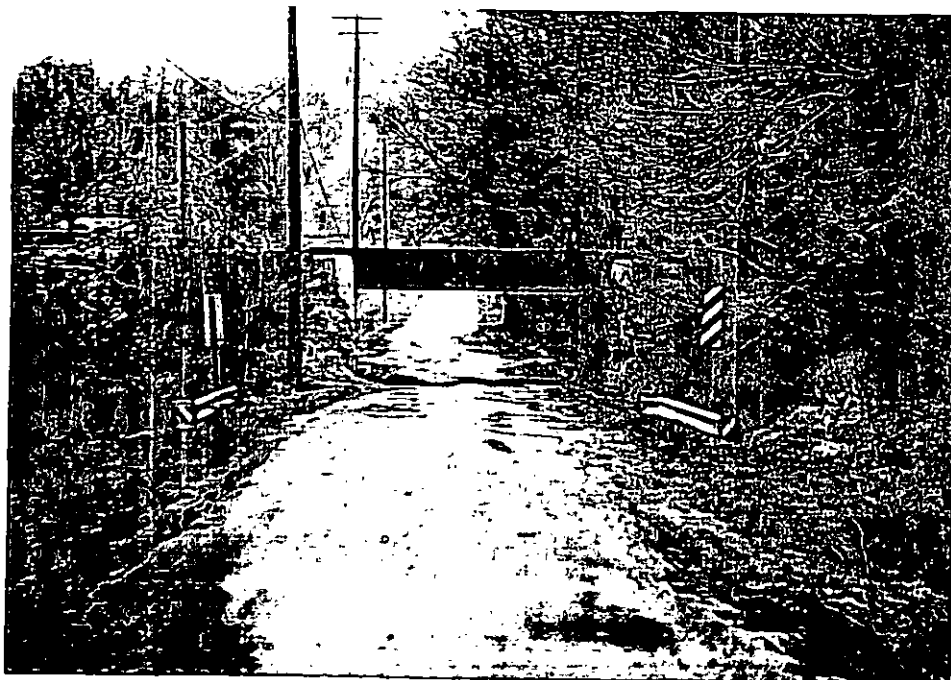
17 A: The structure is a single span half-through steel girder
18 bridge in fair condition.

2 A: According to Department of Transportation design criteria,
3 the pavement width, shoulder width and vertical clearance
4 are substandard. I observed that the bottom flanges on one
5 of the girders was bent back. This probably is a result of
6 a vehicle hitting the underside of the bridge.

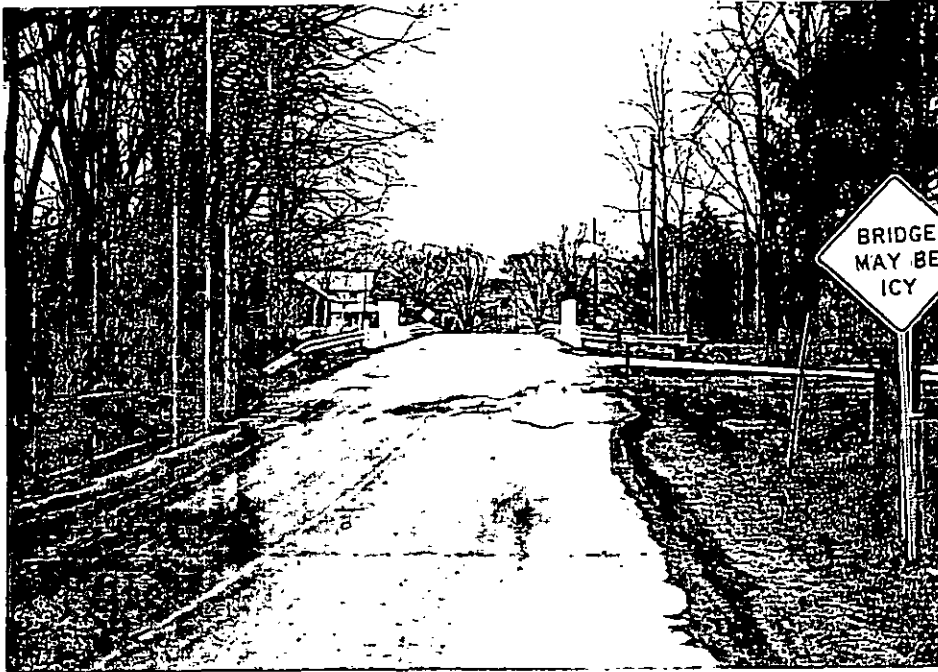
PUC STAFF EXHIBIT #31

1 Q: Please describe what is depicted in PUC Staff Exhibit 31.
2 A: Exhibit No. 31 is the southerly approach roadway looking
3 north.
4
5 Q: Please describe the type of structure at Crossing No. 18 and
6 describe its condition.
7 A: The structure at Crossing No. 18 is a prestressed concrete
8 box beam bridge.
9
10 Q: Are there any conditions at this crossing which are unsafe
11 or substandard?
12 A: No.
13
14 Q: Are you aware of any Commission orders which assign
15 maintenance responsibilities for this structure?
16 A: Yes. There is a Commission Order entered September 8, 1988,
17 at Docket No. A-00104797 which directs the Department of
18 Transportation to maintain the bridge and directs Conrail to
19 reimburse the Department for fifty percent of its
20 maintenance costs.
21
22

3 A: The bridge constructed in the 1980's is generally in good
4 condition and meets current roadway construction criteria.
5 The bridge should remain in place. Future disposition
6 should be determined at a time when it is no longer
7 economically practical to repair the structure.
