CONSULTANT
REPORT ON *PRO*
6/7/01
STABILITY OF THE *A-00116257*
EAST BRADY TUNNEL *6-00981552*
OJL

Consolidated Rail Corporation Shared Assets
1000 Howard Boulevard, Suite 450
Mt. Laurel, NJ 08054

Gordon M. Elliott, Ph.D., P.E.
Wexford Consulting Group, Inc.

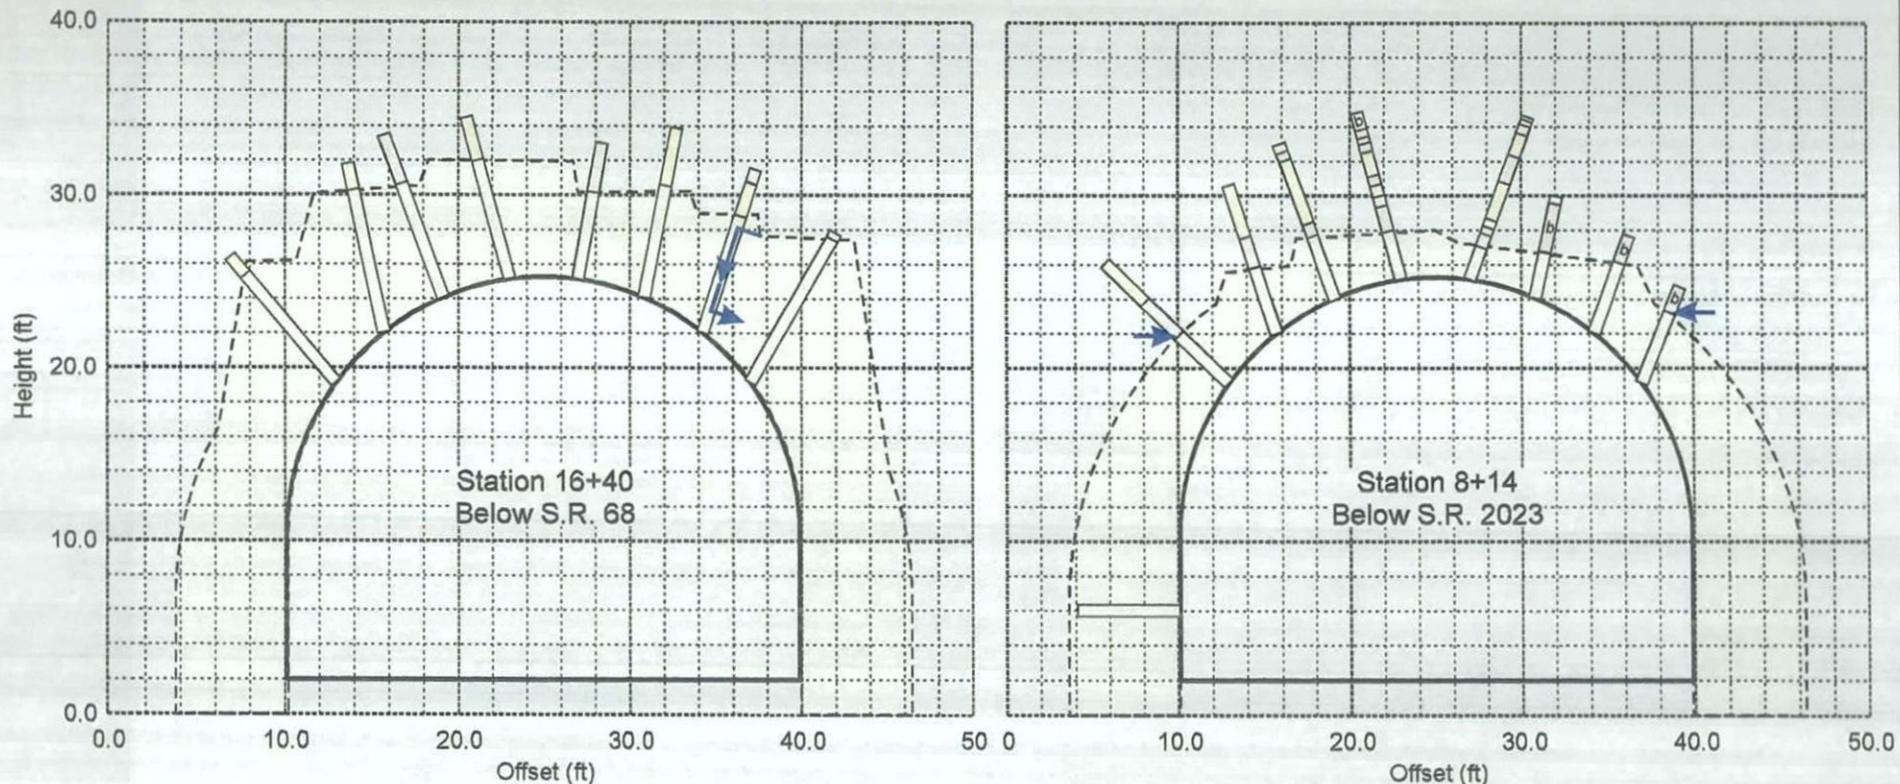
Figure 6
Interpretation of Probe Hole Surveys
East Brady Tunnel, PA

In each of the holes we initially encountered a surprisingly significant thickness of sound concrete immediately behind the brick layer that is observed in the arch. The thickness of the concrete is generally 2.75-ft or more in the crown, 4-ft or more in the lower regions of the arch, and at least 6-ft thick at a point approximately 4-ft above the invert. We found that the brickwork in the arch is only a veneer, being only one course thick.

Outside of the concrete lining, we encountered what appeared to be unweathered sandstone beds and variably weathered shale or claystone beds. At Station 16+40 (measured from the south portal) beneath SR68, we found a considerable thickness of concrete (between 5-ft and 9.5-ft) which limited our observation beyond the liner. Generally no void was observed between the concrete and the excavation, and the rock was found to be either a hard, grainy material

interpreted to be unweathered sandstone, or a softer weathered shale or claystone. At Station 8+14, beneath SR 2023, we observed what appeared to be bedding separation, and debris immediately outside the lining, particularly on the right side. At both locations, the variability of materials encountered, and the relatively small thickness of beds of different rock types suggests that the material in the arch of the tunnel is the Quakertown bed between the Upper and Lower Connequenessing Sandstone beds. A study of the photographs of the surface exposures of these materials in the rock face at the south portal (Figure 5.) supports this interpretation.

In general holes were dry to damp, and free water was only observed in three holes. At station 8+14, beneath SR2023, strong flows discharged from the lowest holes on either side of the tunnel immediately the holes broke through the concrete. This flow dissipated to a small run over a period of 5 to 10 minutes, and to a steady drip after 24-hours. No other free water was observed in the remaining holes at this station, despite penetrating what appeared to be bedding separations and other voids. At station 16+40, beneath SR68, water was only encountered in one hole, and here it entered the hole before the hole broke through the concrete, and disappeared back into the concrete before it was able to discharge into the tunnel. Nevertheless, it appears that the hydrostatic loading on the lining is generally low in magnitude, and localized.

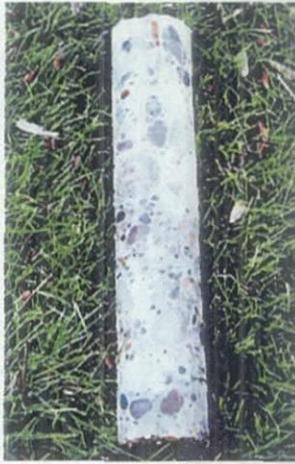
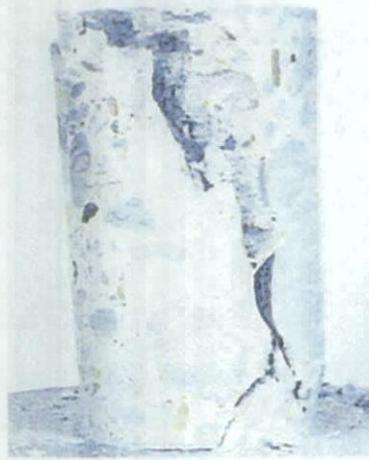
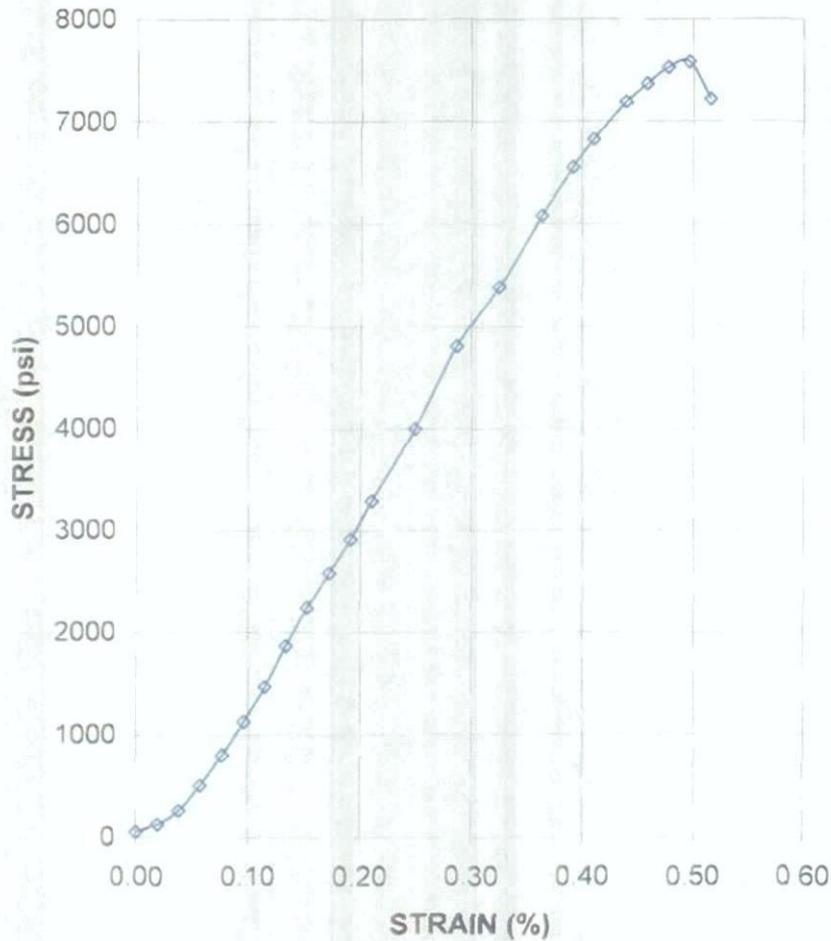
Figure 7
Unconfined Compressive Strength Test
Results for Concrete Core from Sta. 8+14
East Brady Tunnel, PA

The results of an unconfined compressive strength test (see Figure 7) on a 3-in diameter core recovered from the wall at Station 8+14, yielded an uncorrected failure stress of 7,582 psi, which is approximately twice the strength of concrete used in construction applications today. This would suggest that the quality of the concrete in the arch is excellent.

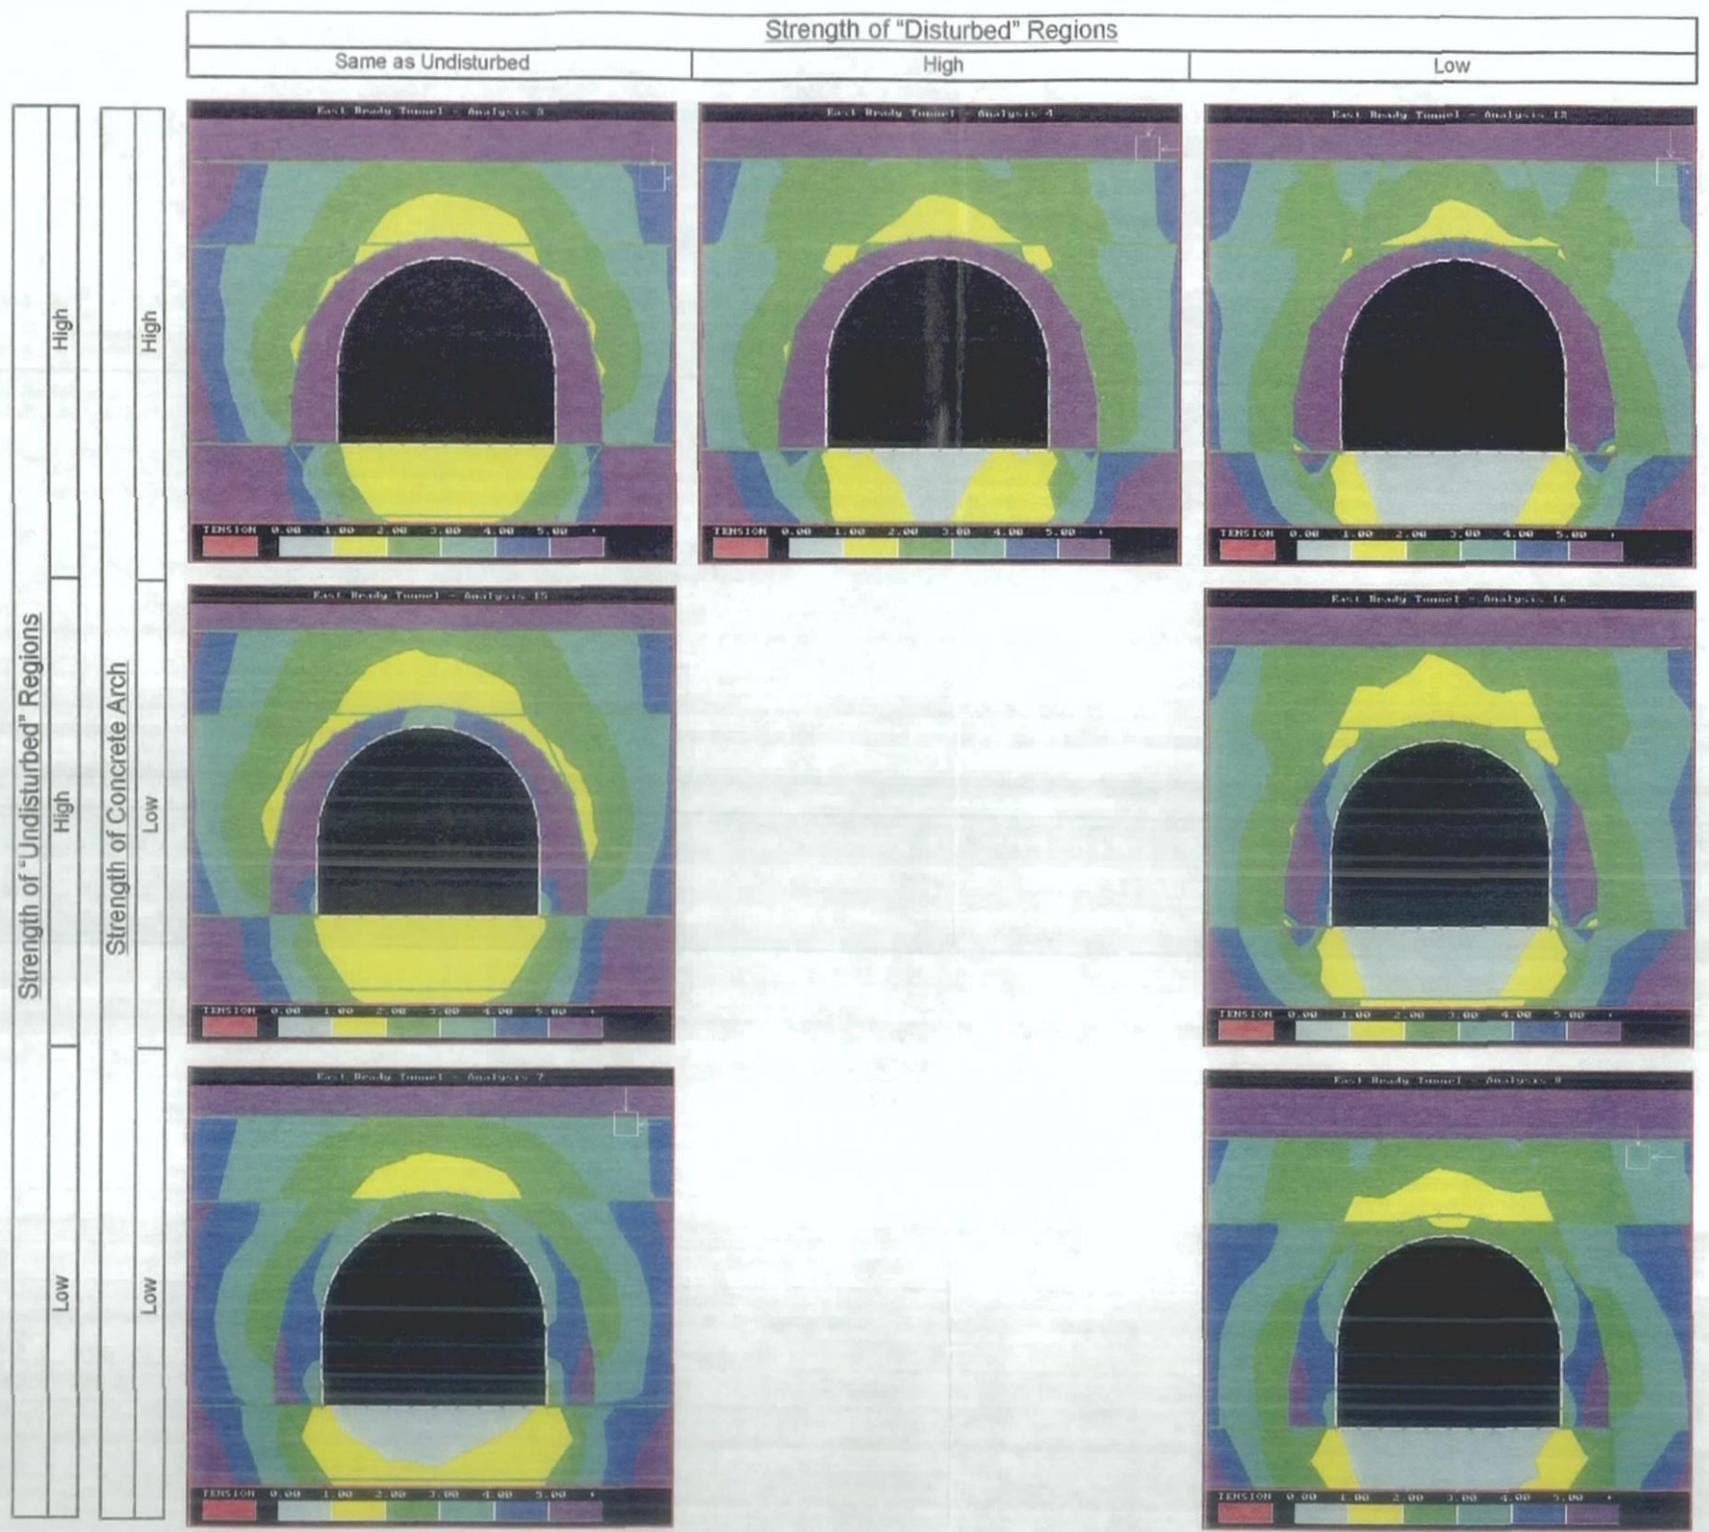
Figure 10
Strength Factors for Integral Arch Model
East Brady Tunnel, PA

The strength factor diagram and the displacement diagram for the integral model incorporating the concrete arch are presented in Figures 10 and 11 respectively. These results clearly show that when the lining is present the displacements in the rock mass are considerably lower and the bulb of highly stressed rock (low strength:stress ratio) above the crown is smaller than had the arch not been present. Furthermore, the results show that the factor of safety in the strength of the arch materials is high even under "low" strength assumptions. This suggests that the arch is experiencing loads that are well within its operating capacity, and that the strength would have to decrease appreciably to precipitate a failure of the lining.

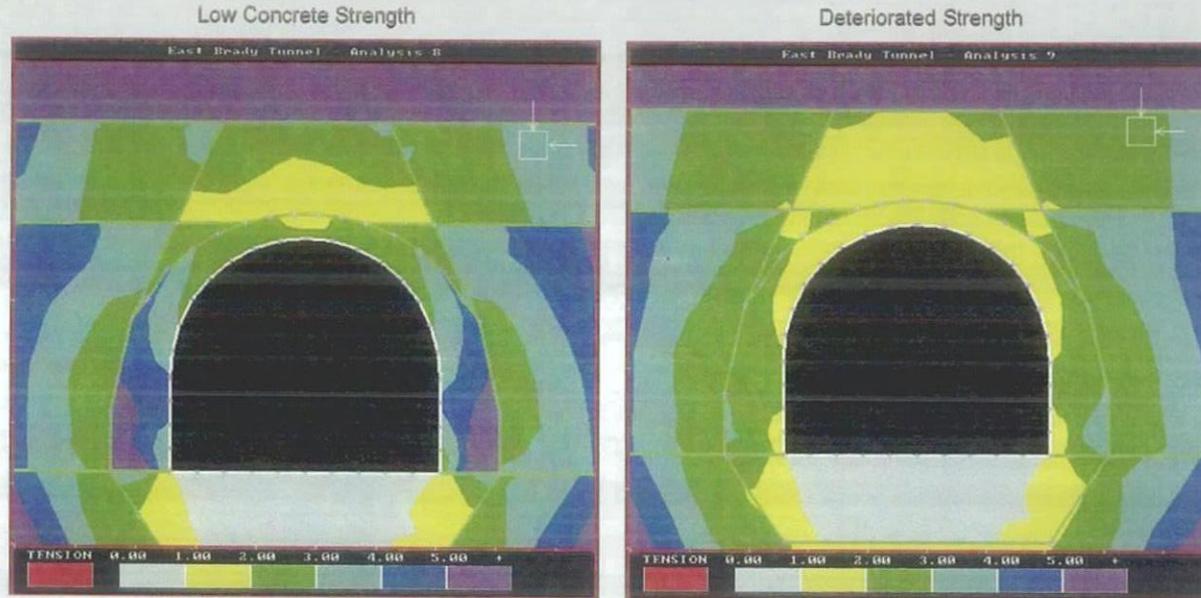
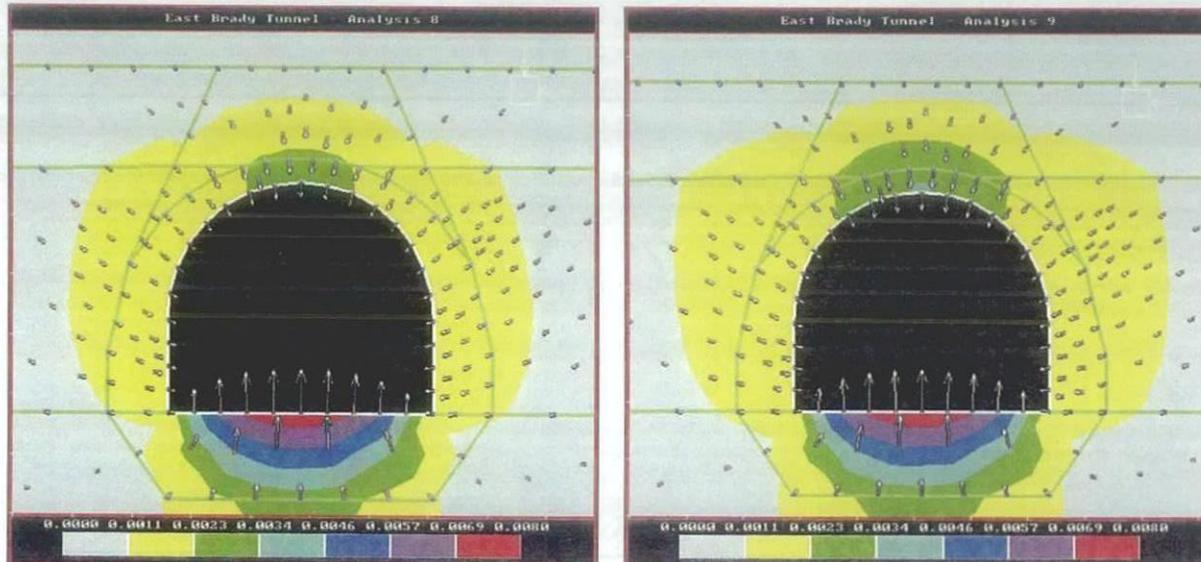
Figure 12
Comparison of Liner Stability
under Deteriorated Strength
East Brady Tunnel, PA

The likelihood of an appreciable decrease in strength occurring in the foreseeable future at points so far from either portal is considered extremely small. The most obvious process that can reduce the concrete strength appreciably is ice deterioration. No evidence of ice deterioration is present at the points in the tunnel below the highways that cross over, as the high concrete strength from the test core attests. The only sections of tunnel where ice deterioration is observed are at the north portal and a small region inside the south portal. Nevertheless, an analysis of the integral model was carried out using the test strengths for ice-deteriorated concrete in Big Savage Mountain Tunnel. This is considered to represent a "worst-case" scenario. In Figure 12, the results of this analysis are compared with the results of the analysis carried out using the "low" estimate for concrete strength. Both analyses assumed the "low" value of strength for the surrounding "disturbed" and "undisturbed" rock materials. Even under these significantly reduced strength conditions, the minimum stress-factor in the concrete lining is greater than 1.1. Hence these calculations support the conclusion that even under the remote possibility of an appreciable deterioration of the concrete lining, the arch would still be stable.

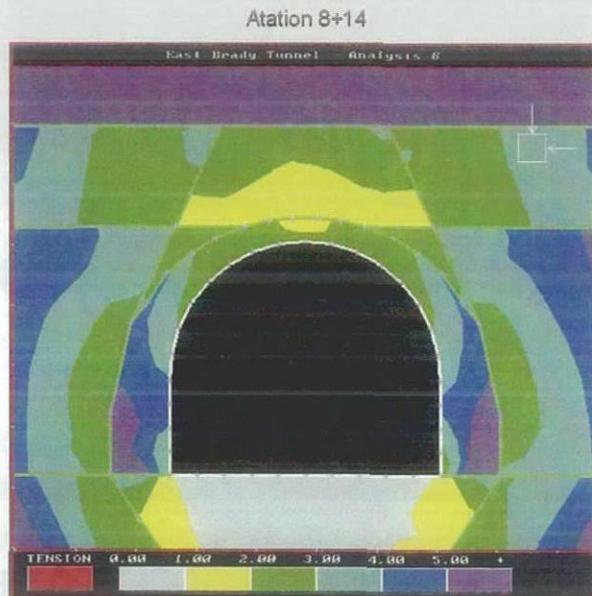
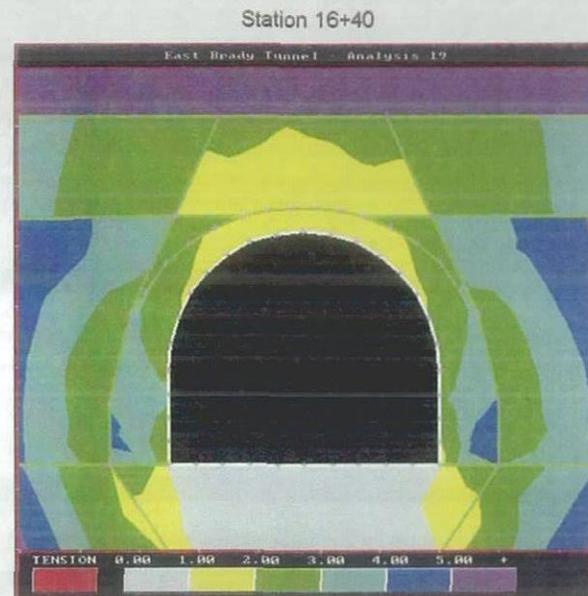
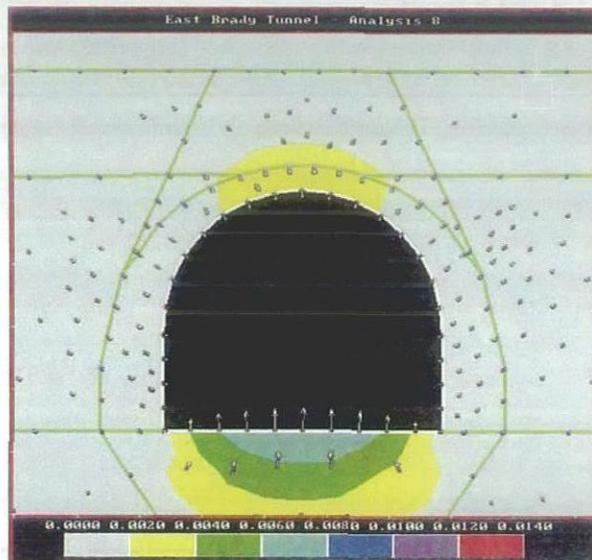
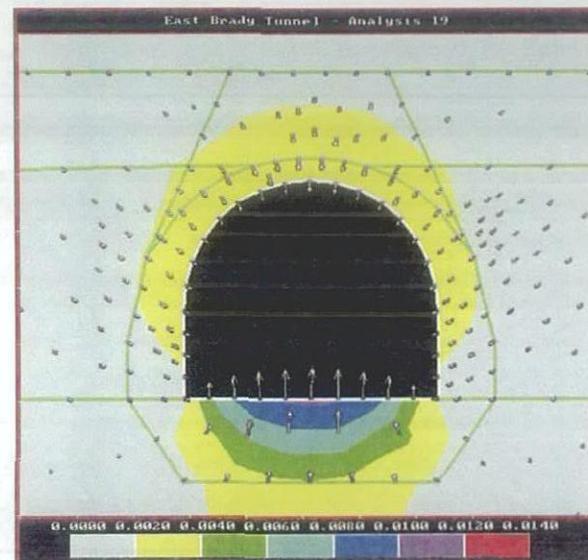
Figure 13
Comparison of Liner Performance
at Stations 8+14 and 16+40
East Brady Tunnel, PA

The foregoing discussion of results is for the conditions at Station 8+14, beneath SR 2023. The overburden stress at Station 16+40, beneath SR68, is slightly higher. The worst case run for the arch support at 8+14 was re-run using the overburden stress for Station 16+40. The results of the

two sets of runs are shown in Figure 13. As would be expected, the results show that the stresses induced in the crown increase, and the strength factor reduces below 2.0, but remains above 1.0, over a substantial portion of the arch. If the assumptions used in this analysis closely represented in situ conditions, one might expect to see some signs of arch distress at Station 16+40. However, the condition of the arch at 16+40 is excellent, and one might conclude that the "low" strength assumptions used in these analyses are conservative.

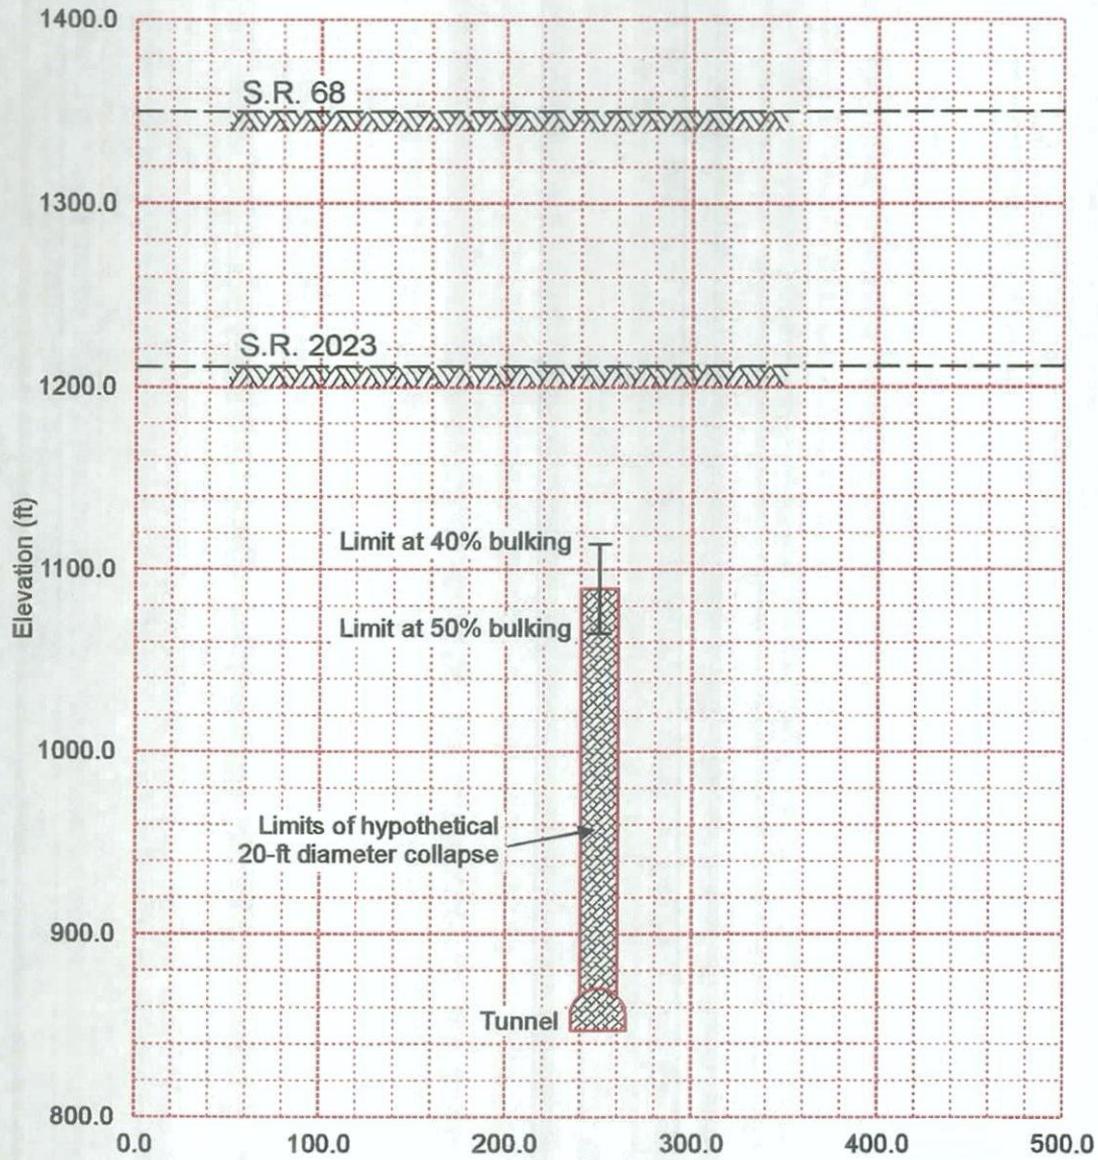
Figure 15
 Limits of Hypothetical
 Tunnel Collapse
 East Brady Tunnel, PA

In the unlikely event that a collapse does occur, the initial volume of rock that would fall into the tunnel would be limited to the weathered claystones and shales immediately above the crown. Our calculations have shown that the strength factor of the sandstone overlying the disturbed claystone unit exceeds 5 even under the most conservative of assumptions. A collapse of the claystone materials would unlikely propagate immediately upward beyond the first competent sandstone unit since this would act as a stable beam that would "bridge" the collapse zone.

But let us suppose that the more competent rocks do not "bridge" and material continues to fall, the collapse process will eventually stabilize itself for the following reason. The falling material will "bulk" when it lands (i.e. the volume of broken material would be greater than the original volume of unbroken material as a result of increased porosity), and a point will be reached when the volume of the "bulked" material equals the available void space. At this point, the displacement of additional broken material is prevented. Typical bulking factors used in the mining industry range between 1.4 and 1.5. If we consider the very conservative and unlikely scenario that a cylinder of rock, 20-ft in diameter (i.e. approximately 2/3 of the diameter of the tunnel) collapses through the tunnel lining, and the collapse propagates upward through the competent sandstone units, it can be shown that the collapse would stabilize itself between 237-ft and 286-ft beneath SR-68 and between 97-ft and 146-ft below SR-2023. This is illustrated in Figure 15. Consequently, this calculation would further indicate that even under an extreme and unlikely scenario, the tunnel does not pose a threat to the highways that cross over it.

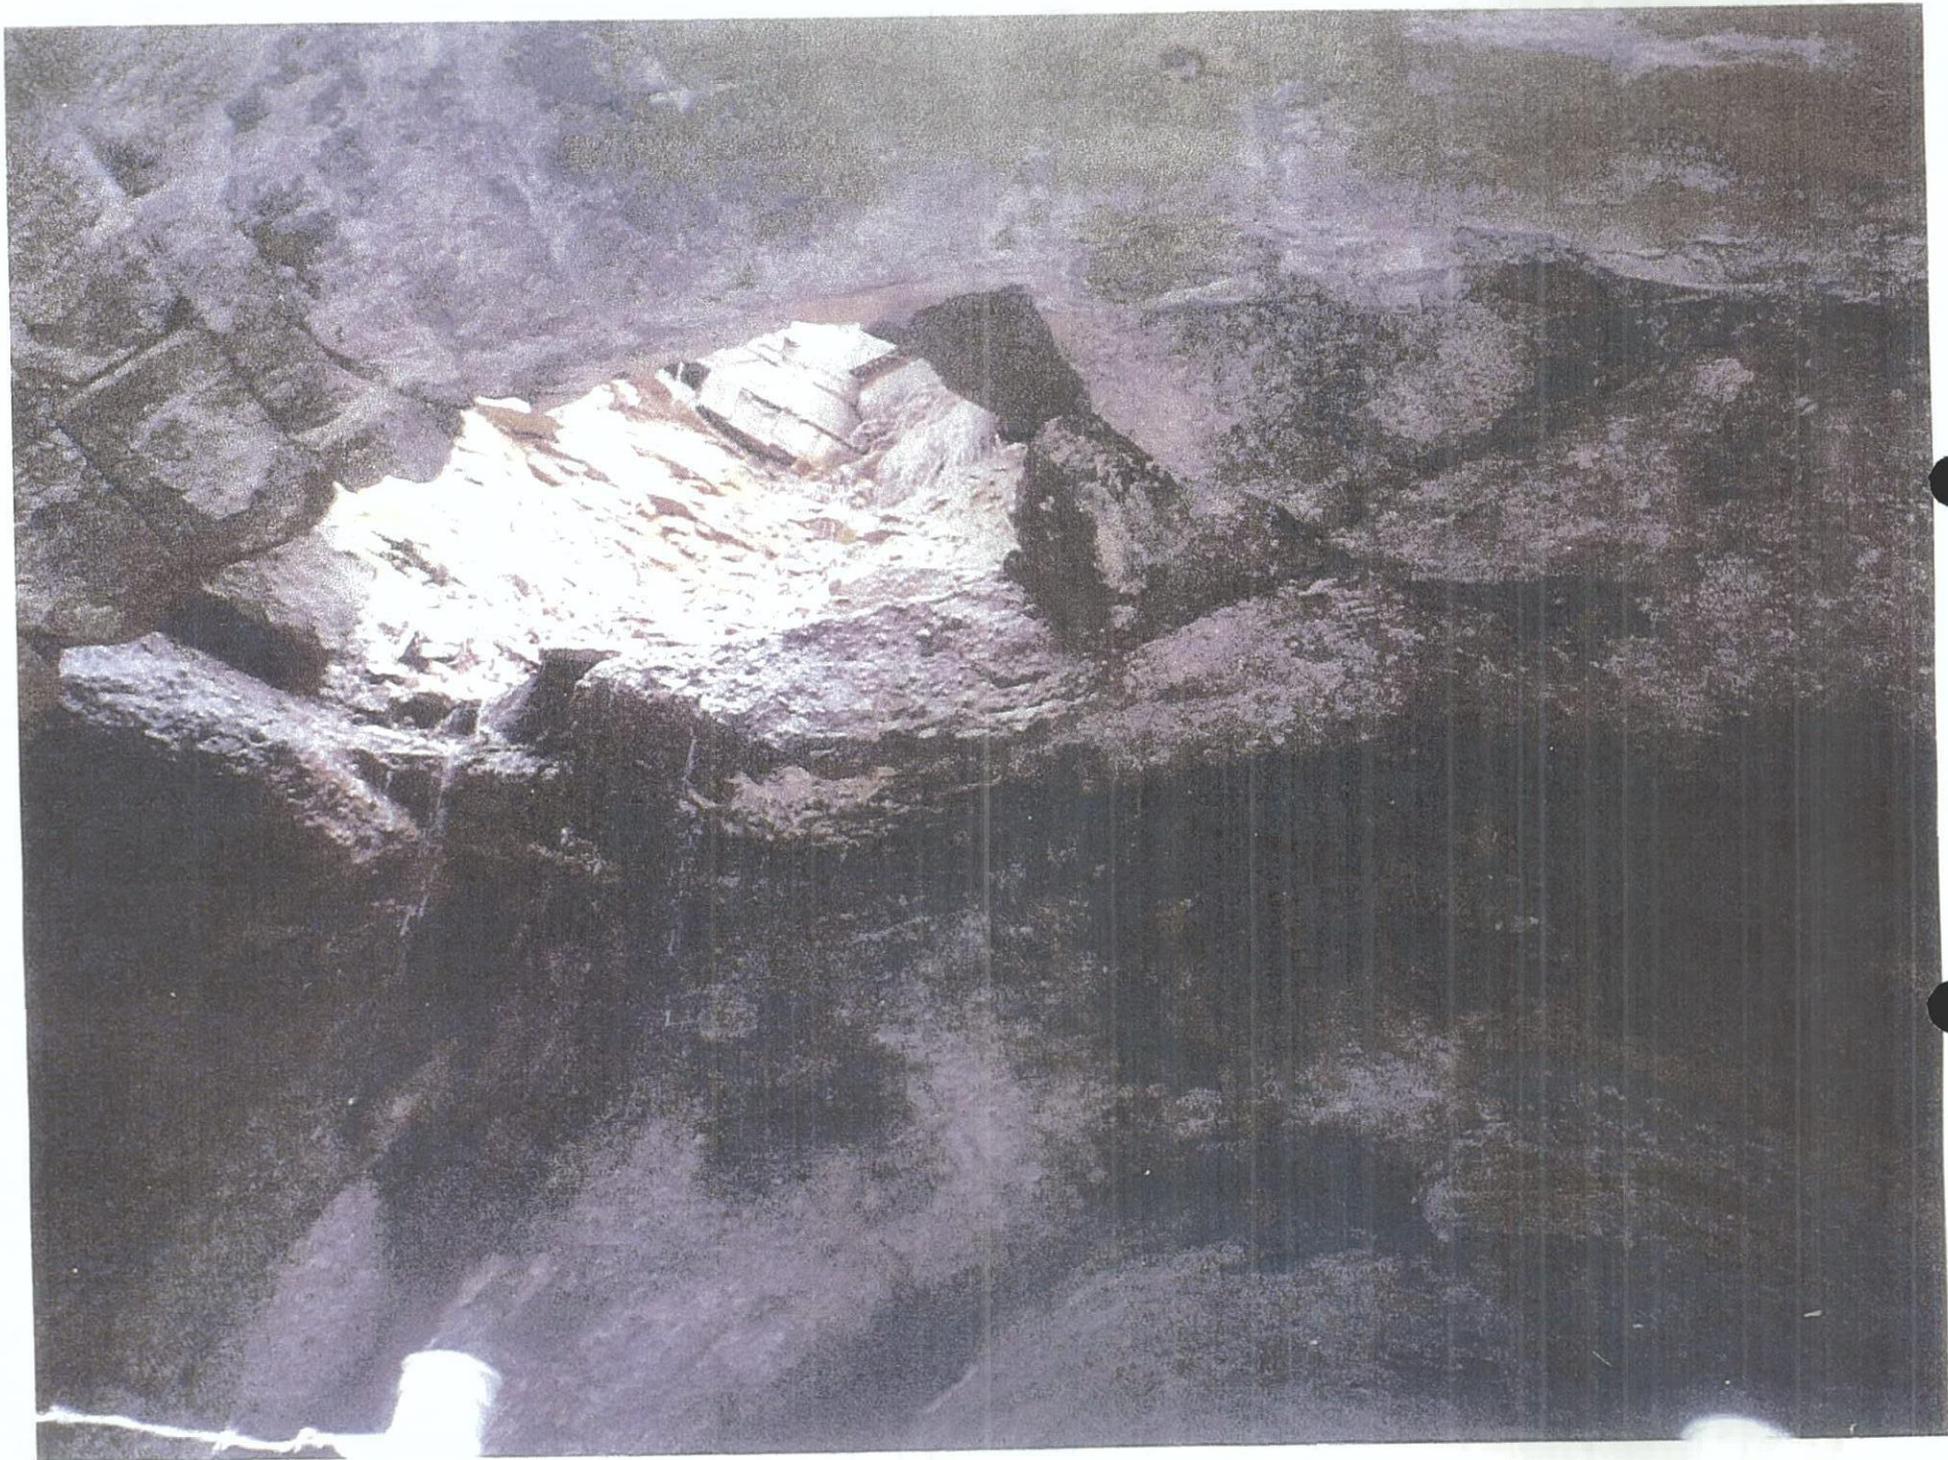
- No. 10 Photo up through hole in roof. Note water falling over rock into tunnel (bottom center right) see also on (bottom left) edge of stone arch and vertical cracking in stone. Rock out crop visible through hole.
- No. 11 Photo above fencing posts to top of arch and through hole just inside north portal. Timber cribbing (three rows) are visible and top edge of sluice is visible. Water flow drips into tunnel from rock or concrete edges around hole in top of arch.
- No. 12 Photo of damage to fencing and gate at north portal. Wheel tracks of hi-lift are visible as marks on material and bucket edge marks also are visible. Large stone along entrance of portal were not traversed. Vehicle came through tunnel from south end of tunnel.

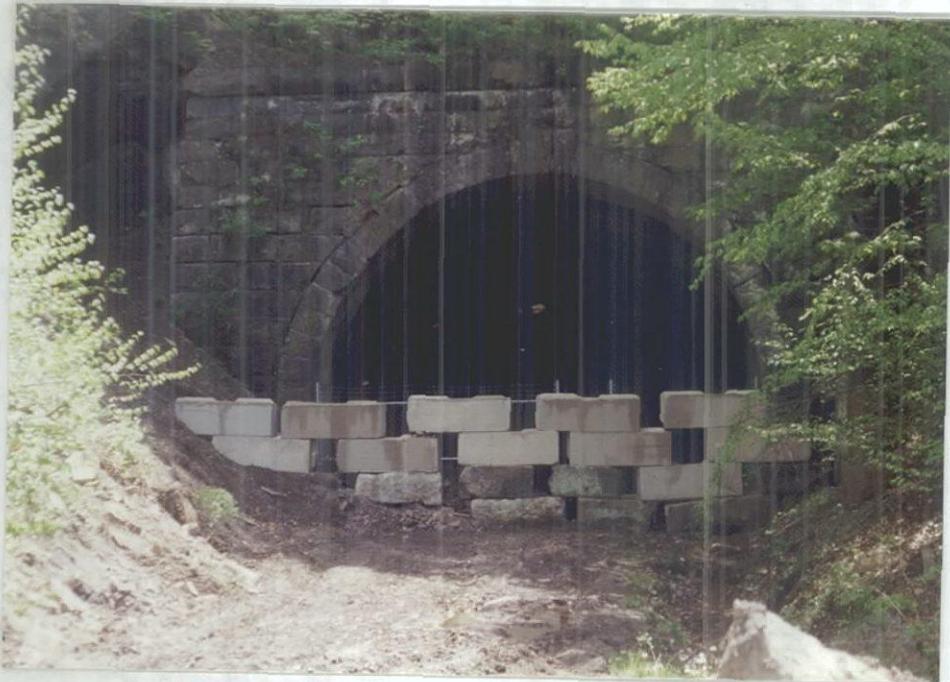
NORTH PORTAL
LARGE CONCRETE
BLOCKS PUT ON TOP
OF LARGE STONE

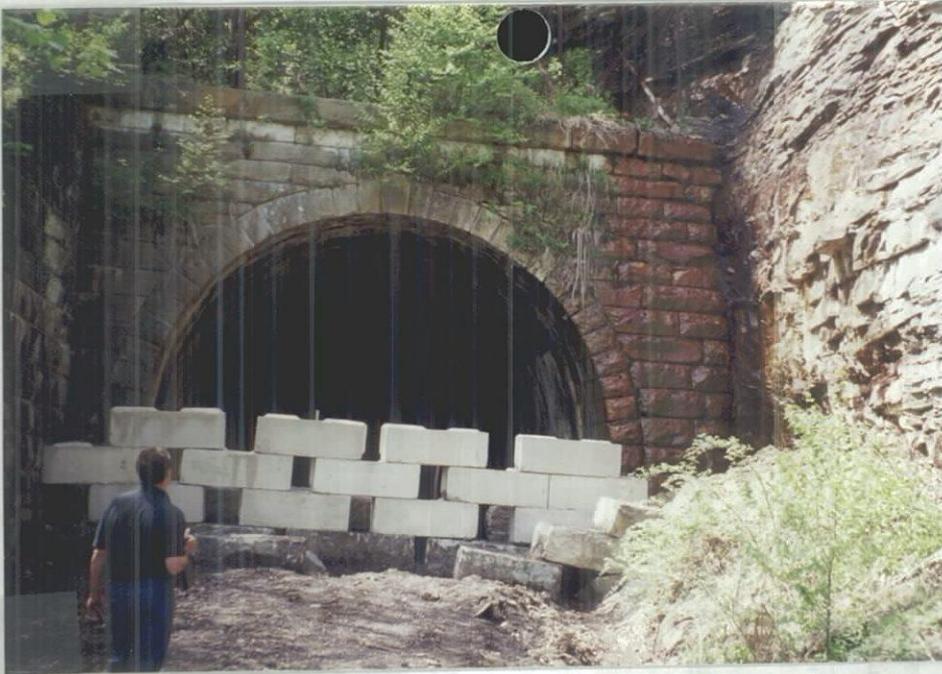
SOUTH PORTAL
WOODEN SLUICE
ABOVE TUNNEL

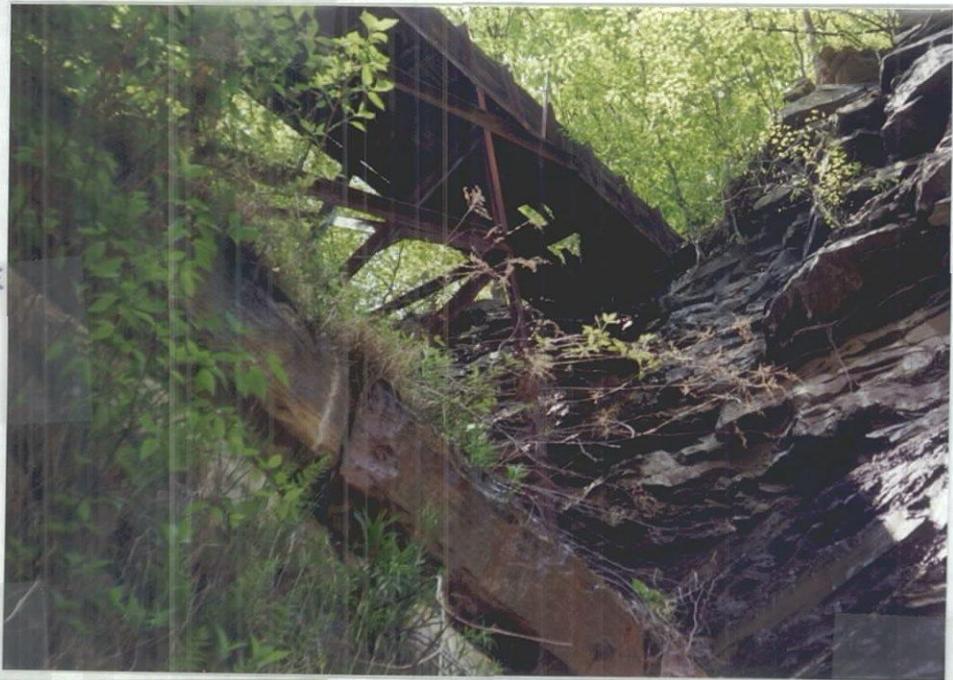
SOUTH PORTAL
VIEW UNDER SLUICE
NOTE WOODEN PLANKS
ROTTED - HOLES VISIBLE

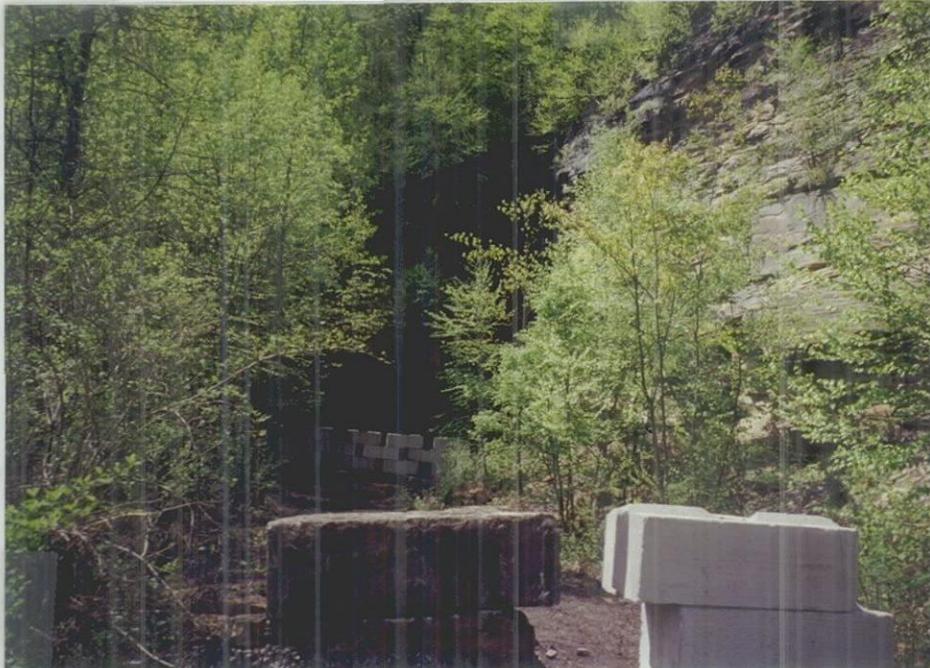
SOUTH PORTAL
VIEW FROM TURNOUT
TOWARD SOUTH PORTAL
MORE LARGE STONES
AND CONCRETE BLOCKS
