**HIDDEN VALLEY UTILITY SERVICES, L.P. – ENGINEER'S REPORTS (2) AND
REVISED BILL FORM**

HIDDEN VALLEY FOUR SEASONS RESORT SANITARY SEWER SYSTEM FACILITIES STUDY

APRIL 2018

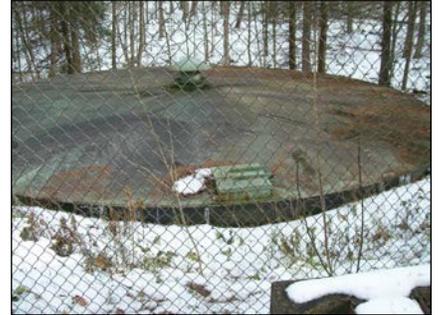
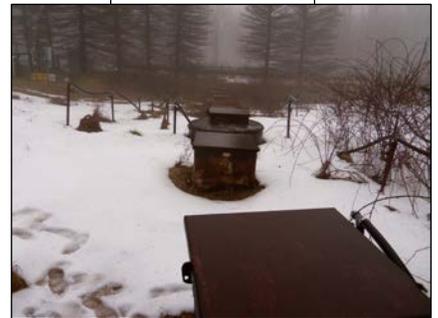
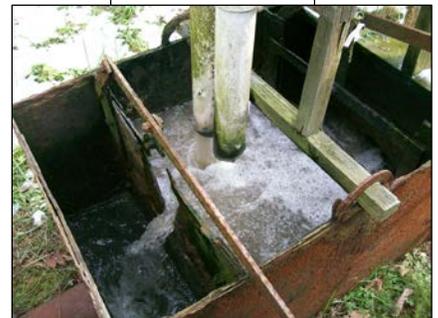
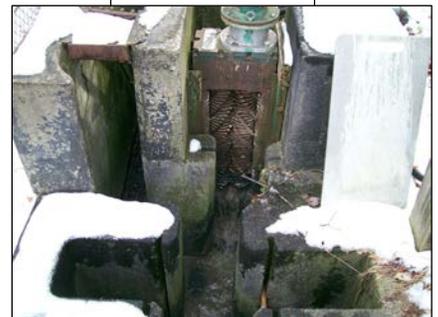
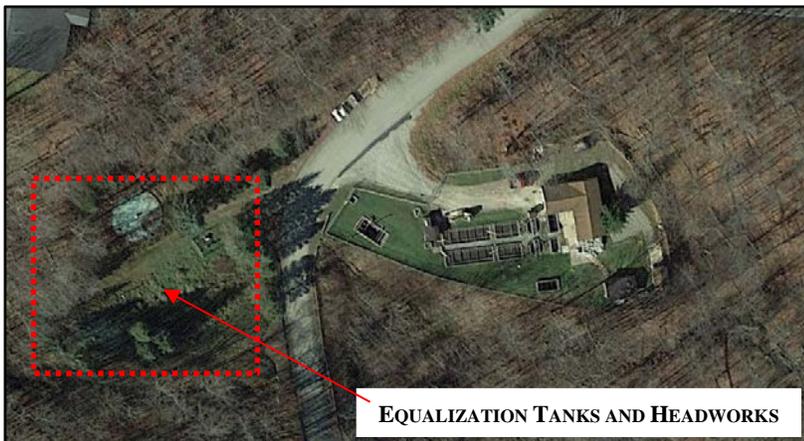
STP No. 1 – HEADWORKS AND EQUALIZATION TANKS

- Muffin Monster is operational.
- Muffin Monster blade edges have dulled.
- Light to moderate corrosion on muffin monster components.
- Fatigued muffin monster power/control cables with exposed wires located alongside concrete channel.

- Patches of external roof corrosion on circular equalization tanks.
- Moderate to heavy corrosion on exposed surfaces of buried railcar tanks.
- Moderate corrosion on interior of railcar tanks above wastewater levels.
- System Operator informed us the equalization storage aeration system is operable to the circular equalization tanks, but not to the railcar tanks.

- Heavy corrosion on steel equalization splitter box. Total replacement needed.
- One (1) equalization pump operational.
- Second equalization pump not operational.
- Equalization pump manual control operational.
- Equalization pump automatic control not operational
- Bubbler tubes at equalization pump wet well not operational.
- Need slide rail system for pump removal.
- 3-inch submersible pump discharge.

STP No. 1 – HEADWORKS AND EQUALIZATION FACILITIES RECOMMENDED DEFICIENCY PRIORITIZATION REPAIR TABLE					
ASSET	EXISTING CONDITION RATING	PRIORITY	RECOMMENDATIONS	ESTIMATED COST	PA DEP MANUAL COMMENTS
Equalization Pump #2	4	High	Install second equalization pump	\$3,500	At least two pumps shall be provided for each wetwell.
Muffin Monster Power/Control Cables	4	High	Replace or repair existing muffin monster power/control cables	\$1,000	Each flexible cable, located in the wetwell, shall be provided with a water-tight seal.
Muffin Monster Blades	2	High	Replace cutting cartridge	\$10,000	Not Applicable. General Maintenance.
Equalization Splitter Box	4	High	Replace existing flow splitter box	\$7,500	Not Applicable. If structure collapses, STP operations would cease and an emergency situation would ensue.
Equalization Pump Slide Rail System	N/A	High	Install new pump slide rail system for easy pump access	\$7,500	Provisions shall be made to facilitate removing pumps, motors, and other mechanical and electrical equipment.

Bubbler Tubes	5	Moderate	Replace bubbler tubes in equalization facilities with float system	\$5,000	Not Applicable. If high influent BOD ₅ becomes an issue bubbler tube replacement will help settle out some material.
Equalization Pump Automatic Controls	5	Moderate	Replace automatic controls for equalization pumps	\$5,000	Provisions should be made to automatically alternate pumps.
Equalization Control Panel	3	Moderate	Minor repairs to existing control panel	\$1,000	Not Applicable.
Equalization Tank Paint	2	Moderate	Repaint external and internal areas affected by corrosion	\$10,000	Not Applicable. General Maintenance.

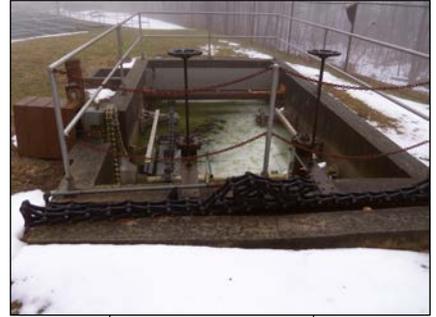
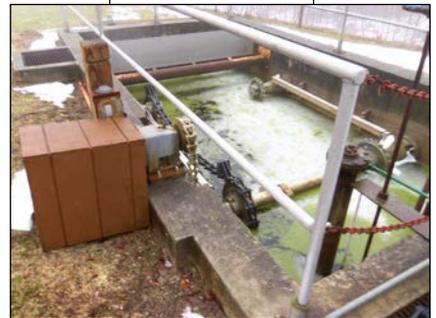
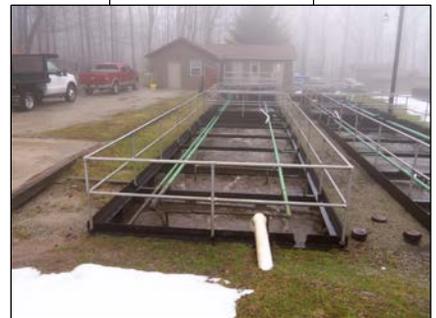
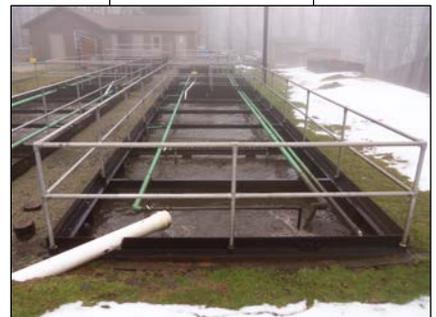
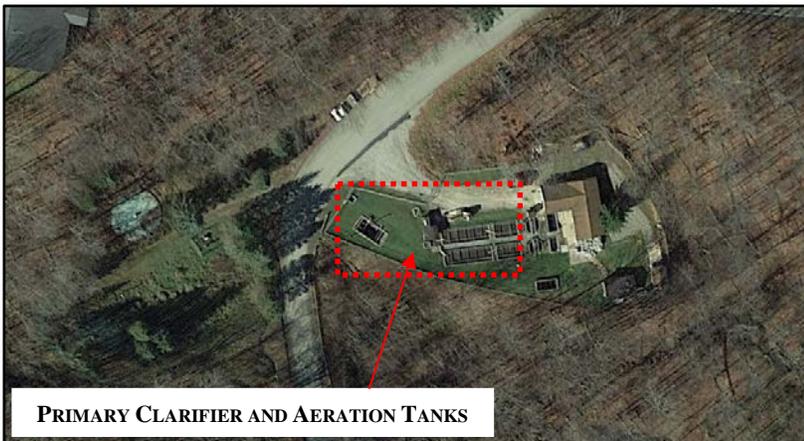
- Good condition.
- Ability to direct flow to between primary clarifier and aeration tanks.

- Not operational. Has not been utilized for 15 years.
- Sludge collector chain damaged and not operational. Unable to verify operation of the sludge collector.

- Confirmed the repair and repainting of both Aeration Tanks with operator. Aeration Tank No. 1 completed in 2016, Aeration Tank No. 2 completed in 2015. Visual observations above water level confirm painting and repairs.
- Diffusors were not able to be examined, but aeration activity visually adequate.
- Froth spray system operational in Aeration Tank No 2. Required maintenance cleaning out some spray nozzles.
- Froth spray system not operational in Aeration Tank No. 1.

STP No. 1 – PRIMARY CLARIFIER AND AERATION TANKS RECOMMENDED DEFICIENCY PRIORITIZATION REPAIR TABLE					
ASSET	EXISTING CONDITION RATING	PRIORITY	RECOMMENDATIONS	ESTIMATED COST	PA DEP MANUAL COMMENTS
Sludge Collector	5	High	Replace sludge collector chains	\$5,000	Not Applicable. Without the sludge collector chains the primary clarifier cannot remove sedimentation.
Primary Clarifier Miscellaneous Repairs	3	Moderate	Miscellaneous repairs to sludge collector system and tank	\$2,500	Not Applicable. General Maintenance.
Froth Spray System Tank No. 1	3	Moderate	Clean existing spray nozzles. Locate and replace damaged or clogged section of line	\$1,000	Not Applicable. Aeration Tank No. 1 does not have ability to spray down froth to help improve plant performance.
Froth Spray System Tank No. 2	2	Low	Clean existing spray nozzles. Replace clogged nozzles.	\$500	Not Applicable. General Maintenance.

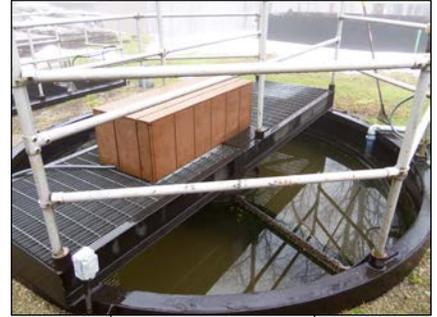
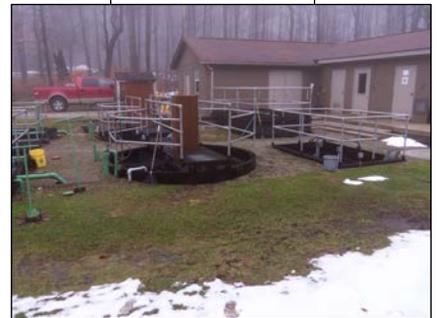
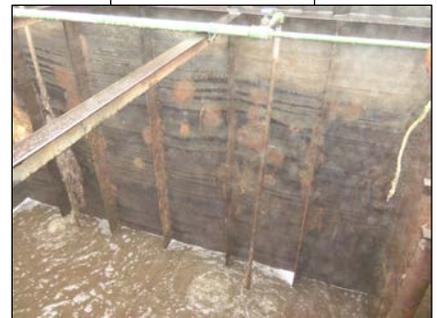
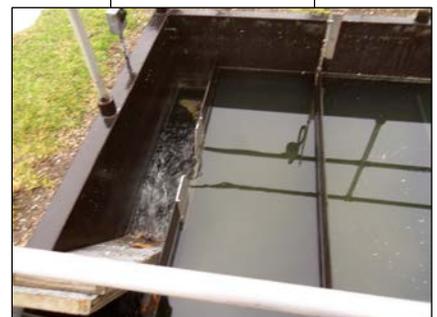
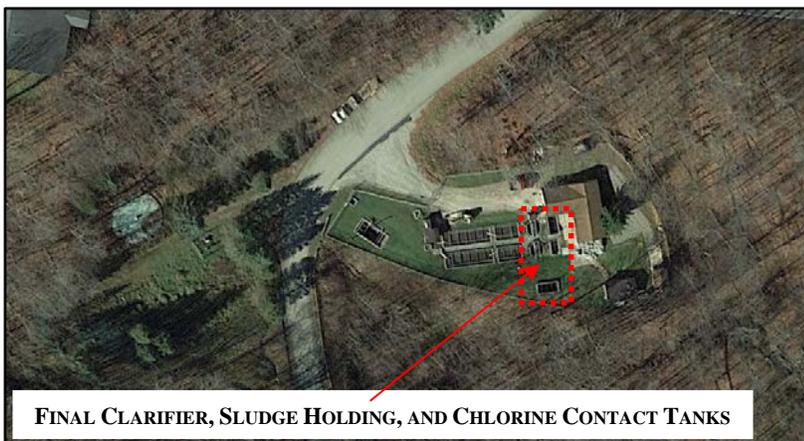
STP No. 1 – FINAL CLARIFIER, SLUDGE HOLDING, AND EFFLUENT TANKS

- Both Tanks in good condition.
- Both motors in good condition. Final Clarifier Tank No. 2 motor rebuilt in 2015.
- Scum return system not operational. Manual airlift system operational and utilized for scum removal.

- Original sludge holding tank in fair condition.
- New sludge holding tank in fair condition.
- Moderate corrosion on walls of both sludge holding tanks.

- Tank in good condition.
- Level sensor operational.

- Heavy corrosion in pit.
- Vault door recently replaced and in good condition.
- Access grating in bad condition. Needs replaced.

- Minor corrosion on components in wetwell.
- Electrical junction box for floats located in wetwell.
- Floats:
 - Lead Pump On Float operational
 - Pump Lag Float operational
 - Pump Off Float operational

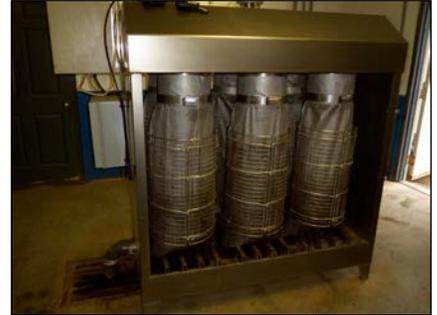
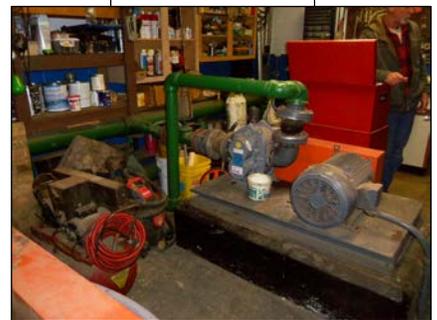
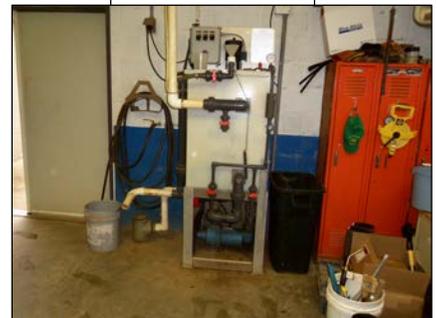
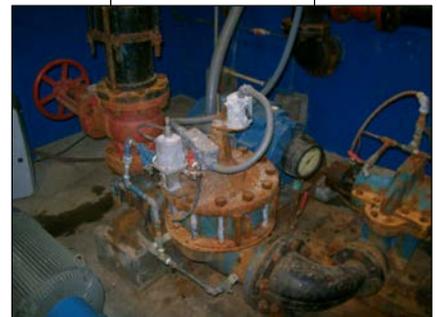
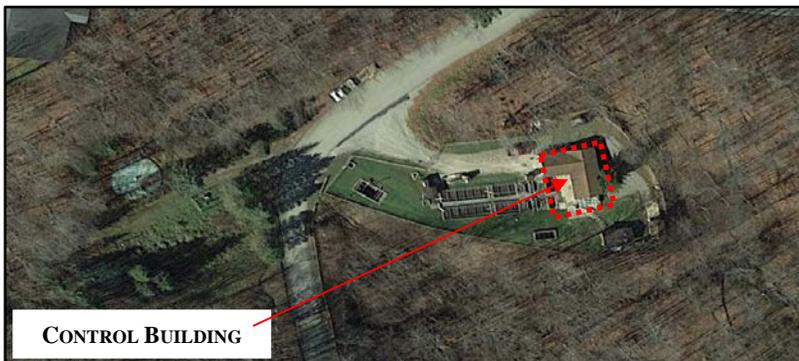
STP No. 1 – CONTROL BUILDING AND EQUIPMENT

- Sludge pump in good condition.
- Sludge bagging and handling system in good condition.

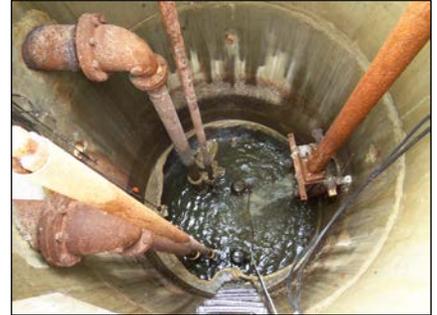
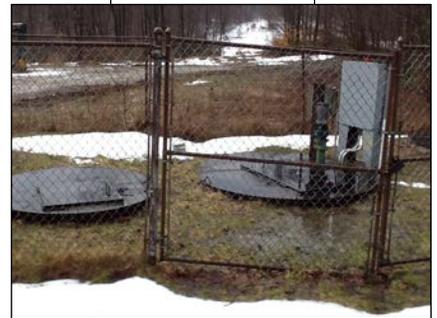
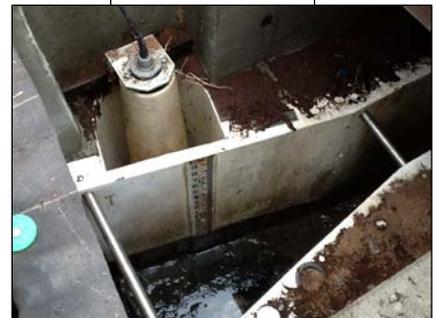
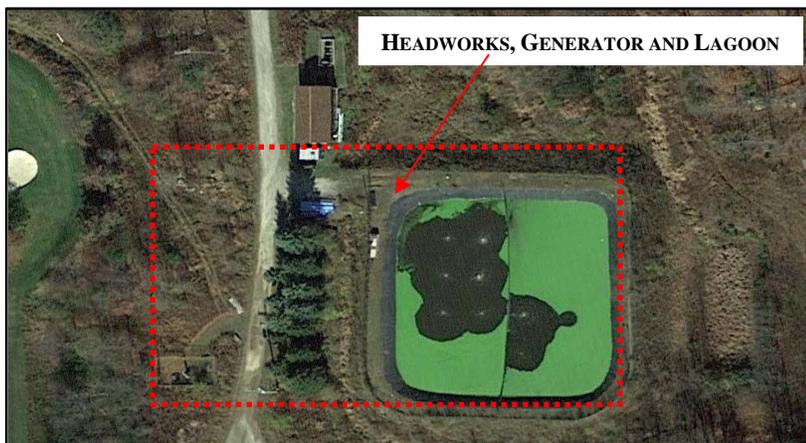
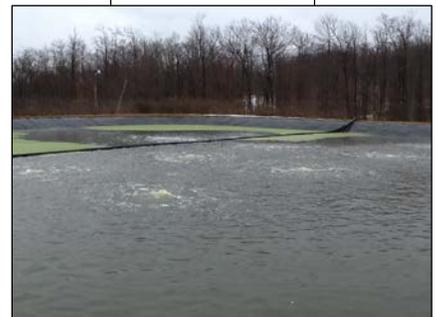
STP No. 2 – HEADWORKS, GENERATOR, AND FACULTATIVE LAGOON

- New batteries are required for backup generator. Generator is not operational.
- Generator requires new coil heater for water line on radiator.

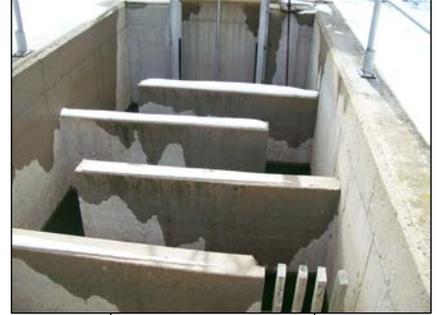
- Concrete channel in good condition.
- Weir Gate not operational. Seized up and may need replaced.

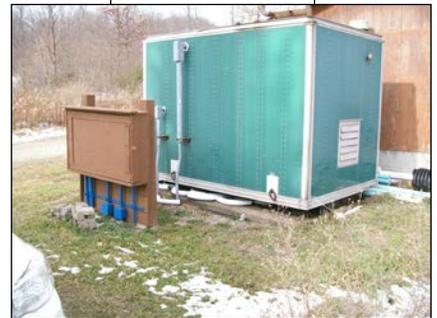
- Alarm buzzer and warning beacon in working order.
- Floats:
 - Lead Pump On Float operational
 - Pump Off Float operational
 - High Wetwell Level Alarm Float operational
 - Pump Lag Float operational

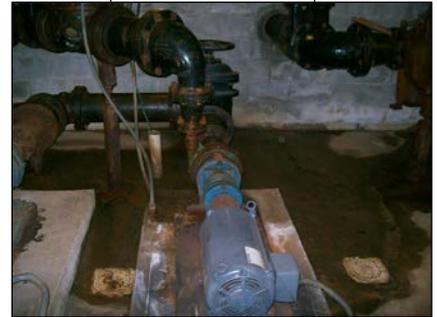
- One (1) effluent pump operational.
- Second pump not operational. Needs replaced.
- Check valve for non-operational pump is not operational. Needs replaced.
- Damaged conduit and exposed wires require maintenance.

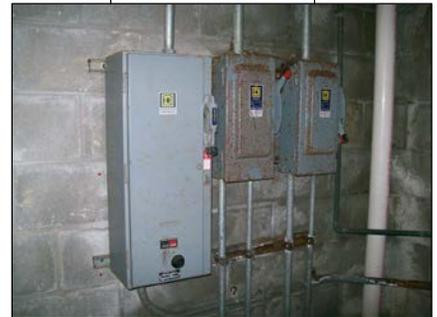
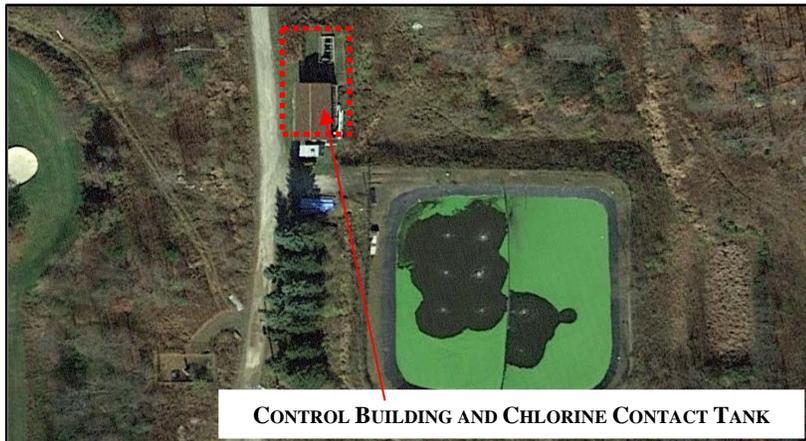
STP No. 2 – CONTROL BUILDING AND CHLORINE CONTACT TANK

- Room vent fan and vent controls operational.
- New liquid sodium hypochlorite system installed.

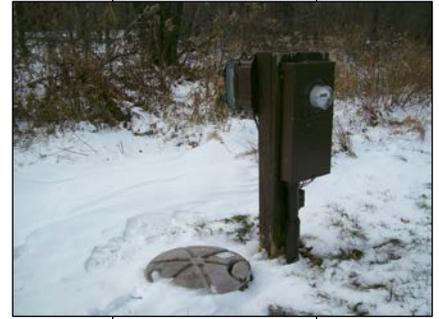
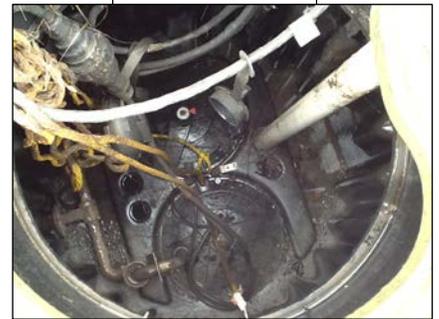
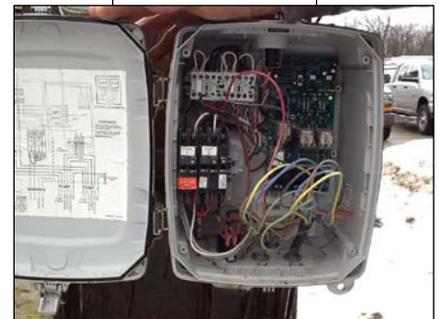
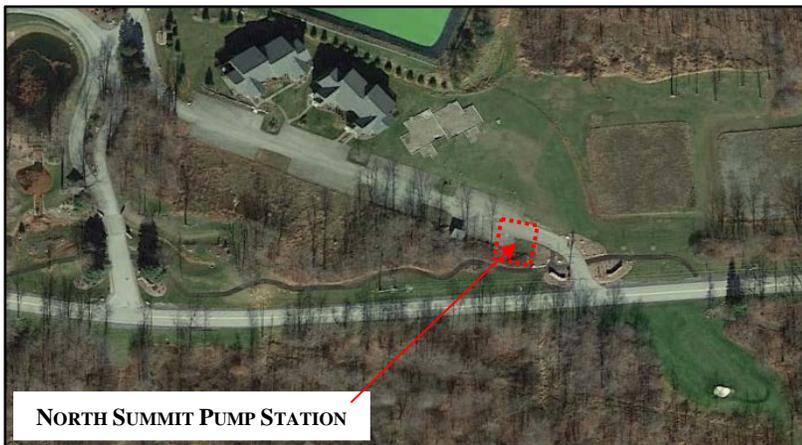
NORTH SUMMIT PUMP STATION

- Pump Station is in fair condition.
- One (1) grinder pump is currently not operational and needs repaired or replaced.
- Detailed List of Deficiencies visually observed at the North Summit Pump Station with recommended repairs and estimated costs can be found in Appendix 5.
- Estimated cost to repair observed deficiencies - **\$ 6,000**

- Panel post/structure in good condition.
- Alarm buzzer and warning beacon in working order.
- Unable to verify operation of pressure transducer controlling automatic mode of pump station.
- Disconnect panel at control panel.
- No method of influent or effluent flow measurement.

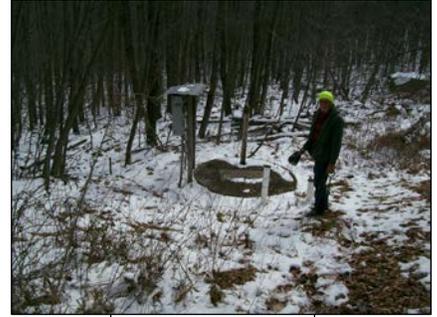
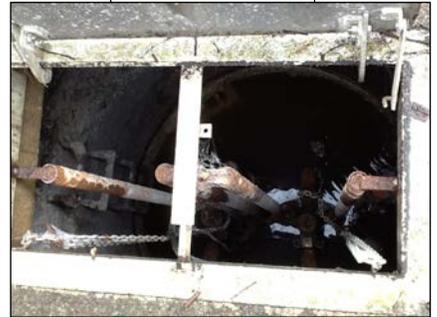
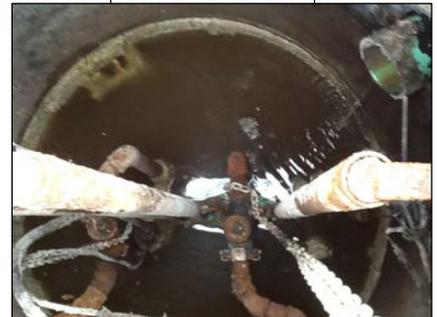
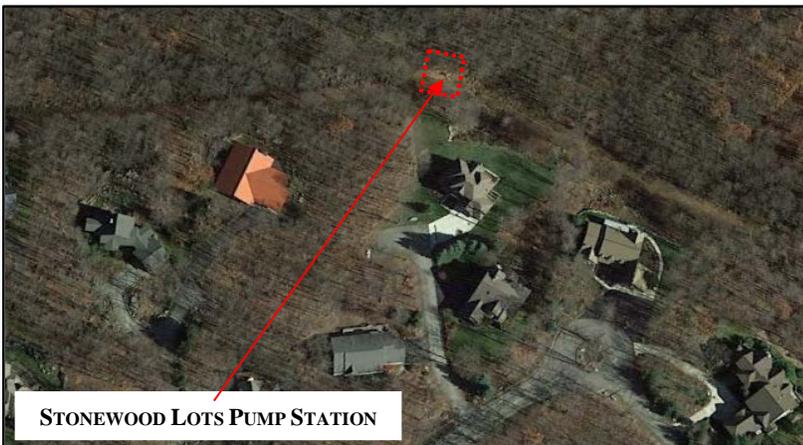
STONEWOOD LOTS PUMP STATION

- Pump Station is in fair condition.
- Difficult access into the pump station wetwell may create a problem in an emergency situation.
- Detailed List of Deficiencies visually observed at the Stonewood Lots Pump Station with recommended repairs and estimated costs can be found in Appendix 6.
- Estimated cost to repair observed deficiencies - **\$ 6,750**

- Panel post/structure in fair condition.
- Panel roof in poor condition and needs replaced.
- Alarm buzzer and warning beacon in working order.
- Floats:
 - Lead Pump On Float operational
 - Pump Off Float operational
 - High Wetwell Level Alarm Float operational
 - Pump Lag Float operational
- Electrical disconnect situated on control panel board.
- Electrical junction box for pump power and controls located in wetwell. Limited access for junction box from wetwell steps.
- No method of influent or effluent flow measurement.
- No provisions for connecting portable emergency generator.

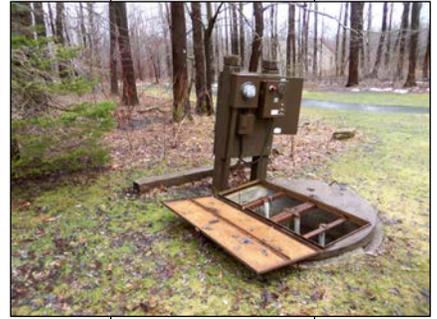
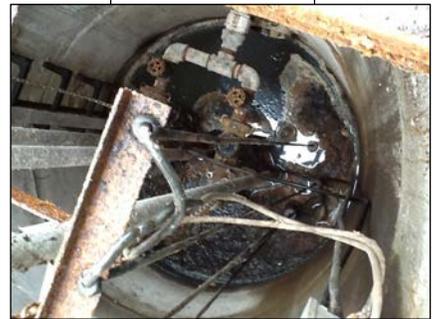
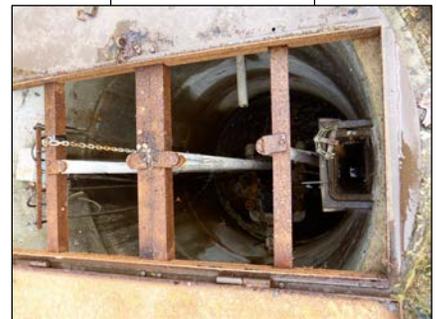
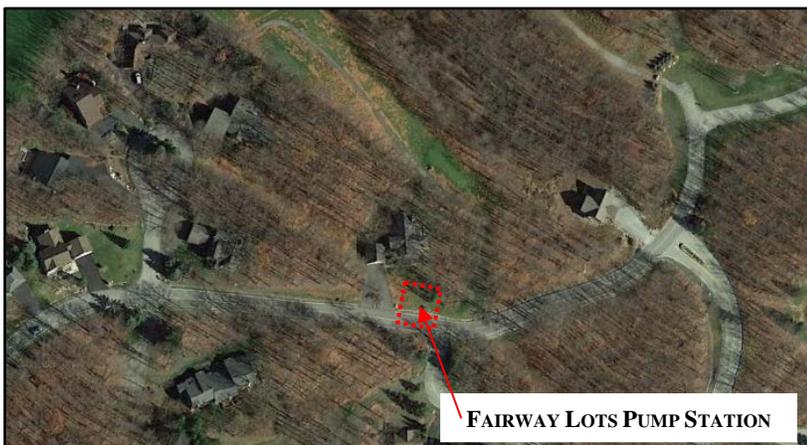
FAIRWAY LOTS PUMP STATION

- Pump Station is in poor condition.
- Pump station control panel is leaning on one (1) remaining support post. Second post needs replaced.
- Detailed List of Deficiencies visually observed at the Fairway Lots Pump Station with recommended repairs and estimated costs can be found in Appendix 7.
- Estimated cost to repair observed deficiencies - **\$ 10,750**

- Panel post/structure in poor condition. Panel leg deteriorated causing the structure to lean.
- Alarm buzzer and warning beacon in working order.
- Floats:
 - Lead Pump On Float operational
 - Pump Off Float operational
 - High Wetwell Level Alarm Float operational
 - Pump Lag Float operational
- Electrical disconnect situated on control panel board.
- Electrical junction box for pump power and controls located in wetwell. Limited access for junction box from wetwell steps.
- No method of influent or effluent flow measurement.
- No provisions for connecting portable emergency generator.

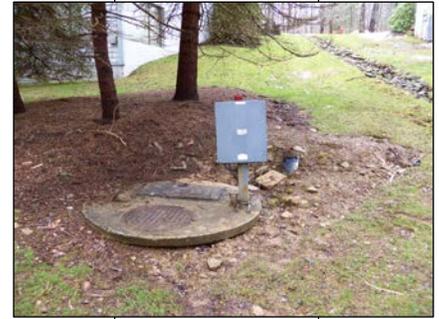
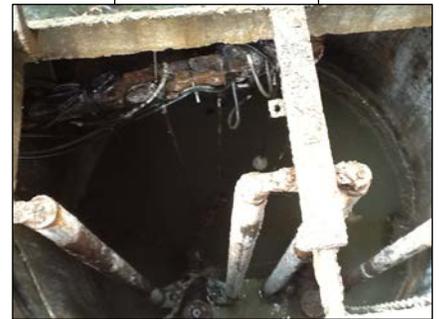
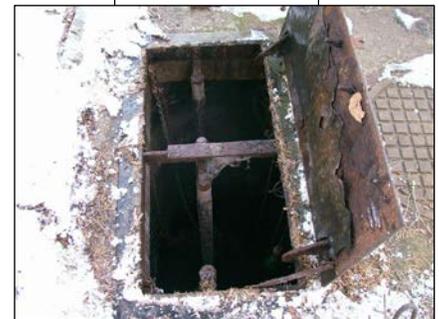
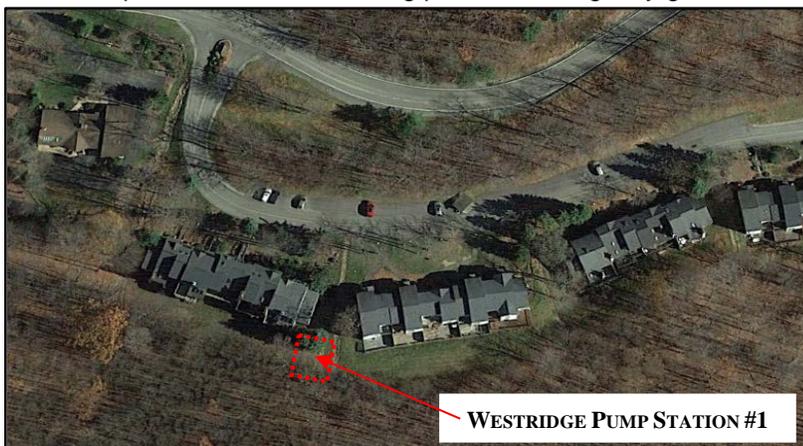
WESTRIDGE PUMPING STATION #1

- Power for the pump station is directly connected to the control panel. Reconfiguration is required to provide disconnect for future work on the control panel.
- Detailed List of Deficiencies visually observed at the Westridge No. 1 Pump Station with recommended repairs and estimated costs can be found in Appendix 9.
- Estimated cost to repair observed deficiencies - **\$ 11,250**

- Panel post/structure in good condition.
- Alarm buzzer and warning beacon in working order.
- Floats:
 - Lead Pump On Float operational
 - Pump Off Float operational
 - High Wetwell Level Alarm Float operational
 - Pump Lag Float not operational
- No disconnect at control panel. Main power runs directly into control panel.
- Ground wire for panel exposed.
- No method of influent or effluent flow measurement.
- No provisions for connecting portable emergency generator.

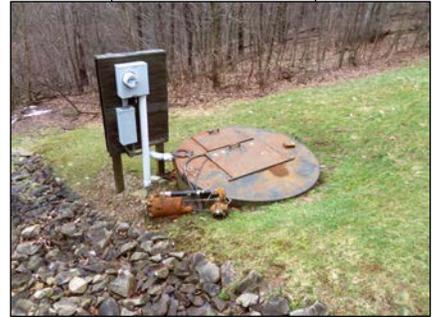
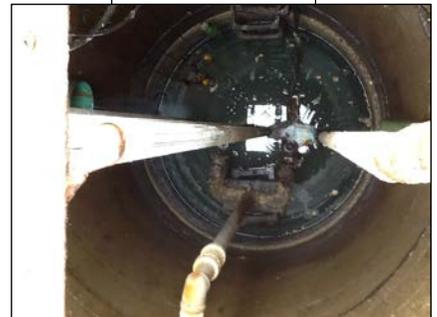
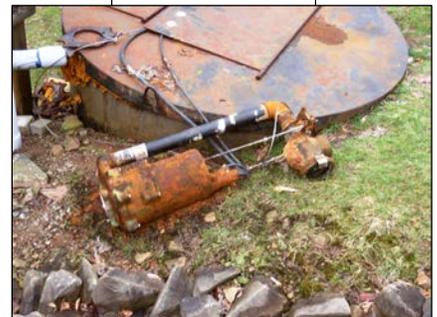
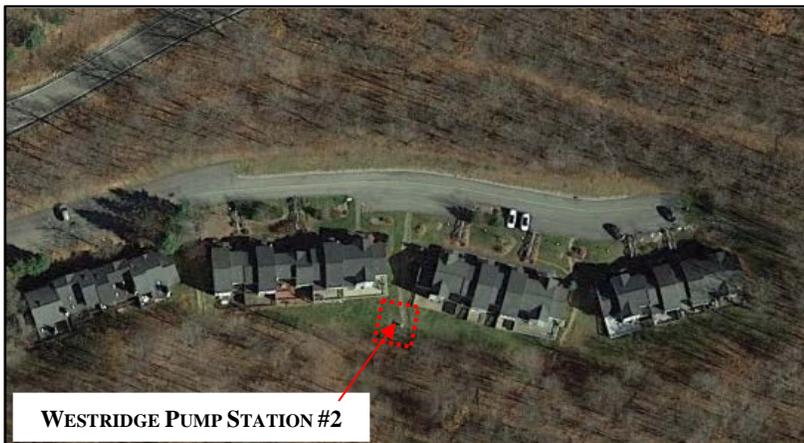
WESTRIDGE PUMP STATION #2

- Pump Station is in fair condition.
- One (1) grinder pump is currently not operational and needs replaced.
- Detailed List of Deficiencies visually observed at the Westridge No. 2 Pump Station with recommended repairs and estimated costs can be found in Appendix 10.
- Estimated cost to repair observed deficiencies - **\$ 10,500**

- Panel post/structure in good condition.
- Alarm buzzer and warning beacon in working order.
- Floats:
 - Lead Pump On Float operational
 - Pump Off Float operational
 - High Wetwell Level Alarm Float operational
 - Pump Lag Float unable to test without second pump
- Electrical disconnect situated on control panel board.
- Pump run time meters included in control panel.
- External port included for quick connect portable emergency generator.
