**Re: Letter of Notification of PPL Electric Utilities Corporation, Filed Pursuant to 52 Pa. Code Chapter 57 Subchapter G, for Approval to Rebuild Approximately 6.4 Miles of Existing Double-Circuit 138 kV Transmission Line between the Gilbert 138-12 kV Substation and the Little Gap 69 kV Transmission Tap Located in Polk Township and Eldred Township, Monroe County, Pennsylvania
Docket No. A-2018-3001324**

**PPL Electric Utilities Corporation
Response to Data Requests of
Bureau of Technical Utility Services, Set II
Dated May 16, 2018
Docket No. A-2018-3001324**

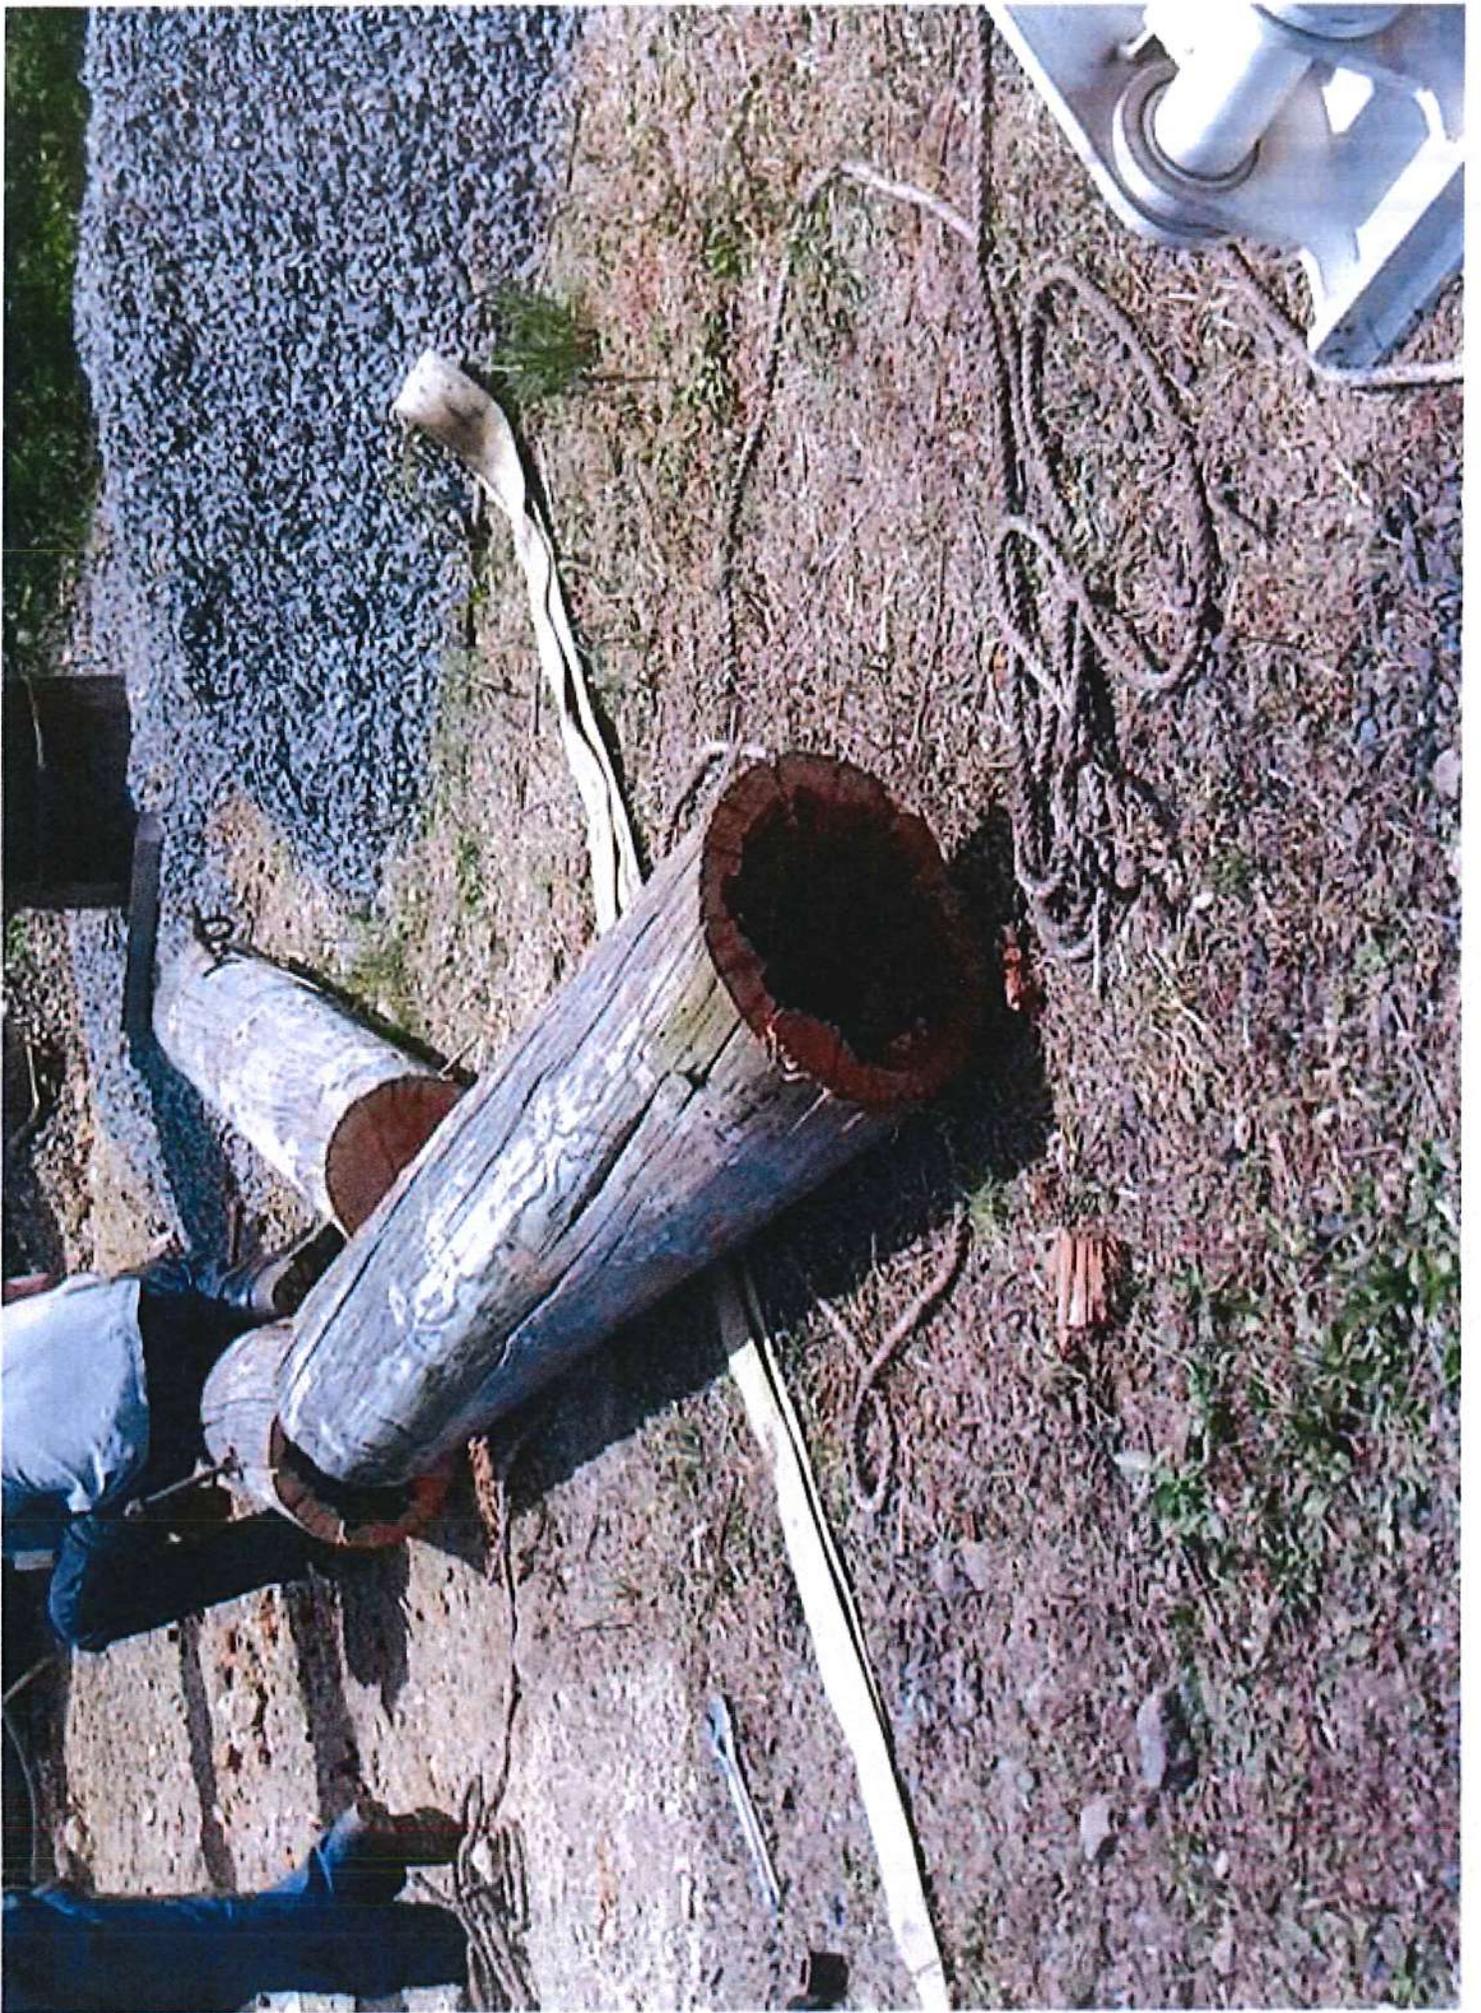
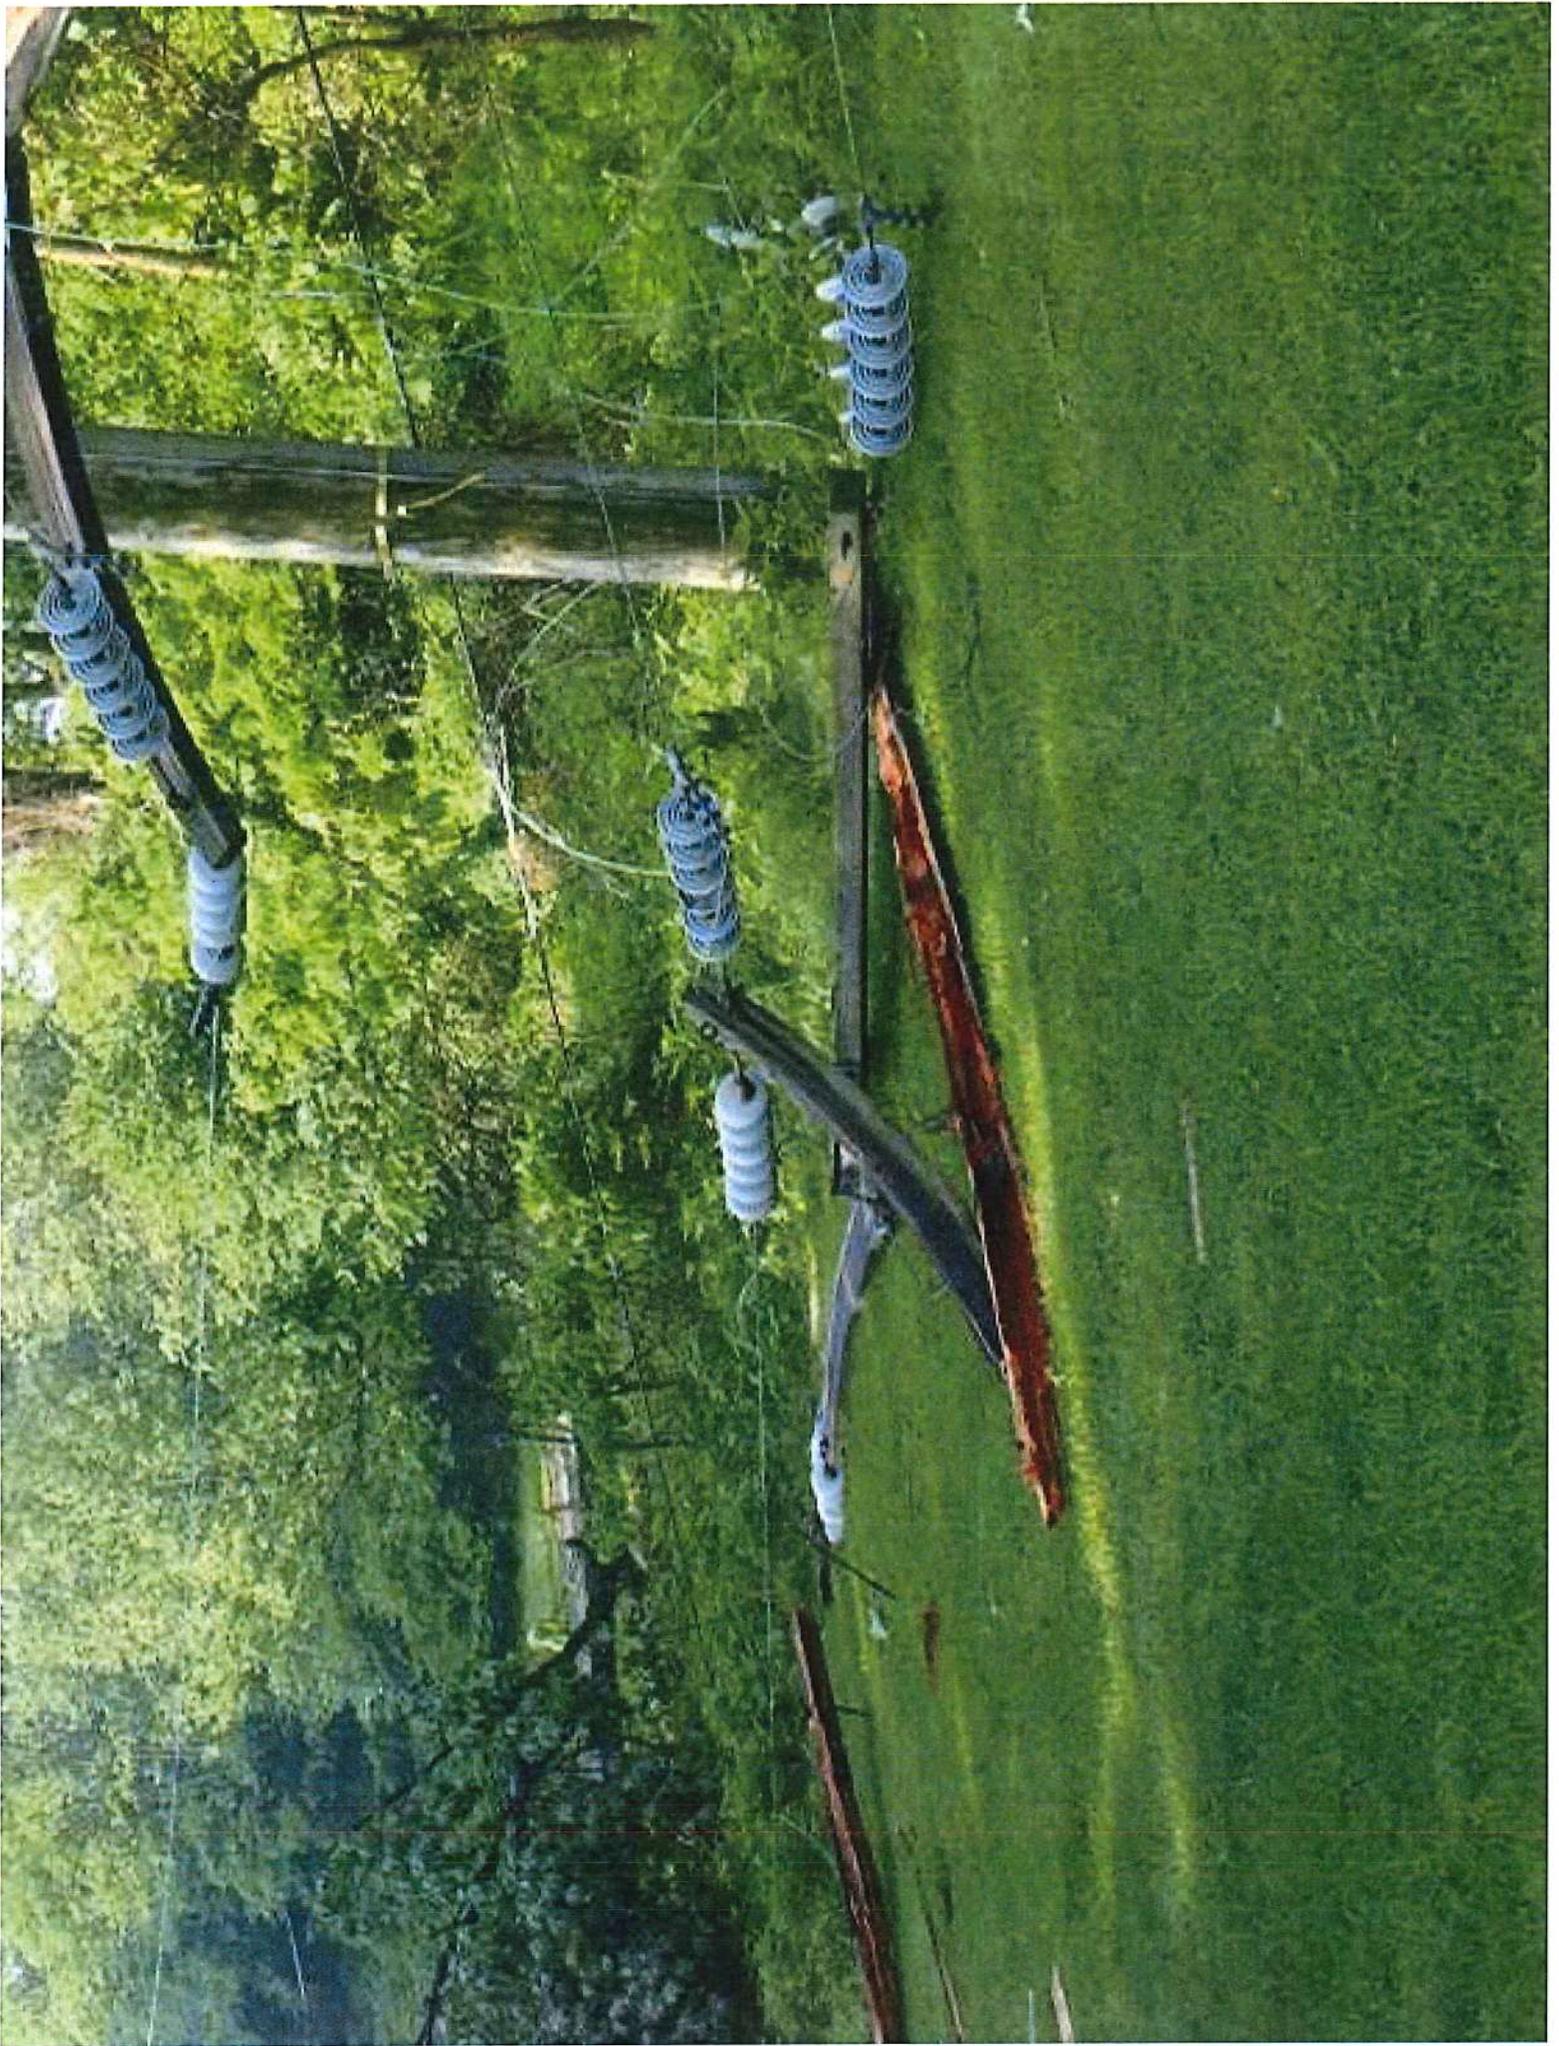
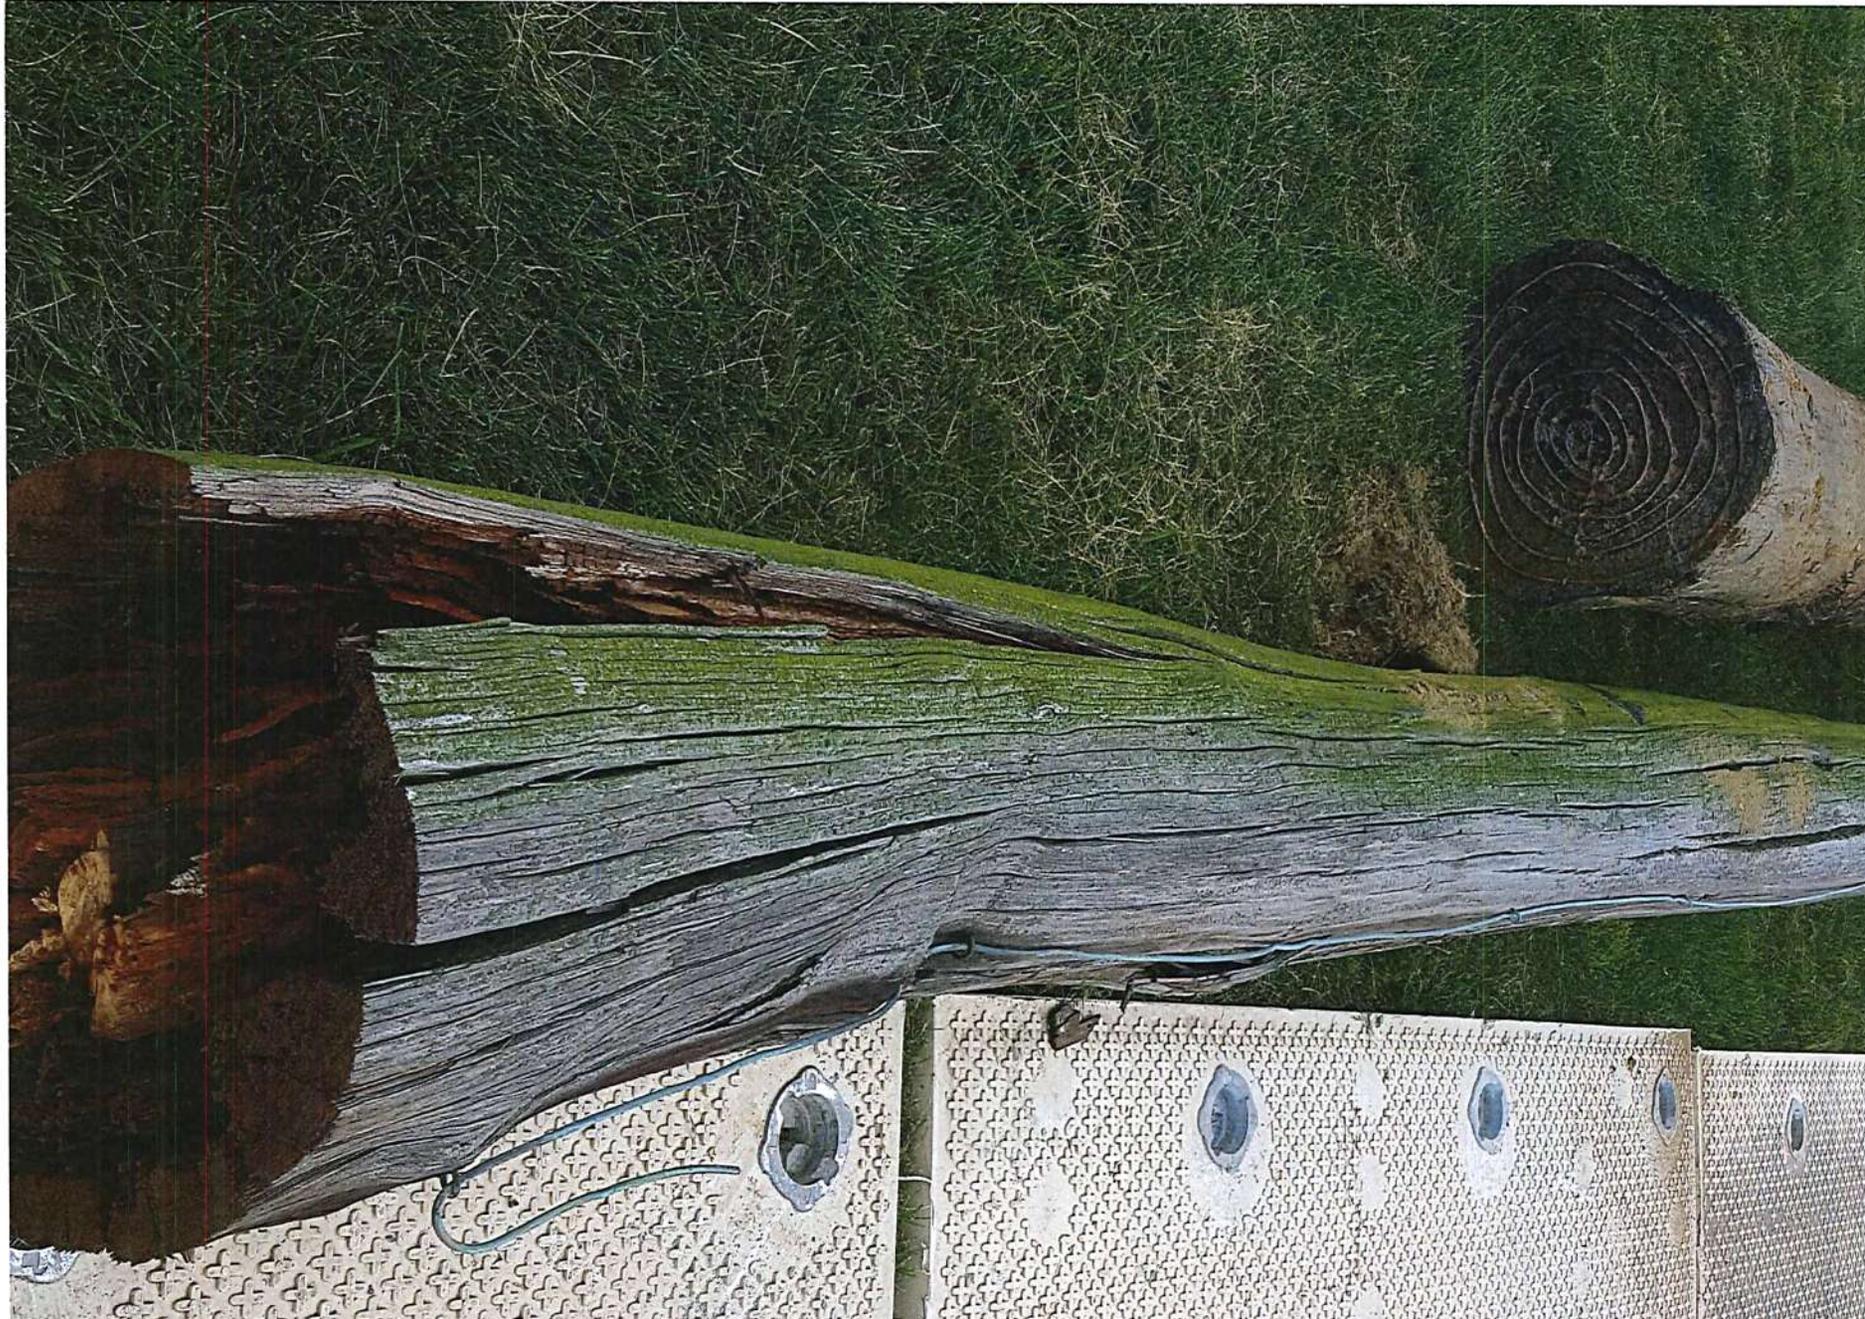
- Q.8 Reference the Letter of Notification, Paragraph 12. Please provide a photograph or image showing the surface and cross-sectional area of a failed cellon treated wood pole and a wood pole treated with some other process.
- A.8 Please see attached pictures of failed cellon treated poles.
