**Re: Letter of Notification of PPL Electric Utilities Corporation, Filed Pursuant to 52 Pa. Code Chapter 57 Subchapter G, for Approval of the Siting and Construction of the Siegfried-East Palmerton #1 & #2 183/69 kV Transmission Lines and Associated Tap Lines Located in Lehigh and Carbon Counties, Pennsylvania  
Docket No. A-2018-3001477**

**PPL Electric Utilities Corporation  
Response to Data Requests of  
Bureau of Technical Utility Services  
Dated August 8, 2018  
Docket No. A-2018-3001477**

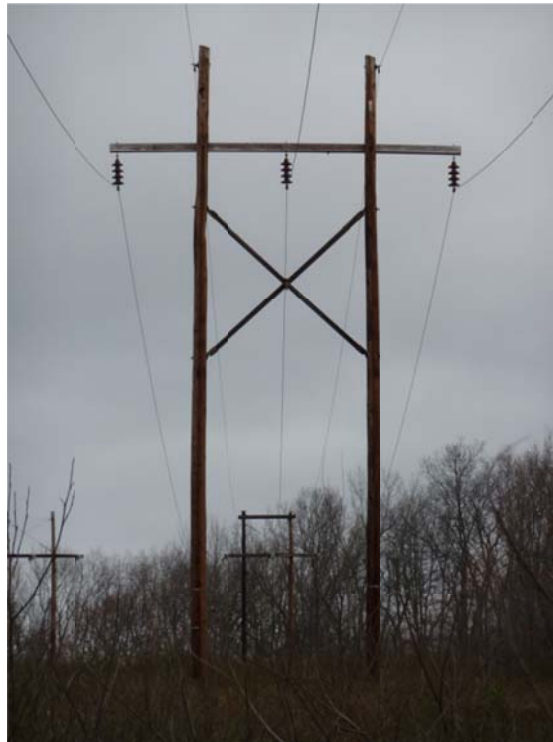
Photo 1 – Typical wood h-frame structure

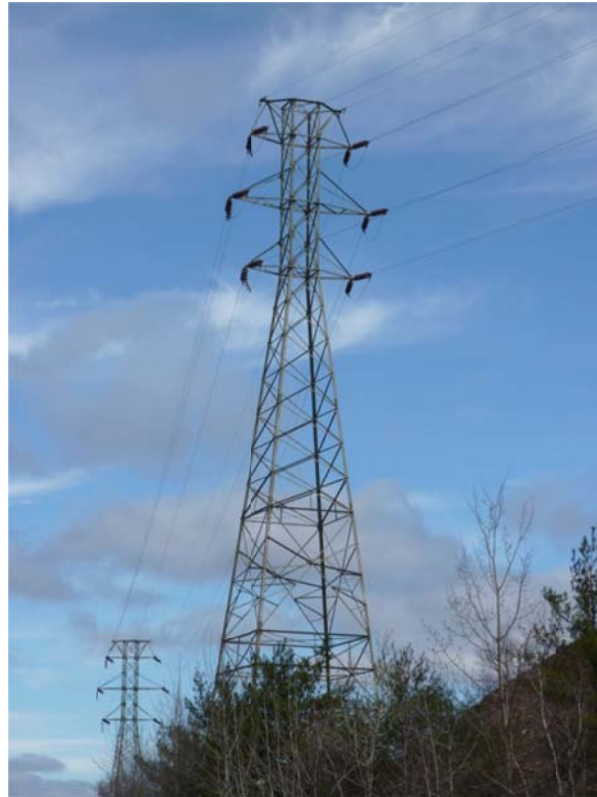
Photo 2 – Typical steel lattice tower

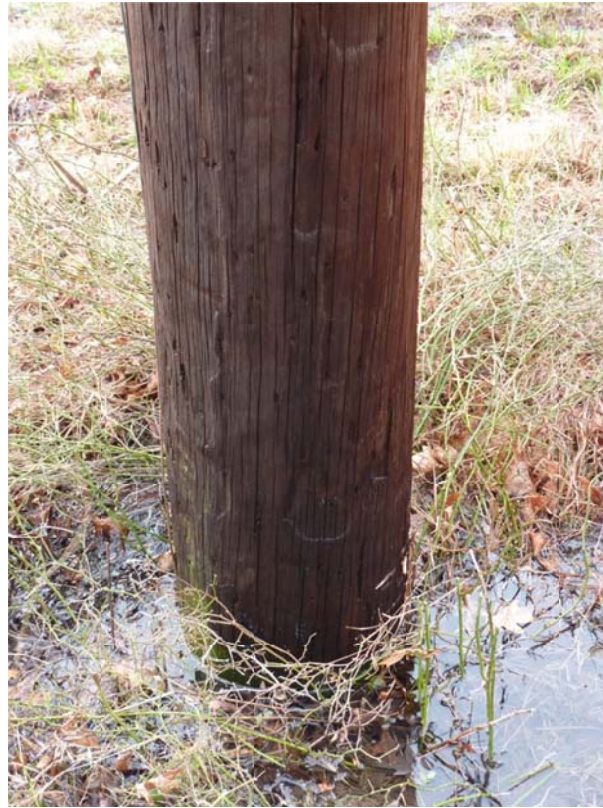
Photo 3 –Typical wood pole located in standing water

- Structure Inspection No. 65 is in severe condition. The poles are set in standing water and are completely water logged at the groundline. The wood is very soft and disintegrating at the groundline. Poles set in standing water is a severe condition.

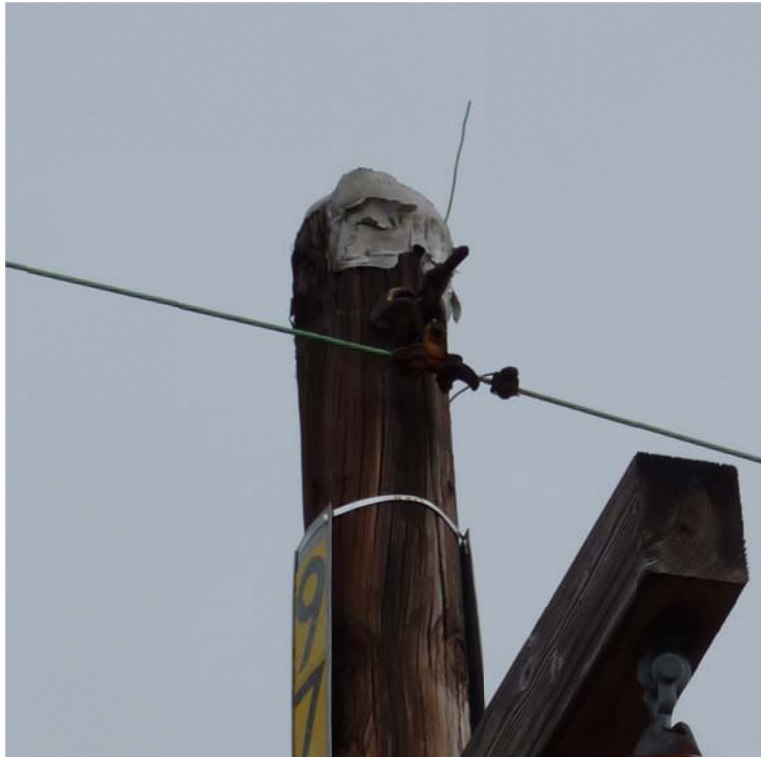
- Shield Wire Hardware: To evaluate the electrical and mechanical connection of the shield wire to the structure and to the adjacent shield wire span
  - The shield wire hardware is difficult to evaluate from the ground. There is a variety of different types of hardware being used. Most hardware that is steel has significant corrosion. U bolts on clamps are also significantly corroded.

Photo 4 – Typical Shield Wire Saddle Clamp Connection (hardware corroded)

- Based solely on age, all hardware such as strain clamps and saddle clamps should be replaced. This may be problematic though due to the use of ductile iron clamps and copper or copperweld conductor. The clamps are likely difficult to remove and the wire is likely damaged.

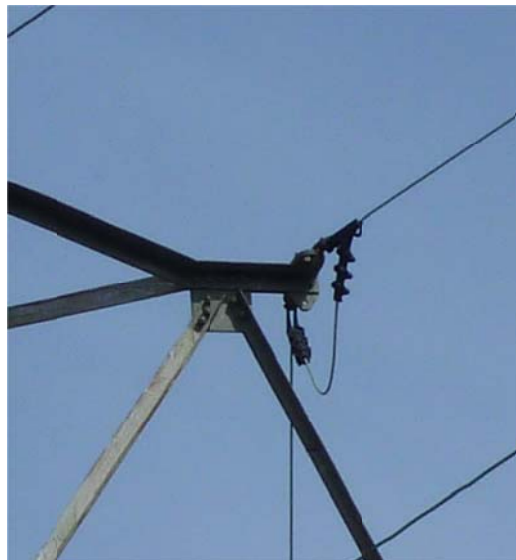
- Two tower structures have strain clamps and the shield wire is jumpered but not bonded to the tower. The hardware has significant surface corrosion. Structures northeast of the Lehigh River have hardware that is significantly more corroded than the rest of the corridor. This is believed to be a result of the industry in the area. These are poor conditions.

Photo 5 – Typical Shield Wire Strain Clamp Connection (jumped but not bonded to tower and hardware very corroded)

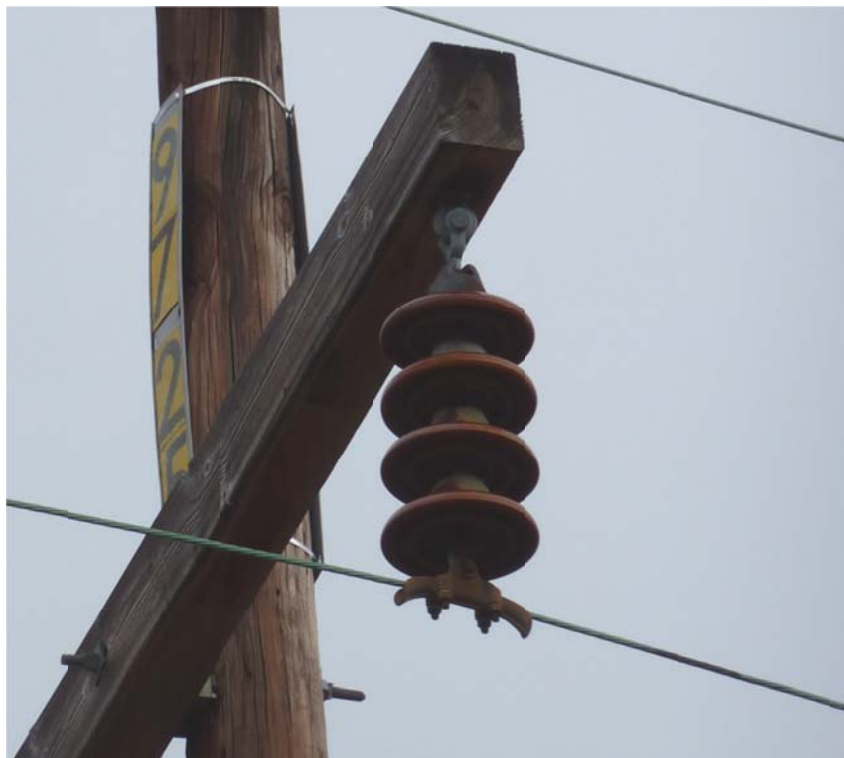
Photo 6 – Typical suspension insulator string

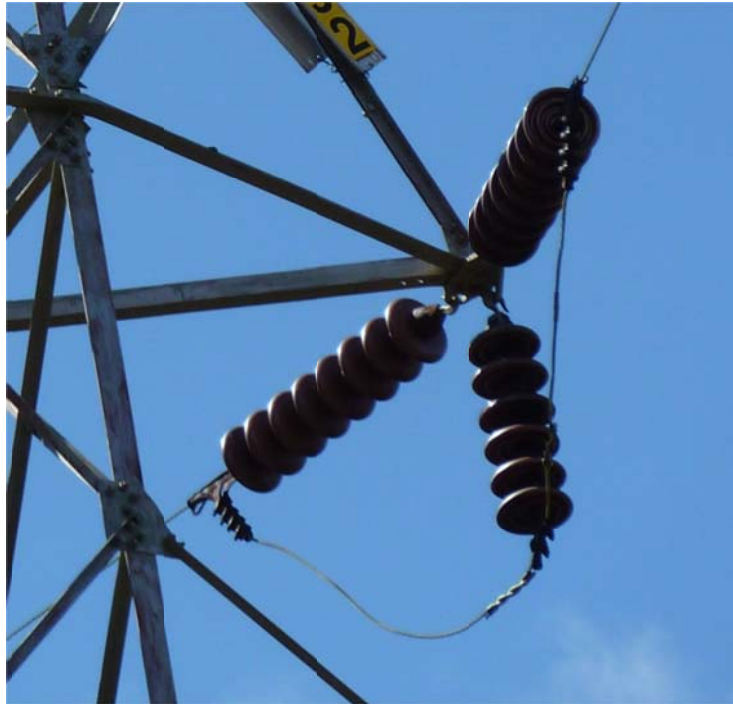
- Two tower structures located to the northeast of the Lehigh River have poor insulator and hardware conditions. Significant corrosion can be seen on all hardware. Similar to the shield wire hardware, this is believed to be a result of the industry in the area. These are poor conditions.

Photo 7 – Heavy corrosion typical strain insulator string on lattice tower

- Based solely on age, hardware such as strain clamps and saddle clamps should be replaced. This may be problematic though due to the use of ductile iron clamps and copper or copperweld conductor. The clamps are likely difficult to remove and the wire is likely damaged.

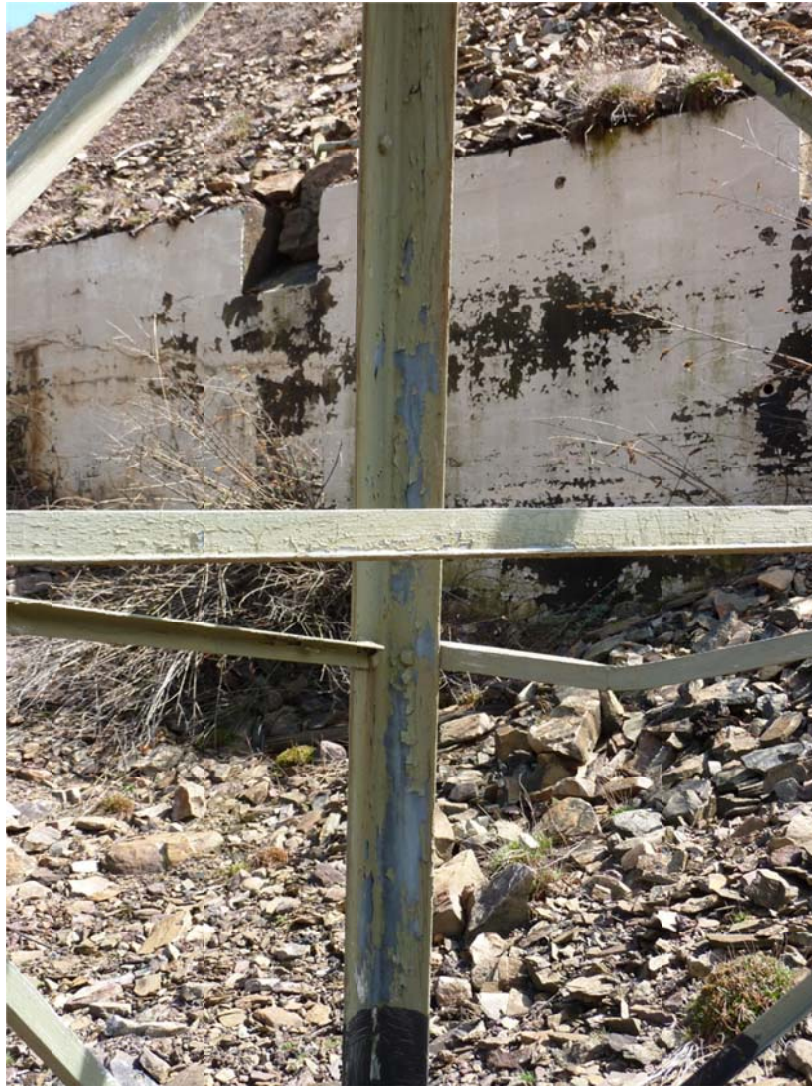
Photo 8 – Fair paint conditions, only peeling at bottom of tower

The two towers inspected have fair paint conditions. There is still life left on the tower coatings. In the near future, the towers will require a thorough scraping, priming and repainting with quality zinc based tower paint. Galvanizing can also be observed on the base of the tower where the paint coatings have peeled off. Some corrosion can be seen up high in the tower. This is thought to be a result of the corrosive environment northeast of the Lehigh River. Most towers on the Siegfried-E. Palmerton lines are located primarily in this region. Moderate surface corrosion on tower steel is evident and with failing coatings and exposed galvanizing, corrosion will begin to increase at a more rapid rate. Reference Figure 1.

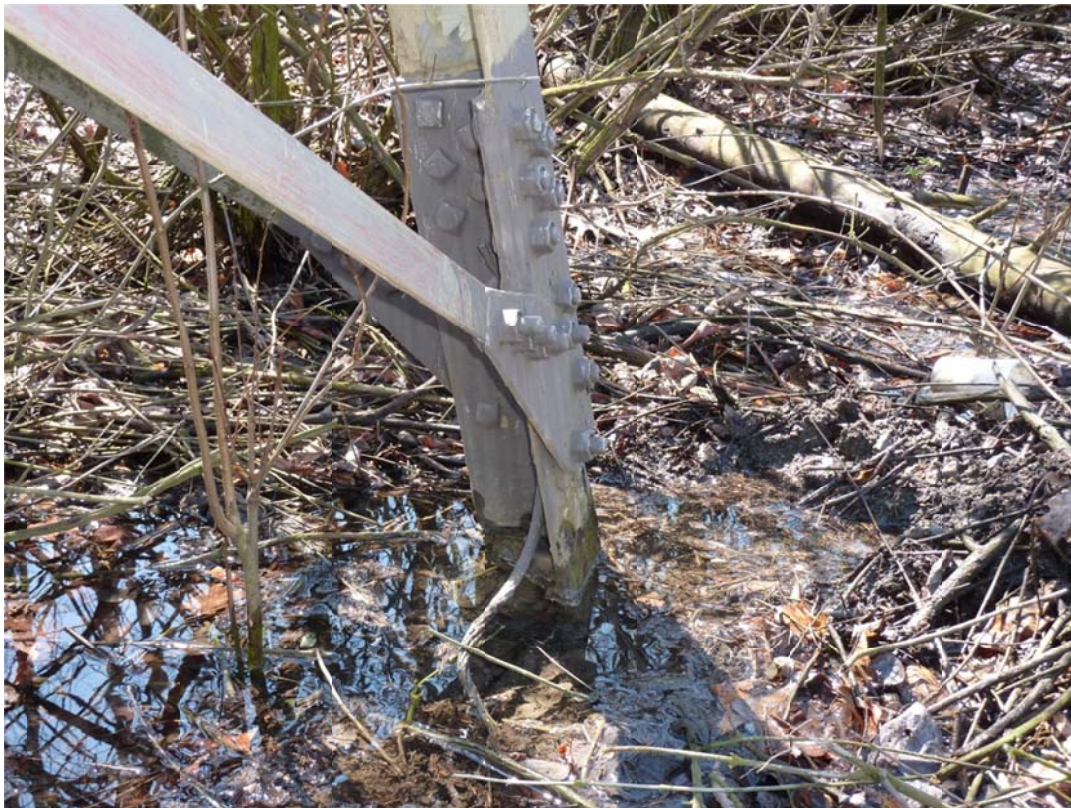
The DiGioia Gray ("DGA") report includes information on the condition of the foundations on these lines. Their main finding was "for all concrete foundations, the protective coal tar epoxy coating is beginning to crack and delaminate". Some foundations are located below grade or even under water, which can accelerate corrosion of the steel, causing section loss and compromising the structural stability of the towers.

- o Structure Inspection No. 70 has poor foundation conditions. Only Leg No. 3 has concrete projection above the groundline. The other three concrete foundations were located below grade and one was submerged under water. No severe condition was observed. There was no visible or detectable section loss, but the water conditions and the foundations being located below grade are not a good combination. These are poor conditions.

Photo 9 – Submerged Concrete Foundation (Structure Inspection No. 70)

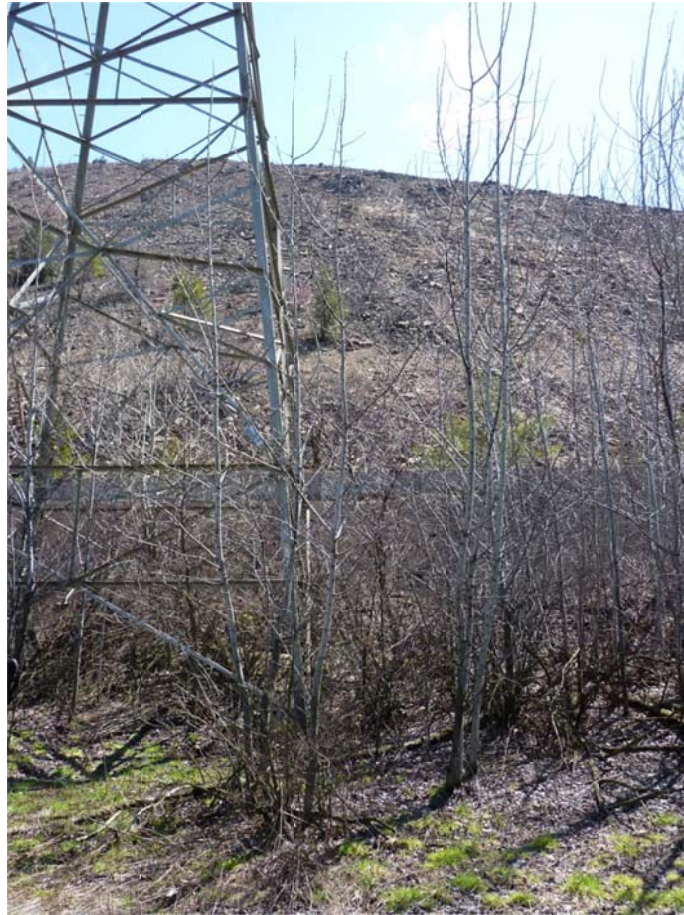
- o Structure Inspection No. 70 has many bushes and trees growing within and around structure. Vegetation inhibits access to structure. This is a poor condition.

Photo 10 – Poor vegetation conditions (Structure Inspection No. 70)
