**Face Rock – Five Forks Inspection of Structures**

NEETRAC Project Number: 16-107

June, 2016

Principal Investigator: Joe Goldenburg, P.E.  
(GA Lic# PE033181)

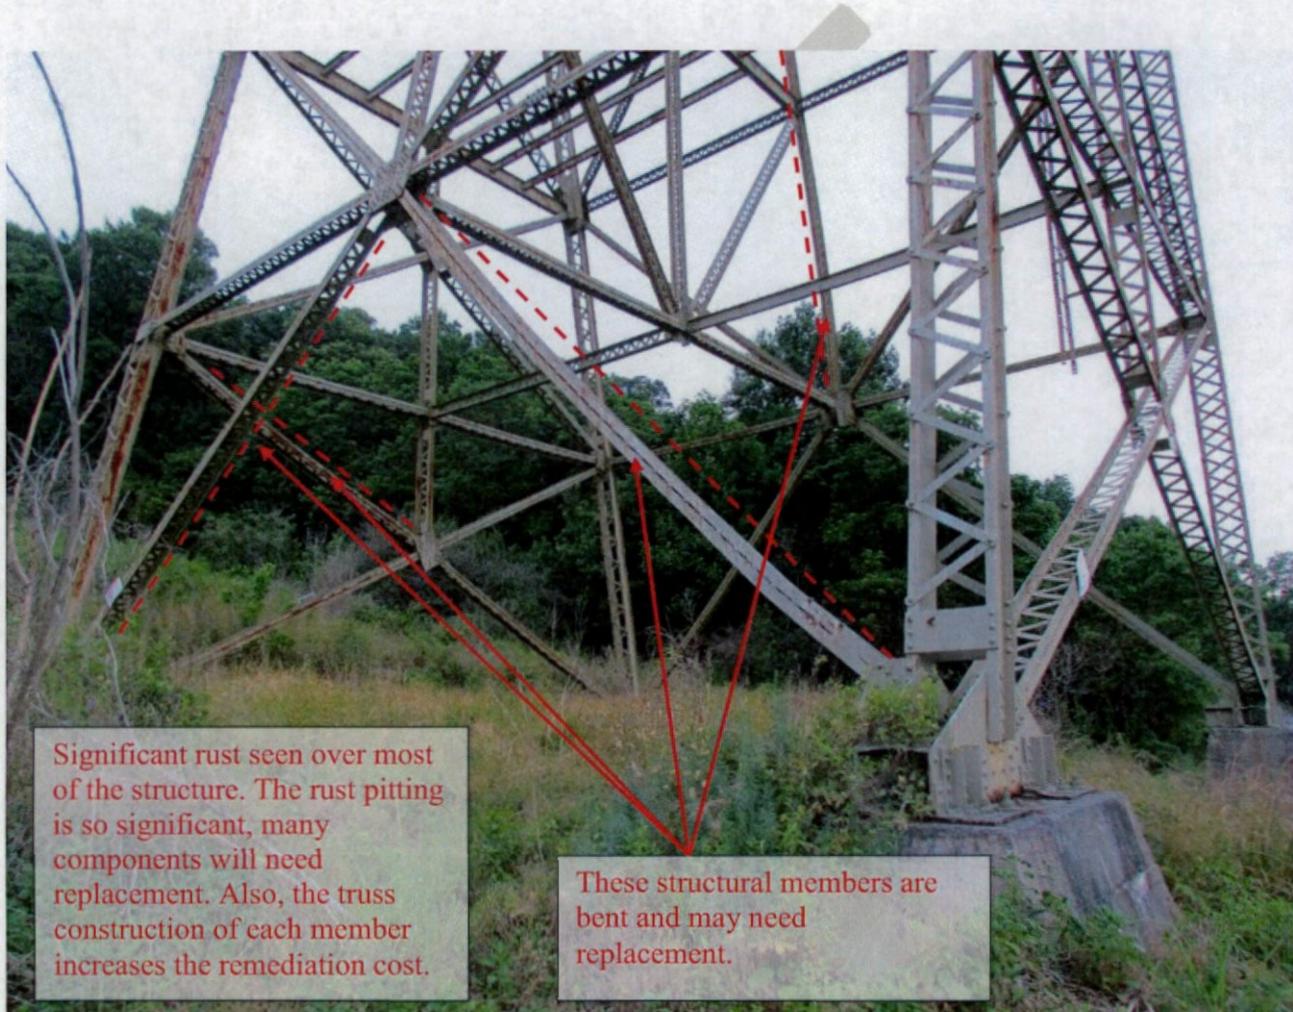
This structure requires immediate action. Several structural members were bent. The corrosion (rust) was pervasive and deep, with significant loss of base material and pack rust. Due to the amount of corrosion and the truss-like construction of the individual members, it is highly unlikely this structure can be saved.

**Figure 1:** 39615S18127 - Significant rust and bent structural members

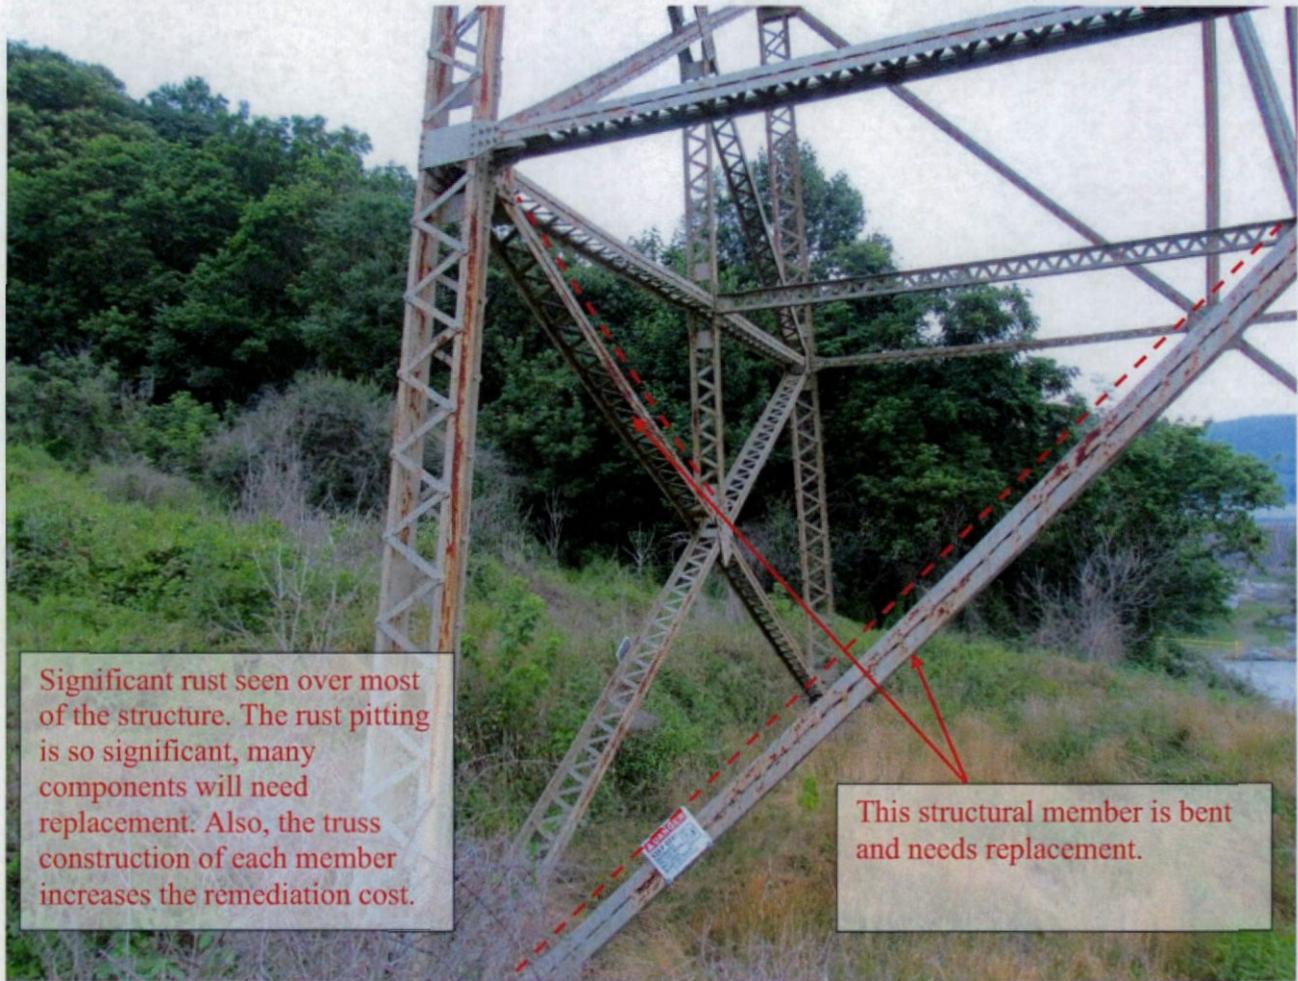
Significant rust seen over most of the structure. The rust pitting is so significant, many components will need replacement. Also, the truss construction of each member increases the remediation cost.

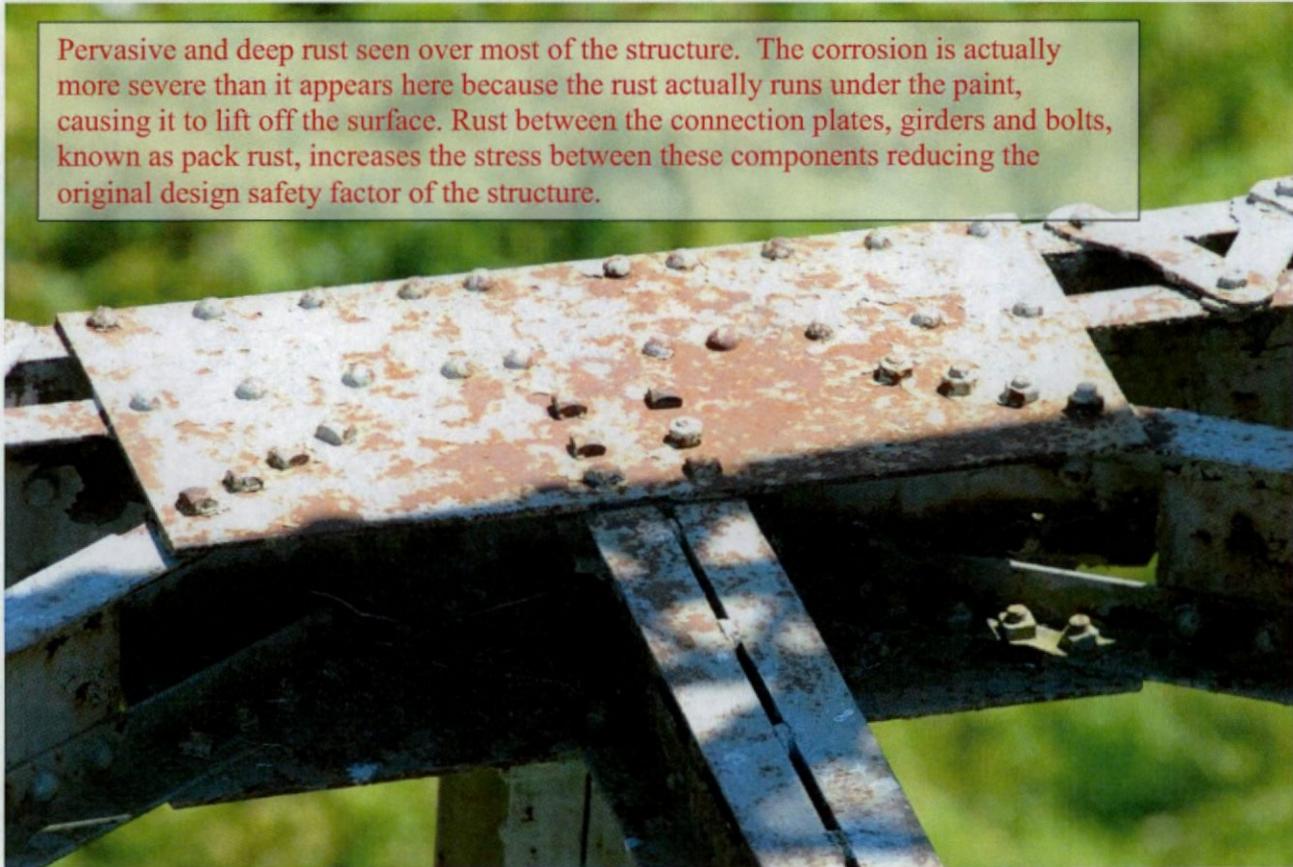
Figure 3: 39615S18127 - Pervasive rust covers most of the structure

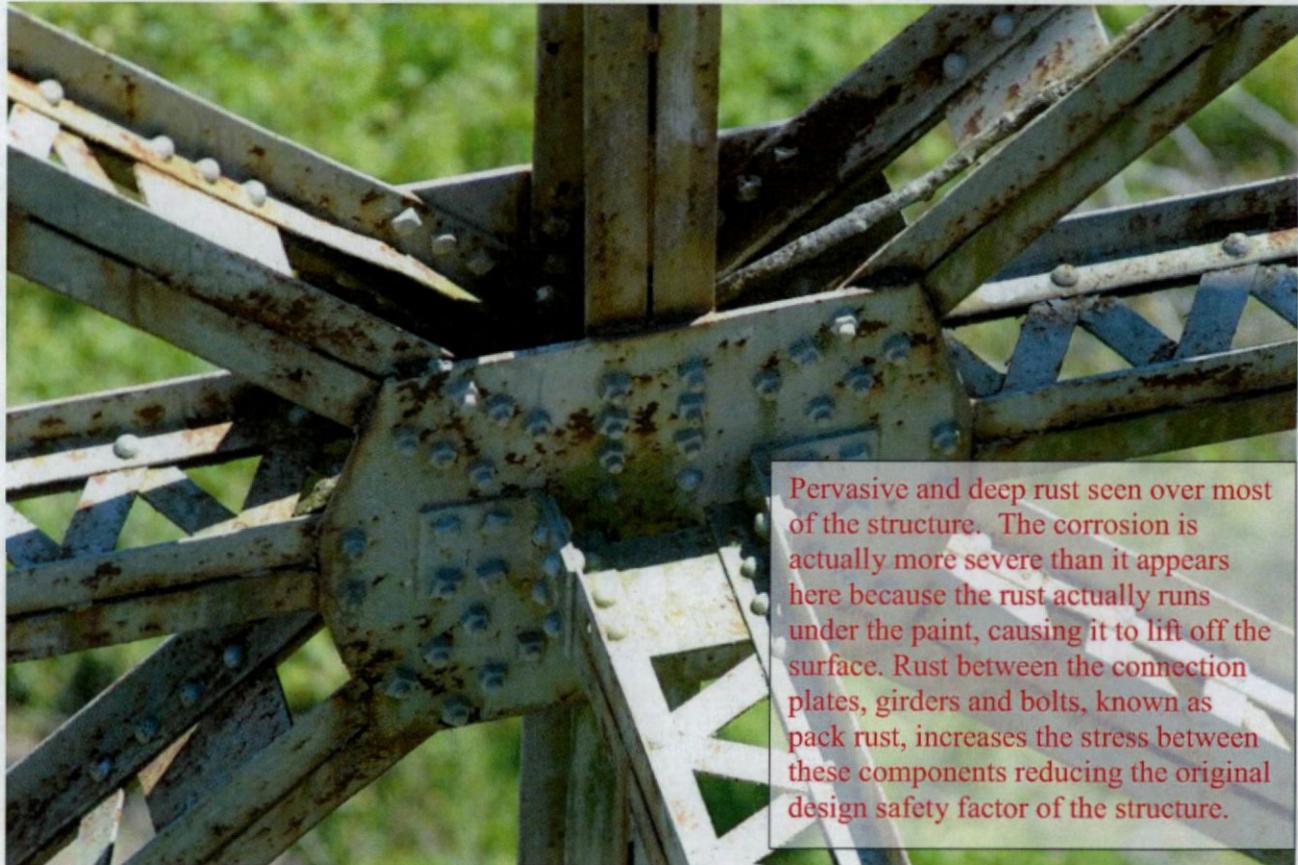
Pervasive and deep rust seen over most of the structure. The corrosion is actually more severe than it appears here because the rust actually runs under the paint, causing it to lift off the surface. Rust between the connection plates, girders and bolts, known as pack rust, increases the stress between these components reducing the original design safety factor of the structure.

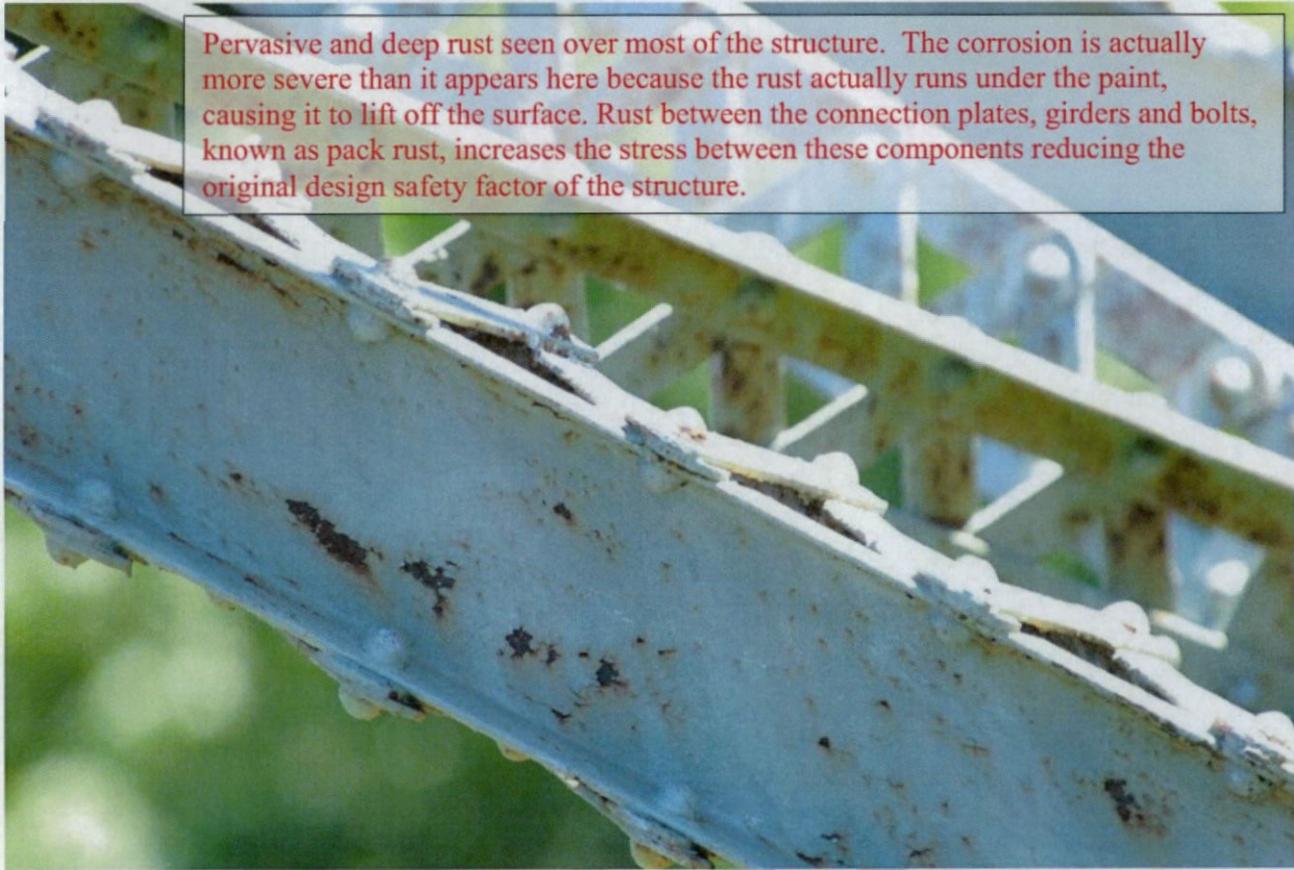
Pervasive and deep rust seen over most of the structure. The corrosion is actually more severe than it appears here because the rust actually runs under the paint, causing it to lift off the surface. Rust between the connection plates, girders and bolts, known as pack rust, increases the stress between these components reducing the original design safety factor of the structure.

**Figure 5:** 39615S18127 - Pervasive rust on the structure

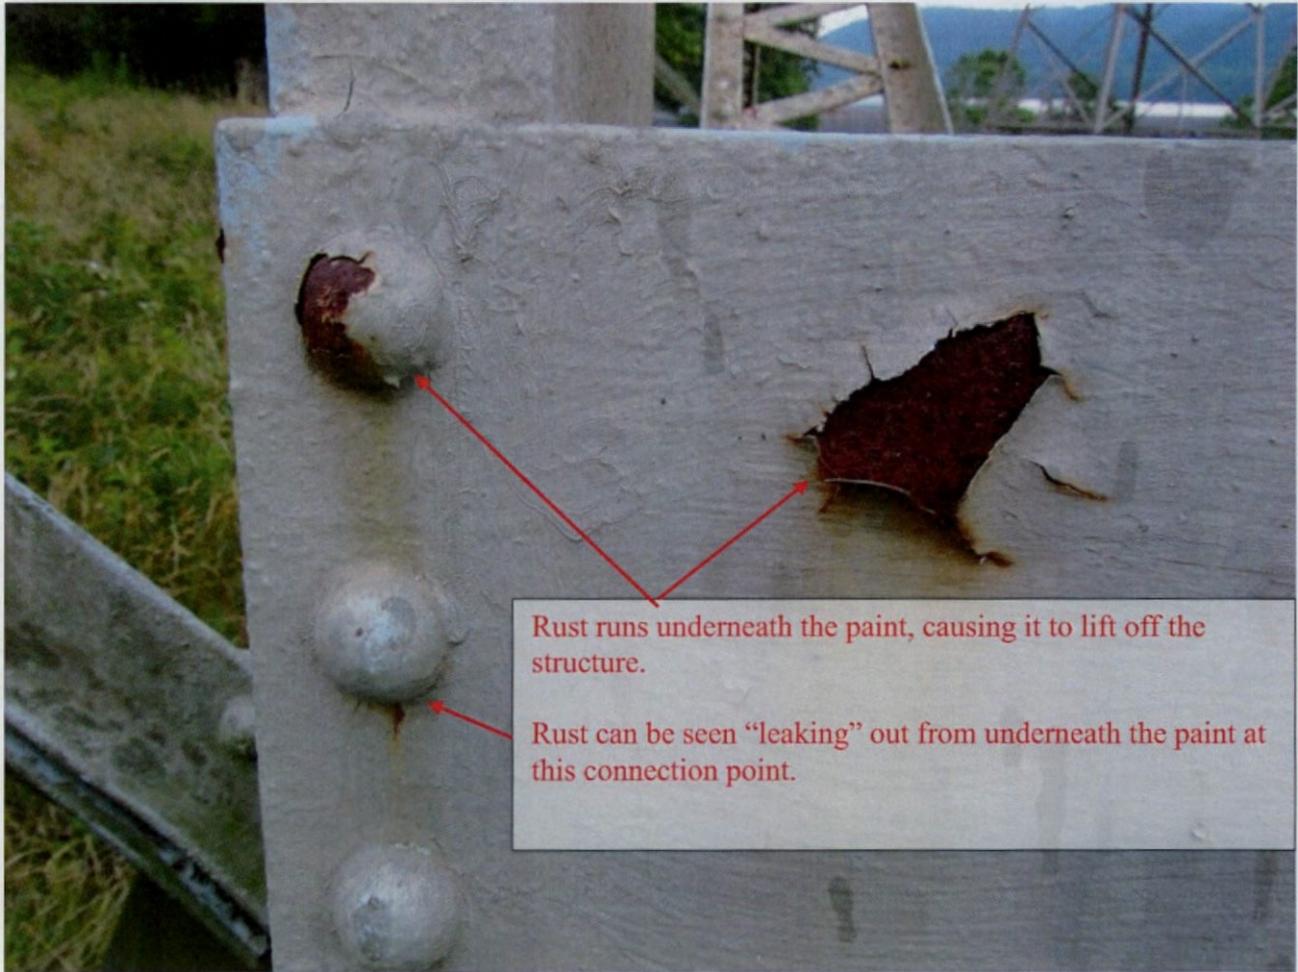
Figure 6: 39615S18127 - Peeling paint and sub-paint corrosion

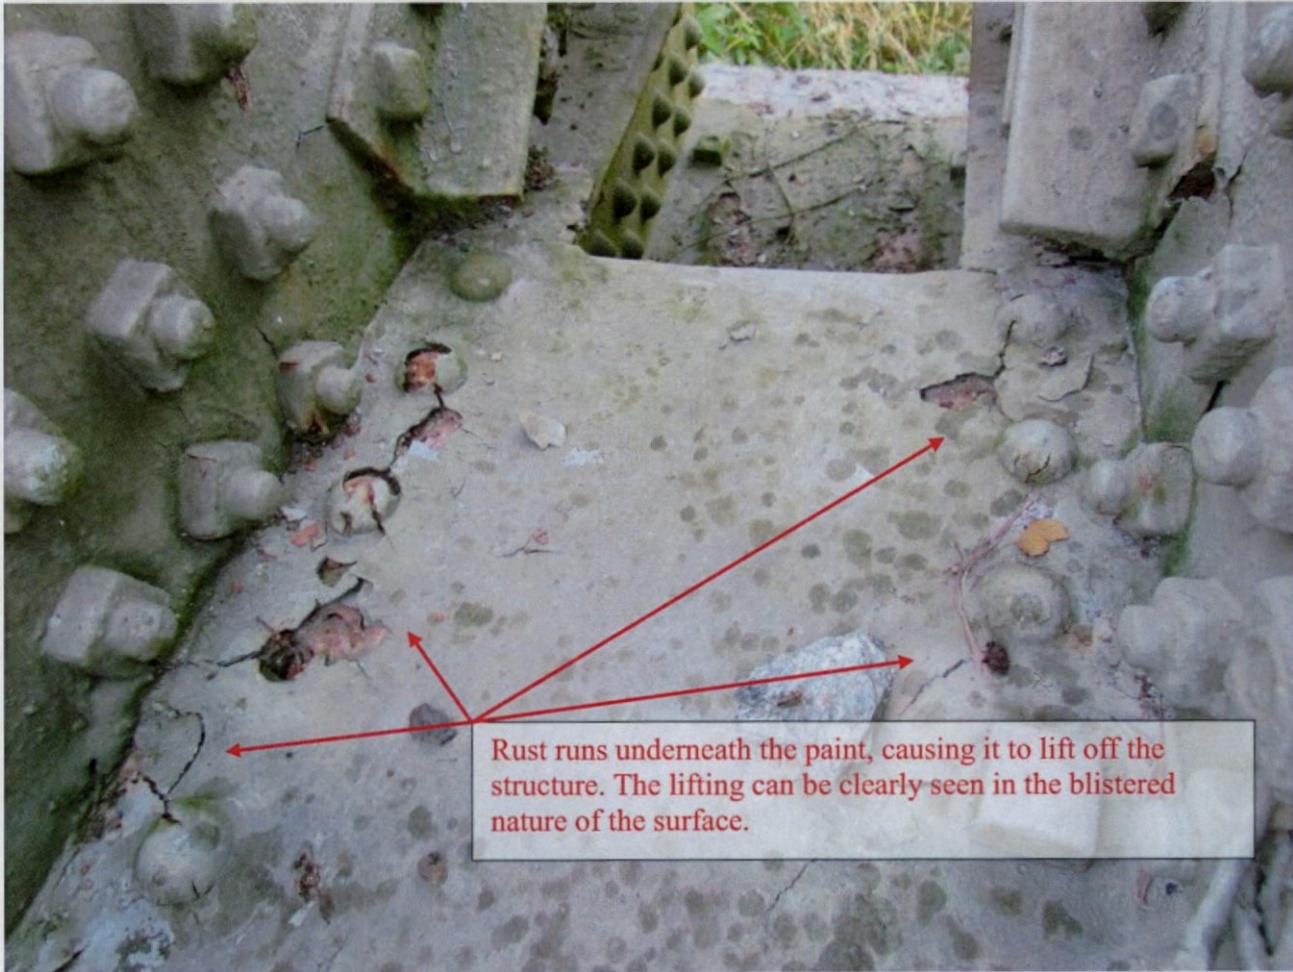
Figure 7: 39615S18127 - Sub-paint rust

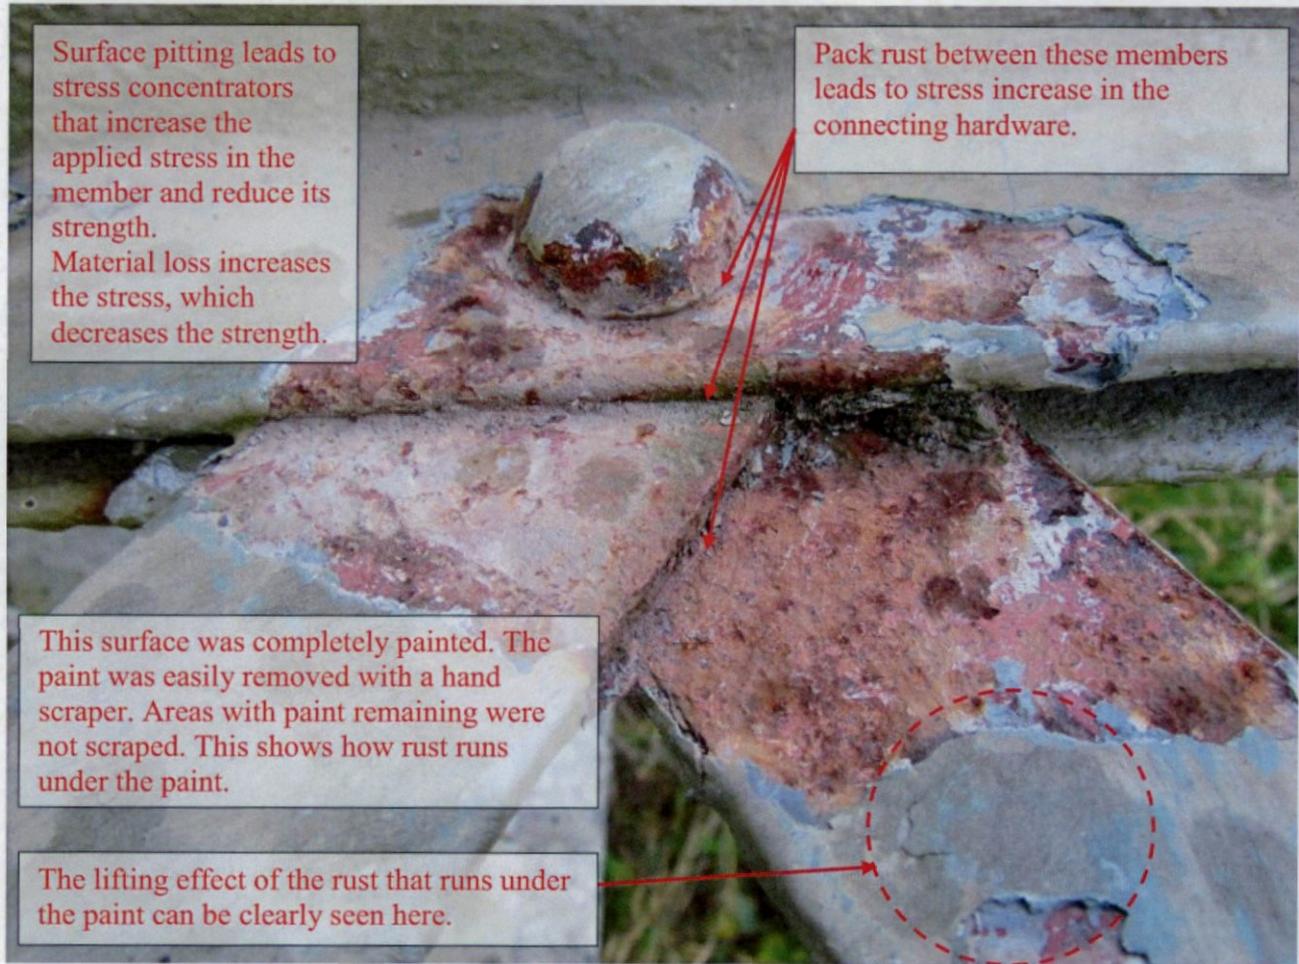
Figure 8: 39615S18127 - Sub-surface rust, rust pitting, pack rust

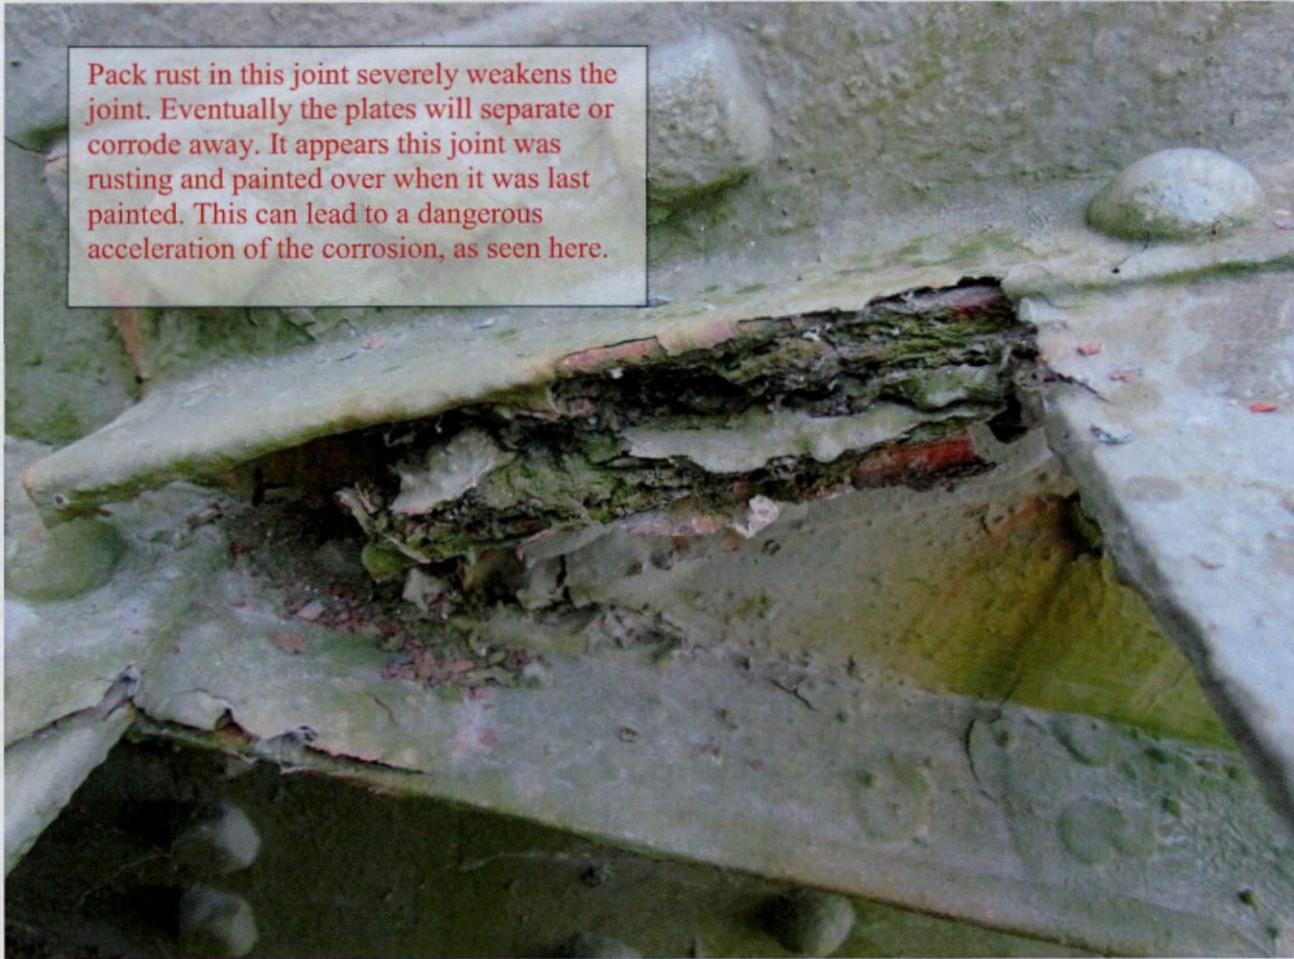
Figure 9: 39615S18127 - Pack rust in a joint

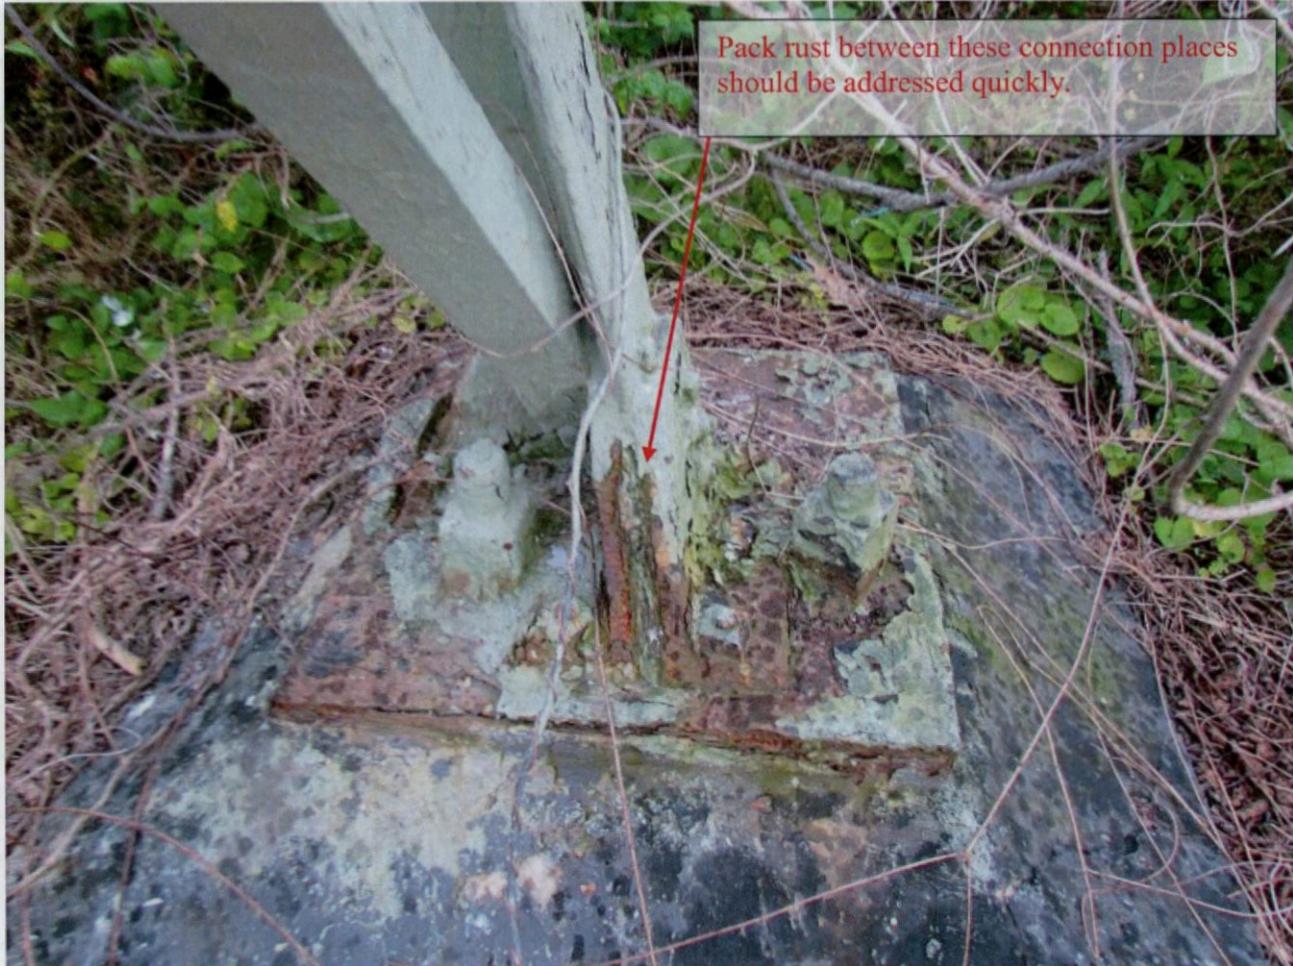
This structure requires immediate attention. There is significant corrosion with pack rust at the footing. Above the footing, some of the structural members have begun corroding. Also, there is poor paint adhesion over most of the structure. However, for much of the structure, the zinc layer is intact. The structure would require a thorough detailed climbing inspection to determine an appropriate remediation plan.

**Figure 10:** 3962S1518116 - Rust at the footing and connection plates

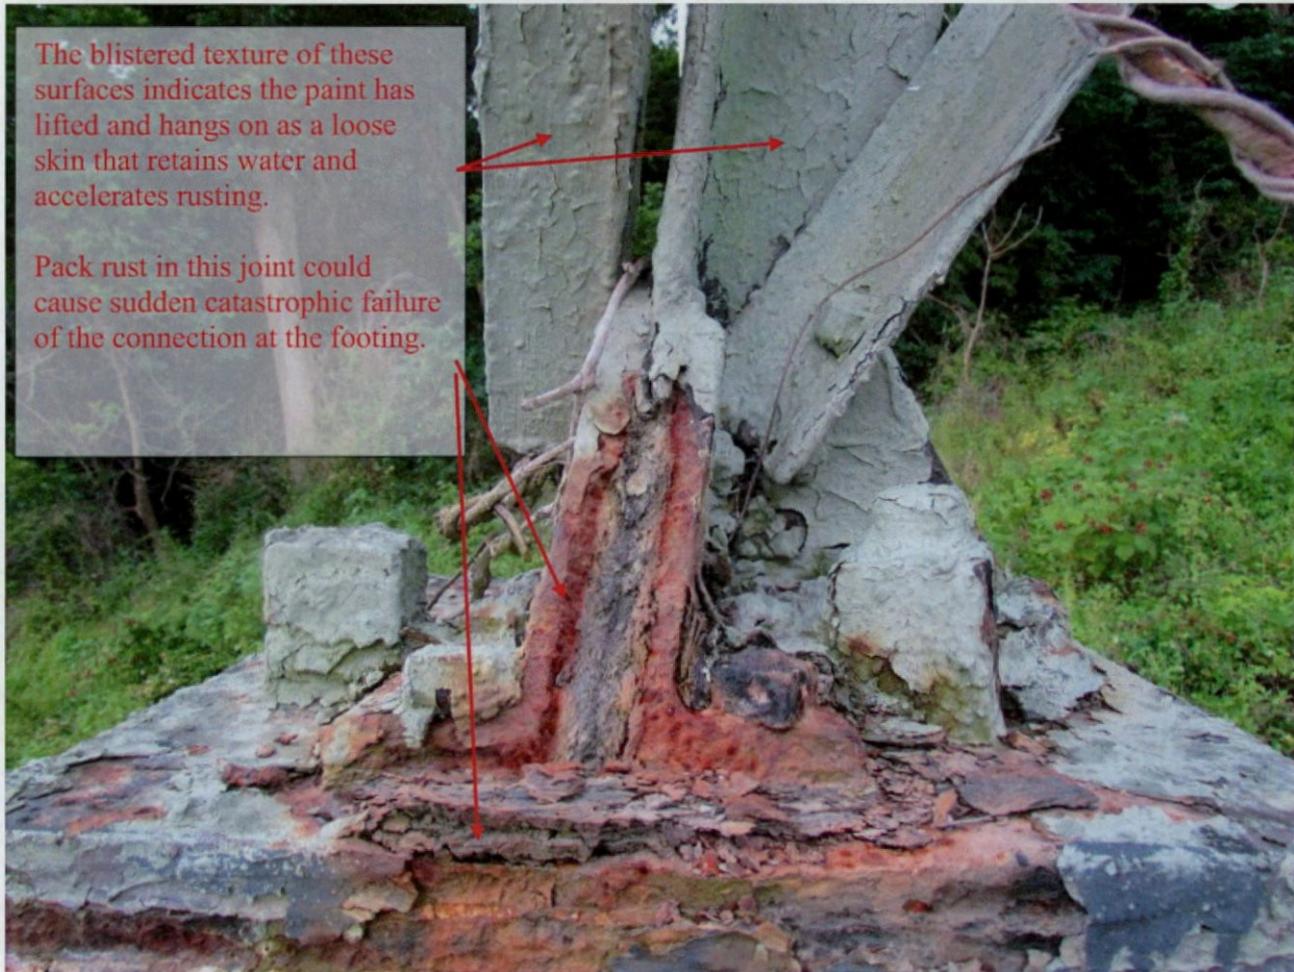
Figure 11: 3962S1518116 - Significant corrosion at the footing

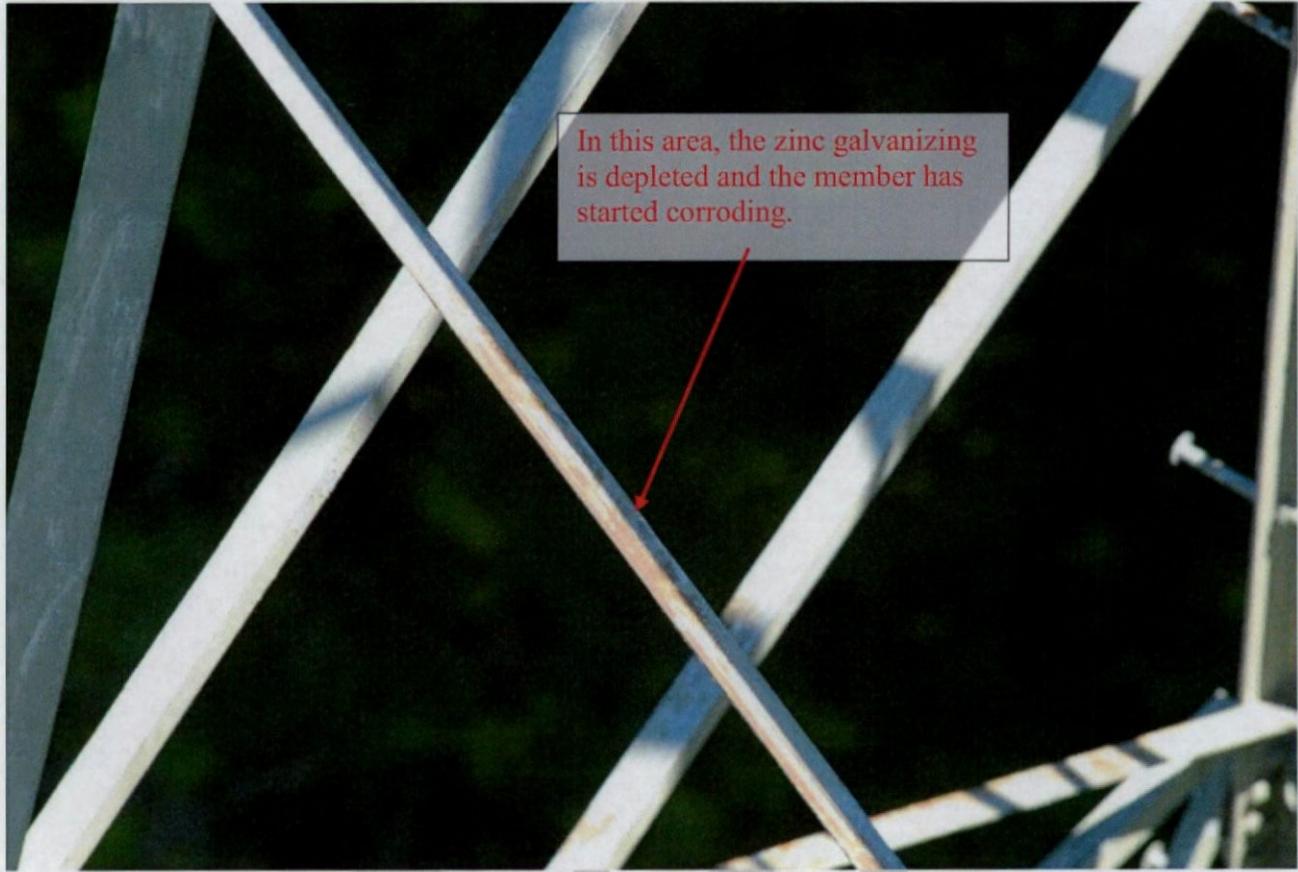
Figure 13: 3962S1518116 - Corrosion on cross bracing

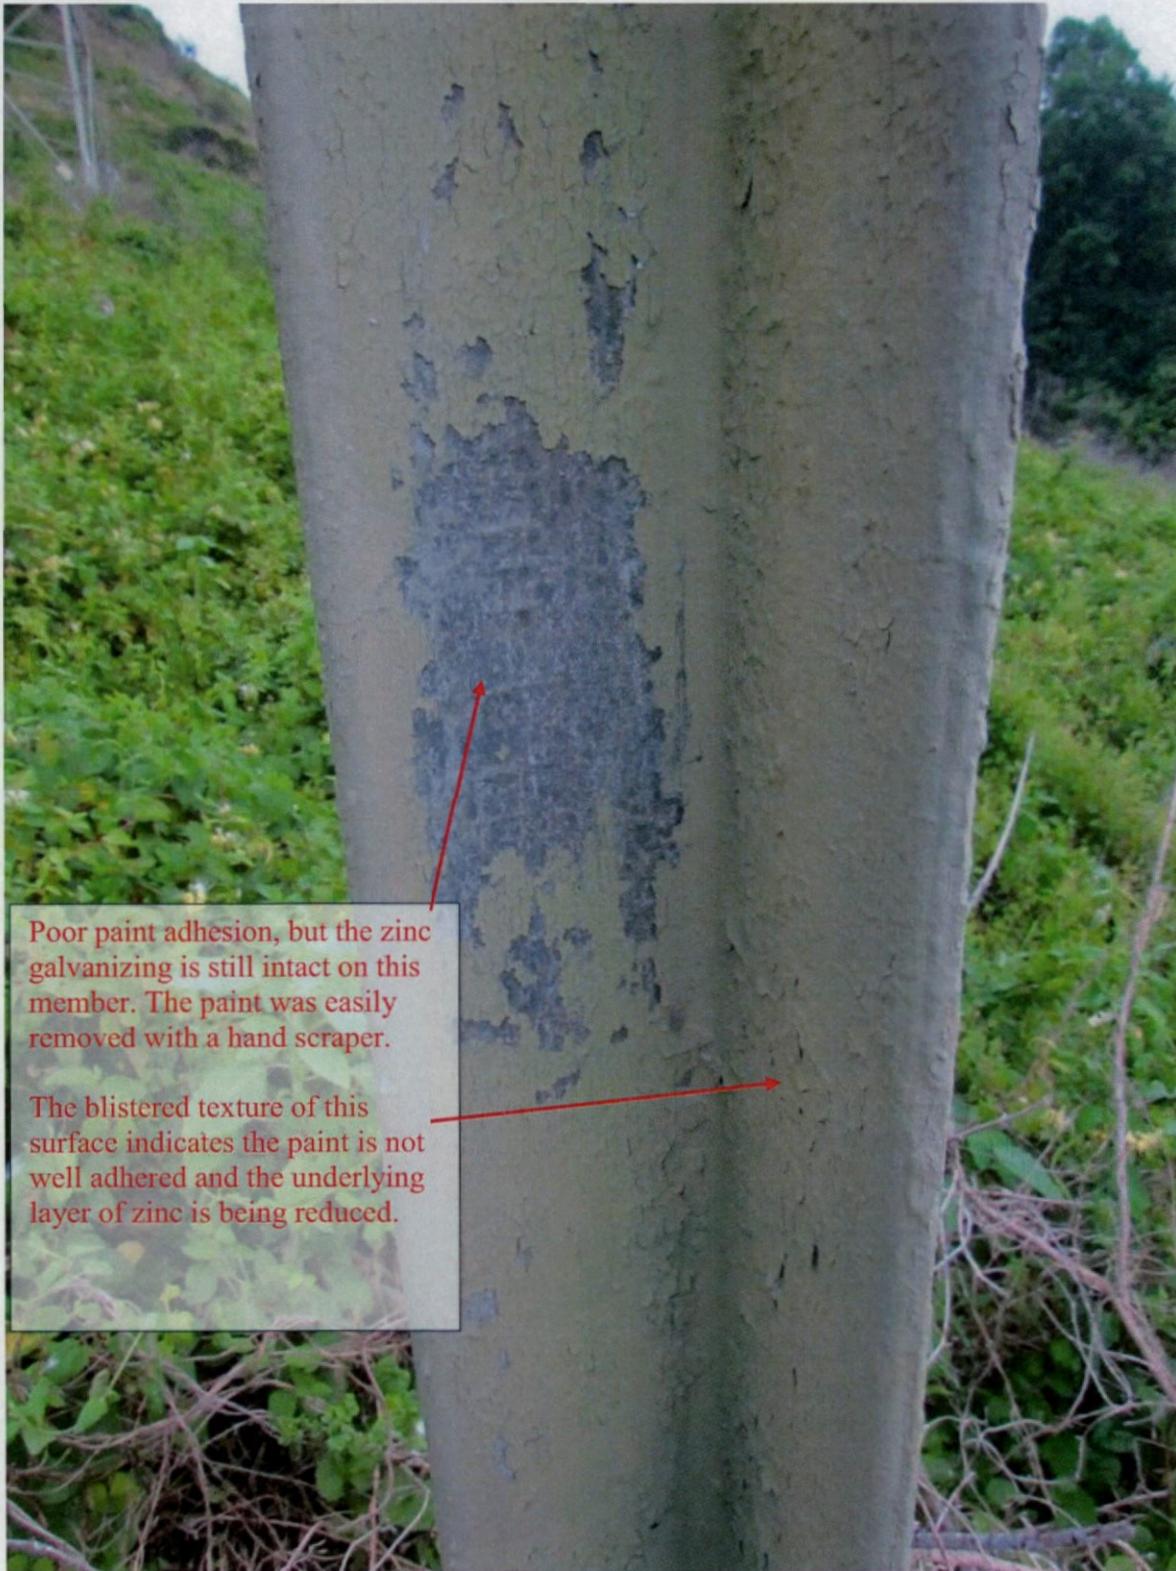
Figure 14: 3962S1518116 - Poor paint adhesion with underlying zinc galvanizing

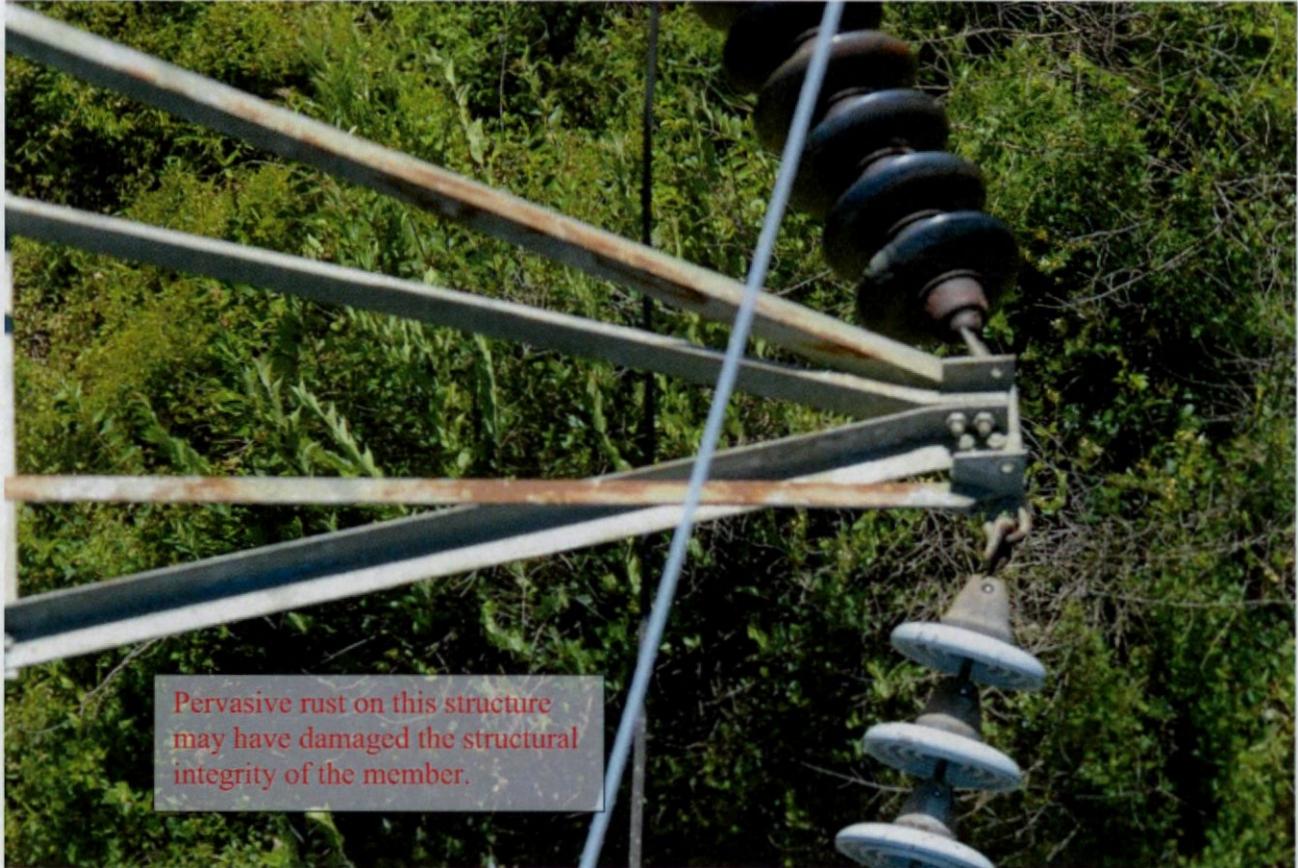
This structure exhibited significant paint peeling and corrosion (rust) along most of the components. A detailed climbing inspection would be needed to determine an appropriate remediation plan. In many areas, the corrosion may be too deep to be removed and the structural member will need to be replaced.

Figure 16: 39513S18076 - Pervasive rust on this structure

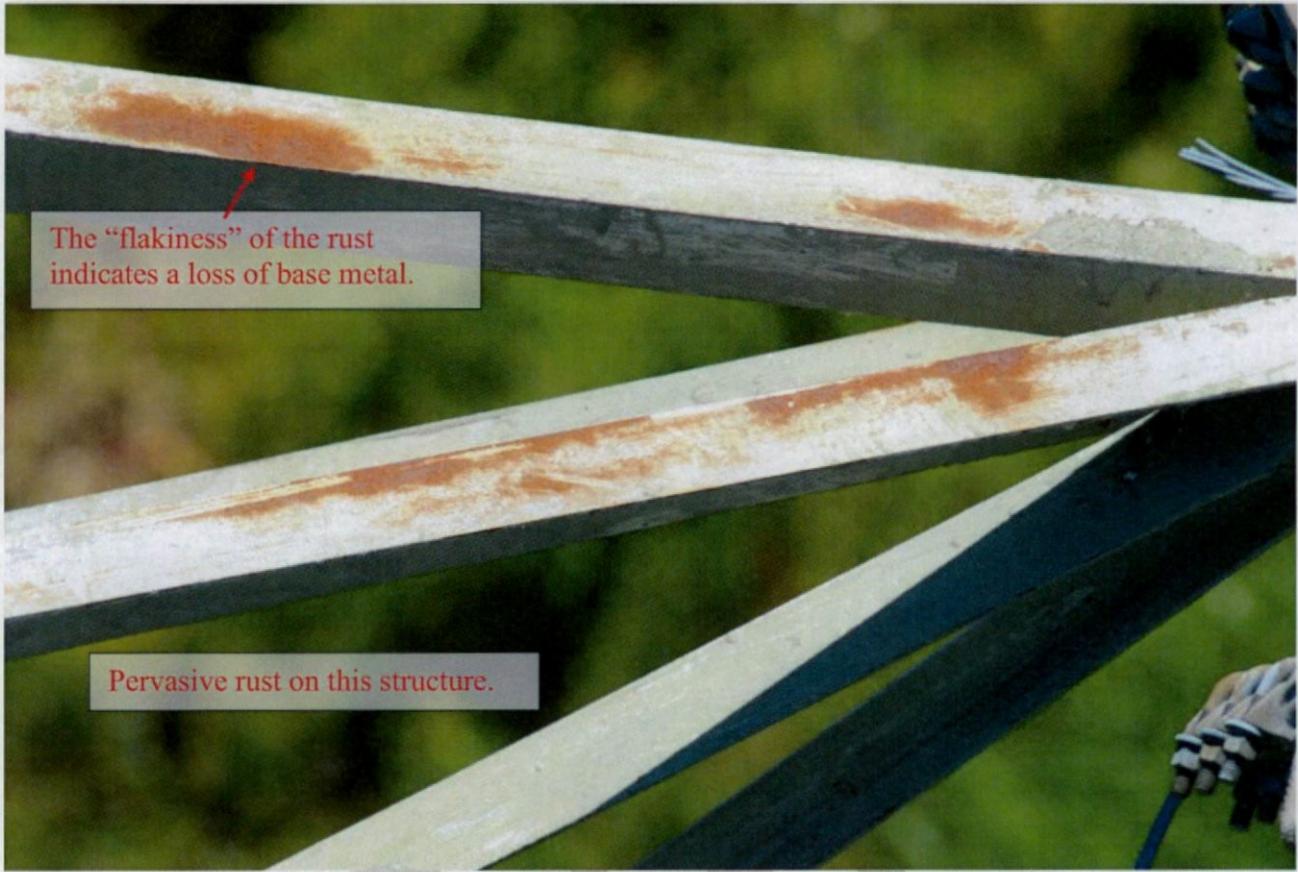
Figure 17: 39513S18076 - Pervasive rust on this structure

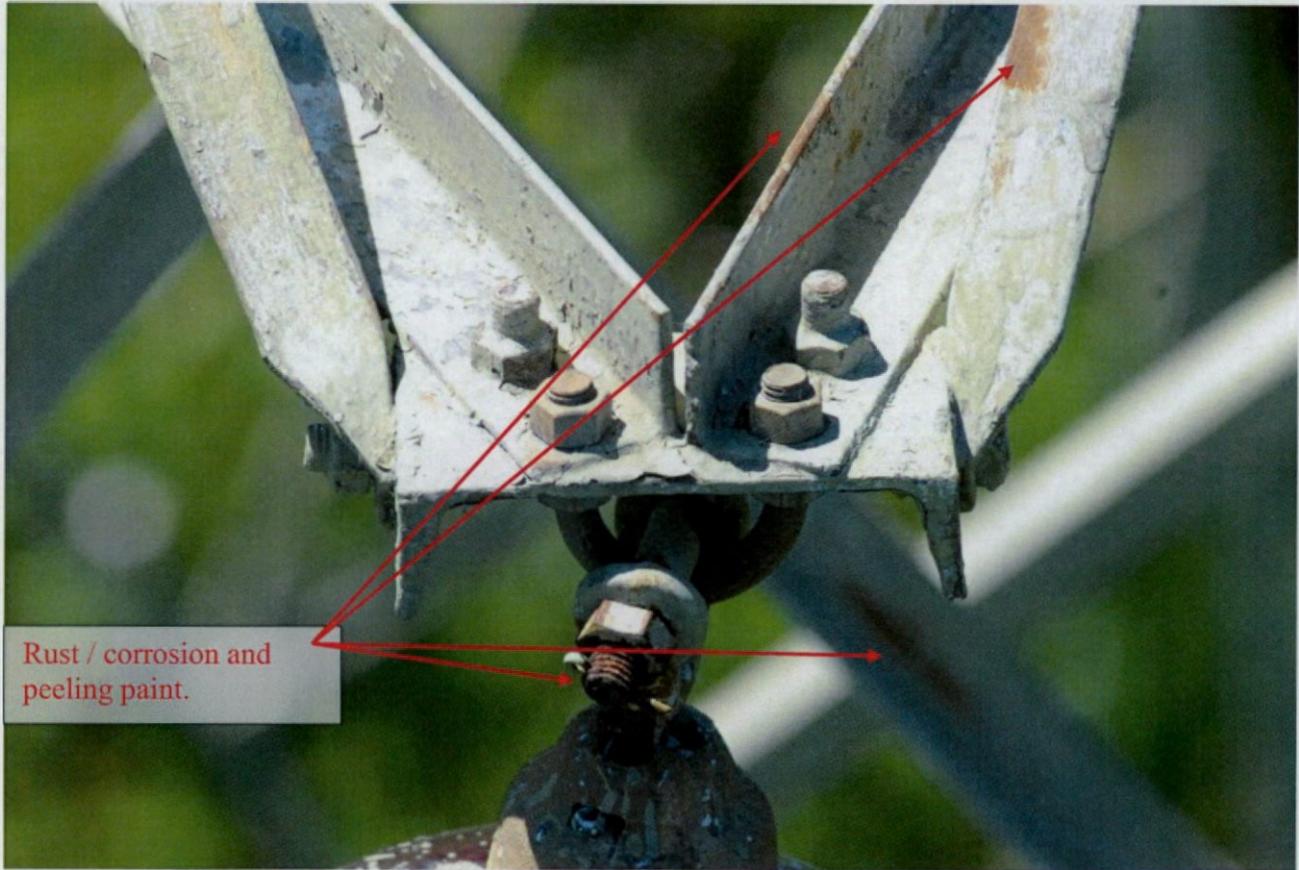
This structure exhibited poor paint adhesion and pervasive rusting along most of the structure. A detailed climbing inspection is needed to determine a remediation plan for this structure.

**Figure 18: 39436S17961 - Corrosion and peeling paint**

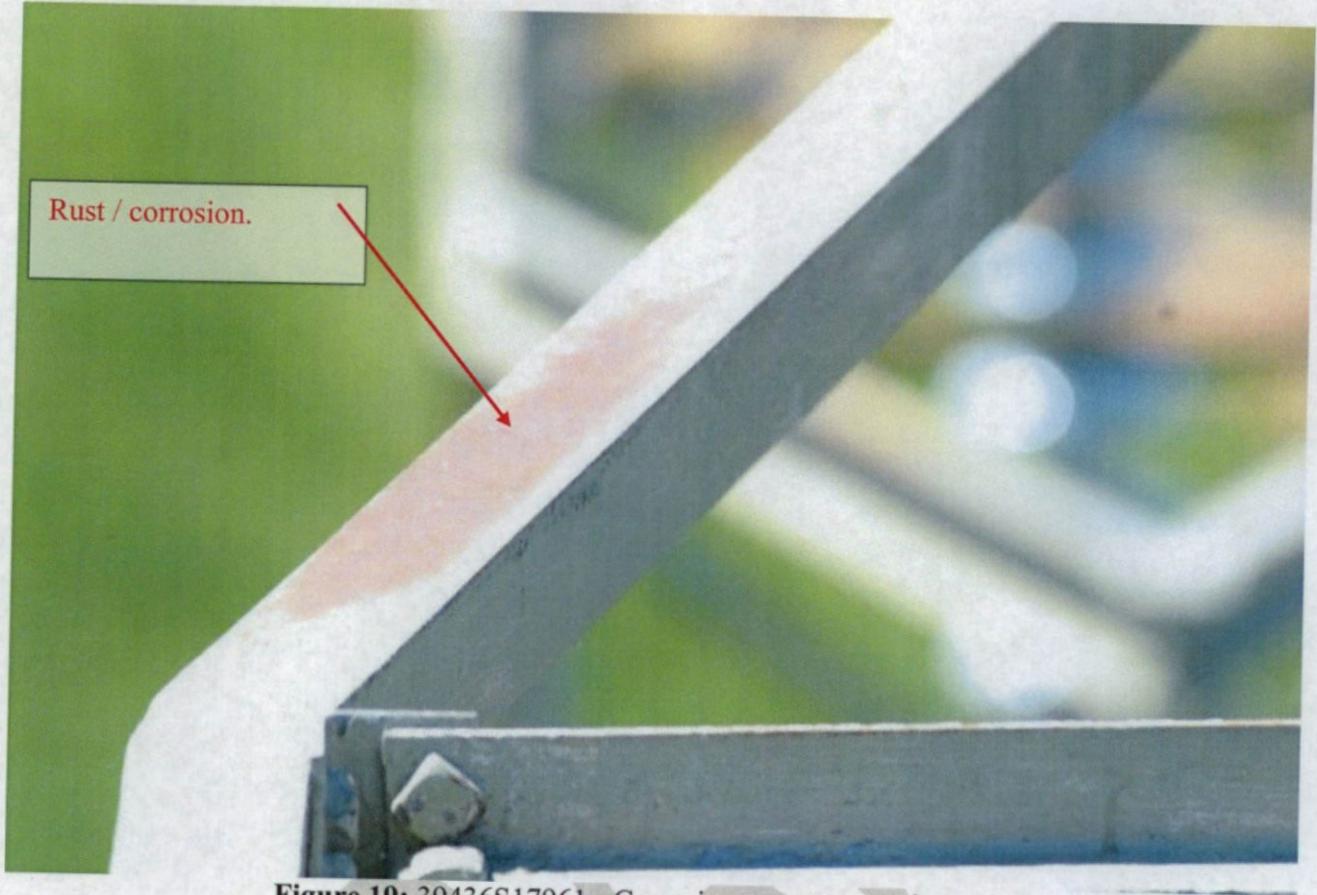
Figure 19: 39436S17961 - Corrosion on a structural member

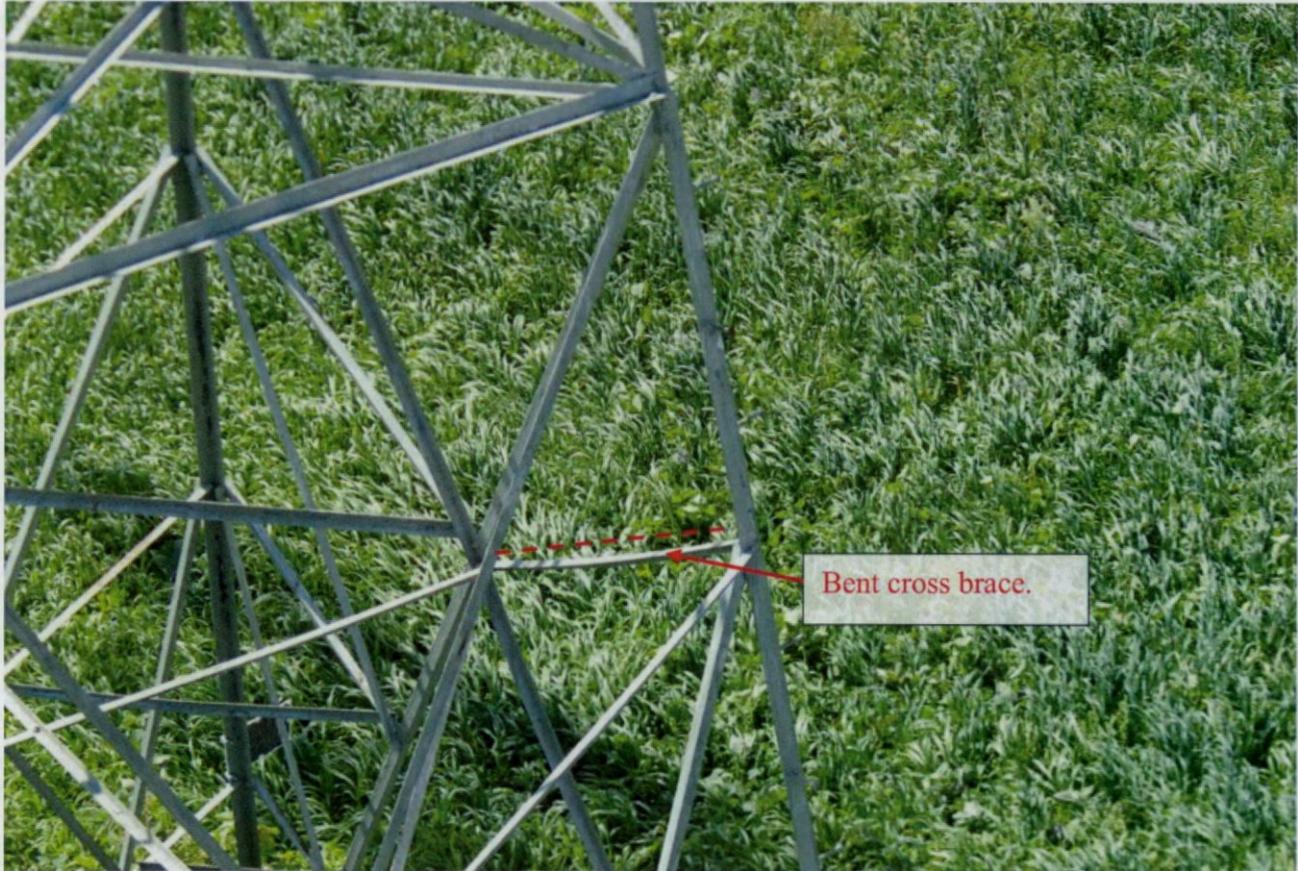
This structure was not on the list, but a bent structural member was noted on flyby.

Figure 20: 39404S17922 - Bent cross brace
