**Face Rock – Five Forks Inspection of Structures**

NEETRAC Project Number: 16-107

June, 2016

Principal Investigator: Joe Goldenburg, P.E.  
(GA Lic# PE033181)

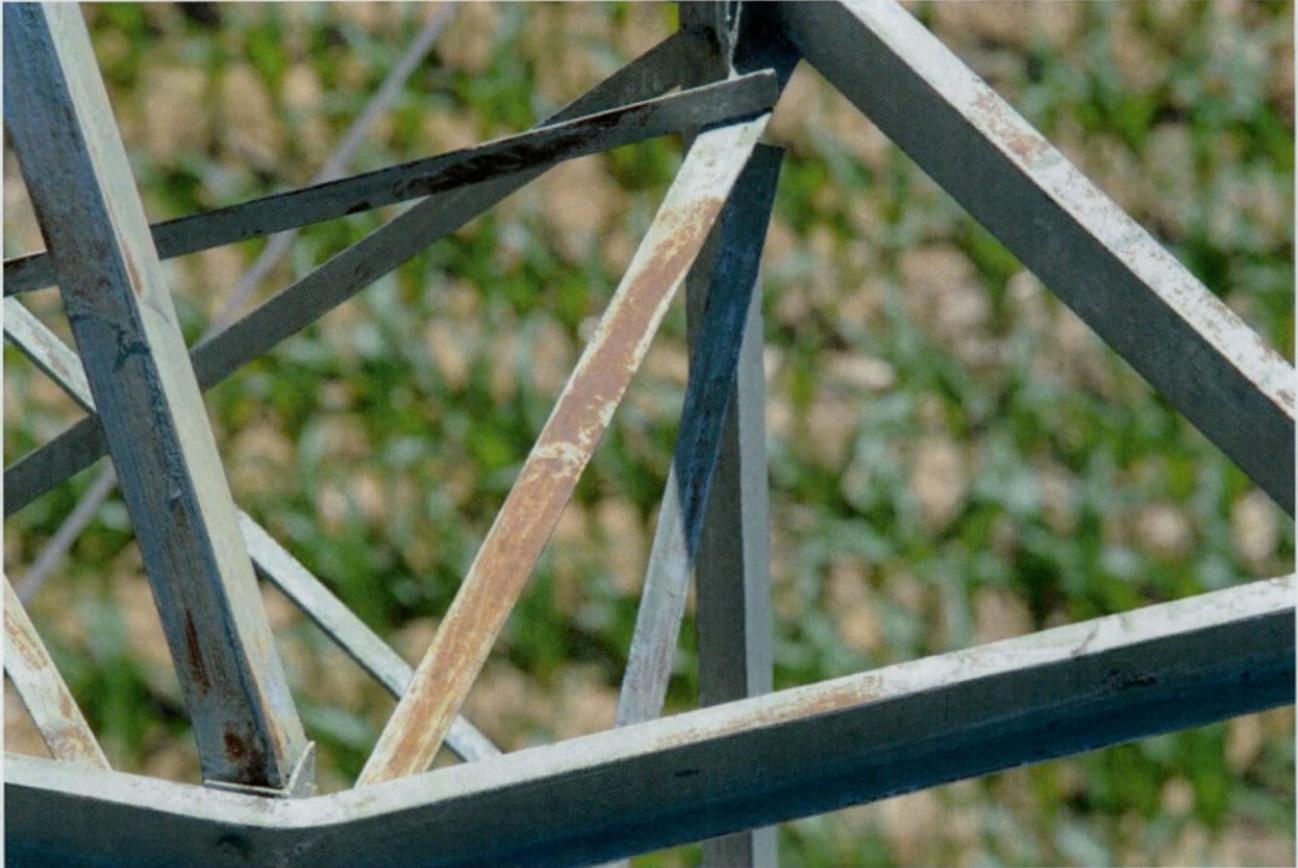
This structure exhibited pervasive paint peeling and significant corrosion that may have reduced structural strength. A detailed climbing inspection would be needed to better evaluate this structure.

**Figure 21:** 39430S17964 - Pervasive corrosion and paint peeling on this structure

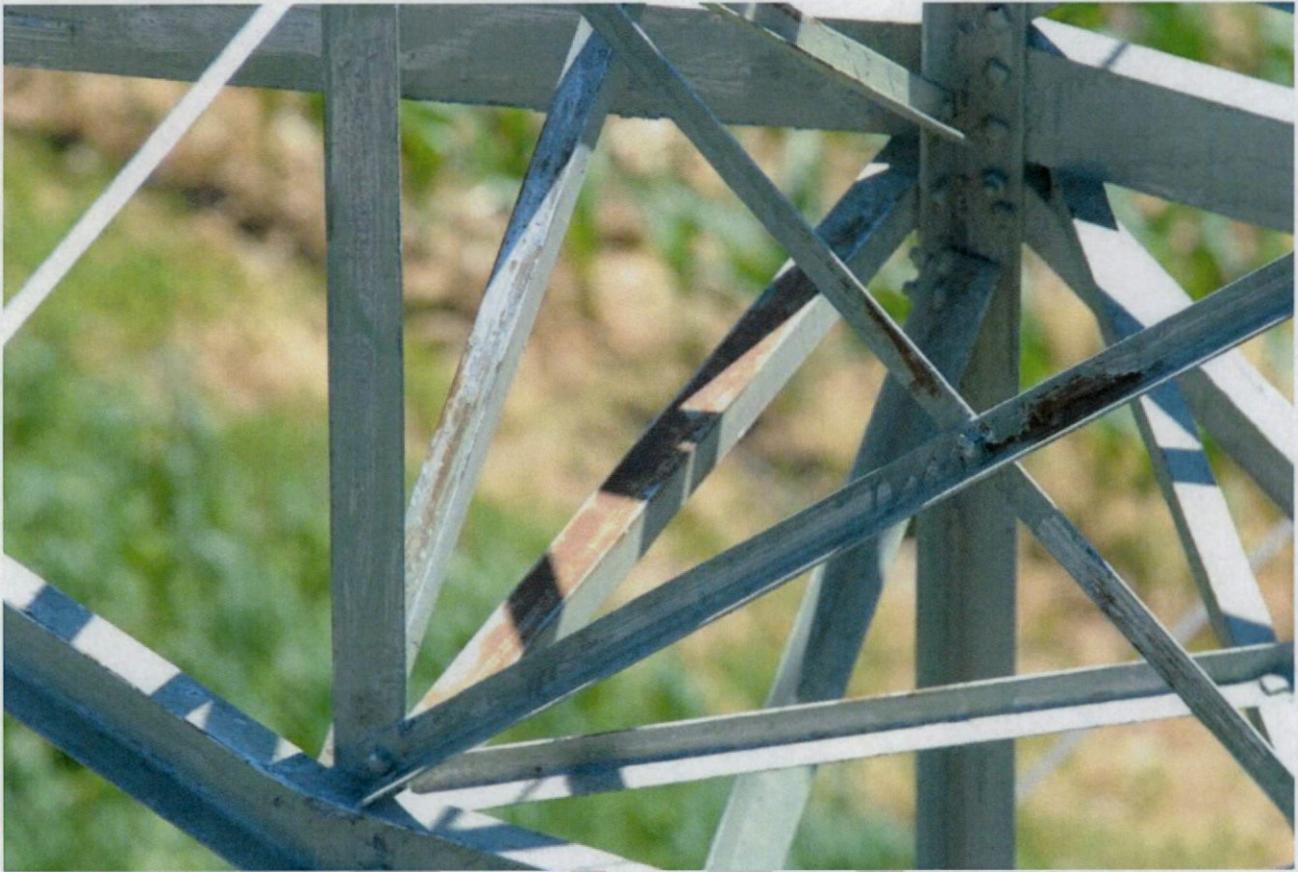
**Figure 22:** 39430S17964 - Pervasive corrosion and paint peeling on this structure

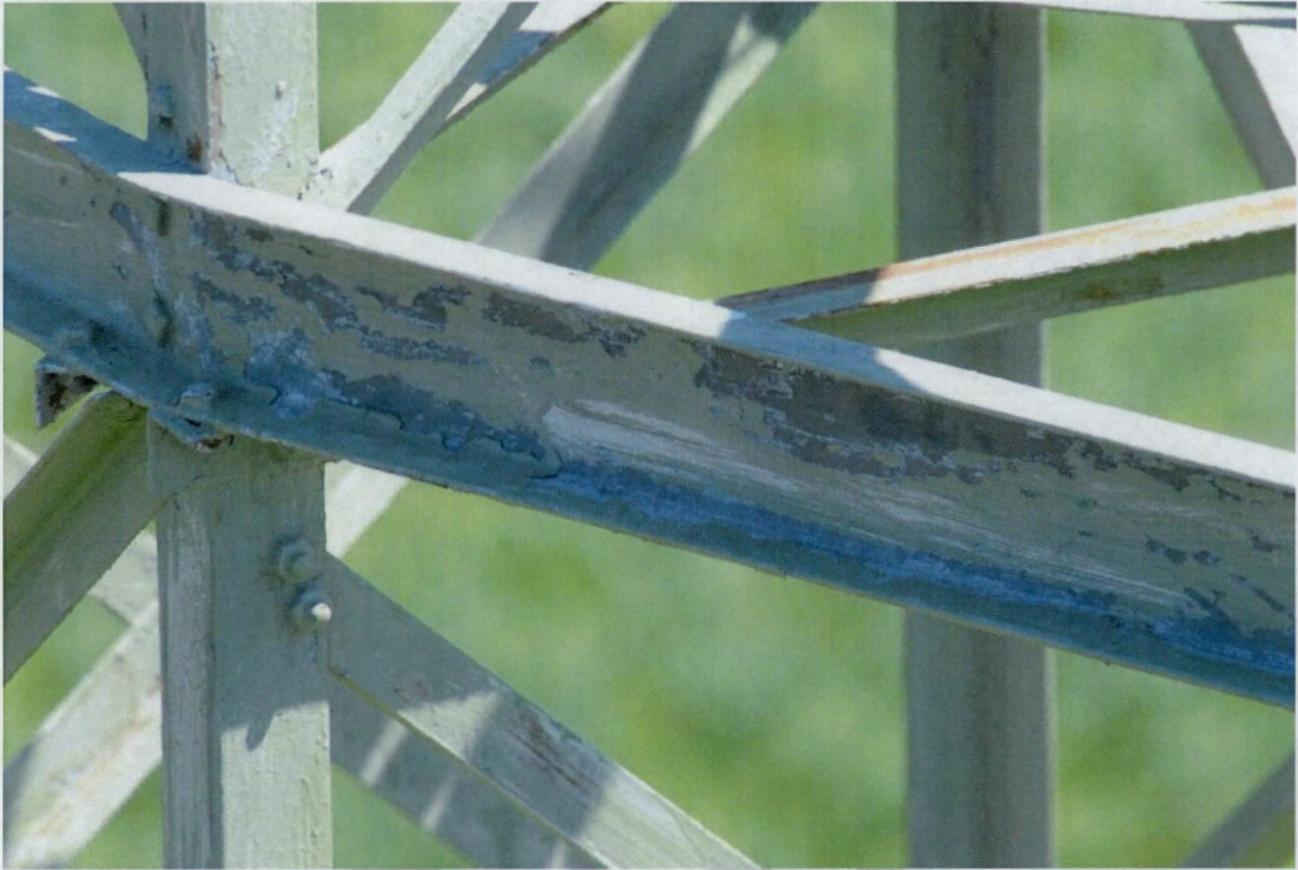
**Figure 23:** 39430S17964 - Significant paint peeling, but mild corrosion in this area of the structure

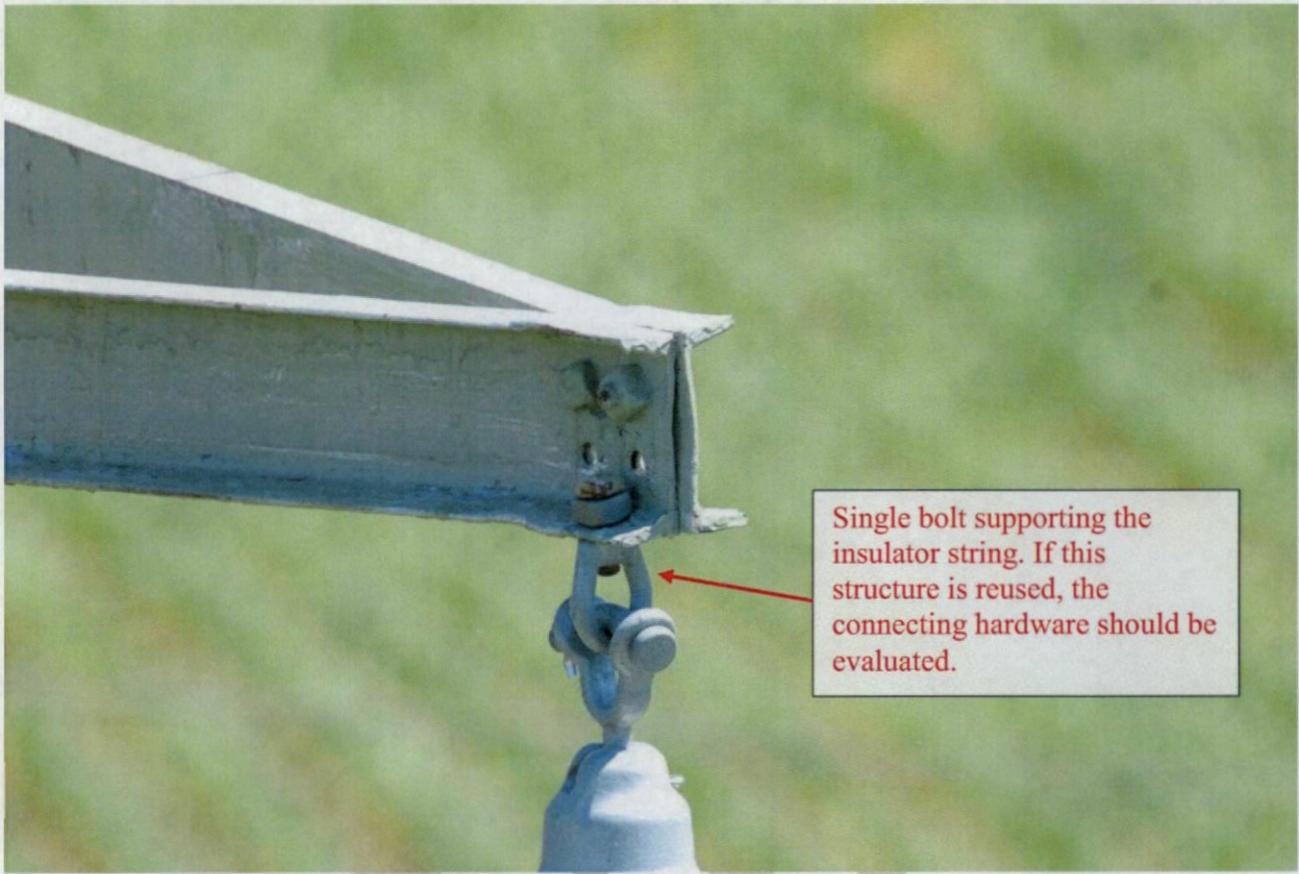
**Figure 24:** 39430S17964 - Insulator string is supported by a single bolt

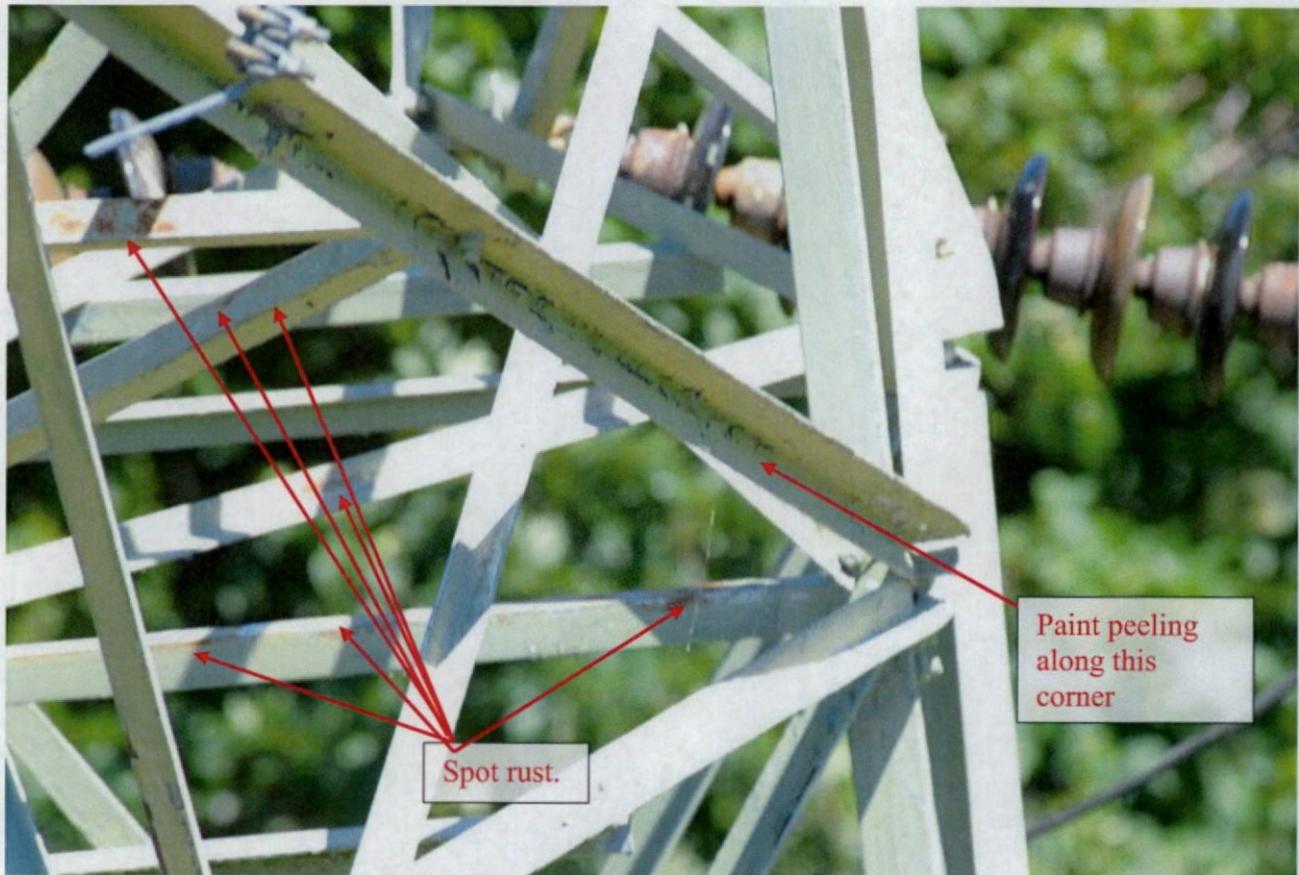
This structure exhibited spotty paint peeling and corrosion.

Figure 25: 3387S17885 - Peeling paint and spotty rust

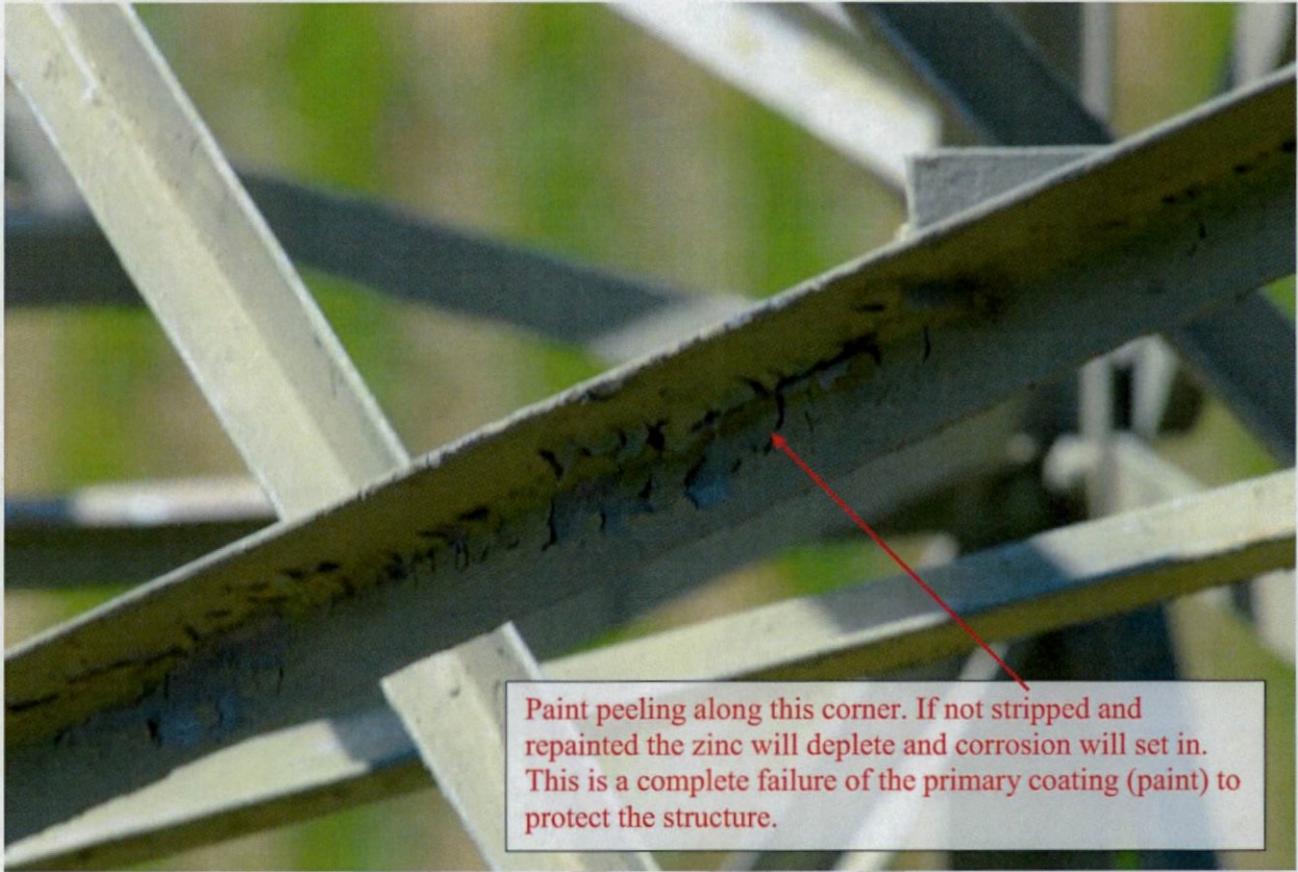
Figure 26: 3387S17885 - Paint peeling

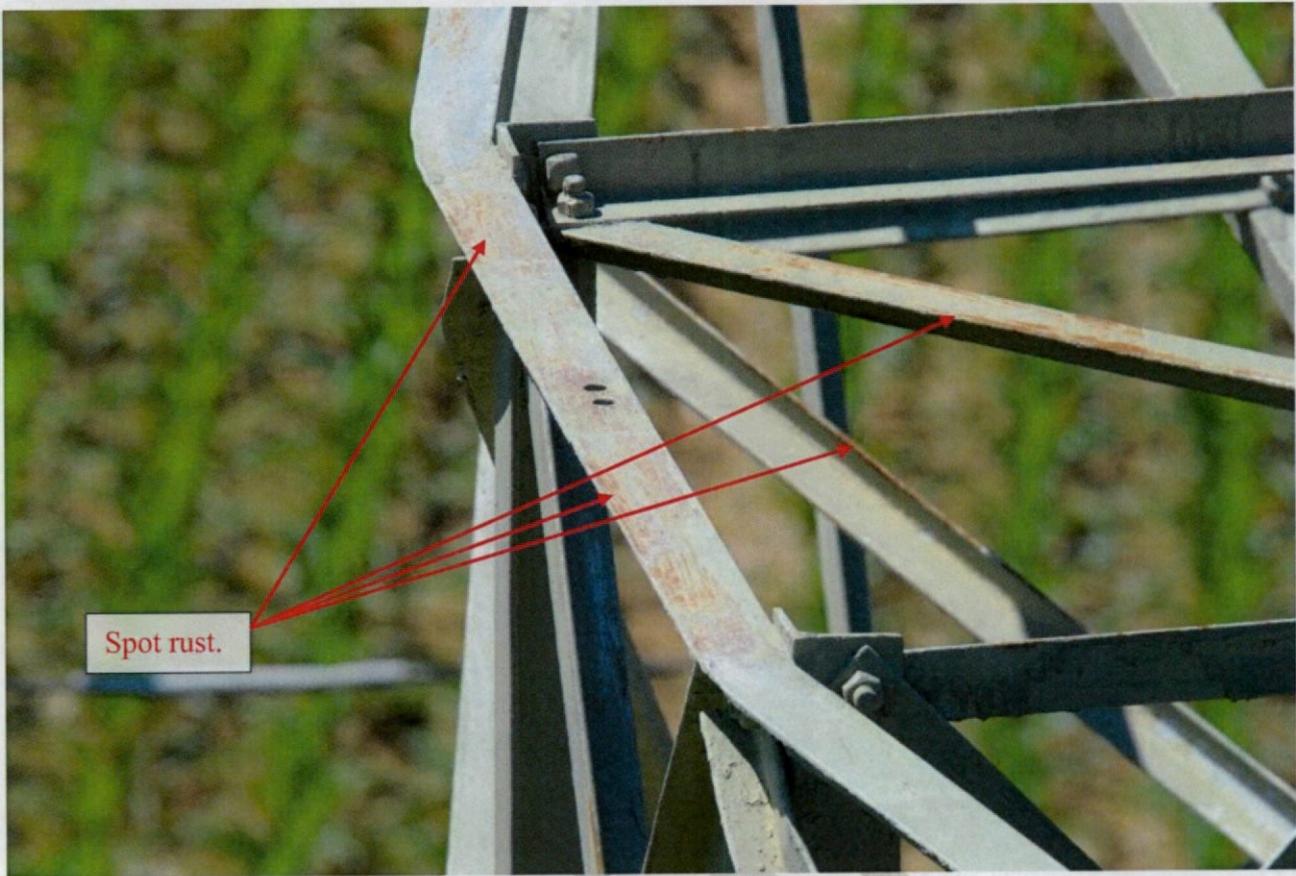
Figure 27: 3387S17885 - Surface rust

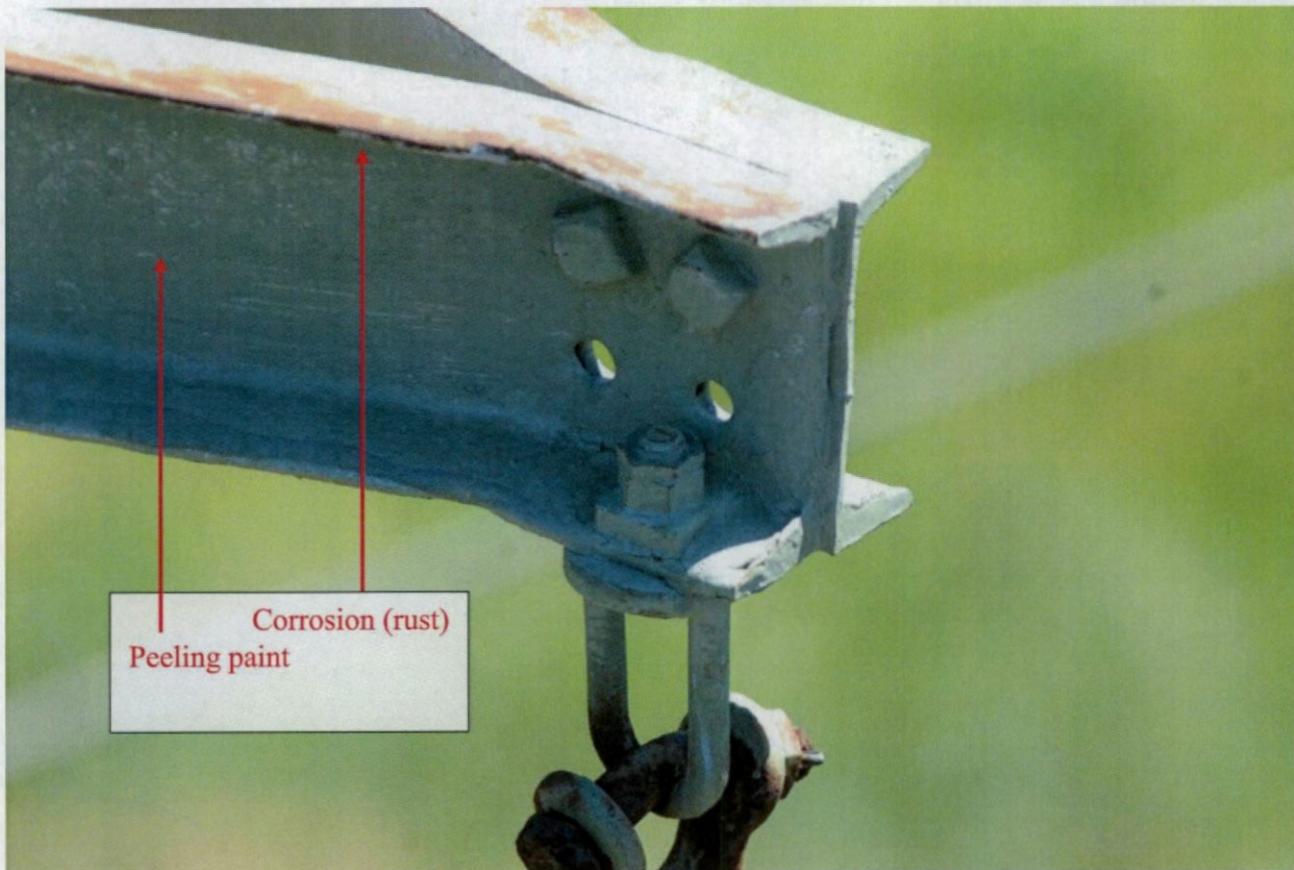
This structure exhibited pervasive corrosion and paint peeling. There was a slight bow in several of the cross braces that couldn't be captured in a photo.

Figure 28: 39282S17888 - Corrosion and peeling paint on a structure

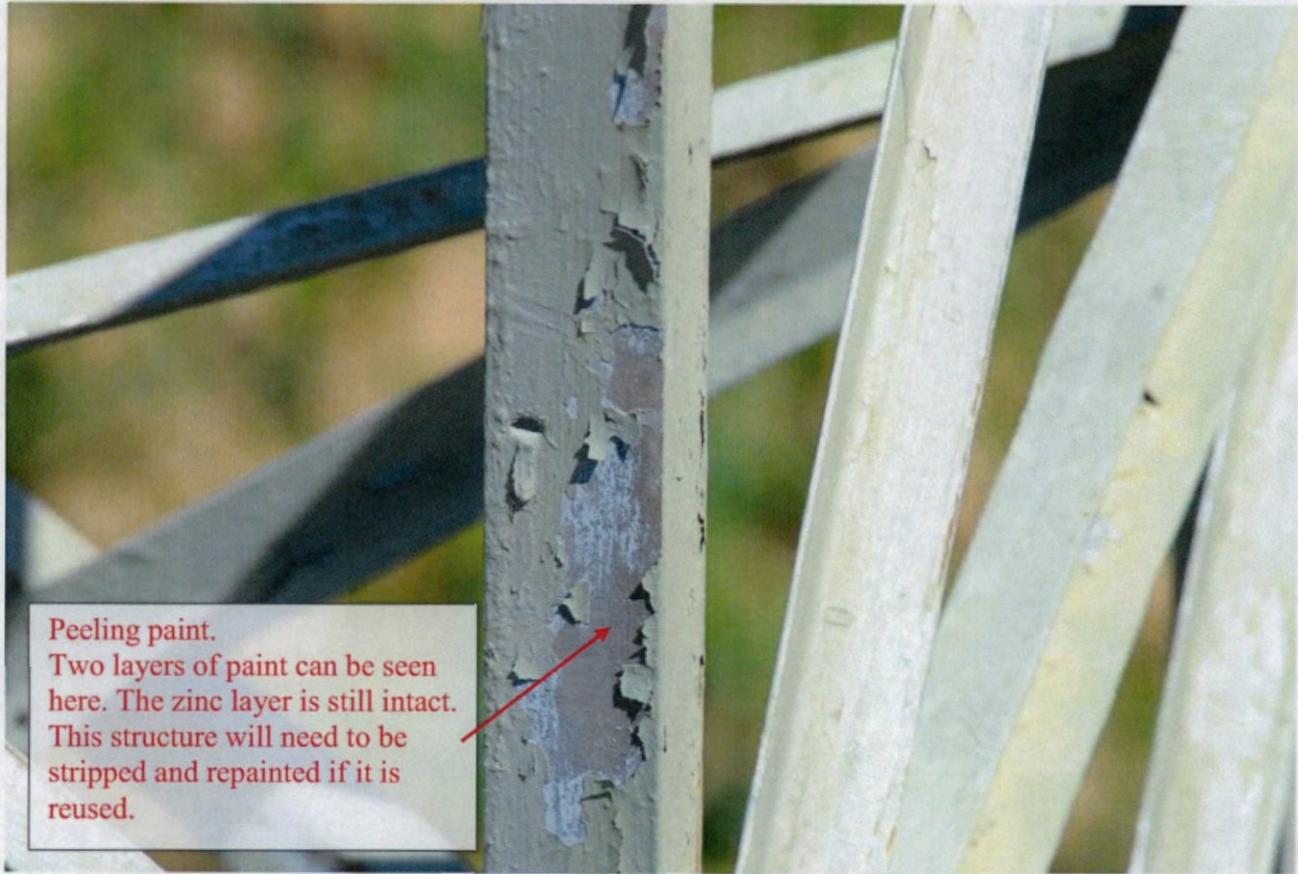
Figure 29: 39282S17888 - Two layers of paint on this structure

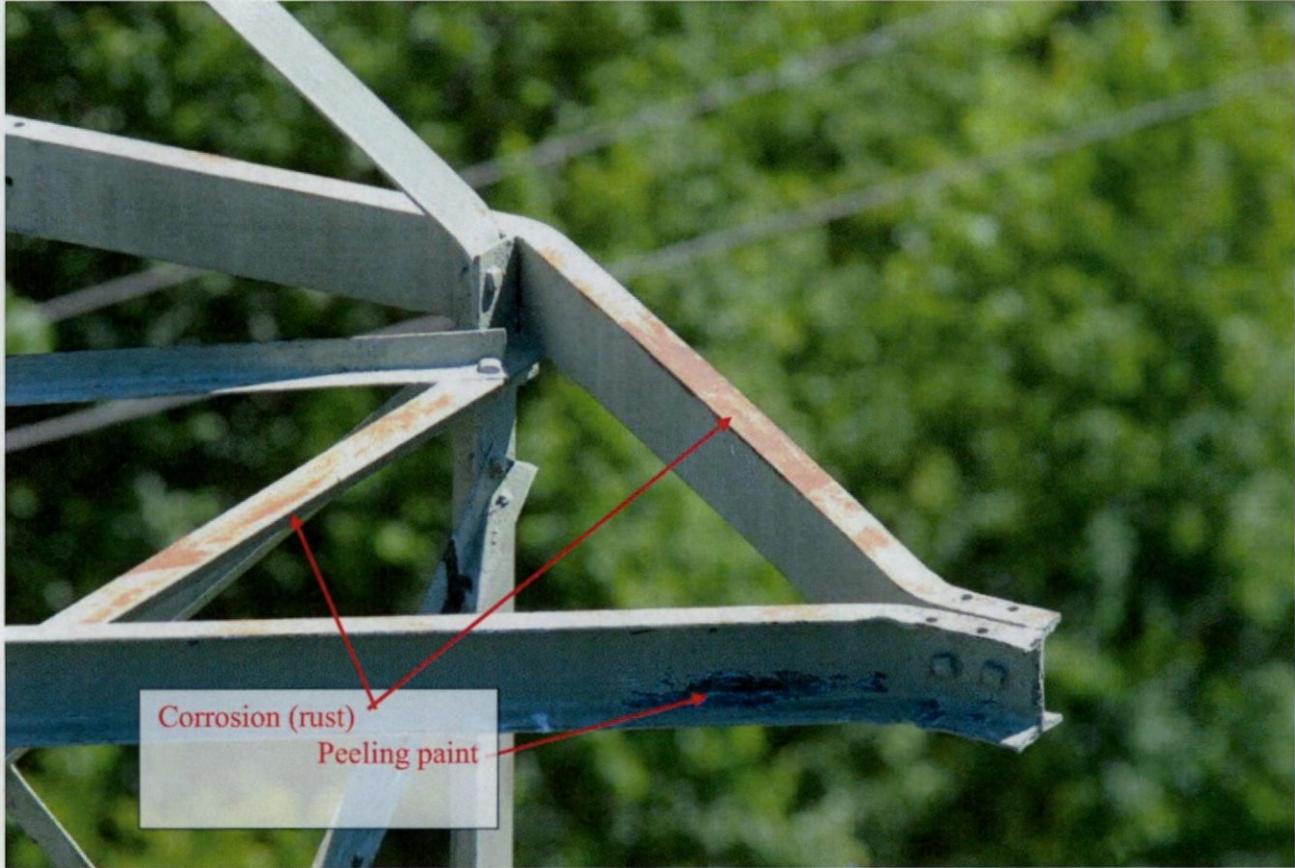
This structure exhibited pervasive corrosion on most of the structural members, as well as poor paint adhesion in several places. A detailed climbing inspection would need to be conducted to determine which corroded structural members need to be replaced.

Figure 30: 39320S17792 - Rust and peeling paint

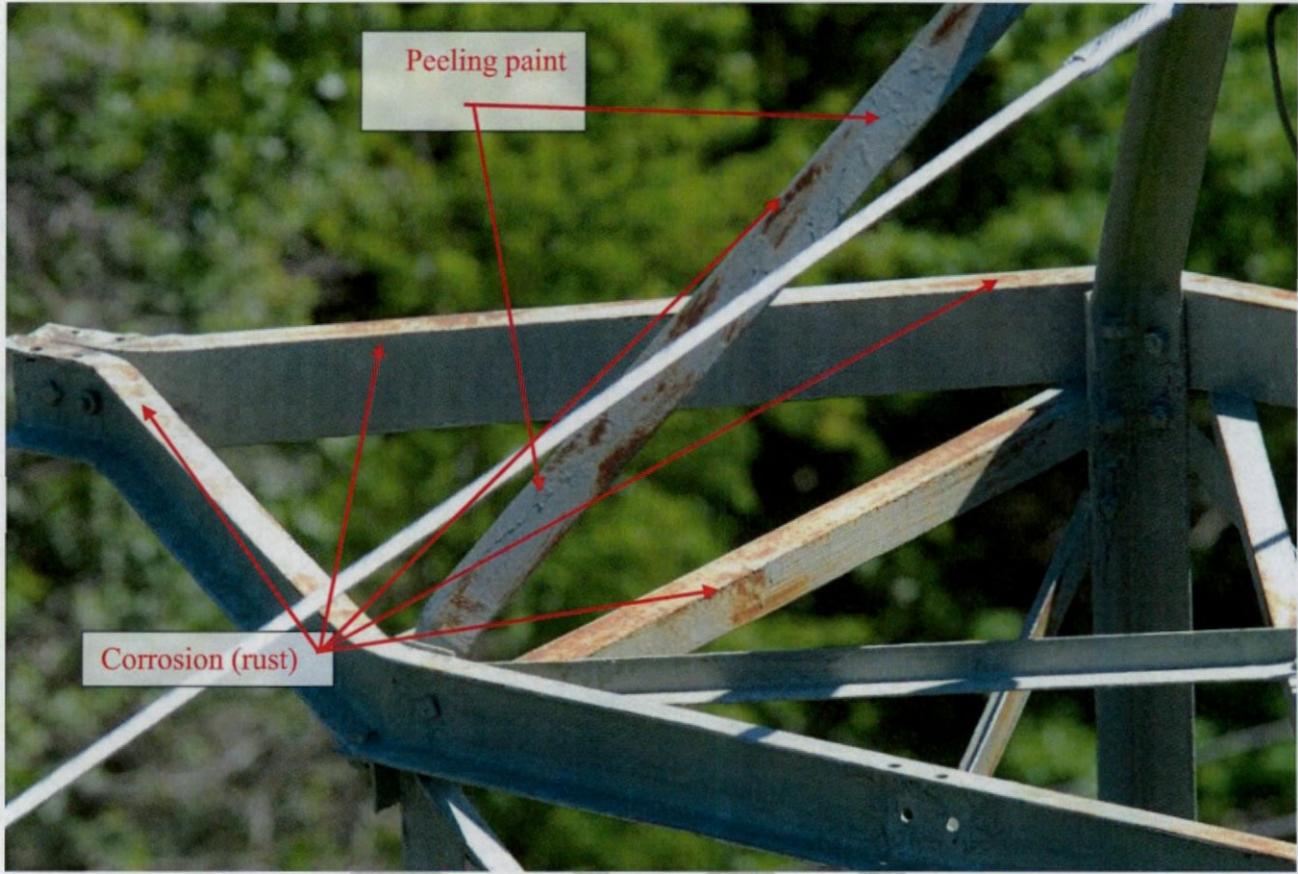
Figure 31: 39320S17792 - Corrosion and peeling paint

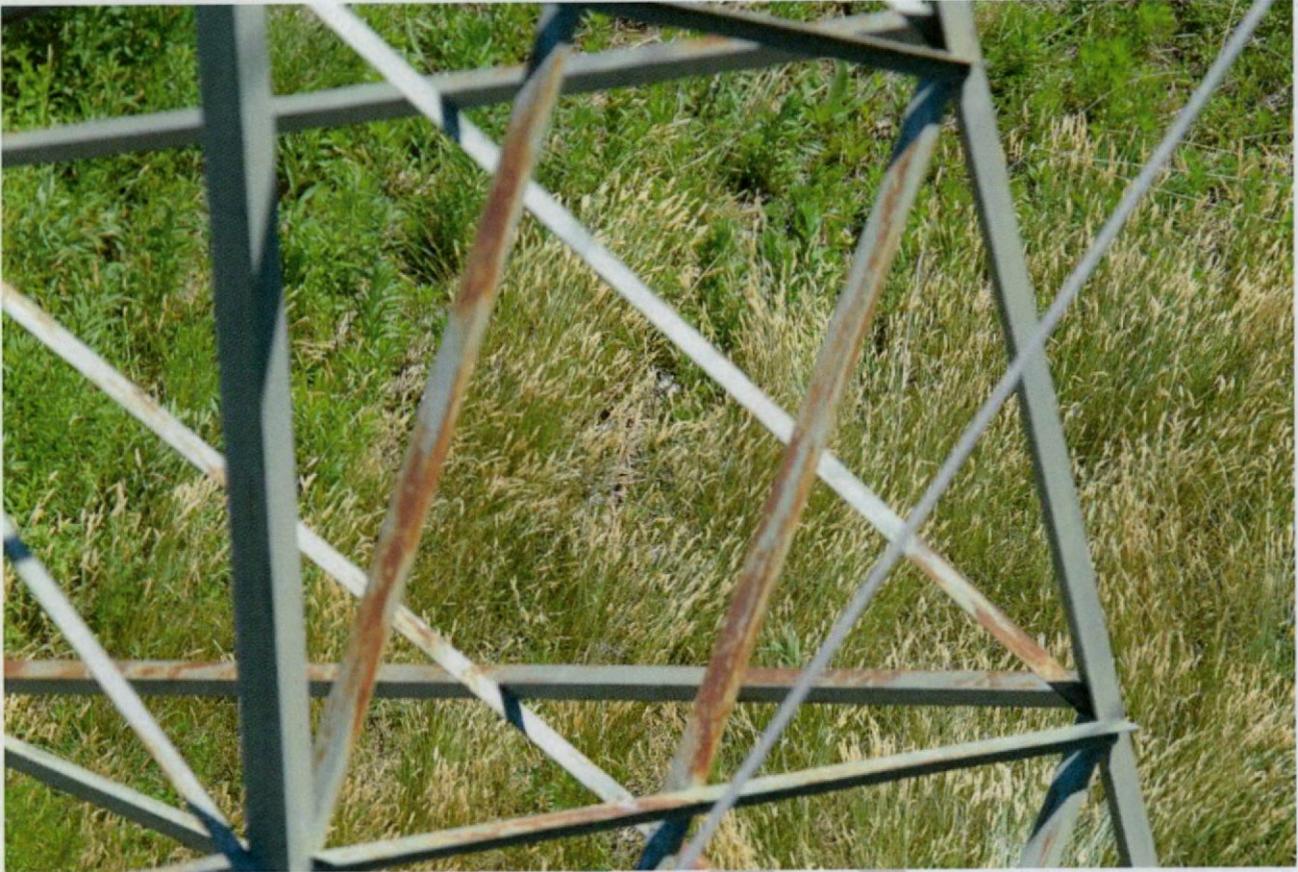
Figure 32: 39320S17792 - Pervasive rust

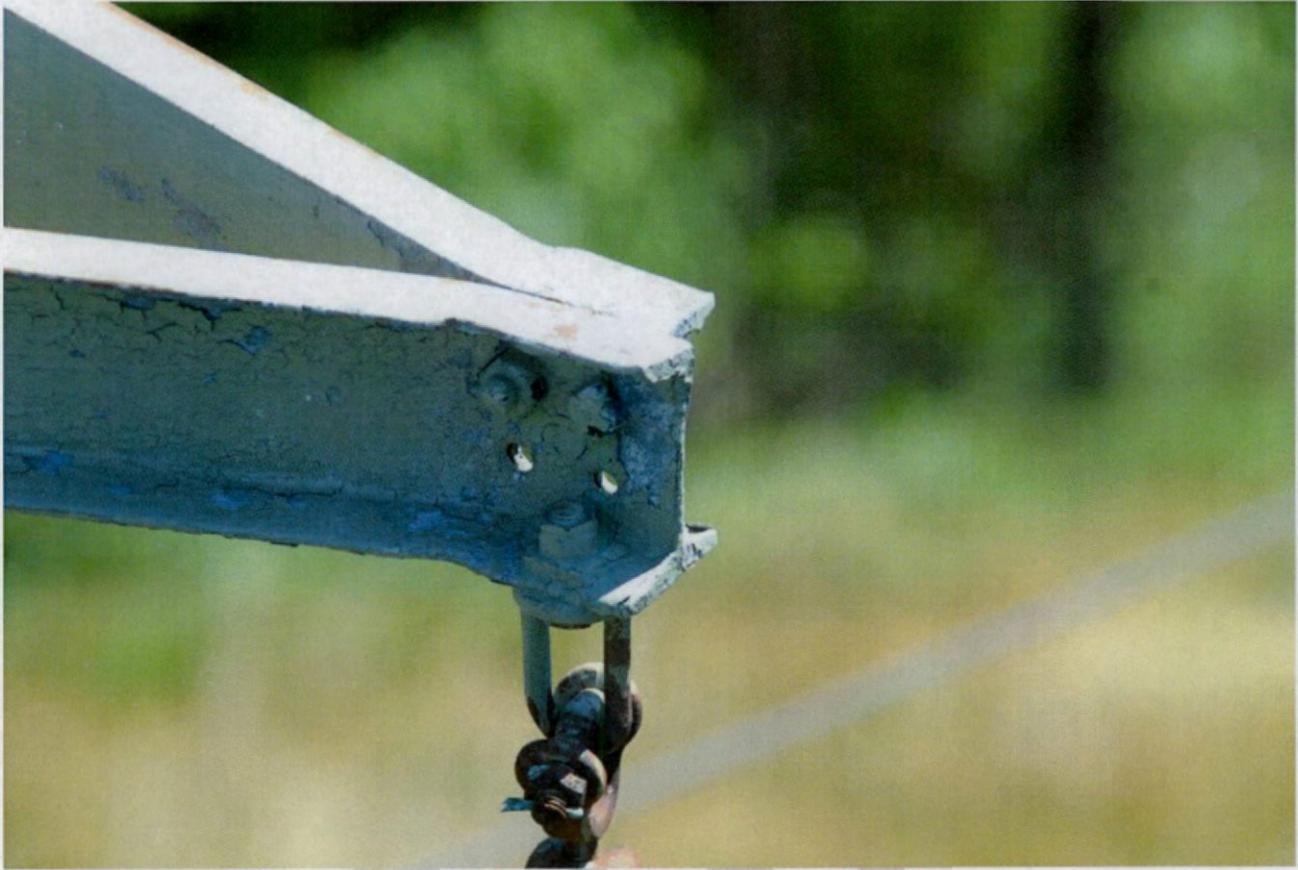
Figure 33: 39320S17792 - Poor paint adhesion

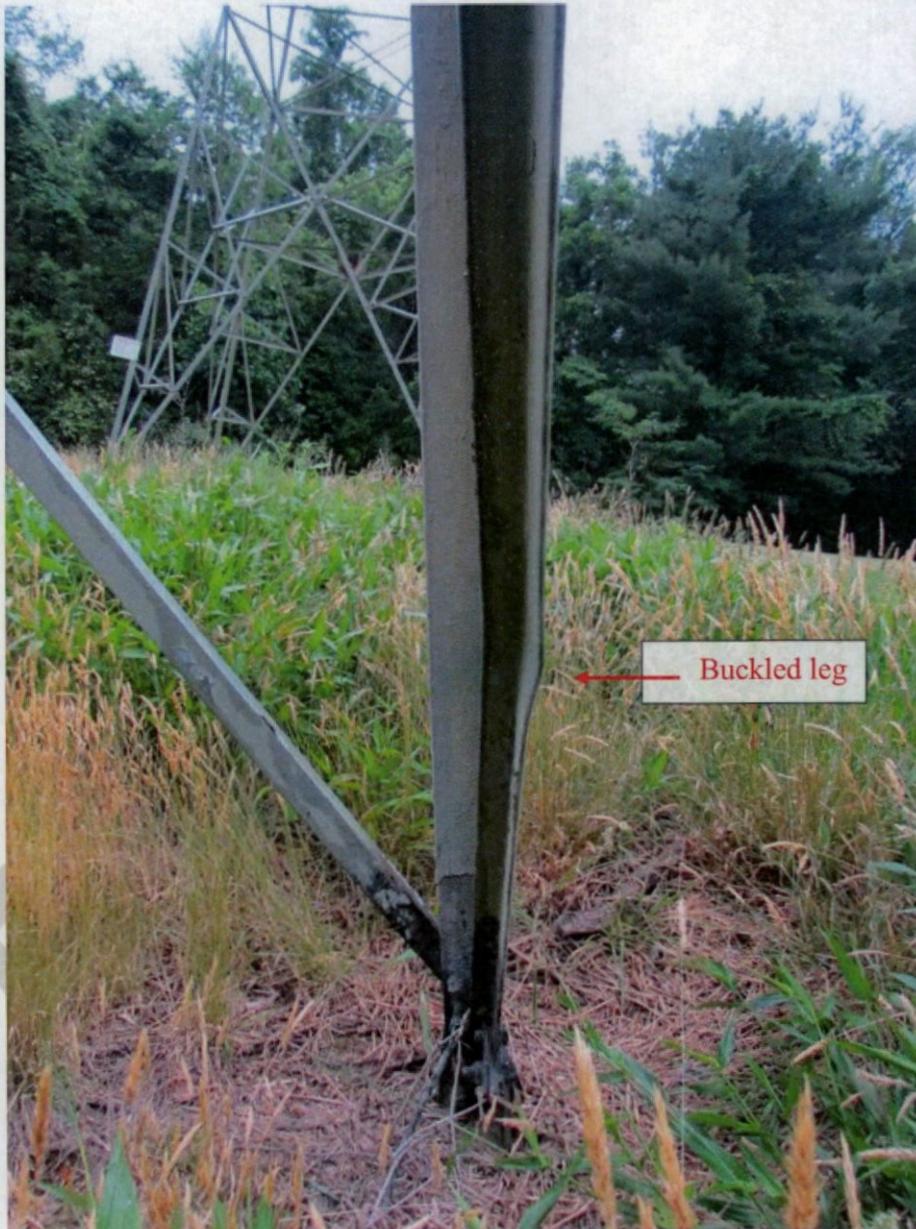
This structure requires immediate attention because it has a buckled leg. This leg is one of the four legs that support the tower. Poor paint adhesion and corrosion were also observed.

**Figure 35:** 39325S17789 - Buckled leg on tower

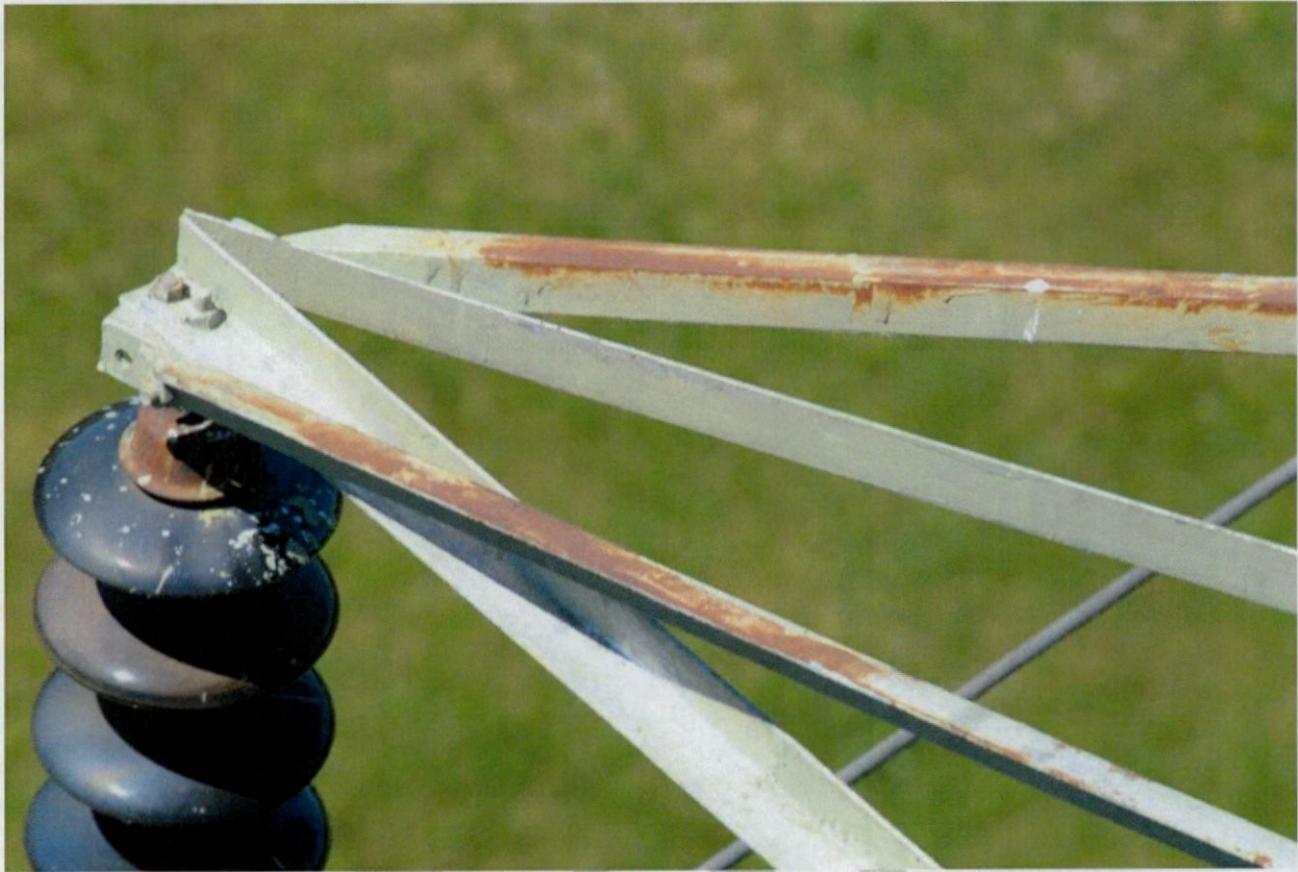
Figure 37: 39325S17789 - Corrosion on structural members

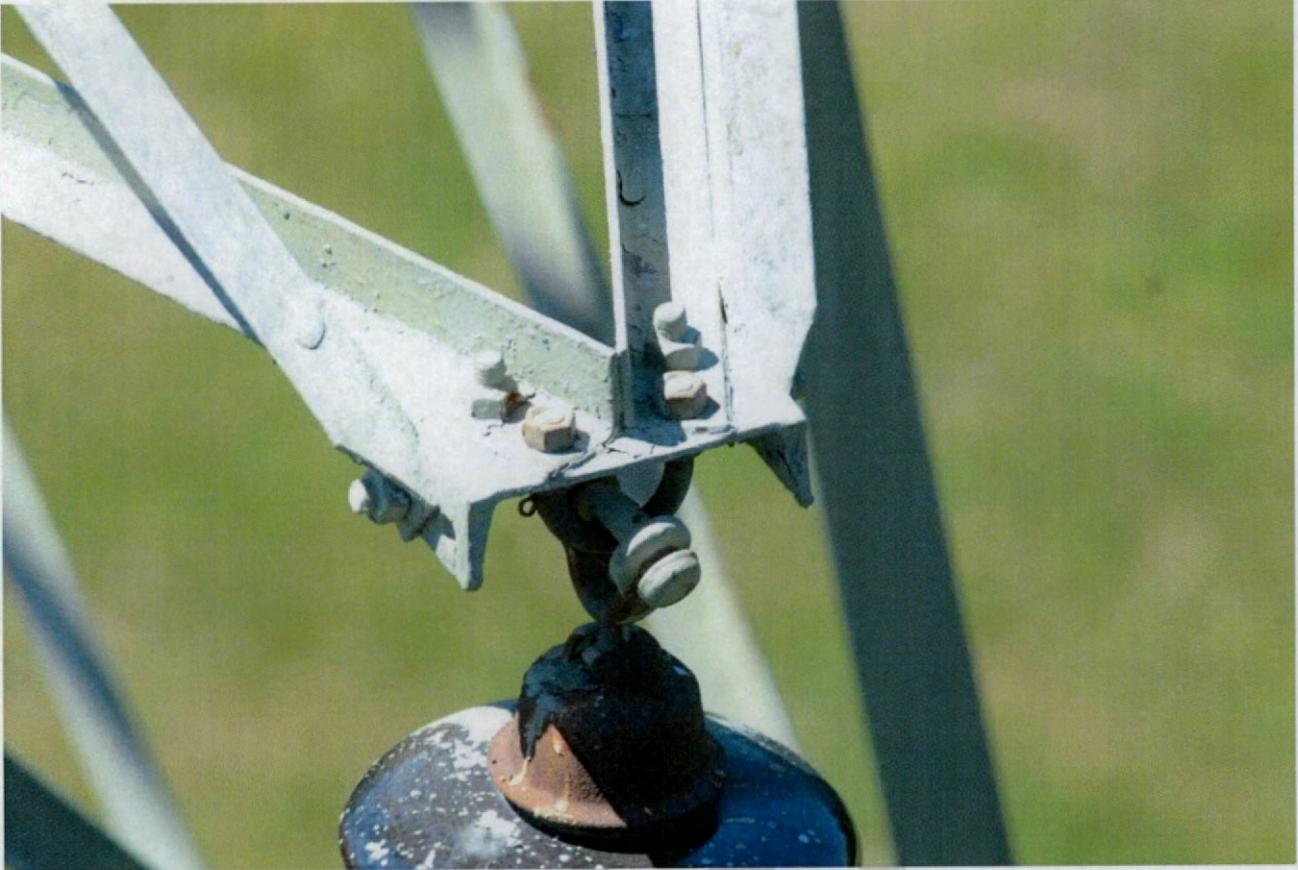
Figure 38: 39325S17789 - Poor paint adhesion

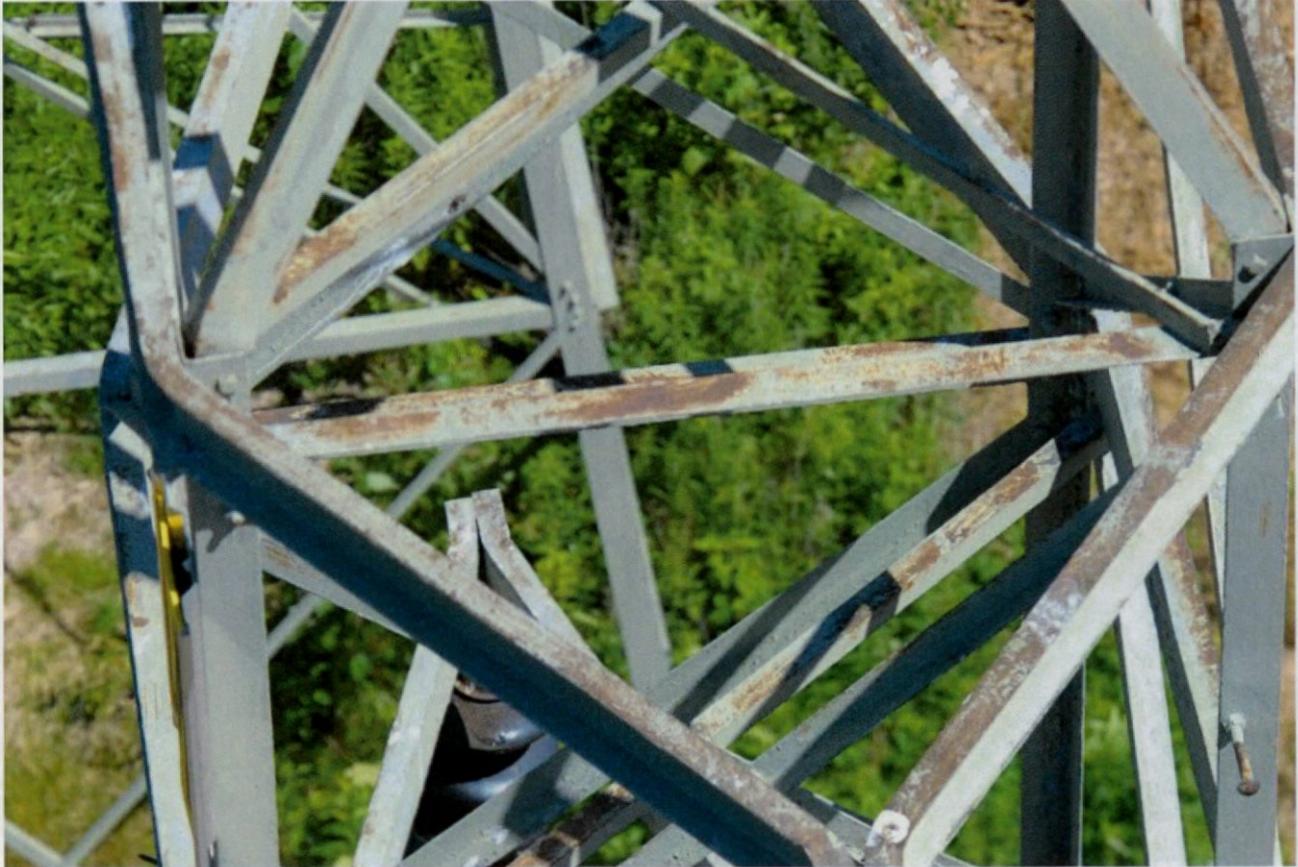
This structure exhibited pervasive corrosion on most of the structural members, with likely structural damage. A detailed climbing inspection is needed to determine a remediation plan.

Figure 39: 39277S17723 - Corrosion on structural members

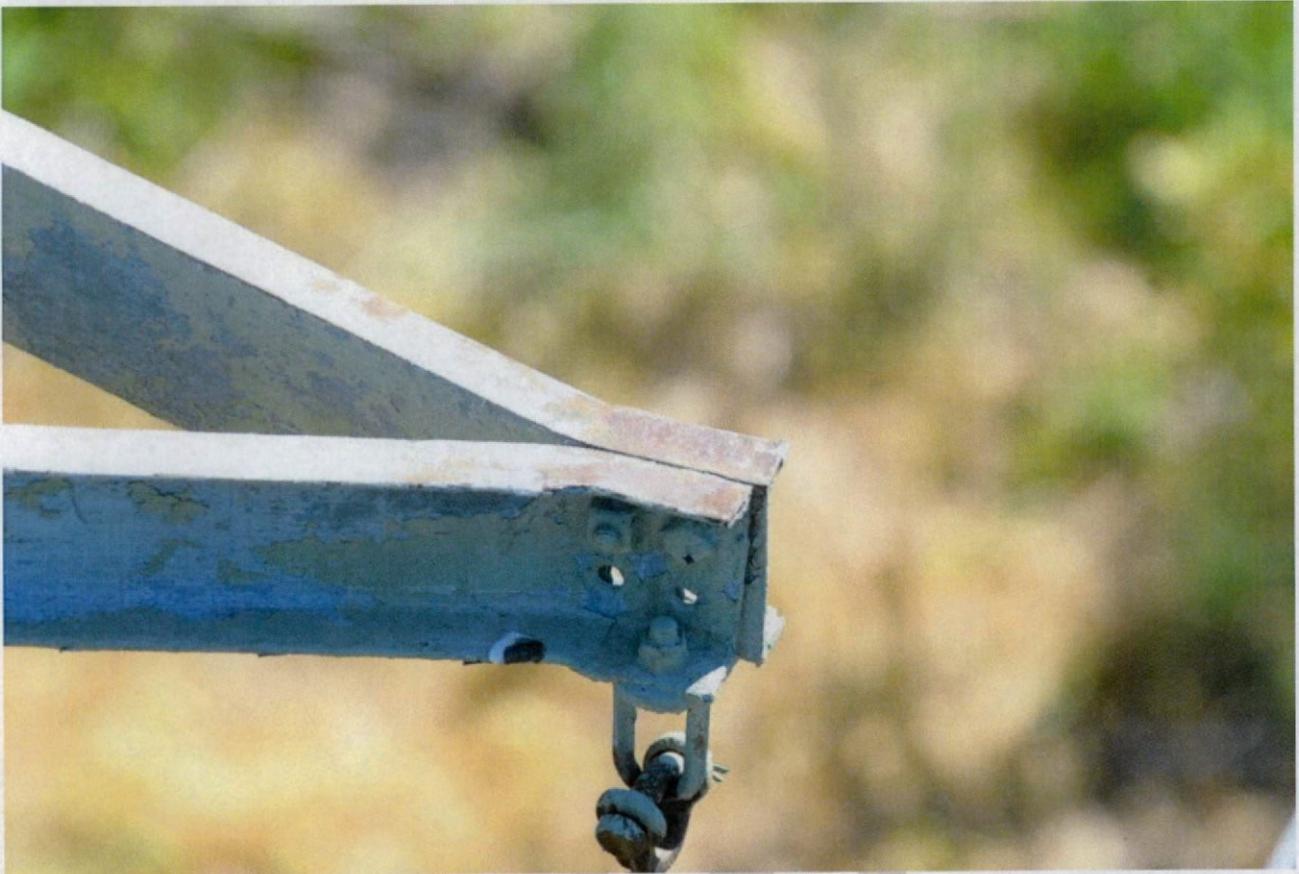
**Figure 40:** 39277S17723 - Corrosion and paint peeling on structural members

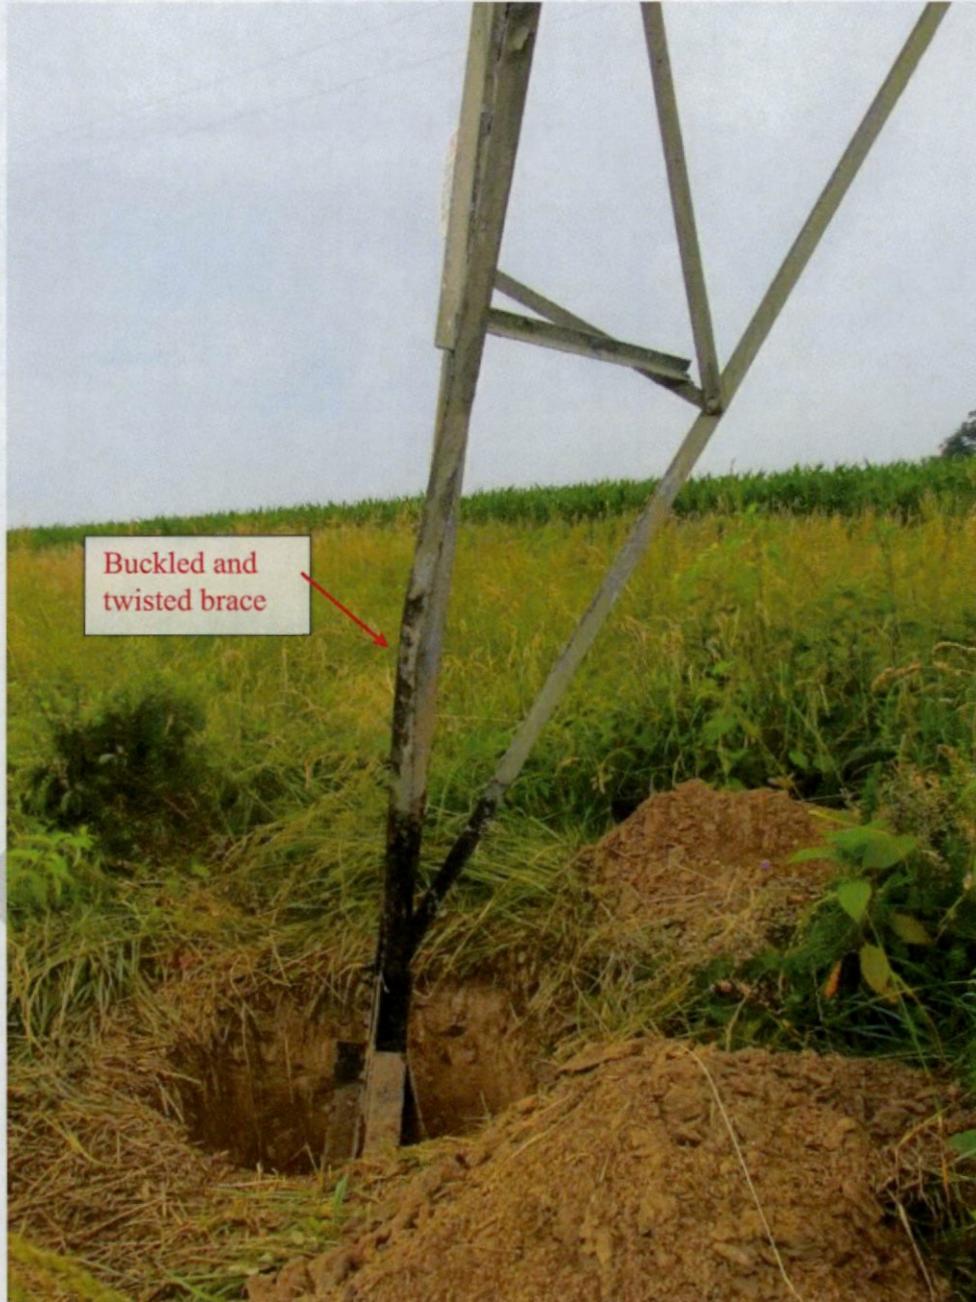
This structure has a buckled and twisted cross brace as well as deformation at the end of one of the crossarms, which needs to be replaced, as well as peeling paint and corrosion. A detailed inspection is needed to determine the remediation process and cost.

**Figure 45:** 39282S17720 - Buckled and twisted brace
