**Face Rock – Five Forks Inspection of Structures**

NEETRAC Project Number: 16-107

June, 2016

Principal Investigator: Joe Goldenburg, P.E.  
(GA Lic# PE033181)

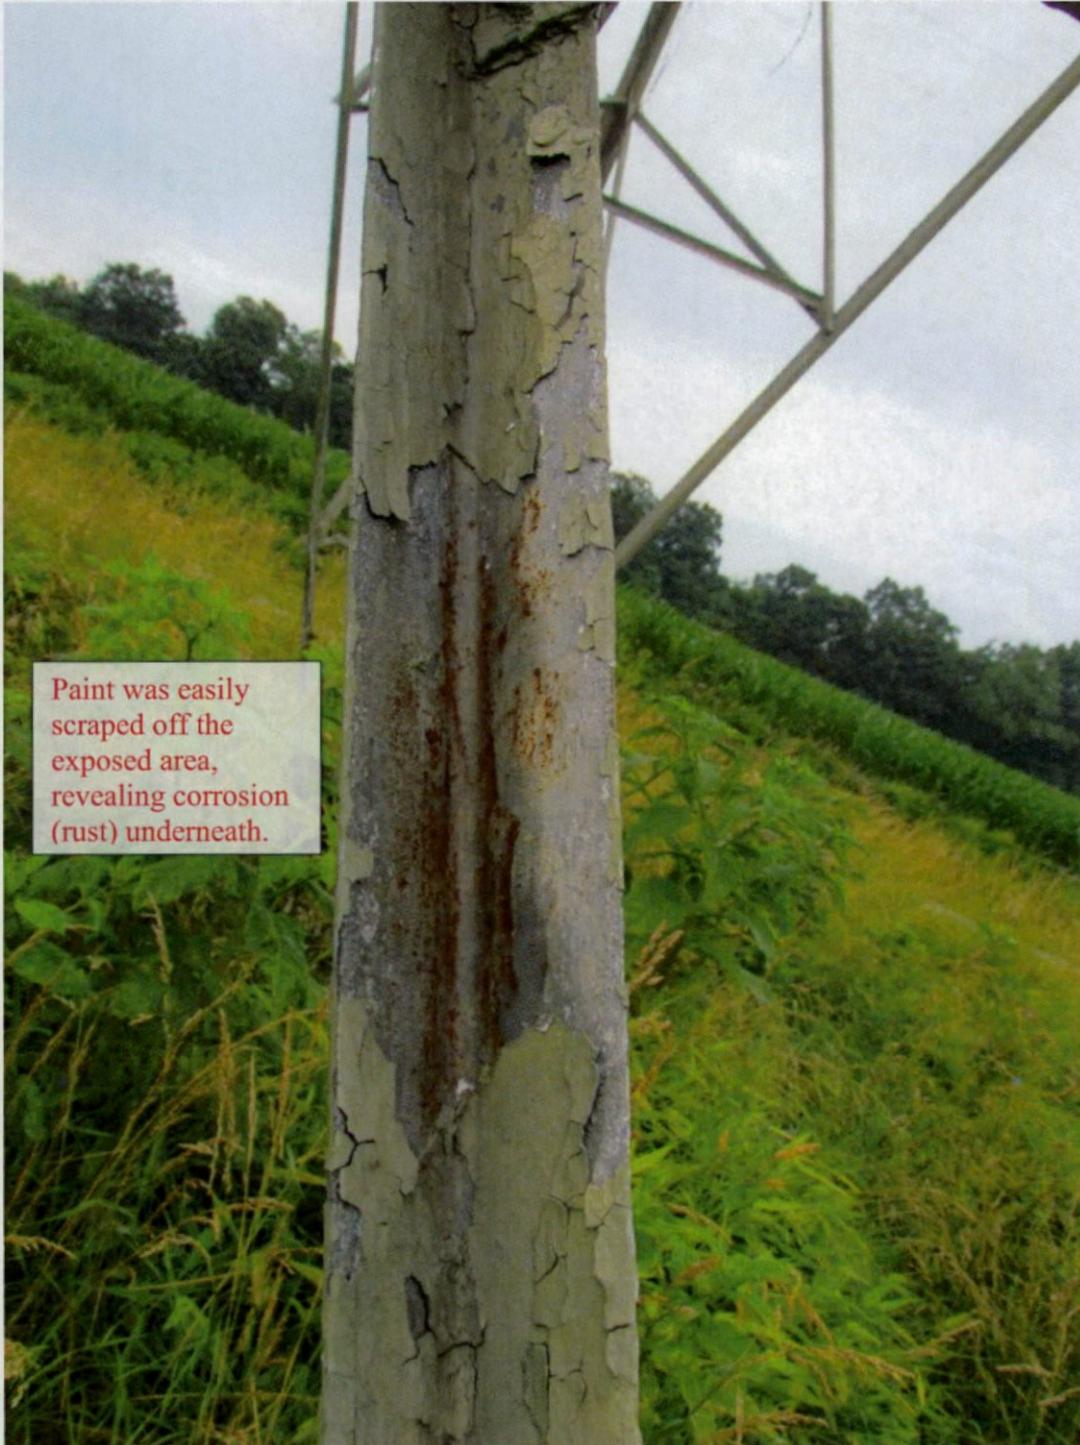
Figure 47: 39282S17720 - Corrosion and paint peeling on structural members

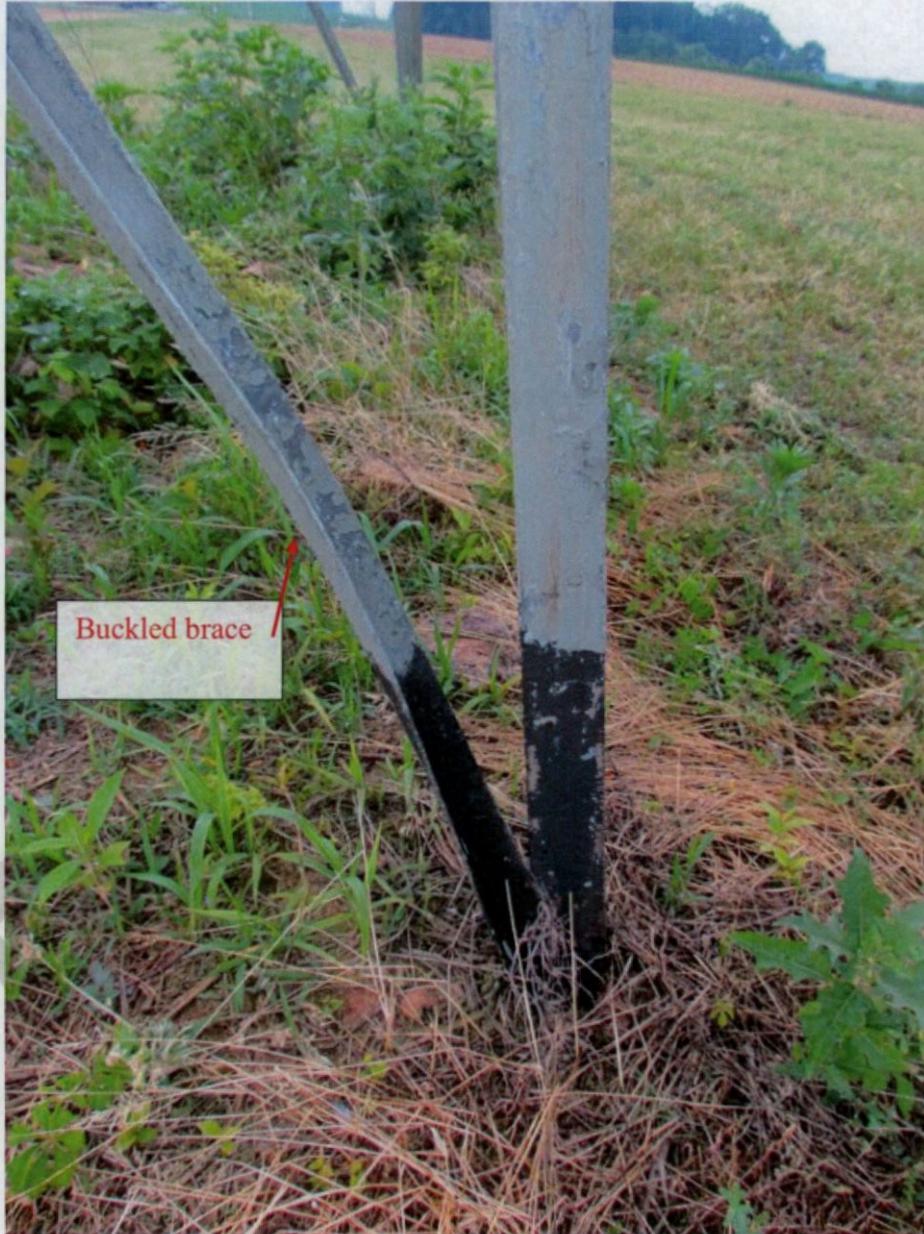
This structure has a buckled brace that needs to be replaced, as well as peeling paint and corrosion.

**Figure 50: 39134S17433 - Buckled support brace**

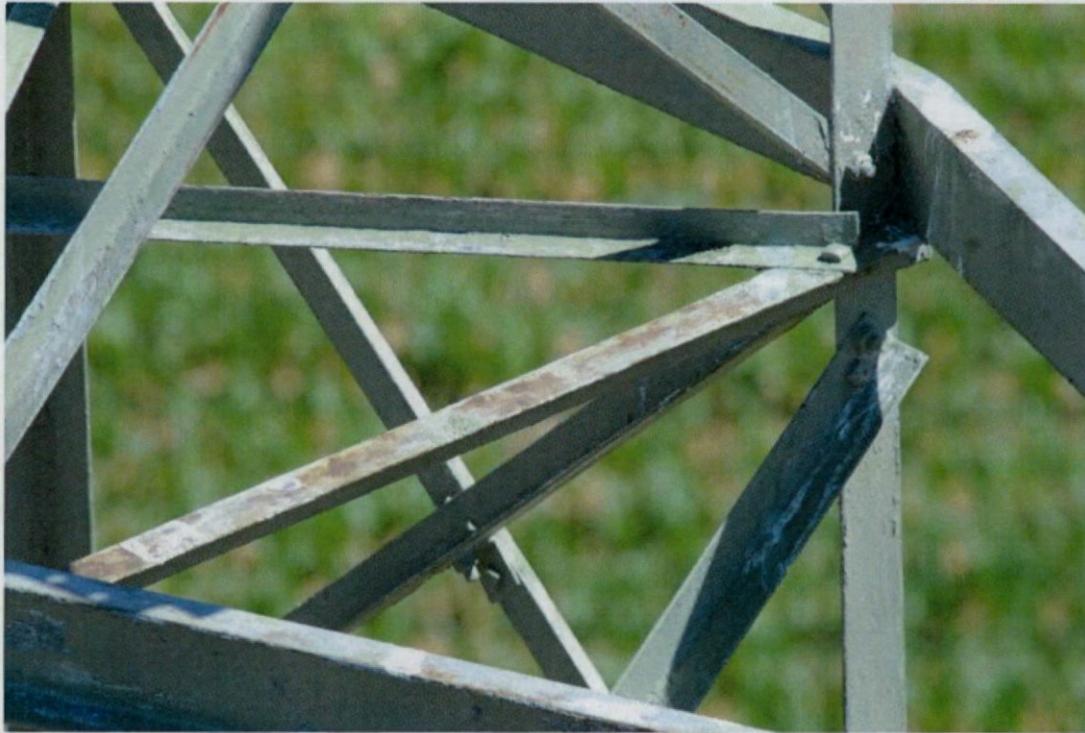
This structure exhibited significant corrosion of some structural members, as well as poor paint adhesion.

**Figure 53:** 39134S17433 - Corrosion and peeling paint

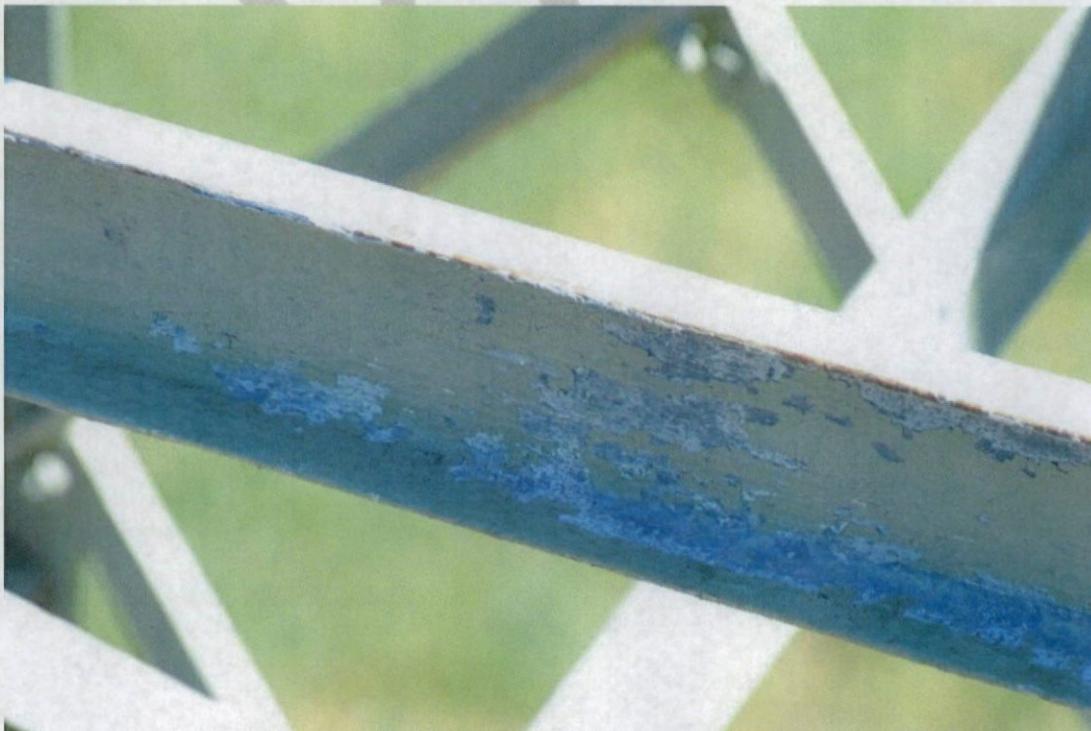
**Figure 54:** 39134S17433 - Peeling paint

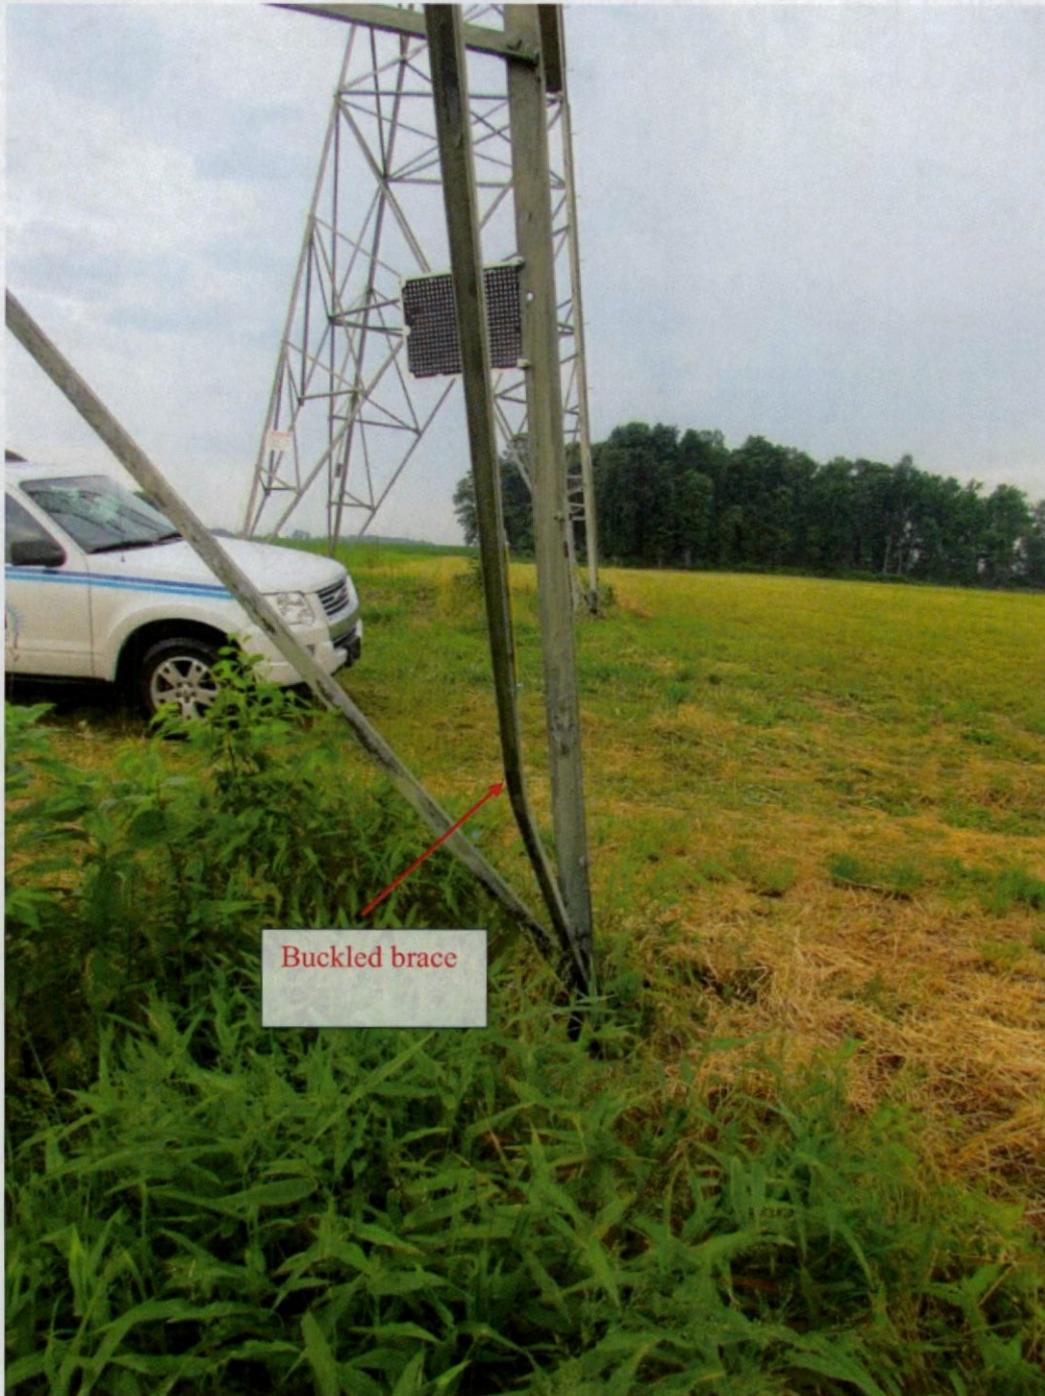
This structure had two (2) bent brace supports, as well as poor paint adhesion and moderate corrosion. The braces need to be replaced and a more detailed inspection needs to be conducted to determine the remediation process and cost.

Figure 55: 38921S16877 – Buckled brace

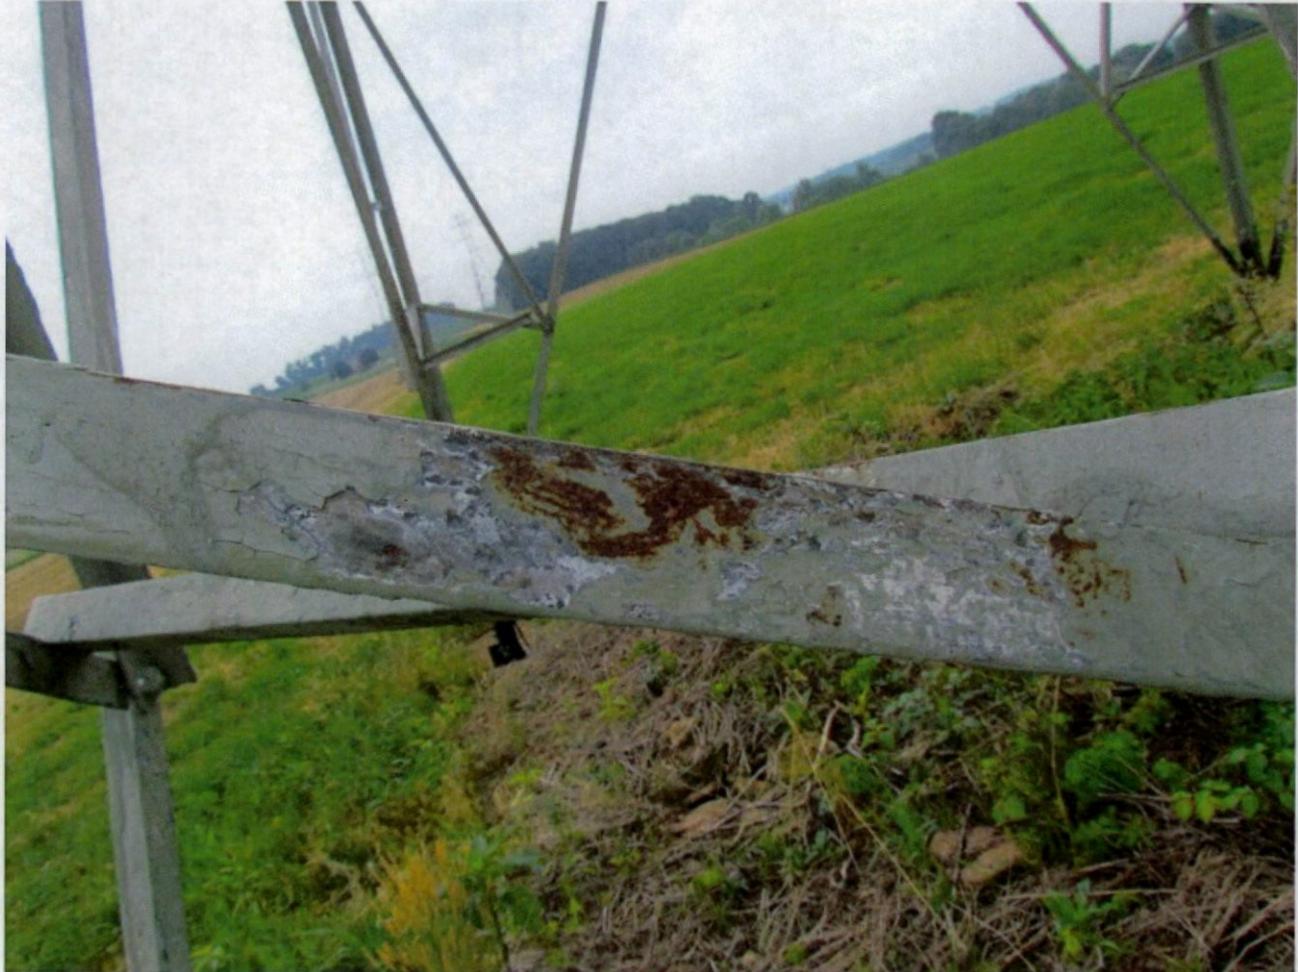
This structure exhibited poor paint adhesion and significant corrosion. Damage to a structural member that had been repaired was also noted.

**Figure 62:** 38916S16879 - Peeling paint and corrosion

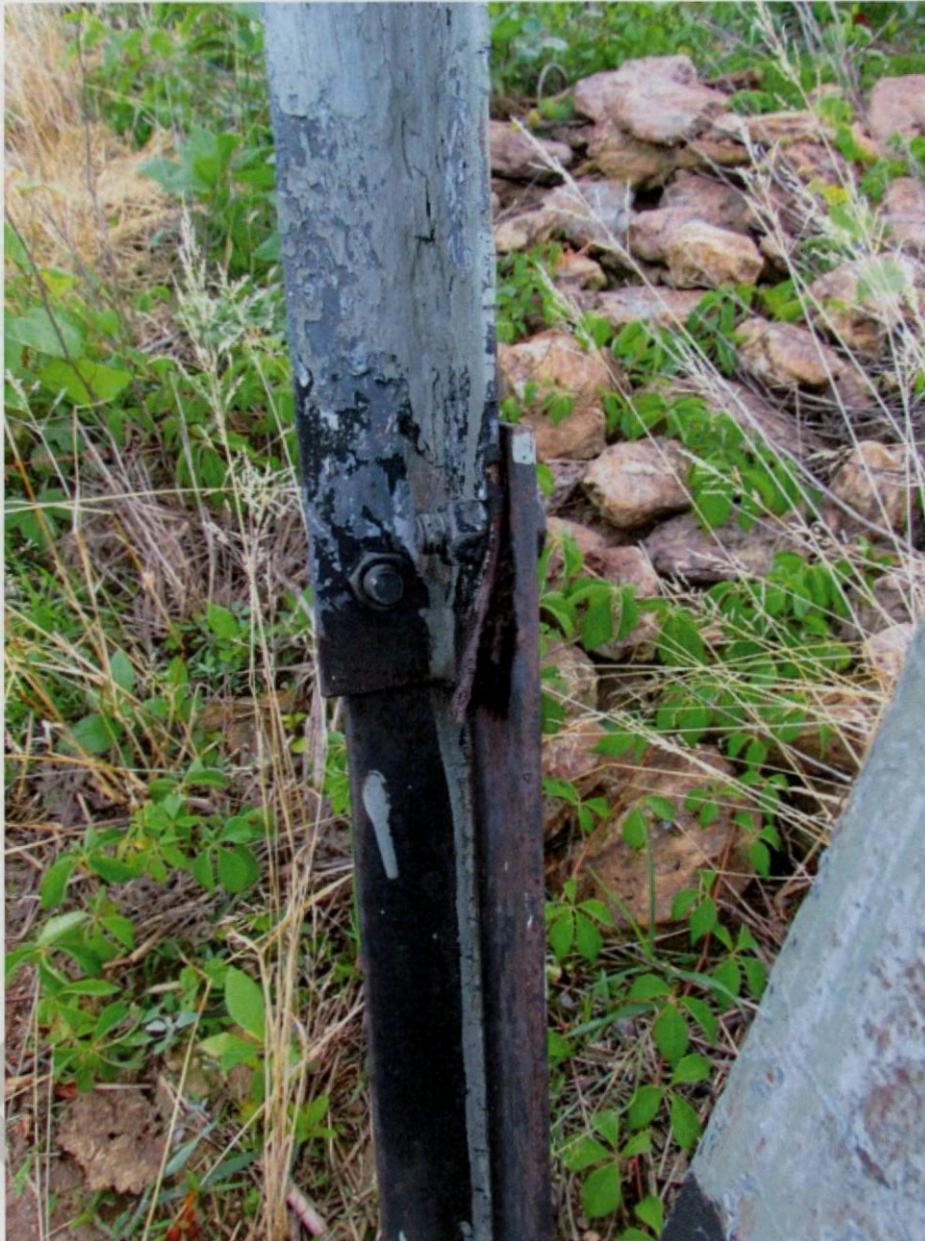
**Figure 63:** 38916S16879 - Damage to a previously repaired structural member

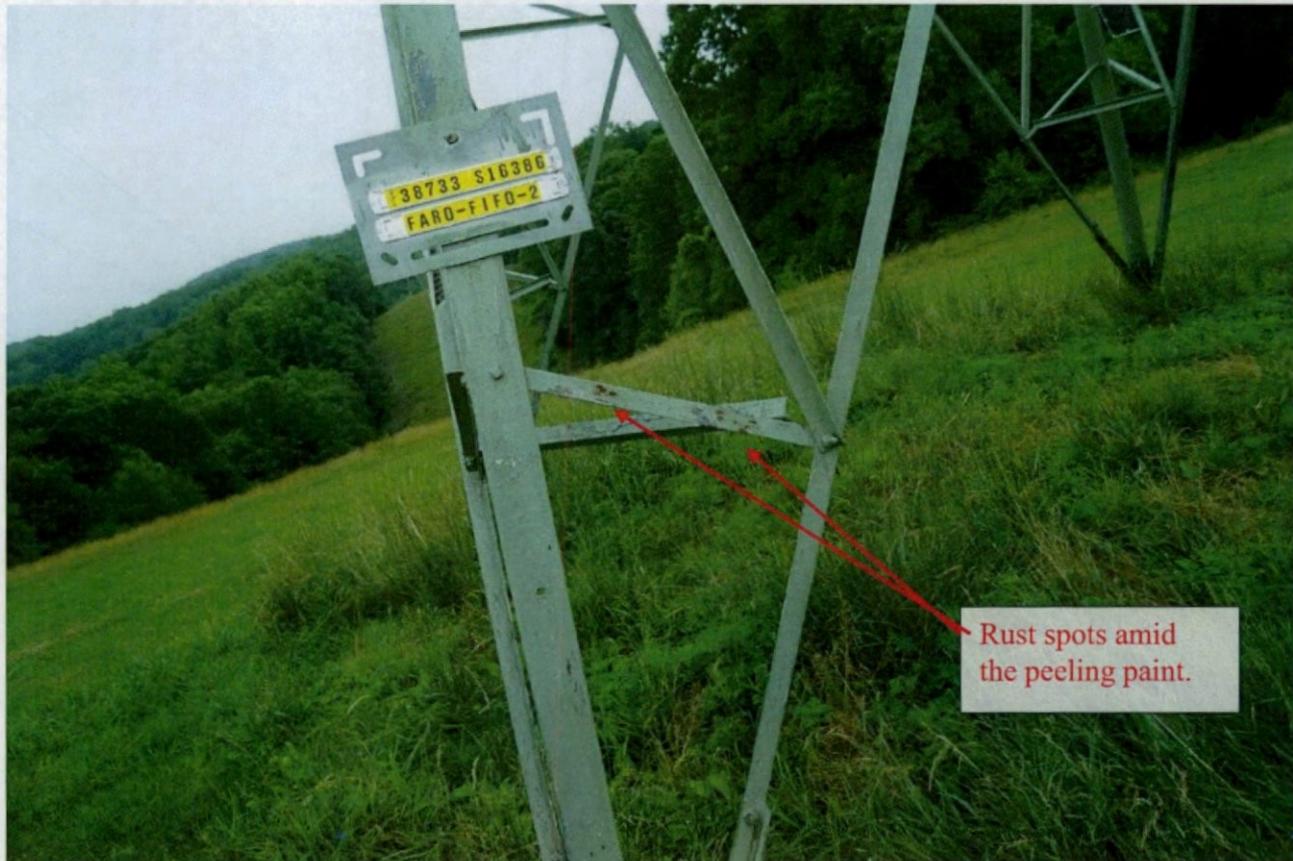
This structure was mislabeled as 38733S16389 in PPL's request. Spot rusting and peeling paint could be seen over much of the structure. A more detailed inspection should be conducted to determine the remediation process and cost.

Figure 70: 38733S16386 - Spot rust and peeling paint

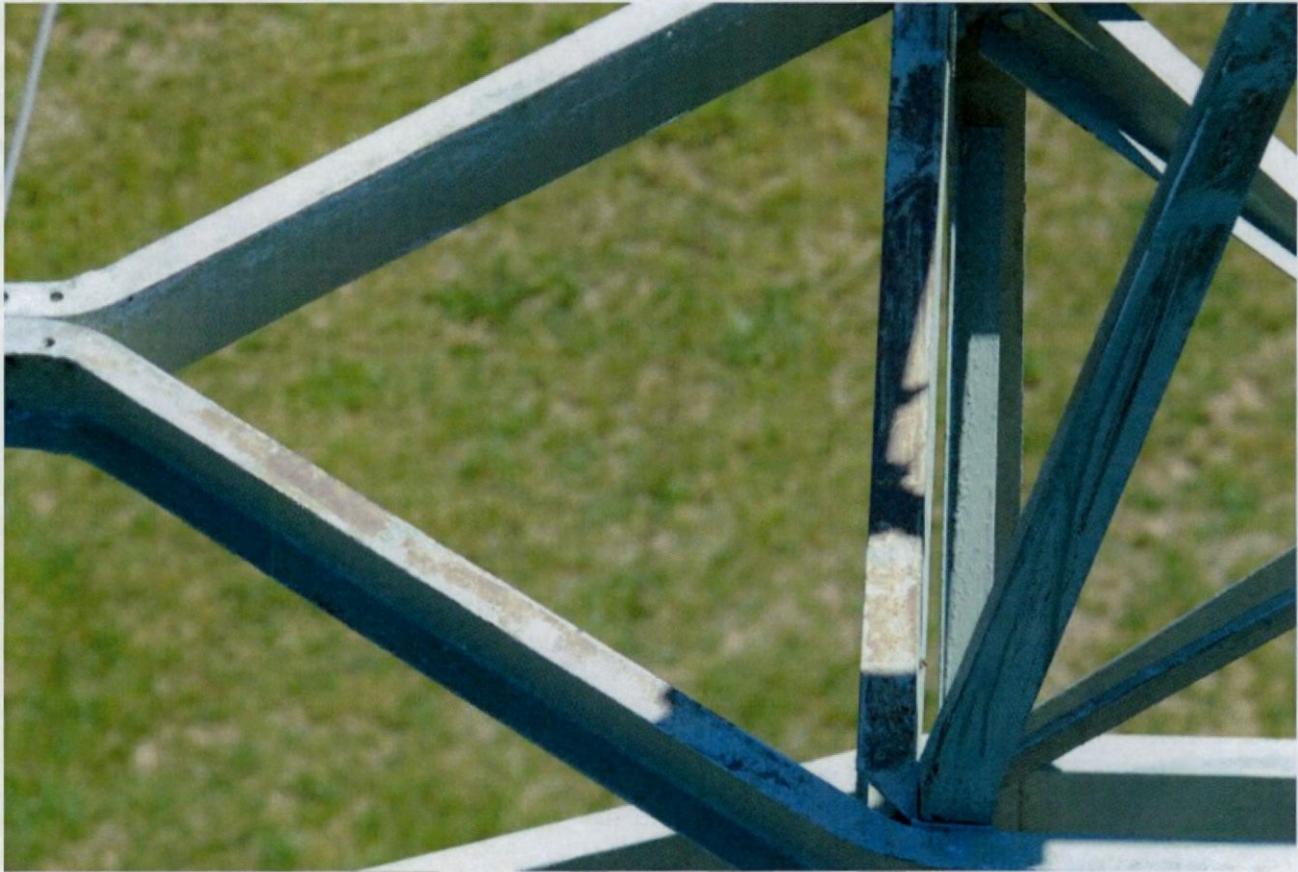
**Figure 71:** 38733S16386 - Structure had more corrosion and paint issues near the top

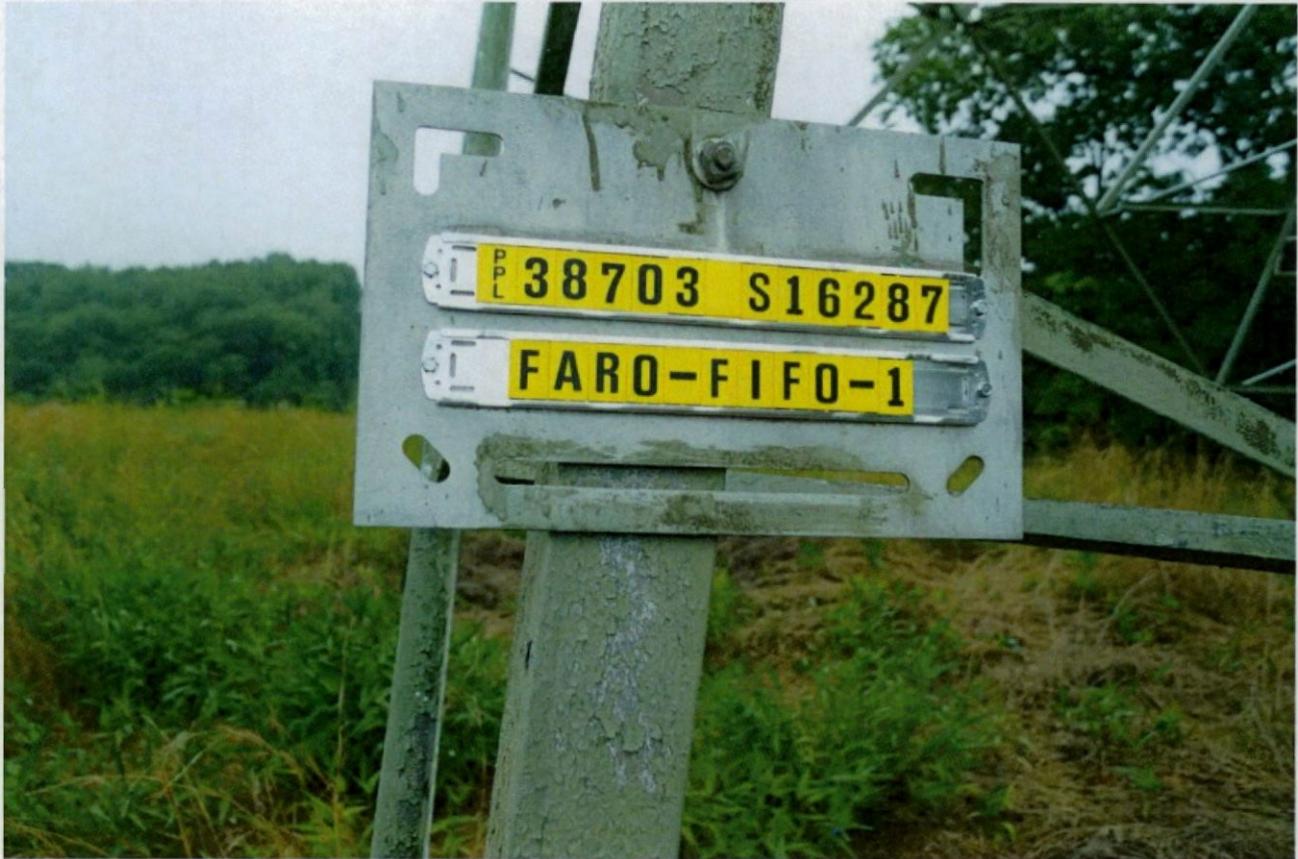
This structure exhibited a significant amount of blistered and peeling paint. Corrosion appeared minimal; however, the amount of bird feces on the top of the structure made it impossible to see paint, rust or metal on top of structure. This structure needs a more detailed climbing inspection to determine the condition of the top of the structure and to determine the remediation process and cost.

Figure 72: 38703S16287 - Paint flaking off the structure

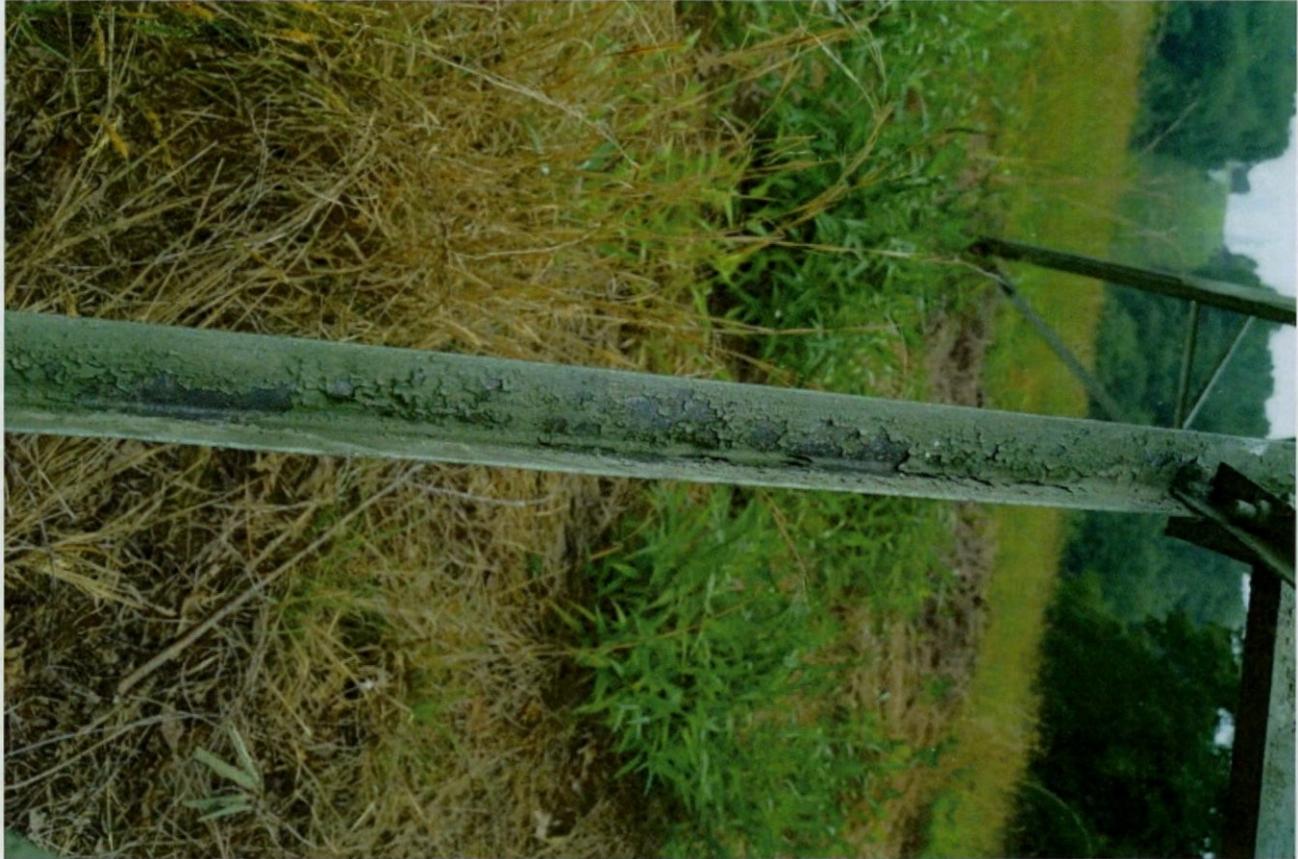
Figure 73: 38703S16287 - Paint condition is typical of the entire structure

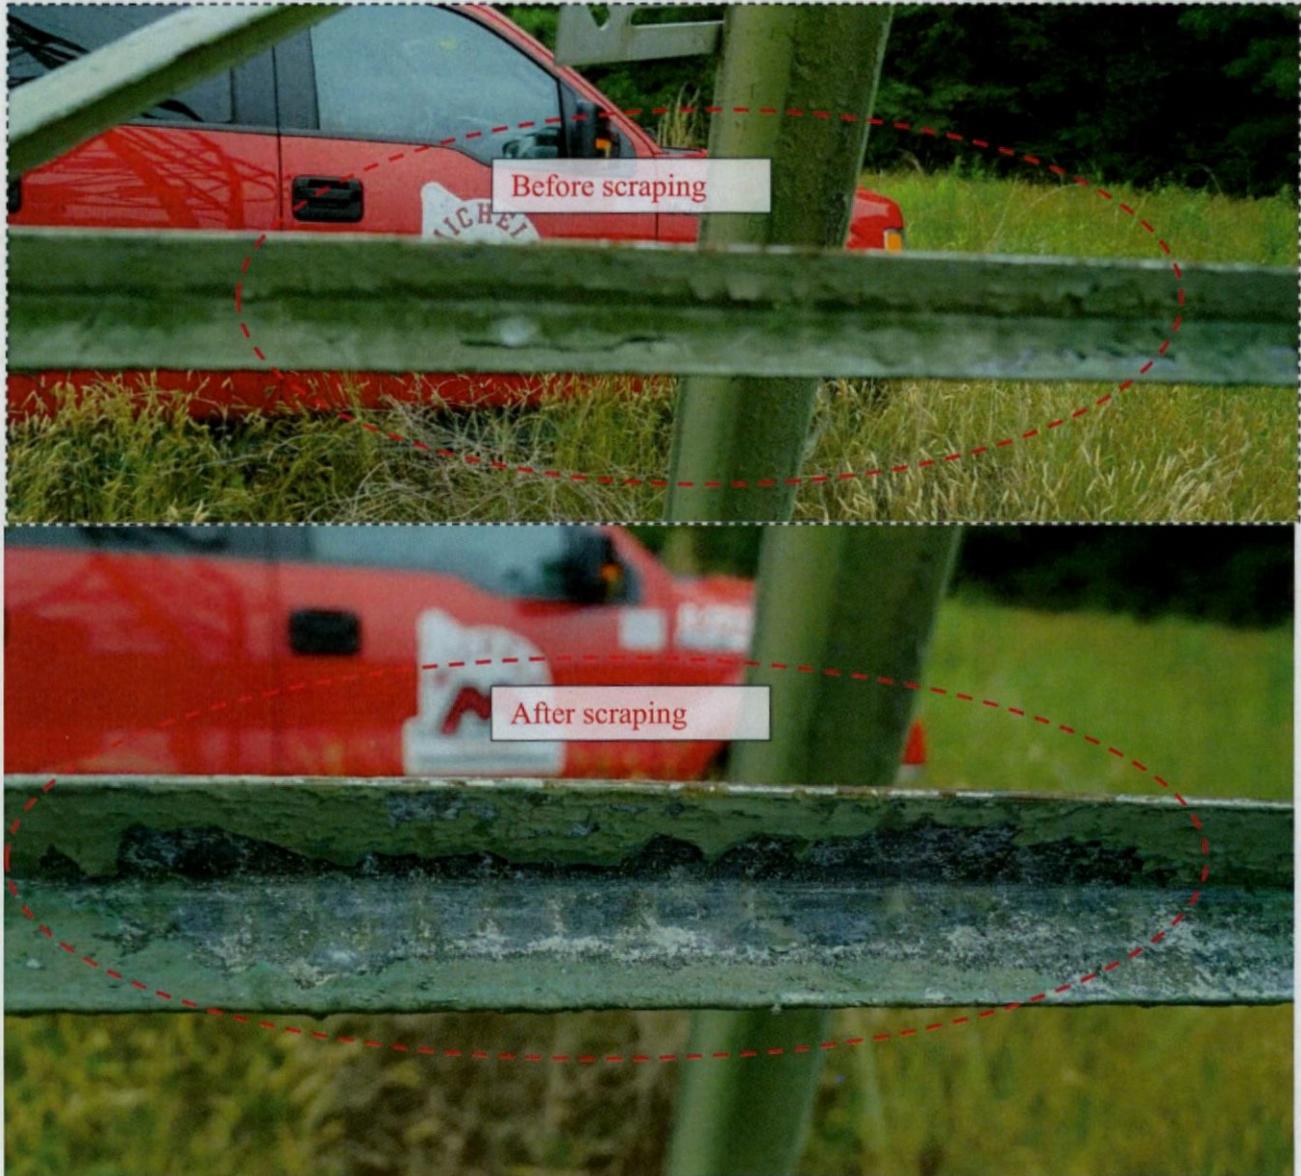
Figure 74: 38703S16287 - Paint before and after scraping with a hand scraper

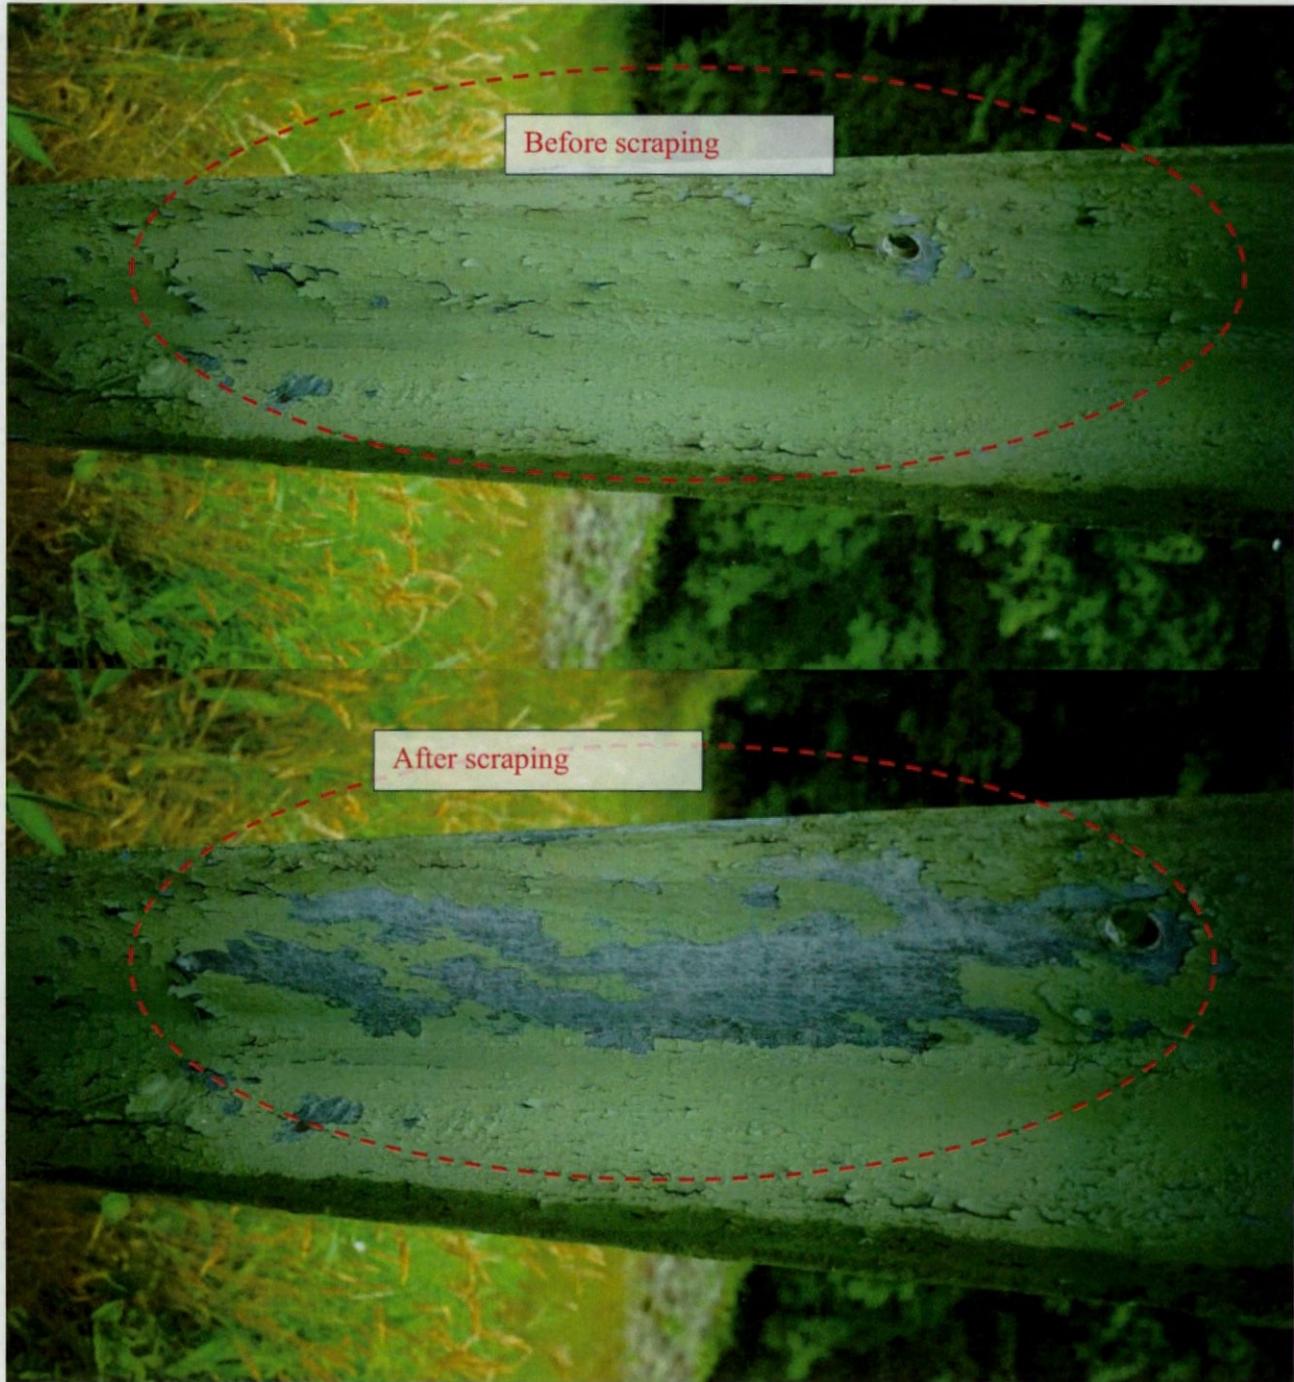
This structure exhibited significant deterioration and peeling of the paint. Corrosion began setting in in some places; however, the overall structure is in good shape. The existing paint needs to be removed and the structure repainted. The corrosion is minimal and should be relatively easy to address.

**Figure 78:** 38698S16295 - Paint before and after scraping with a hand scraper

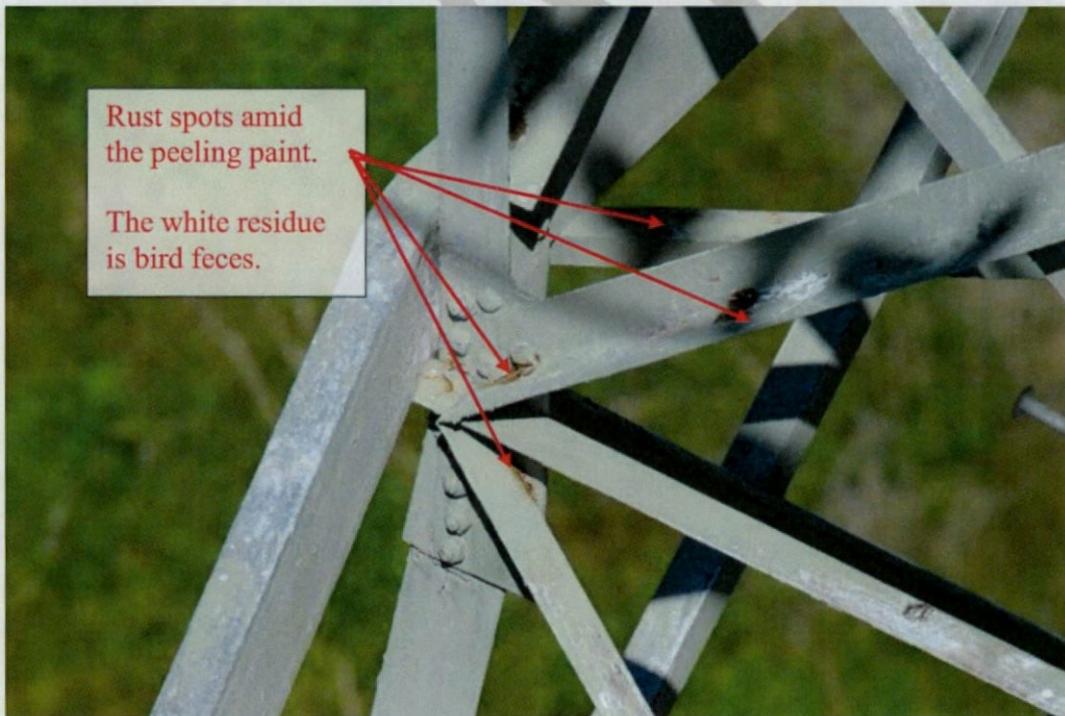
**Figure 81:** 38698S16295 - Spot rust and bird feces

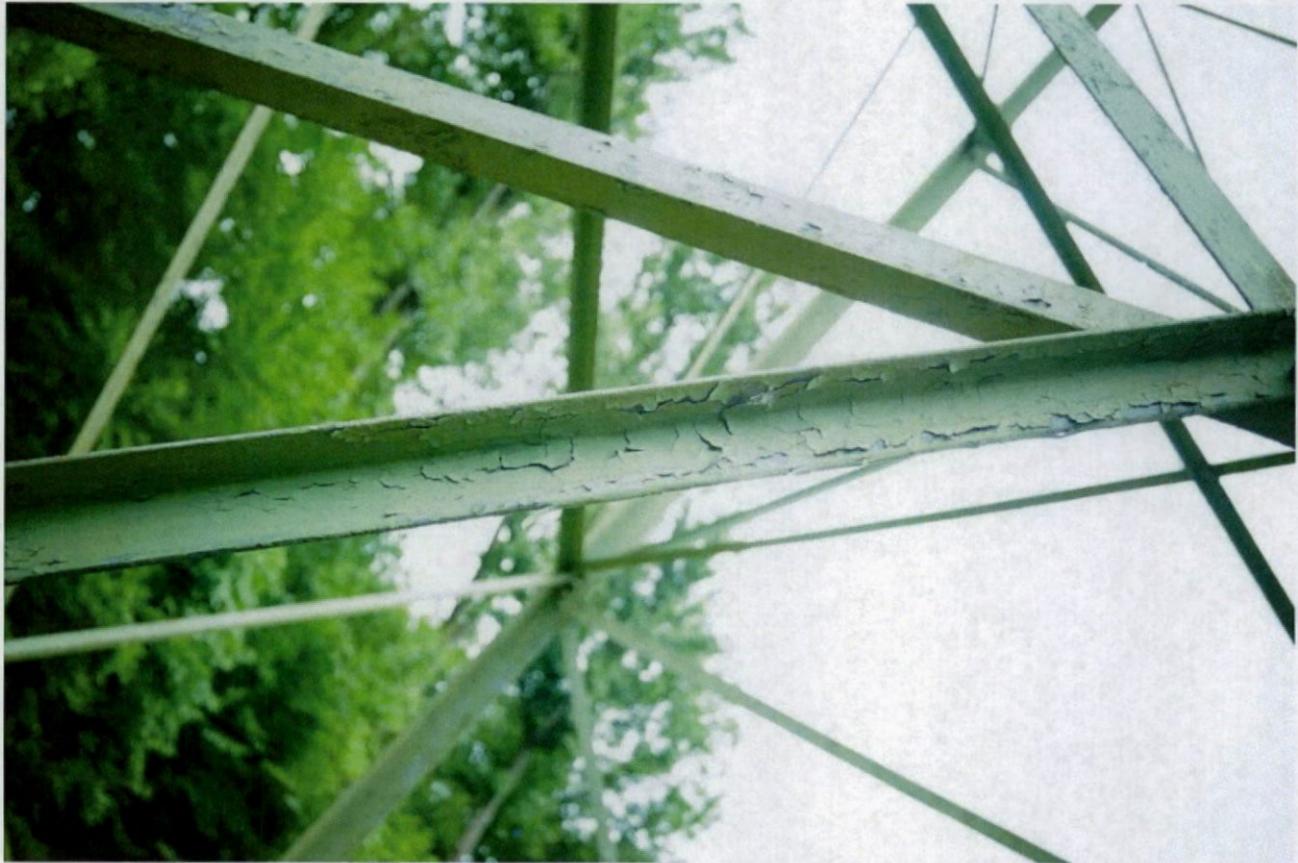
This structure exhibited loose and peeling paint over most of its surface. The lower sections were relatively free of corrosion, while the top of the structure exhibited a significant amount of corrosion. The paint needs to be stripped and the corrosion at the top of the structure needs to be addressed. Then the structure needs to be repainted.

**Figure 82:** 38663S16189 - Cracking and loose paint

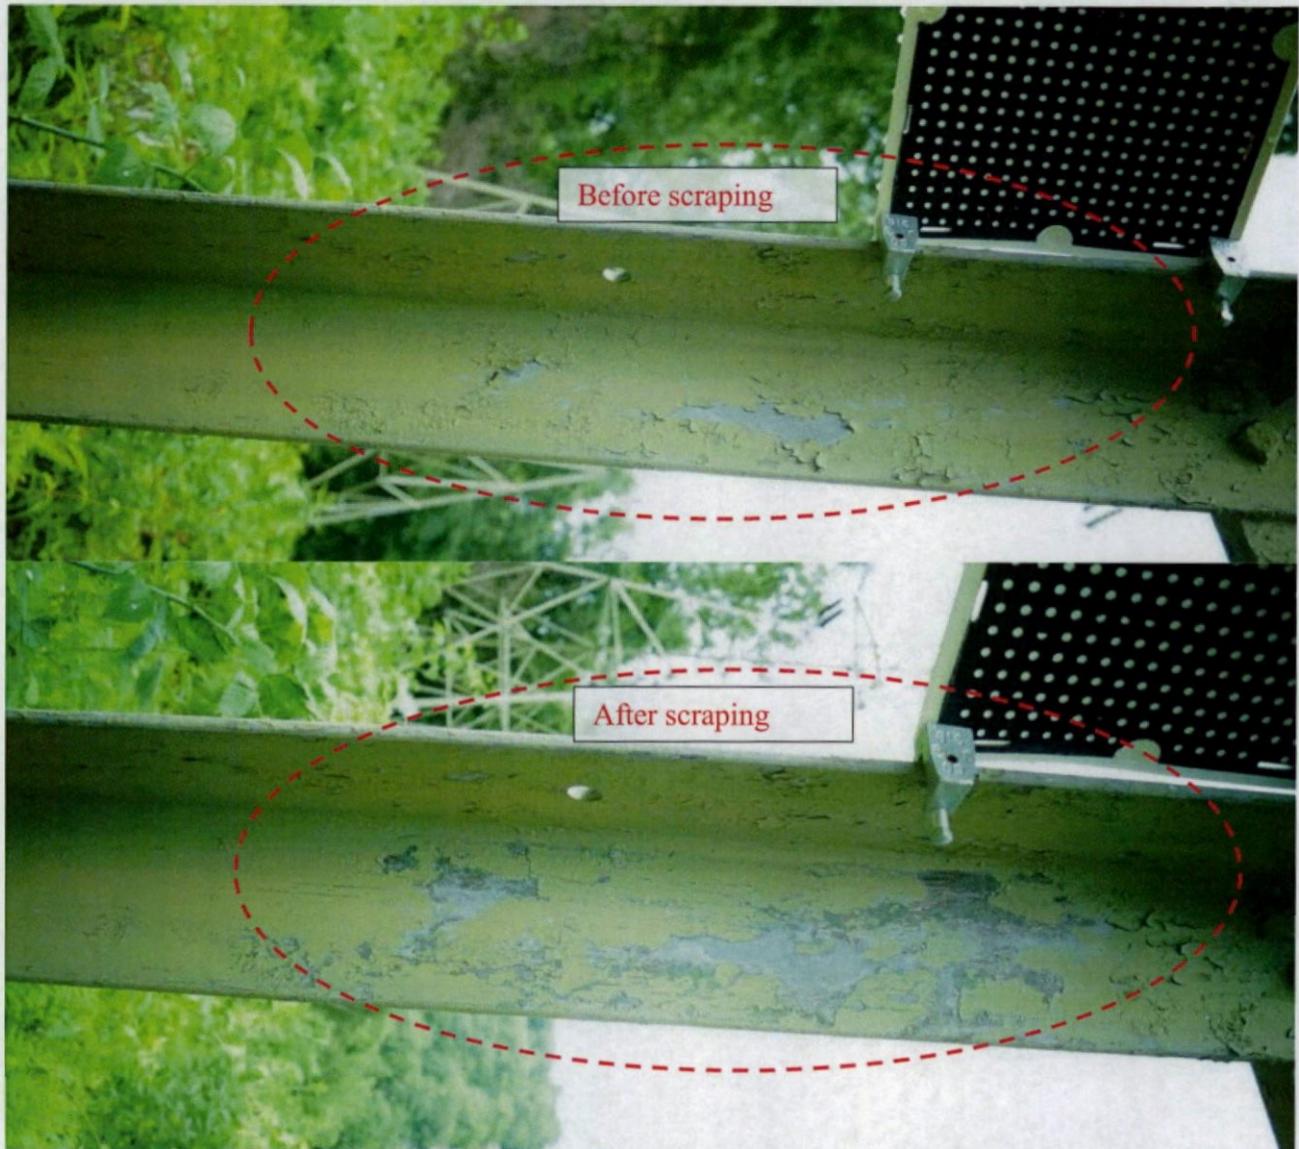
Figure 83: 38663S16189 - Paint condition, before and after scraping

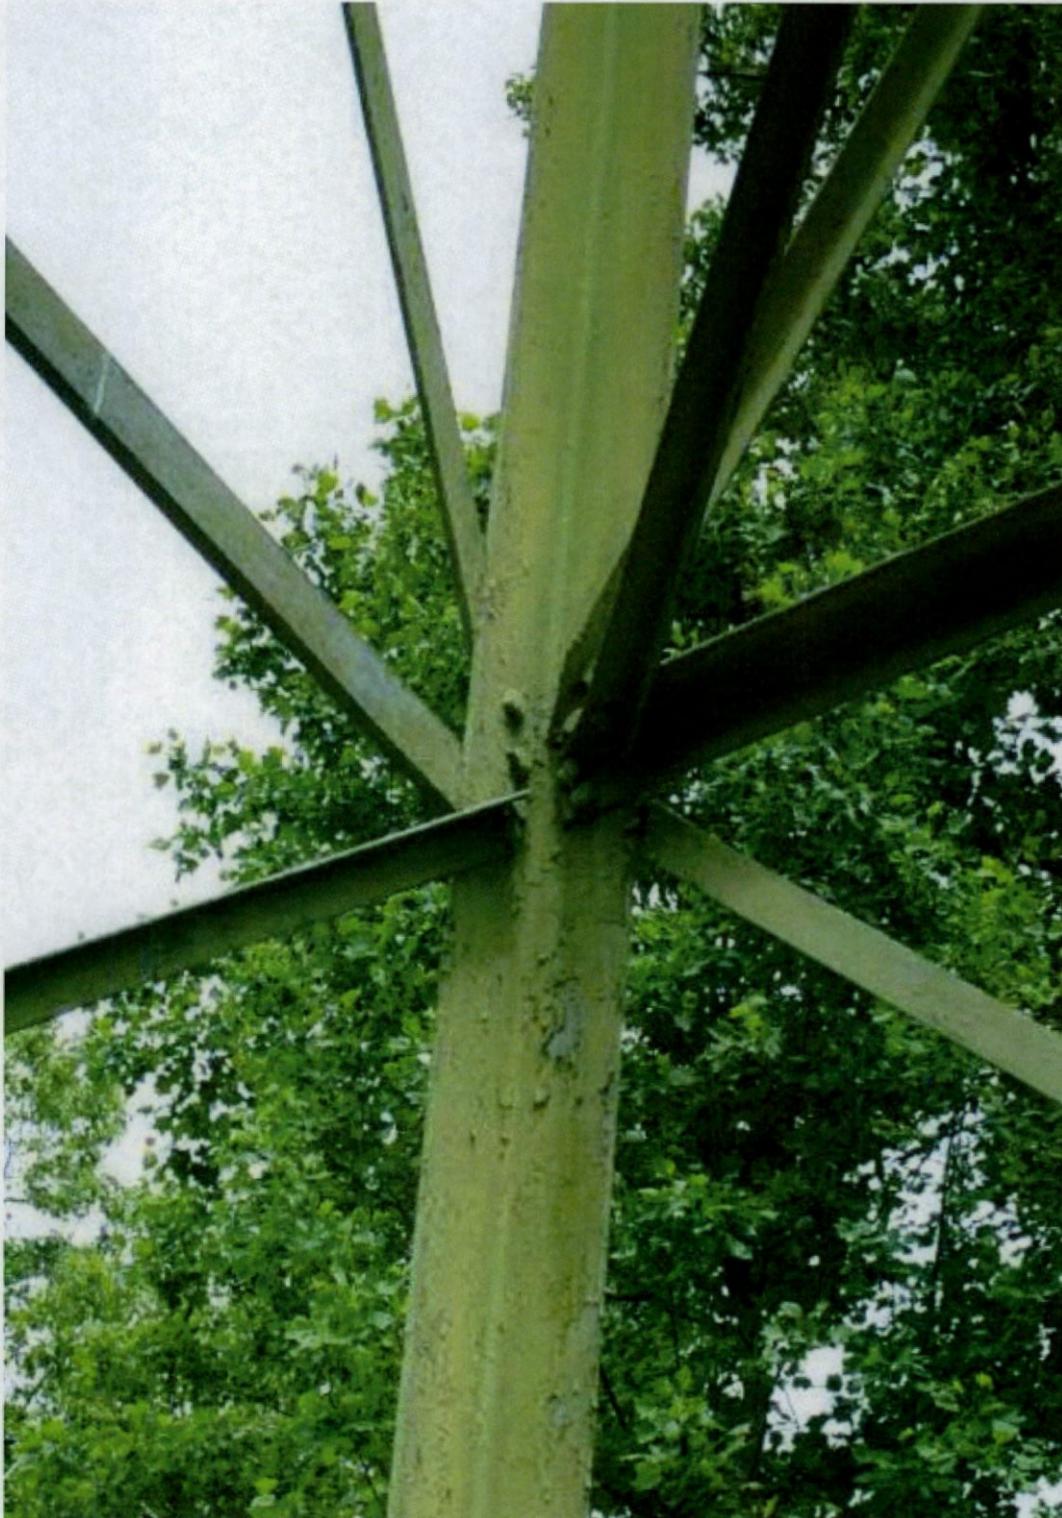
**Figure 84:** 38663S16189 - Paint condition where several braces connect to a support leg

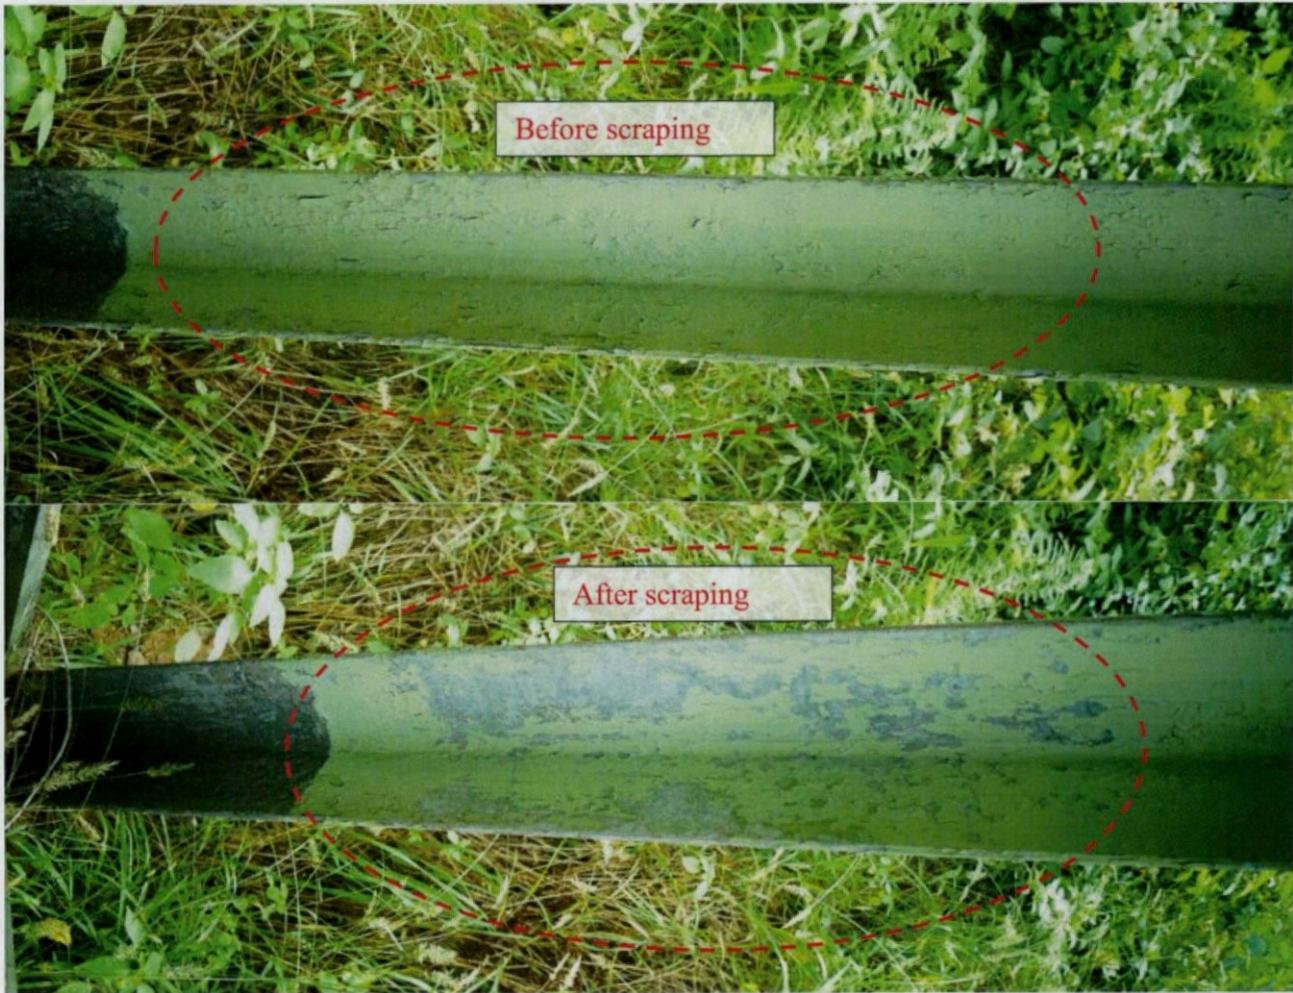
Figure 85: 38663S16189 - Paint condition before and after scraping
