**Face Rock – Five Forks Inspection of Structures**

NEETRAC Project Number: 16-107

June, 2016

Principal Investigator: Joe Goldenburg, P.E.  
(GA Lic# PE033181)

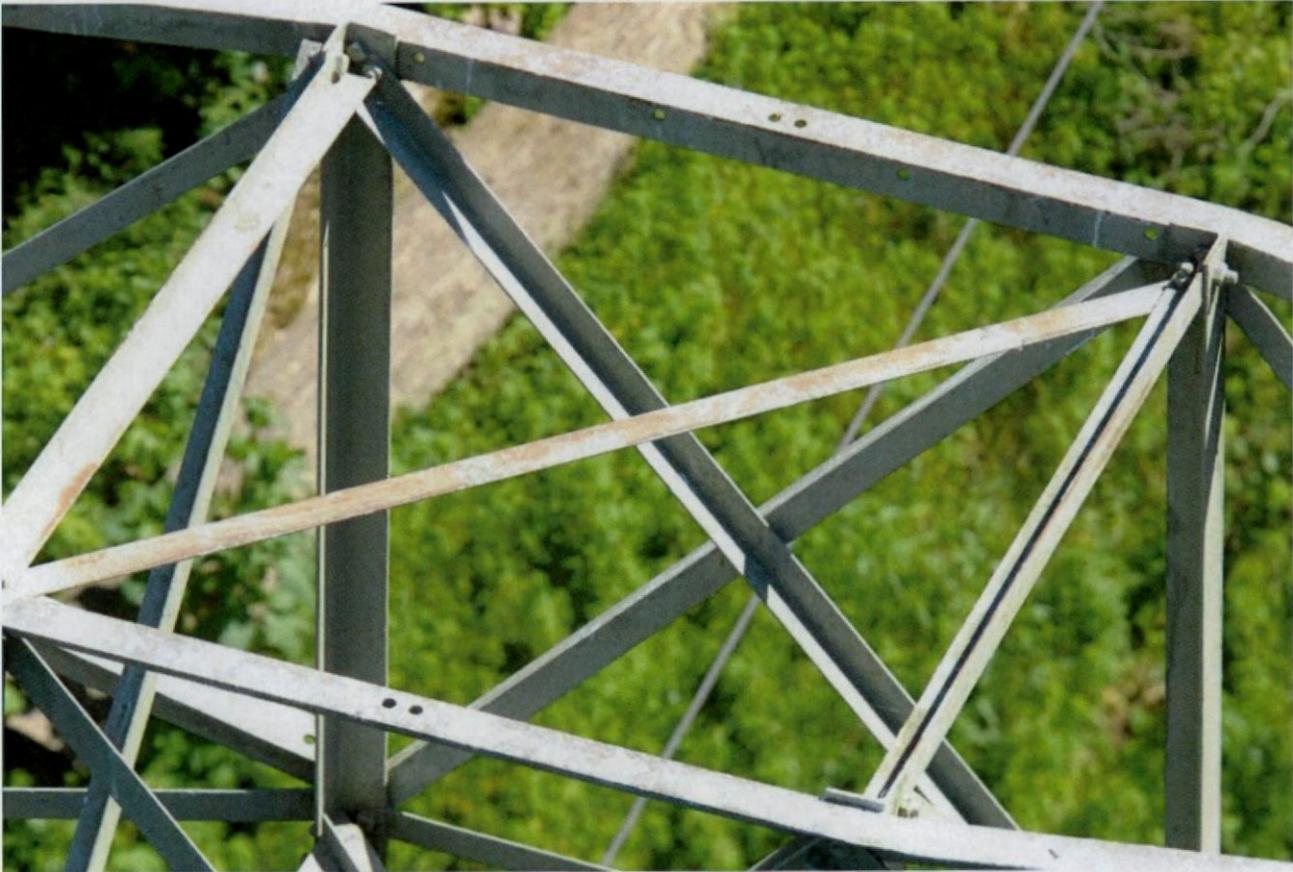
Figure 86: 38663S16189 - Top of the structure exhibited significantly more corrosion than the bottom

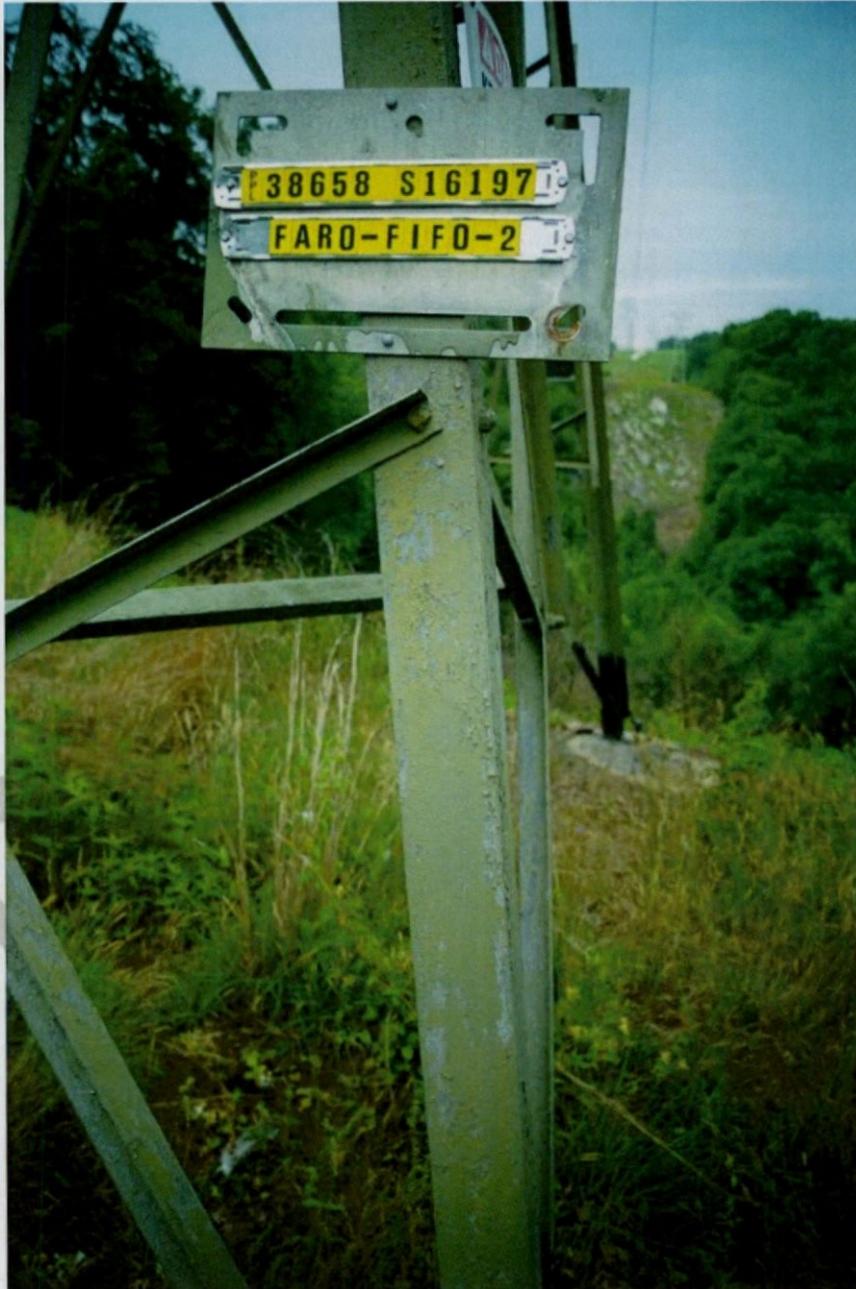
This structure exhibited poor adhesion of the paint over its entire surface. Some components were rusty, especially at the top, but otherwise the structure appeared in good shape. A detailed climbing inspection is needed to evaluate the top of the structure and determine the remediation plan and cost to strip, repair and repaint the structure.

Figure 87: 38658S16197 - Paint peeling off this structure

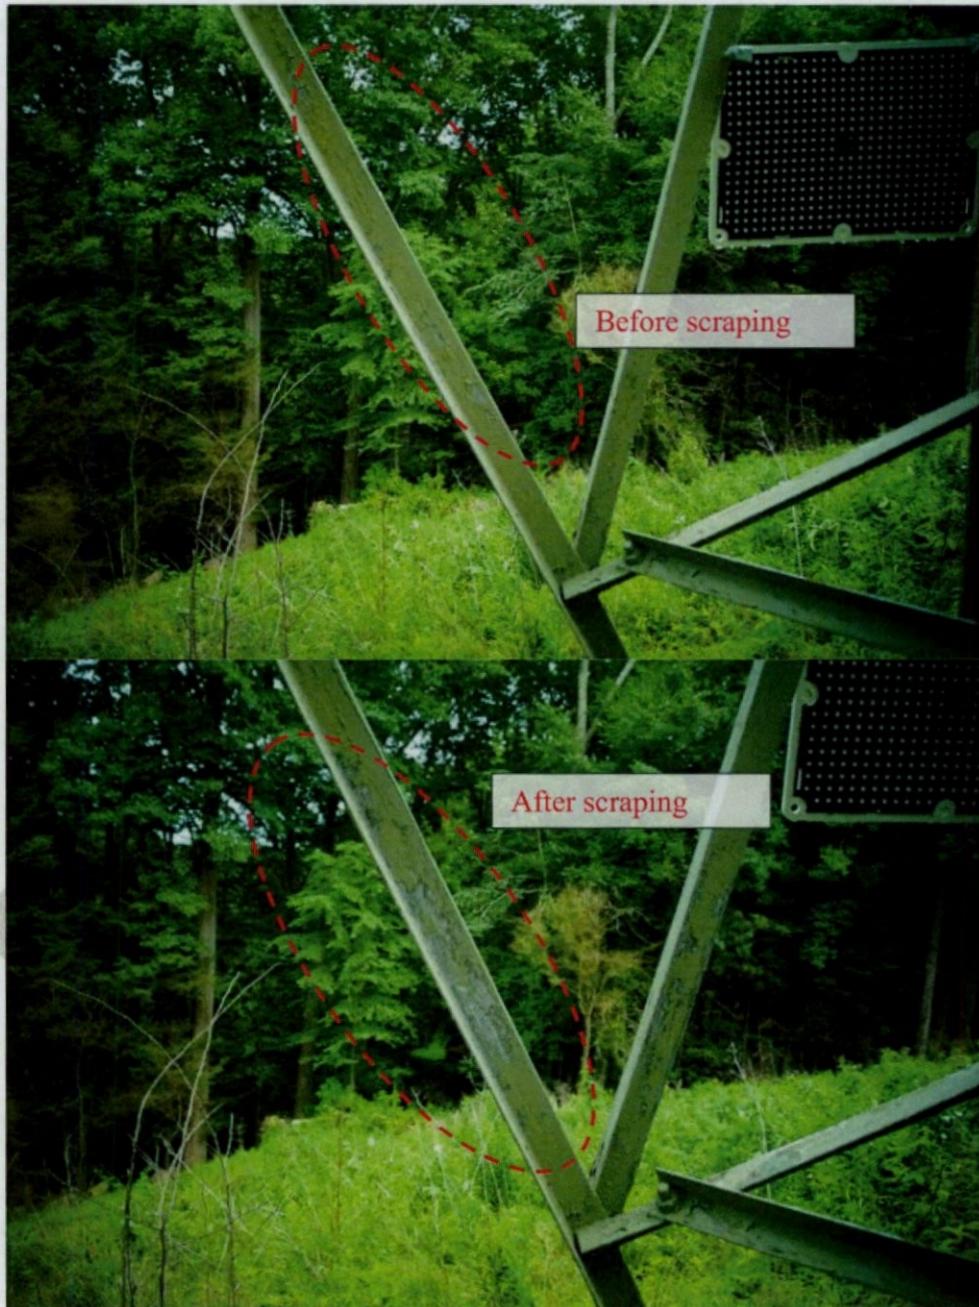
Figure 88: 38658S16197 - Paint condition before and after scraping

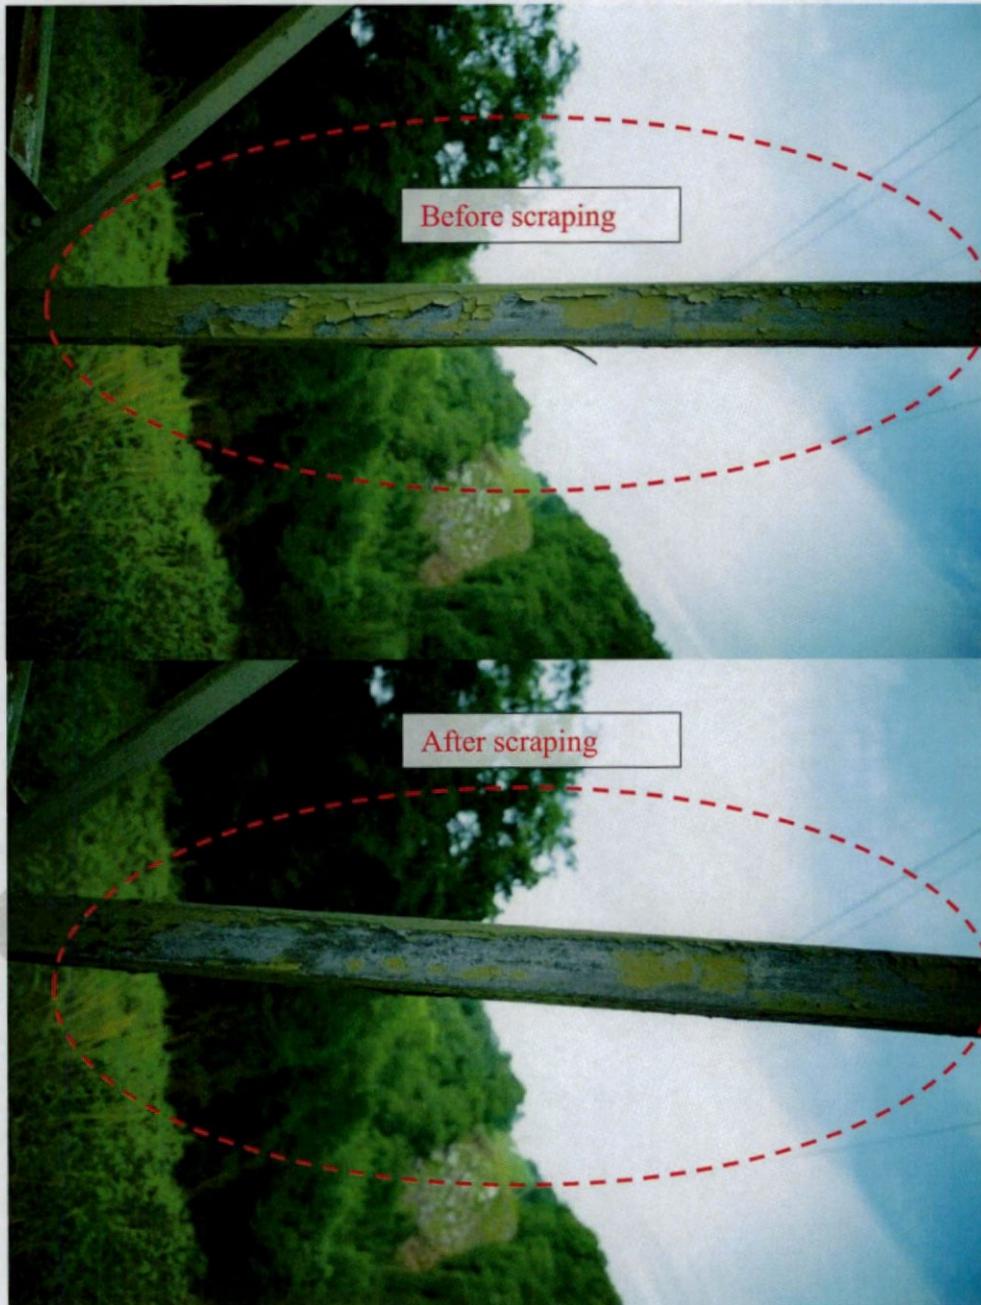
Figure 89: 38658S16197 - Paint condition before and after scraping

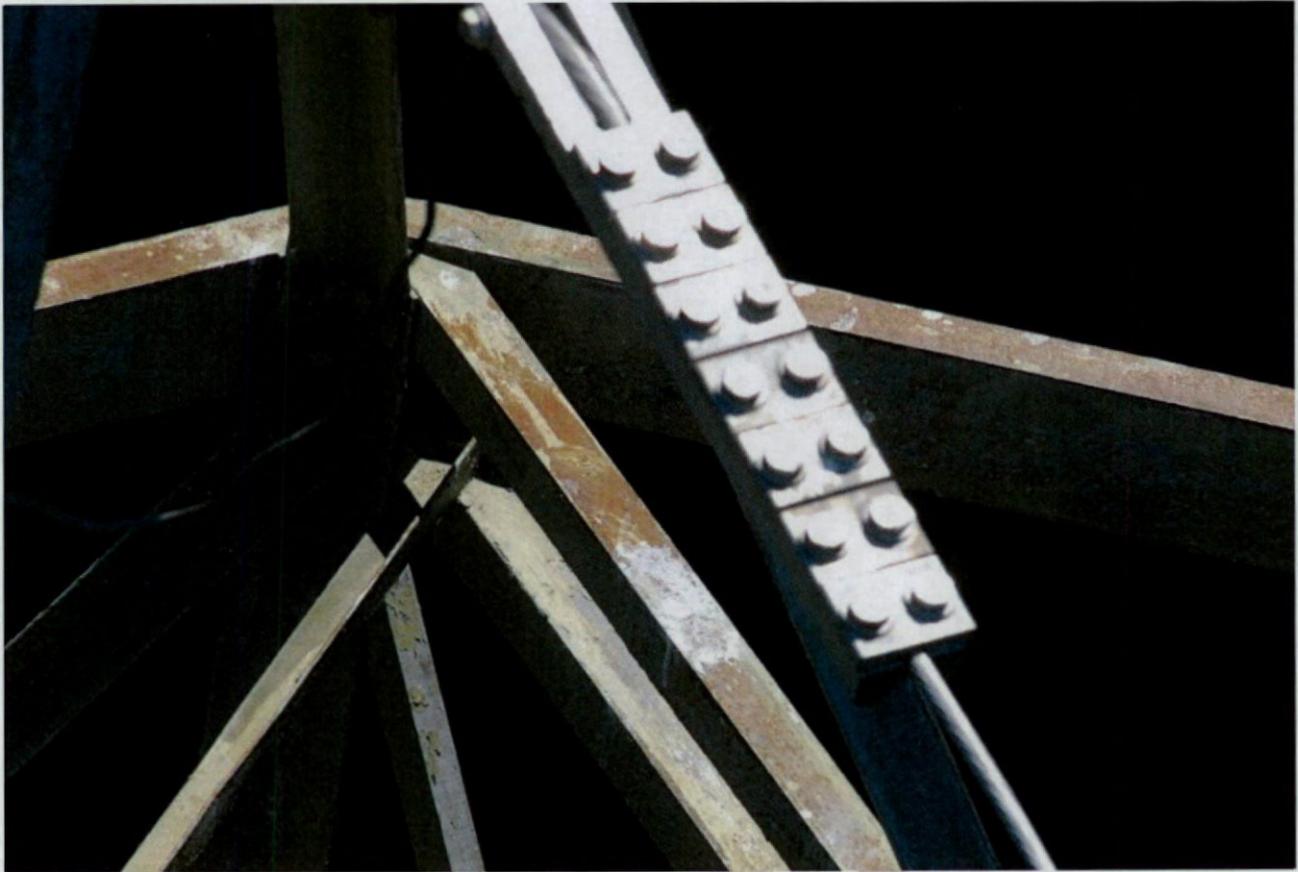
**Figure 92:** 38658S16197 - Top of the structure exhibited significant rusting and bird feces

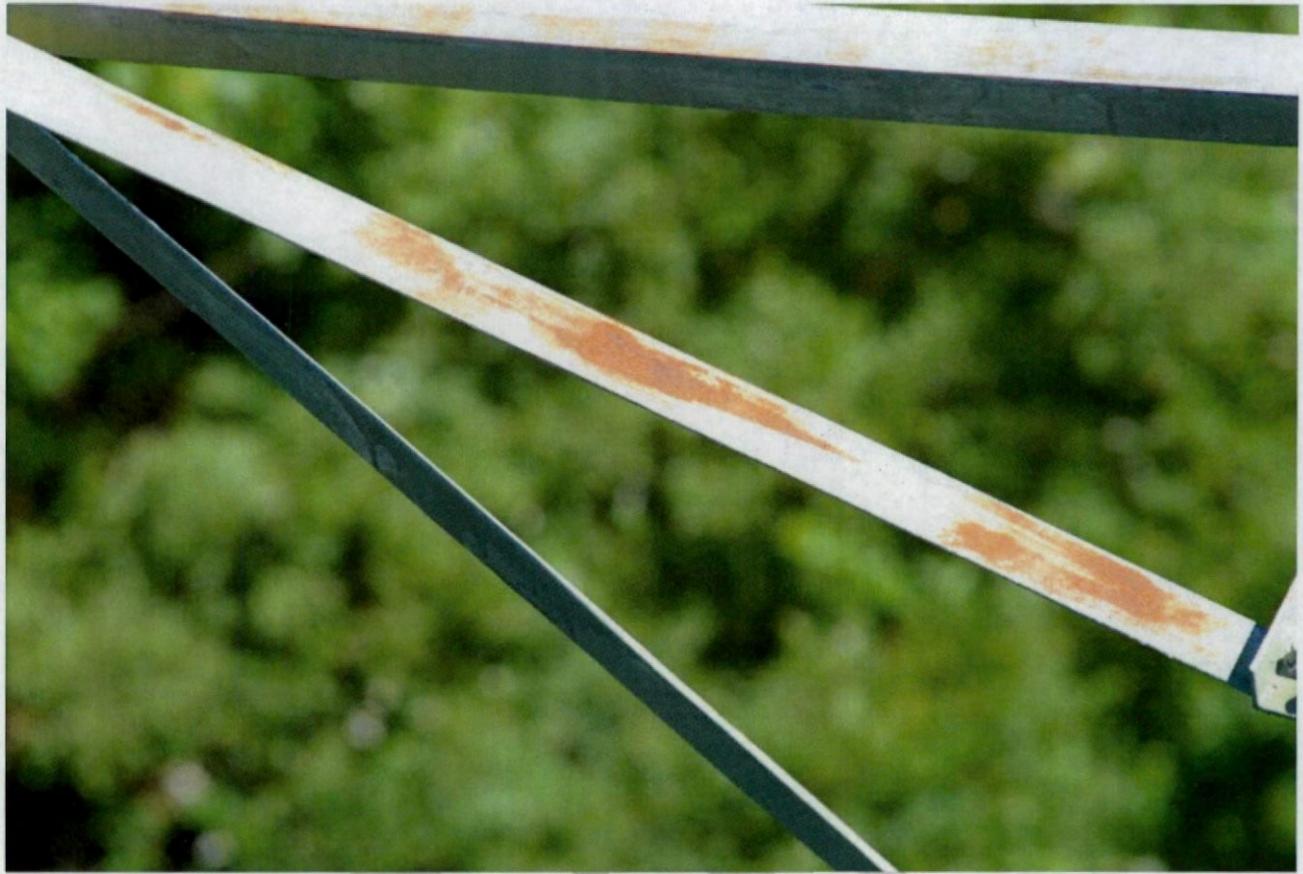
**Figure 101:** 38567S15943 - Top of the structure exhibited significant rust

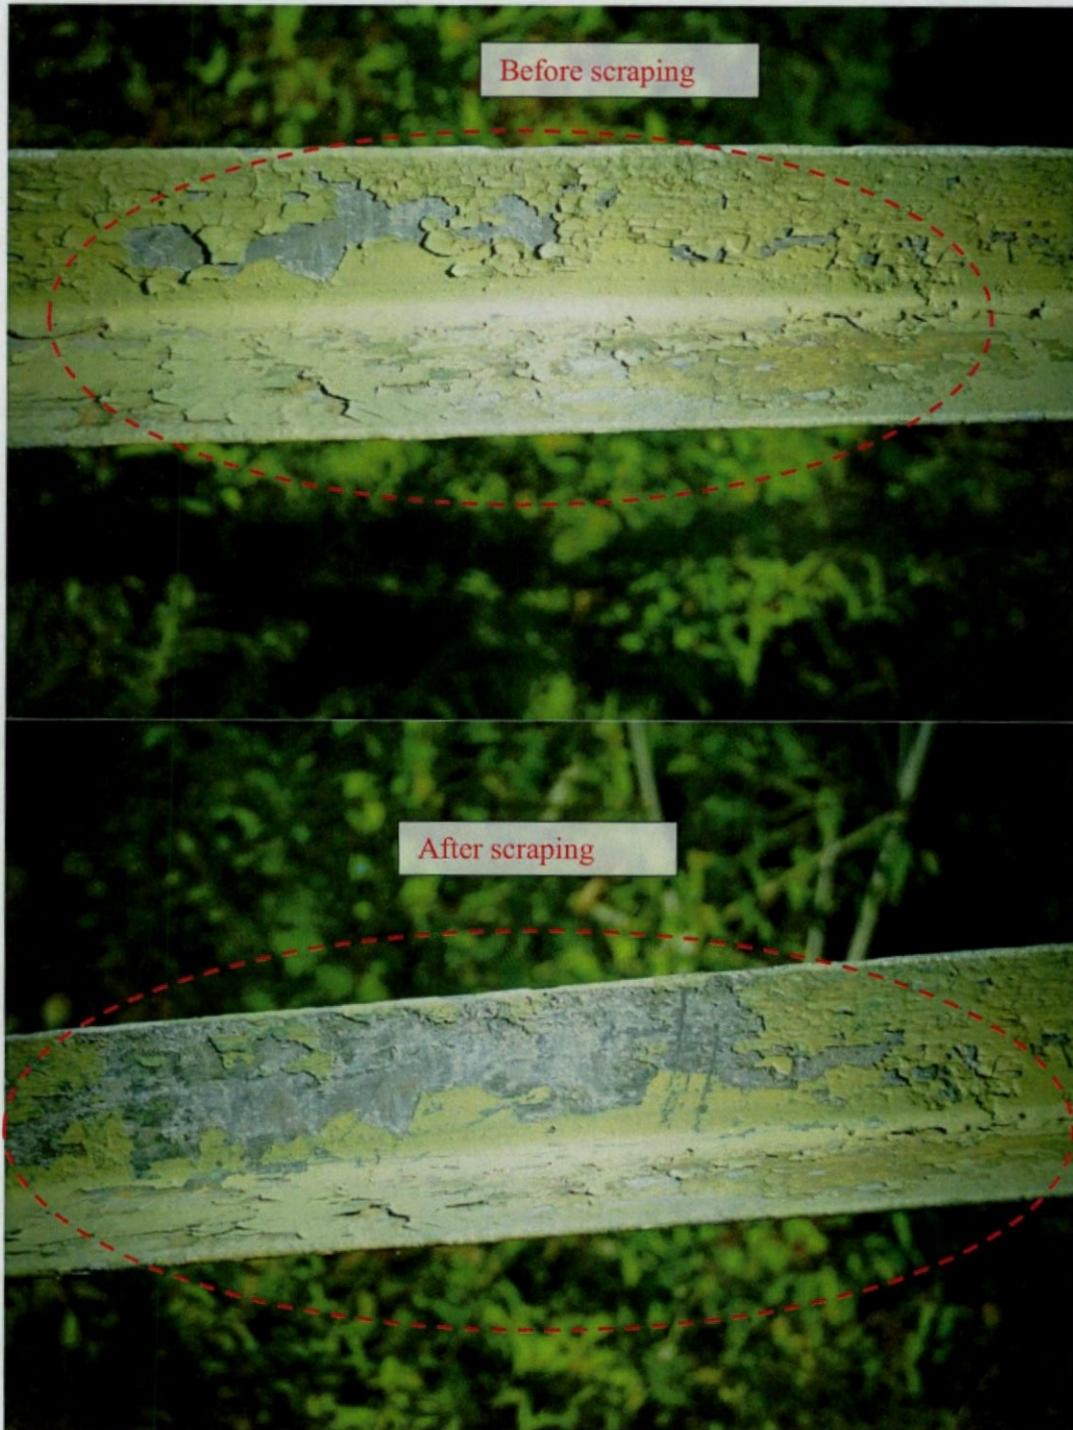
This structure exhibited poor paint adhesion and significant rusting, especially at the top of the structure. A more detailed climbing inspection is needed to determine the extent of the rust at the top of the structure, as well as the remediation plan and cost. Some structural components will need replacement.

Figure 102: 38562S15945 - Paint before and after scraping

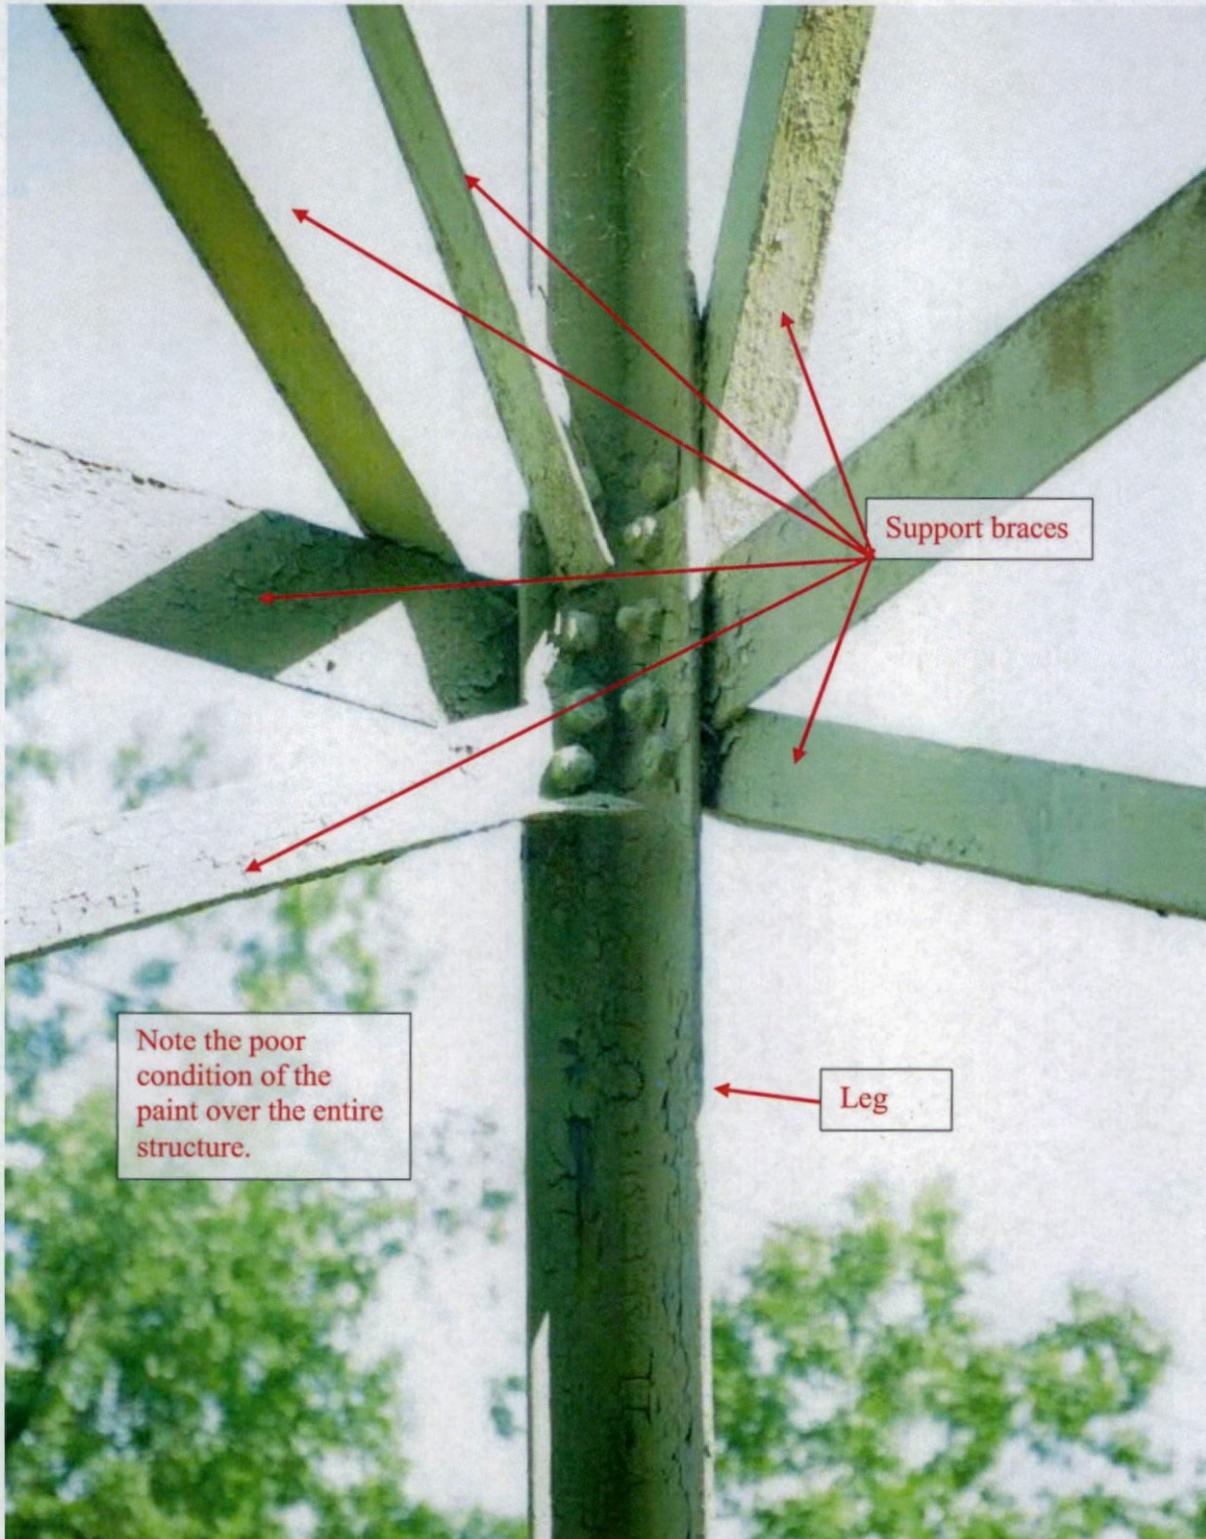
Figure 105: 38562S15945 - Detail of several cross braces connecting to a support leg

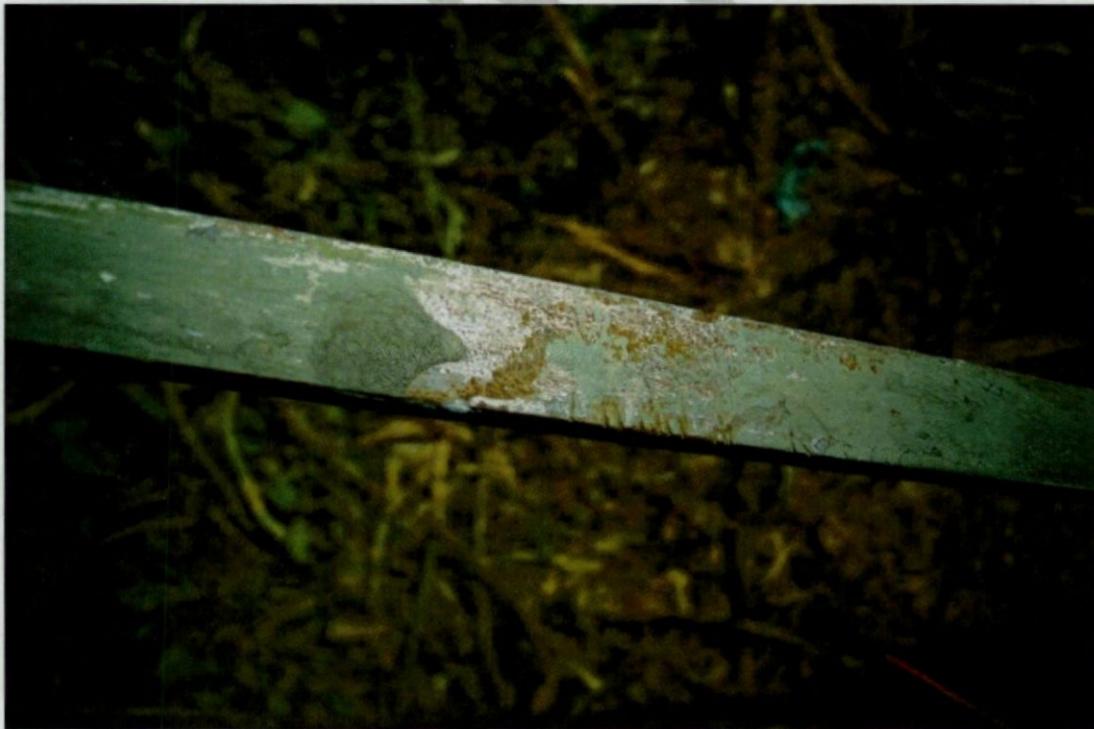
**Figure 109:** 38349S15373 - Poor paint adhesion and corrosion, typical of most of the structure

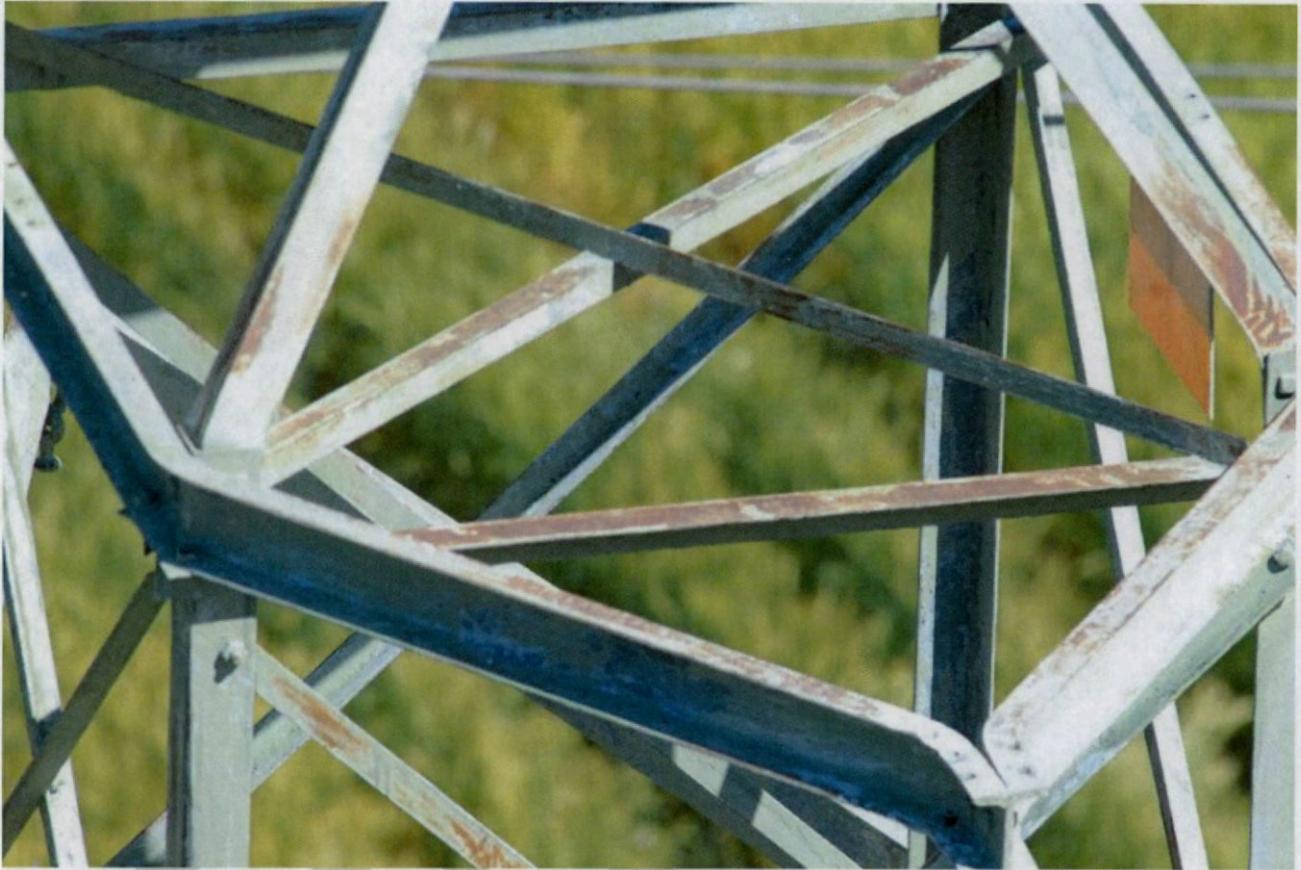
The top of this structure is heavily corroded. A more detailed climbing inspection is needed to determine which components need replacement and to determine a remediation plan and cost.

**Figure 110:** 38378S15471 - Corrosion and bird feces on the top of this structure

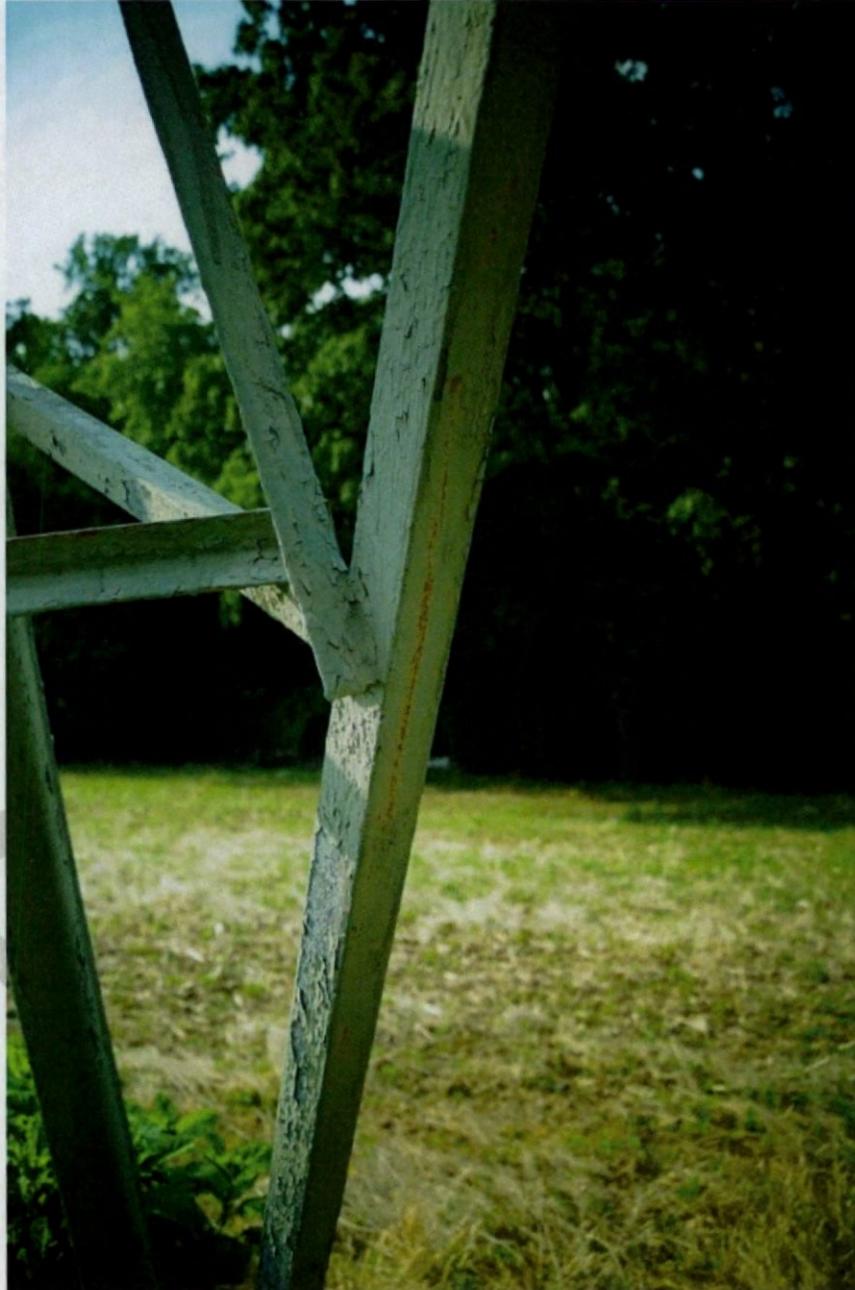
This structure exhibited poor paint adhesion and spot rust over its entire lower surface. The top of this structure exhibited significant rust and several components may need to be replaced. A more detailed inspection is needed to determine the remediation plan and cost.

**Figure 116:** 38124S14790 - Poor paint adhesion and spot rust typical of the lower part of this structure

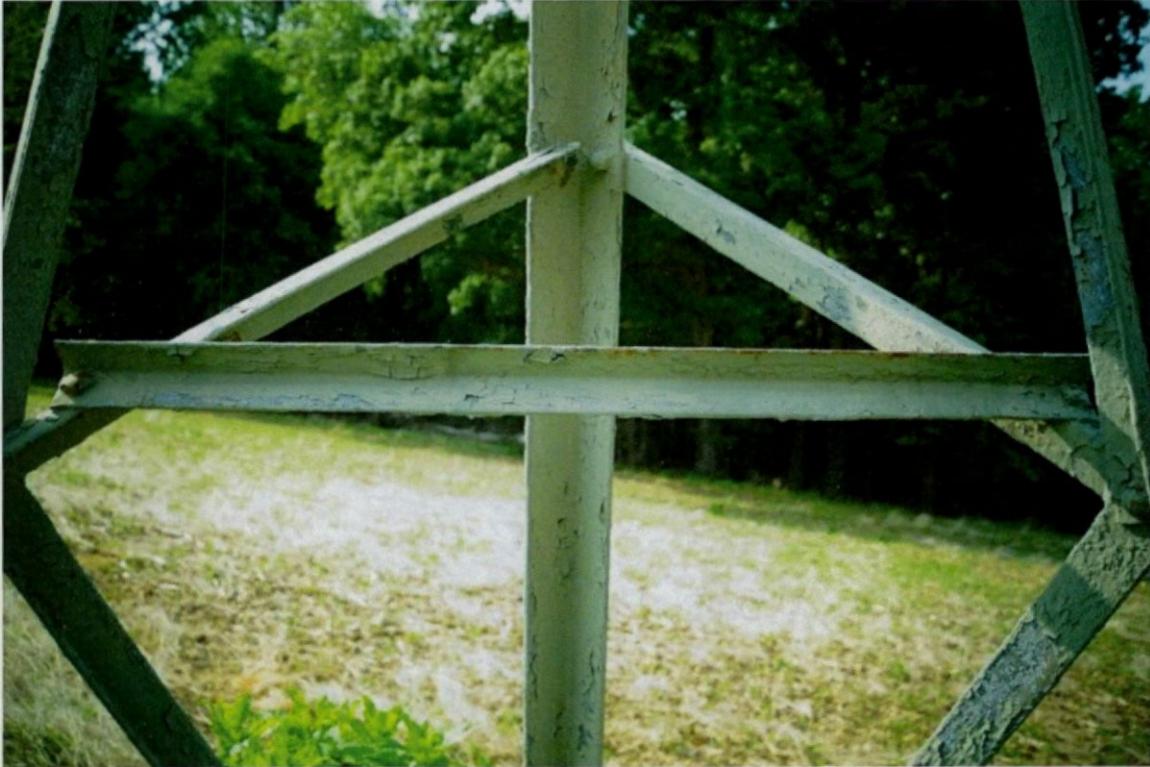
Figure 117: 38124S14790 - Poor paint adhesion and spot rust typical of the lower part of this structure

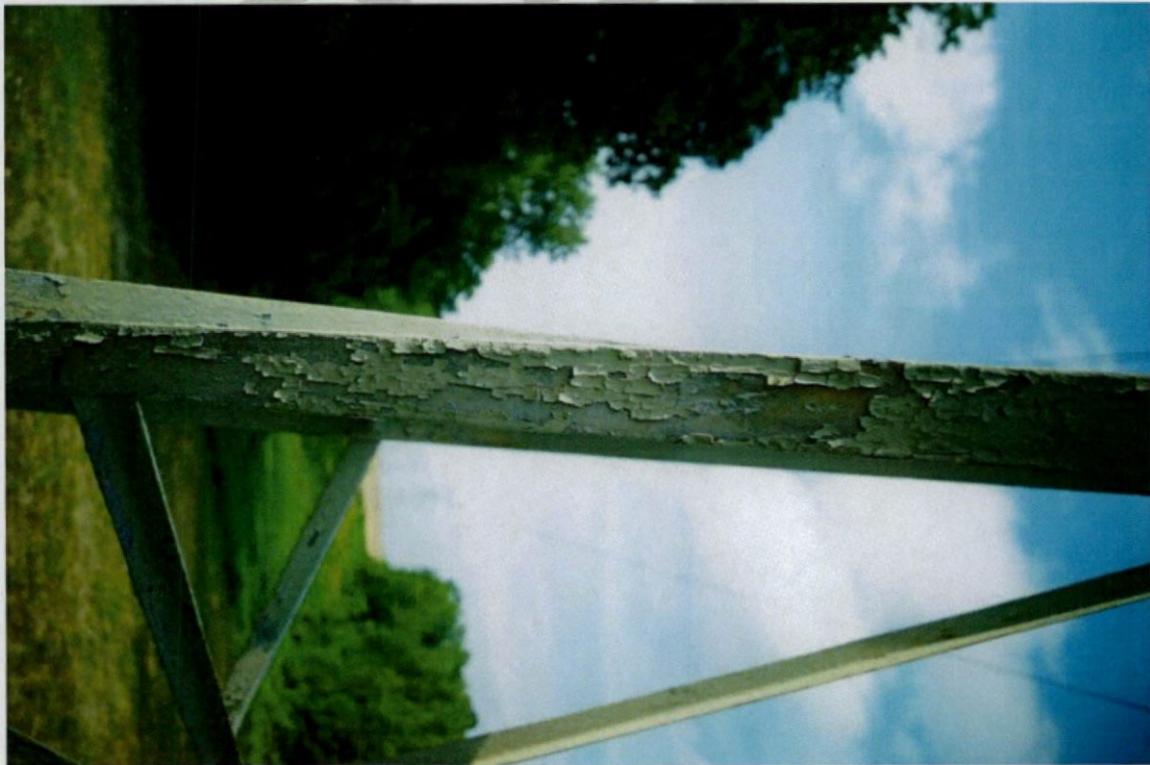
Figure 118: 38124S14790 - Poor paint adhesion and spot rust typical of the lower part of this structure

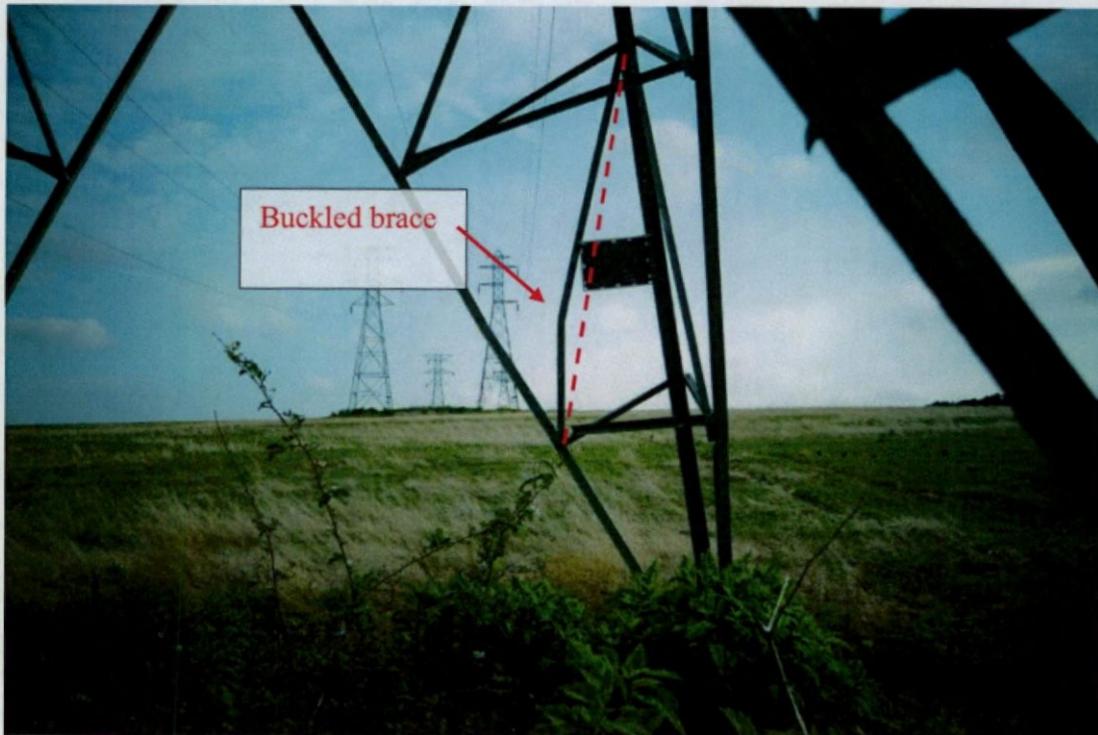
This structure was not on the inspection list. However, several buckled braces were observed while passing it.

Figure 126: 38129S14788 – Buckled brace

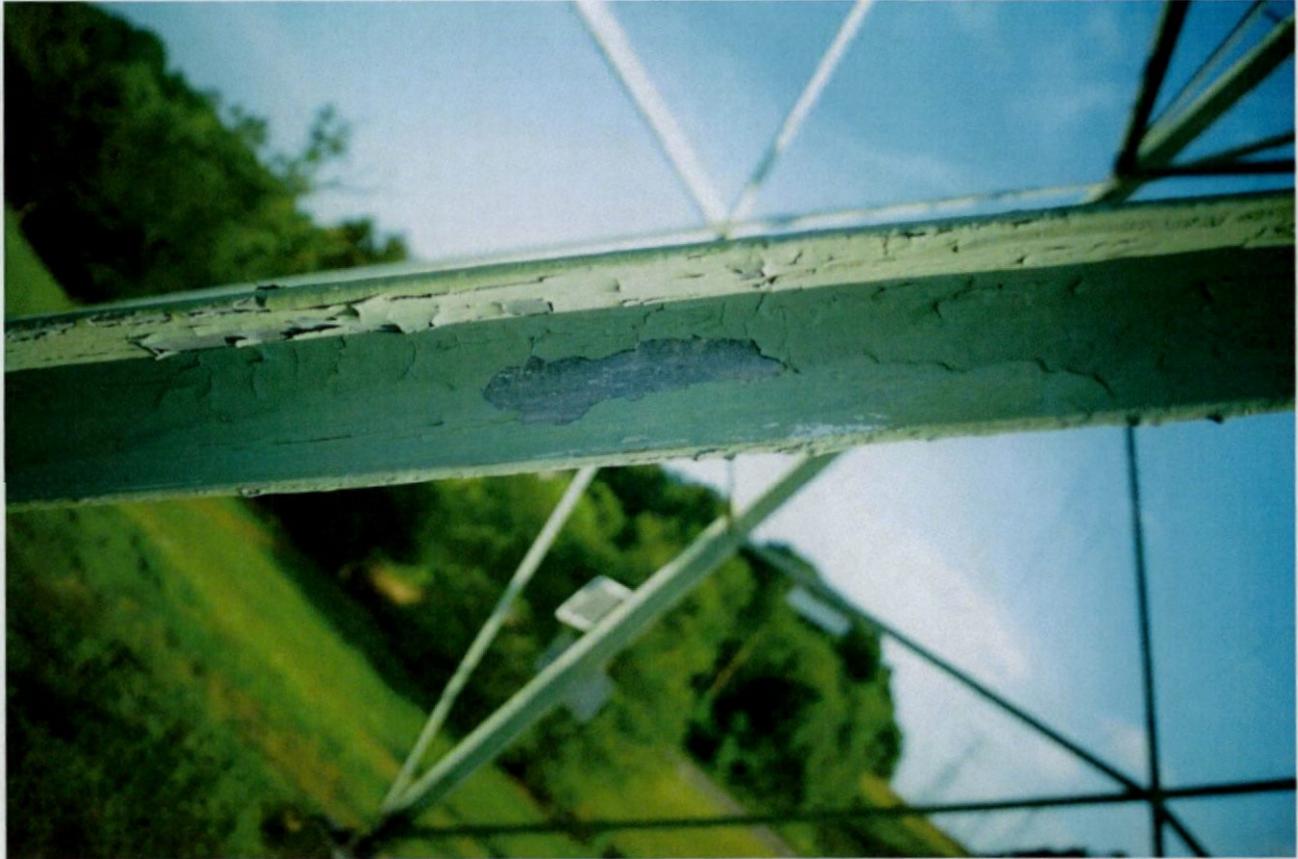
**Figure 134:** 38010S14451 - Poor paint adhesion typical of the entire structure
