PPL Electric Utilities
Steel Transmission Structure
Corrosion Inspection

Lines 577-578 (Face Rock – Five Forks 1 & 2)

Inspection Summary

September 2, 2016

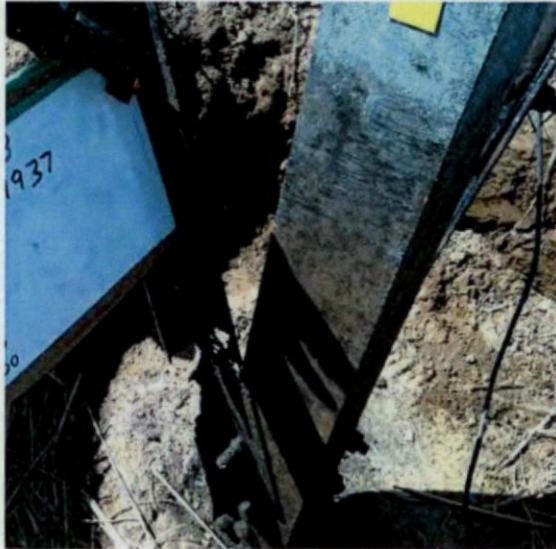
Structure 38178S14937 Leg 4 - Priority

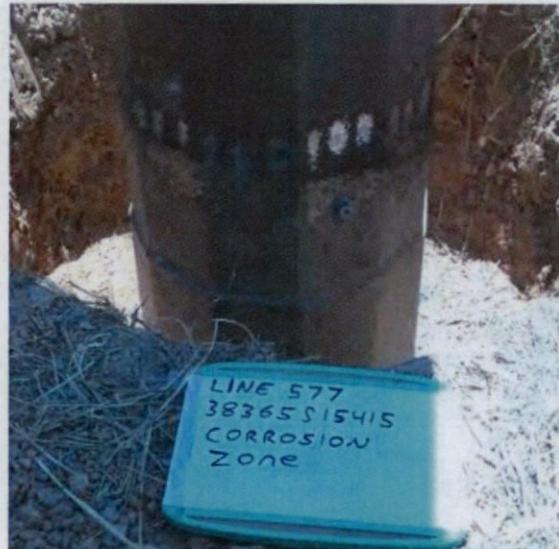
Structure 38365S15415 - Priority

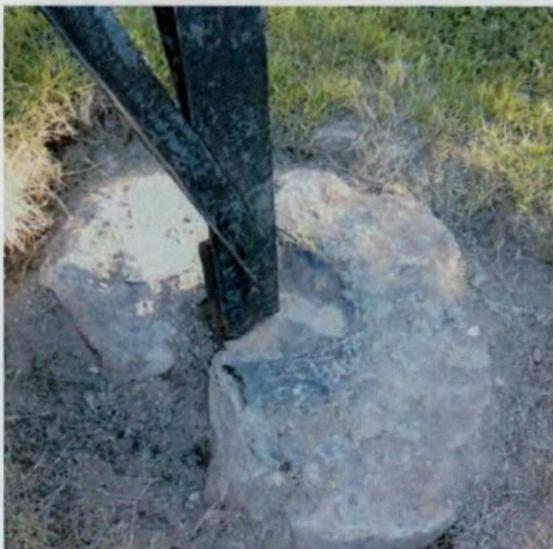
Structure 38529S15855 Leg 4 - Condition D

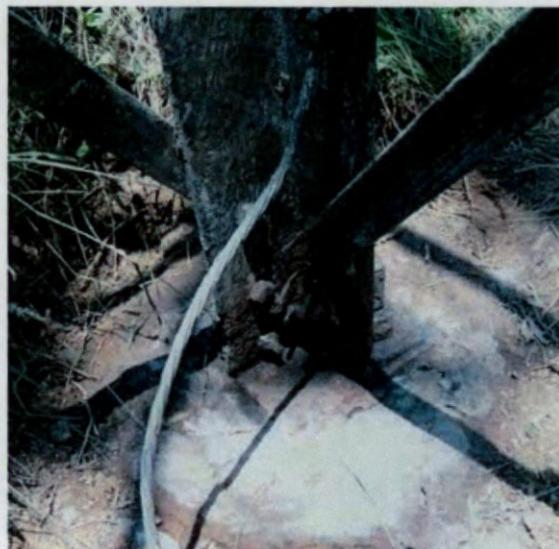
Structure 38663S16189 Leg 4 - Condition D

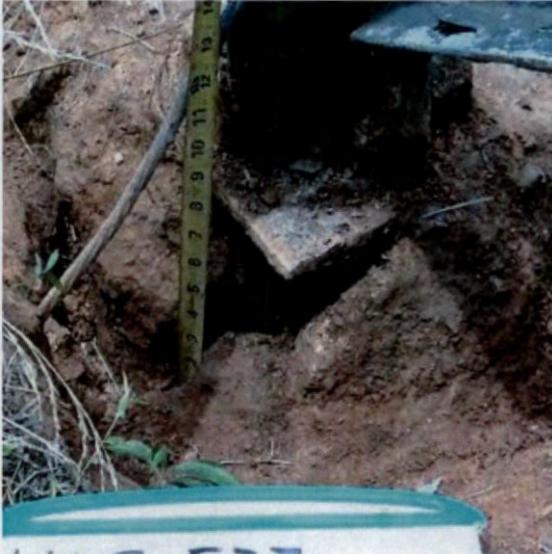
Structure 38064S14615 Leg 4 - Priority

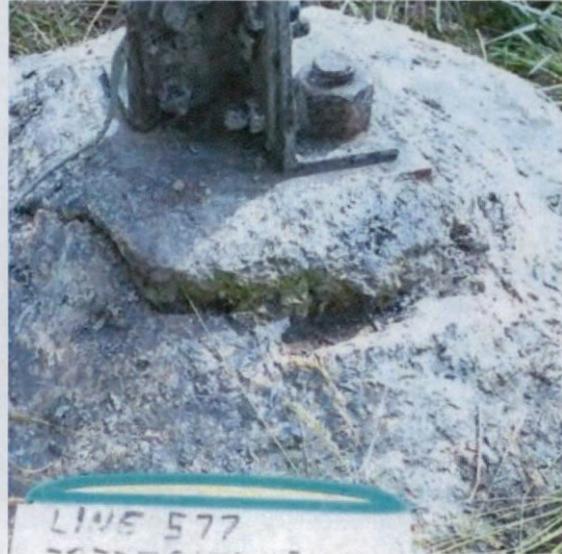
Structure 38335S15338 Leg 3 - Priority

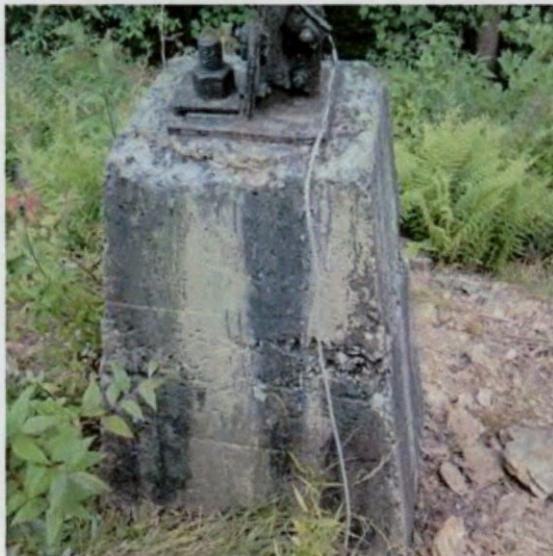
Structure 38567S15943 Leg 1 - Condition D

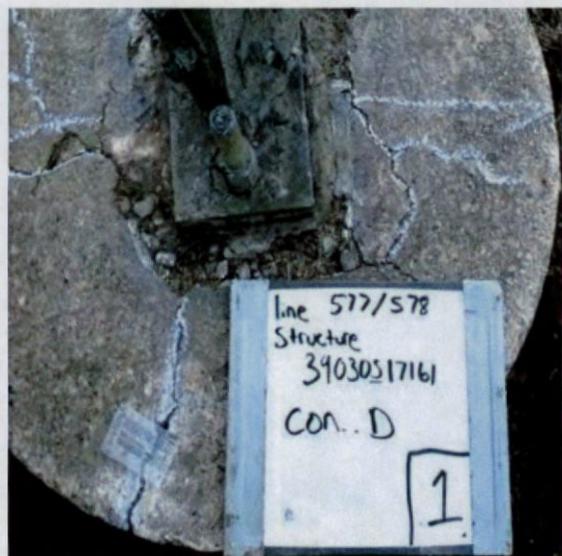
Structure 39030S17161 Leg 1 - Condition D

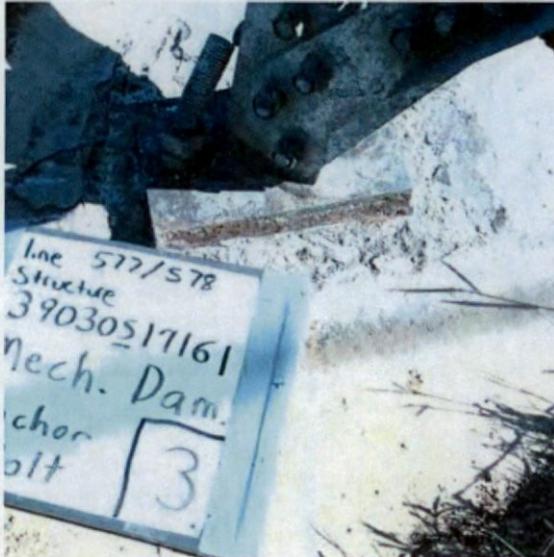
Structure 39030S17161 Leg 3 - Class III

Osmose Utilities Services recommends the (11) foundation and (89) structural “Priority” members be repaired within 3 months, along with the (2) “Class III” mechanically damaged members. Osmose also recommends the (126) structural and (45) foundation “Condition D” members be repaired within 12 months, along with the (22) “Class II” mechanically damaged members. The (35) structural and (290) foundation “Condition C” members should also be considered for corrosion restorations. The remaining “Condition B” members should be re-inspected within 5 years, while the remaining “Condition A” members should be re-inspected within 10 years. Restorations implemented will restore the strength lost due to corrosion and mechanical damage.

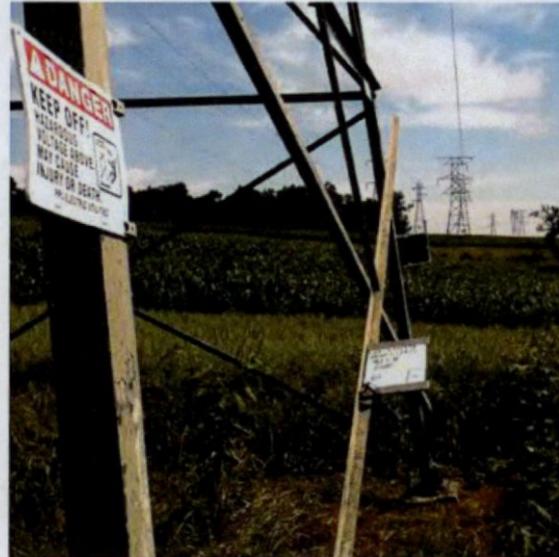
Structure 39154S17472 Leg 2 - Class III

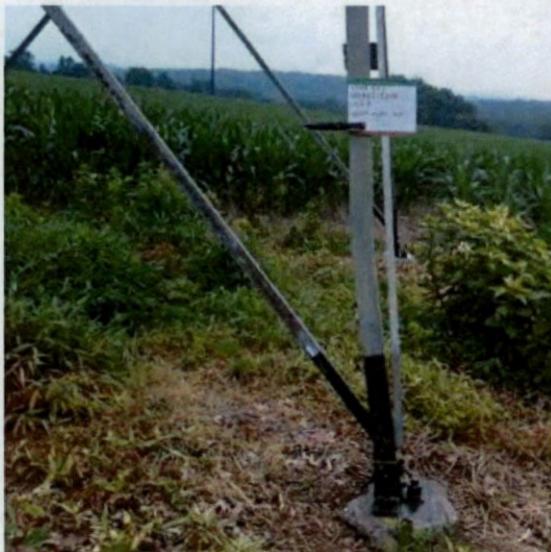
Structure 38286S15208 Leg 3 - Class II

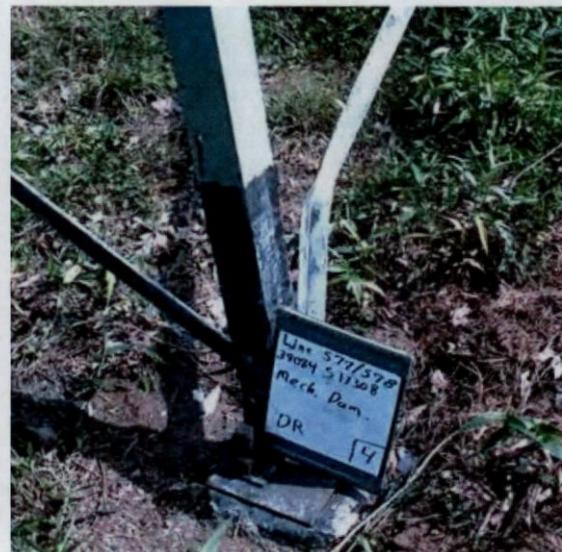
Structure 39090S17305 Leg 4 - Class II
