September 1, 2011

Project 2009-149

Mr. Joseph Marhefka
PPL Electric Utilities
2 North Ninth Street
Allentown, PA 18101-1179
MS: GENN4

*Special Inspection Report for
Zone #1, Hauto-Siegfried #1 and #4 &
Siegfried-E. Palmerton #1 and #2 69kV Transmission Lines*

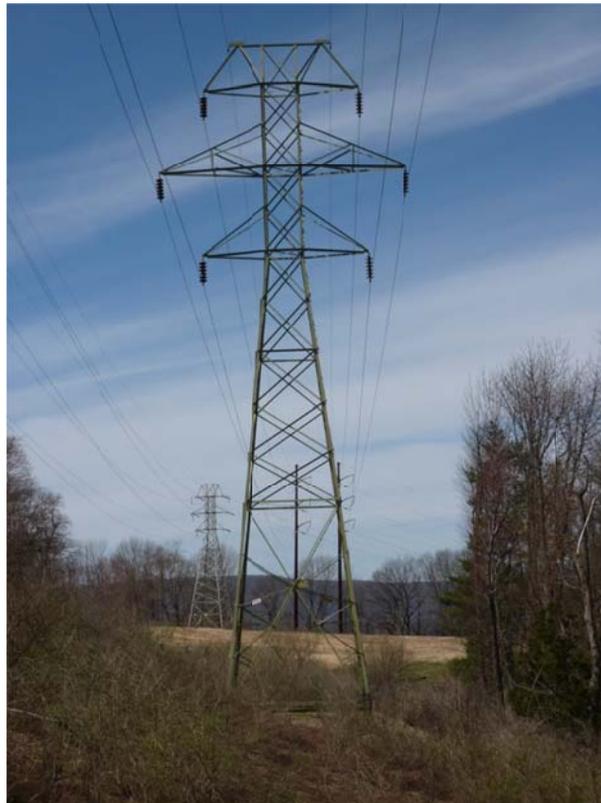
Photo 1 – Typical lattice tower

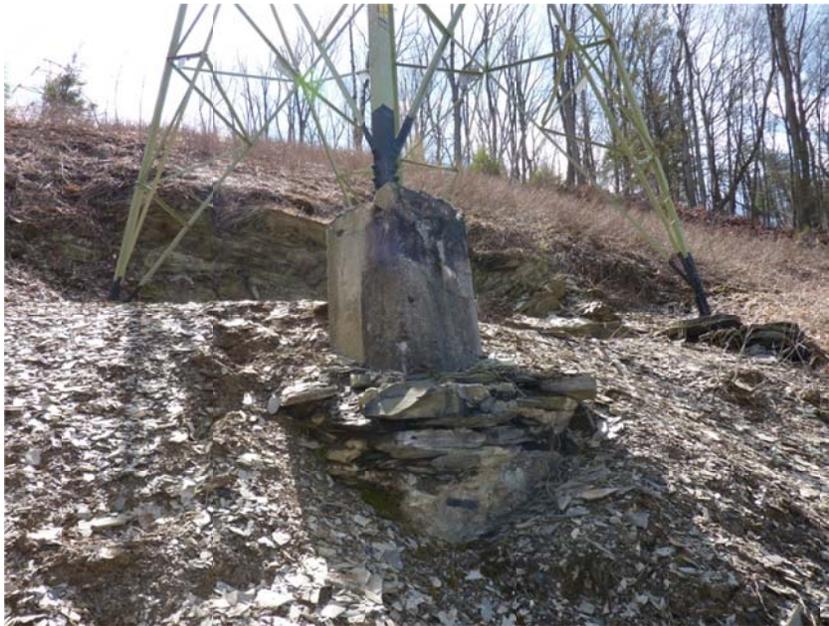
- Structure Inspection No. 58 has very severe geotechnical conditions. The structure is located in a hillside cut in a slide prone area. Tower legs 1 and 4 are being washed out and undermined. These are severe conditions.

Photo 2 – Severe foundation condition (Structure Inspection No. 58)

- Structure Inspection No. 58 and 61 have severe foundation conditions. Some or all foundations on each structure have no concrete projection above groundline. Severe section loss (40%) was found on Leg No. 4 of Inspection No. 58. Significant surface corrosion and pitting was found below groundline on other legs of Inspection No. 58. Structure Inspection No. 58 and 61 also have significant surface corrosion at the steel-concrete interface located below and above the groundline.

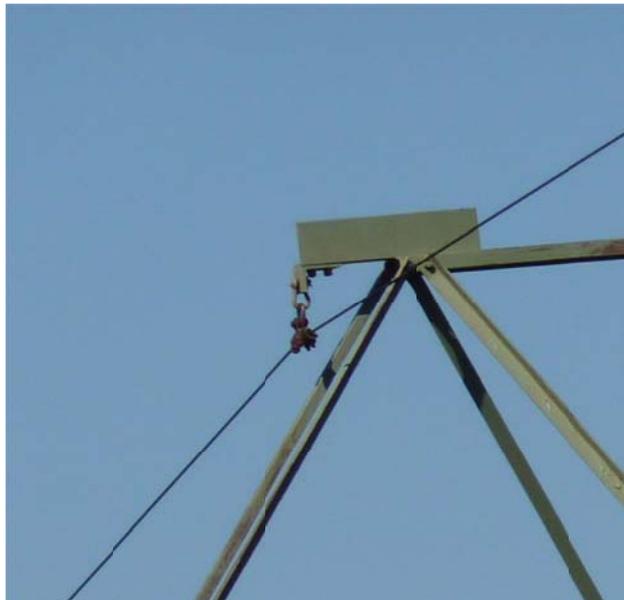
- Four structures have suspension saddle clamps and the shield wire is not bonded to the tower. The hardware has moderate surface corrosion. These are fair conditions.

Photo 3 – Typical Shield Wire Saddle Clamp Connection (not bonded to tower and hardware corroded)

- Based solely on age, all hardware such as strain clamps and saddle clamps should be replaced. This may be problematic though due to the use of ductile iron clamps and copper or copperweld conductor. The clamps are likely difficult to remove and the wire is likely damaged.

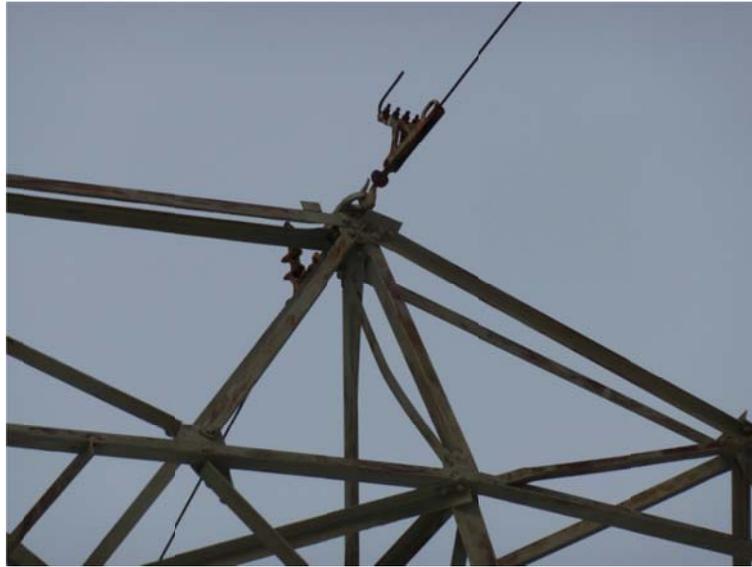
- The remaining thirteen structures have strain clamps. The shield wire is not jumpered or bonded to the structure at five of these locations. All hardware has significant surface corrosion. Structure Inspection No. 63 provides no shielding into Siegfried Substation. These are poor conditions.

Photo 4 – Typical Shield Wire Strain Clamp Connection (not jumpered or bonded to tower and hardware corroded)

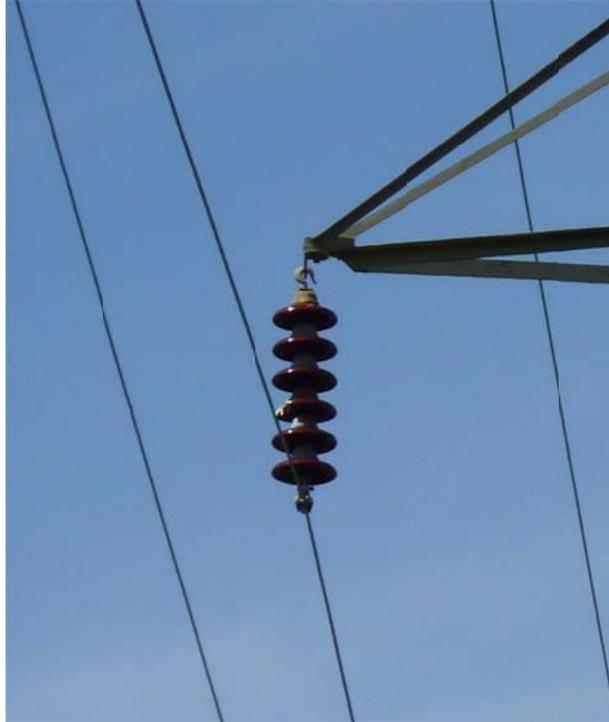
- The majority of structures (sixteen) inspected have fair insulator and hardware conditions. Some surface corrosion can be seen on the insulator caps and the hardware. U bolts on clamps are difficult to evaluate, but corrosion can be seen on them.

Photo 5 – Typical suspension insulator string

- Based solely on age, hardware such as strain clamps and saddle clamps should be replaced. This may be problematic though due to the use of ductile iron clamps and copper or copperweld conductor. The clamps are likely difficult to remove and the wire is likely damaged.

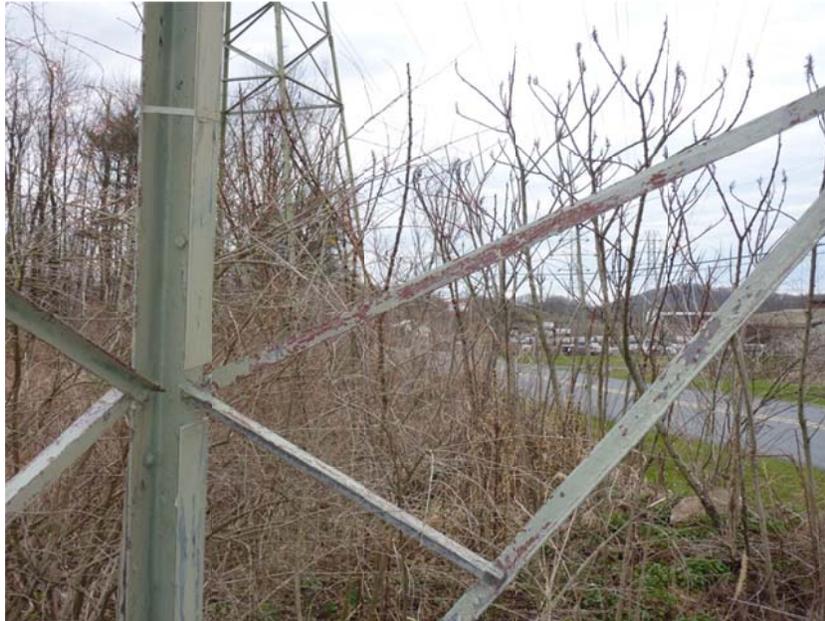
Photo 6 – Fair steel corrosion conditions

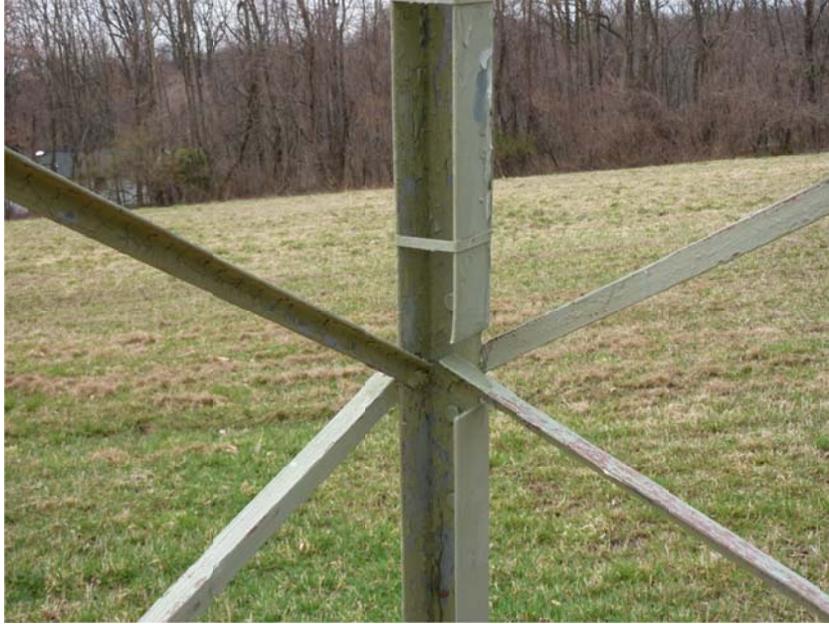
- Paint: Evaluation of paint or other above ground coatings
 - On three inspected structures, tower paint is in poor condition. Paint is rapidly peeling off on entire tower and crossarms. Red paint and galvanizing is visible near base of tower and at top of towers, especially on crossarms and hangars. These are fair conditions.
 - On thirteen inspected structures, the paint is just starting to peel off near the base of the structures. Some red paint is visible on these towers due to issues with paint coverage, but over the paint is in fair condition.
 - One structure has paint in very good condition. It is apparent that this tower has been repainted in the past decade.
 - 1/17 structures Rating 2 – good condition.
 - 13/17 structures Rating 3 – fair condition.
 - 3/17 structures Rating 4 – poor condition.

Photo 7 – Poor paint conditions

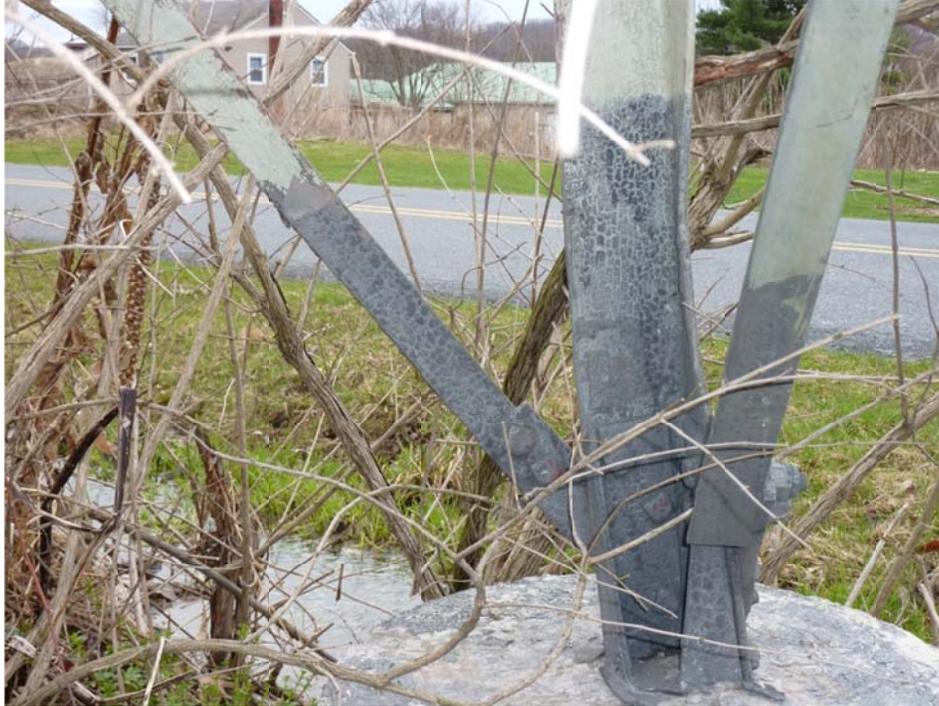
- Structure Inspection No. 53 has Leg No. 2 bent due to a vehicle collision. The foundation on Leg No. 2 was built up to protect the leg but the leg capacity is greatly reduced due to the bent leg. This is a severe condition, as leg strength is greatly reduced.

Photo 8 – Bent leg due to vehicle impact (Structure Inspection No. 53)

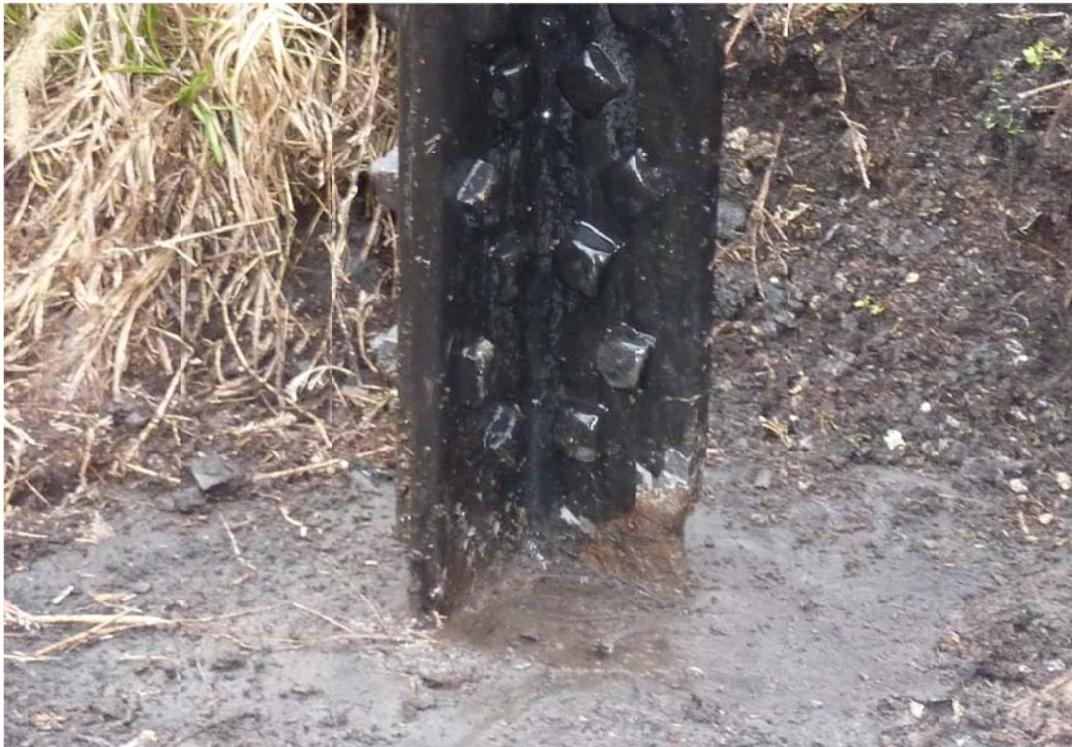
- Structure Inspection No. 63 has very severe foundation conditions. Only one leg has concrete projection. The buried legs have severe section loss at the steel-concrete interface. The section loss has been painted over with coal tar epoxy. This is a very severe condition.
- The concrete steel interface is best located above grade to avoid corrosion problems.
- For all concrete foundations, the protective coal tar epoxy coating is cracking and delaminating above the concrete line and is no longer protecting the steel.
- 2/8 structures Rating 3 – fair condition.
- 2/8 structures Rating 4 – poor condition.
- 4/8 structures Rating 5 – severe condition.

Photo 9 – Severe section loss (Structure Inspection No. 63)

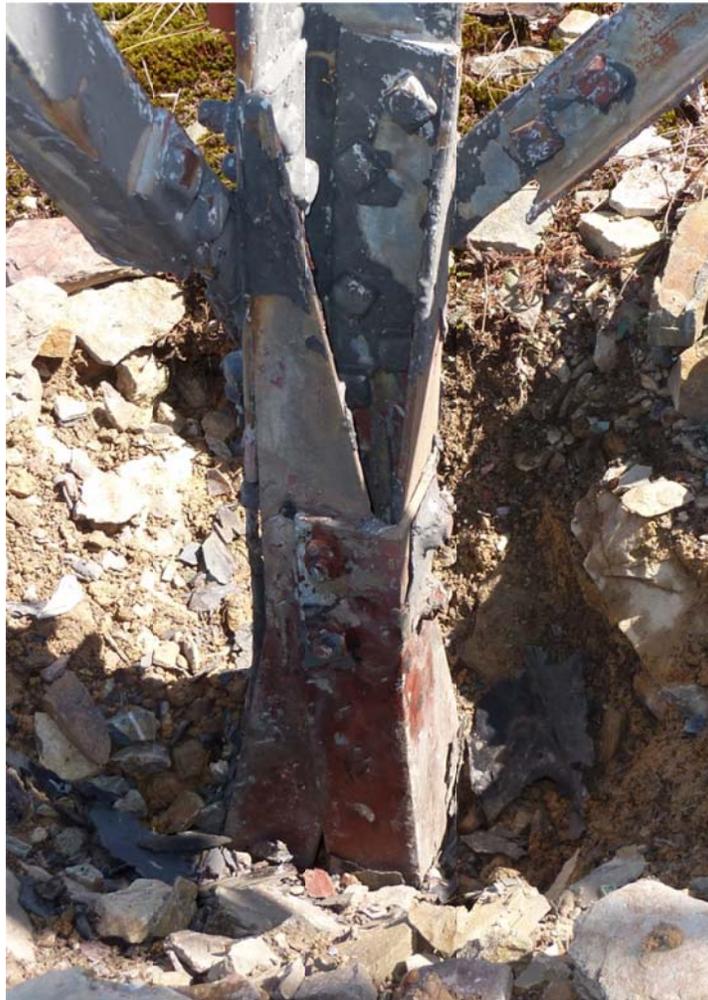
Photo 10 – Typical groundline coating failure (red paint visible)

Near the ground line and below ground line, the coal tar epoxy coating is at the end of its life and is no longer protecting the steel. In many instances, the original red tower paint and galvanizing can be seen where the coal tar epoxy has flaked off. Over 80% of structures are experiencing surface corrosion below ground line. Generally, the losses were not enough to compromise the structure, but action needs to be taken immediately to prevent further losses and emergency conditions to develop, similar to Structure Inspection No. 63. Based on the inspection results from the Hauto-Siegfried Inspections and other PPL inspections, steel corrosion and section loss doesn't always occur at the ground line. Grillage foundations appear to be the predominant foundation type for the steel lattice towers on the Hauto-Siegfried-E. Palmerton lines. The whole of the embedded steel in a grillage foundation tends to corrode over time, but occasionally accelerated corrosion can occur just below the groundline up to a few feet. Careful attention also needs to be paid to buried concrete foundations. The interaction between the steel, concrete and the soil leads to significantly accelerated corrosion of the steel.

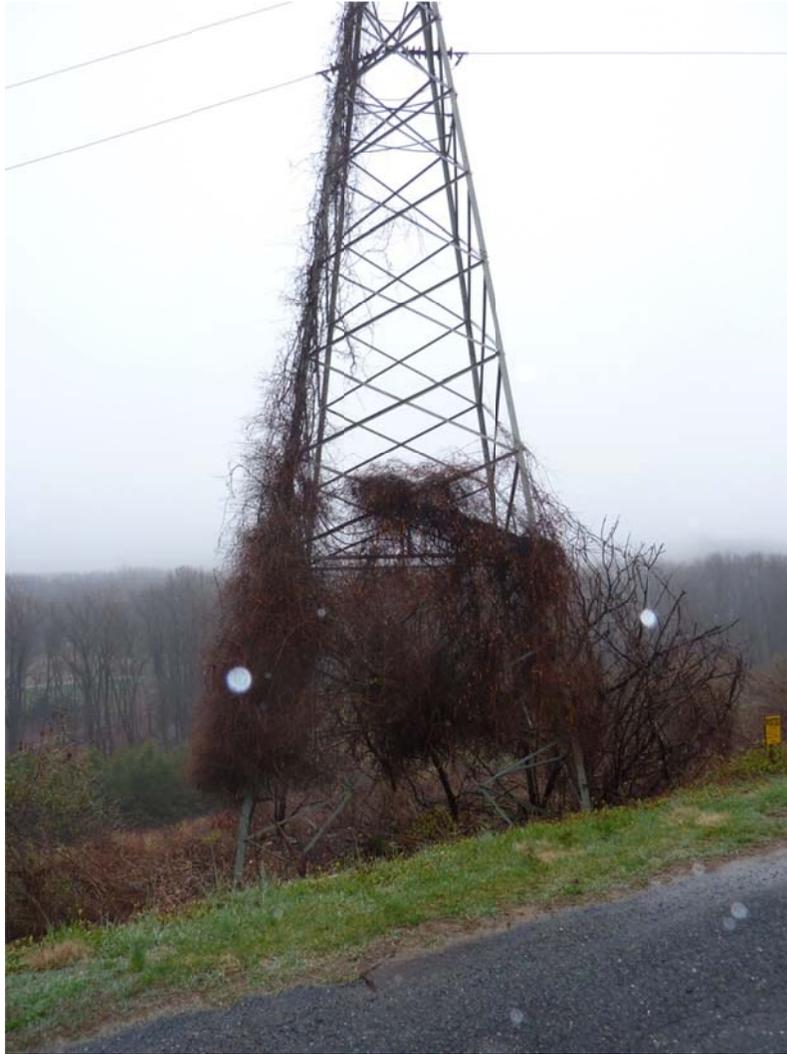
- Structure Inspection No. 60 has vines covering nearly 1/3 of the tower, all faces. The vines have been cut at groundline, but the vegetation was left on the structures, significantly increasing the wind area of the tower. This is a poor condition.

Photo 11 – Vegetation growing on tower (Structure Inspection No. 60)
