Project 2009-149

*Special Inspection Report for Zone #2  
Siegfried-E. Palmerton #1 and #2 69kV Transmission Lines*

Mr. Joseph Marhefka Zone #2, Line #454 & #457, Siegfried-E. Palmerton 69kV Lines  
Project 2009-149  
September 2, 2011

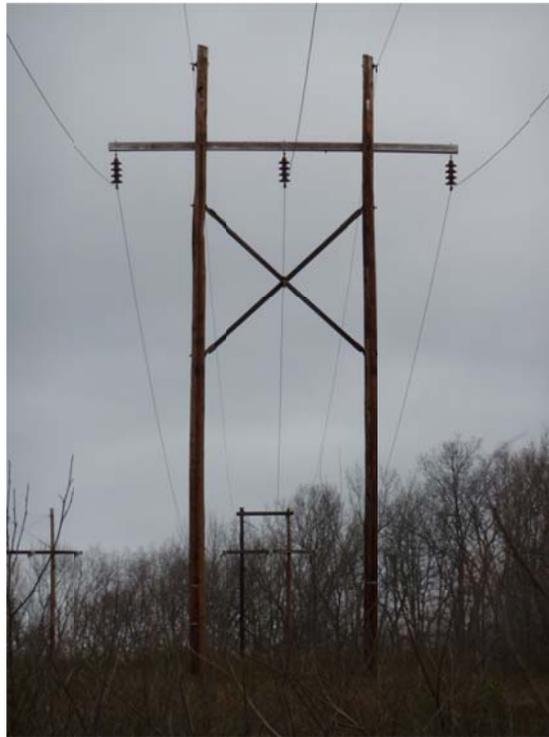
Photo 1 – Typical wood h-frame structure

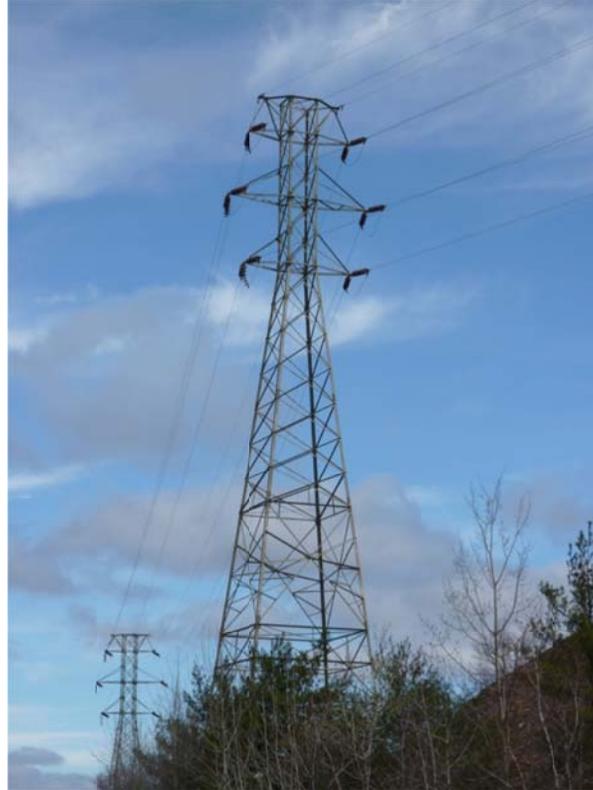
Photo 2 – Typical steel lattice tower

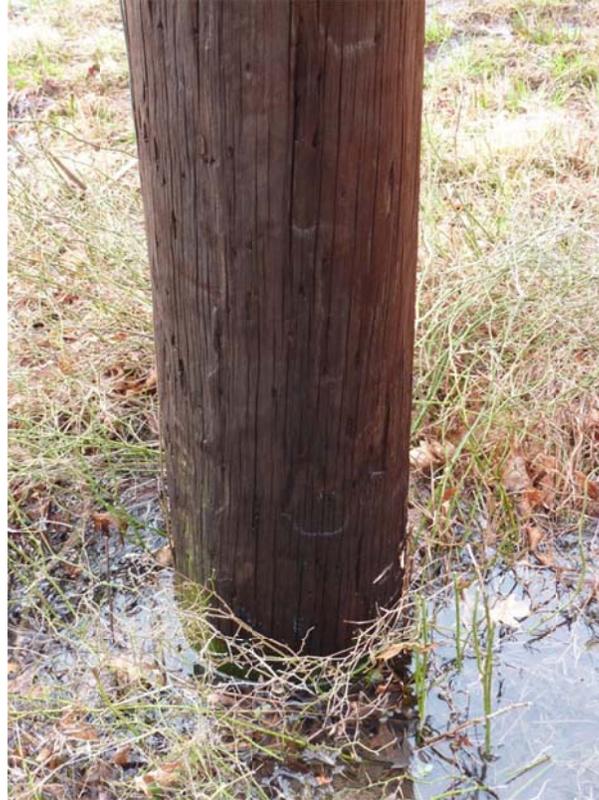
Photo 3 –Typical wood pole located in standing water

- Structure Inspection No. 65 is in severe condition. The poles are set in standing water and are completely water logged at the groundline. The wood is very soft and disintegrating at the groundline. Poles set in standing water is a severe condition.

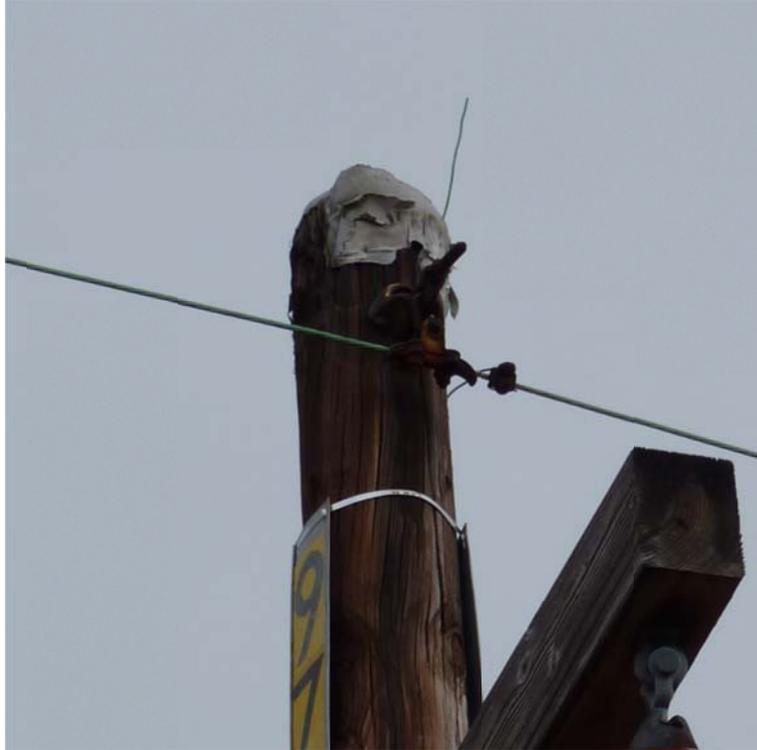
- Structure inspection No. 64, 65, 66, 67 & 68 are all wood pole h-frames with suspension saddle clamps. The shield wire hardware is bonded to the ground lead in all cases. Hardware has surface corrosion. These are fair conditions.

Photo 4 – Typical Shield Wire Saddle Clamp Connection (hardware corroded)

- Based solely on age, all hardware such as strain clamps and saddle clamps should be replaced. This may be problematic though due to the use of ductile iron clamps and copper or copperweld conductor. The clamps are likely difficult to remove and the wire is likely damaged.

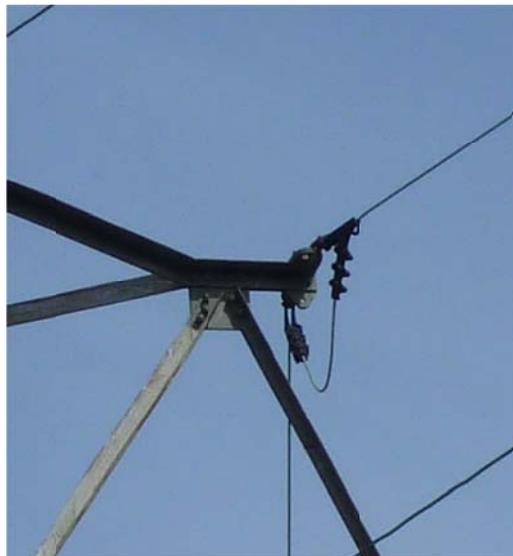
- Two tower structures have strain clamps and the shield wire is jumpered but not bonded to the tower. The hardware has significant surface corrosion. Structures northeast of the Lehigh River have hardware that is significantly more corroded than the rest of the corridor. This is believed to be a result of the industry in the area. These are poor conditions.

Photo 5 – Typical Shield Wire Strain Clamp Connection (jumpered but not bonded to tower and hardware very corroded)

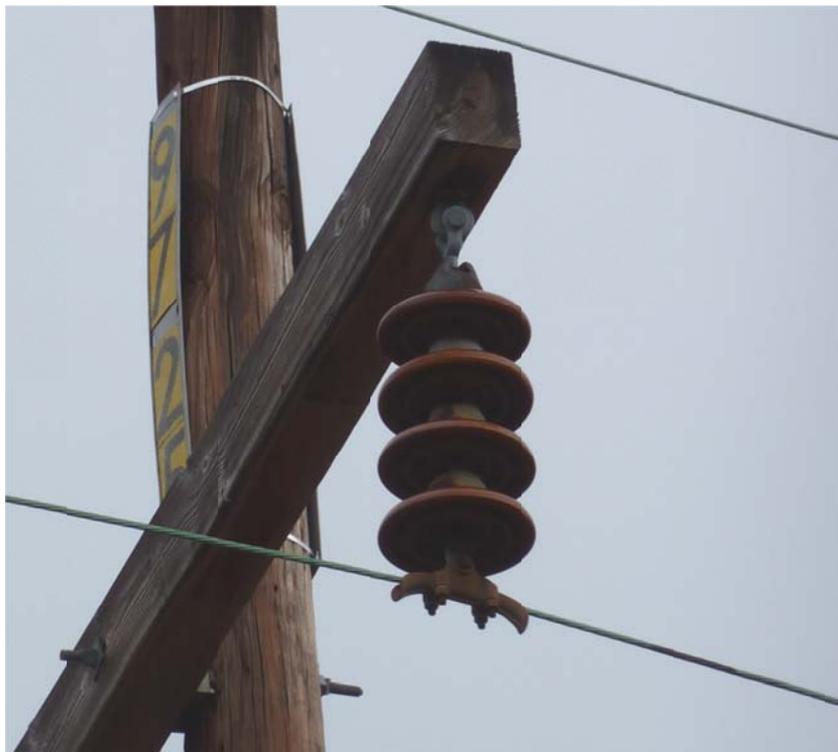
Photo 6 – Typical suspension insulator string

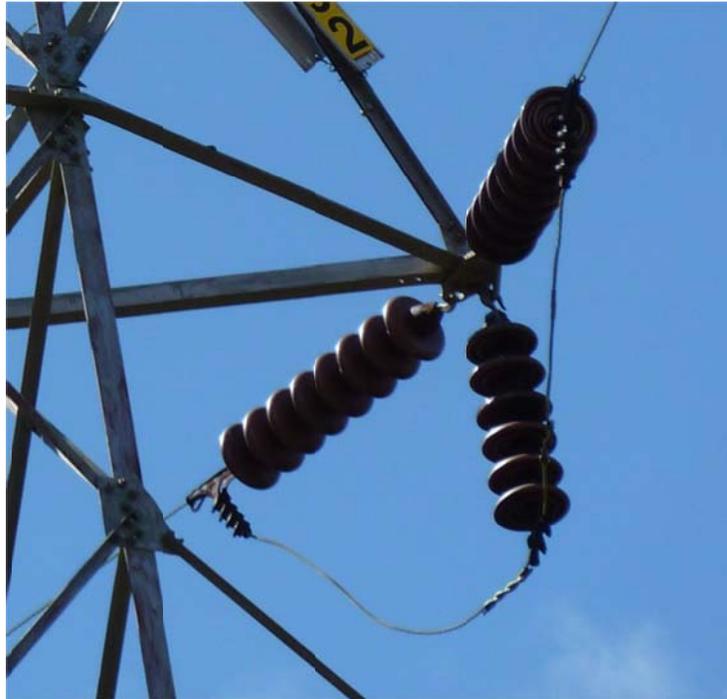
- Two tower structures located to the northeast of the Lehigh River have poor insulator and hardware conditions. Significant corrosion can be seen on all hardware. Similar to the shield wire hardware, this is believed to be a result of the industry in the area. These are poor conditions.

Photo 7 – Heavy corrosion typical strain insulator string on lattice tower

- Based solely on age, hardware such as strain clamps and saddle clamps should be replaced. This may be problematic though due to the use of ductile iron clamps and copper or copperweld conductor. The clamps are likely difficult to remove and the wire is likely damaged.

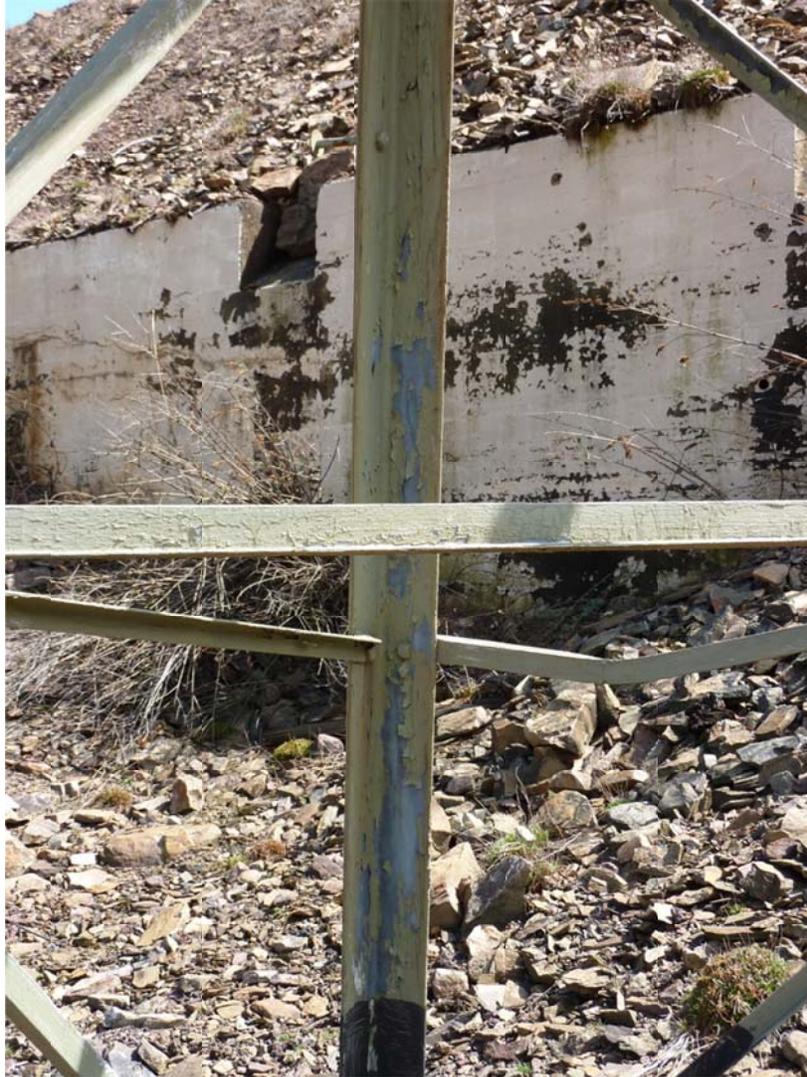
Photo 8 – Fair paint conditions, only peeling at bottom of tower

The two towers inspected have fair paint conditions. There is still life left on the tower coatings. In the near future, the towers will require a thorough scraping, priming and repainting with quality zinc based tower paint. Galvanizing can also be observed on the base of the tower where the paint coatings have peeled off. Some corrosion can be seen up high in the tower. This is thought to be a result of the corrosive environment northeast of the Lehigh River. Most towers on the Siegfried-E. Palmerton lines are located primarily in this region. Moderate surface corrosion on tower steel is evident and with failing coatings and exposed galvanizing, corrosion will begin to increase at a more rapid rate. Reference Figure 1.

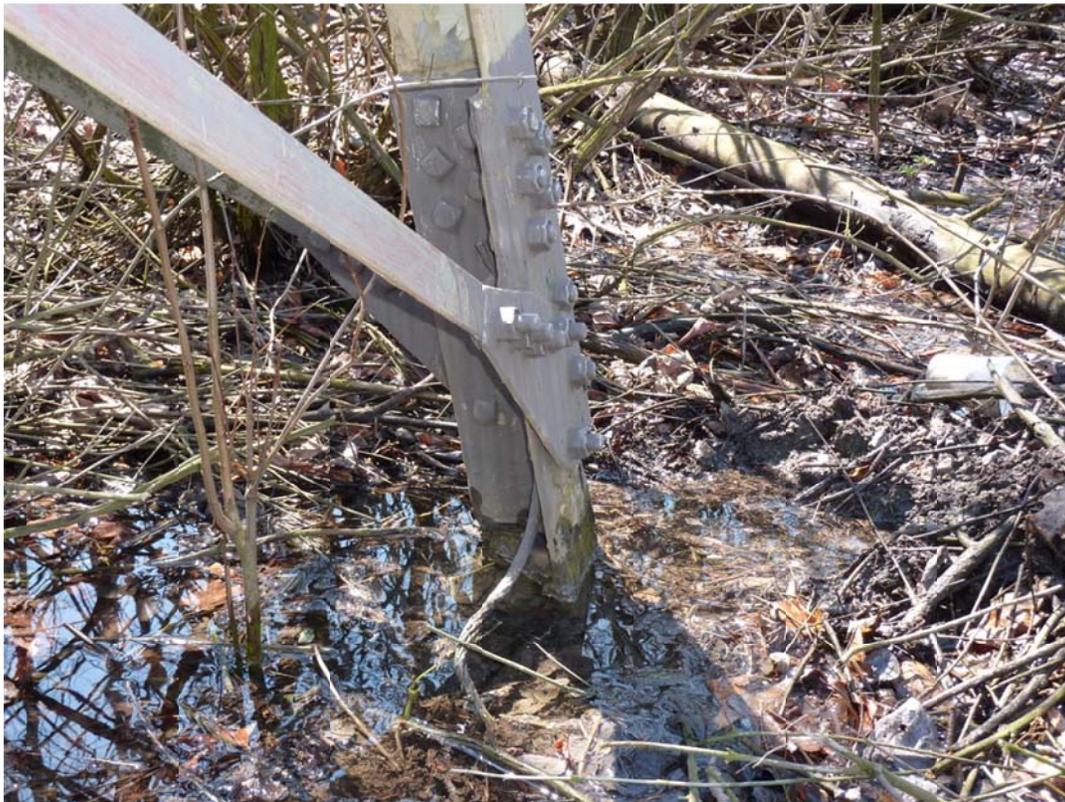
- Structure Inspection No. 70 has poor foundation conditions. Only Leg No. 3 has concrete projection above the groundline. The other three concrete foundations were located below grade and one was submerged under water. No severe condition was observed. There was no visible or detectable section loss, but the water conditions and the foundations being located below grade are not a good combination. These are poor conditions.

Photo 9 – Submerged Concrete Foundation (Structure Inspection No. 70)

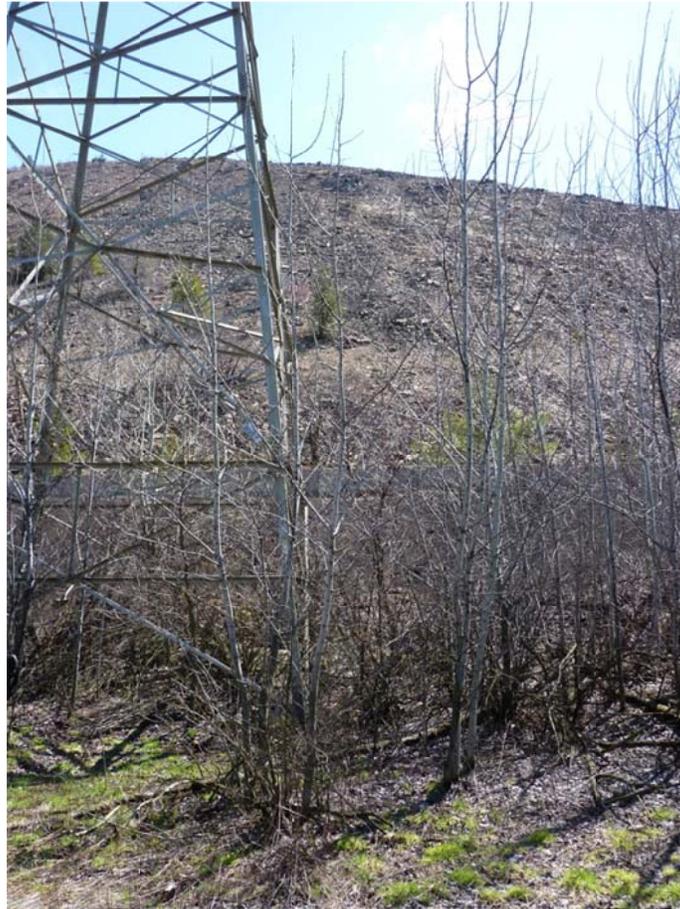
- Structure Inspection No. 70 has many bushes and trees growing within and around structure. Vegetation inhibits access to structure. This is a poor condition.

Photo 10 – Poor vegetation conditions (Structure Inspection No. 70)

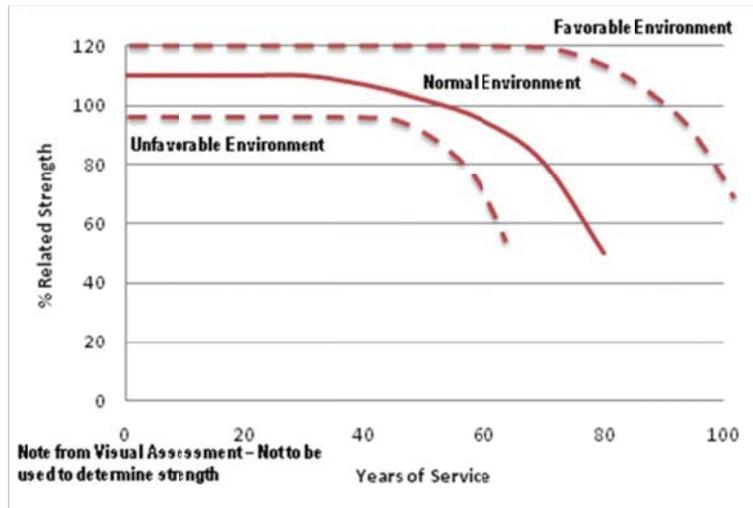
approaching the age marking the period in which rapid decline in strength begins. The useful life of all original insulators and hardware is approaching its end. In the area northeast of the Lehigh River, the insulators and hardware are especially corroded. This area is very industrial, or used to be very industrial. There is evidence of a zinc processing facility on the original plan and profiles. Other industries and the remnants of past industries can be seen in this area and this is believed to have significantly contributed to the accelerated corrosion on this side of the river.

Figure 1 – Relation between Service Life and Rated Strength (Galvanized Steel) (from EPRI *Overhead Transmission Inspection and Assessment Guidelines – 2009*)
