Project 2009-149

*Special Inspection Report for  
Zone #3 Hauto-Siegfried #1 and #4 69kV Transmission Lines*

Mr. Joseph Marhefka Zone #3, Line #449 & #452, Hauto-Siegfried 69kV Lines  
Project 2009-149  
September 1, 2011

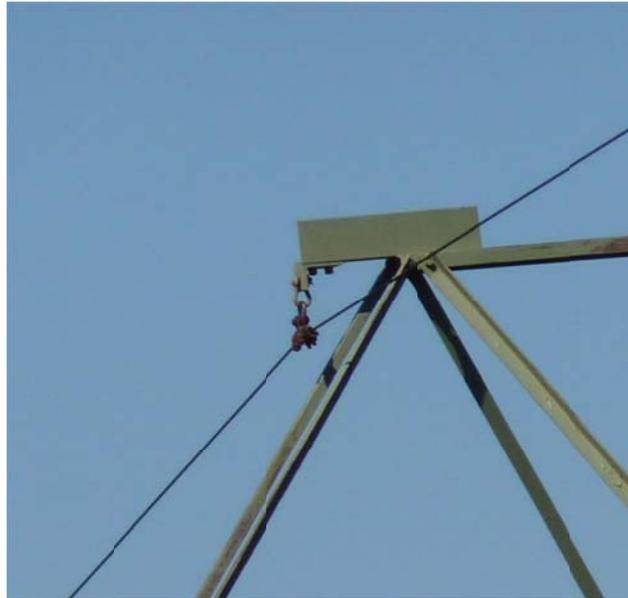
- Eighteen structures have suspension saddle clamps and the shield wire is not bonded to the tower. The hardware has moderate surface corrosion. These are fair conditions.

Photo 2 – Typical Shield Wire Saddle Clamp Connection (not bonded to tower and hardware corroded)

- Based solely on age, all hardware such as strain clamps and saddle clamps should be replaced. This may be problematic though due to the use of ductile iron clamps and copper or copperweld conductor. The clamps are likely difficult to remove and the wire is likely damaged.

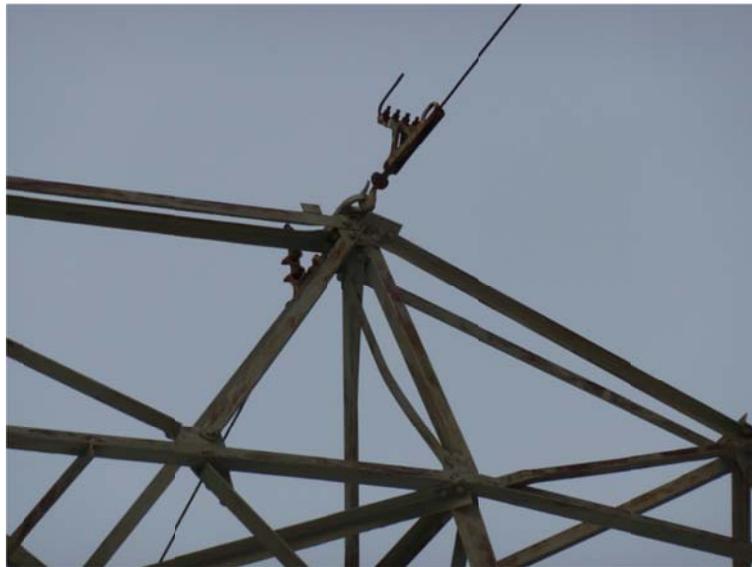
- Six structures have strain clamps. The shield wire is not jumpered or bonded to the structure at five of these locations. All hardware has significant surface corrosion. These are poor conditions.

Photo 3 – Typical Shield Wire Strain Clamp Connection (not jumpered or bonded to tower and hardware corroded)

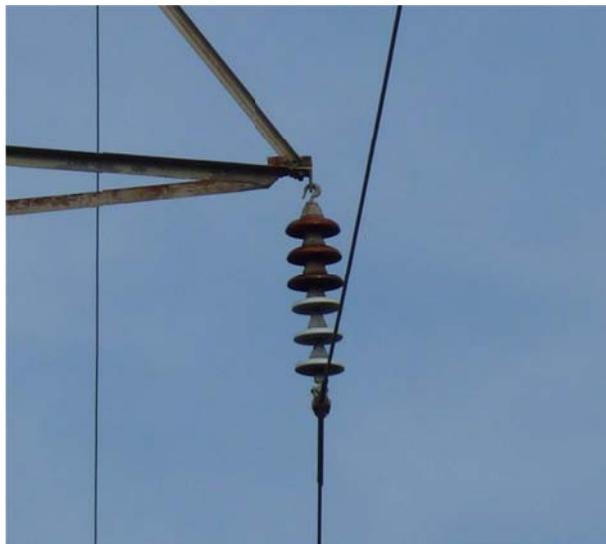
Photo 4 – Typical suspension insulator string

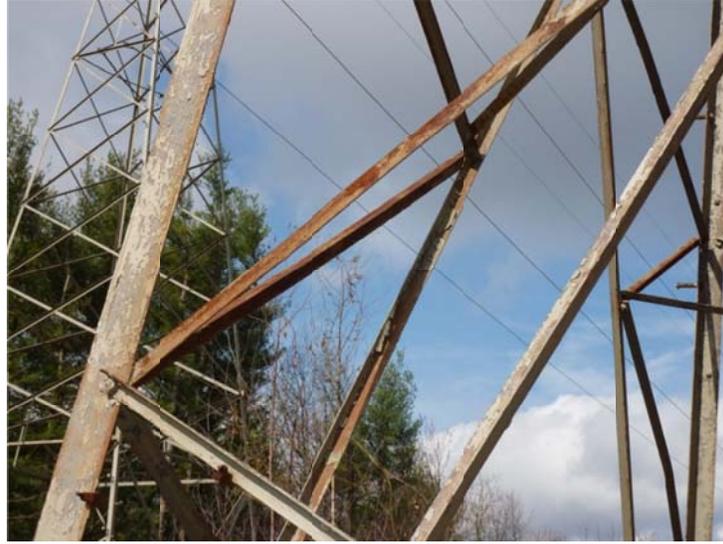
Photo 5 – Poor steel corrosion conditions

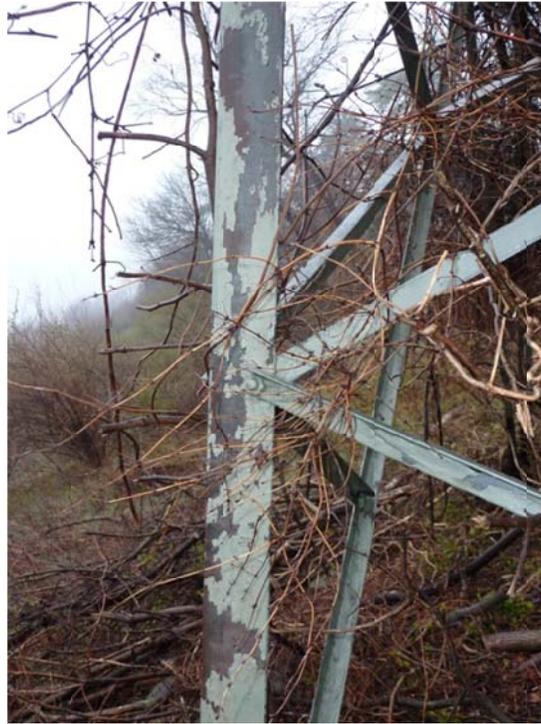
- Paint: Evaluation of paint or other above ground coatings
  - On thirteen inspected structures, tower paint is in poor condition. Paint is rapidly peeling off on entire tower and crossarms. Red paint and galvanizing is visible near base of tower and at top of towers, especially on crossarms and hangars. These are fair conditions.
  - On nine inspected structures, the paint is just starting to peel off near the base of the structures. Some red paint is visible on these towers due to issues with paint coverage, but overall the paint is in fair condition.
  - One structure has paint in very good condition. It is apparent that this tower has been repainted in the past decade.
  - 1/23 structures Rating 2 – good condition.
  - 9/23 structures Rating 3 – fair condition.
  - 13/23 structures Rating 4 – poor condition.

Photo 6 – Poor paint conditions

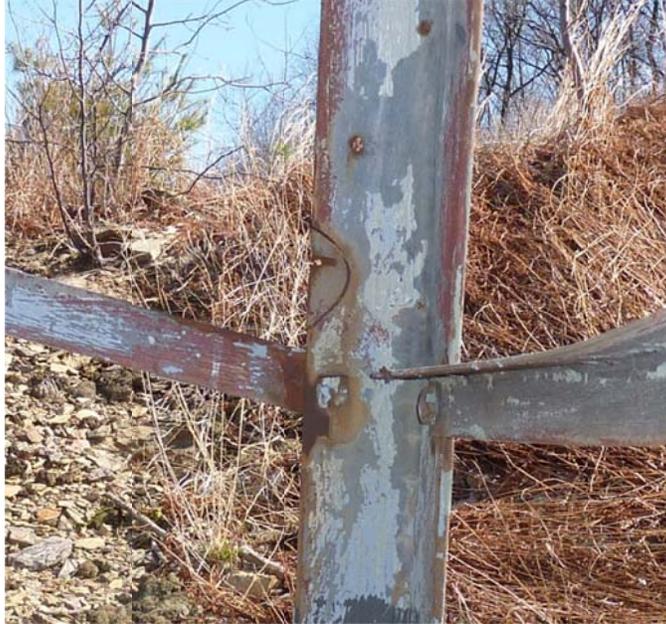
- Structure Inspection No. 41 has a bent redundant member on Face B and Leg No. 2 was shot with a rifle and the angle was fractured. This is a severe condition, as leg strength is greatly reduced.

Photo 7 – Fractured Leg due to bullet impact (Structure Inspection No. 41)

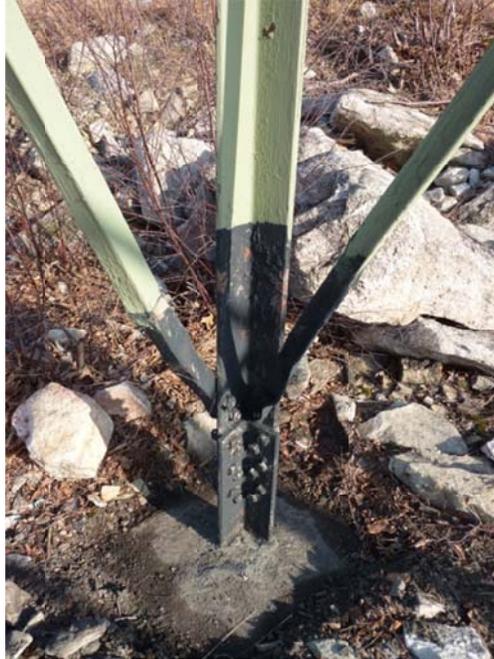
- The concrete steel interface is best located above grade to avoid corrosion problems.
  - For all concrete foundations, the protective coal tar epoxy coating is cracking and delaminating above the concrete line and is no longer protecting the steel.

Photo 8 – Buried concrete foundation

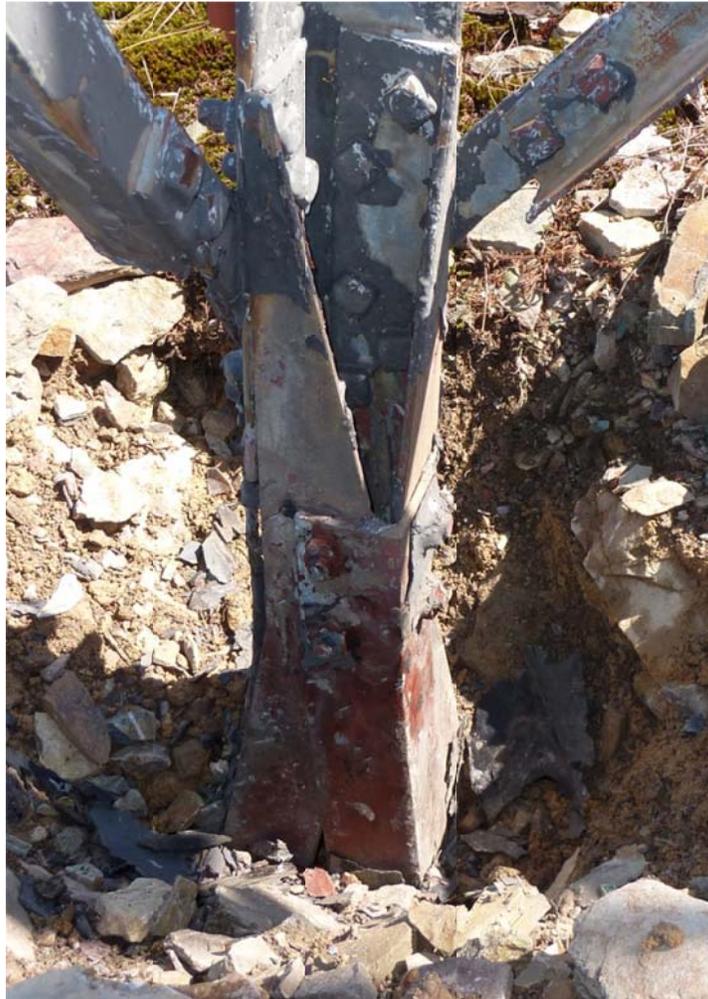
- Twelve of the inspected structures are all experiencing failure of the protective coal tar epoxy coating at and below the groundline. Minor surface corrosion was common. No section loss was discovered on these twelve structures. These are all poor conditions due to the failure of the groundline coating.

Photo 9 – Typical groundline coating failure (red paint visible)

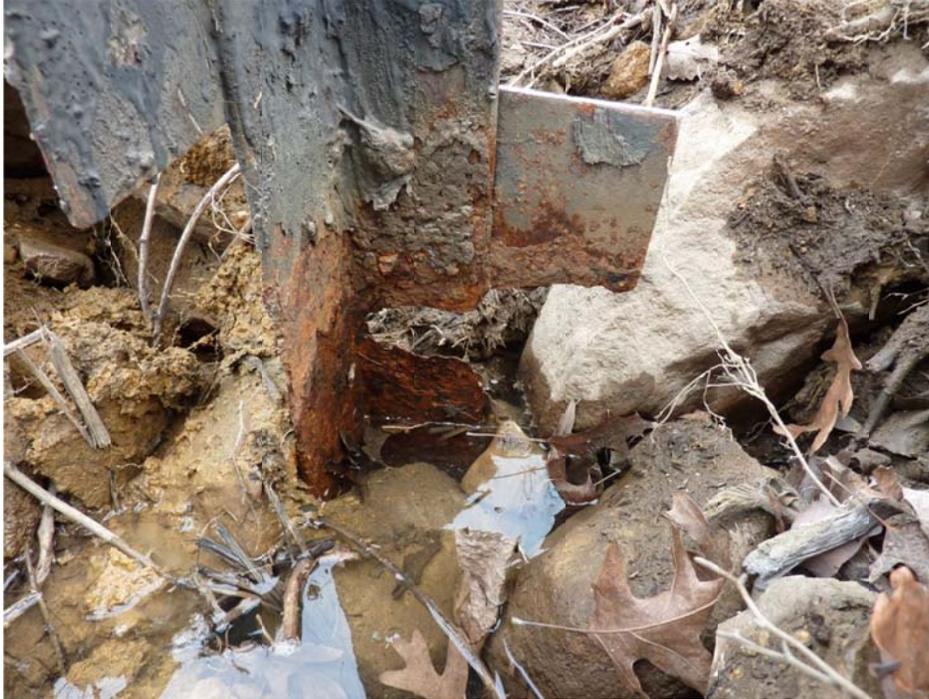
- The original red paint and galvanizing is visible on most structures when the steel was exposed below groundline.
  - On ten inspected structures, severe corrosion was discovered. Severe pitting of the steel, section loss on nuts and bolts and section loss on the embedded steel leg angle were common. Structure Inspection No. 47 is experiencing complete section loss on Leg No. 4. All of these are severe conditions that require immediate remediation.

Photo 10 – Complete Section loss (Structure Inspection No. 47)

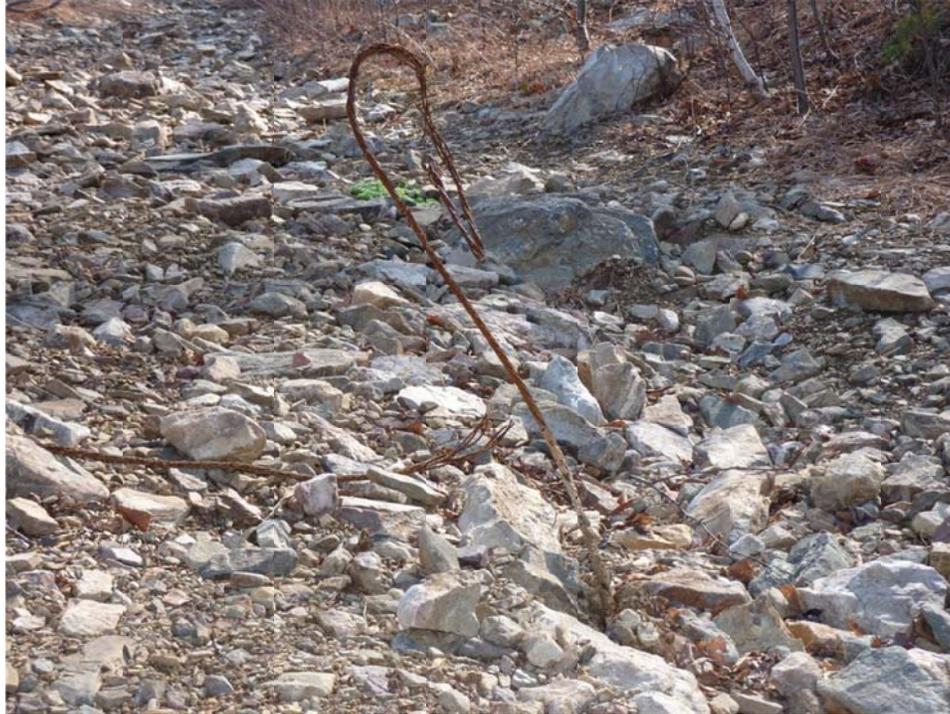
Photo 11 – Exposed and torn continuous counterpoise

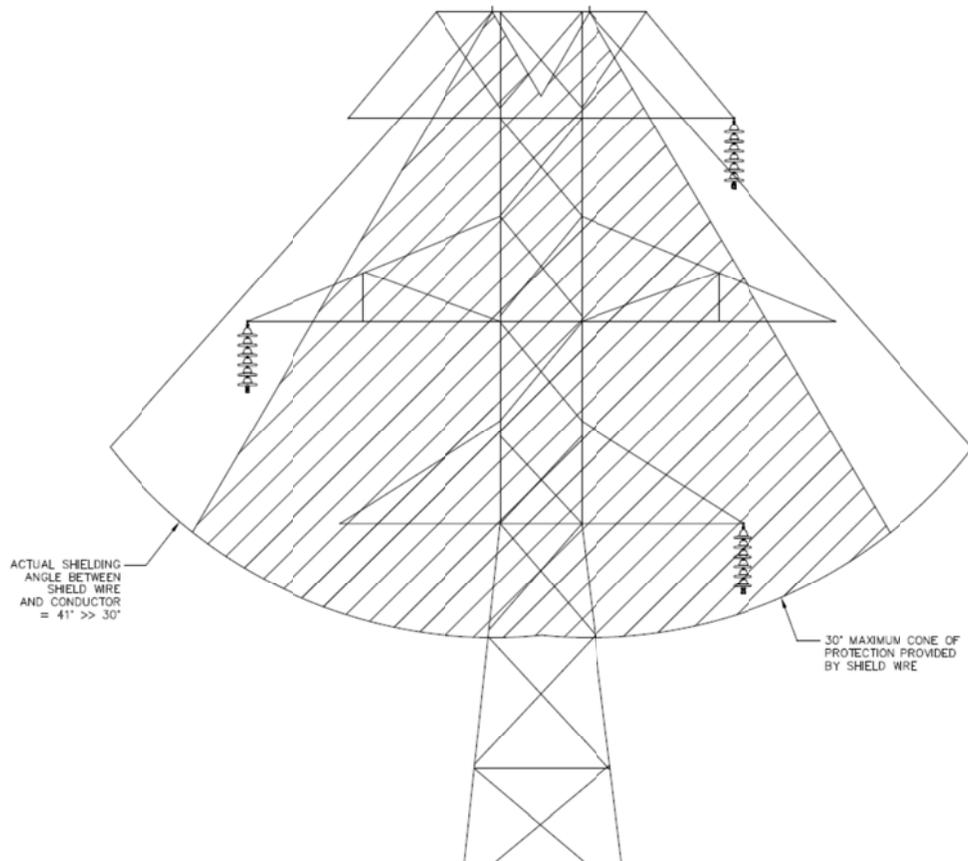
Lightning protection research was a work in progress when the Hauto-Siegfried structures were designed and built. In general, the shielding provided is adequate. Only at structures with strain shield wire connections does it appear to be inadequate. Historically, the maximum shielding afforded by an overhead shield wire is a 30 degree cone at tangent structures. The cone necessary to protect the conductors at strain structures on the Hauto-Siegfried lines is 41 degrees at a minimum. This is unrealistic. A more refined analysis was performed for the structures shown in Figures 2 and 3 using IEEE and EPRI guidelines. The refined shielding analysis yields the same conclusions of the 30 degree rule of thumb. In general, all structures except ones with strain shield wire connections were adequately shielded. Fortunately, most structures are connected using a suspension clamp, thus most structures are adequately shielded. Additionally, since the shield wires are connected to the structures using a suspension saddle clamp, there is not an adequate electrical connection to the structure. The lightning current is expected to follow a path along the shield wire, down the tower and through the tower footing resistance to the ground. With a saddle suspension clamp, this expected path cannot be relied upon. The shield wires should be physically bonded to select towers to provide the required electrical connection, without forming a closed loop for induced current to circulate, resulting in a resistance heating line loss. See Figure 2 and 3 below for schematics of the shielding angle for two structure types on the Hauto-Siegfried lines.

Figure 3 – Inadequate shielding angle schematic for structures with strain shield wire connection

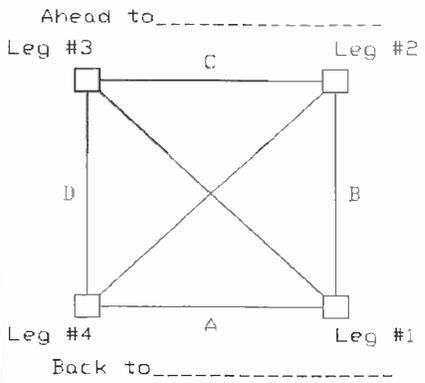
Structure Inspection No.	28		<div style="text-align: left; margin-bottom: 5px;">Ahead to -----</div>

- Structure Inspection No. 28 has bent diagonals on all faces. This appears to be the result of equipment collision, as the tower is located in a farmer's field. Since load carrying diagonals are bent on all faces, this is a severe condition.

Paint	4	poor condition, paint rapidly peeling off	galvanizing and red paint is visible in many areas
Bent Missing Steel	5	all diagonals bent on all faces	appears to be result of equipment collision
Steel Foundations	5	Leg No. 3	Leg No. 2 dug -very minor surface corrosion -no section loss -coal tar epoxy flaking off -red paint visible
		Leg No. 4	Leg No. 1 dug -surface corrosion of steel -significant section loss on nuts and bolts below groundline -coal tar epoxy flaking off -red paint visible
Grounding	4	Leg No. 3 & 4 are grounded	non-functioning due to use of continuous counterpoise
Vegetation by Str	2	no issues	
Signage	2	all signage good	
Notes	tower legs reinforced
