# 2018 Line Assessment

PPL Electric Utilities

Hauto-Siegfried 1 & 4 and Siegfried-East  
Palmerton 1 & 2 Lines

25 January 2019

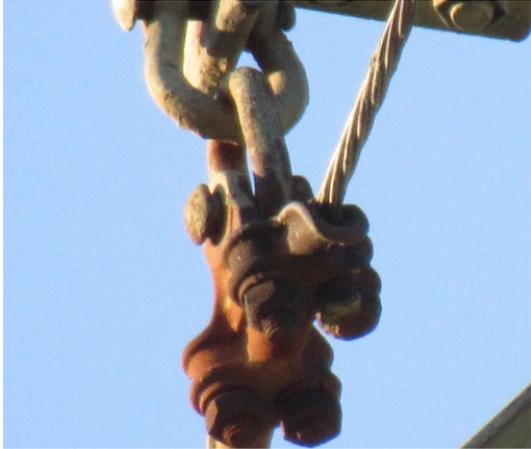
Worn Attachment Point Hardware

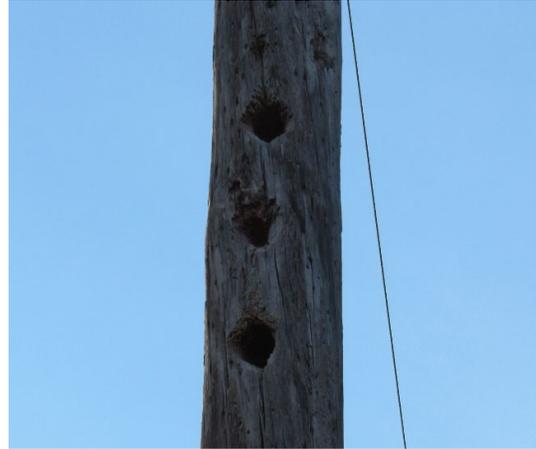
Wood Pecker Holes

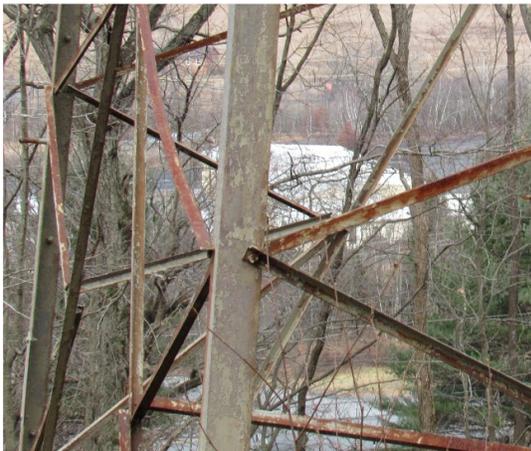
Atmospheric Corrosion

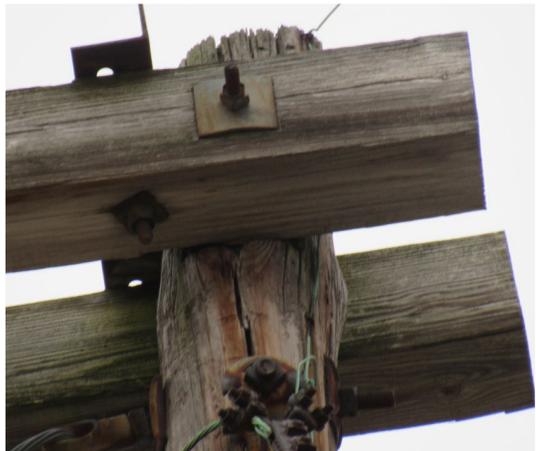
Split Top

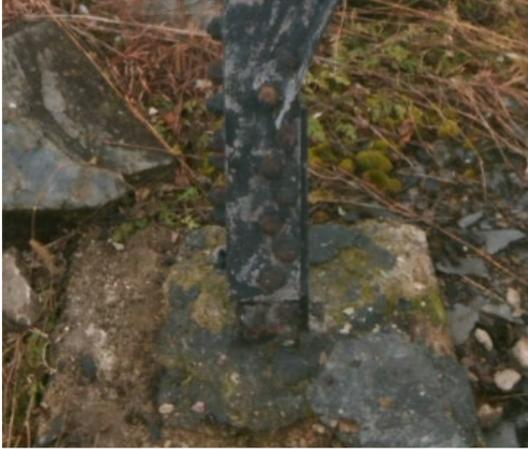
Structure 58686S52191 Leg 3  
Concrete Foundation  
Priority

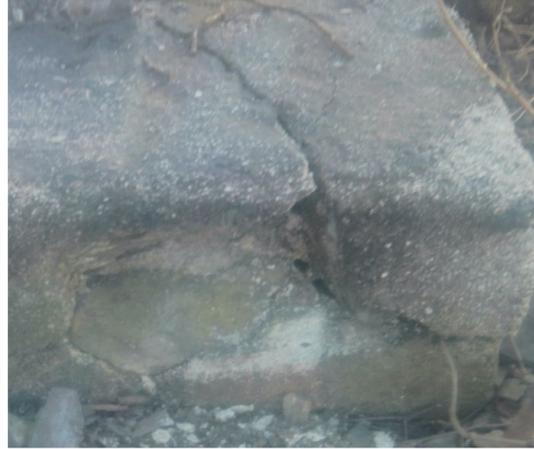
Structure 60007S51512 Leg 1  
Concrete Foundation  
Priority

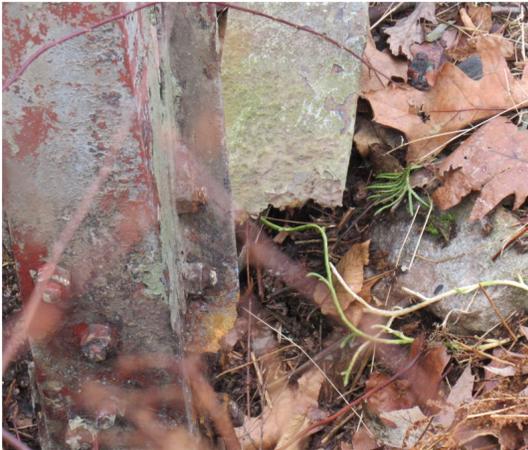
Structure 51718N25329 Leg 3  
Right Horizontal Wrap  
Structural Priority

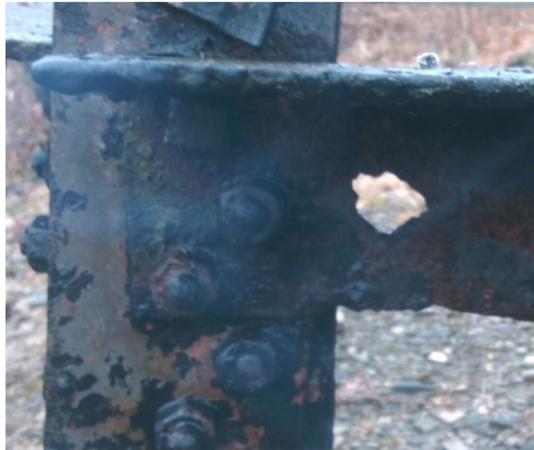
Structure 58884S51960 Leg 1  
Right Horizontal Wrap  
Structural Priority

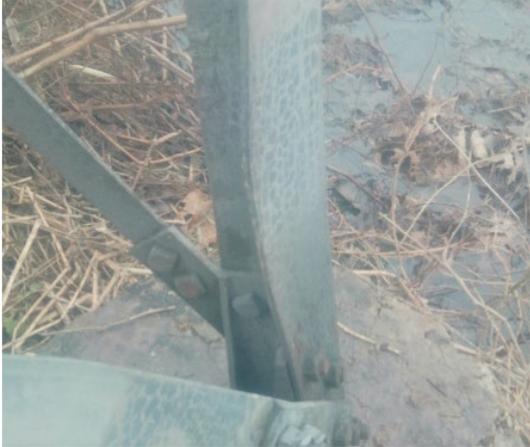
Structure 58442S52310 Leg 3  
Post Leg  
Class II Mechanical Damage

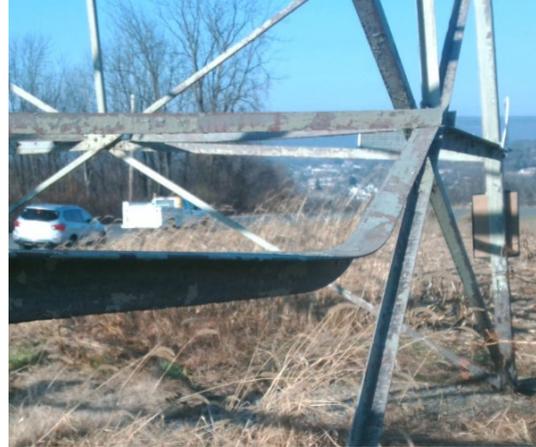
Structure 59745S51558 Leg 3  
Right Horizontal Redundant  
Class II Mechanical Damage

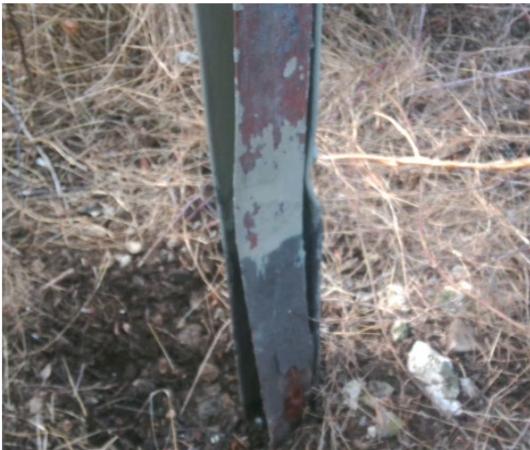
Structure 60129S51442 Leg 1  
Post Leg  
Class III Mechanical Damage

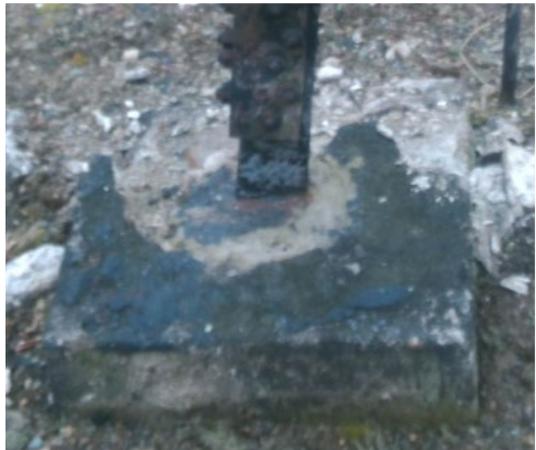
Structure 58676S52250 Leg 2  
Concrete Foundation  
Priority

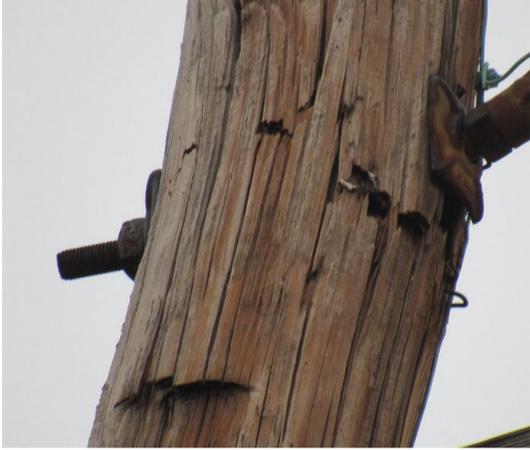
Structure 58238S53004  
Compression Wood  
Priority Non Restorable Reject

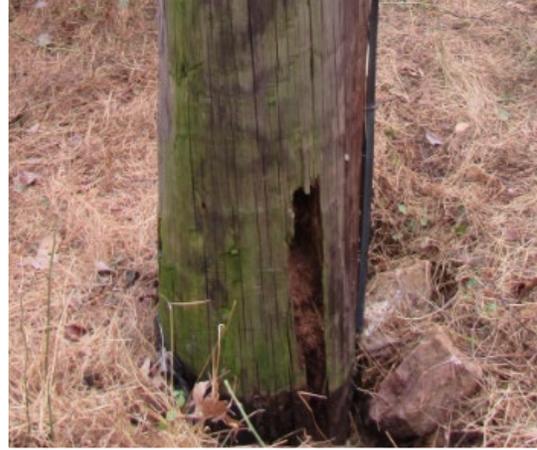
Structure 58411S53066  
Exposed Pocket  
Priority Non Restorable Reject

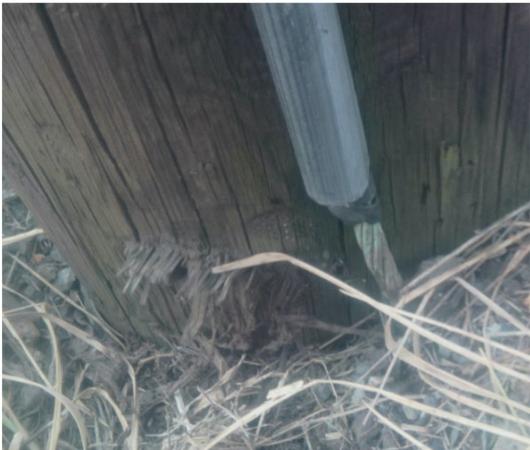
Structure 59819N24072  
Mechanical Damage  
Osmose Non Reject

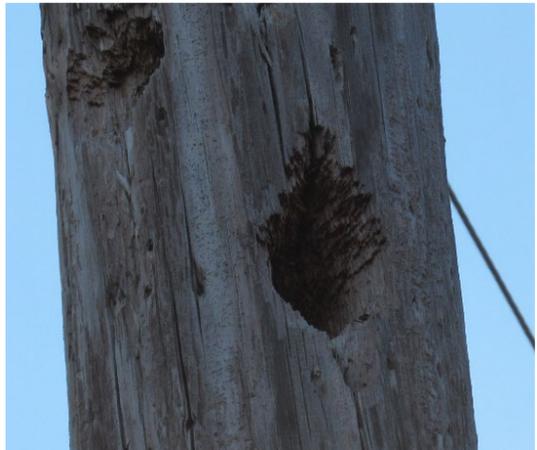
Structure 58970S53259  
Large Woodpecker Holes  
Reported Item

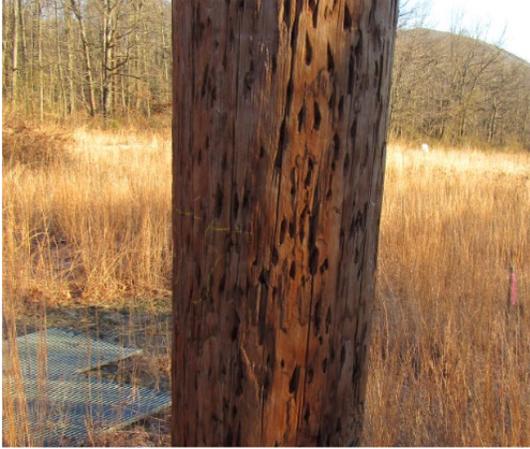
Structure 59096S53295  
Excessive Spur Cuts  
Reported Item

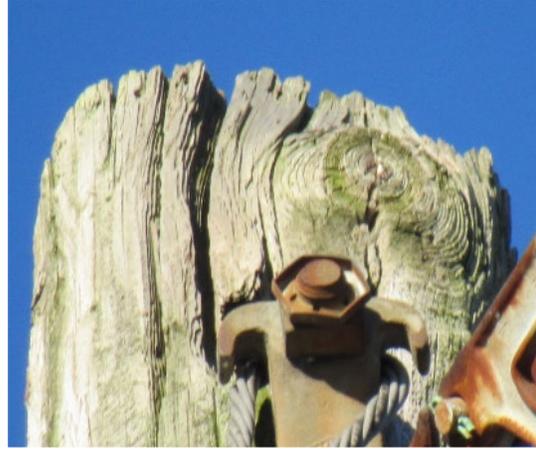
Structure 61261S51038  
Split Top  
Reported Item

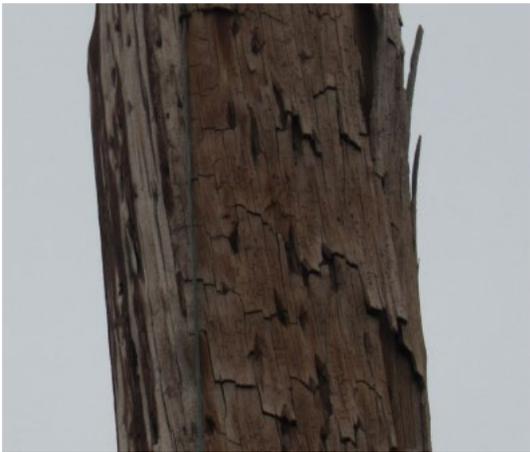
Structure 58261S53014  
Shell Rot Above  
Reported Item

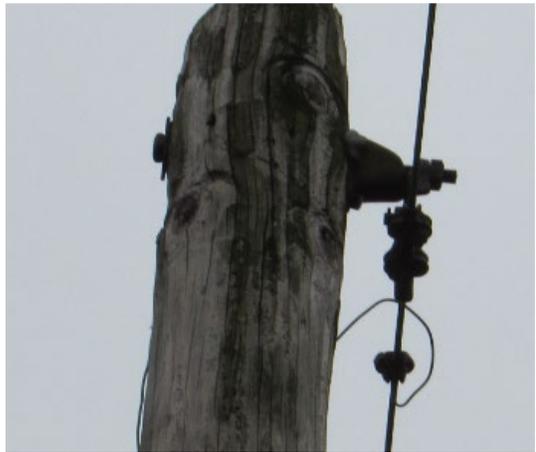
Structure 58106S52817  
Mold or Stain  
Reported Item

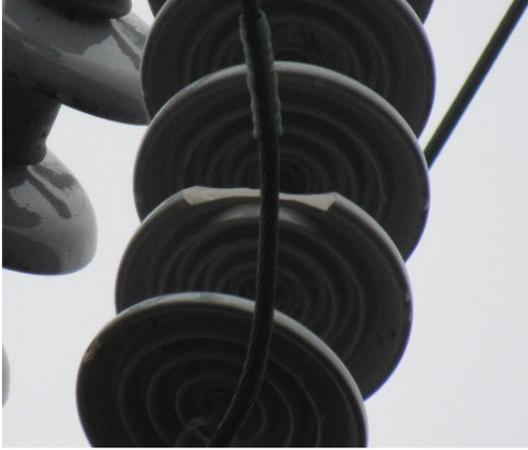
Structure 58634S52291  
Broken or Damaged Insulator  
Reported Item

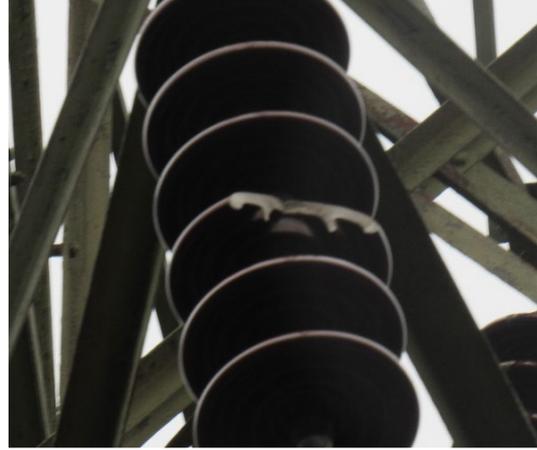
Structure 58884S51960  
Broken or Damaged Insulator  
Reported Item

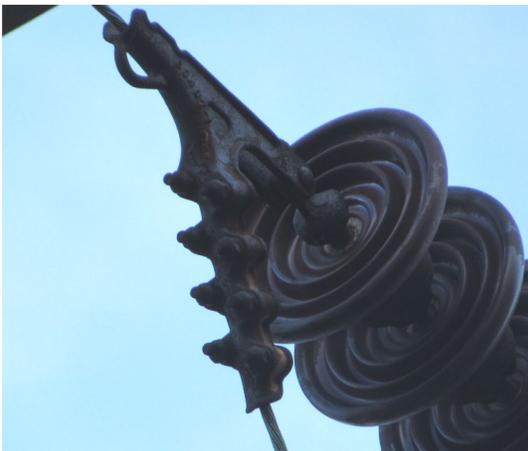
Structure 59313N23679  
Red Rust on Conductor Attachments  
Reported Item

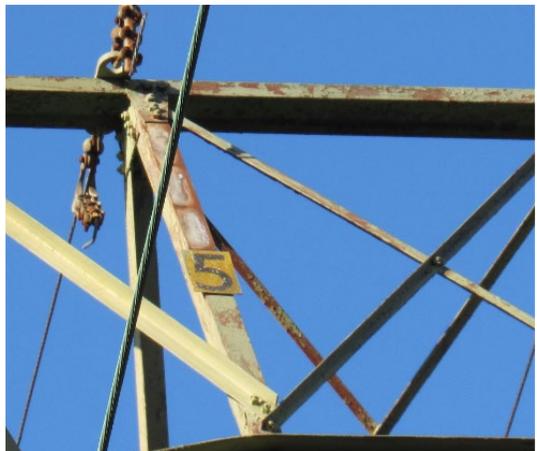
Structure 60707S51215  
Atmospheric Corrosion  
Reported Item

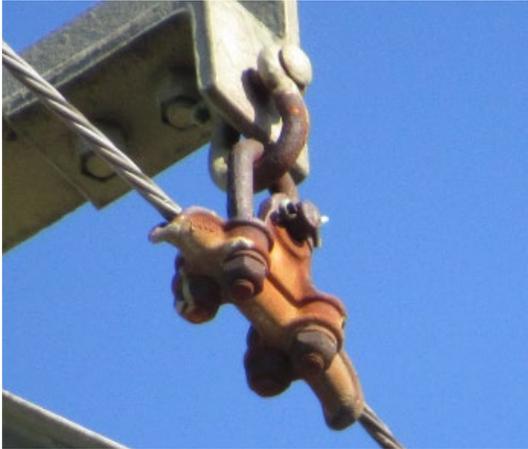
Structure 60582S51258  
Worn Attachment Point Hardware  
Reported Item

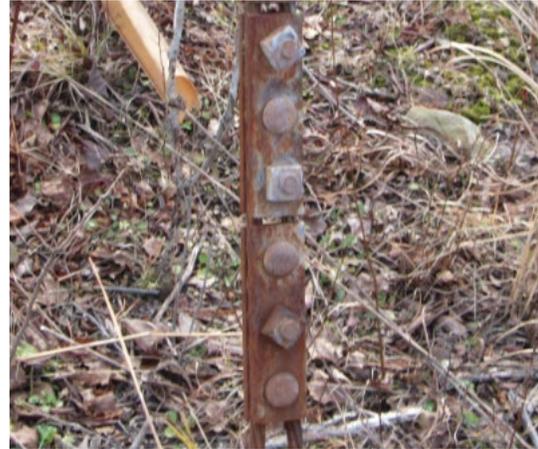
Structure 59271S53552  
Anchor Deteriorated  
Reported Item

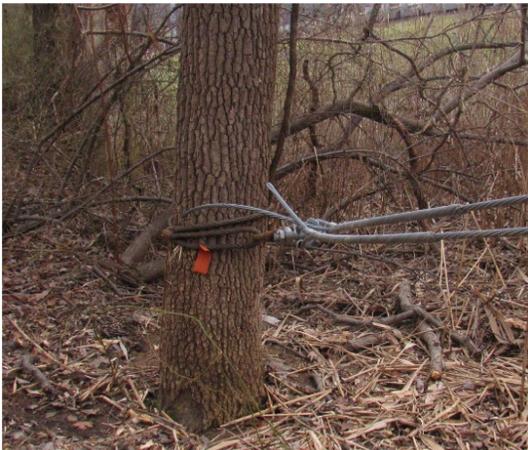
Structure 58238S53004  
Guy Wire Needs Attention  
Reported Item

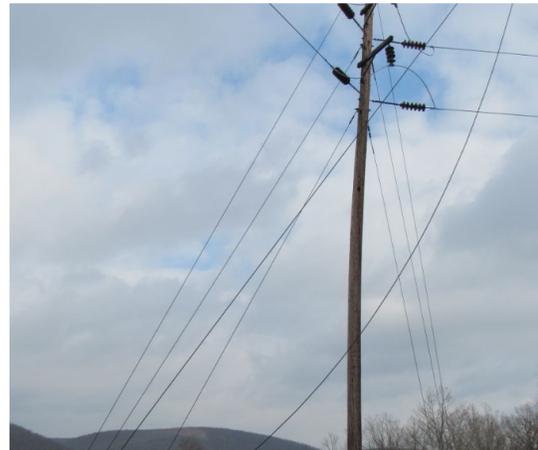
Structure 52103N25514  
Slack Guy Wire  
Reported Item
