IN-DEPTH INSPECTION REPORT

FOR
RAILROAD BRIDGE
OVER
TRAFFIC ROUTE 690
BOROUGH OF MOSCOW

Prepared For:
THE CITY OF SCRANTON

AUGUST, 1988

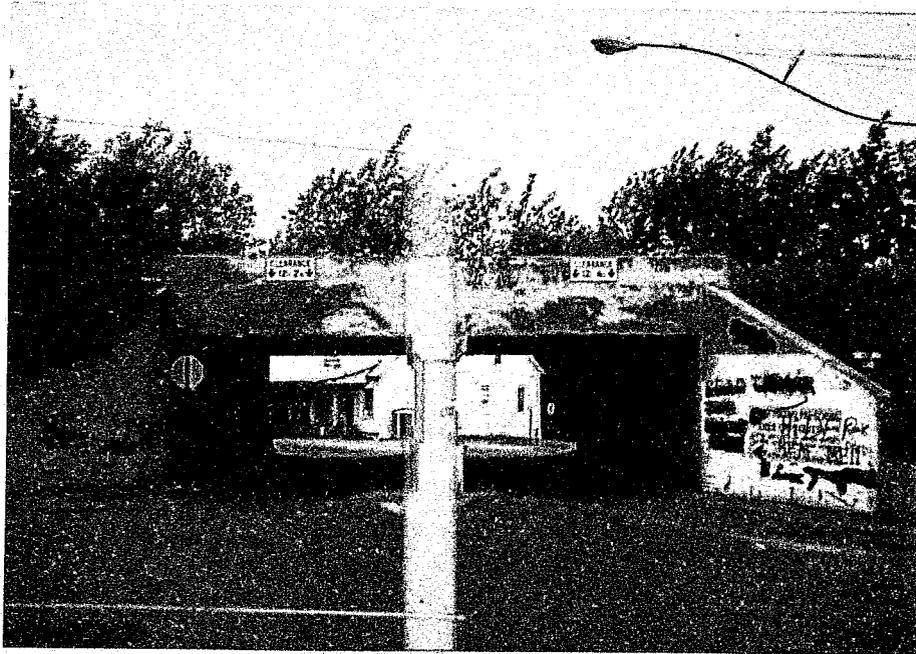
PHOTOGRAPH # 1

DESCRIPTION: Elevation View Looking North At The Structure

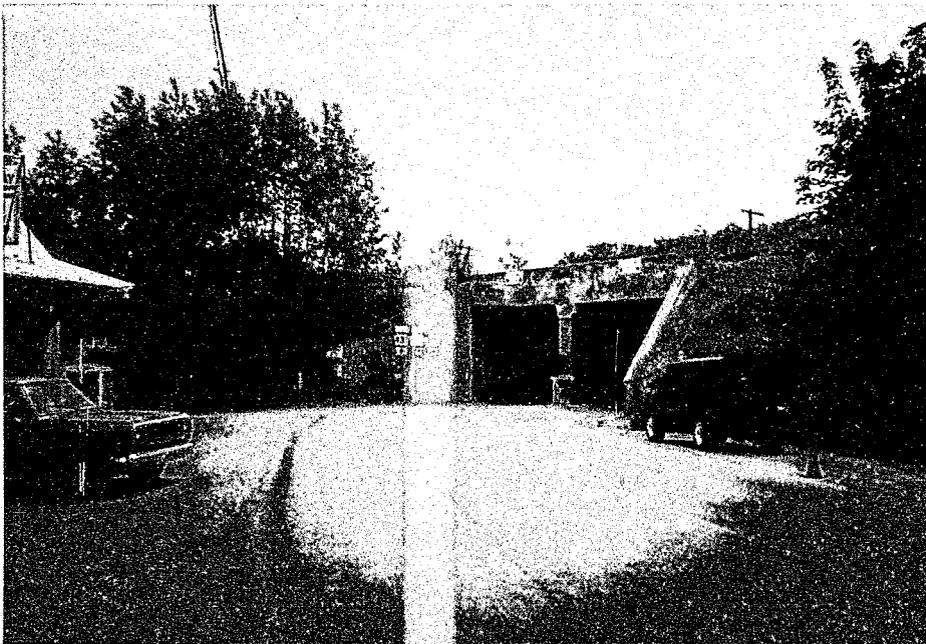
PHOTOGRAPH # 2

DESCRIPTION: Elevation View Looking South At the Structure

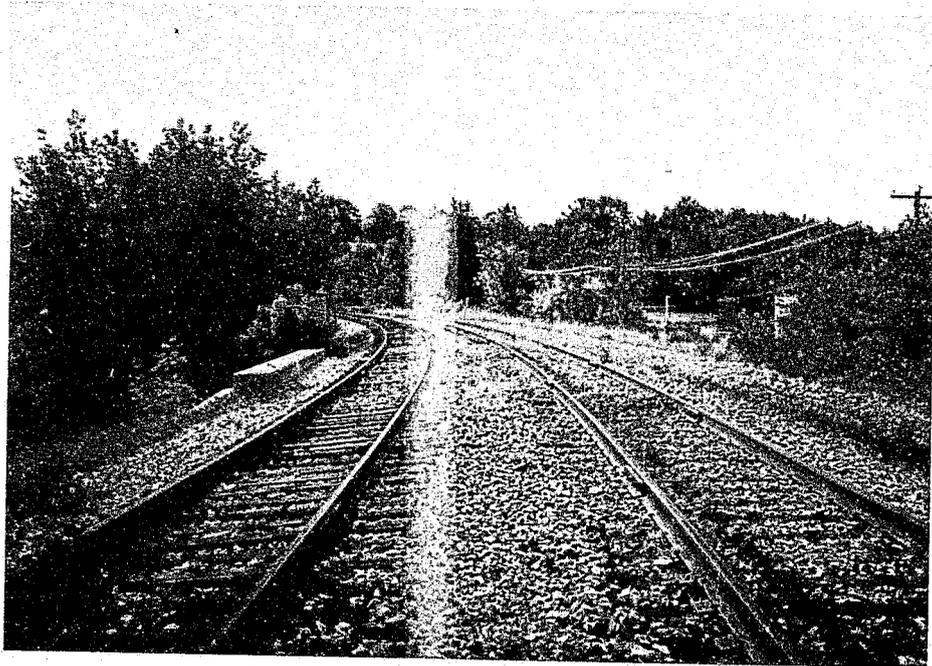
PHOTOGRAPH # _____ 3

DESCRIPTION: Looking Ahead Across The Structure

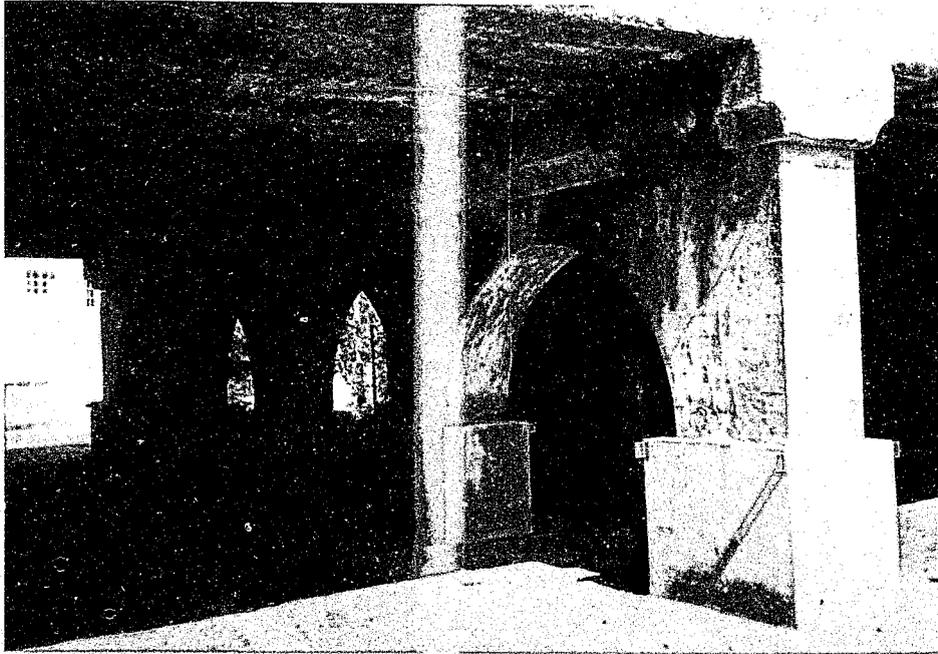
PHOTOGRAPH # 7

The concrete gravity abutments are in poor condition with heavy spalling throughout. The pier is also in extremely poor condition with extensive scaling and spalling throughout. Although repairs have been recently made to the substructure, the majority of these repairs are now hollow sounding indicating the presence of moisture and lack of bonding between the original concrete and the repair material. The pier has also experienced shrinkage cracking throughout the columns. This is probably due to the lack of reinforcing in this portion of the pier. The pier cap is heavily spalled and deteriorated.

DESCRIPTION: Pier

It is recommended that if the structure is to remain, that a substructure rehabilitation plan be developed and implemented to preserve remaining portions of the substructure. In addition, cleaning and rehabilitating the precast concrete deck panels is also recommended. If, however, it is anticipated that heavy railroad loading will occur in the future, load testing and analysis should be performed prior to permitting the resumption of rail traffic.

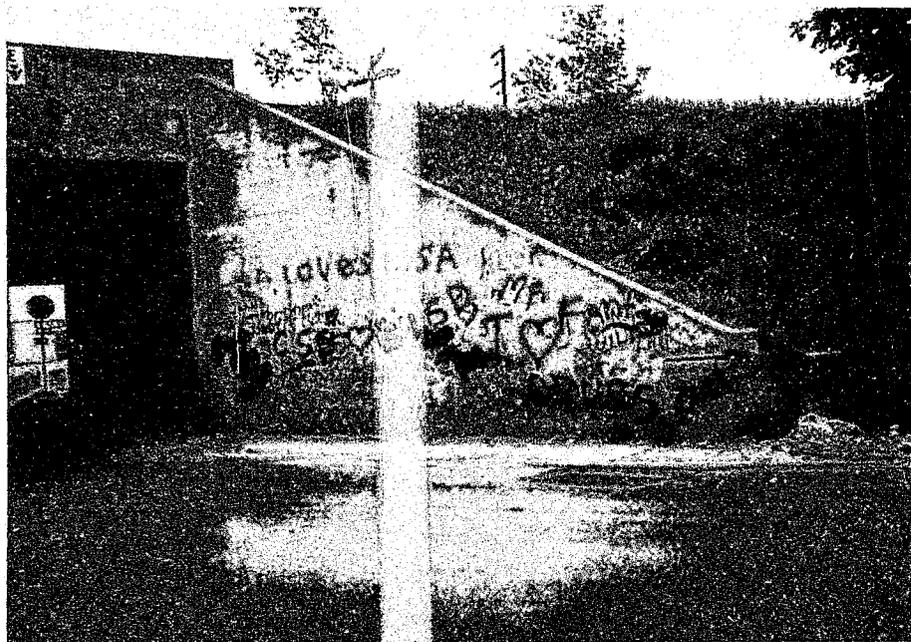
PHOTOGRAPH # 12

DESCRIPTION: Typical Wing
