PENNSYLVANIA TURNPIKE COMMISSION
In Depth Inspection Report
Bridge No. WB-206 - Milepost 12.6

BRIDGE INSPECTION REPORT

IN-DEPTH INSPECTION REPORT
OF
VEHICULAR WEARING SURFACE, EXPANSION DAMS
AND
UNDERLYING SUPPORTING ELEMENTS
HOMEWOOD BRIDGE
AT
HOMEWOOD BOROUGH, PENNSYLVANIA

HOMEWOOD BRIDGE INSPECTION REPORT

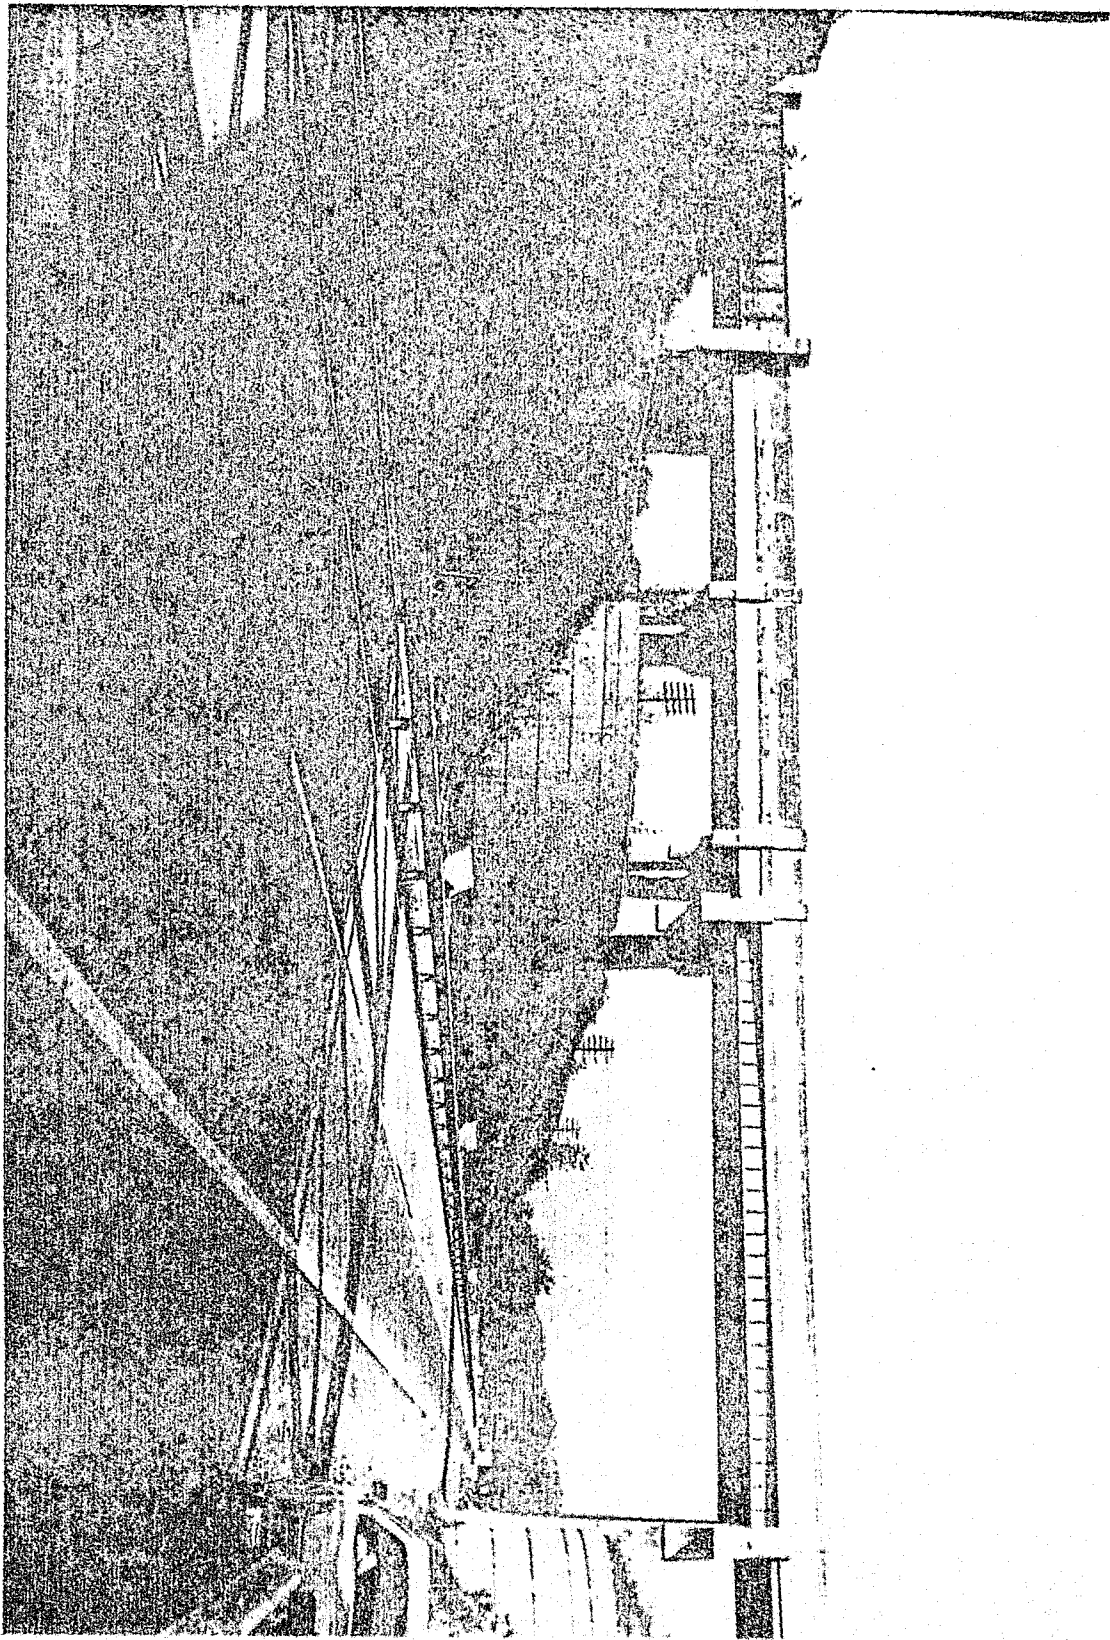
View of Easterly Side of Bridge looking west from Turnpike

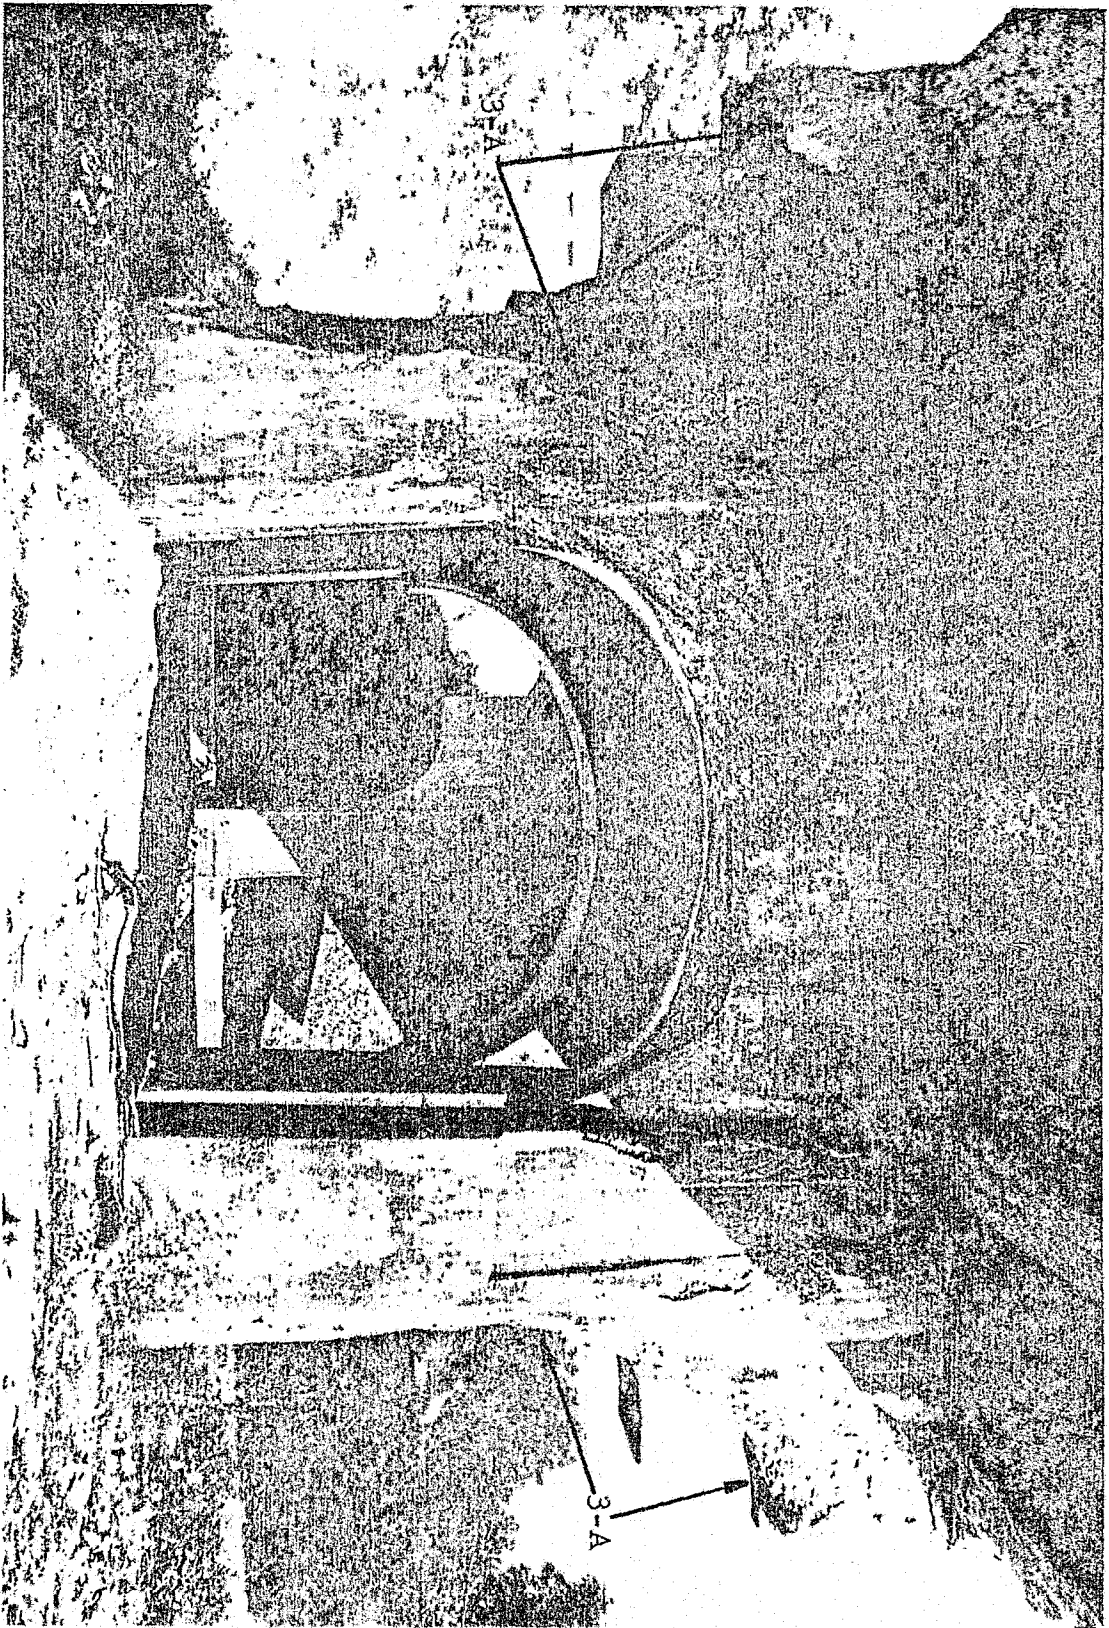
The original portion of the pier structure reveals substantial surface deterioration, at various locations, with loss of concrete to depths of up to 6". (3-A, 4-A & 5-A) Several reinforcing bars are exposed and show corrosion, however, the corrosion affects a relatively small percentage of the total area of reinforcing steel. (3-A) This observed deterioration has not progressed to the point where Pier "O" is considered to be incapable of sustaining the lateral or longitudinal forces imposed by Span "1" of the Commission structure.

South side of Pier "O", looking north

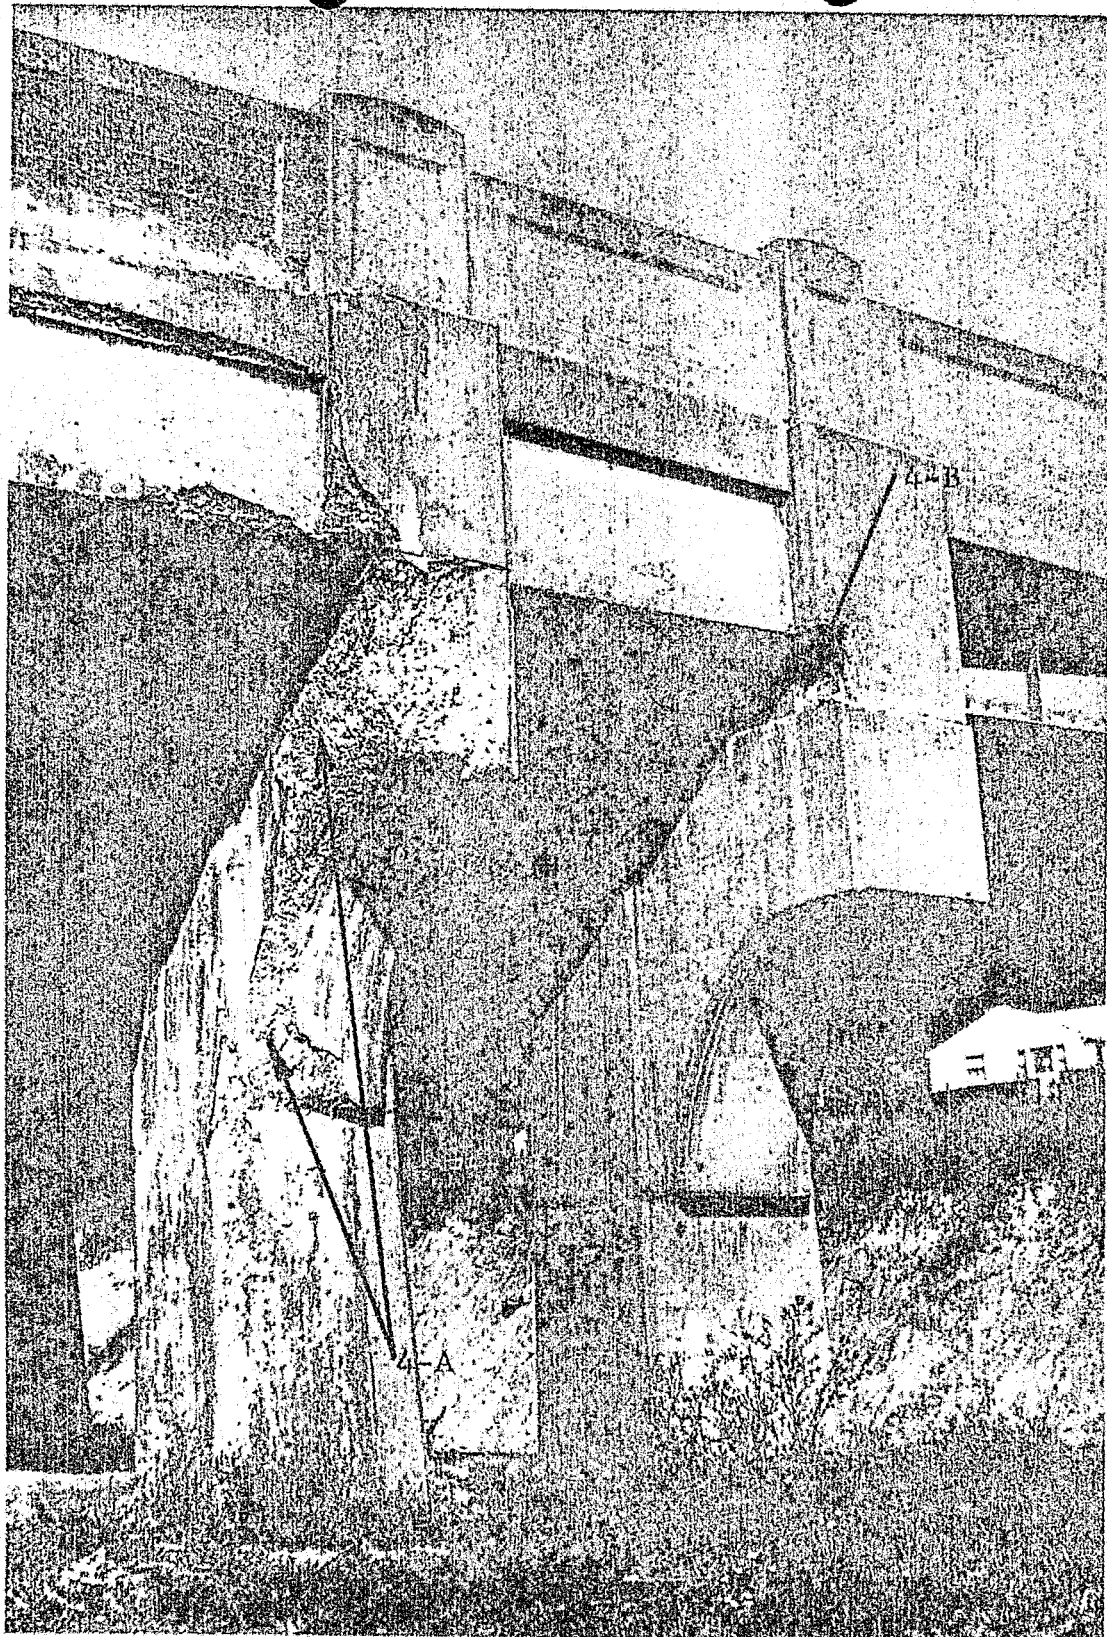
East sides of Pier "0" and Pier "1", looking northwest

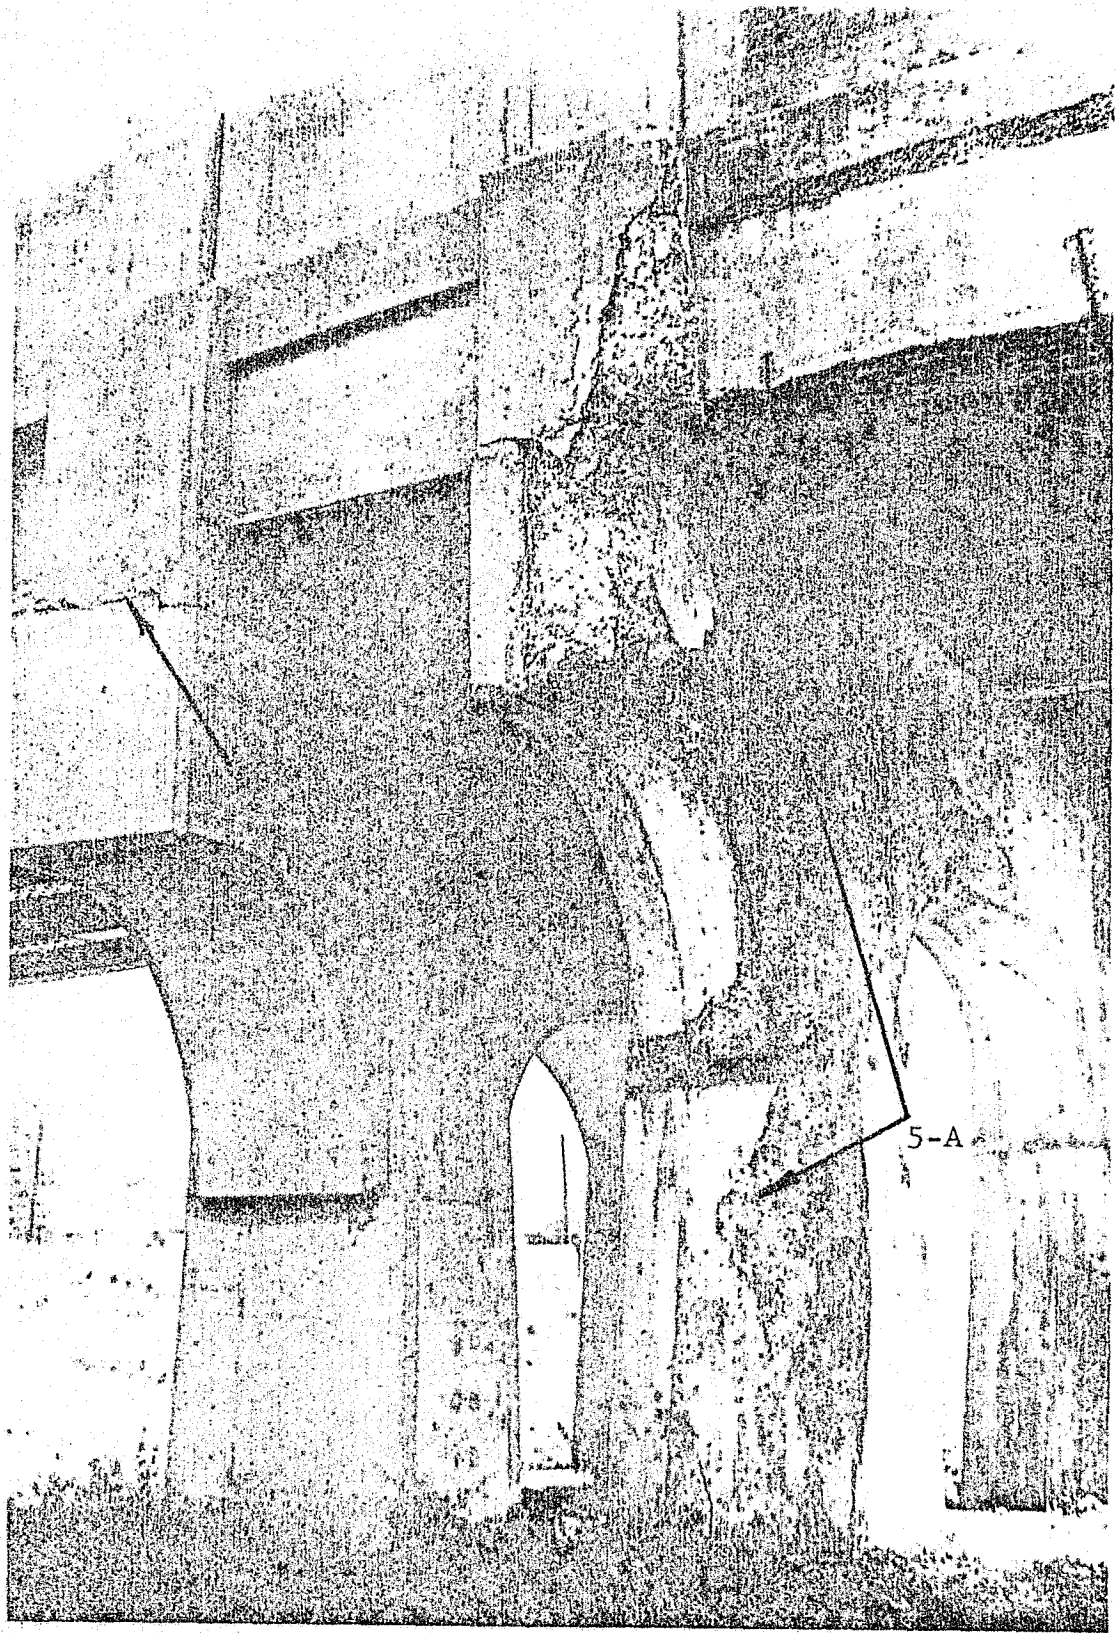
Pier "1" and attached retaining walls are in excellent structural condition and conform to the original design drawings. Slight shrinkage cracks were noted at several locations along the curved retaining walls with no differential settlement in evidence at any of the shrinkage cracks. On the west side of the pier cap slight deterioration is noted at the joint between the pier cap and parapet post which forms part of the superstructure. (5-B) On the east side of pier a small section of cheek wall is missing. (4-B) The noted deterioration has no adverse affect on the structural adequacy of Pier "1".

West sides of Pier "0" and Pier "1", looking northeast

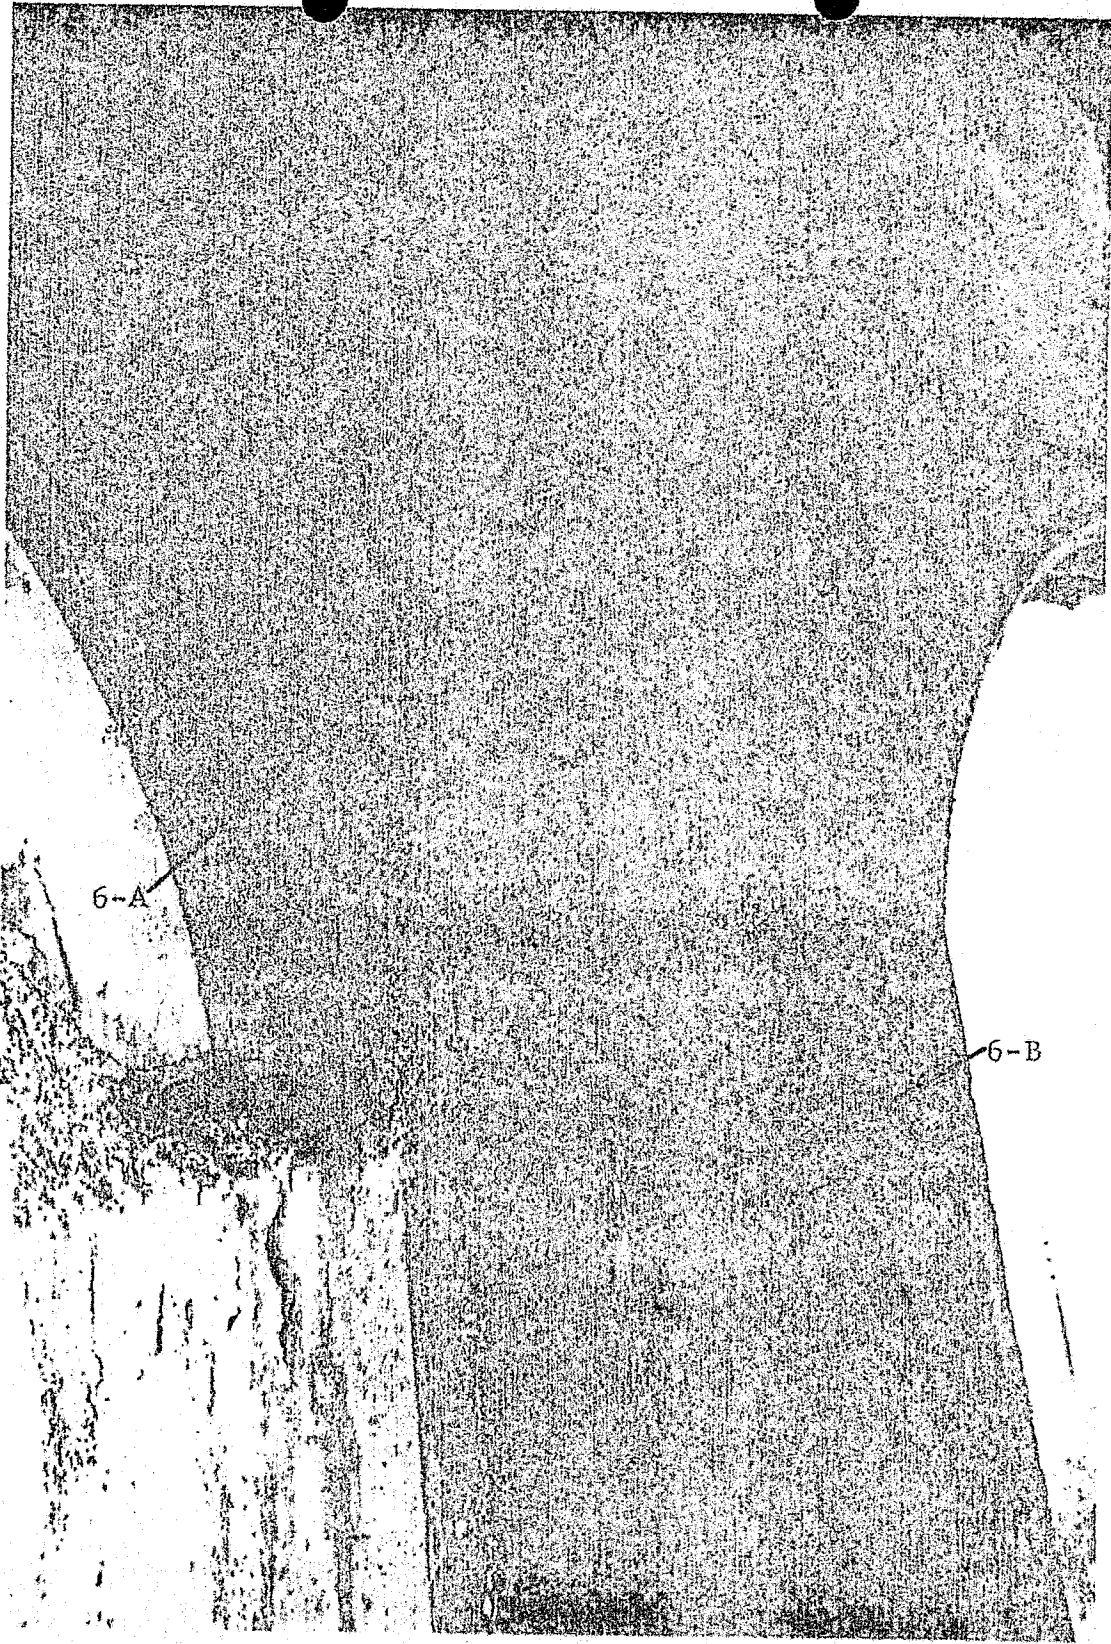
The concrete modification added at the time of Turnpike construction shows a small area of unpatched honeycomb (6-A) and a small area of superficial deterioration due to moisture leaching through a construction joint. (6-B) Neither of these deficiencies are deemed to adversely affect the capability of the modification

North face of westerly column of Pier "O"

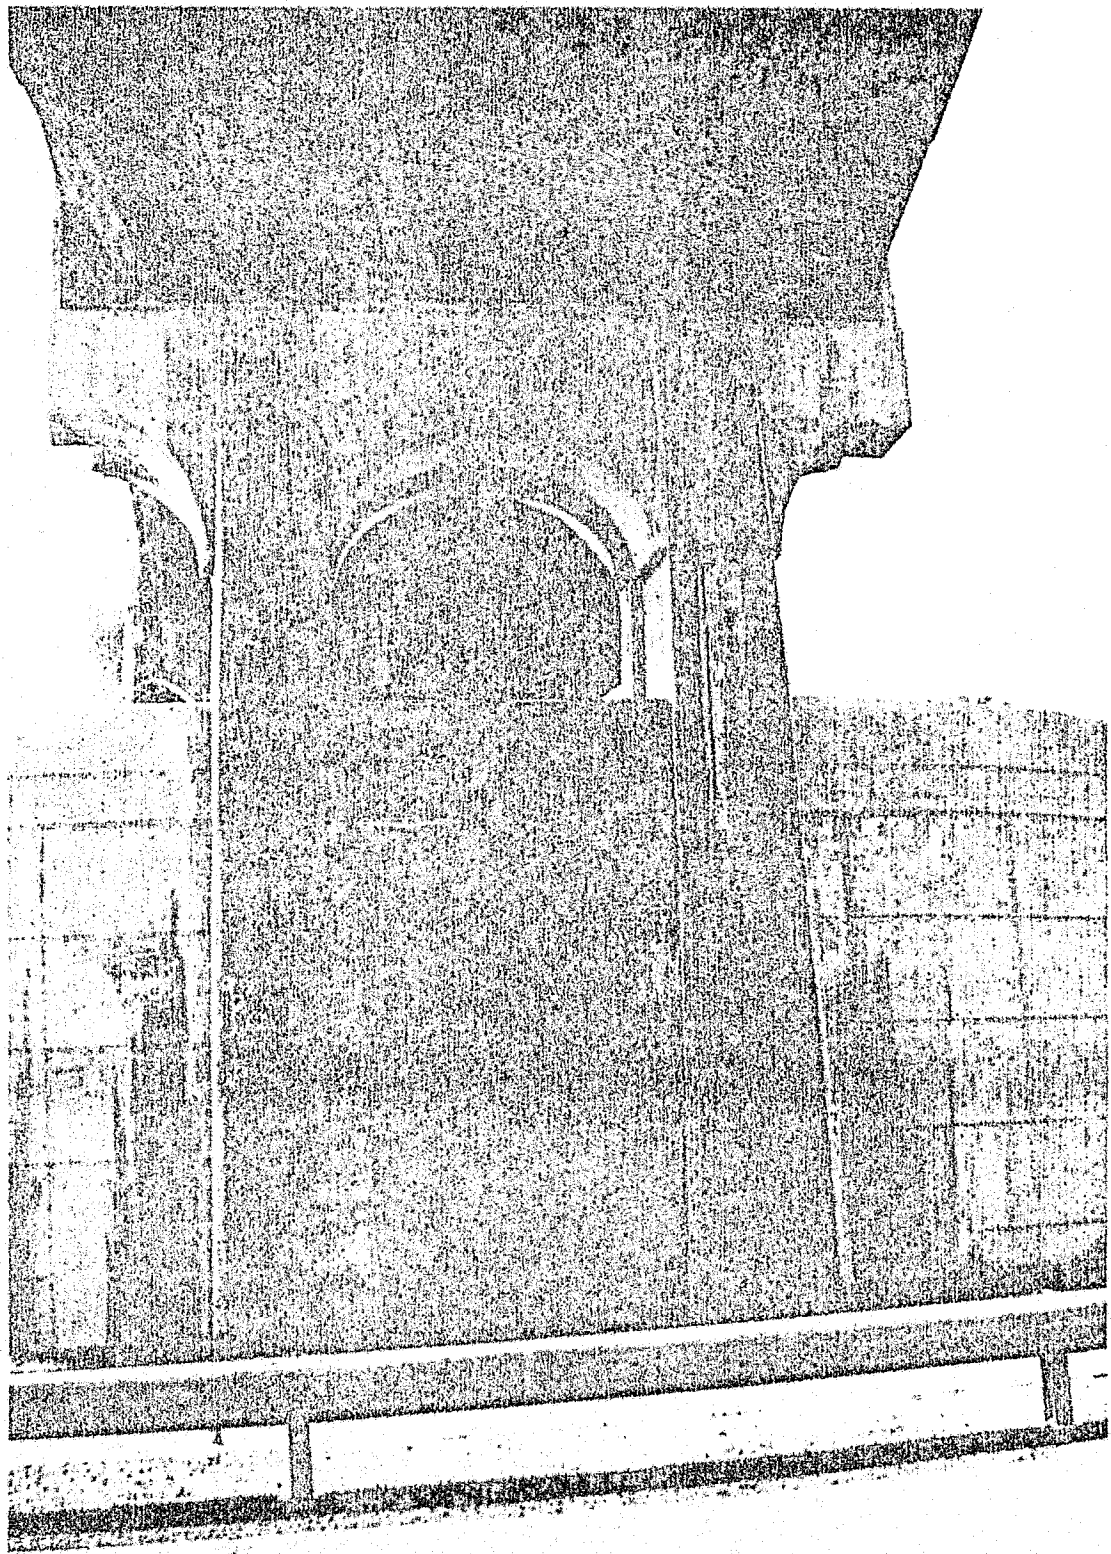
North side of Pier "1", looking south

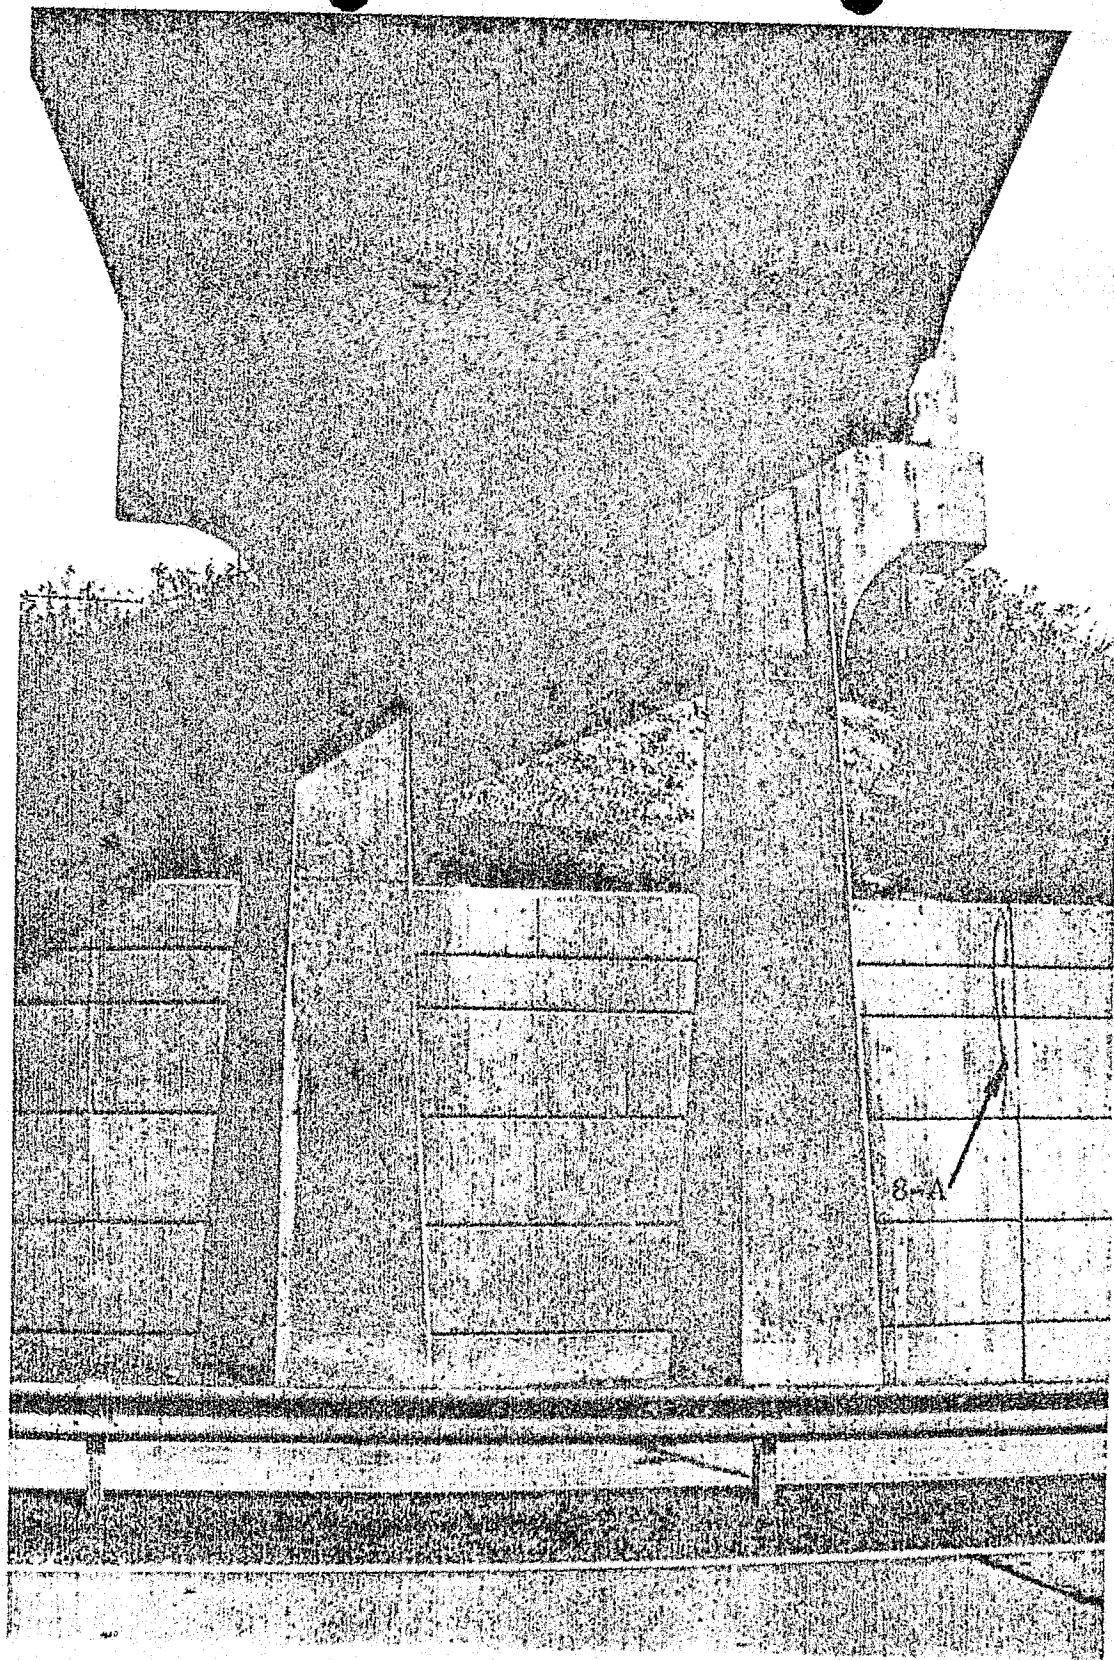
Pier "2" and attached retaining walls are in excellent structural condition and conform in general to the original design drawings. The curved retaining walls reveal several shrinkage cracks which are not accompanied by differential settlement. A keyed construction joint between the pier structure and retaining wall located 10 feet ± east of the eastern pier column is slightly opened at the top and indicates slight differential settlement, toward the south, of the eastern section of the retaining wall in the order of 3/4". This settlement has cracked a small piece of the wall in front of the keyed joint, (8-A) however no damage

South side of Pier "2", looking north

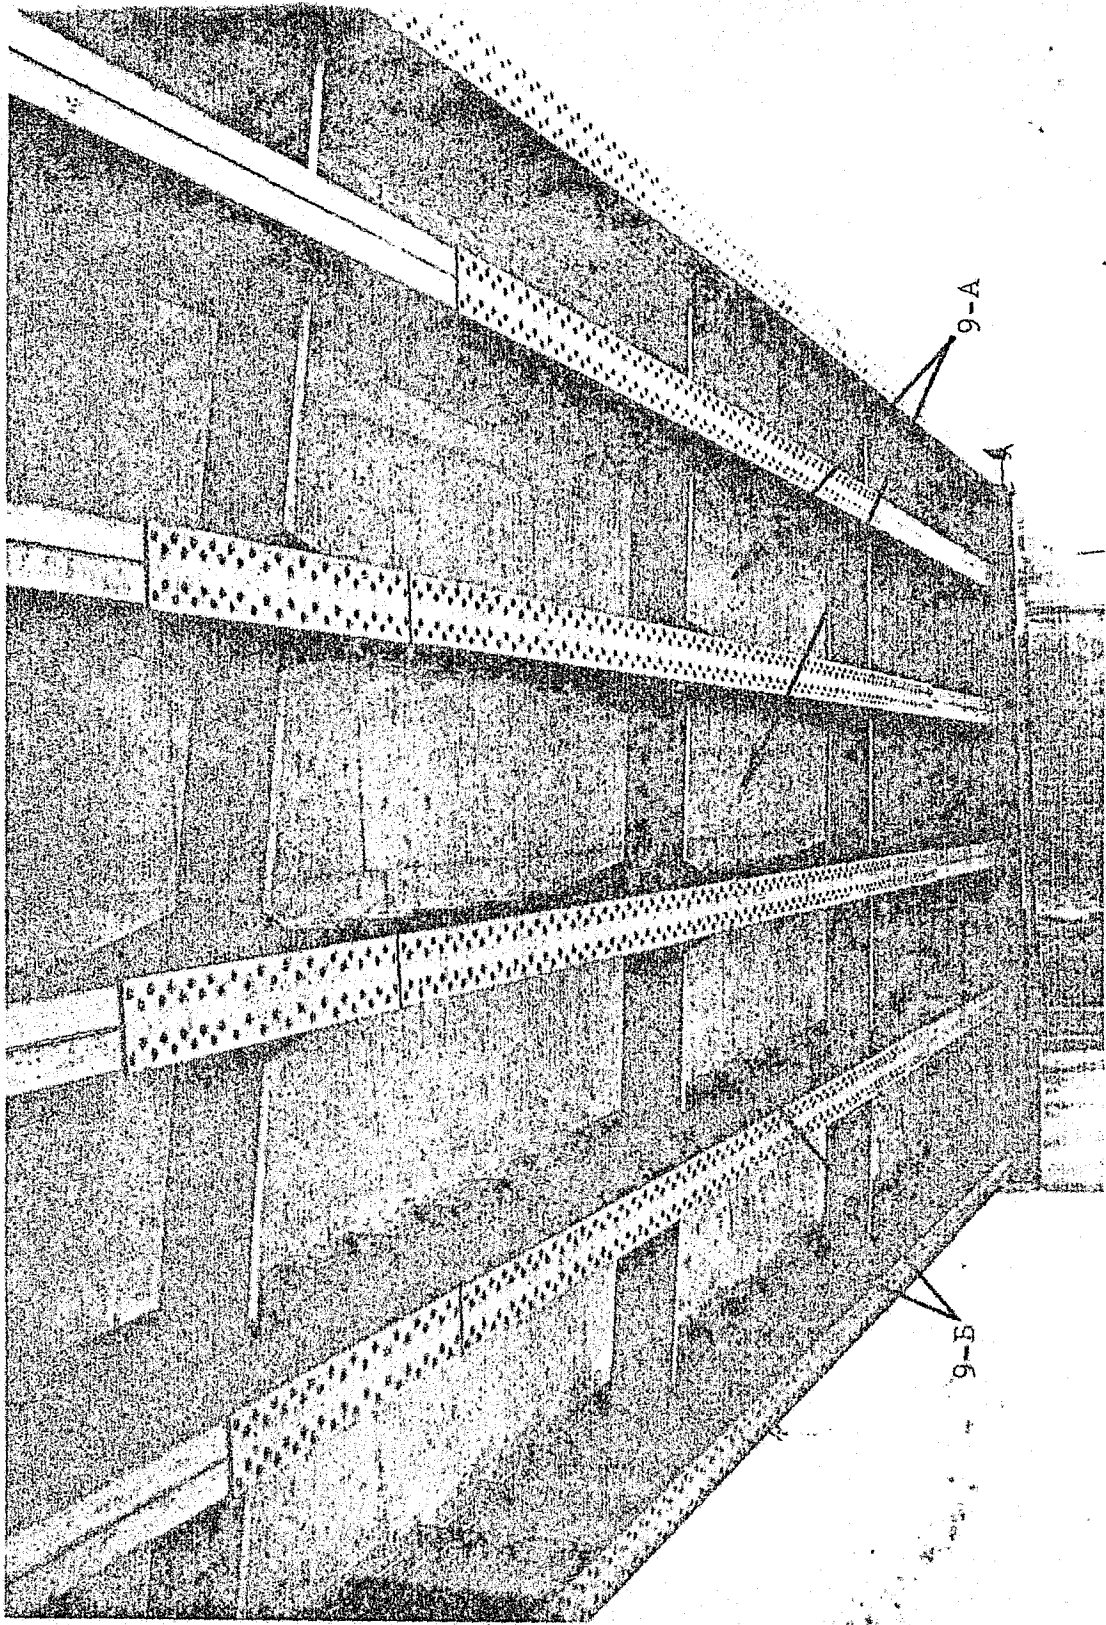
In Spans "1", "2" and "3" the underdeck inspection indicated that there was no leaching of moisture through the deck nor other evidence of deck deterioration. (9-A) The steel girders in Span "2" were found to be in excellent condition with no evidence of corrosion or other deterioration. (9-B)

View of underside of deck, Span "2", looking north from Pier "1"

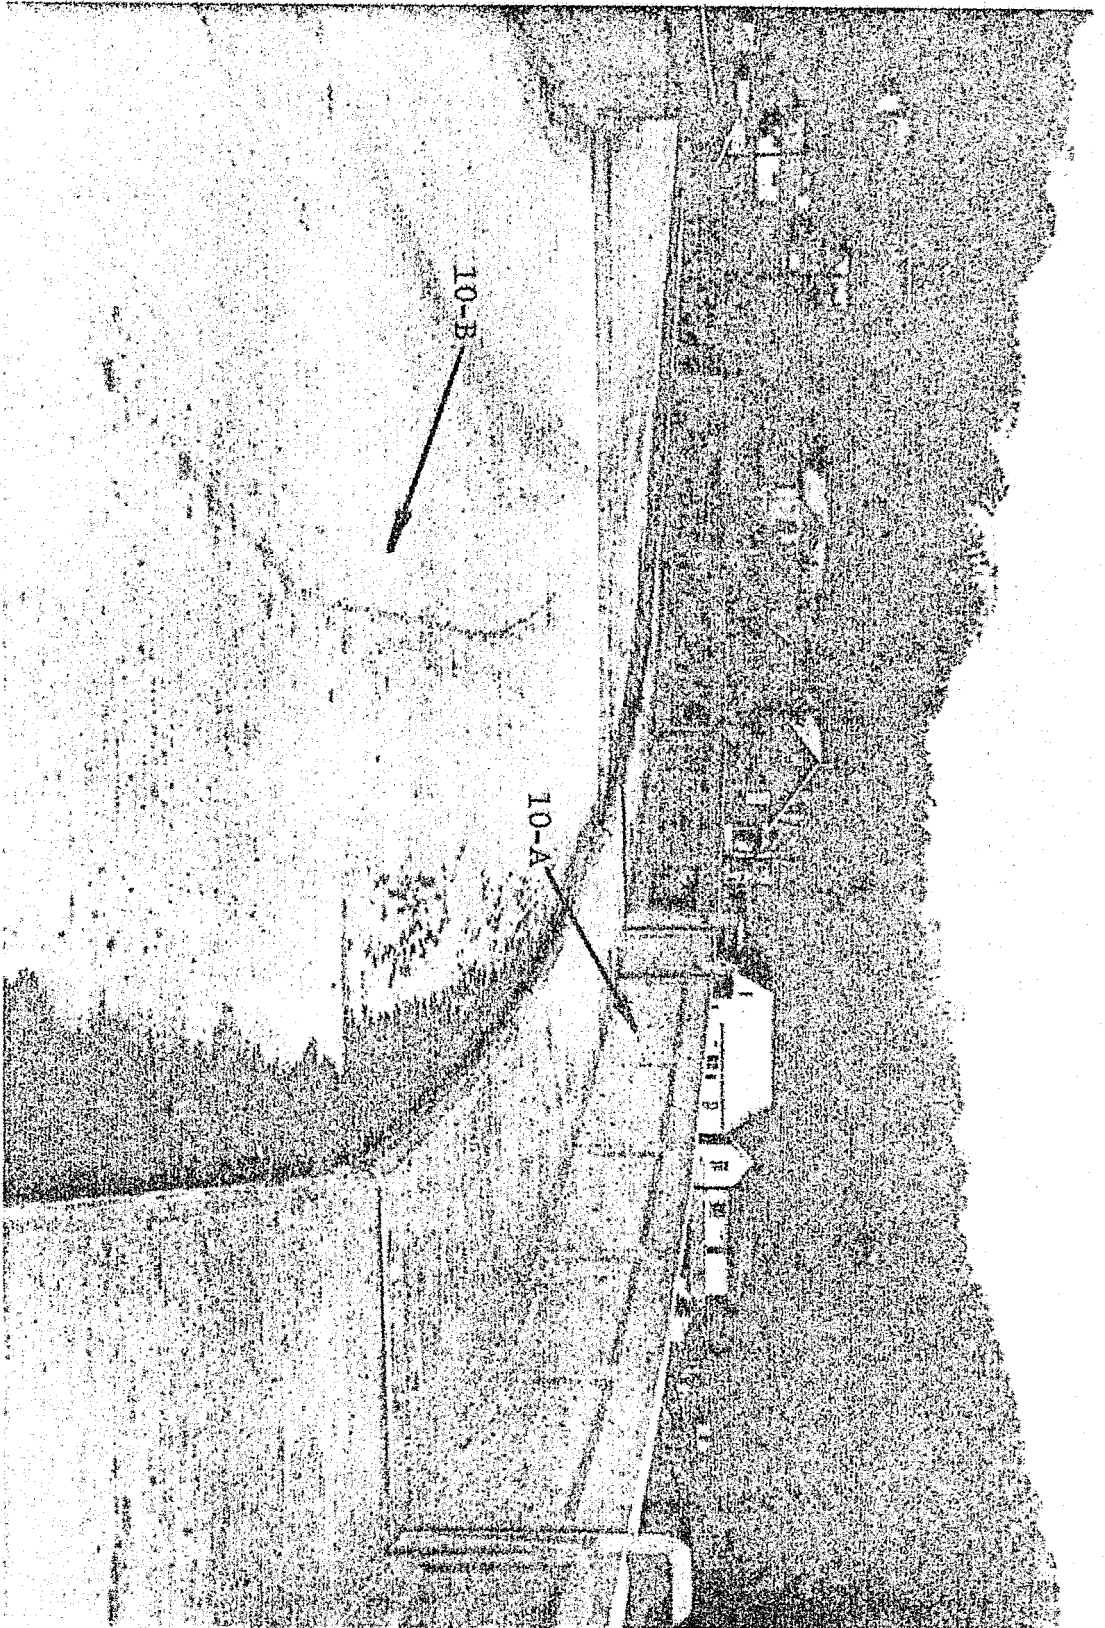
Above deck inspection revealed that minor scattered spalling and exposure of reinforcing bars has occurred in the parapets. (10-A & 11-A) The curb along the east side of the bridge and the sidewalk along the west side of the bridge are in good condition. Concrete deck surface was not visible due to bituminous concrete surface course which had been placed, however, the good condition of the bituminous surface (10-B & 11-B) together with the lack of visible deterioration under the deck indicate that the deck is in satisfactory structural condition.

View of Roadway, Sidewalk and parapets, looking south from Span "3"

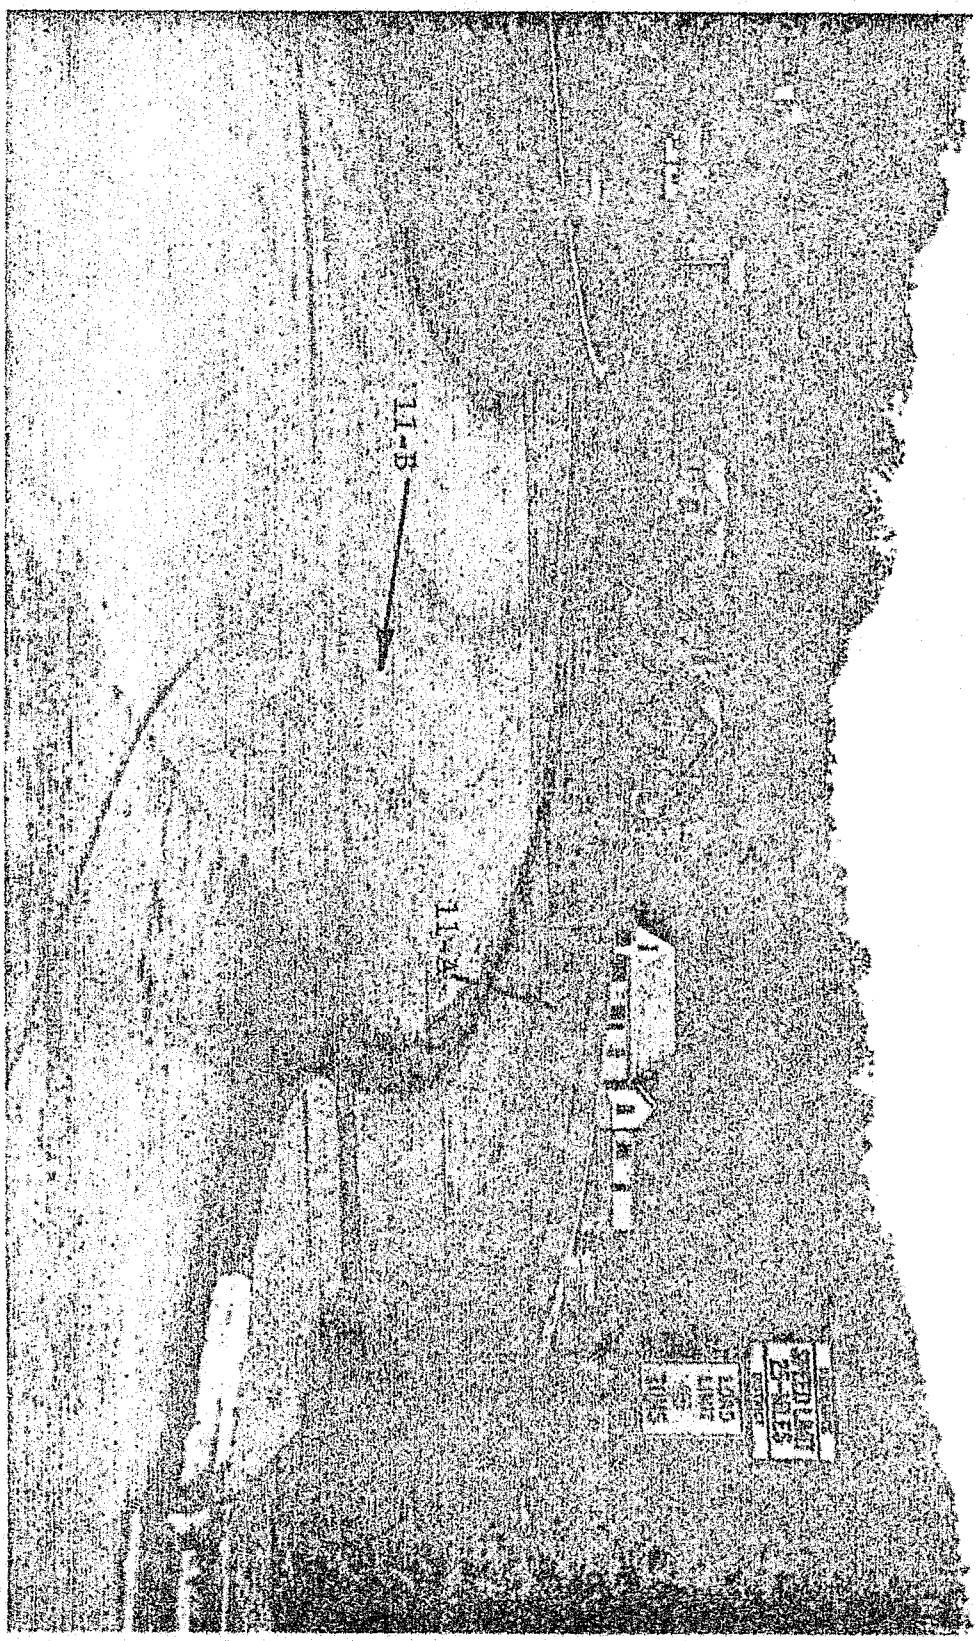
P H O T O G R A P H
11

View of Roadway, Sidewalk and parapets, looking south from north of bridge

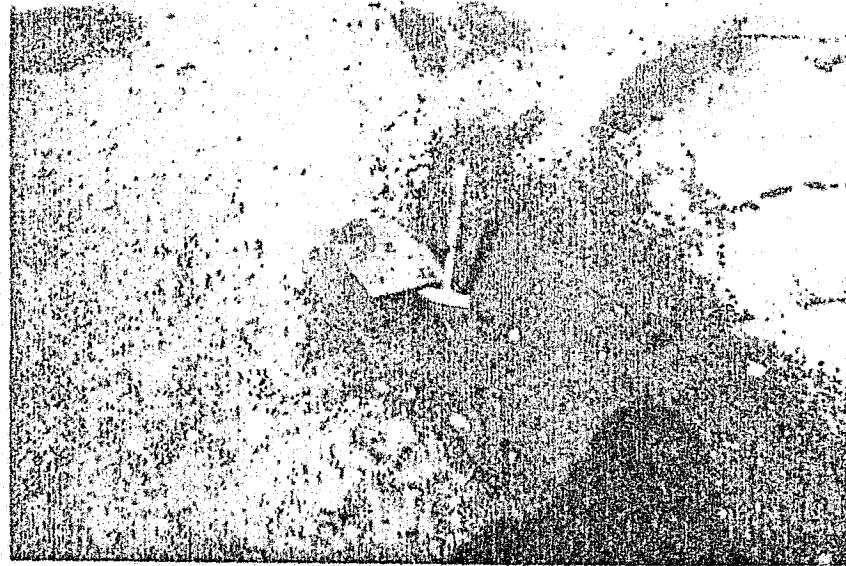
PHOTO 13

The original reinforced concrete deck has been paved with asphalt, which has deteriorated badly. All spans exhibit numerous potholes and a very irregular wearing surface. Refer to photo's 1 through 35 of appendix "A", for an illustrative view of the entire roadway wearing surface. The photo's start at the south approach and proceed, in order of spans, to the north end of the bridge. At many points, at the intersection of the roadway and side walk curb and east parapet wall, holes have formed around the expansion dams to the full depth of the deck. For instance, refer to photo's 13 and 29. In some cases, due to lack of sufficient bearing, the expansion dam is tilted and/or bent.

West end of expansion dam over Pier 4
showing tilted dam

2 - Remove and replace the existing expansion dams (exclusive of the expansion dams over pier 14 and 15, of the Turnpike section). Also included in this work is the rebuilding of certain concrete stringers and portions of the underside of the deck as well as previous concrete patch repair,

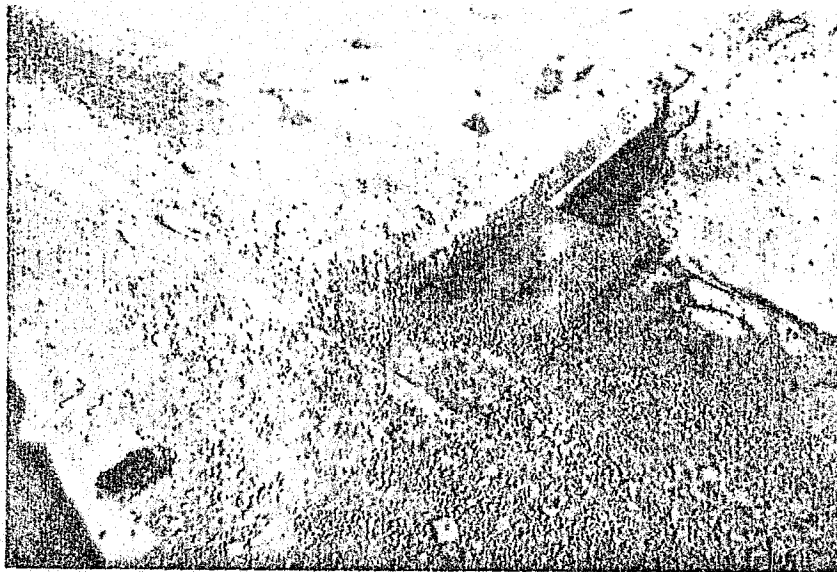
PHOTO 25

West curb area of expansion dam at Pier 10
Showing hole through deck and welded plate

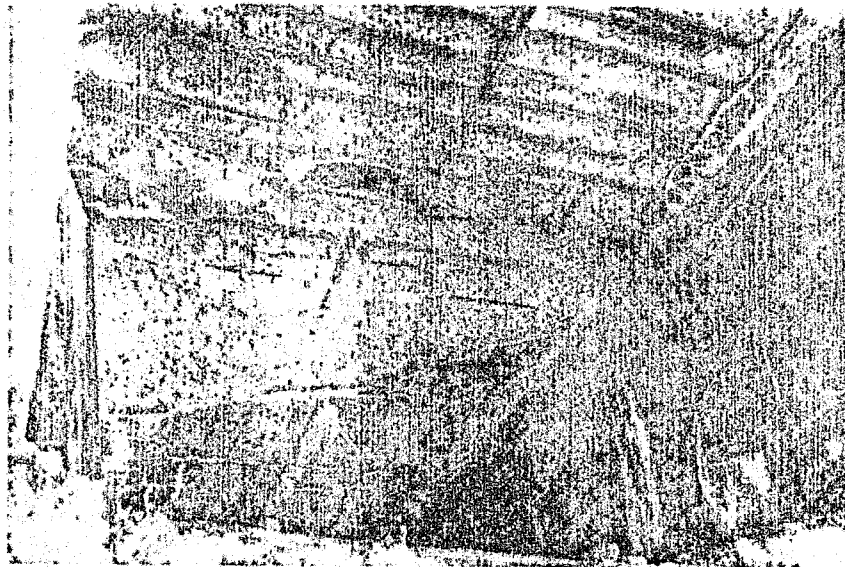
PHOTO 1 - BAY 2/1

The concrete around the expansion dam at bay 2/1 is badly deteriorated. Concrete has already spalled 3"-4", with additional concrete in loose condition. No concrete bearing exists at the west fascia stringer, resulting in the anchoring system being exposed and rusting, with approximately 50 percent of section remaining.

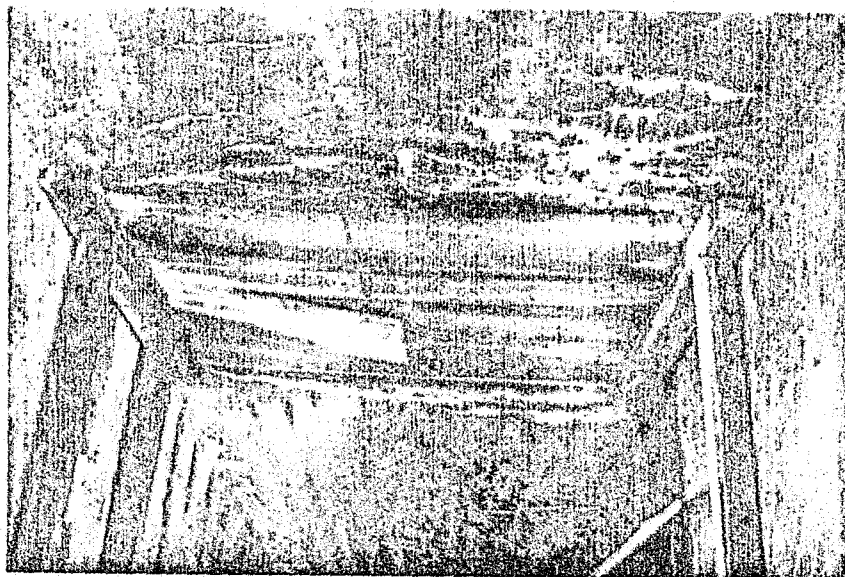
PHOTO 2 - BAY 2/2

At bay 2/2, the form work from previous repairs is still in place. Water seepage is evident around the concrete repair.

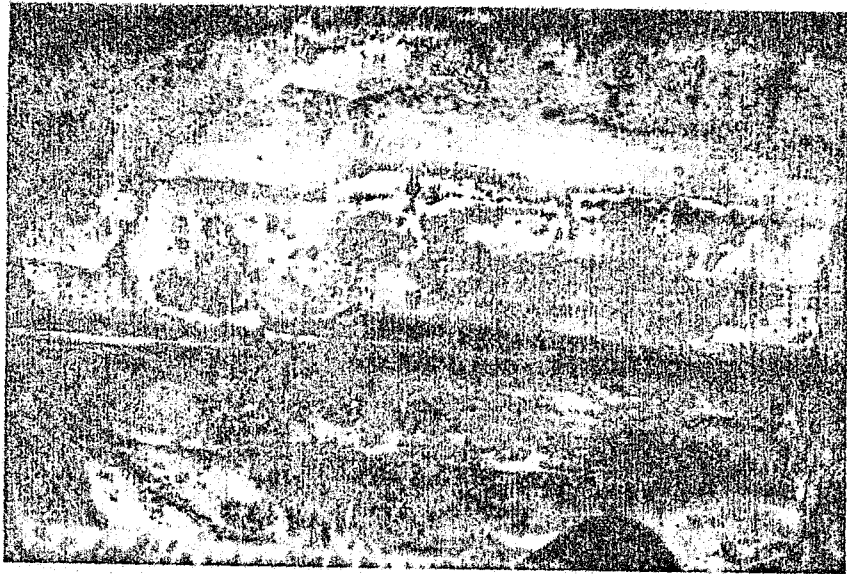
PHOTO 3 - BAY 2/3

The repair made at bay 2/3 is still in good condition, with minor water seepage occurring. The expansion dam is not exposed and wood is still wedged between the slabs of span 1 and 2.

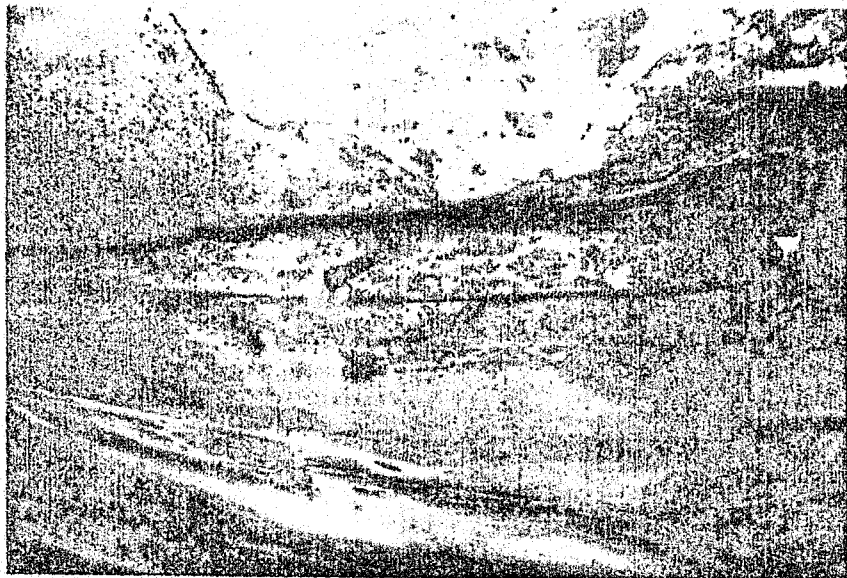
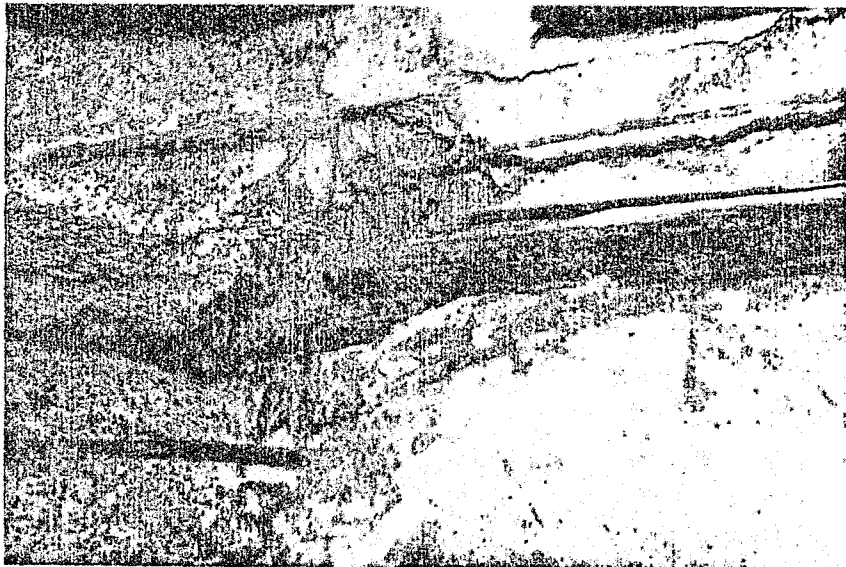
PHOTO 4 - BAY 2/4

The expansion dam at bay 2/4, is in very poor condition. Both vertical legs of the expansion dam support are exposed, as well as anchor bolts and deck rebars. Some support anchor bolts have deteriorated 90 percent. At the east fascia beam, there is a large hole in the deck.
