PENNSYLVANIA TURNPIKE COMMISSION
In Depth Inspection Report
Bridge No. WB-206 - Milepost 12.6

BRIDGE INSPECTION REPORT

IN-DEPTH INSPECTION REPORT
OF
VEHICULAR WEARING SURFACE, EXPANSION DAMS
AND
UNDERLYING SUPPORTING ELEMENTS
HOMEWOOD BRIDGE
AT
HOMEWOOD BOROUGH, PENNSYLVANIA

HOMEWOOD BRIDGE INSPECTION REPORT

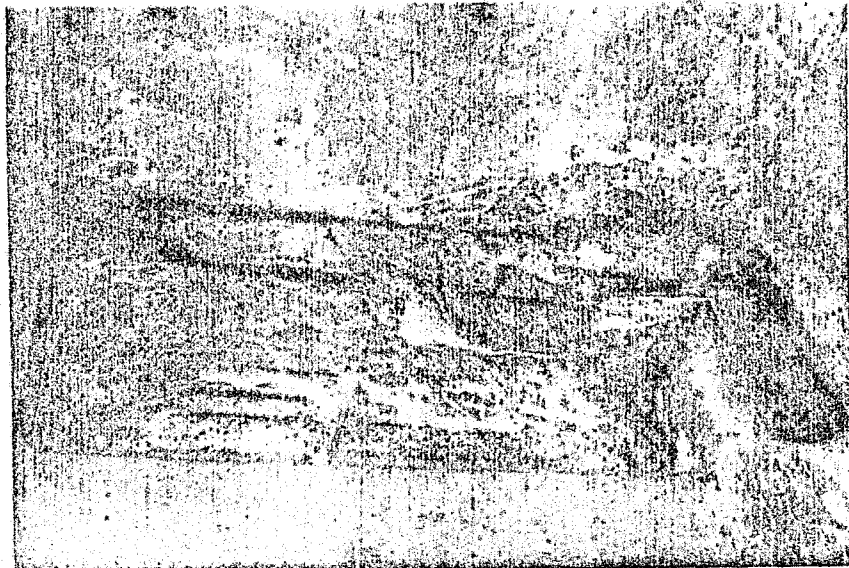
PHOTO 6 - BAY 4/1

At bay 4/1 the original concrete and new concrete repair, directly below the expansion dam, is deteriorated to a depth of 3"-4", with a section exposing approximately one and one-half feet of the underside of the expansion dam. Additional concrete can be chipped loose very easily.

2 - Remove and replace the existing expansion dams (exclusive of the expansion dams over pier 14 and 15, of the Turnpike section). Also included in this work is the rebuilding of certain concrete stringers and portions of the underside of the deck as well as previous concrete patch repair,

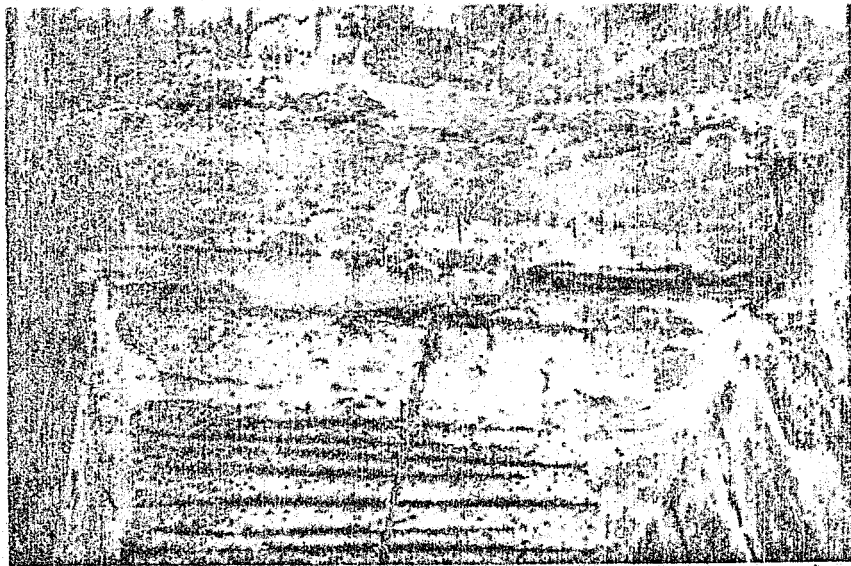
PHOTO 7 - BAY 4/2

The expansion dam at bays 4/2 and 4/3, exhibit similar deterioration, in that spalling of the original concrete has reached a depth of 3"-5", and a two (2) foot section of new concrete repair has broken out.

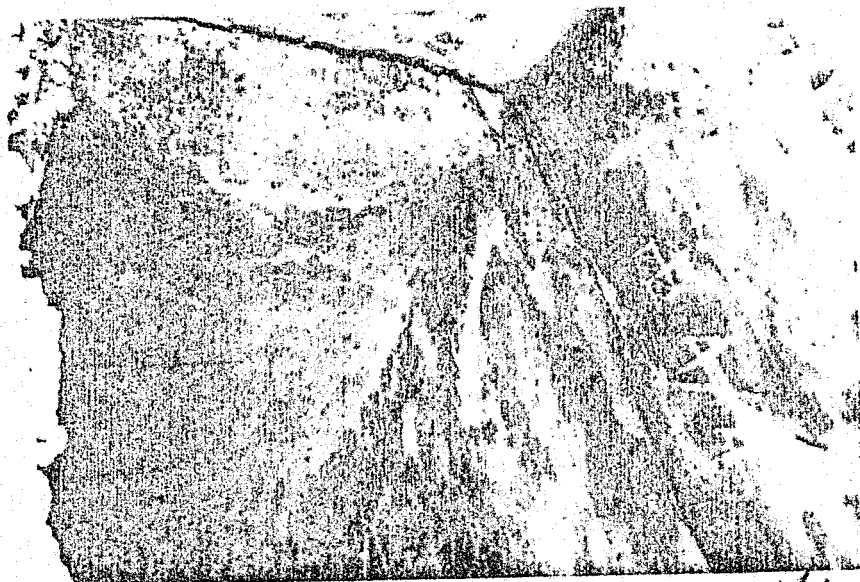
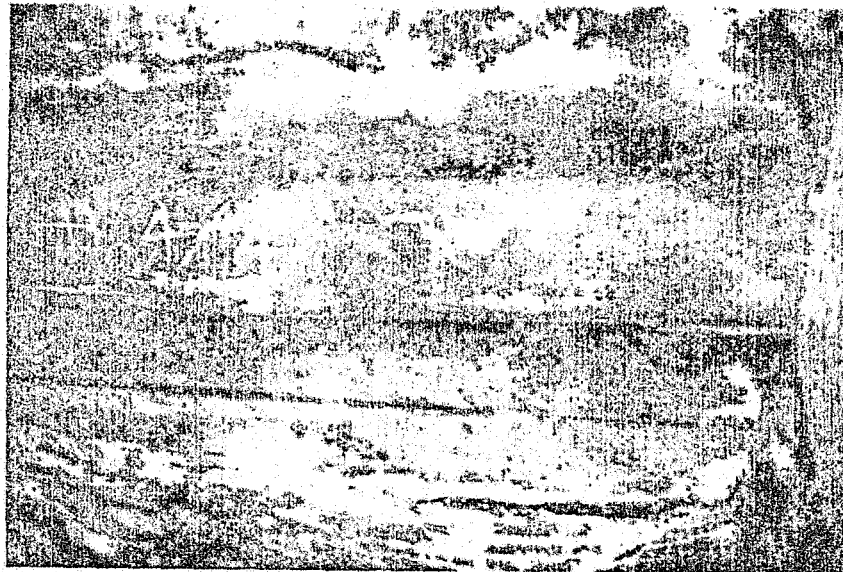
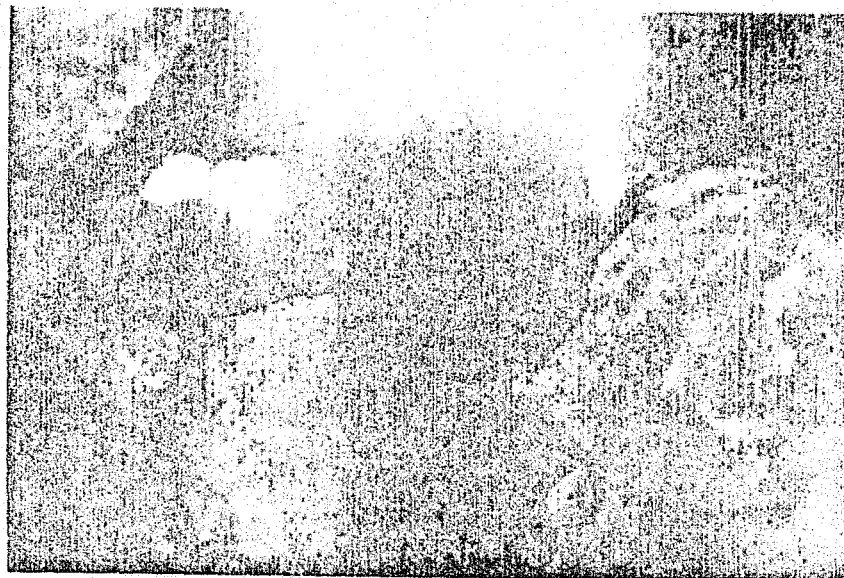
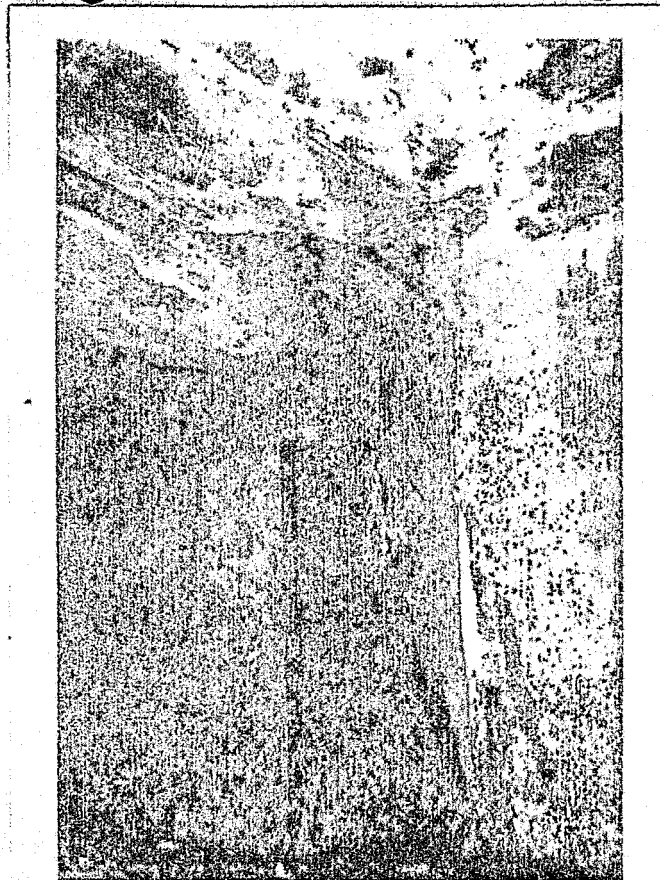
PHOTO 8 - BAY 4/4

Very heavy deterioration exists at bay 4/4; in particular at the East fascia beam. The entire underside of the expansion dam is exposed for a length of two feet. Both horizontal and vertical legs of the expansion dam support, as well as anchor bolts, are exposed. Also, a large hole through the deck, exists around the dam.

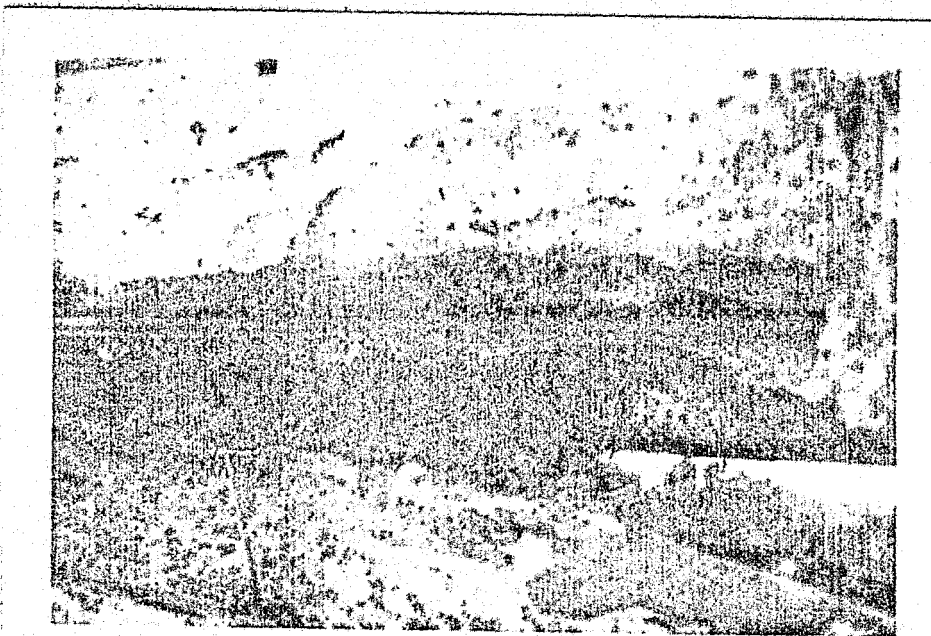
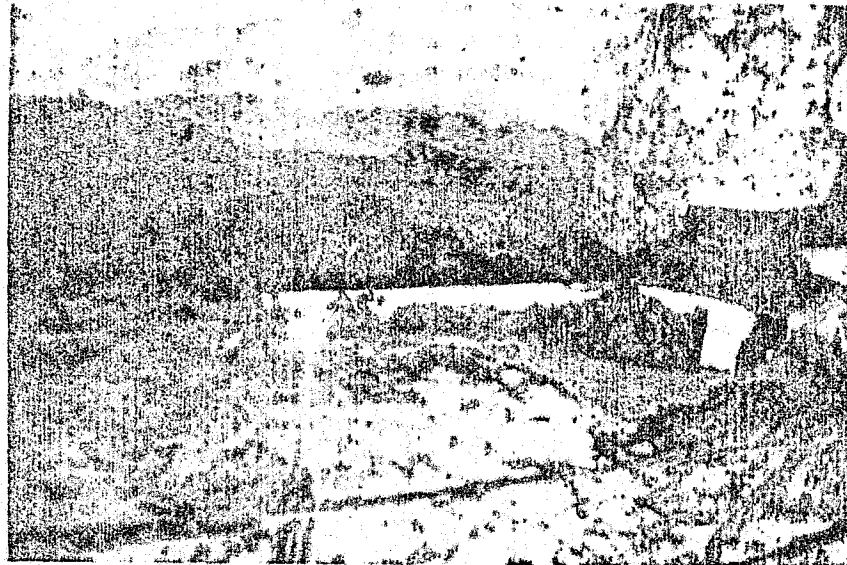
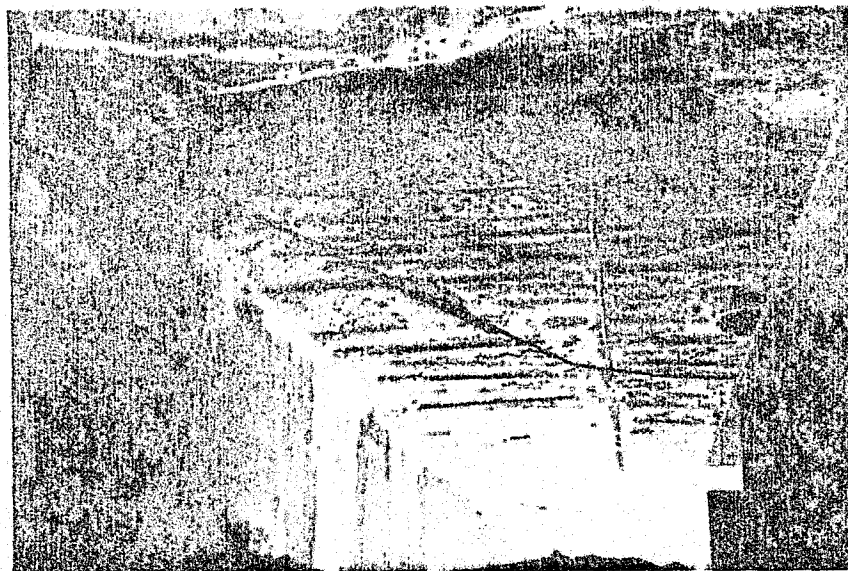
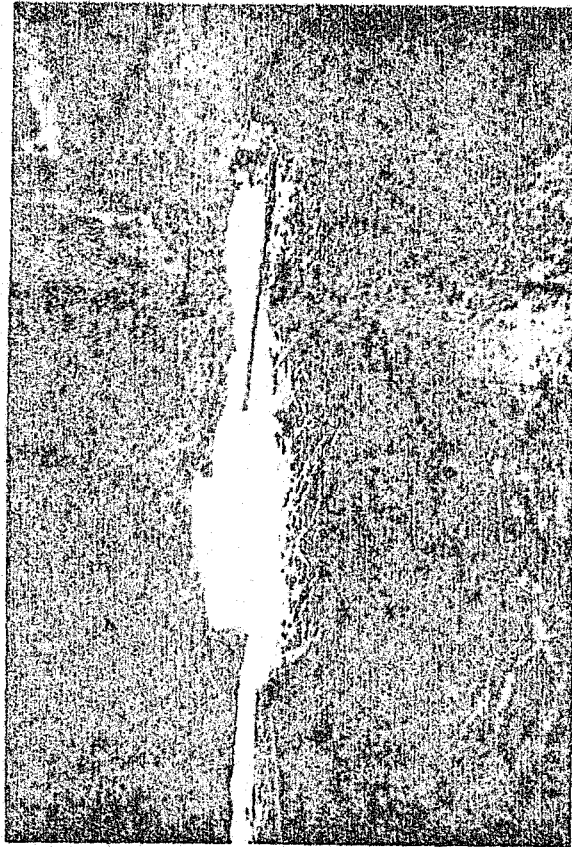
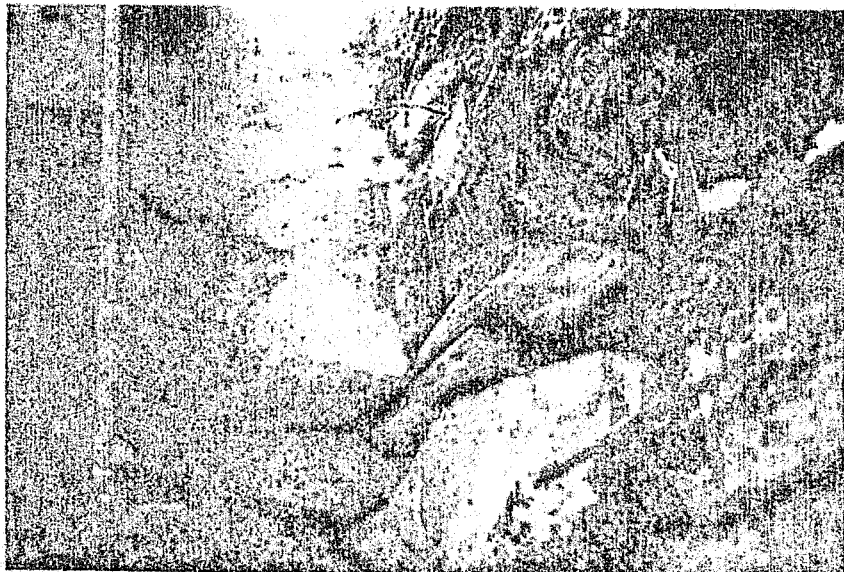
PHOTO 12 - BAY 6/1

The concrete at expansion dam 6/1 is extremely deteriorated, with the horizontal and vertical legs of the expansion dam support, as well as anchor bolts and deck rebars, exposed. Almost no bearing is provided for the dam at this location. As pictured in photo's 6/1, large holes exist through the deck around the expansion dam, Bays 6/2, 6/3 and 6/4, have concrete patches around the expansion dams that are in fairly good condition.

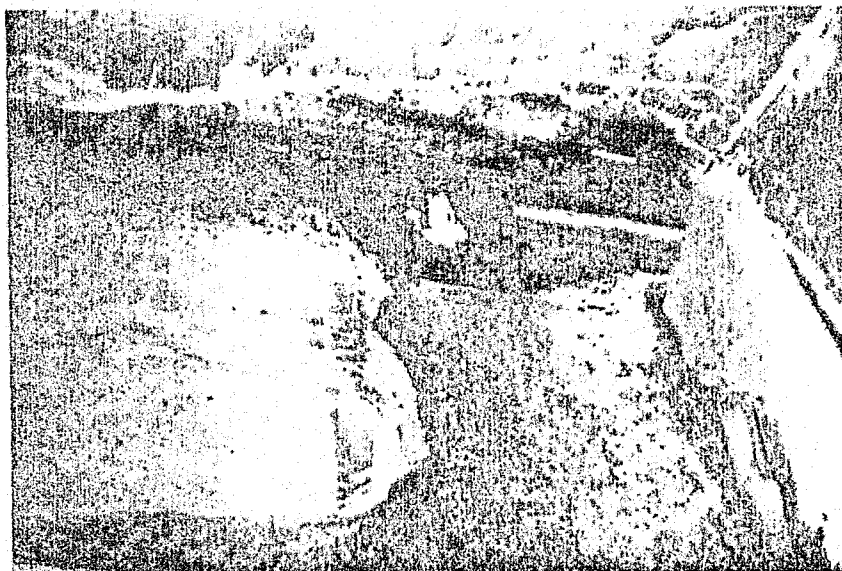
PHOTO 20 - BAY 10/1

Bay 10/1 exhibits a lot of deterioration around the expansion dam. The expansion dam support is completely exposed, along with numerous deck rebars. The loose concrete is easily chipped away from depths of 3"-5".

Large holes exist through the deck.

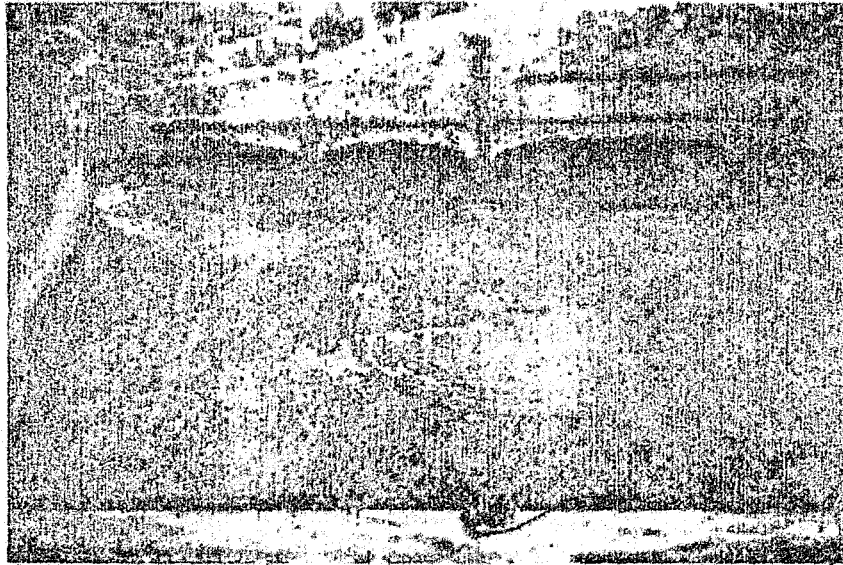
PHOTO 21 - BAY 10/2

At bays 10/2, 10/3, and 10/4, the original concrete has spalled 3"-4", with the vertical legs of the expansion dam support partially exposed.

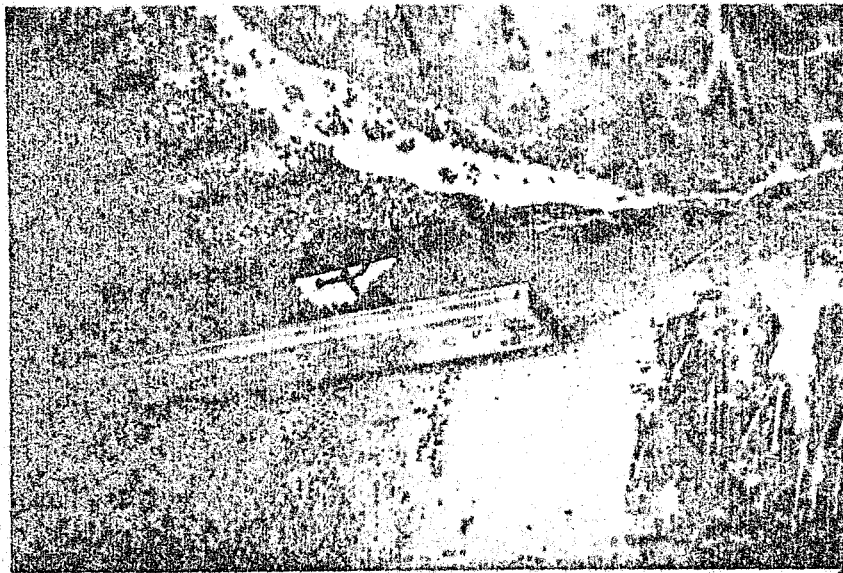
PHOTO 22 - BAY 11/1

The horizontal and vertical support angle legs of the expansion dam at bay 11/1, are exposed for three feet. One large hole through the deck exists at the center of the bay, approximately 1½' x 1' wide. One dam support anchor bolt is completely exposed. All concrete around the dam sounds hollow.

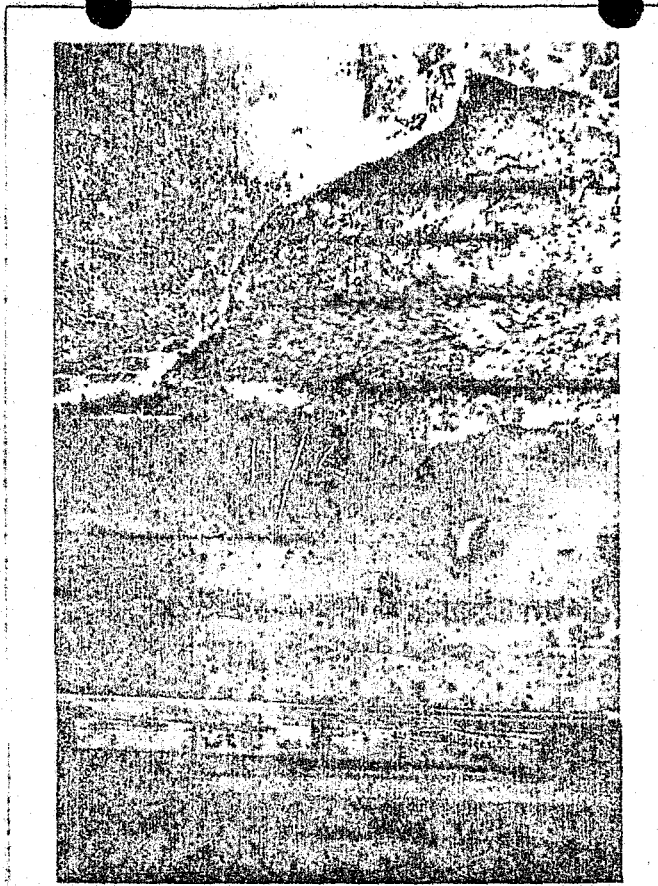
PHOTO 23 - BAY 11/2

At bay 11/2, the concrete is in good condition. The underside of the expansion dam is not exposed.

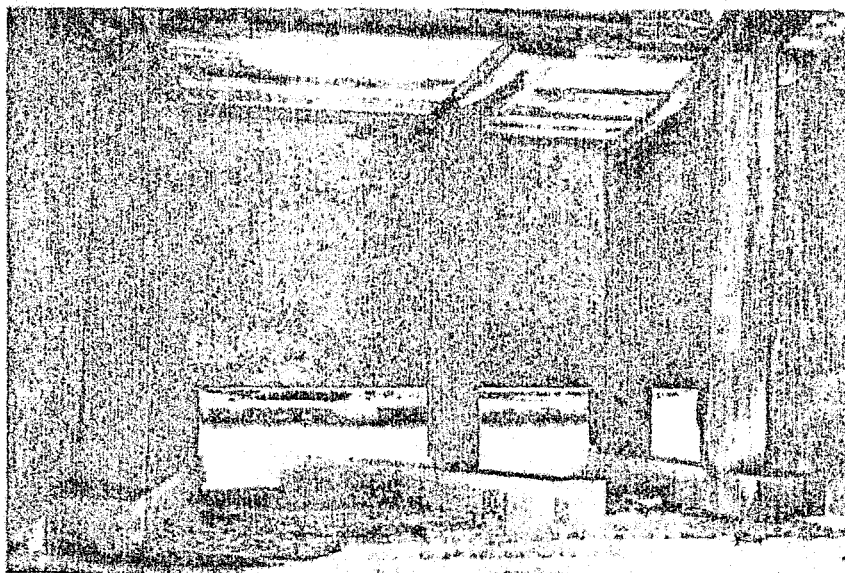
PHOTO 24 - BAY 11/3

Bays 11/3 and 11/4 still have form work, used in previous repairs, in place, therefore the dam is not visible. The fact that water seepage and concrete spalling is not evident indicates the concrete repairs are in good condition.

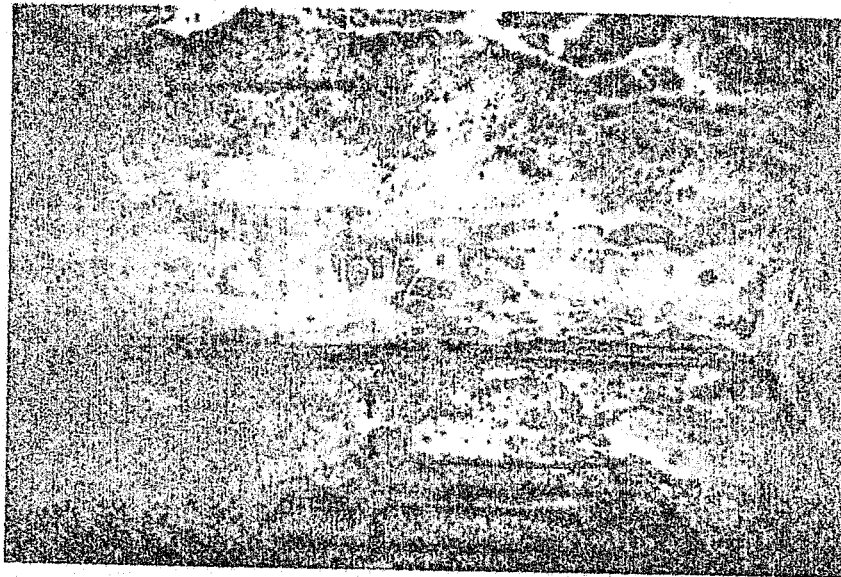
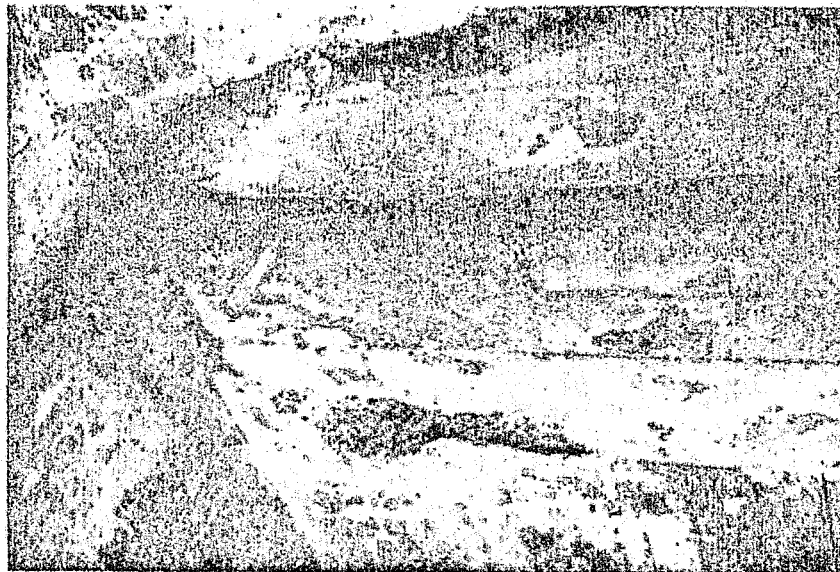
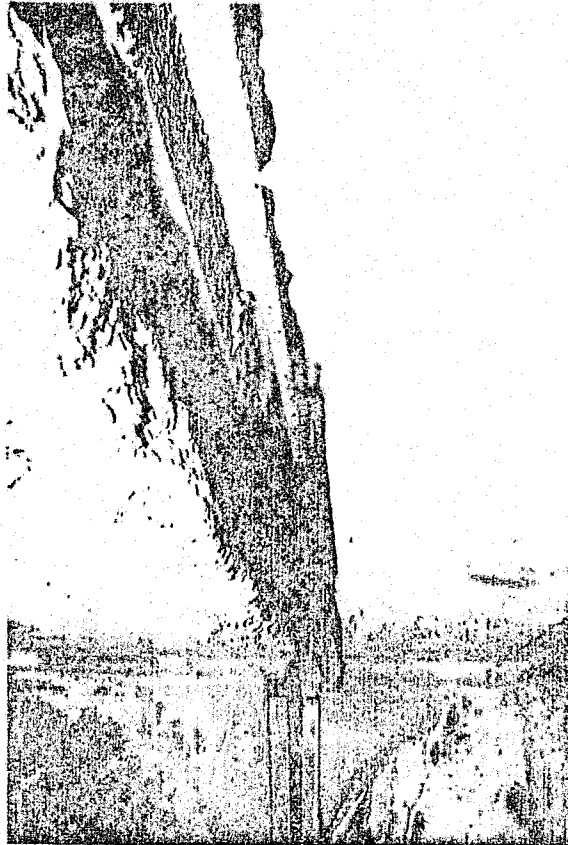
Bays 12/2 and 12/3, are similarly deteriorated around the vertical legs of the expansion dam support angles. Their concrete repairs are in fair condition.

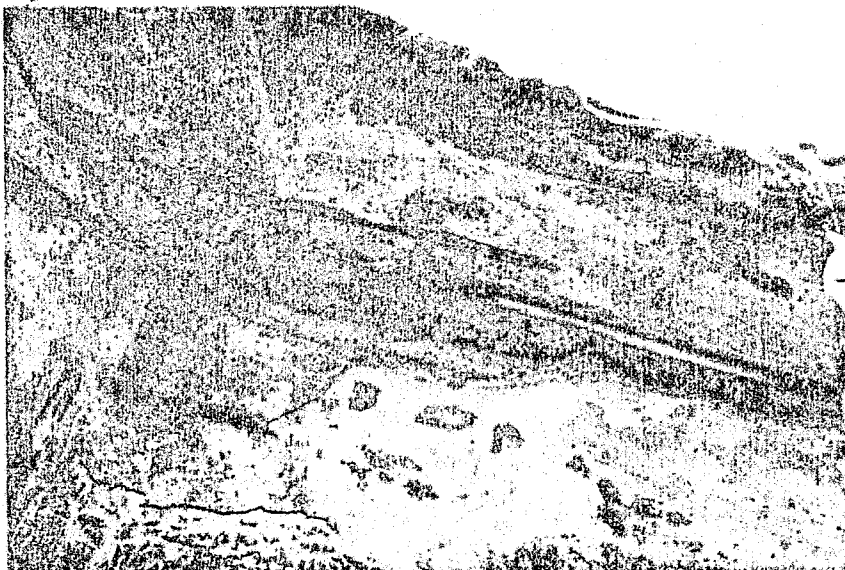
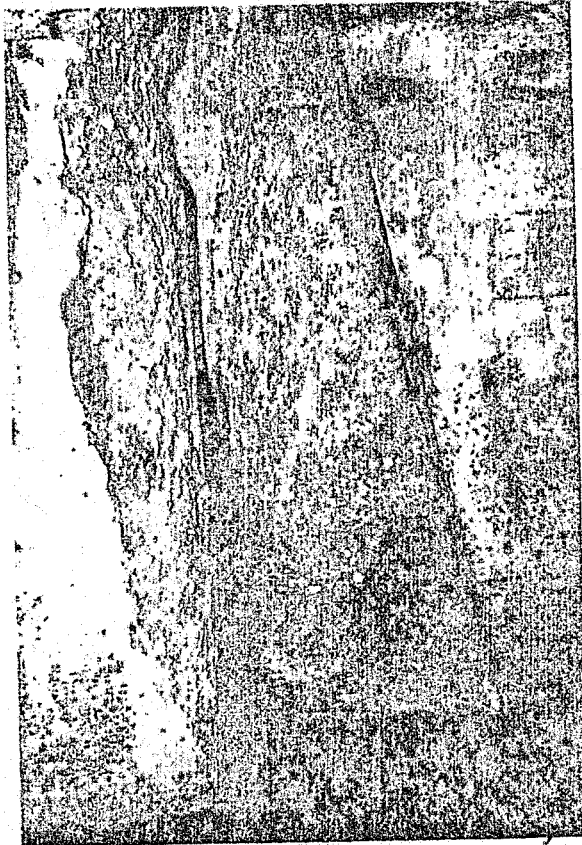
PHOTO 30 - BAY 12/4

Bay 12/4 is heavily deteriorated, exposing both vertical

legs of the dam support angles and 30 percent of the horizontal legs. Also, two (2) dam support anchor bolts are completely exposed, along with several deck rebars.
