CHAPTER 94 MUNICIPAL WASTELOAD MANAGEMENT ANNUAL REPORT

For Calendar Year: 2018

GENERAL INFORMATION			
Permittee Name:	Radnor Township	Permit No.:	PA
Mailing Address:	301 Iven Avenue	Effective Date:	
City, State, Zip:	Wayne, PA 19087	Expiration Date:	
Contact Person:	Steve Norcini	Renewal Due Date:	
Title:	Township Engineer	Municipality:	Radnor Township
Phone:	610-688-5600	County:	Delaware
Email:	snorcini@radnor.org	Consultant Name:	Gannett Fleming, Inc.

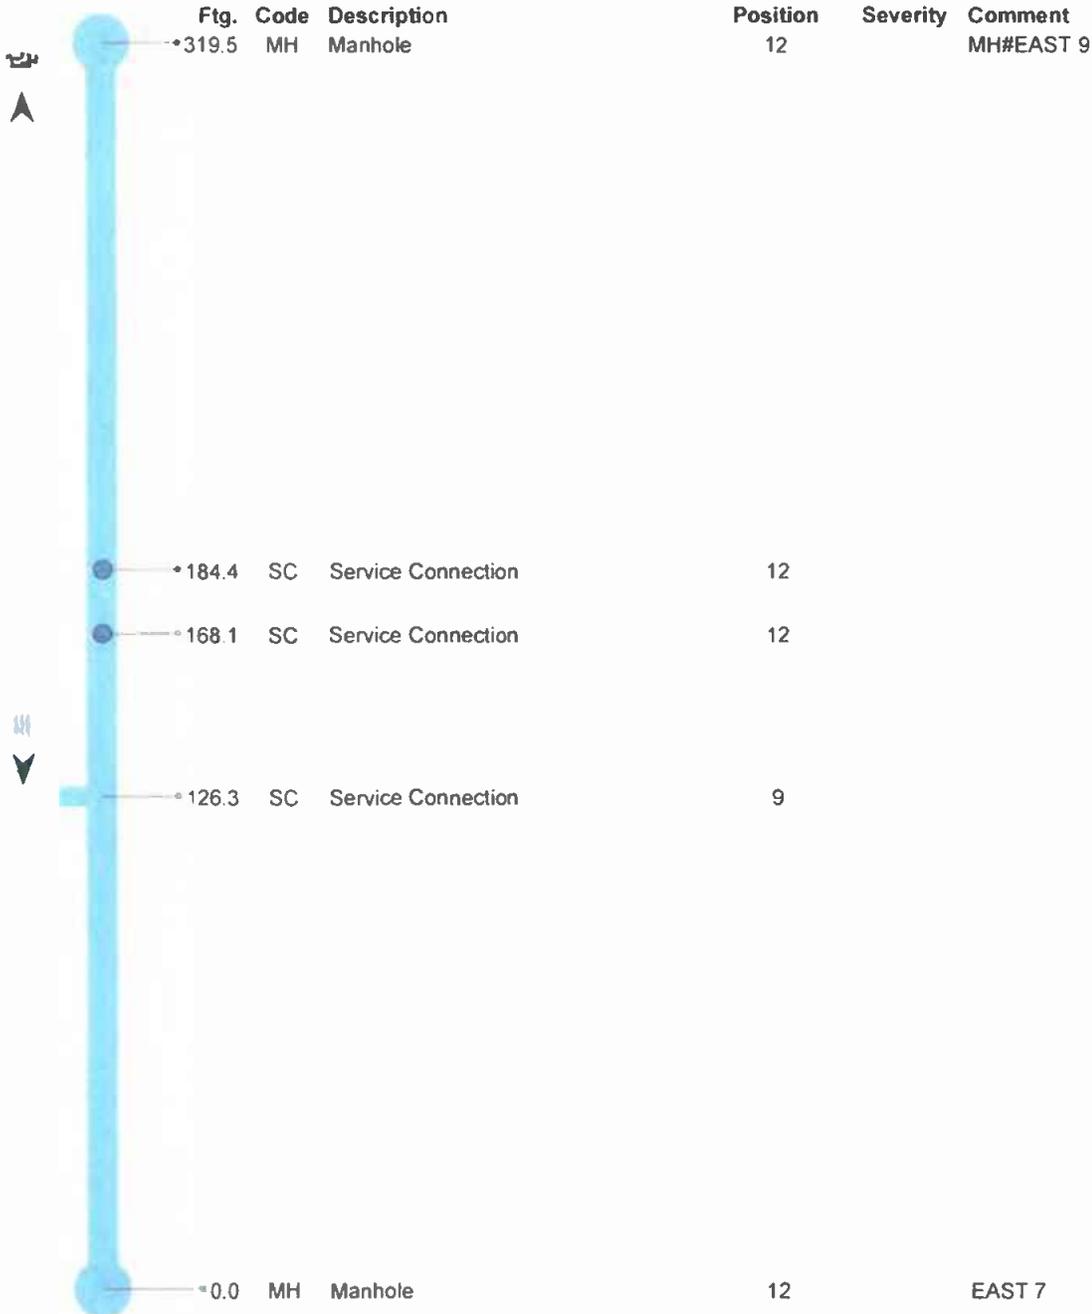
Owner TREDYFFRIN TWP.	Customer TREDYFFRIN TWP.	Upstream MH EAST 9	Downstream MH EAST 7	Date 01-Oct-2018
Surveyor PATRICK	Street CHESTER RD.		City	Weather Dry
Size 8	Material Transite Pipe	Sewer Use Sanitary	Purpose Routine Assessment	Length
Comments SEWER MAIN IN GOOD CONDITION			Pre-Cleaning No Pre-Cleaning	TV Length 319.5

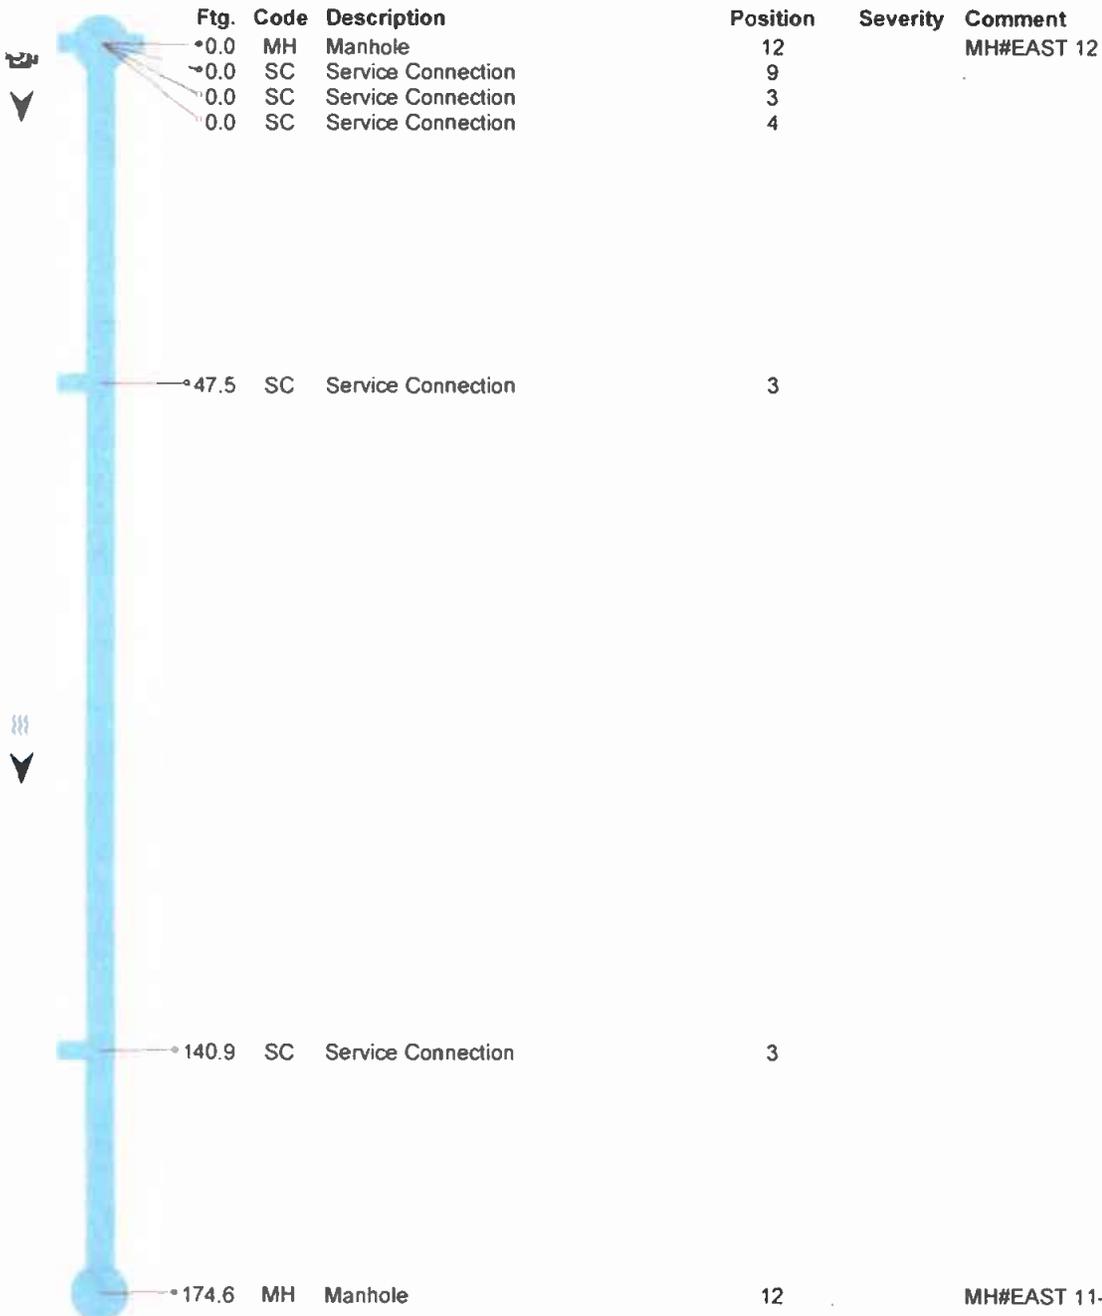
Owner TREDYFFRIN TWP.	Customer TREDYFFRIN TWP.	Upstream MH EAST 12	Downstream MH EAST 11-1	Date 01-Oct-2018
Surveyor PATRICK	Street DORSET RD.		City	Weather Dry
Size 8	Material Transite Pipe	Sewer Use Sanitary	Purpose Routine Assessment	Length
Comments SEWER MAIN IN GOOD CONDITION			Pre-Cleaning No Pre-Cleaning	TV Length 174.6

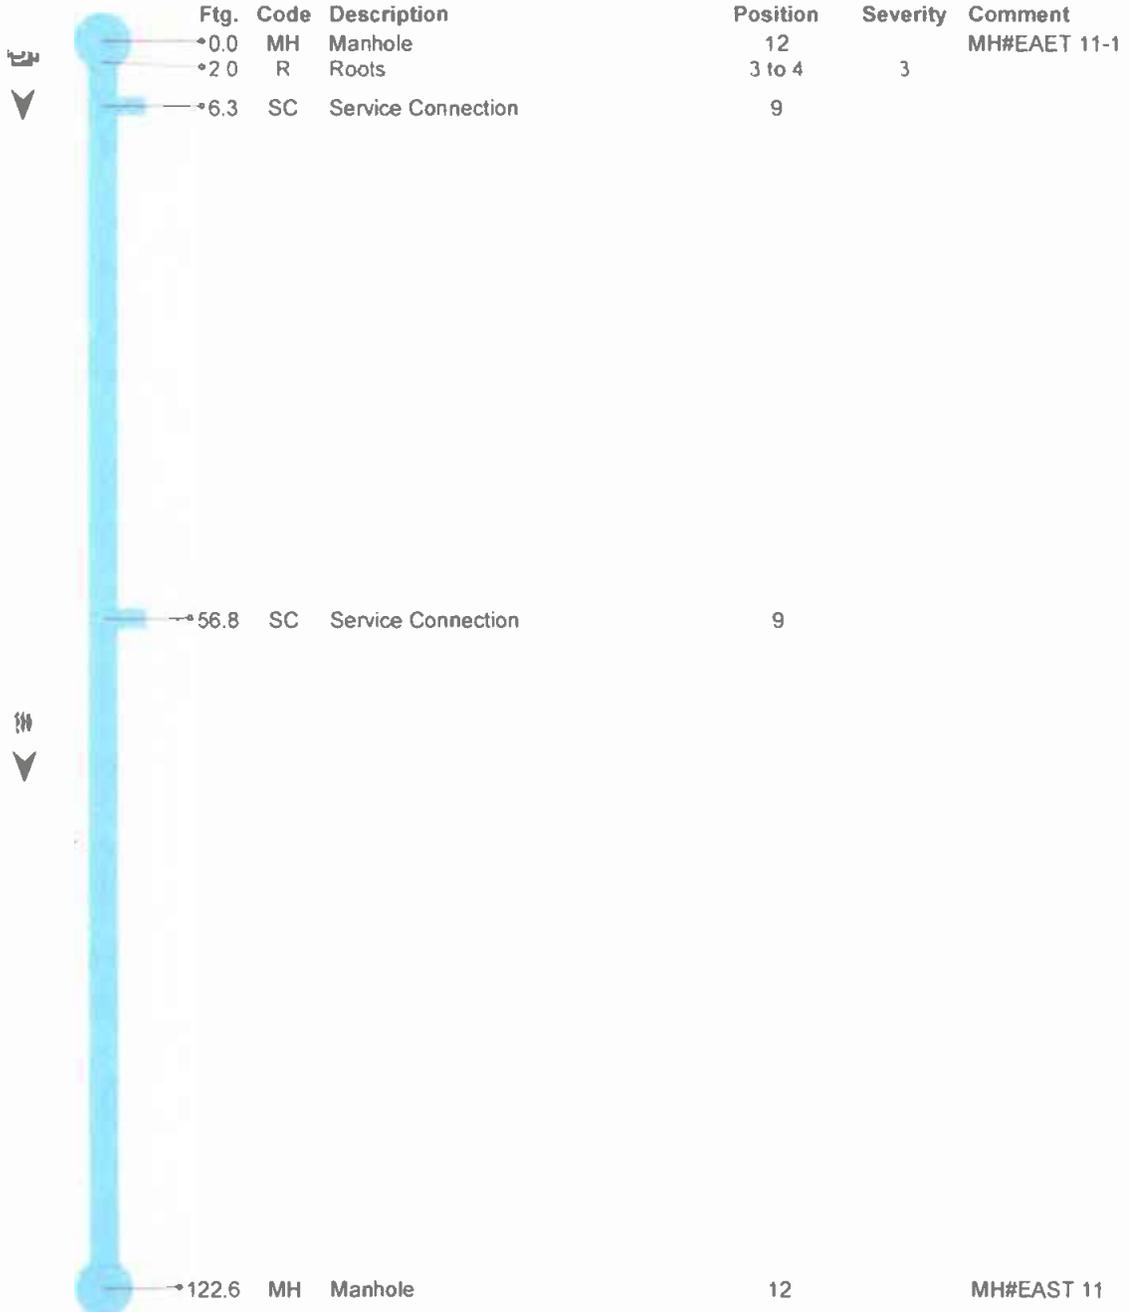
Owner TREDYFFRIN TWP.	Customer TREDYFFRIN TWP.	Upstream MH EAST 11-1	Downstream MH EAST 11	Date 01-Oct-2018
Surveyor PATRICK	Street DORSET RD.		City	Weather Dry
Size 8	Material Transite Pipe	Sewer Use Sanitary	Purpose Routine Assessment	Length
Comments RAZOROOTER:MINOR ROOTS IN MAIN			Pre-Cleaning No Pre-Cleaning	TV Length 122.6

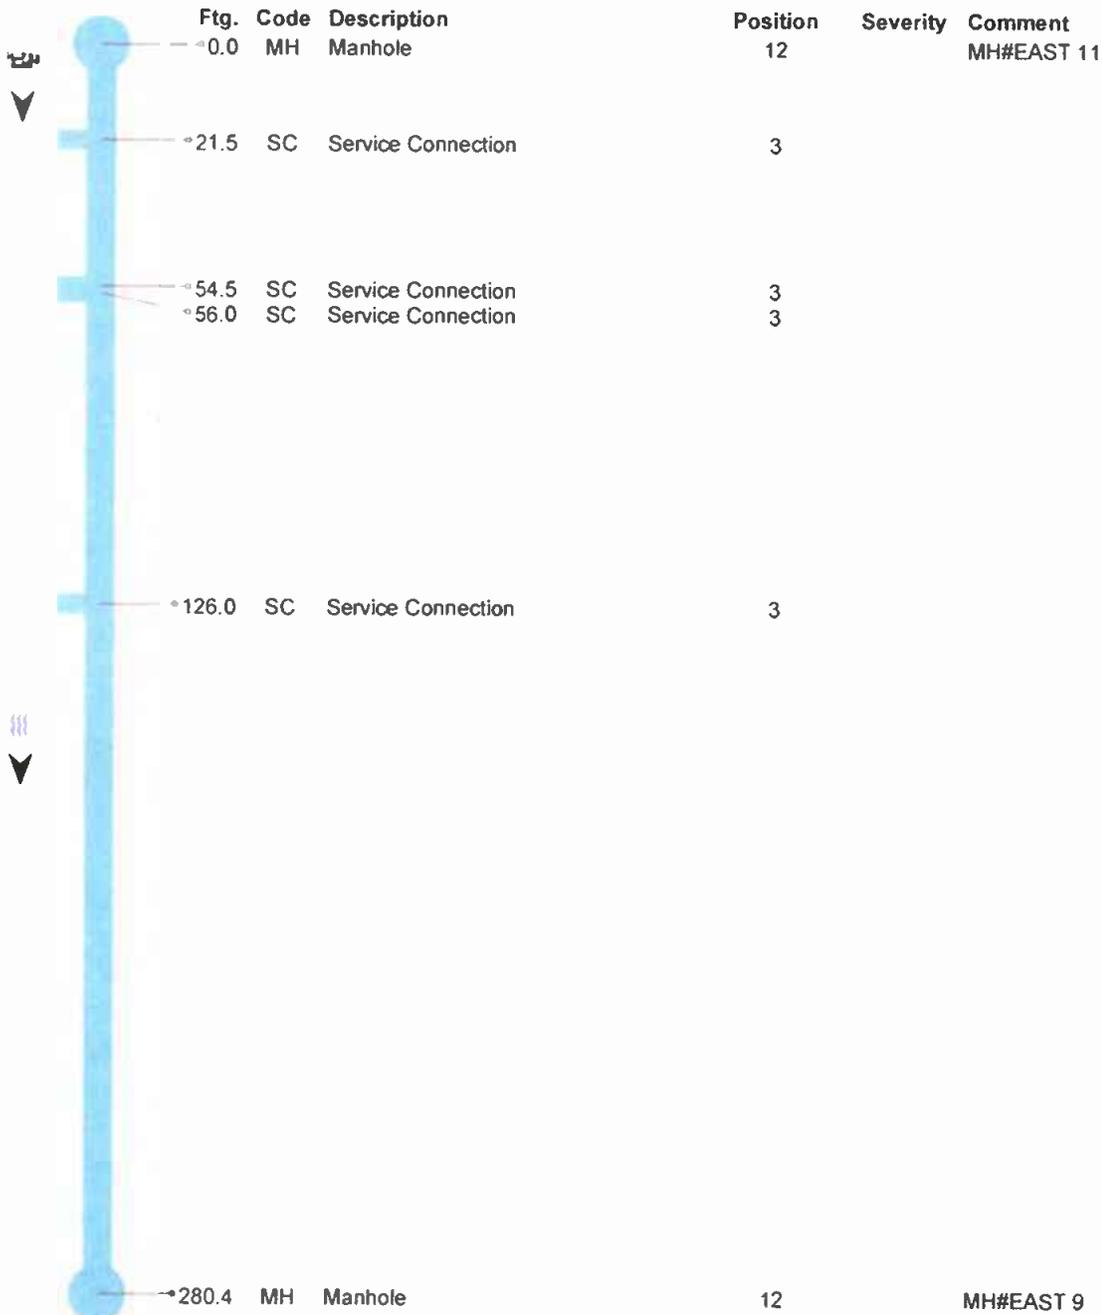
Owner TREDYFFRIN TWP.	Customer TREDYFFRIN TWP.	Upstream MH EAST 11	Downstream MH EAST 9	Date 01-Oct-2018
Surveyor PATRICK	Street DORSET RD.		City	Weather Dry
Size 8	Material Transite Pipe	Sewer Use Sanitary	Purpose Routine Assessment	Length
Comments SEWER MAIN IN GOOD CONDITION			Pre-Cleaning No Pre-Cleaning	TV Length 280.4

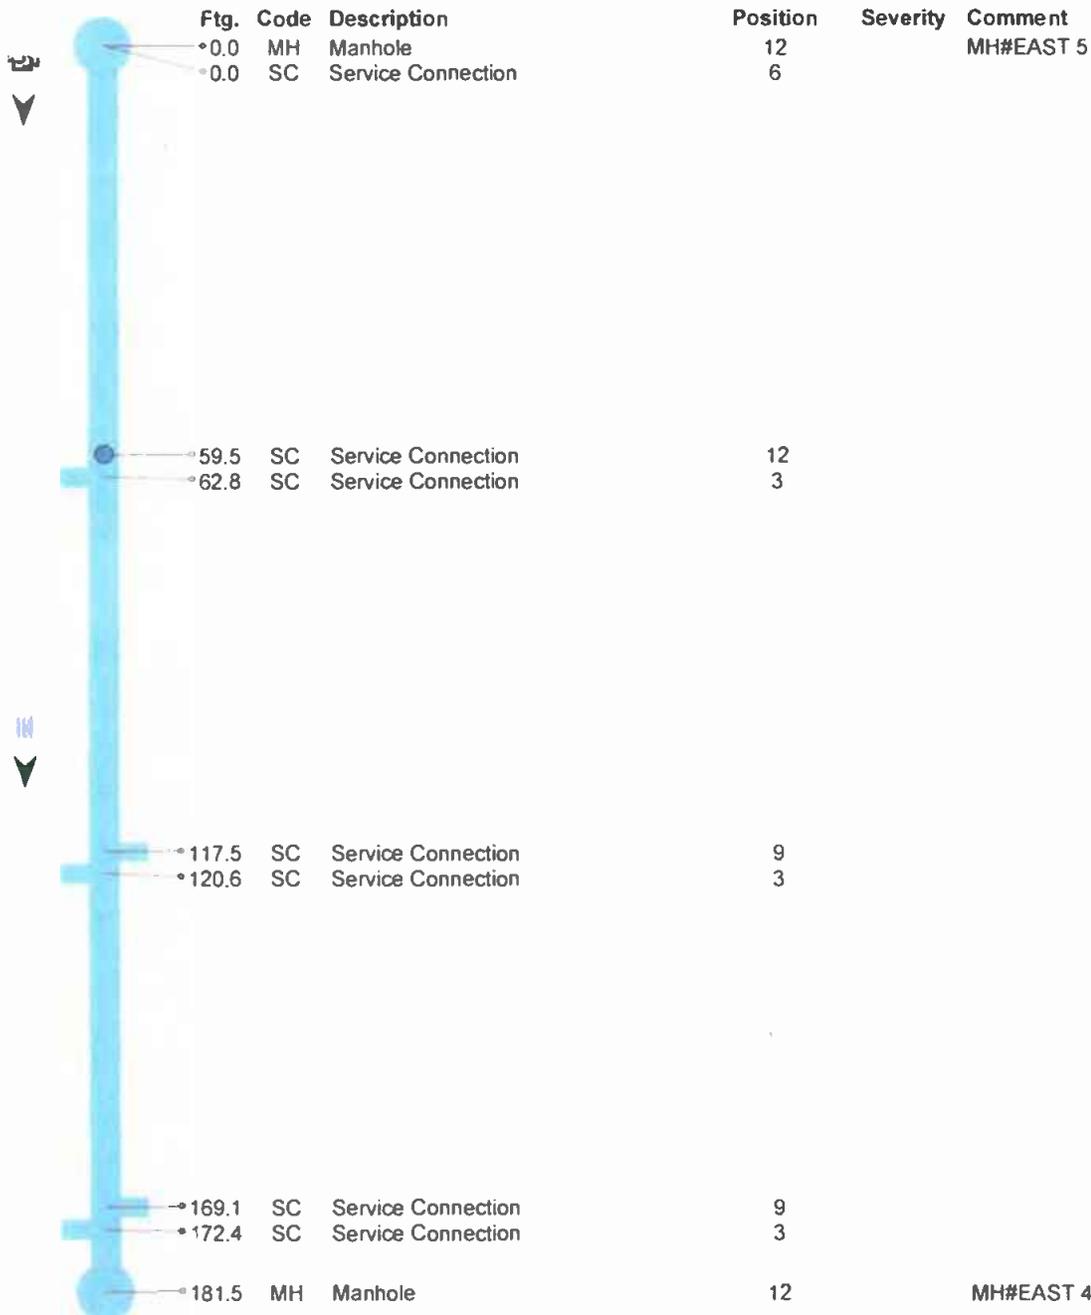
Owner TREDYFFRIN TWP.	Customer TREDYFFRIN TWP.	Upstream MH EAST 5	Downstream MH EAST 4	Date 01-Oct-2018
Surveyor PATRICK	Street BELL VISTA RD.		City	Weather Dry
Size 8	Material Transite Pipe	Sewer Use Sanitary	Purpose Routine Assessment	Length
Comments SEWER MAIN IN GOOD CONDITION			Pre-Cleaning No Pre-Cleaning	TV Length 181.5

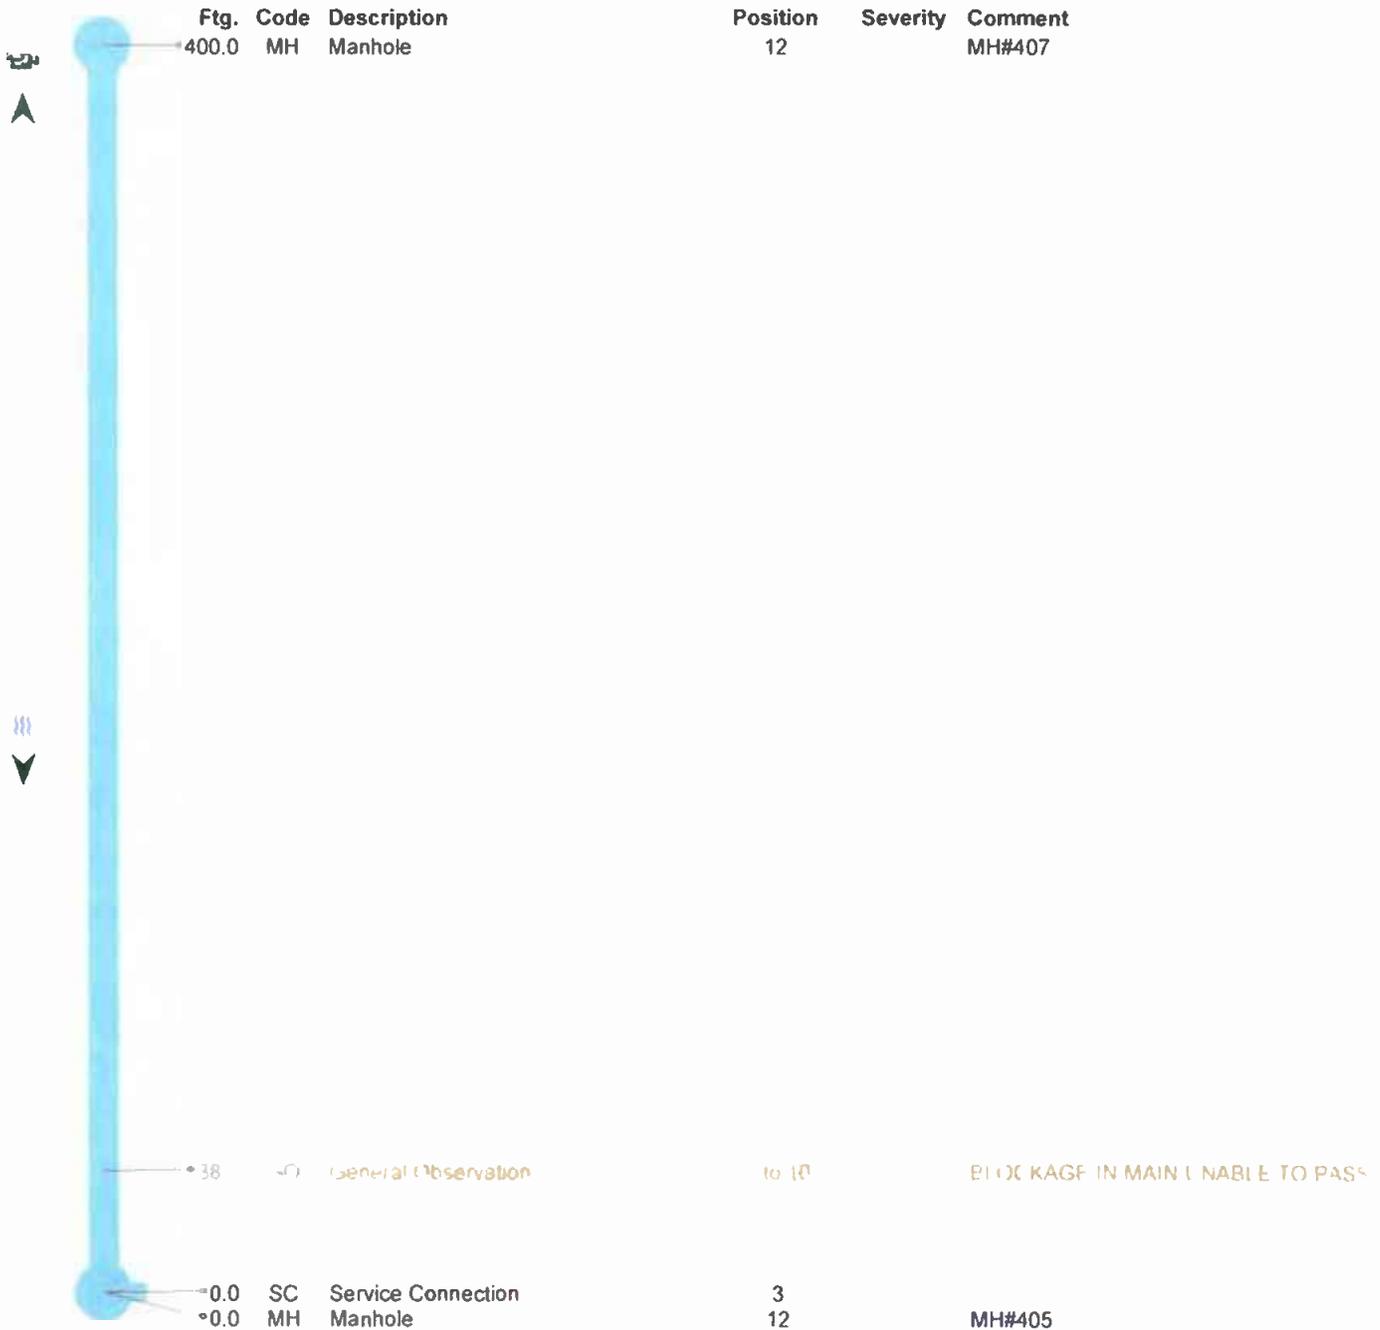
Owner TREDYFFRIN TWP.	Customer TREDYFFRIN TWP.	Upstream MH 407	Downstream MH 405	Date 02-Oct-2018
Surveyor PATRICK	Street RED FOX LA.		City	Weather Dry
Size 8	Material Transite Pipe	Sewer Use Sanitary	Purpose Routine Assessment	Length
Comments JET:BLOCKAGE IN MAIN			Pre-Cleaning No Pre-Cleaning	TV Length 400

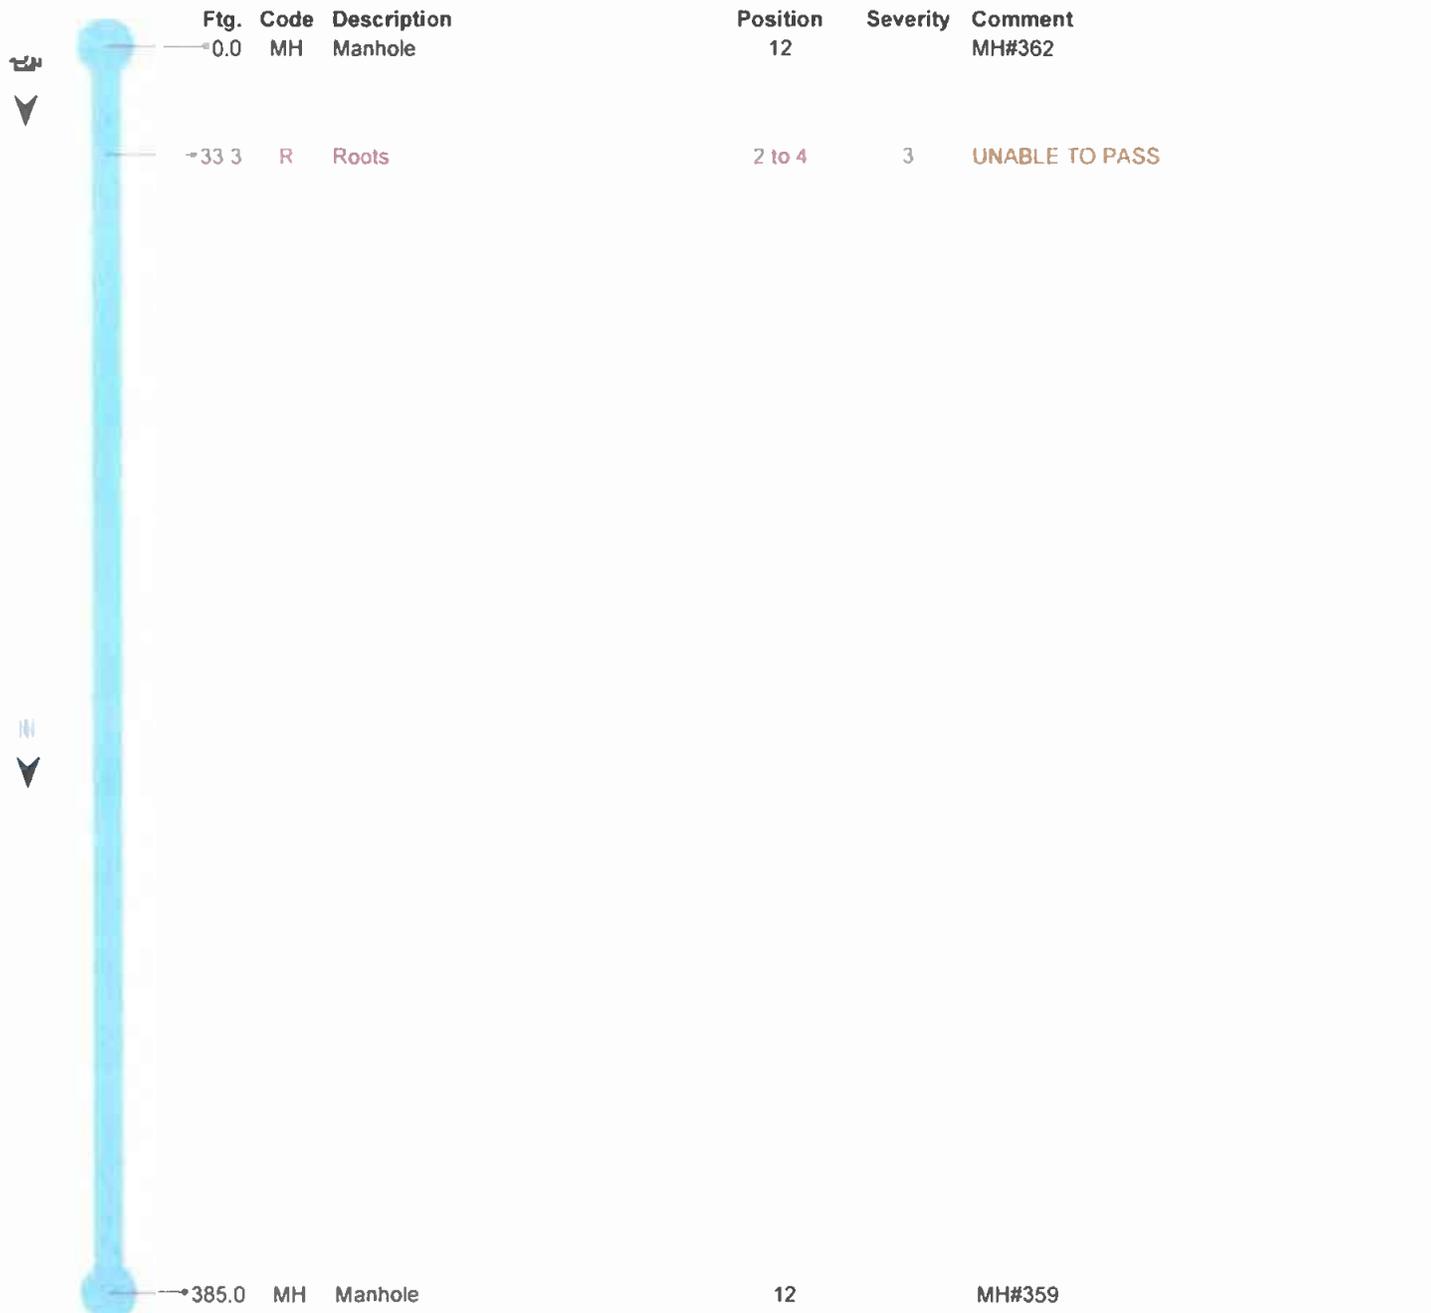
Owner TREDYFFRIN TWP.	Customer TREDYFFRIN TWP.	Upstream MH 362	Downstream MH 359	Date 03-Oct-2018
Surveyor PATRICK	Street ROBINWOOD RD.		City	Weather Dry
Size 8	Material Transite Pipe	Sewer Use Sanitary	Purpose Routine Assessment	Length
Comments RAZOROOTER:ROOTS IN MAIN			Pre-Cleaning No Pre-Cleaning	TV Length 385

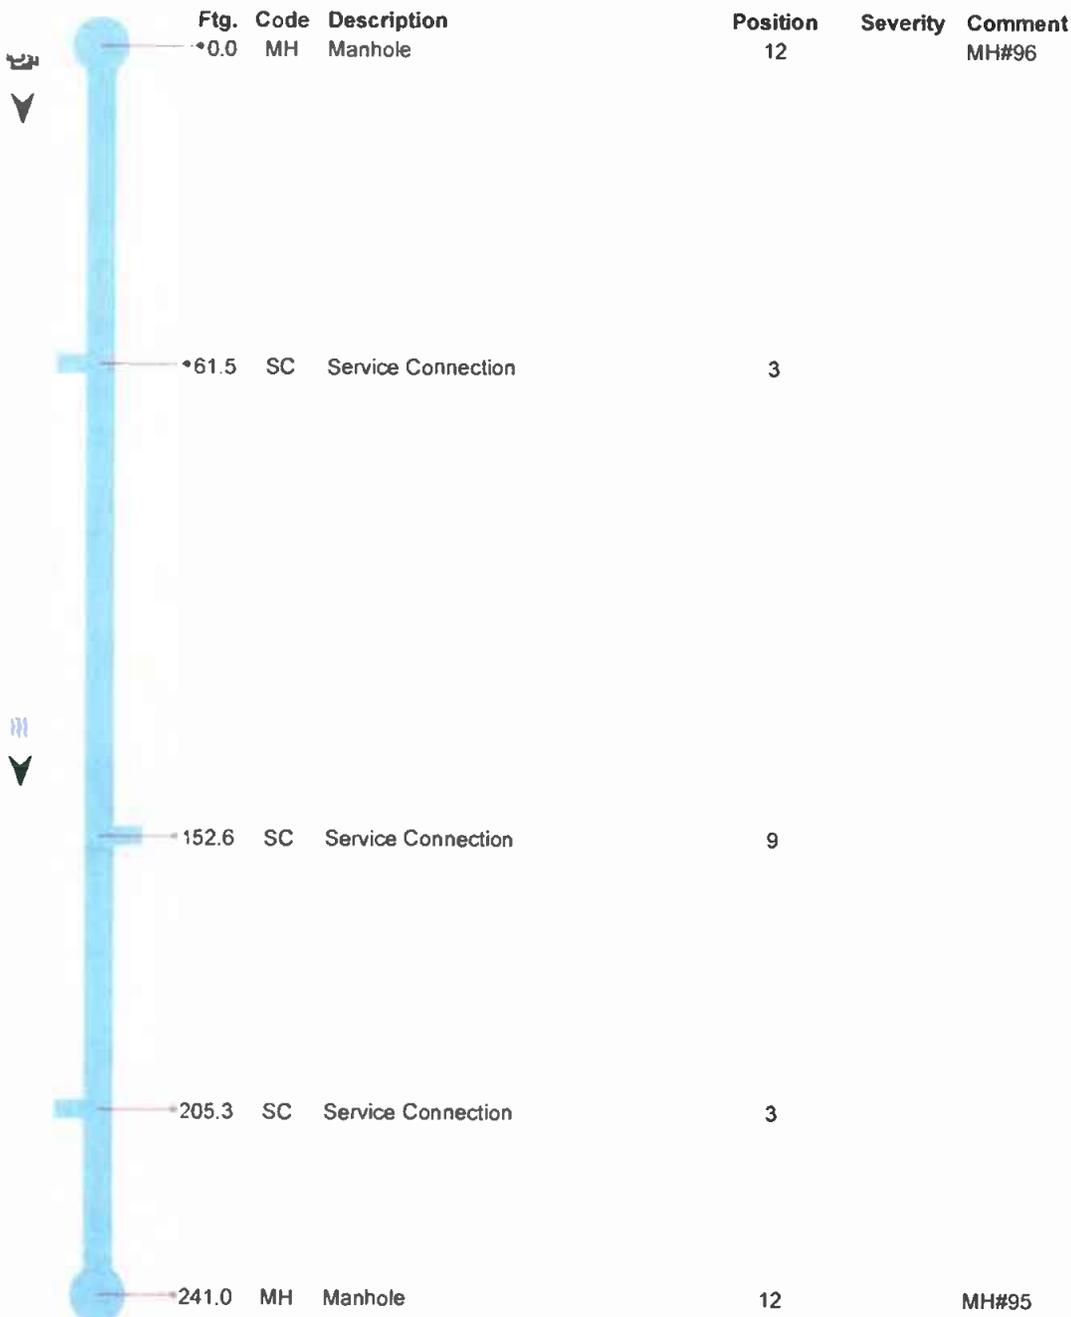
Owner TREDYFFRIN TWP.	Customer TREDYFFRIN TWP.	Upstream MH 96	Downstream MH 95	Date 03-Oct-2018
Surveyor PATRICK	Street STEEPELECHASE RD.		City	Weather Dry
Size 8	Material Transite Pipe	Sewer Use Sanitary	Purpose Routine Assessment	Length
Comments RAZOROOTER:MINOR ROOTS IN MAIN			Pre-Cleaning No Pre-Cleaning	TV Length 241

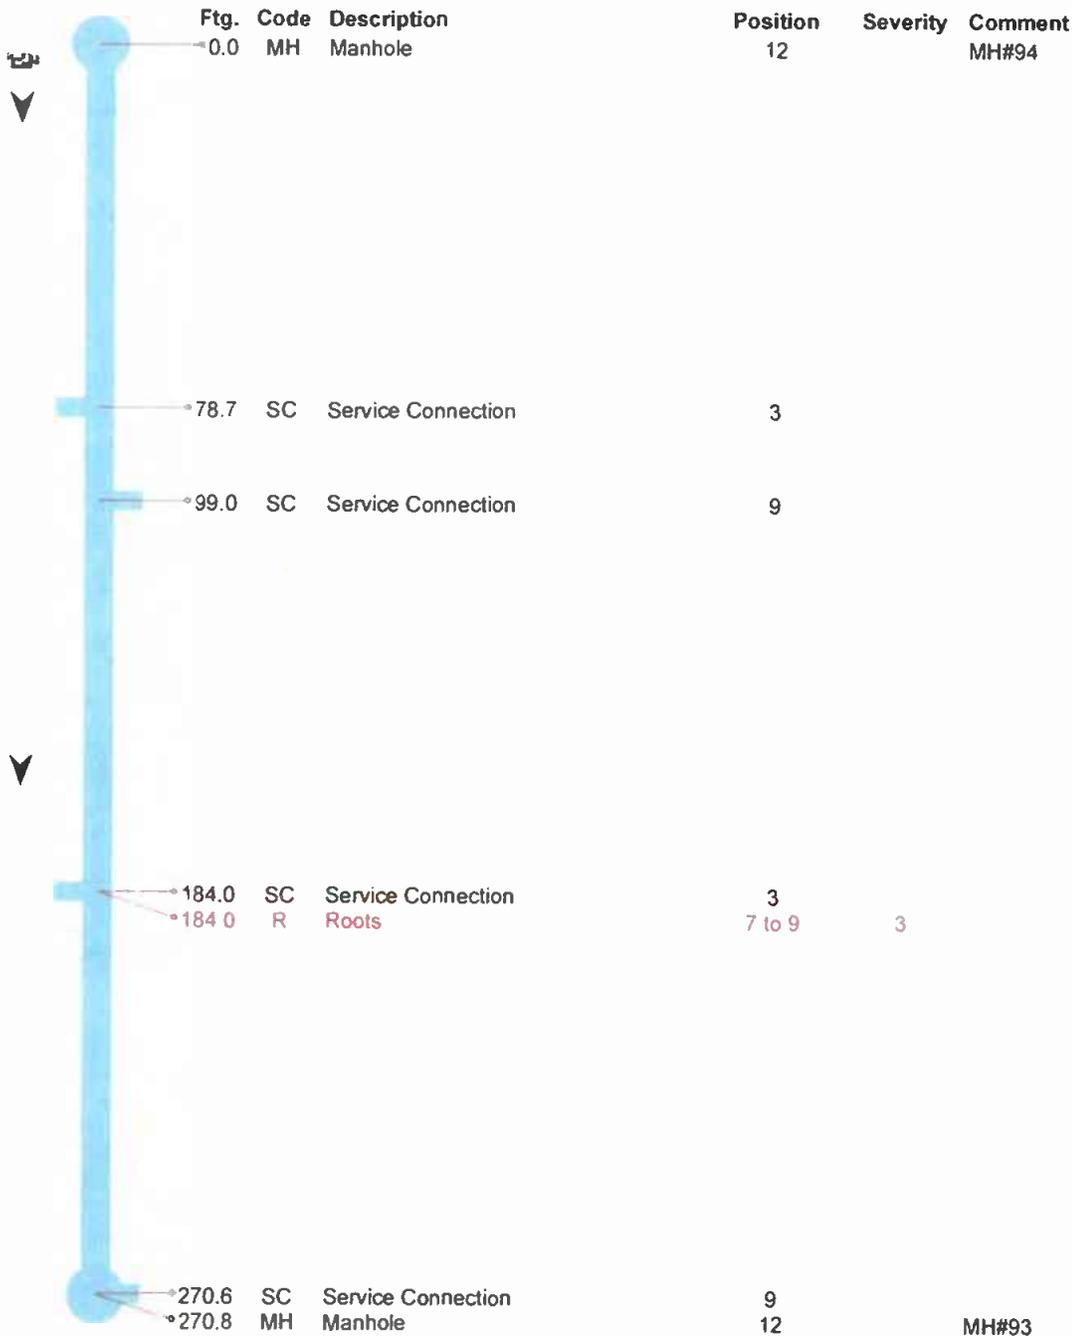
Owner TREDYFFRIN TWP.	Customer TREDYFFRIN TWP.	Upstream MH 94	Downstream MH 93	Date 03-Oct-2018
Surveyor PATRICK	Street HUNTERS LA.		City	Weather Dry
Size 8	Material Transite Pipe	Sewer Use Sanitary	Purpose Routine Assessment	Length
Comments REHAB:TOP WORK, RAZOROOTER:ROOTS IN MAIN			Pre-Cleaning No Pre-Cleaning	TV Length 270.8

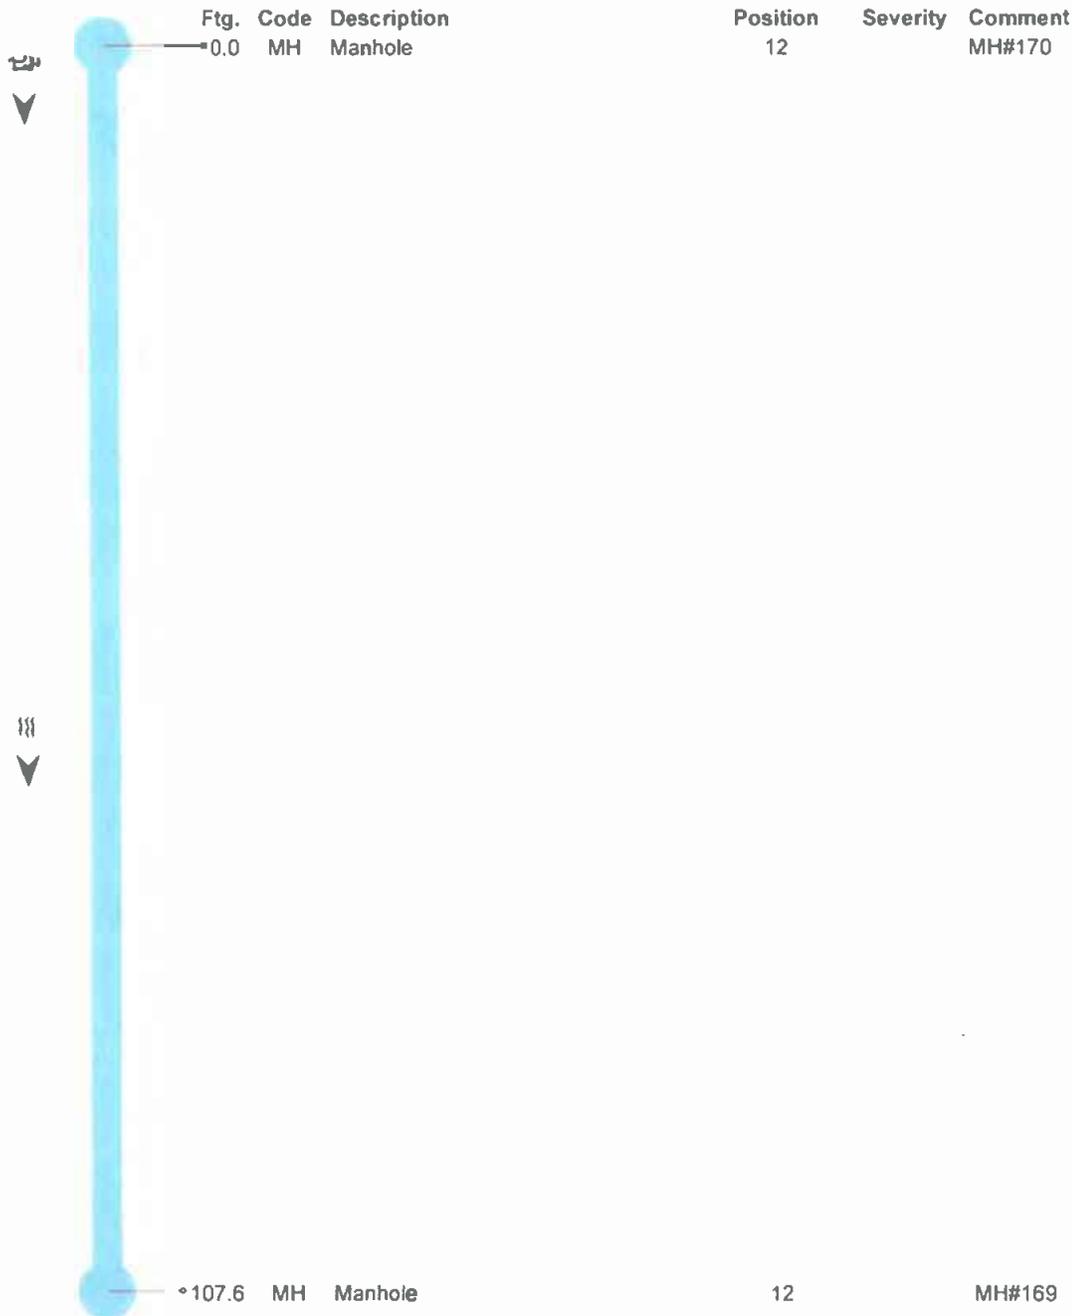
Owner TREDYFFRIN TWP.	Customer TREDYFFRIN TWP.	Upstream MH 170	Downstream MH 169	Date 04-Oct-2018
Surveyor PATRICK	Street HOMESTEAD RD.		City	Weather Dry
Size 8	Material Transite Pipe	Sewer Use Sanitary	Purpose Routine Assessment	Length
Comments REHAB:TOP WORK			Pre-Cleaning No Pre-Cleaning	TV Length 107.6

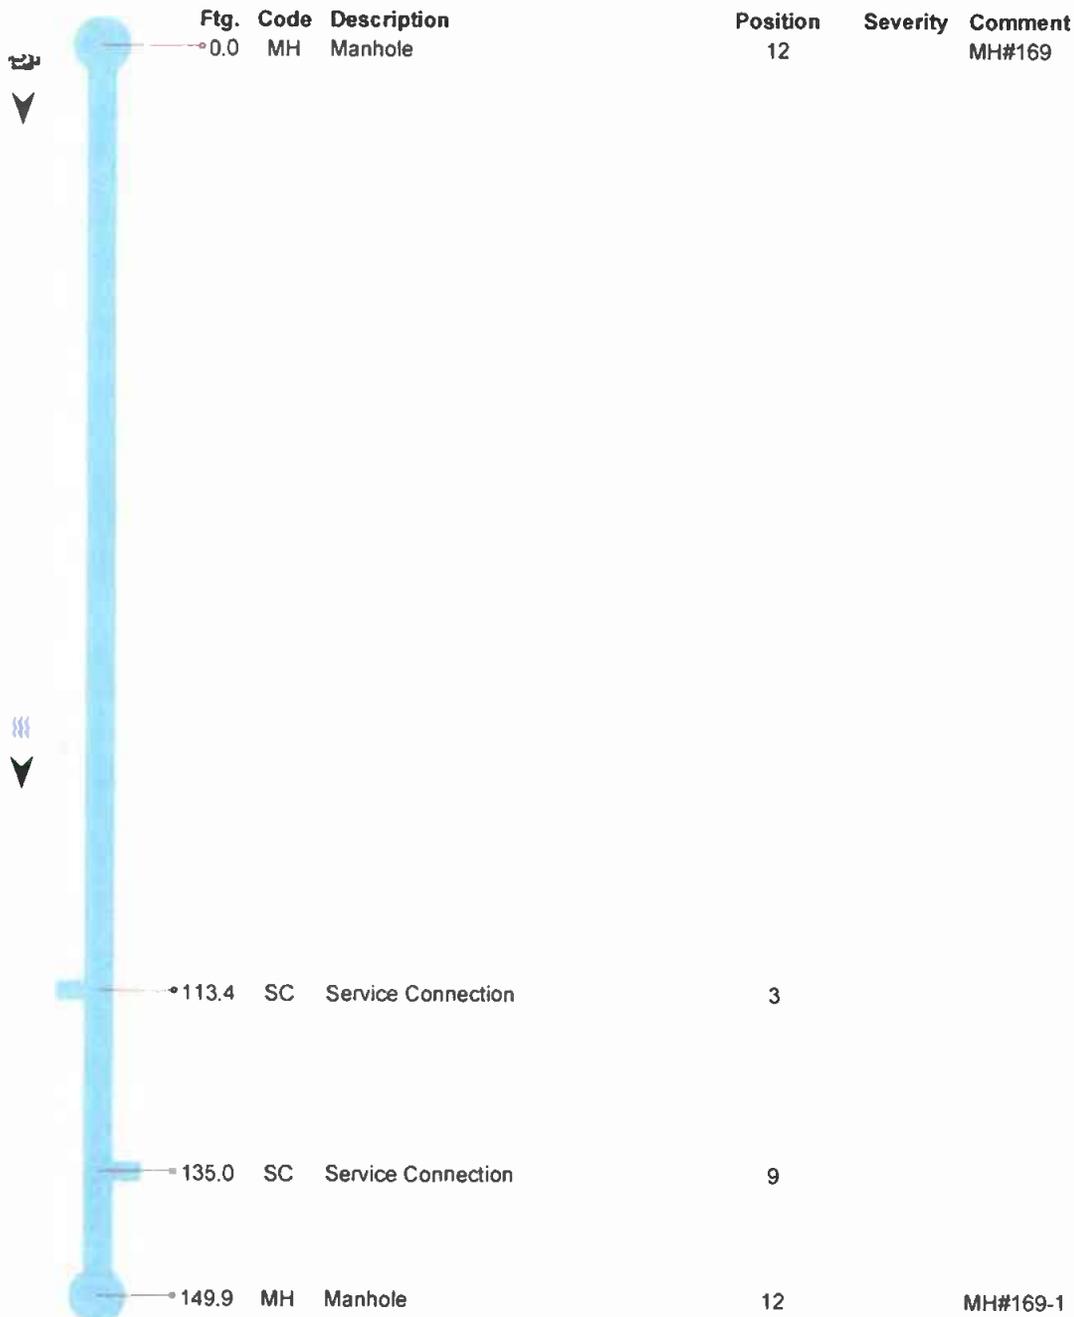
Owner TREDYFFRIN TWP.	Customer TREDYFFRIN TWP.	Upstream MH 169	Downstream MH 169-1	Date 04-Oct-2018
Surveyor PATRICK	Street HOMESTEAD RD.		City	Weather Dry
Size 8	Material Transite Pipe	Sewer Use Sanitary	Purpose Routine Assessment	Length
Comments REHAB:TOP WORK			Pre-Cleaning No Pre-Cleaning	TV Length 149.9

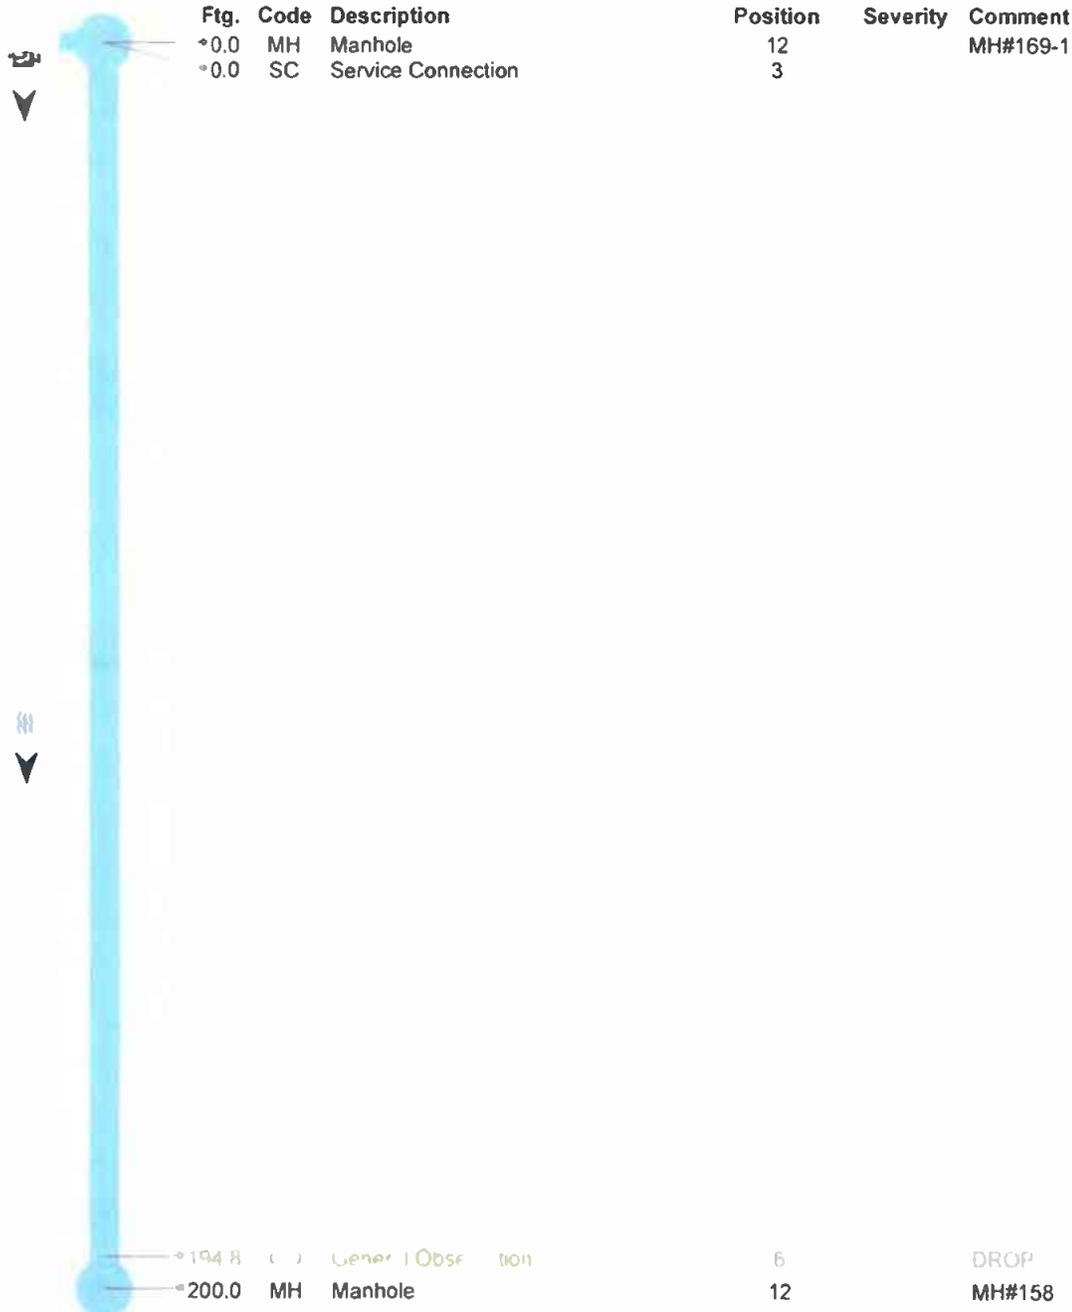
Owner TREDYFFRIN TWP.	Customer TREDYFFRIN TWP.	Upstream MH 169-1	Downstream MH 158	Date 04-Oct-2018
Surveyor PATRICK	Street HOMESTEAD RD.		City	Weather Dry
Size 8	Material Transite Pipe	Sewer Use Sanitary	Purpose Routine Assessment	Length
Comments REHAB: TOP WORK			Pre-Cleaning No Pre-Cleaning	TV Length 200

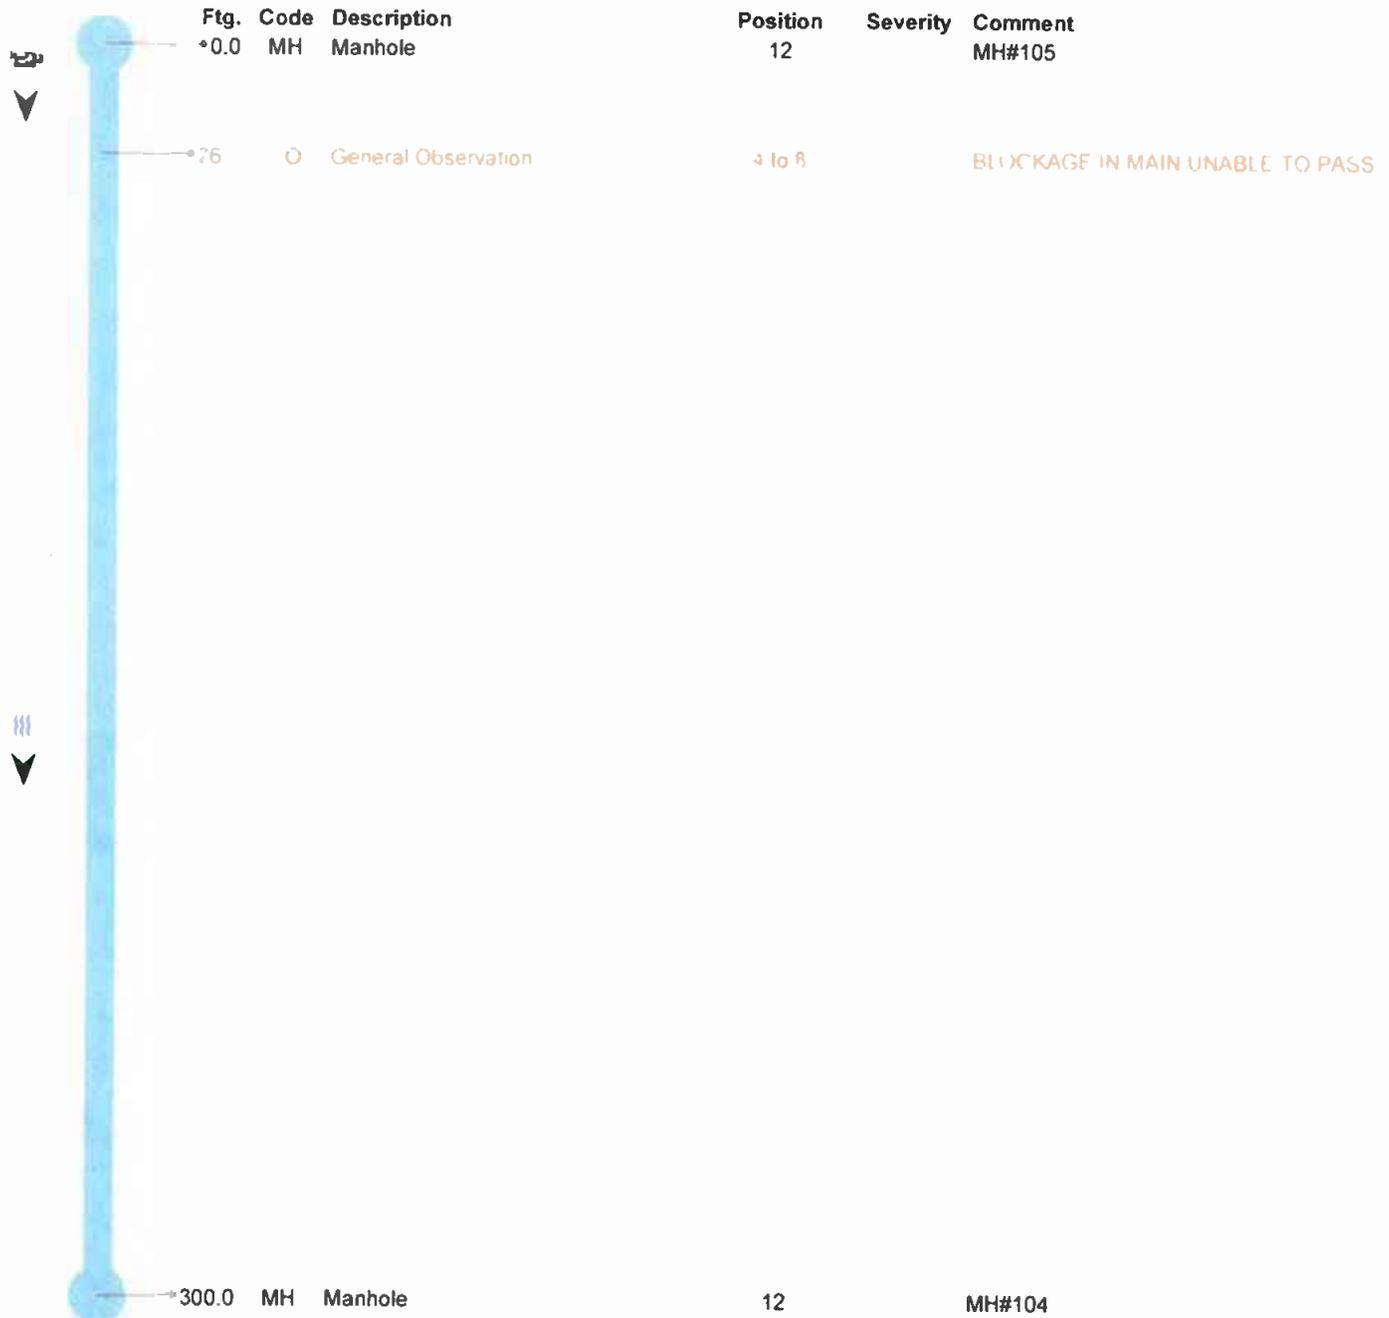
Owner TREDYFFRIN TWP.	Customer TREDYFFRIN TWP.	Upstream MH 105	Downstream MH 104	Date 05-Oct-2018
Surveyor PATRICK	Street STEEPLCHASE RD.		City	Weather Dry
Size 8	Material Transite Pipe	Sewer Use Sanitary	Purpose Routine Assessment	Length
Comments JET:BLOCKAGE IN MAIN			Pre-Cleaning No Pre-Cleaning	TV Length 300

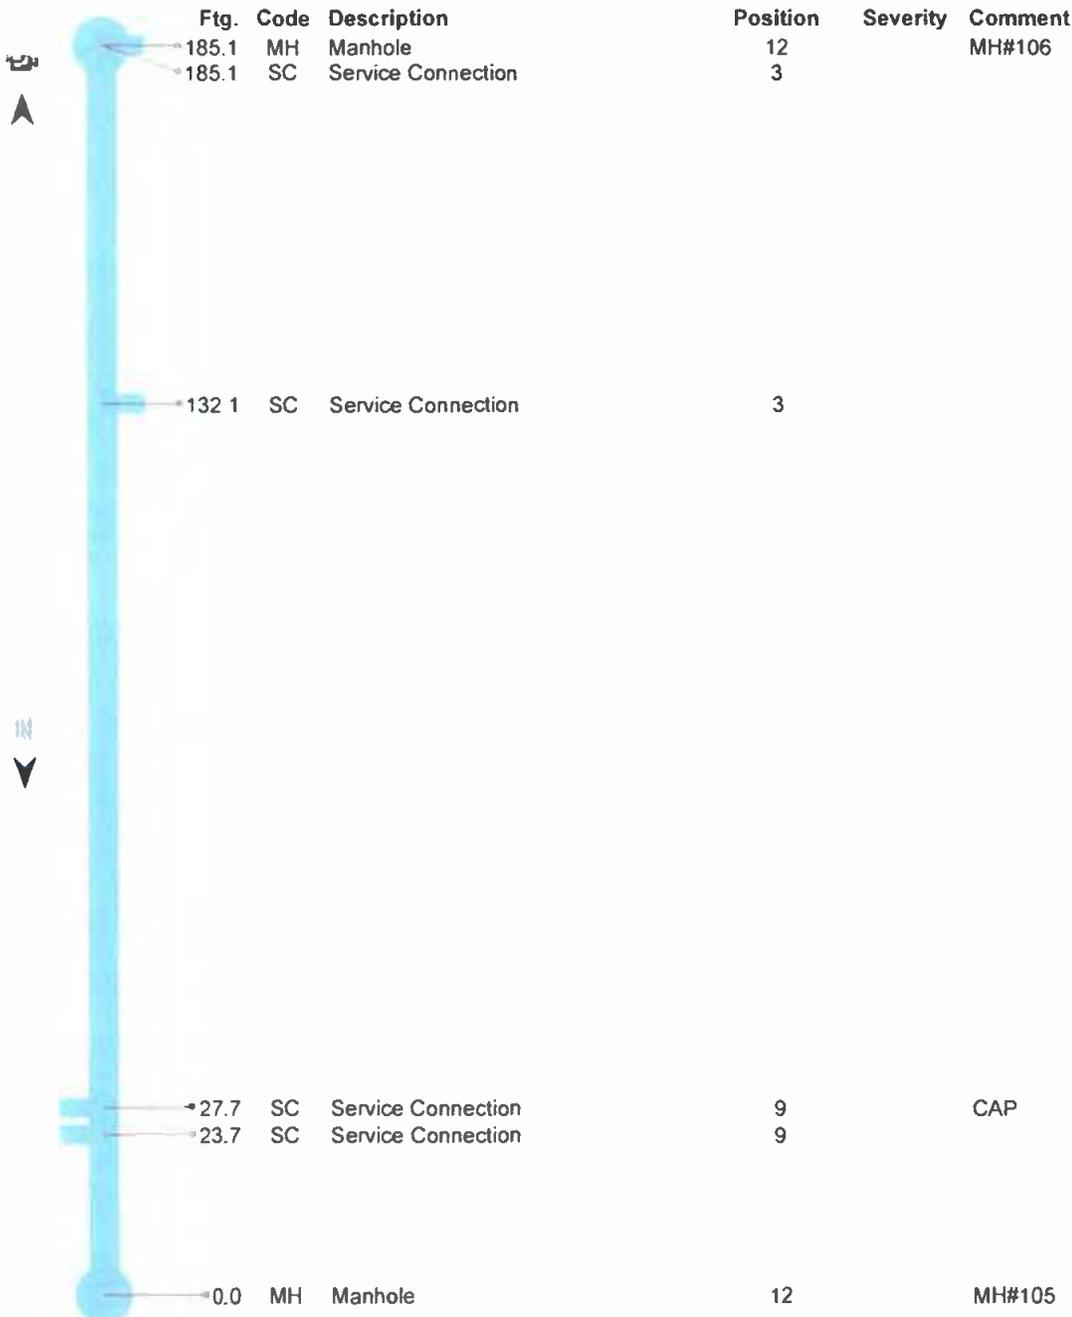
Owner TREDYFFRIN TWP.	Customer TREDYFFRIN TWP.	Upstream MH 106	Downstream MH 105	Date 05-Oct-2018
Surveyor PATRICK	Street STEEPLECHASE RD.		City	Weather Dry
Size 8	Material Transite Pipe	Sewer Use Sanitary	Purpose Routine Assessment	Length
Comments RAZOROOTER:ROOTS IN MAIN			Pre-Cleaning No Pre-Cleaning	TV Length 185.1
