CHAPTER 94 MUNICIPAL WASTELOAD MANAGEMENT ANNUAL REPORT

For Calendar Year: 2018

GENERAL INFORMATION			
Permittee Name:	Radnor Township	Permit No.:	PA
Mailing Address:	301 Iven Avenue	Effective Date:	
City, State, Zip:	Wayne, PA 19087	Expiration Date:	
Contact Person:	Steve Norcini	Renewal Due Date:	
Title:	Township Engineer	Municipality:	Radnor Township
Phone:	610-688-5600	County:	Delaware
Email:	snorcini@radnor.org	Consultant Name:	Gannett Fleming, Inc.

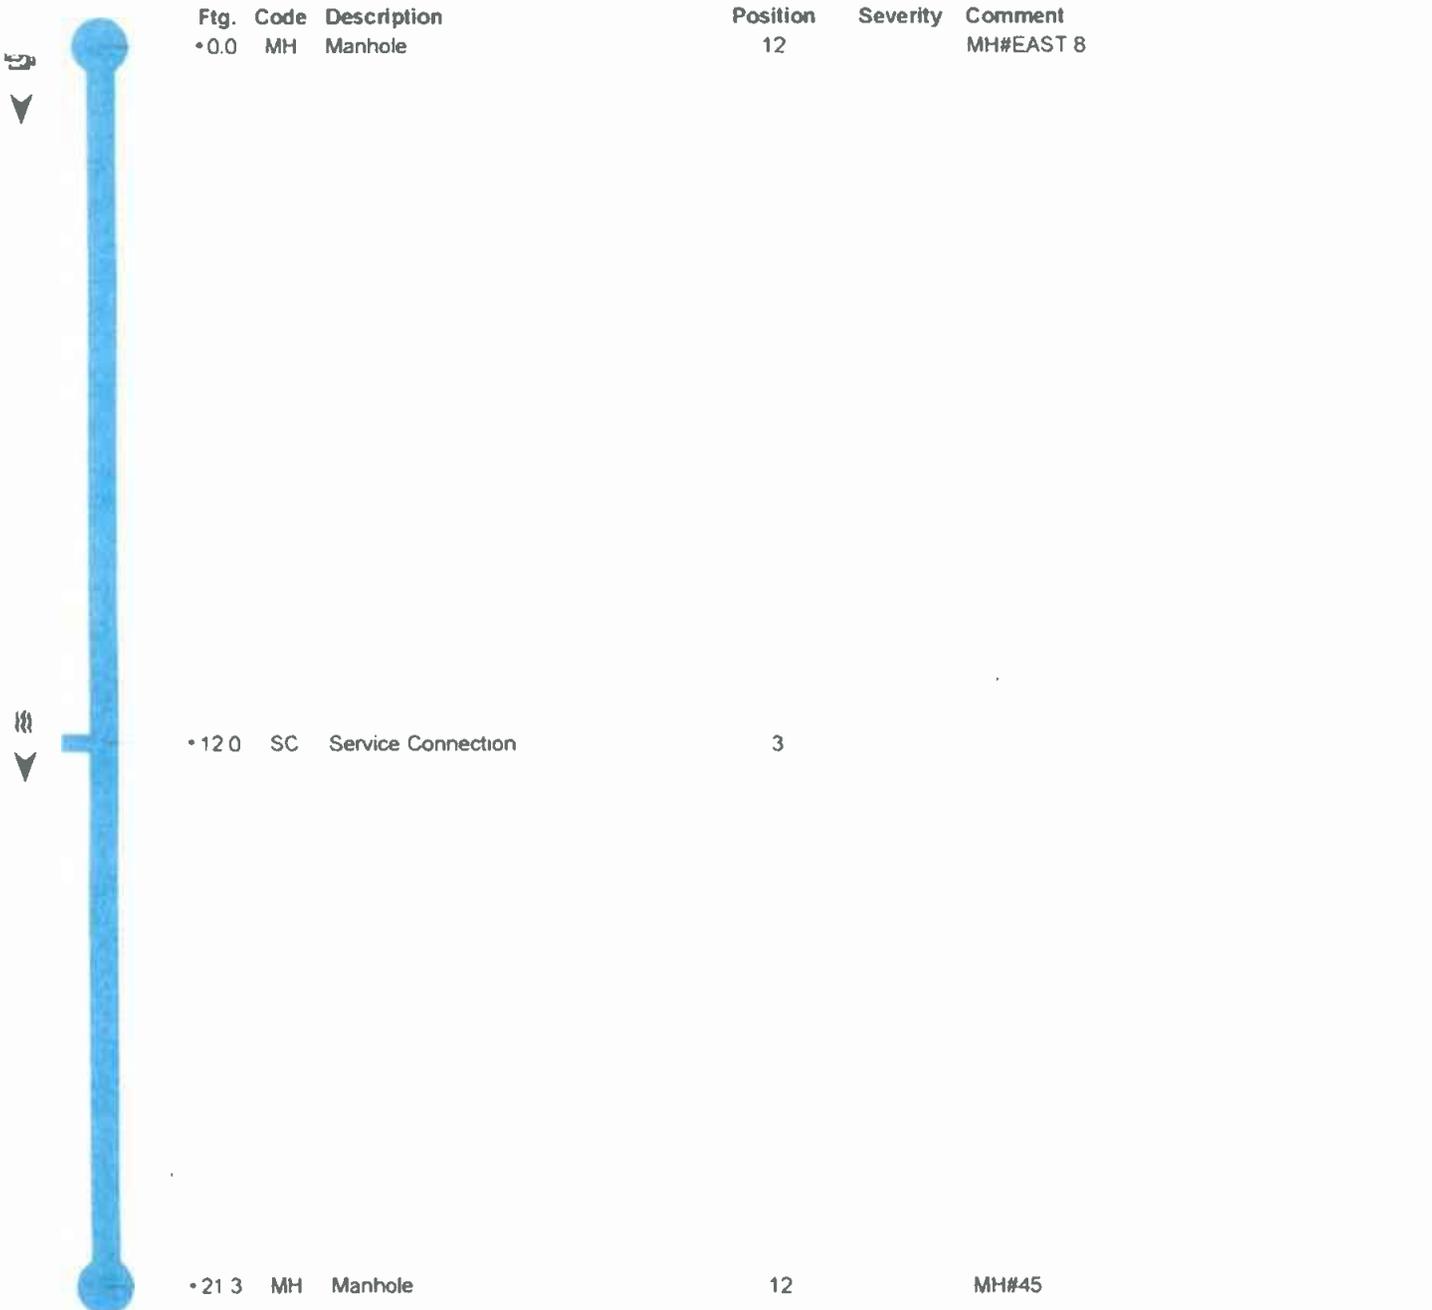
Owner TREDYFFRIN TWP.	Customer TREDYFFRIN TWP.	Upstream MH EAST 8	Downstream MH 45	Date 30-Mar-2018
Surveyor PATRICK	Street SOUTH VALLEY FORGE RD.	City	Weather Dry	
Size 8	Material Transite Pipe	Sewer Use Sanitary	Purpose Routine Assessment	Length
Comments JET MINOR DEBRIS IN MAIN			Pre-Cleaning No Pre-Cleaning	TV Length 21.3

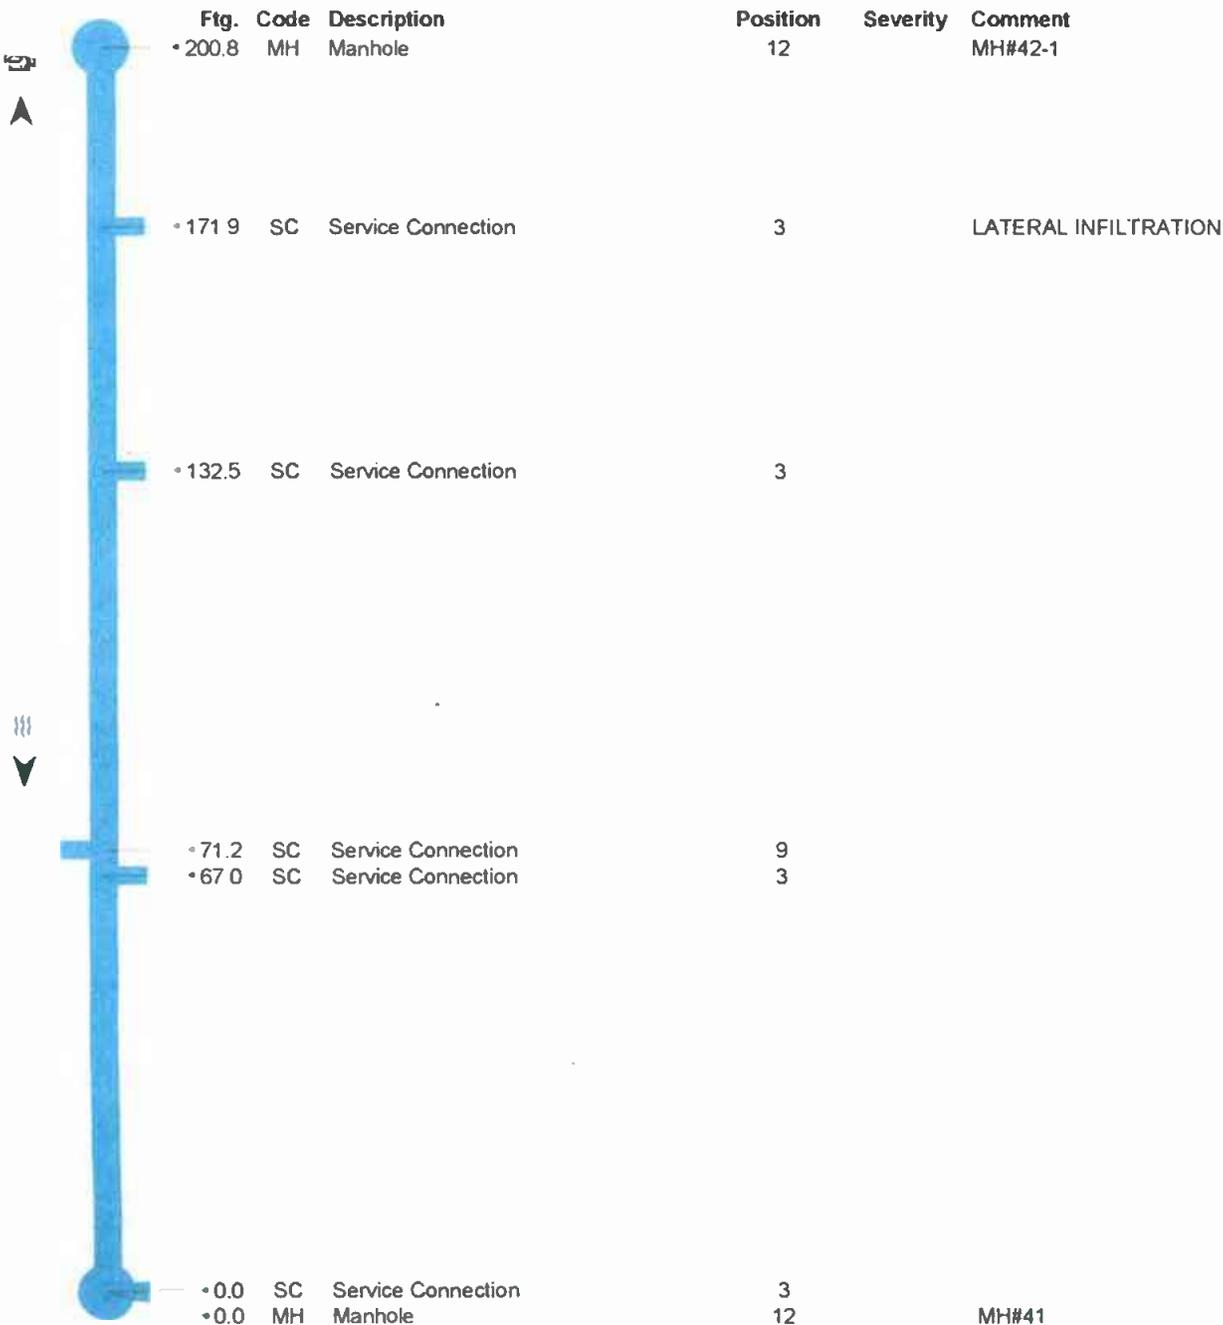
Owner TREDYFFRIN TWP.	Customer TREDYFFRIN TWP.	Upstream MH 42-1	Downstream MH 41	Date 29-Mar-2018
Surveyor PATRICK	Street POPLAR AVE.		City	Weather Dry
Size 8	Material Transite Pipe	Sewer Use Sanitary	Purpose Routine Assessment	Length
Comments HEAVY LATERAL INFILTRATION NEEDS WEIR READING			Pre-Cleaning No Pre-Cleaning	TV Length 200.8

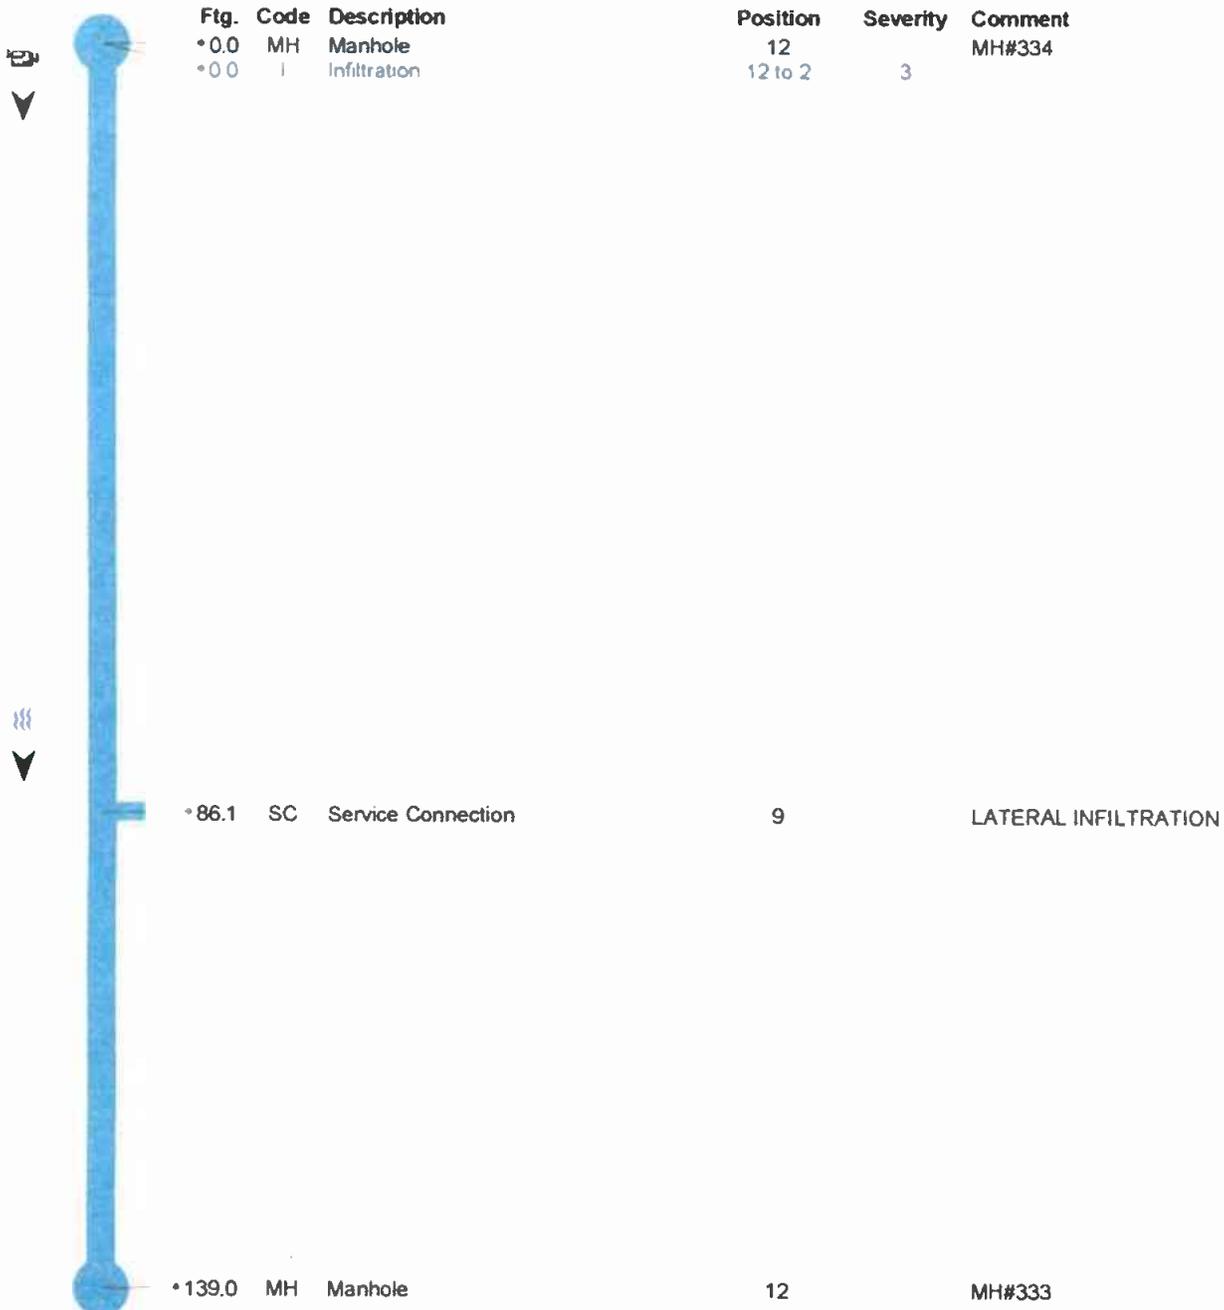
Comments REHAB:INFILTRATION IN MANHOLE, LATERAL INFILTRATION	Pre-Cleaning No Pre-Cleaning	TV Length 139
--	--	-------------------------

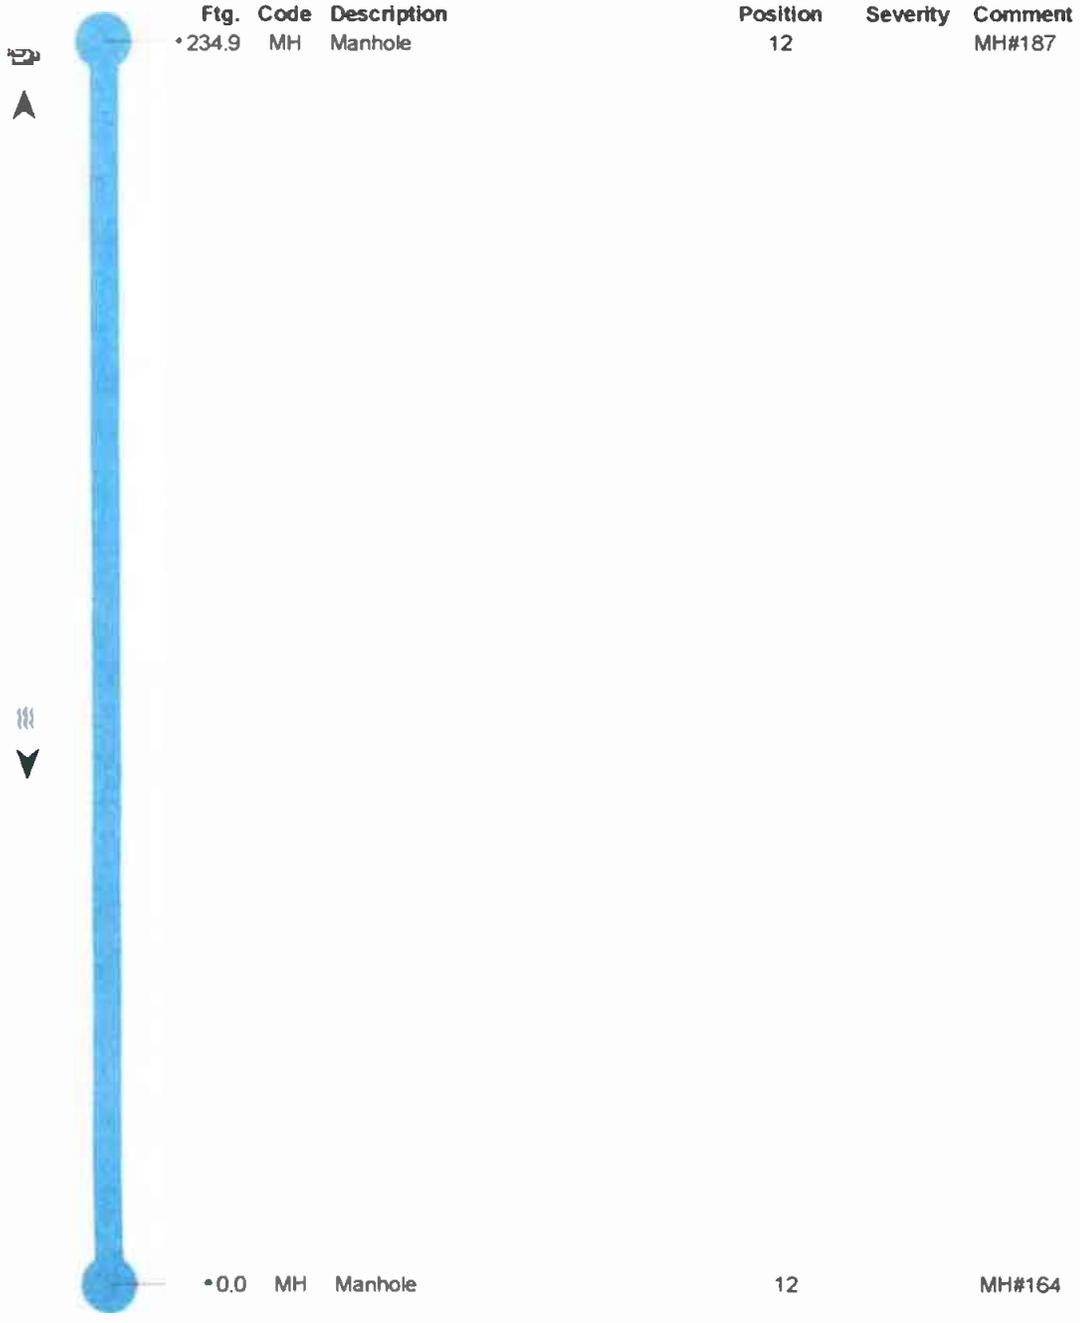
Owner TREDYFFRIN TWP.	Customer TREDYFFRIN TWP.	Upstream MH 187	Downstream MH 164	Date 26-Mar-2018
Surveyor PATRICK	Street WOODLAND RD.		City	Weather Dry
Size 8	Material Transite Pipe	Sewer Use Sanitary	Purpose Routine Assessment	Length
Comments RAZOROOTER:MINOR ROOTS IN MAIN			Pre-Cleaning No Pre-Cleaning	TV Length 234.9
