THE PENNSYLVANIA PUBLIC UTILITY COMMISSION

In re: C-80092154 Glenfield Borough vs. Consolidated Rail Corporation, Penn Central Transportation Company, Allegheny County and Pennsylvania Department of Transportation Alleging unsafe and hazardous conditions exist where the Glenfield viaduct crosses the tracks of Consolidated Rail Corporation, in the Borough of Glenfield, Allegheny County. Further Hearing.

TRANSCRIPT OF PROCEEDINGS

August 24, 1982

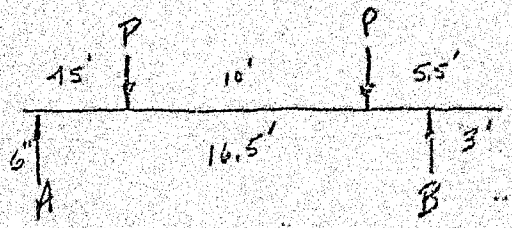
* LOADS POSITIONED FOR MAX ON GIRDER A (WEST) *

$\therefore A = 0.91P$ MAX. ←
