In Re: Application of Columbia Water Company Pursuant to Sections 1102 of the Public Utility Code For: Approval Of the Acquisition Of the Water System Of East Donegal Township Municipal Authority; Approval Of The Right For Columbia Water Company To Offer, Render Furnish And Supply Water Service To The Public In Portions Of East Donegal Township, Lancaster County; Registration Of A Securities Certificate; And all Other Approvals Or Certificates Appropriate, Customary Or Necessary Under The Public Utility Code To Carry Out The Transactions Described In The Application; Request For Certificates Of Filing For Contracts Between Columbia Water Company And East Donegal Township Municipal Authority, Pursuant To Section 507 Of The Public Utility Code; Docket No. A-2021-3027134 and S-2021-3027145; **RESPONSES TO OFFICE OF CONSUMER ADVOCATE'S INFORMAL DISCOVERY REQUESTS**

# COLUMBIA WATER COMPANY EDTMA CONDITION ASSESSMENT

August 2020

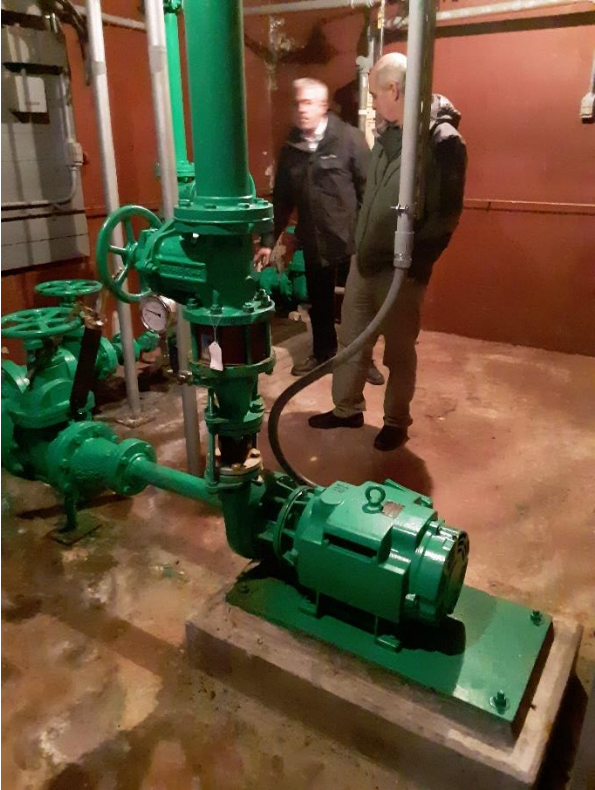
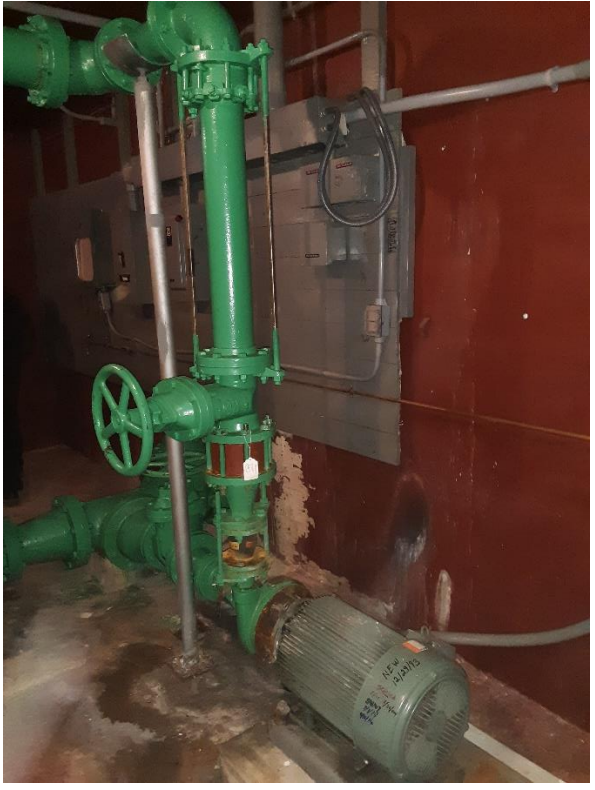
ASSET	MAKE	MODEL	YEAR INSTALLED	CONDITION RANKING	COMMENTS	PHOTOS
Pump House Building	-	-	1948	3	725 sq ft block two story building (basement and ground floor). Concrete foundation walls and ground floor. Wood truss roof structure. Asphalt shingle roof. Steel doors require painting. Ground floor is cast in place concrete that appears to be failing in at least one location. Concrete is spalled/cracked and rebar is exposed and corroded.	1,2,3
Mechanical Systems	-	-	1948?	2	Unit heater and exhaust fan on first floor. No heat or ventilation on lower floor.	
Spring Basin Upgrade	-	-	1982	2	Concrete below grade walls. Stone bottom. Block above grade walls. Wood truss roof structure. Asphalt shingle roof.	4,5
Fencing	-	-	?	2	6 ft high fence with 10 ft wide gate.	6
Security System	Select Security	-	?	1	Motion detector, door switches, and lower level flooding switch.	
Pumps (2)	Peerless	-	2009 & 1993	2	Horizontal, direct coupled, 25 HP. Rated at 250 gpm.	7,8

- Replacement of Pump Building roof
- Replacement of older pump.

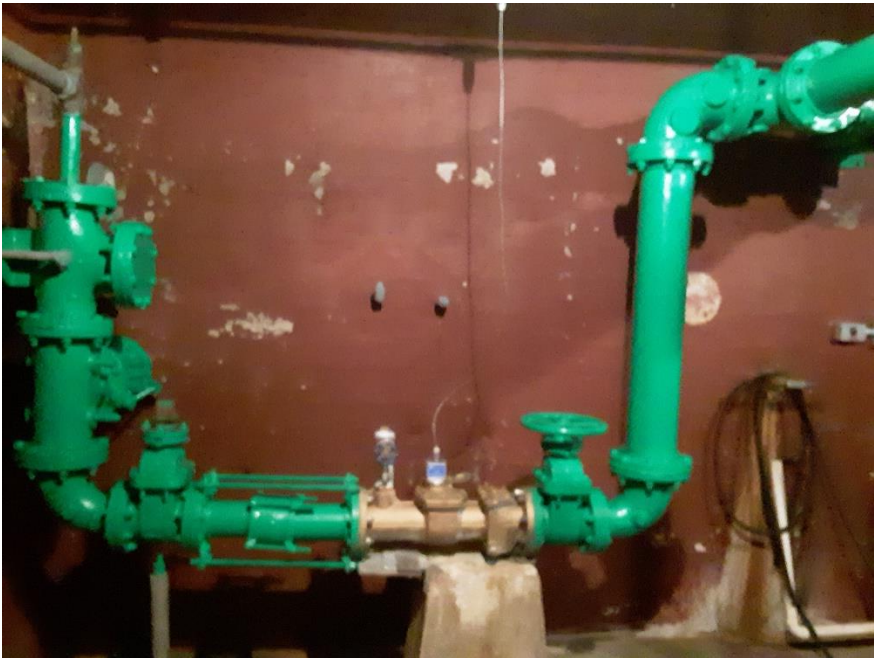
Photo 9

Piping & Valves	-	-	2009	2	No significant corrosion.	9

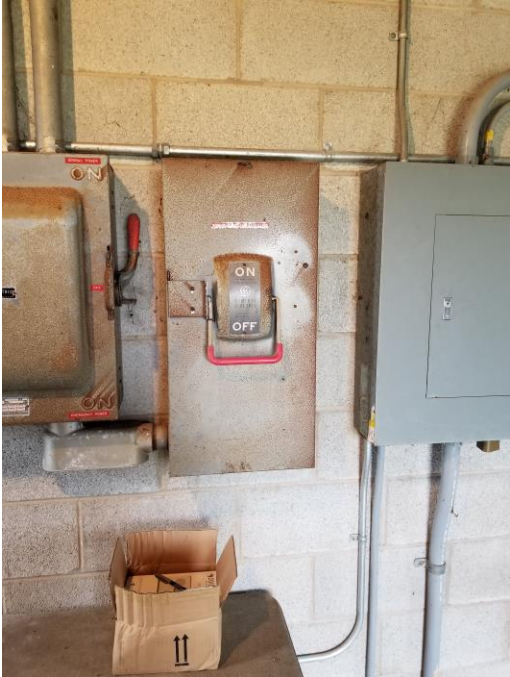
Photo 11

<b>ASSET</b>	<b>MAKE</b>	<b>MODEL</b>	<b>YEAR INSTALLED</b>	<b>CONDITION RANKING</b>	<b>COMMENTS</b>	<b>PHOTOS</b>
Main Distribution Panel	Square D	QMB Saflex	Unknown	4	400A, 120/240V, 3-phase, 4-wire distribution panelboard showing signs of rusting, replacement parts would be difficult to find. Panel might be original to when structure was added over pump vault.	10
Lighting Panel	Square D	Type NQO Panelboard	Unknown	2	100A MLO panelboard in good condition. Feeds lights, receptacles, SCADA RTU, and instrumentation.	
Disconnect Switch	Square D	Series 1	Unknown	4	300A disconnect switch showing severe signs of rust. Nothing is connected to switch and is therefore out of service. Disconnect may be original to when structure was added over pump vault.	
Manual Transfer Switch	General Electric	Enclosed switch MTS	Unknown	4	MTS is showing severe signs of rust. Generator has been removed and therefore the emergency side of the switch is out of service. However, normal power might still be running through normal side of switch. MTS may be original to when structure was added over pump vault.	11

- Replacement of the manual transfer switch and generator disconnect switch
- Install emergency/standby generator to meet DEP uninterrupted system service plan requirements.

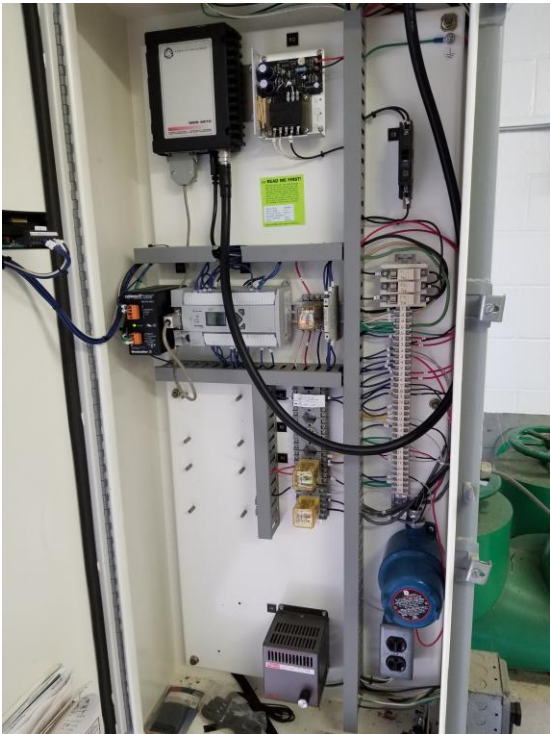
Photo 7

VFD Disconnect	Square D	Heavy Duty Enclosed Switch	2001	2	Disconnect Switch in good condition. Enclosure beginning to show the first signs of rust.	
Manual Transfer Switch	Square D	Double Throw Safety Switch	2015	1	Manual transfer switch in great condition. Used to select whether combination starter of VFD is used to power the well pump. Was installed when VFD was replaced so that combination starter could power the pump while VFD was unavailable.	
Combination Starter	Furnas	Various Components	2001	2	Combination Pump Starter that provides power to the well (when selected) in good shape. Outer enclosure beginning to show minor signs of deterioration.	
SCADA RTU	Built by Tri-Star Inc	Various Components	2001	2	Panel exterior shows a few spots of paint chipping and deterioration, but all internal components are like new. Panel houses Allen Bradley MicroLogix PLC and MDS Radio for communication as well as miscellaneous control components. Components may become obsolete in the near future.	7

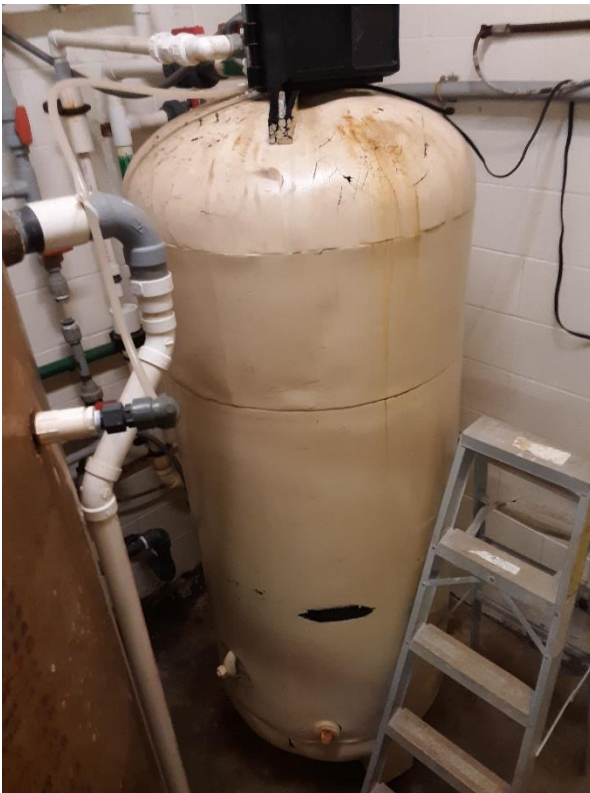
Photo 14

Water Softener	Kisco	KS-390-1	1990	Unknown	Galvanized steel vessel. Insulated, so condition not known. May be approaching the end of expected service life.	14
Air Compressors (2)	Speed Air	3/4 HP	2016 & 2018	2	Portable compressor/receiver connected with hose.	15
Brine Tank	-	600 gallon	1990	3	4 ft diameter FRP tank.	
Buried Chlorine Contact Tanks	-	7000 gal 4,000 gal 6,000 gal	1981 1989 1999	Unknown	Condition Unknown.

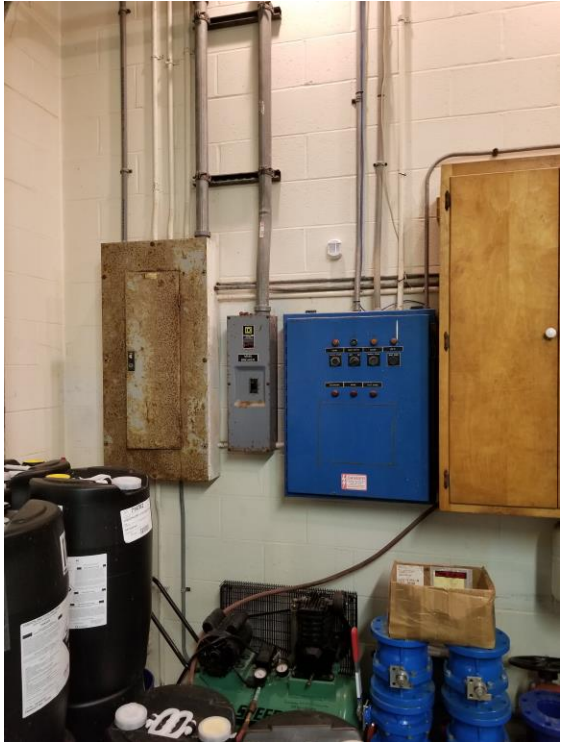
Photo 16

<b>ASSET</b>	<b>MAKE</b>	<b>MODEL</b>	<b>YEAR INSTALLED</b>	<b>CONDITION RANKING</b>	<b>COMMENTS</b>	<b>PHOTOS</b>
Main Breaker	Square D	Enclosed Circuit Breaker	1991	4	200A enclosed main circuit breaker in poor condition. Breaker is the main disconnecting means for the whole facility. Panel has been damaged by the corrosive chemicals stored in the area.	16
PRL#-1	Challenger	PowerMaster	1991	5	200A, 120/240V, 1-phase, 3-wire panelboard in poor condition. Feeds power to lighting, receptacles, instrumentation, and heaters but is not backed up by the generator. Panel has been damaged by the corrosive chemicals stored in the area. Challenger panelboards are notorious for failures, and should be replaced as soon as possible.	16
Tank Control Panel	Not Listed	Various Components	1991	3	Control Panel for the facility that controls regeneration cycles. Panel has been damaged by the corrosive chemicals stored in the area, but is in better shape than the adjacent Main Breaker and Panelboard.	16

Auto Transfer Switch	Cummins Onan	LT	2000	1	Automatic Transfer Switch in great condition. Automatically transfers power to generator well utility power is lost.	
SCADA RTU	Built by Tri-Star Inc	Various Components	2000	2	SCADA RTU Panel. Panel houses Allen Bradley MicroLogix PLC and MDS Radio for communication as well as miscellaneous control components. Components may become obsolete in the near future.	
Conduit System	Various	Various	Various	2	Conduit throughout the building is aging, but shows no signs immanent problems with the exception of the conduits above the Main Breaker and PRL#-1, which should be replaced with panels are replaced.	16

- Refurbishment/replacement of the ion exchange vessels. If the vessels interiors are recoated, it is recommended that the resin be replaced at that time
- Replacement of the ion exchange system controls
- Inspection and painting or replacement of system piping and valves
- Construction of a separate ventilated room/building with secondary containment for chlorine feed and chemical storage
- Replacement of the water softener
- Resolution of the waste brine disposal issues. The current method of addressing clogging of the sanitary sewer system is not expected to be permissible
- Replacement of electrical main breaker
- Replacement of electrical panel PRL#-1.

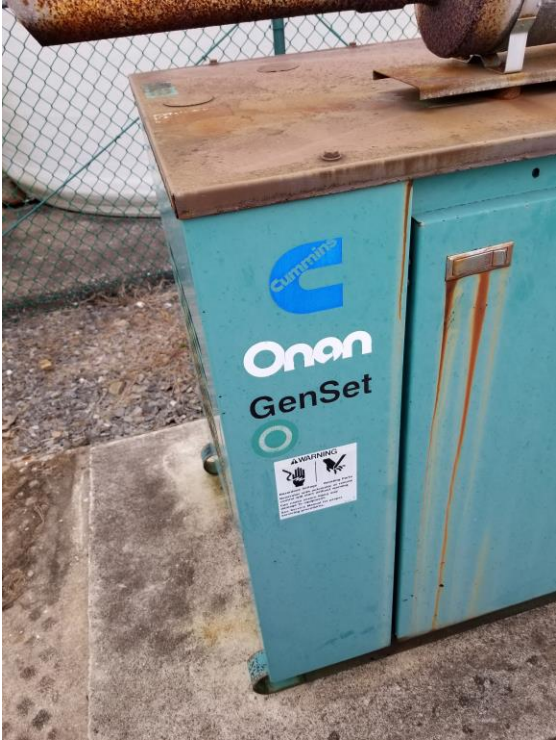
Photo 17

Panel A	Square D	NQOD Panelboard	2000	1	100A, 120/240V, 1-phase, 3-wire panelboard with main breaker in great condition. Feeds power to lighting, receptacles, instrumentation, and generator appurtenances. Equipment on this panel is backed-up by the generator.	
Generator	Cummins Onan	20GGBD	2000	3	20kW/25kVA standby propane exterior generator in good condition. Outer Enclosure is showing signs of rusting. Propane is feed from 500 gallon propane tank located next to Generator. Generator is run weekly and serviced yearly under a service contract. Generator is obsolete and replacement parts will be hard to find.	17

- Replacement of the ion exchange resin
- Replacement of the generator (in good shape, but obsolete and replacement parts will become hard to find).
