**REVIEW OF THE RELIABILITY
OF THE METROPOLITAN EDISON
COMPANY'S LYNNVILLE CIRCUIT**

BUREAU OF TECHNICAL UTILITY SERVICES

OCTOBER 2023

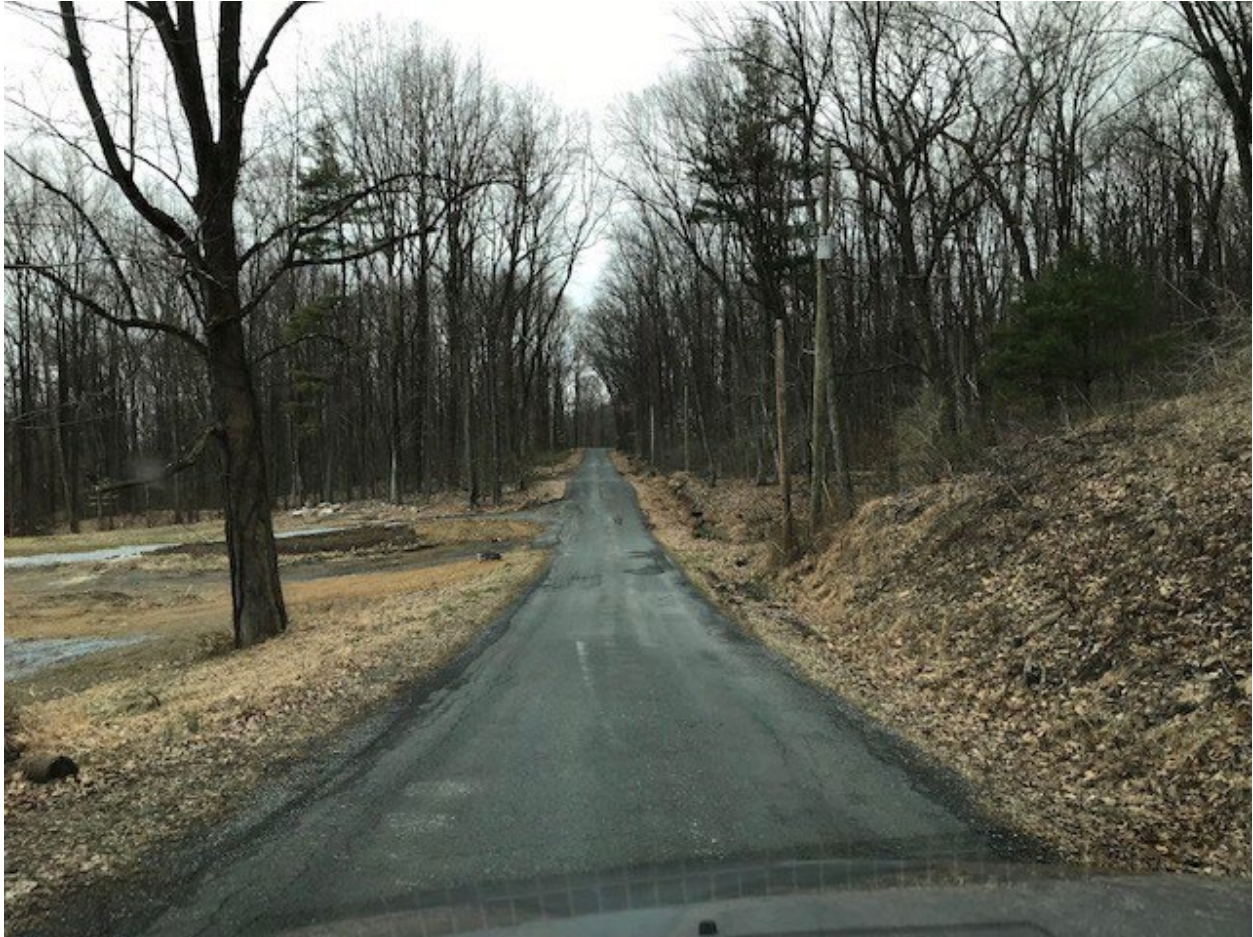
Figure 1: Single phase primary along Sousley Road. Note the tall, overhanging limbs from OROW trees.

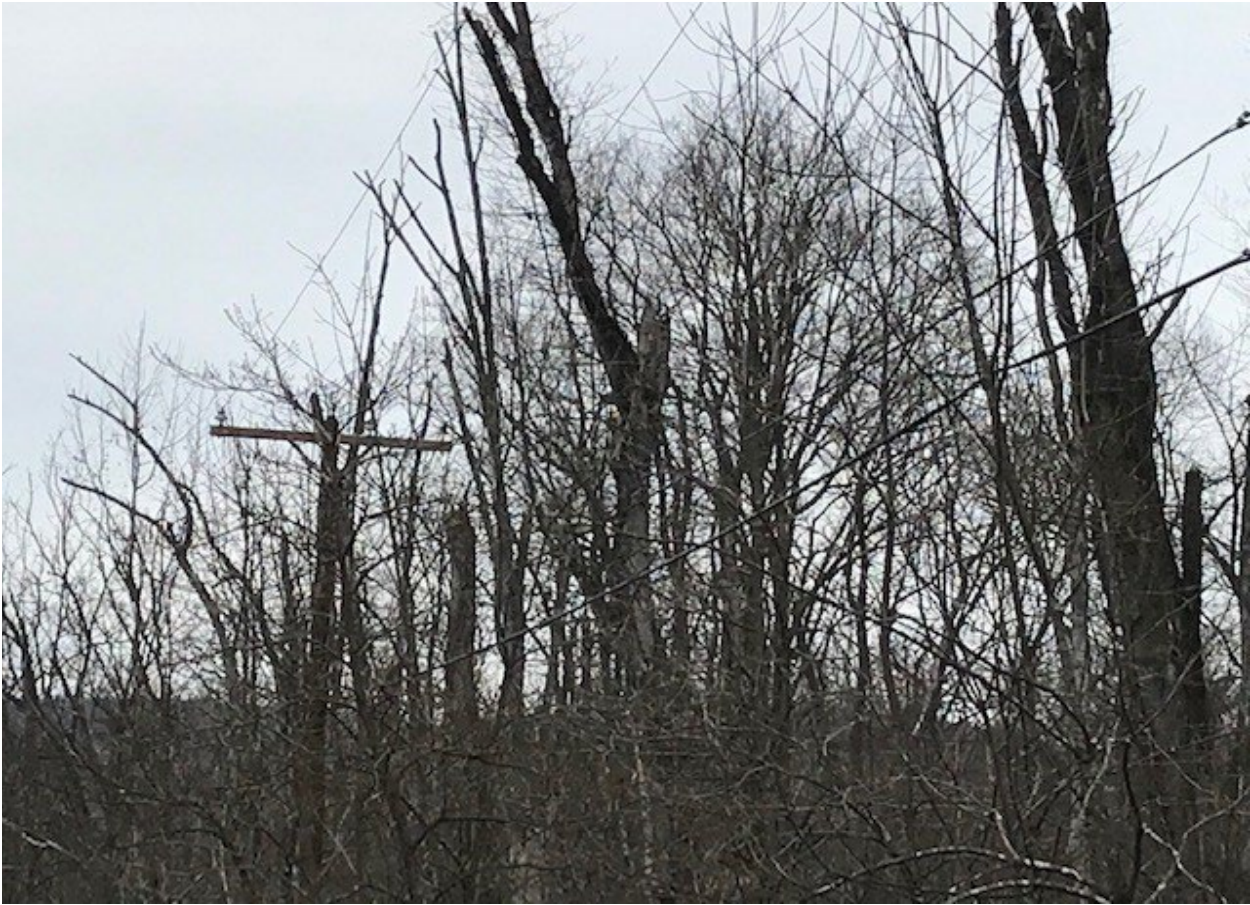
Figure 2: Three-phase OROW line section of 737-1 12kV. Note the floor vegetation and difficult access.

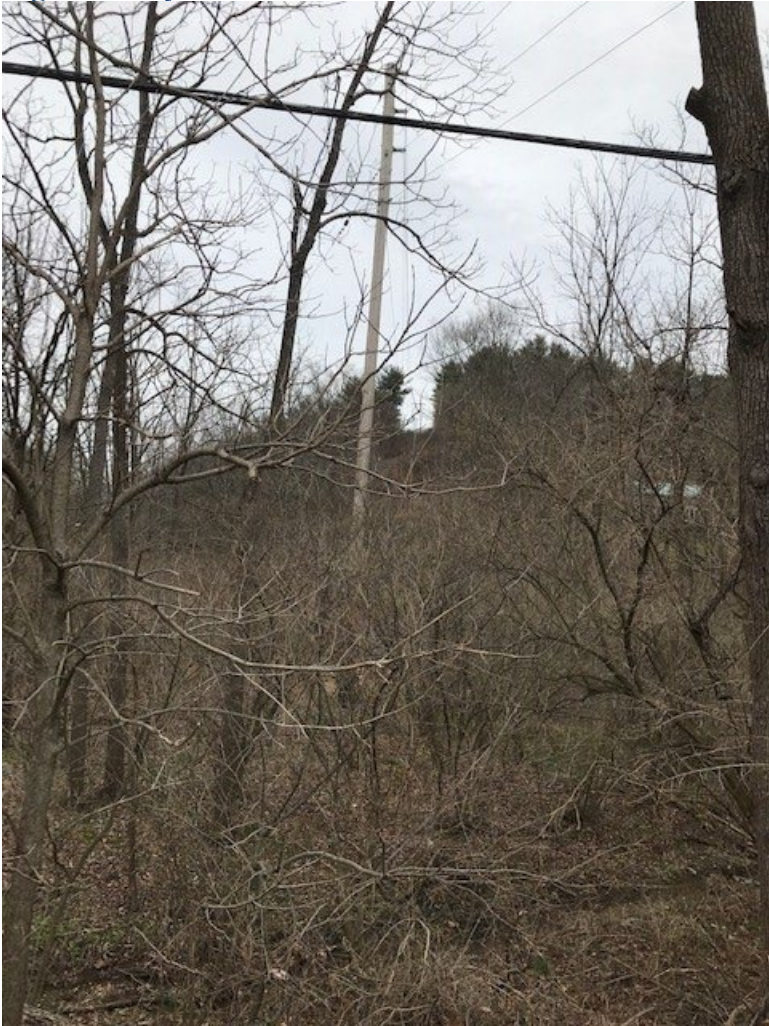
Figure 3: Lynnville 737-1 12kV. Note the difficult terrain and adequate trimming.

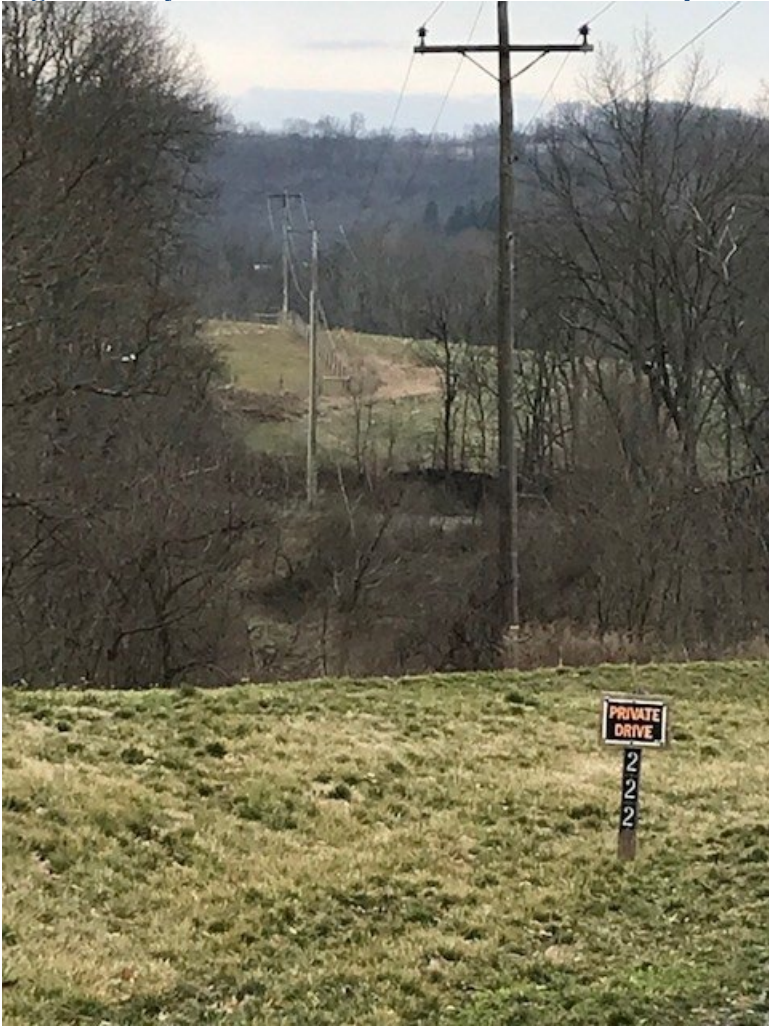
Figure 4: Lynnville 737-1 12kV OROW with adequate tree trimming.

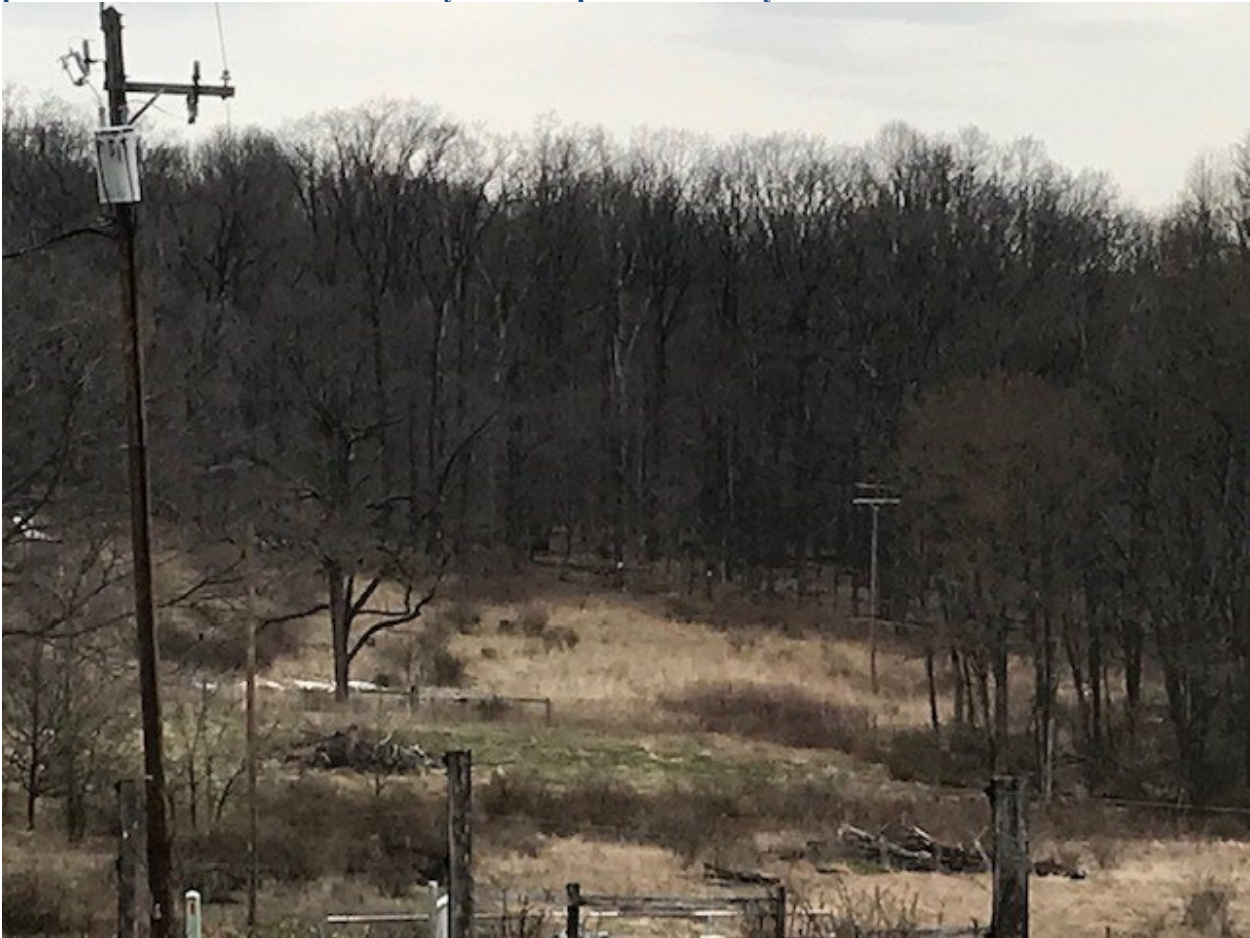
Figure 5: Single-phase tap off of the two-phase tap that serves Sousley Rd. Note the two-phase location is South of Sousley Rd and predominantly forested and inaccessible.

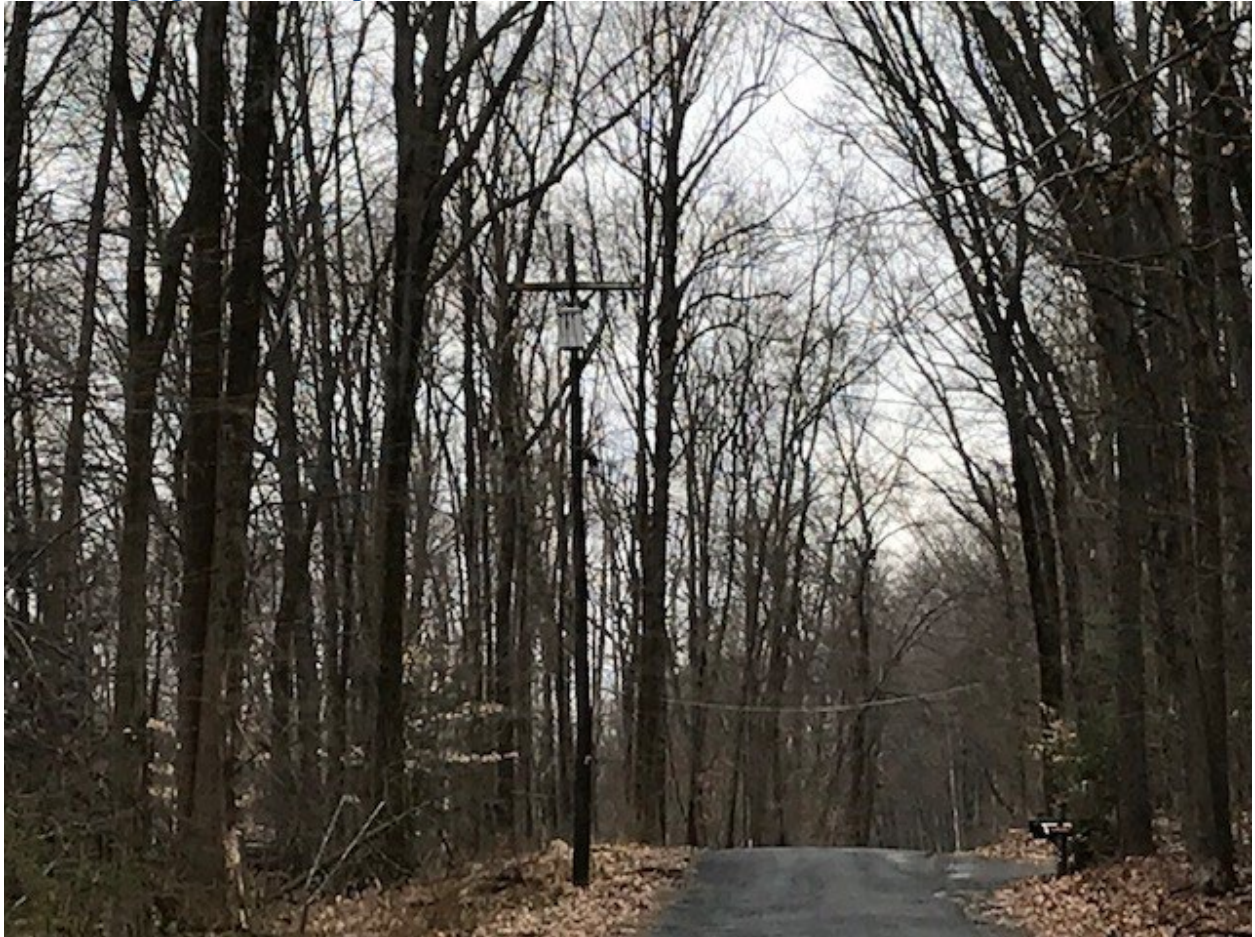
Figure 6: Sousley Rd looking West. Note the very tall canopy trees and overhanging limbs. This area is trimmed in accordance with Met-Ed's Vegetation Management Policy, but over-hanging limbs are a possible issue.

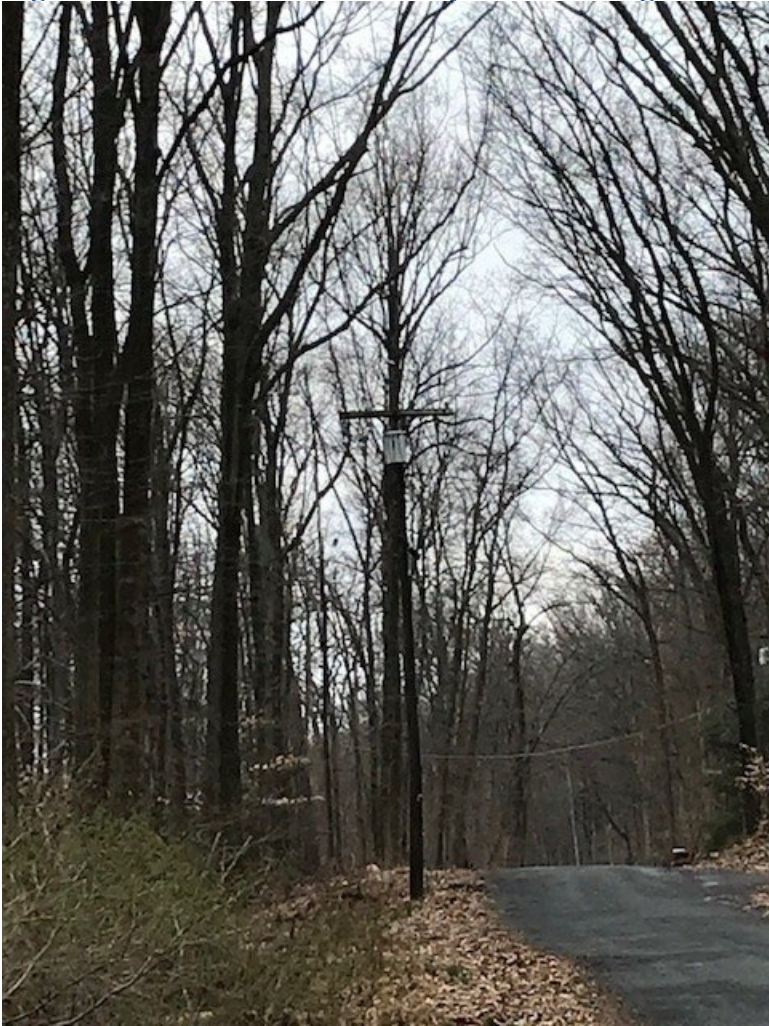
Figure 7: Another view of Sousley Road looking West. Better view of situation.

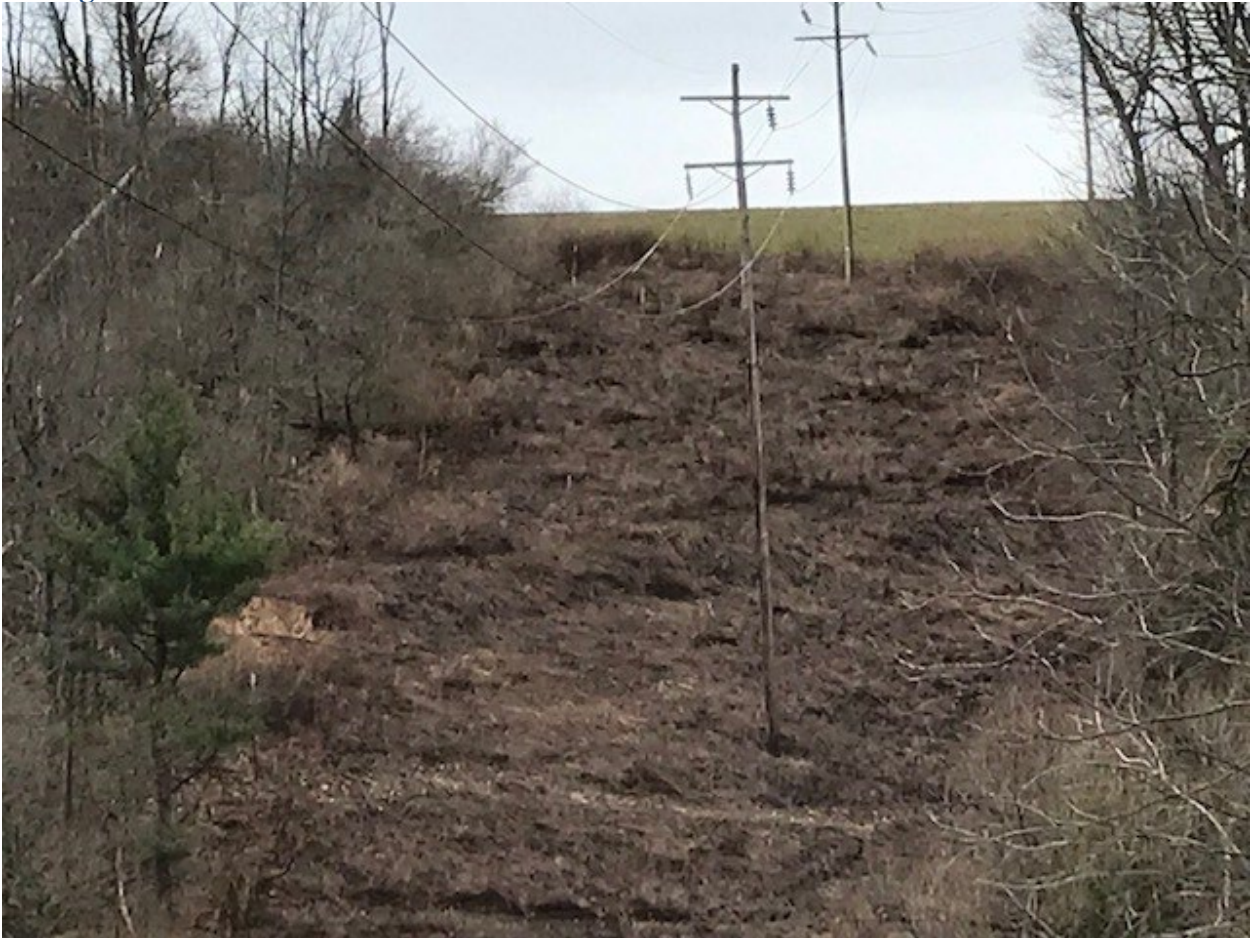
Figure 8: Sub-Transmission line that supplies the Lynnville Sub. Very good vegetation management.

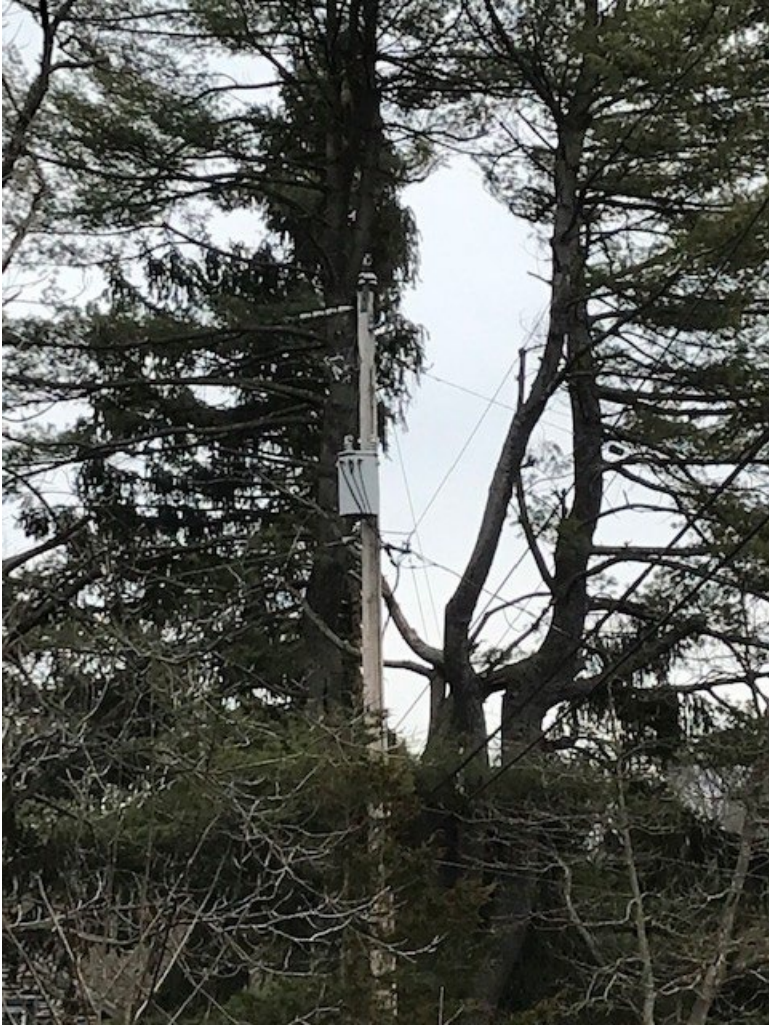
Figure 9: Example of Met-Ed vegetation management near the tap for Sousley Road. Refer to Figure 11 in Appendix B for context.

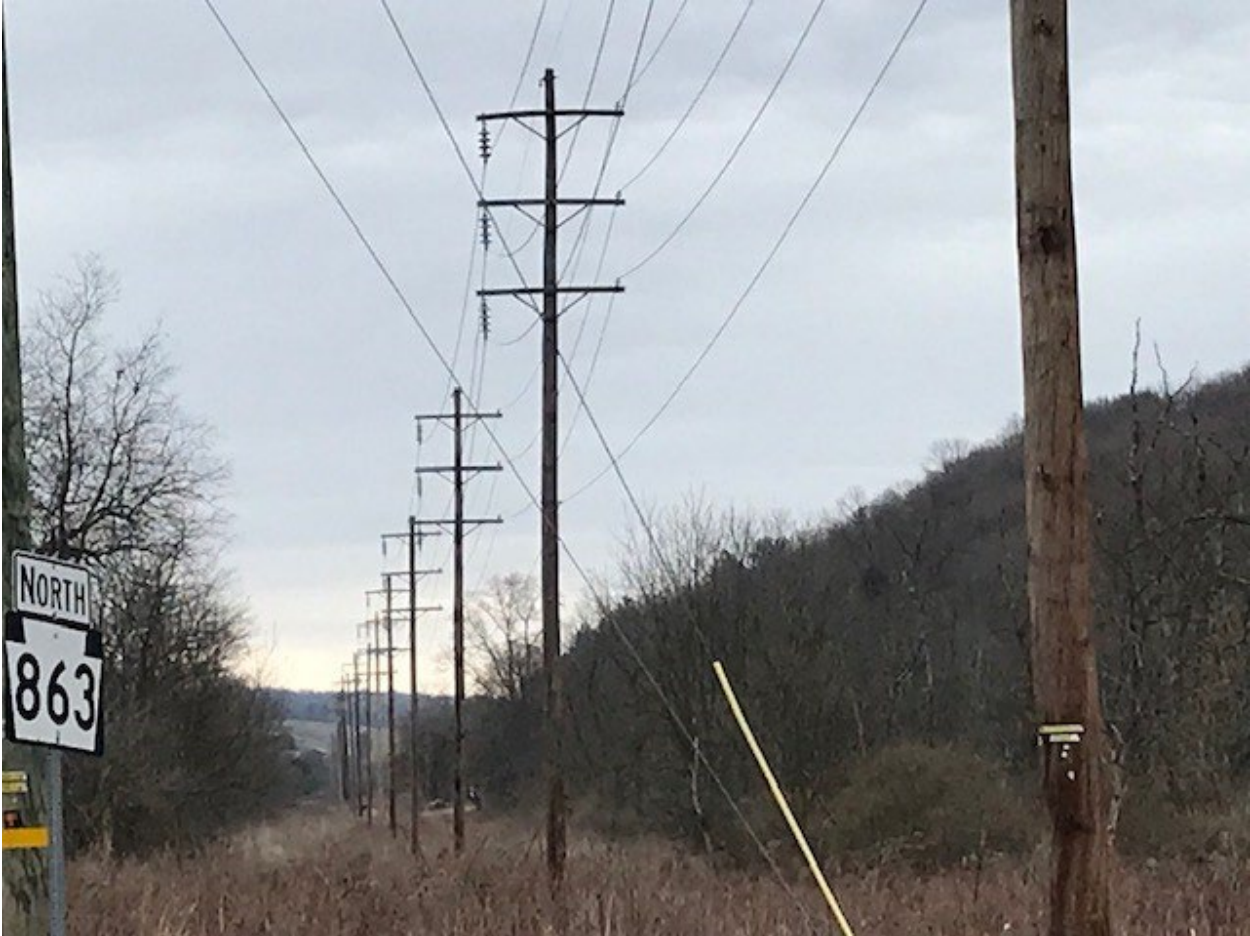
Figure 10: Dual Circuit line section near the Lynnville Sub. The Sub Transmission Feeder in on the left and the Lynnville 737-1 12kV line is on the right. Note very well-maintained line tree trimming.
