RE: Ronald and Sheila Derian vs. Pennsylvania American Water Company
Docket # c-2023-3041252

Included please find Exhibits 1 thru 7 to be entered concerning the above case # c-2023-3041252.

G:\Projects\41000\41370 Travelers - Derian Property\Docs\Report.docx

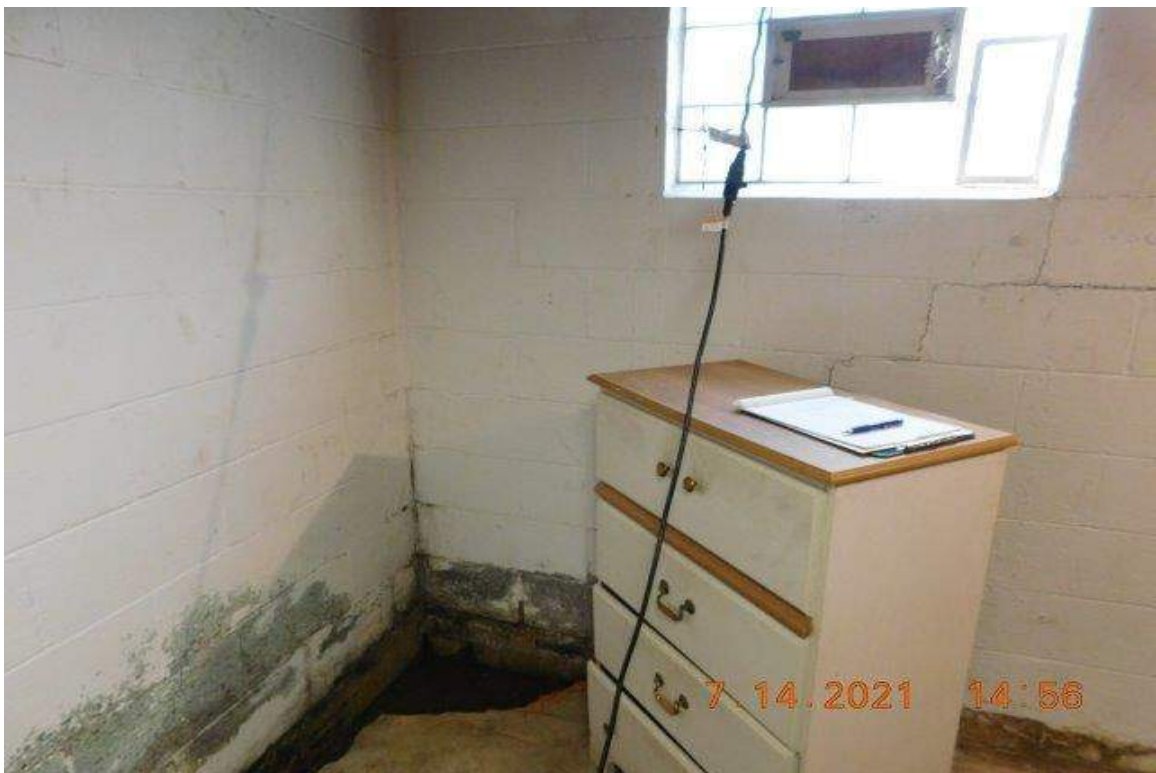
PHOTO 10 - RIGHT (WEST) REAR CORNER OF BASEMENT

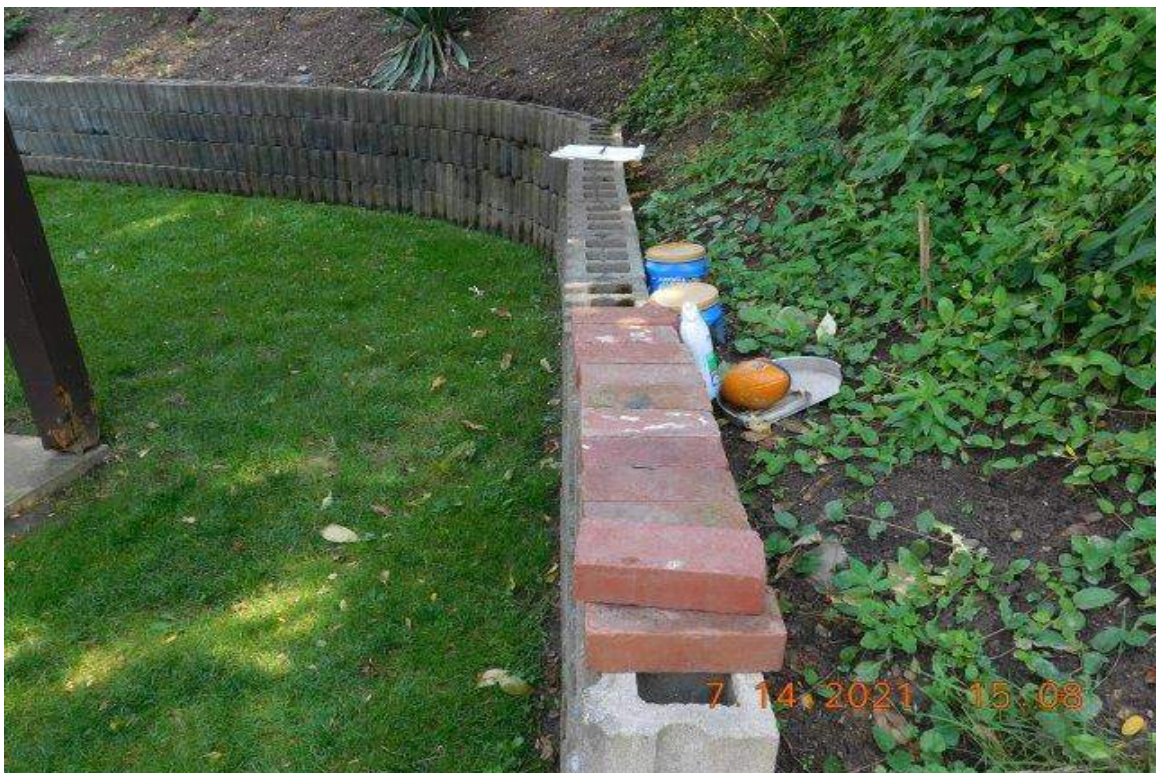
PHOTO 50 - RETAINING WALL IN REAR PORTION OF RIGHT YARD

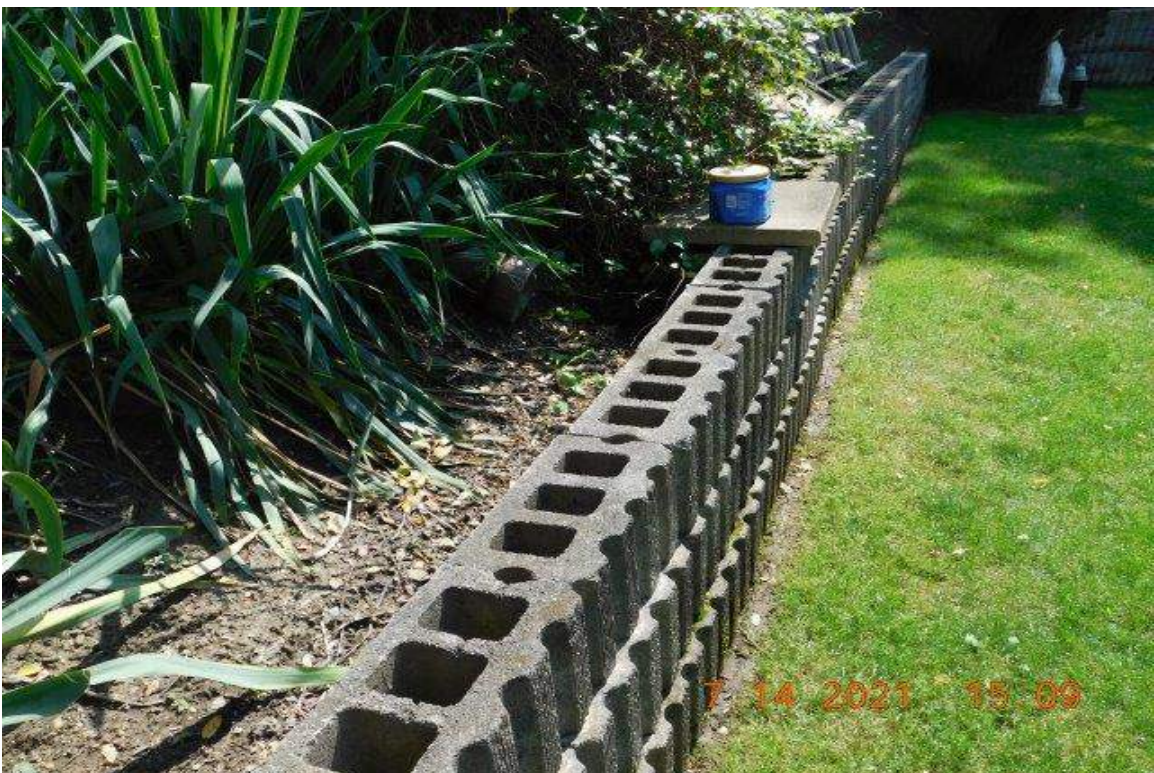
PHOTO 54 - LEFT YARD RETAINING WALL LOOKING SOUTH

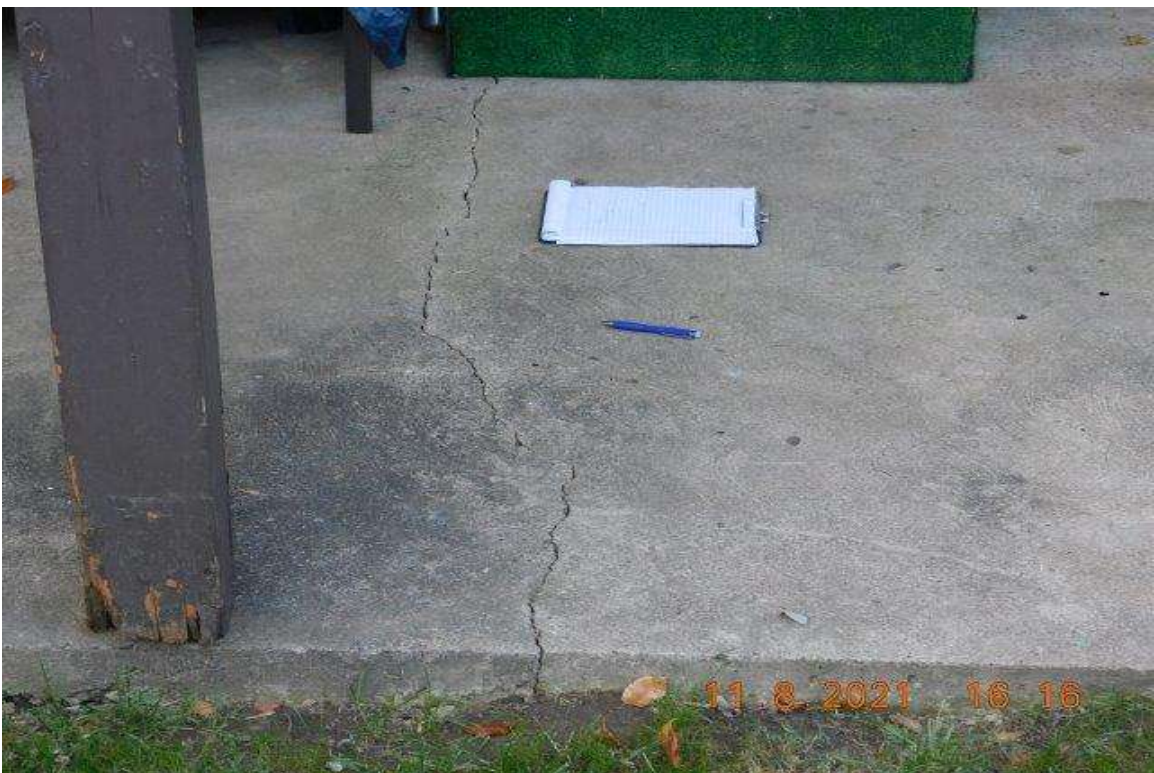
PHOTO 18 - REAR PATIO SLAB LOOKING NORTH

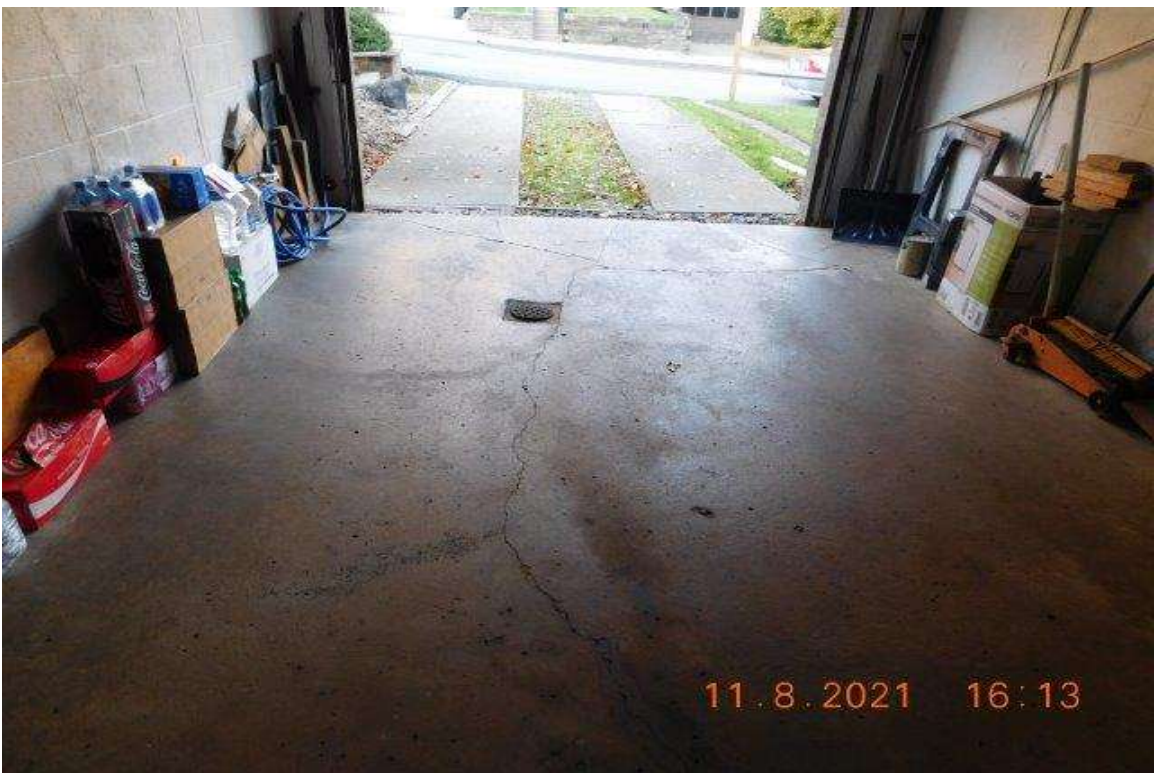
PHOTO 38 - GARAGE FLOOR LOOKING NORTH

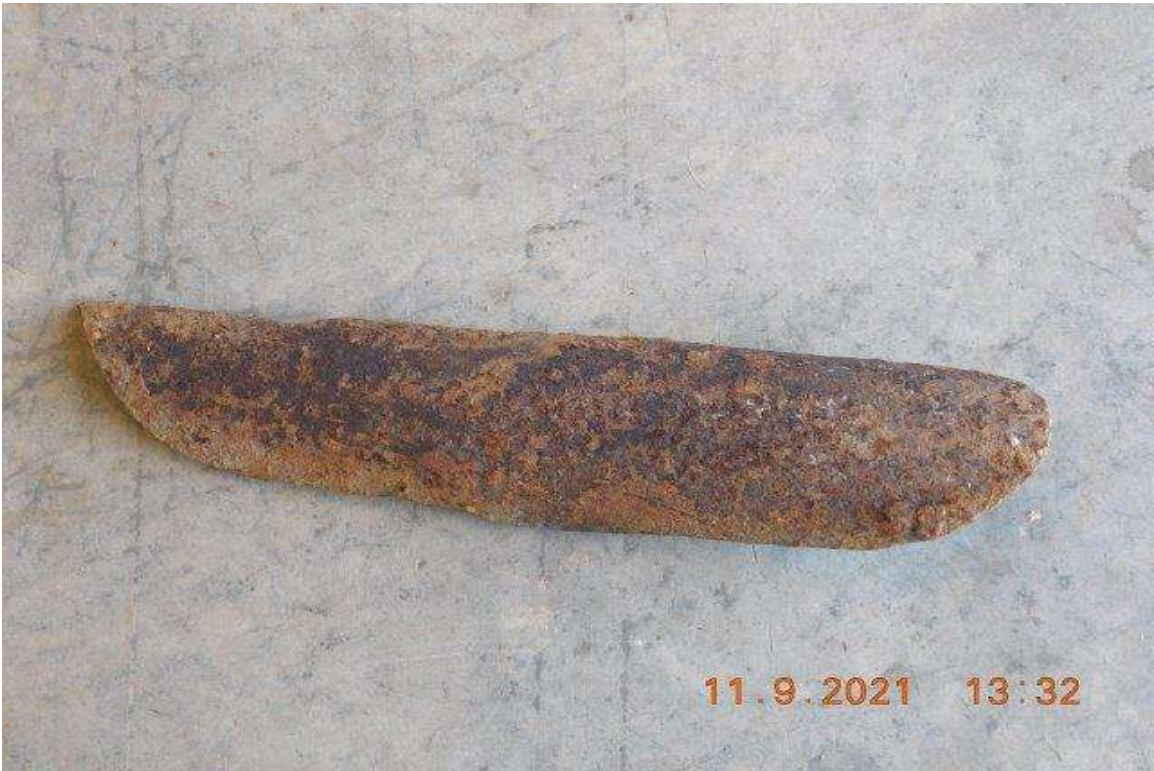
PHOTO 47 - EXTERIOR FACE OF PIECE OF BROKEN WATER LINE

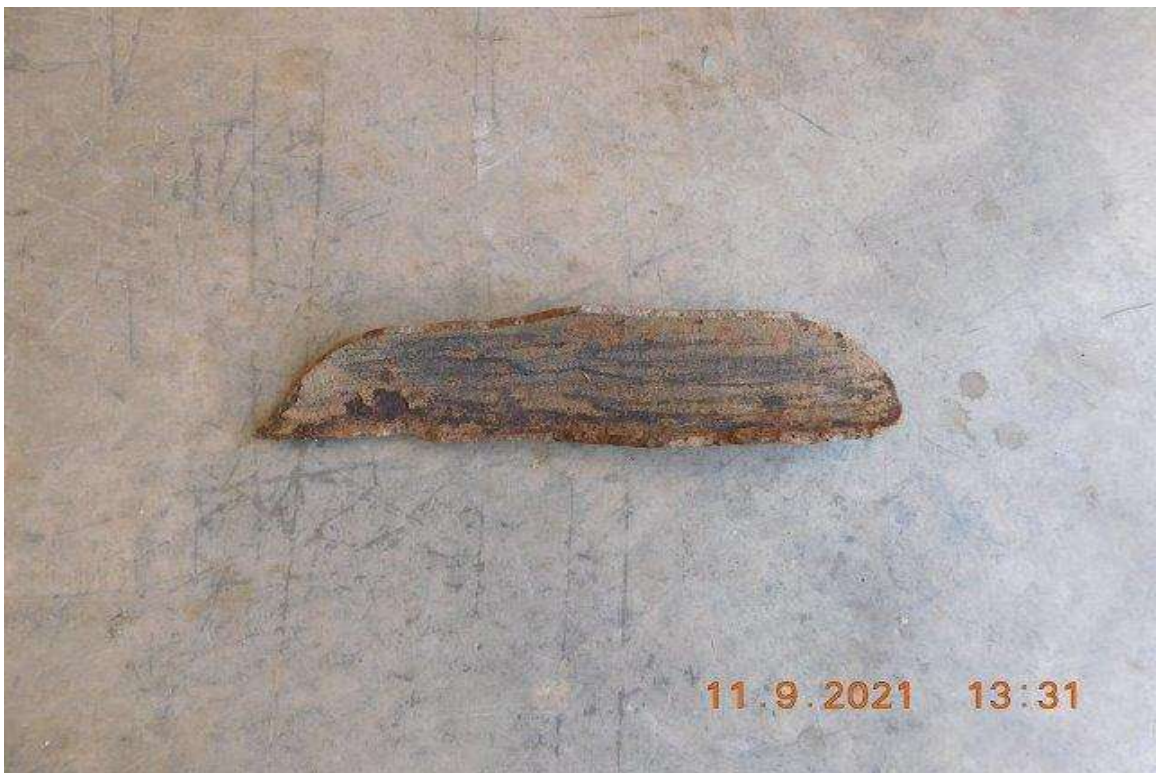
PHOTO 50 - INTERIOR FACE OF PIECE OF BROKEN WATER LINE
