BUREAU OF  
INVESTIGATION  
&  
ENFORCEMENT

Re: Pennsylvania Public Utility Commission,  
Bureau of Investigation and Enforcement v.  
UGI Utilities, Inc. (Gas Division)  
Docket No. C-2023-  
**Formal Complaint (Non-Proprietary and Proprietary Version)**

14. On December 25, 2020, at approximately 1:44 a.m., a pipeline failure occurred in the westward travelling lane of Lower Swiftwater Road, Swiftwater, Pennsylvania, 18370.

15. The pipeline failure occurred at a butt fusion<sup>2</sup> of 12-inch high-pressure high-density plastic pipe in the natural gas service territory of Respondent.

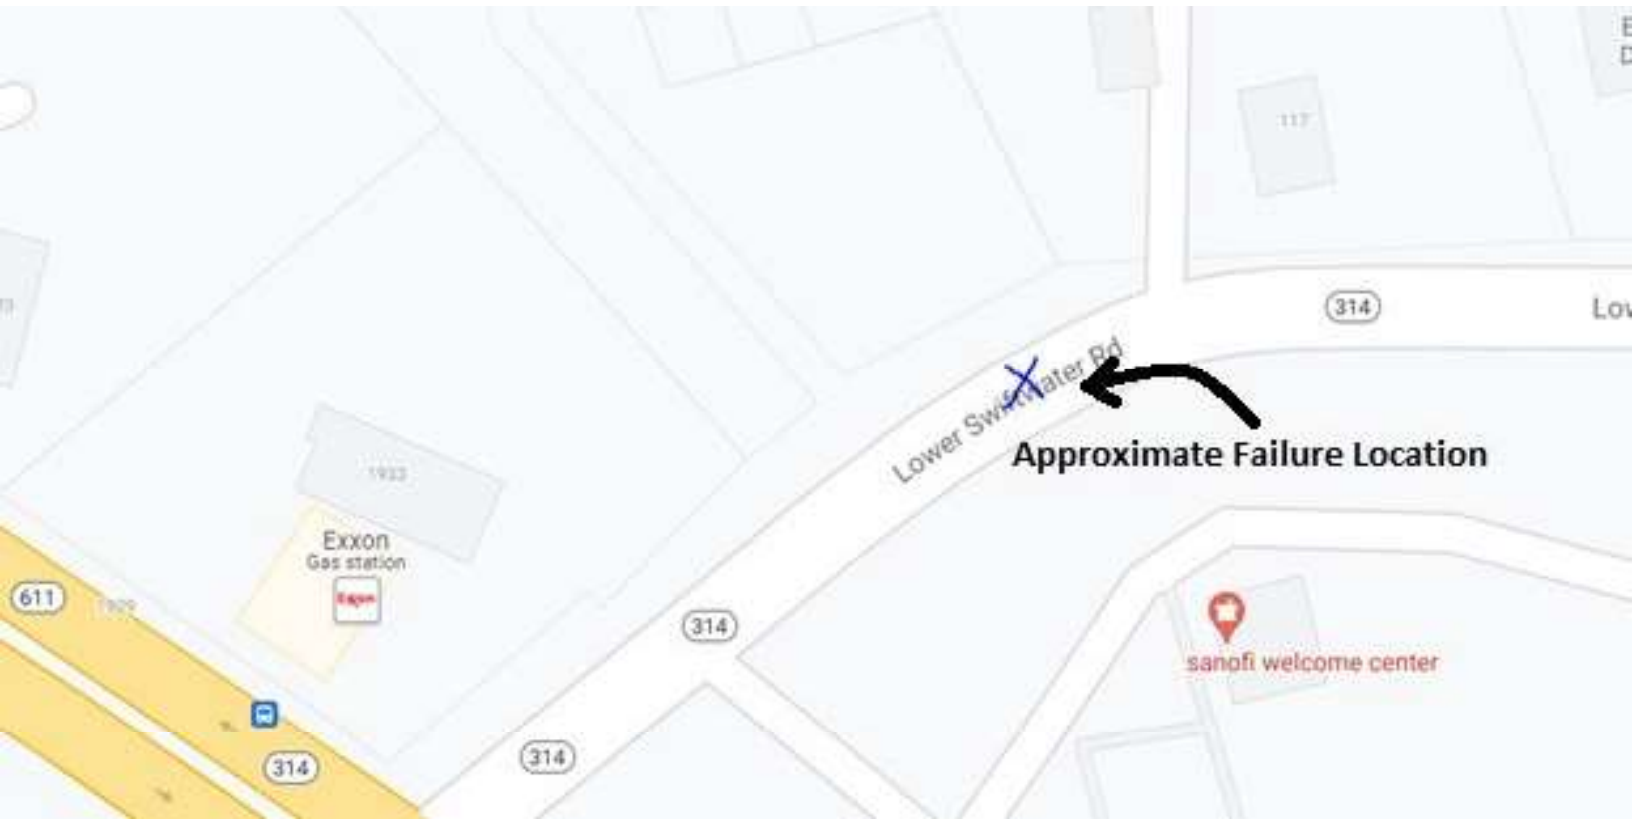
**I&E**  
**Exhibit 1**

48. On December 25, 2020, at approximately 1:44 a.m., the butt fusion failure and gas release occurred at the westward travelling lane of Lower Swiftwater Road, Swiftwater, PA in UGI Hazelton's operating area. See attached I&E Exhibit 1.

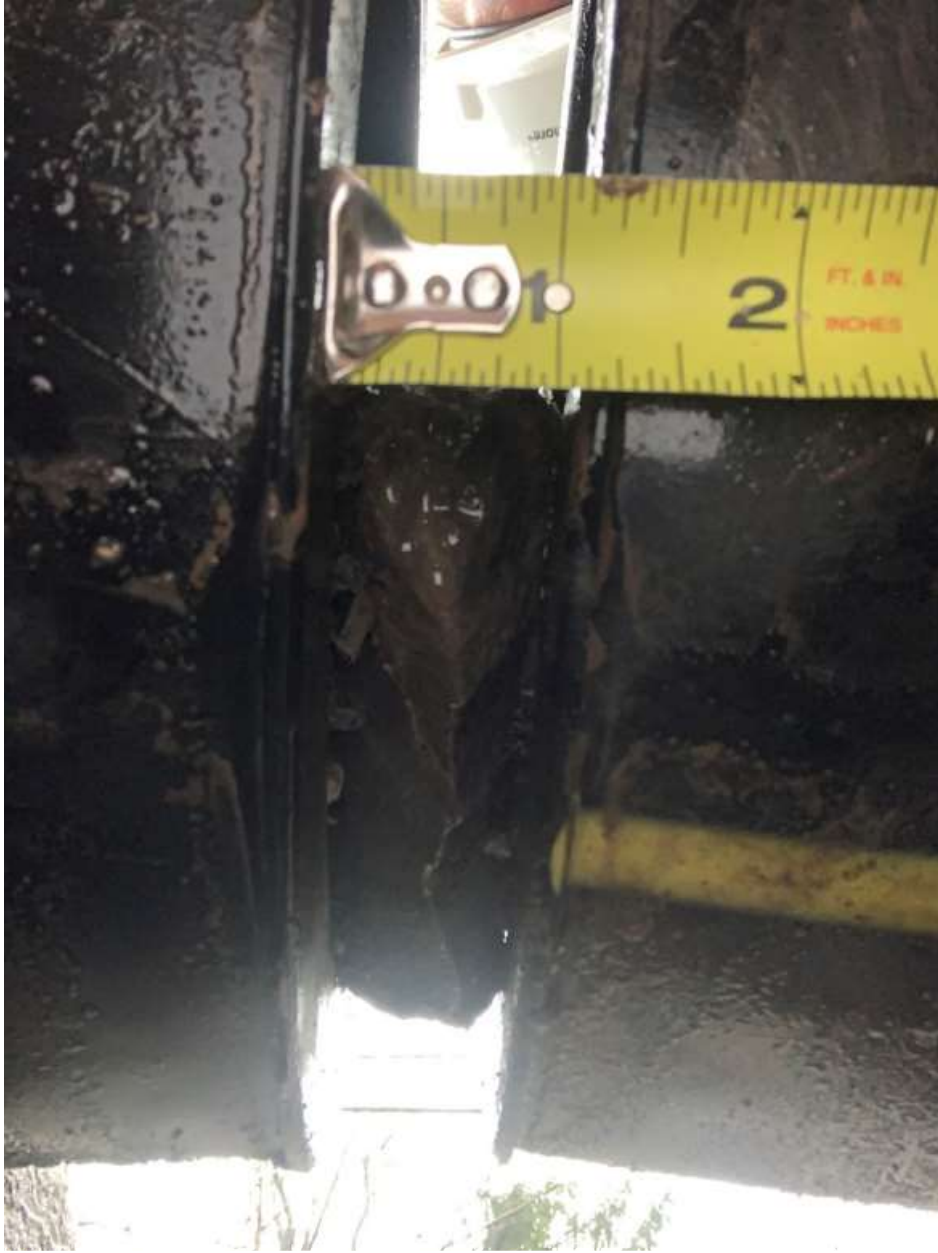
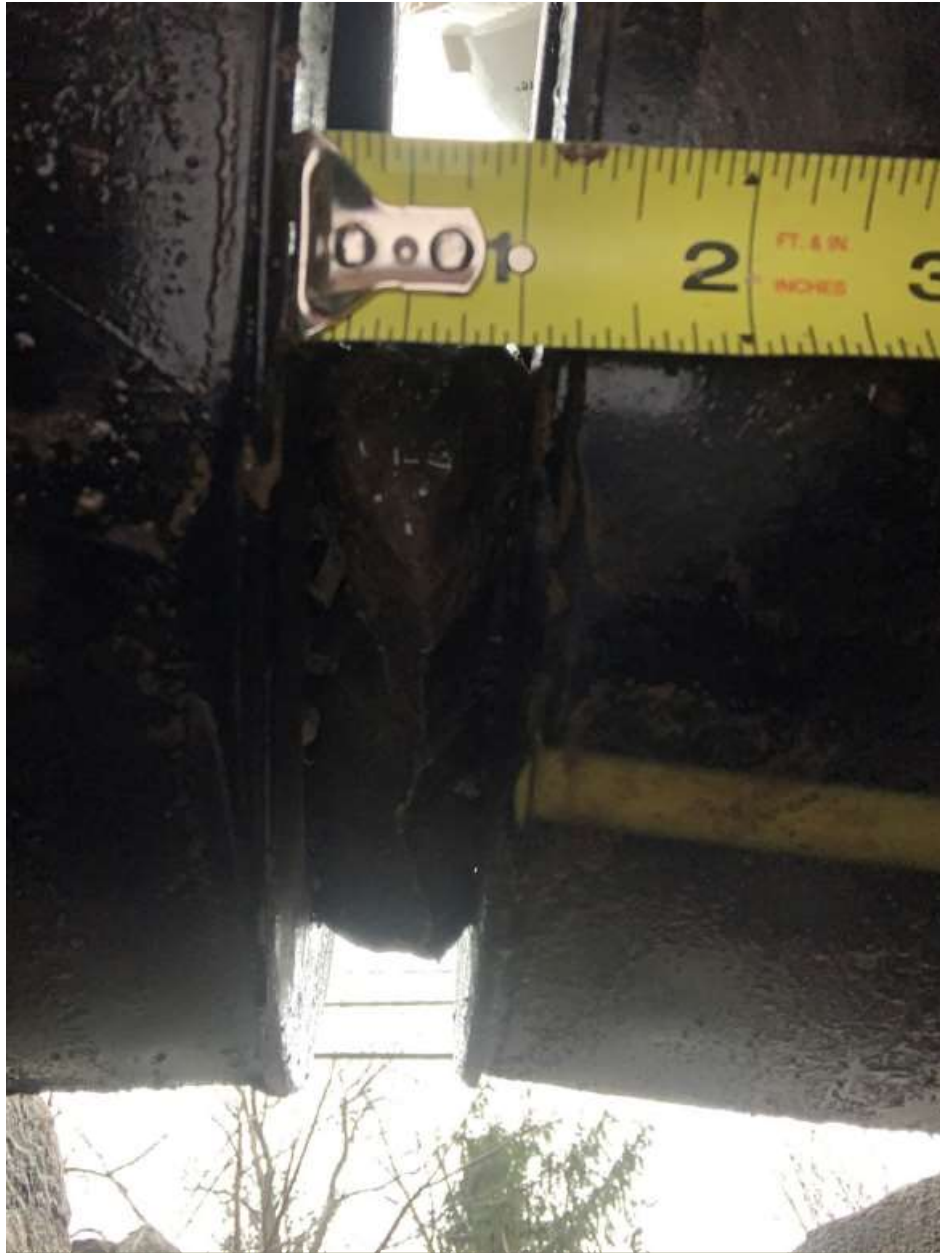
**I&E**  
**Exhibit 3**

59. While at the scene, I&E-Safety measured the roll back bead of the butt fusion on the failed joint to be 1/8-inches. See attached I&E Exhibit 3.

140. The bead size on the failed butt fusion joint had a roll back bead that was 1/8-inches, which was smaller than the minimum size required. See attached I&E Exhibit 3.

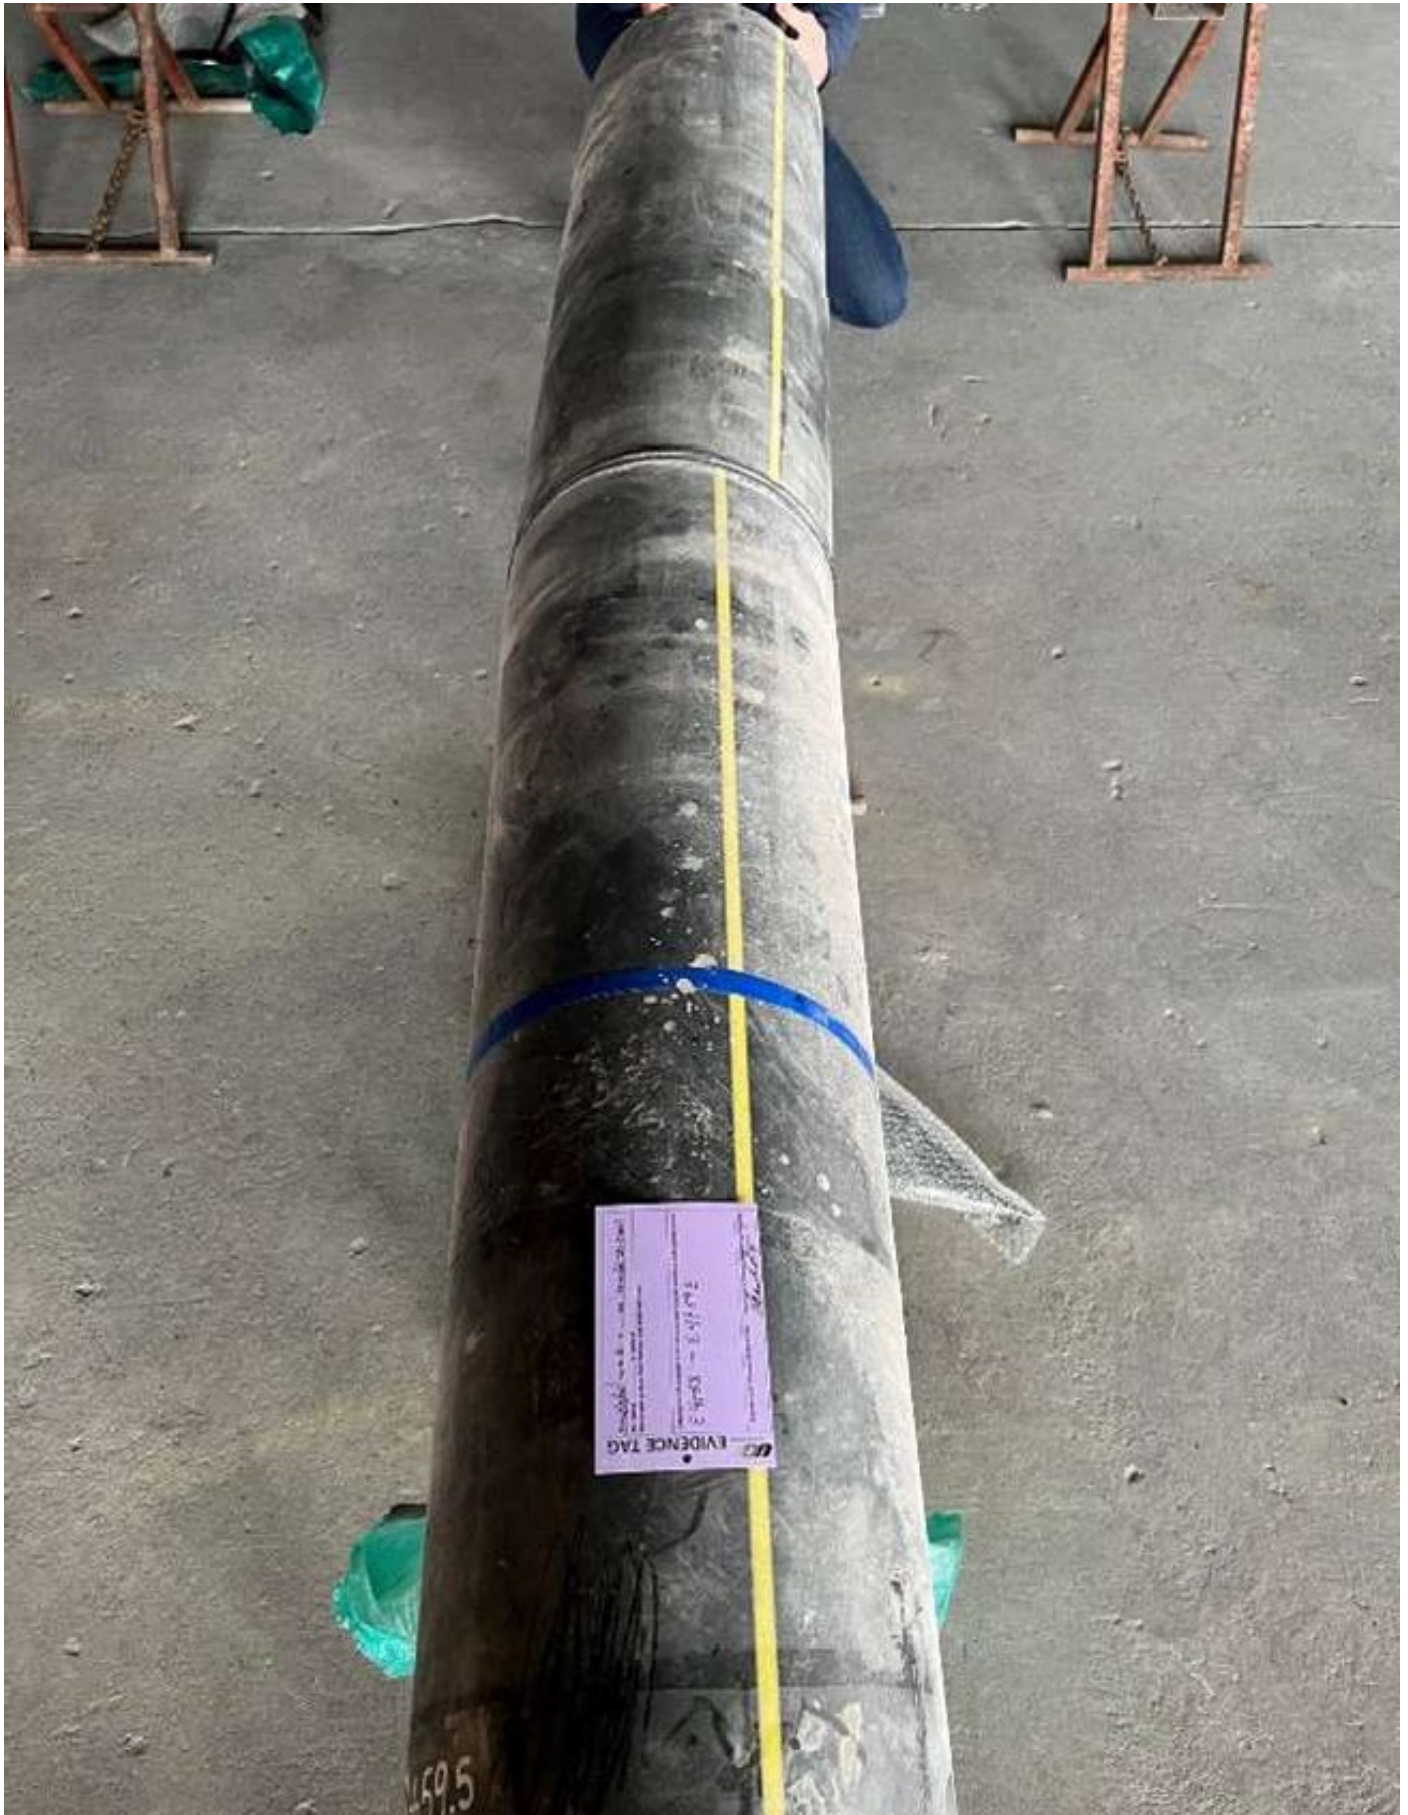
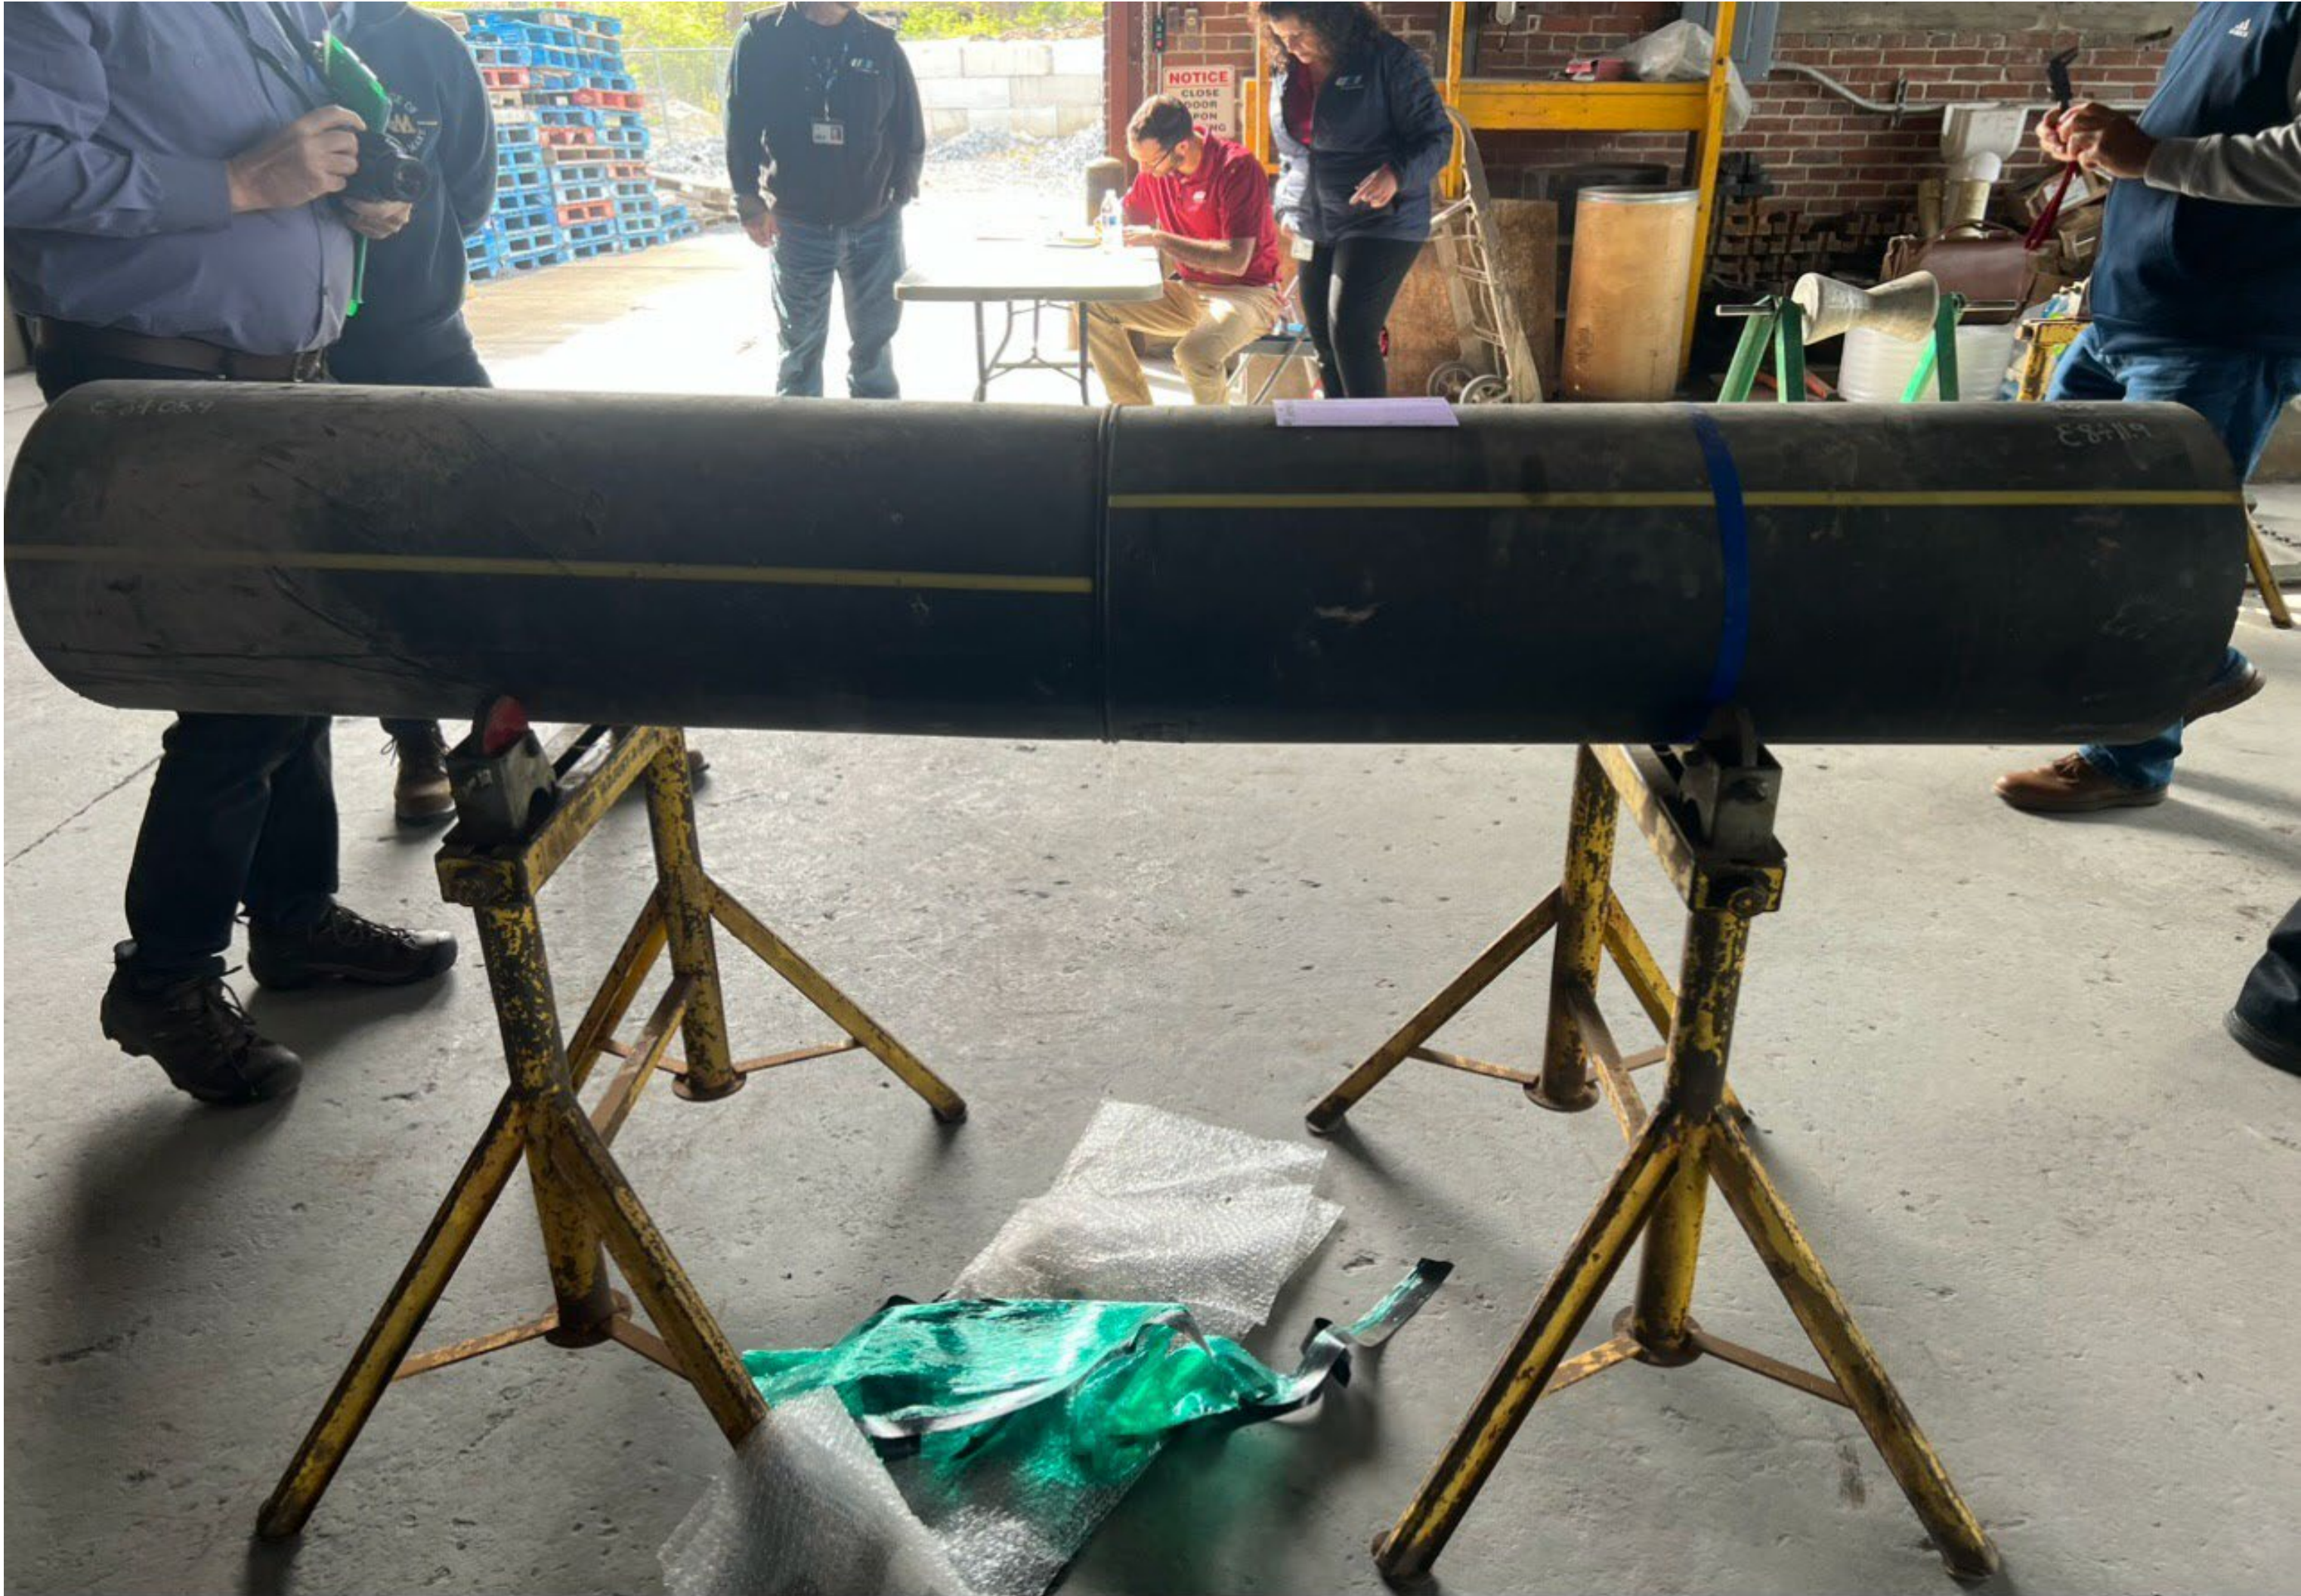
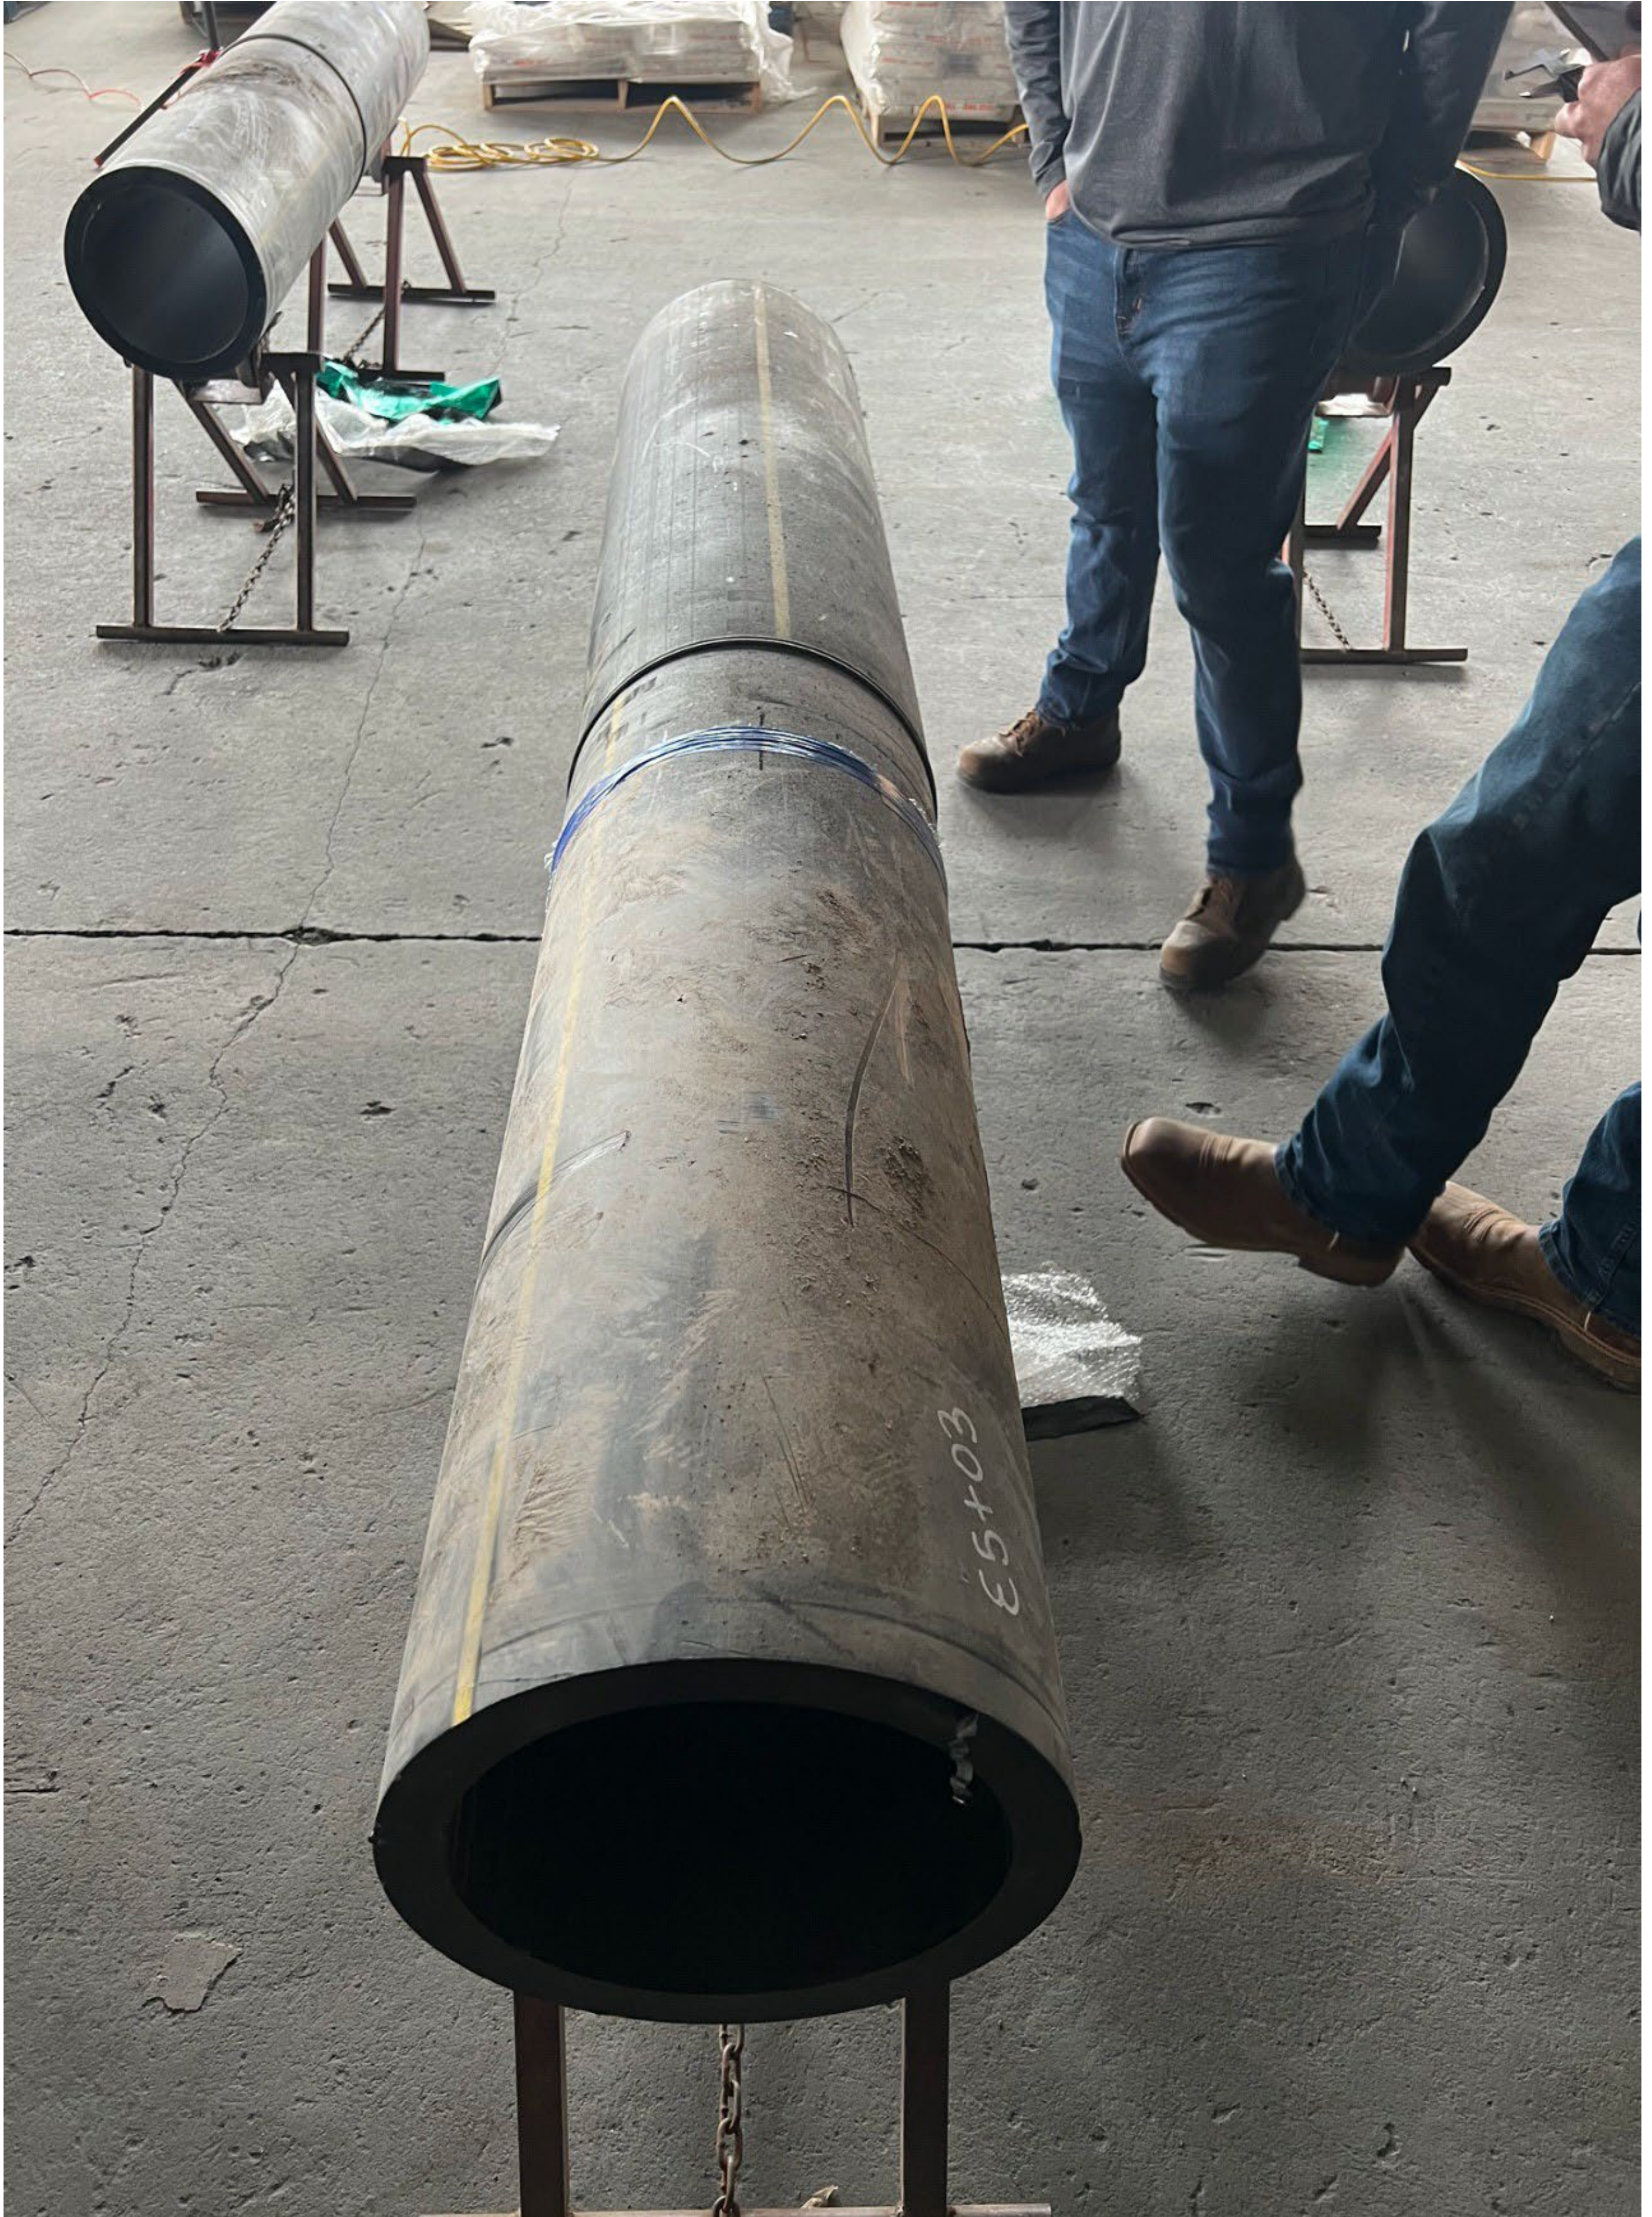
**I&E**  
**Exhibit 6**

76. During this replacement project in January and February 2022, UGI removed 500 feet of the 12-inch plastic main, abandoning 1,400 feet in place, and discovered another three (3) plastic butt fusion joints which were visually unacceptable. See attached I&E Exhibit 6.

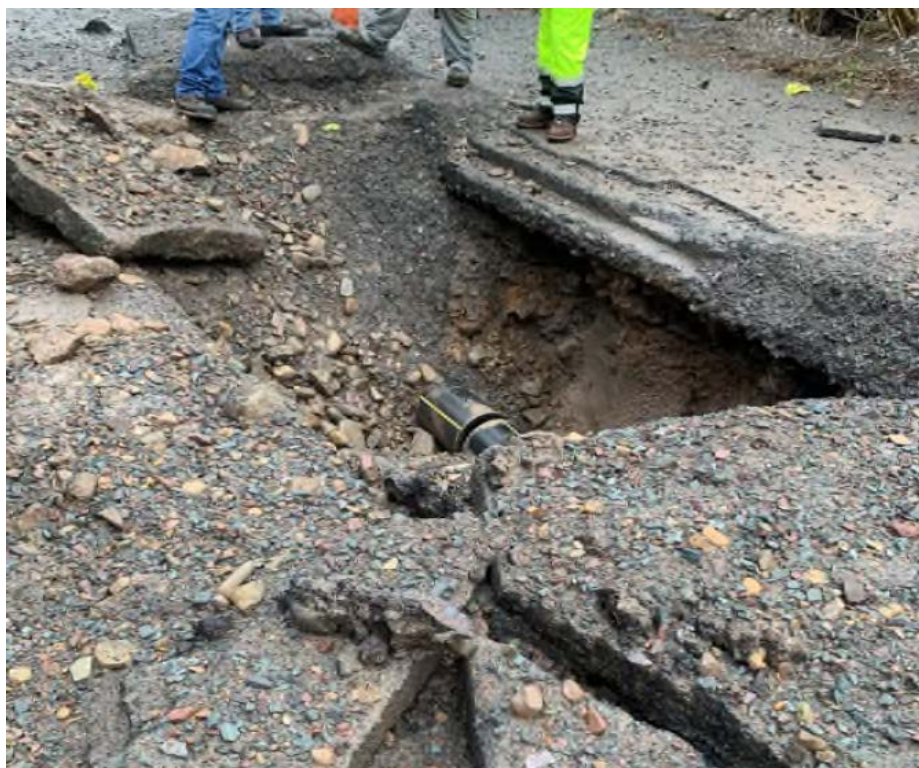
**Photo 1 – Gas Release Area, December 25, 2020**

- Based on discussions at the site, it is understood that the pipeline was originally installed in the summer. Installation continued through daylight hours, but finished after sunset.
- Based on discussions at the site, it is understood that heavy precipitation preceded the gas release incident and that heavy surface water flows were observed in the incident area, including "a river" of surface water flowing from the north side of Lower Swiftwater Road to the south side of the road near the incident location.
- The failure in the pipeline was at a joint in the HDPE pipe. The failure was a clean break at the joint and a gap of about 1 ¾ to 2 inches was observed (see Photos 1 and 2, below).

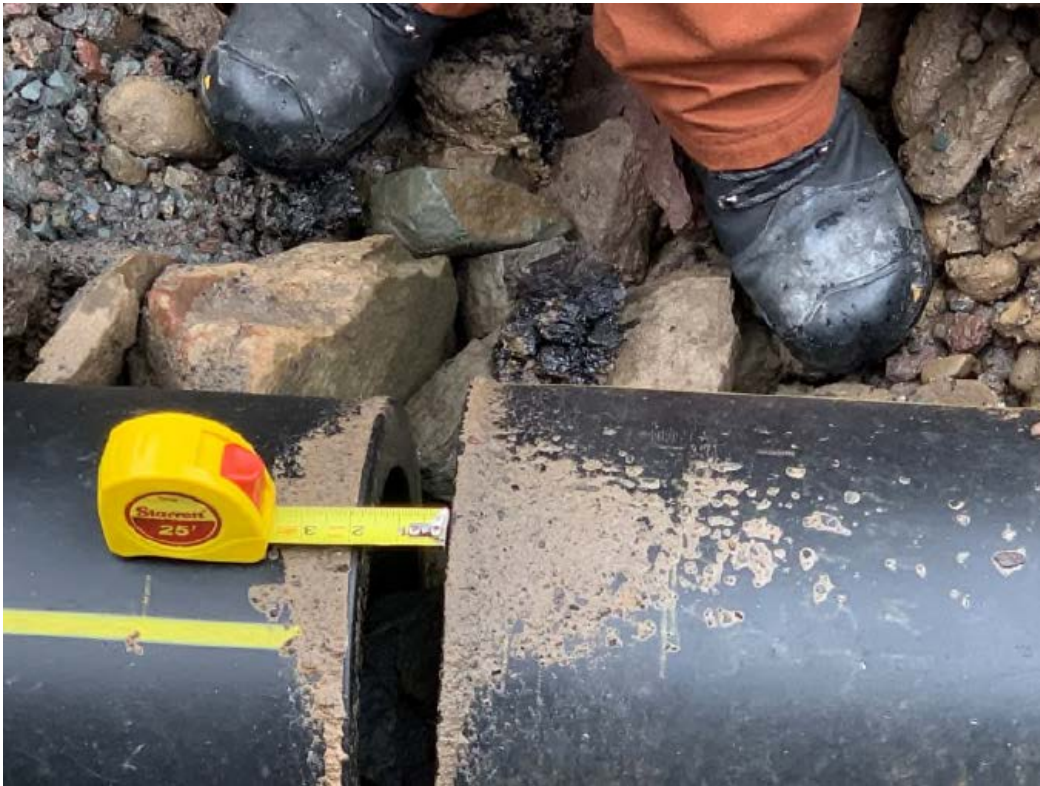
**Photo 2 – Failed Joint**

104. ARM concluded that the pipeline joint was substandard, based on the understanding that a properly constructed joint should not have failed as cleanly as what was observed at the incident site. See attached I&E Exhibit 7.

- The pipeline joint construction was sub-standard. Based on our knowledge of pipeline engineering and construction, a properly constructed joint should not have failed as cleanly as evidenced in Photo 2.
- The pipeline was apparently under significant tension stress at the time of joint failure. This is likely due to the difference in temperatures of the HDPE materials at the time of installation and at the time of the incident. Installation procedures may have also added to the tension stresses. The tension stresses were further verified when the HDPE pipeline was cut in mid-January 2021 during repair activities.
- The pipeline separation does not appear to be related to potential slope instability to the south of the gas release area. This conclusion is based on observations of the roadway

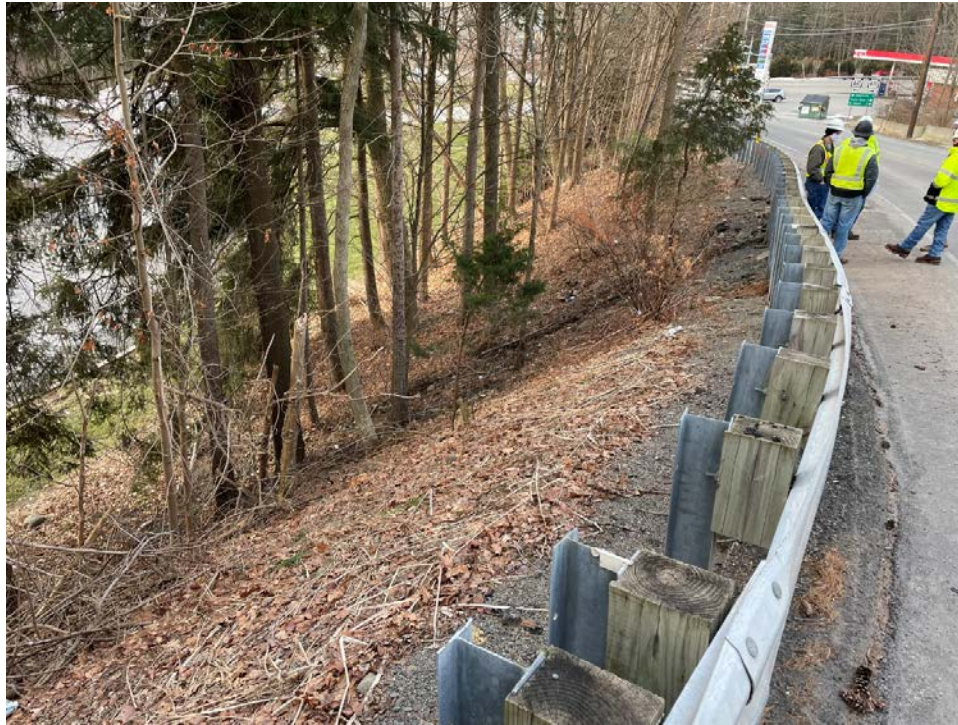
**Photo 3 – Slope to South of Gas Release Area**

- Observations of the open hole following the gas release incident revealed glacially derived materials (till) and bedding materials for the pipeline. It is likely that some of the till material was native and that some of the materials may have been placed as fill.
- Based on discussions at the site, it is understood that while the hole was open following the incident, a geologist working for UGI probed the hole with a rod and determined that conditions on the south side of the pipeline were significantly easier to penetrate with the rod when compared with the bottom or north side of the excavation.
- A relatively steep slope was noted to the south of the gas release incident area, south of the roadway. Surface erosion was evident along the surface of the slope adjacent to the roadway (see Photo 3, below).

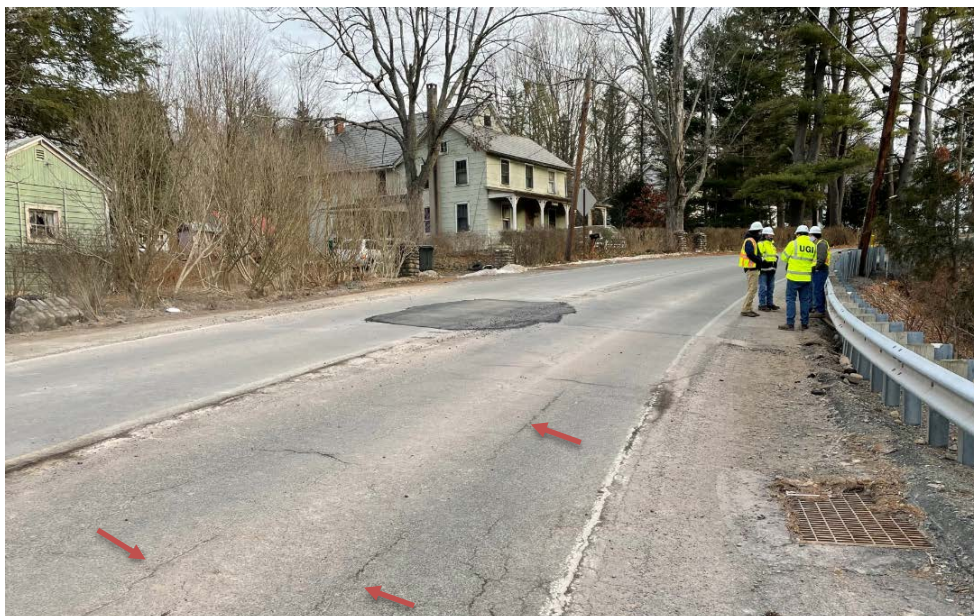
**Photo 4 – Cracking in Roadway Along Utility Trench Limits**

106. ARM explained that the observed cracking in the pavement was consistent with substandard compaction of soils above a utility trench, as well as normal wear and tear of an asphalt pavement in Northeastern Pennsylvania. See attached I&E Exhibit 7.

- Observations of the roadway revealed that buried utility line(s) were present in the east-bound lane of Lower Swiftwater Road and there was evidence of cracking of the asphalt along the observable length of the road, towards State Road 611. This was further evident in observations of earlier images of the area as seen in Google Map street-level view. The Google Map images were from July 2019 (see Photos 4 and 5, below).
