In re: Joint Petition of Pennsylvania-American Water Company and the Pennsylvania Department of Environmental Protection Requesting an *Ex Parte* Emergency Order in Regard to Receivership of East Dunkard Water Authority

Docket No. P-2023-3043950

This document provides the 60-day Initial Status Report required by the Order¹. Conditions found and actions taken are summarized in Section 2. Improvement projects are discussed in Section 3.

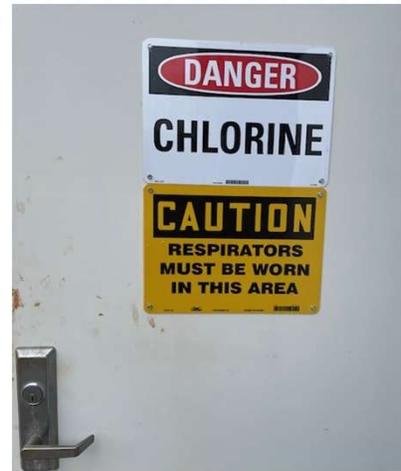
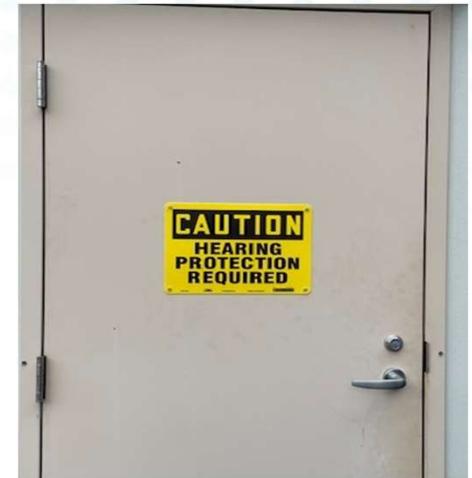
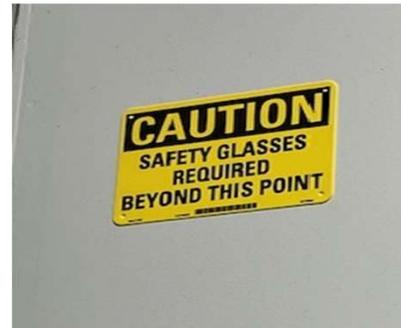
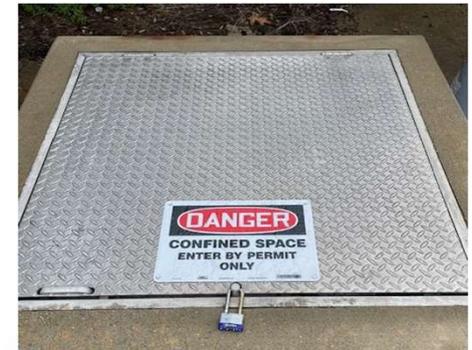
Issue: Safety signage not in place.

- PPE signage needed to identify PPE requirements.
- Signage not in place on exterior of chlorine room to identify chlorine hazard and PPE required.
- Confined spaces not labeled to identify requirements to protect personnel for entry.

Action Taken: Signage put in place to ensure personnel are aware of PPE requirements and hazards.

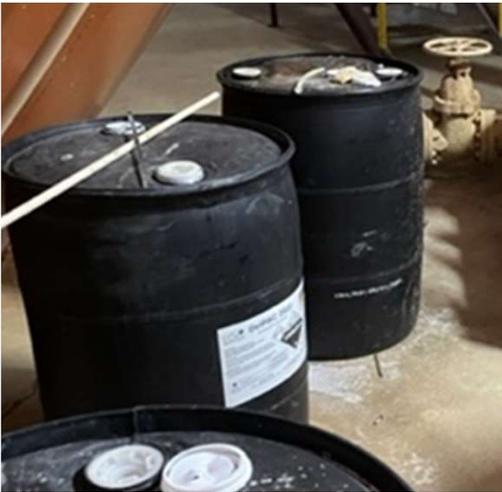
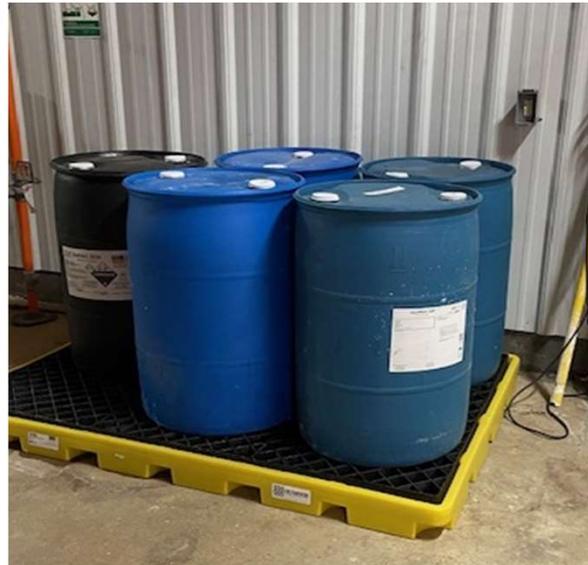
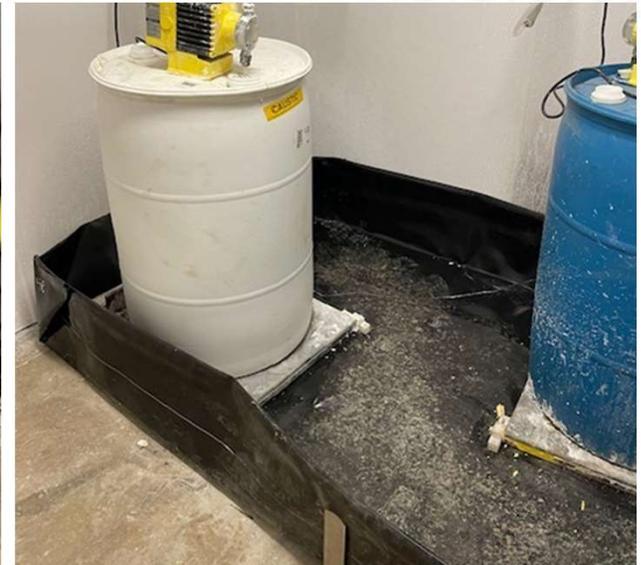
Photo 2 - Secondary Containment

Issue:

- Chemical Room did not have secondary containment in place.
- 55-gallon drums located around Clarifier without secondary containment.

Action Taken: Secondary containment installed outside Chemical room for 55-gallon drums.

Action Taken: Secondary containment installed in chemical room; plug installed in drain in chemical room floor.

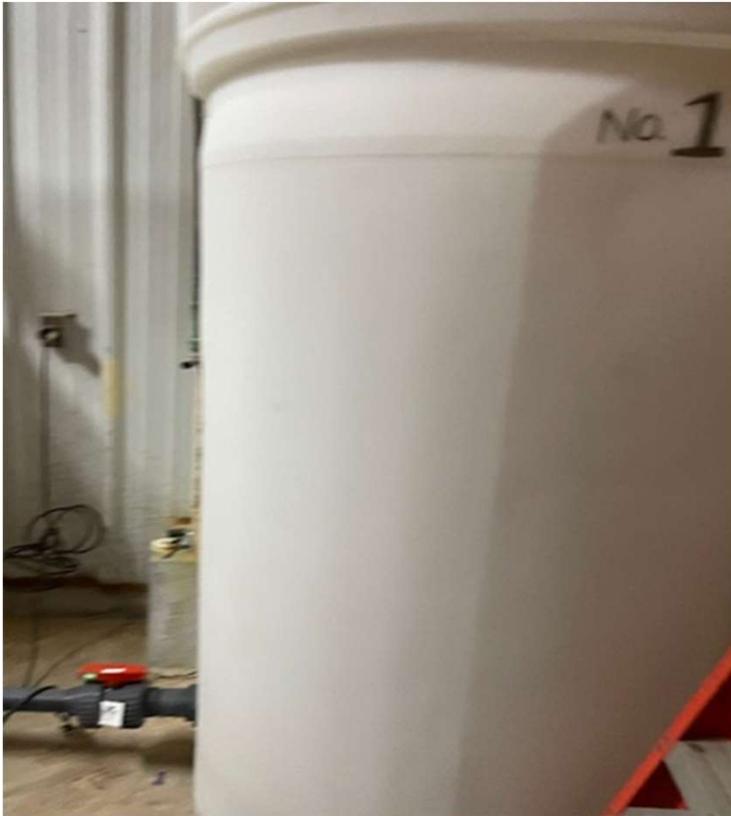
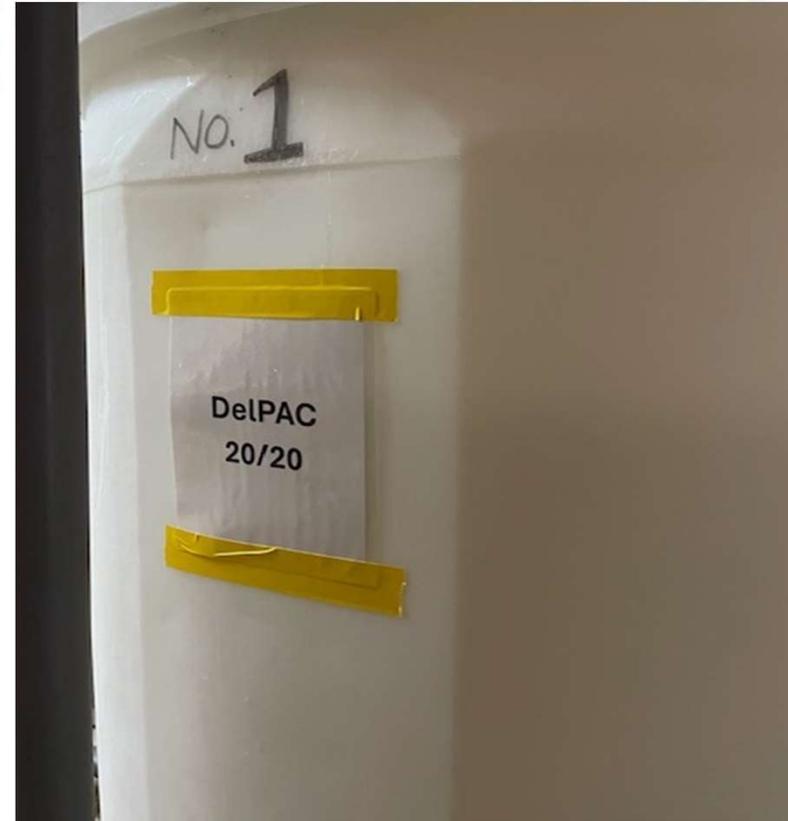
Photo 3 - Chemical Tank Labeling

Issue: Labeling not in place on chemical tanks.

Action Taken: Temporary labeling installed.

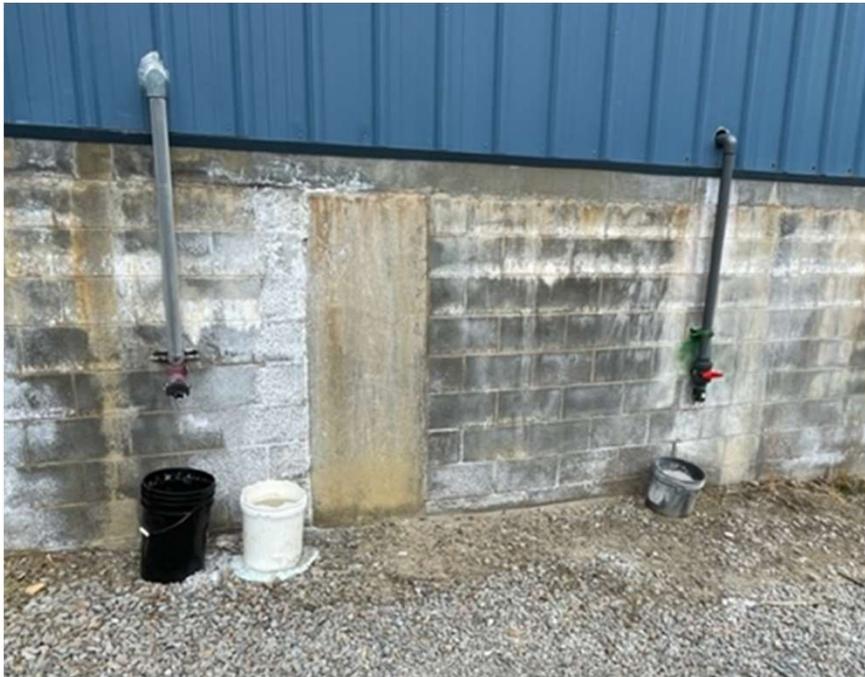
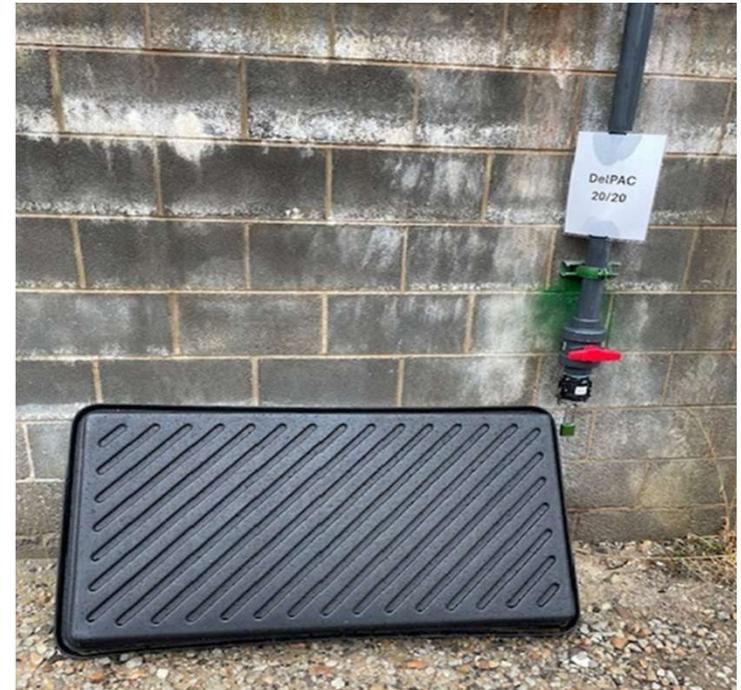
Photo 4 - Chemical Fill Ports / Unloading Area

Issue: Chemical unloading area missing signage and labels to prevent unloading into wrong tank, no locks in place, no containment catch trays in place.

7. Installed locks, labeled fill ports, and provided containment pan at chemical truck unloading area (photo 4).
8. Installed new leak detection system with emergency shut down, proper signage at entry door to identify hazard and PPE requirements, and new windsock identify wind direction in the event of an emergency (photo 5).

Action Taken: Locks installed, temporary signage in place, catch tray put in place for use while transferring chemical.

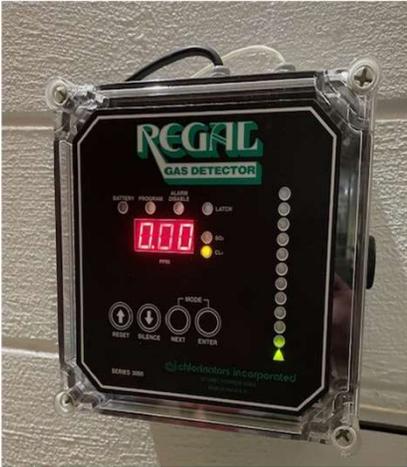
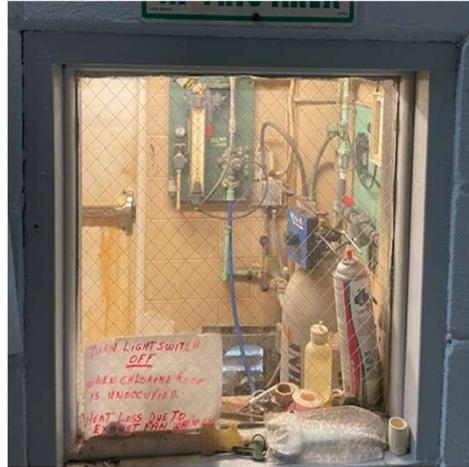
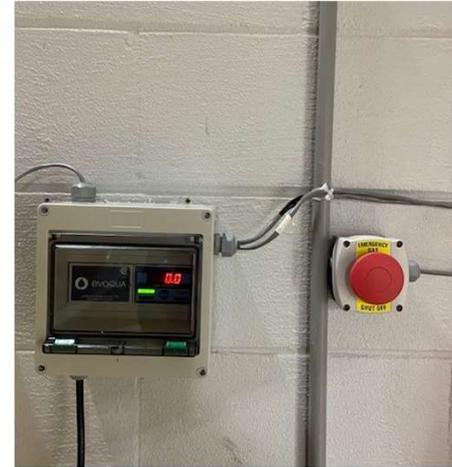
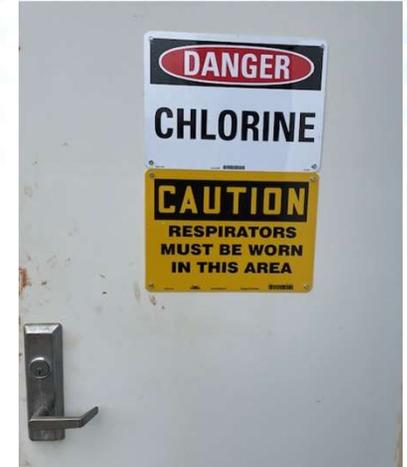
Photo 5 - Chlorine Gas Safety

Issue: No calibration records for chlorine leak detection system, no halogen valve in place, exterior has no signage in place. No windsock in place to identify wind direction in the event of a release.

Action Taken: Halogen valve installed. Leak detection system with emergency shut down installed. Proper signage installed at entry door to identify the hazard and PPE requirements. Windsock installed to identify wind direction in the event of an emergency.

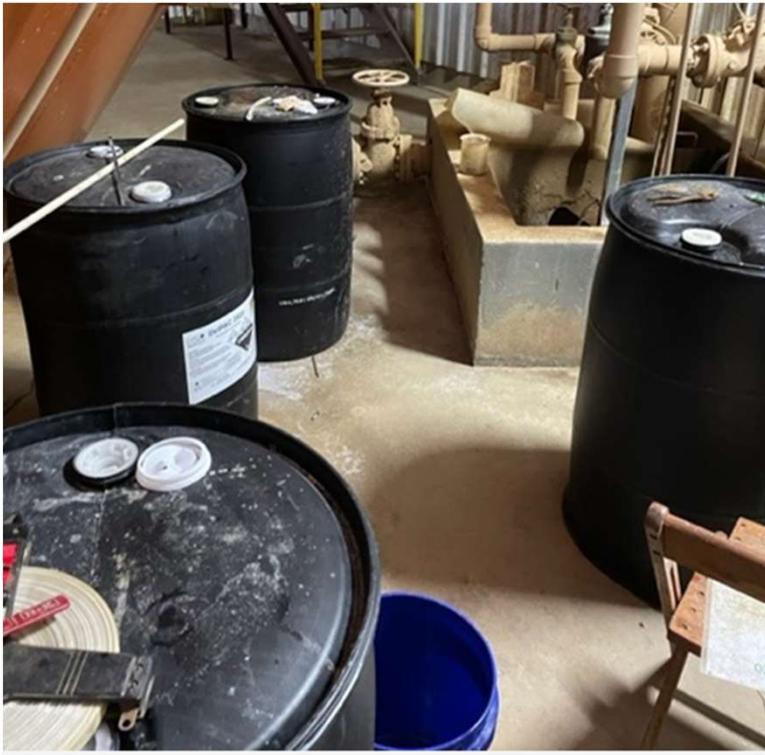
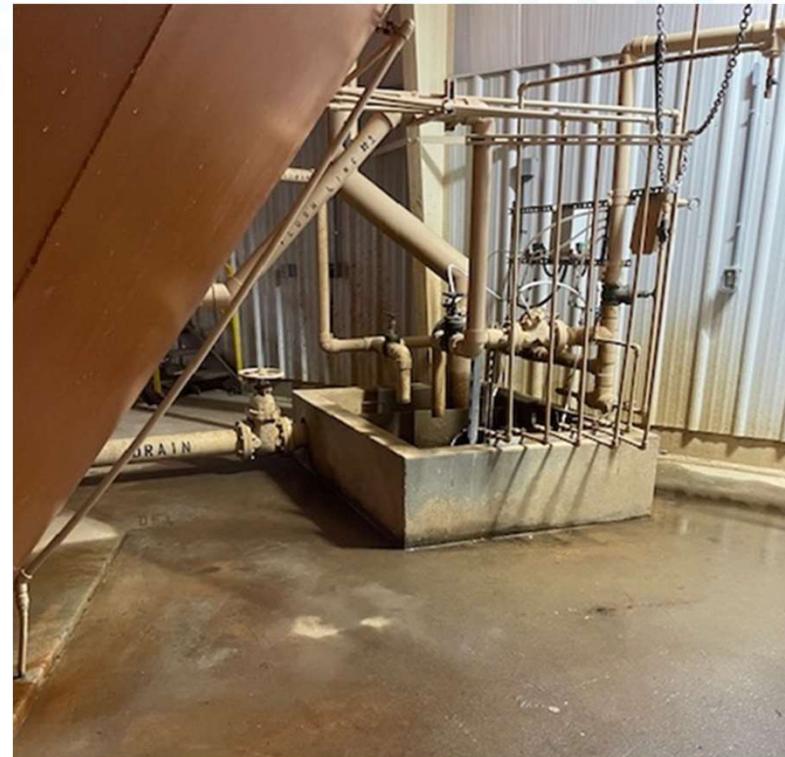
Photo 6 – Waste Chemicals

Issue: 15 drums and 2 day-tanks on facility need properly disposed.

9. Removed fifteen (15) drums and two (2) large day tanks of waste chemicals from plant; packaged and ready for disposal by hazardous materials contractor (photo 6).

Action Taken: Waste being properly removed from facility and disposed.

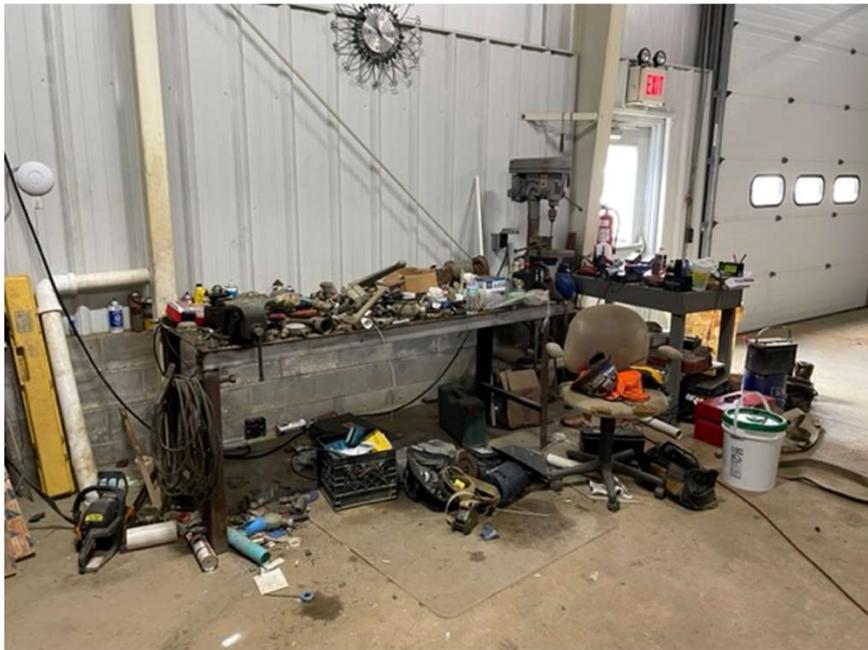
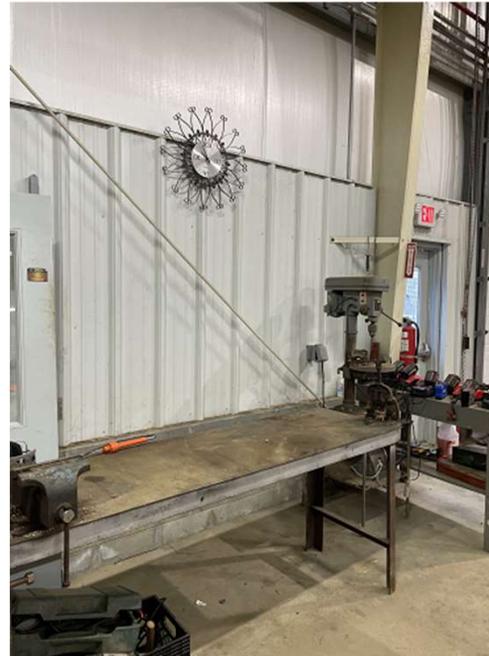
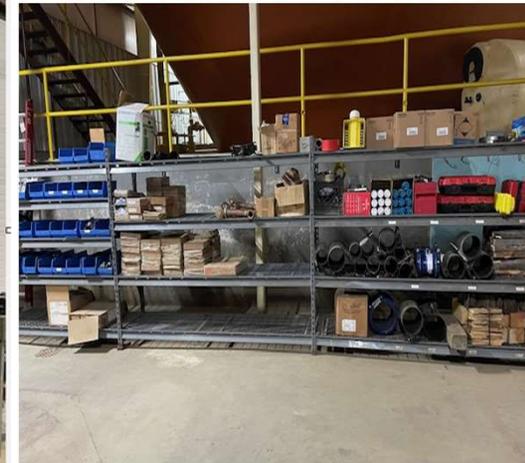
Photo 7 - Housekeeping Slip/Trip/Fall Hazards

1. Poor housekeeping presented slip/trip/fall hazards throughout the facility.
2. Dangerous stairway leading to river sampling location.
3. Dangerous platform leading to lagoon sampling location.

Issue: Material throughout garage area creating potential slip, trip, fall hazards.

Action Taken: Housekeeping conducted at facility to eliminate potential slip, trip, fall hazards.

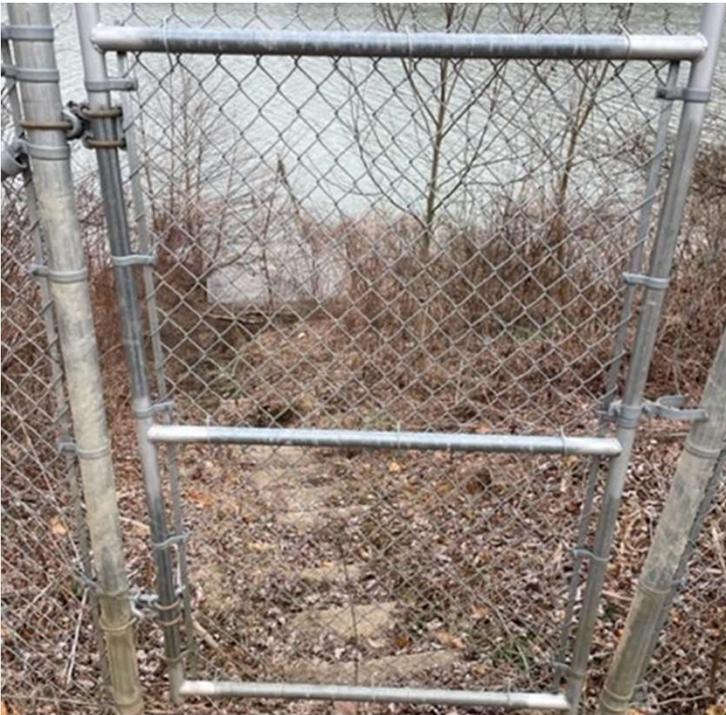
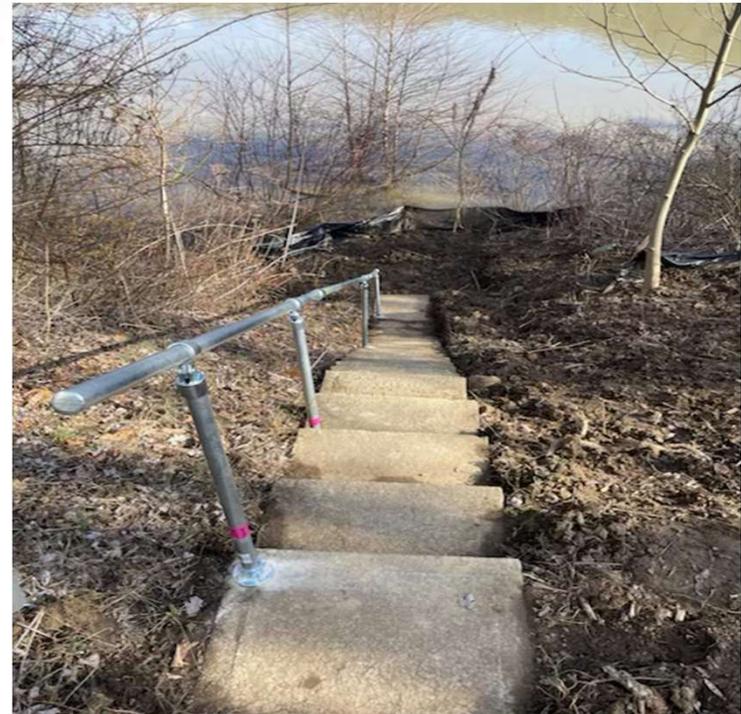
Photo 8 - Stairway to River Sampling Location

Issue: Steps buried with no handrail in place. Access needed for sampling.

Action Taken: Debris/material removed from stairway; guardrail installed for safe access.

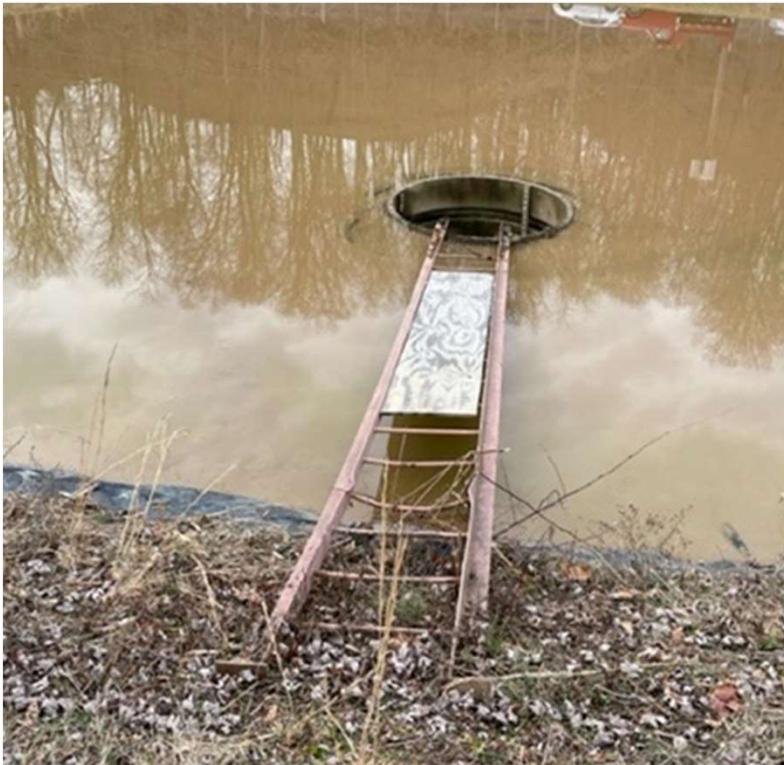
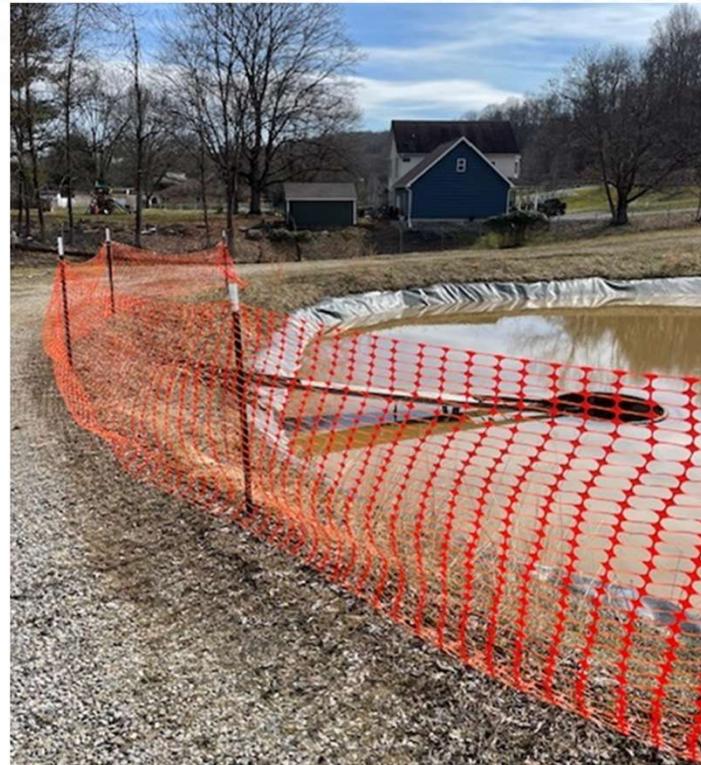
Photo 9 – Platform to Lagoon Sampling Location

Issue: Improper walking platform for sampling. Missing guardrails, material used is not designed for use as a walking platform.

Action Taken: Initial action taken. Area barricaded off; platform not permitted to be utilized.

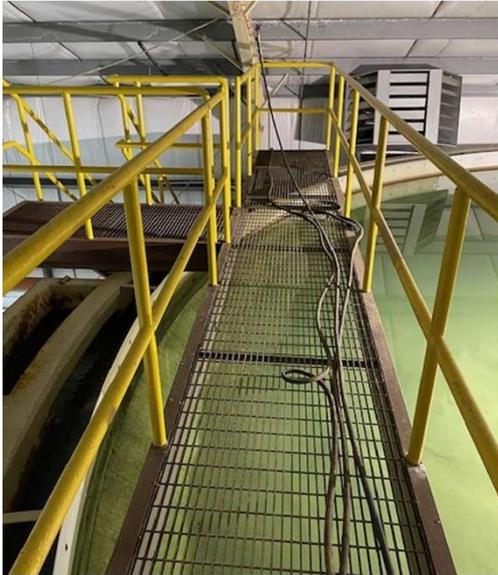
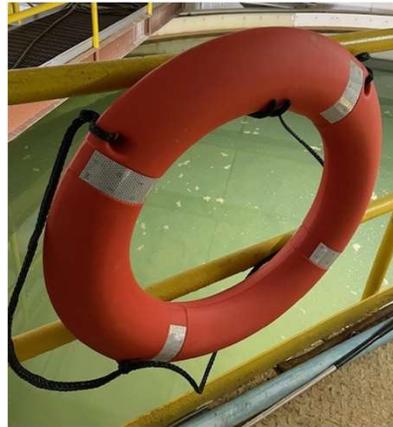
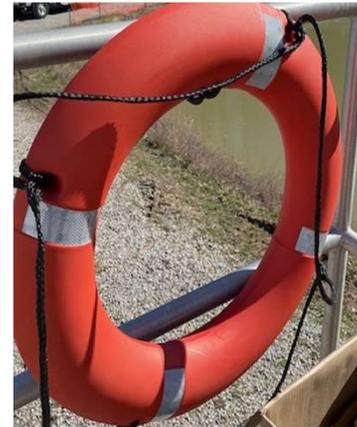
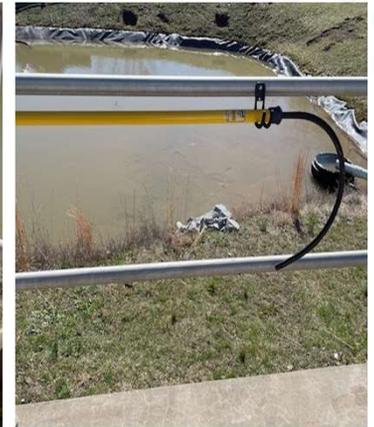
Photo 10 – Life Rings/Rescue Hooks

4. No life rings or rescue hooks for a fall into clarifier, filters or lagoon.
5. Missing section of guardrail on clarifier platform.
6. Guardrails on elevated platforms were missing kick plates which presents a hazard to employees from falling tools/equipment.
7. Several trip hazards due to deteriorated grating/concrete and uneven surfaces.
8. Inadequate lighting inside and outside plant.
9. Unsafe and unpassable access road leading from public road to Griffin Tank and its critical entry point sampling location.

Issue: No life rings/rescue hooks in place for the filters, clarifier or lagoon.

Action Taken: Rescue hook onsite. Life Rings installed at the filters, clarifier, lagoon for rescue.

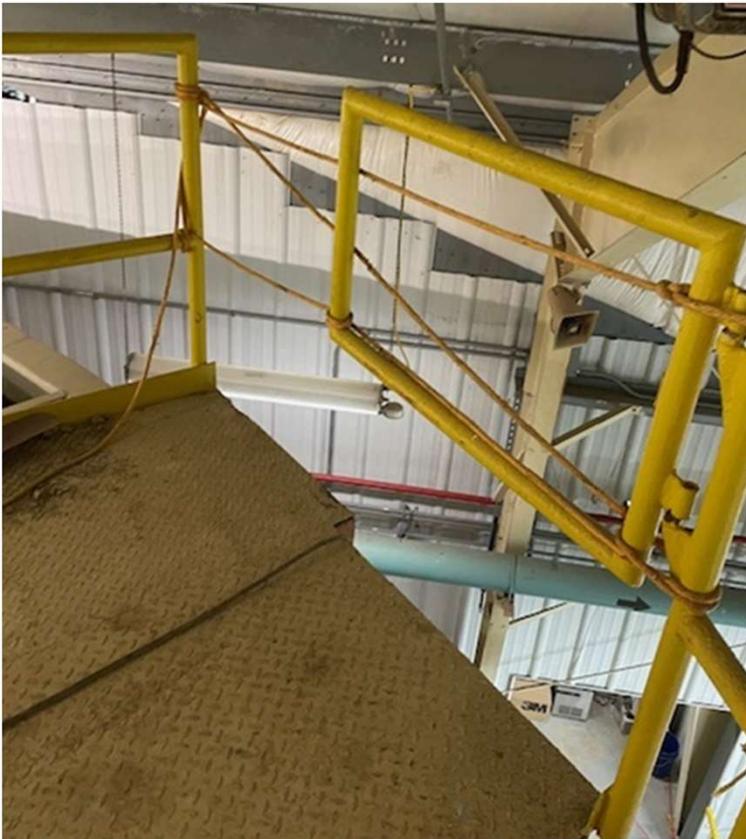
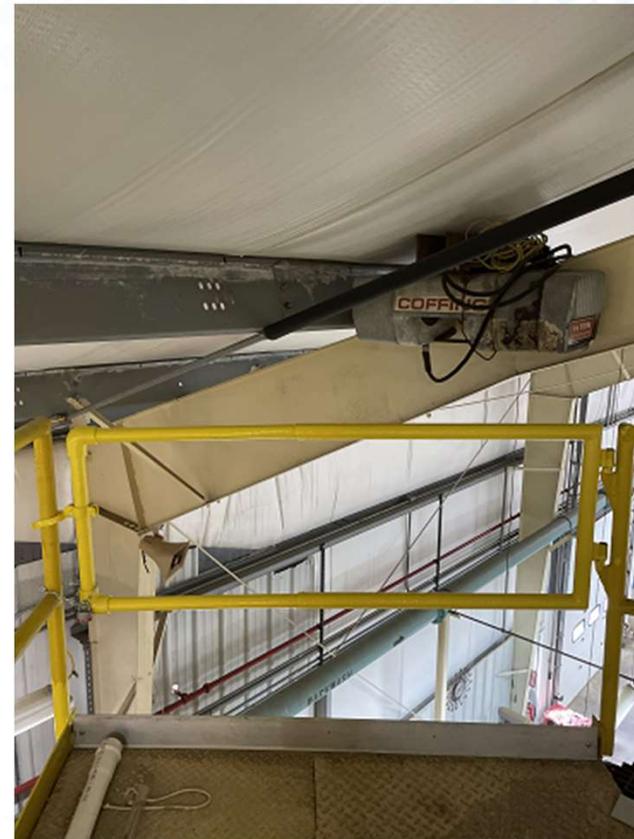
Photo 11 – Clarifier Platform Guardrail

Issue: Fall hazard from unprotected guardrail.
Temporary rope protection in place.

Action Taken: Guardrail extended for complete protection.

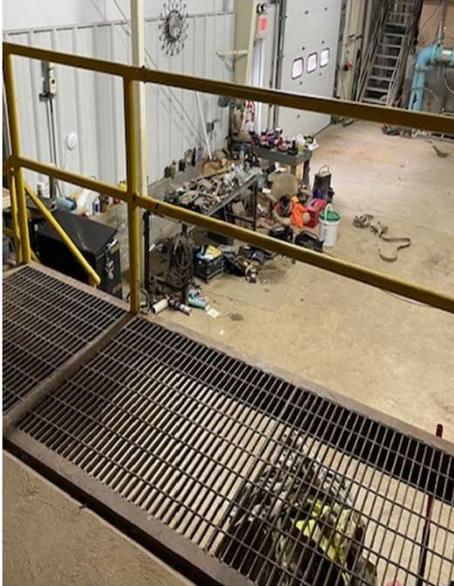
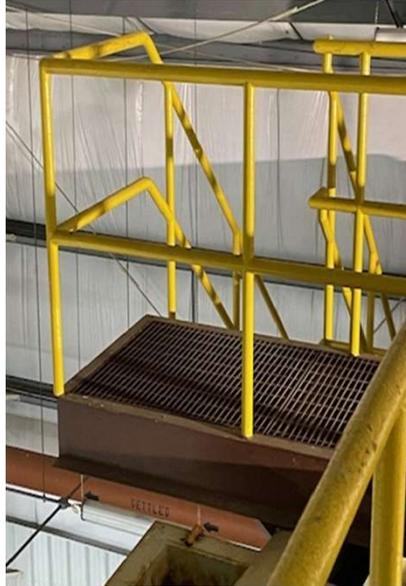
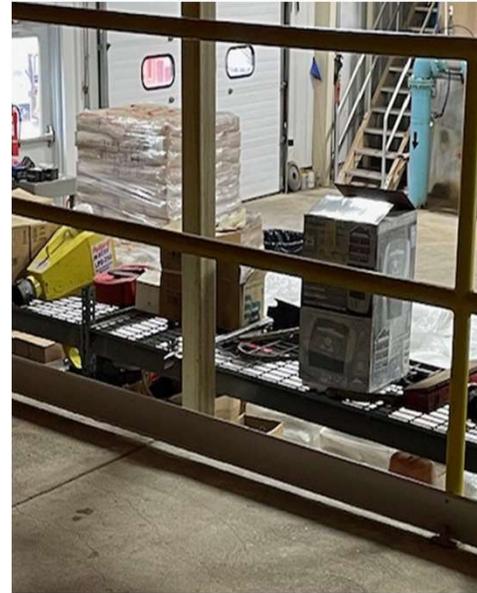
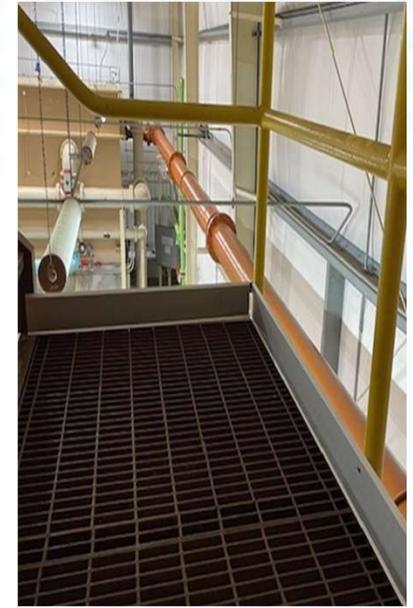
Photo 12 – Guardrail Kick Plates

Issue: Guardrails missing kick plates.

Action Taken: Kick plates installed on guardrails to prevent tools/material falling and impacting personnel.

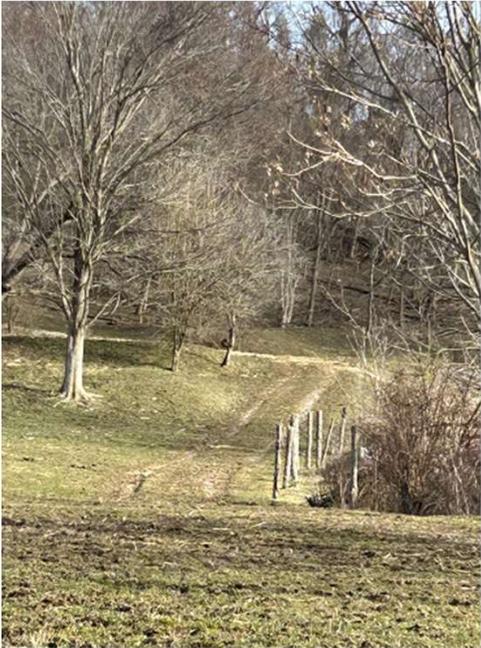
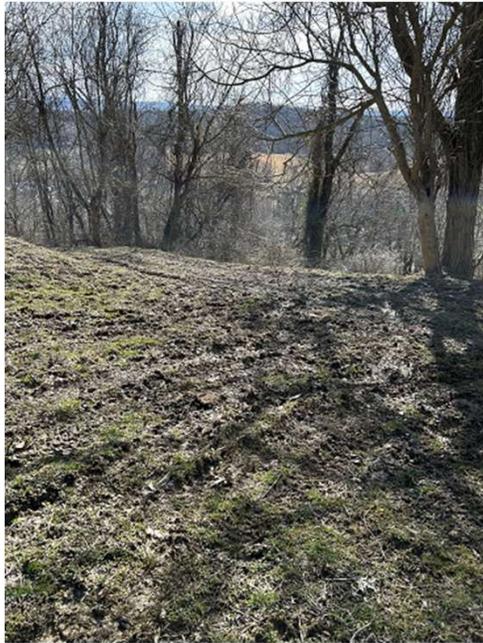
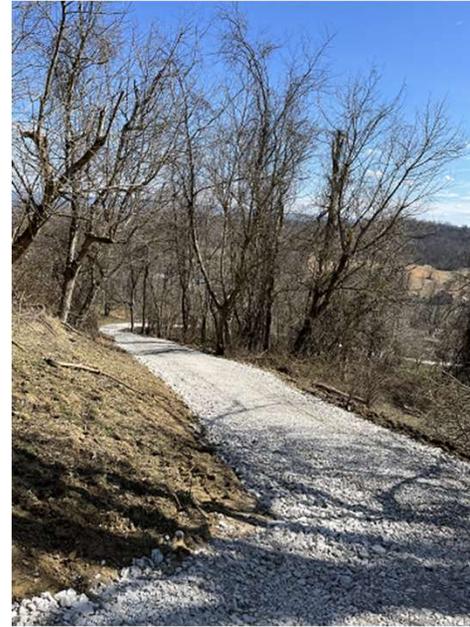
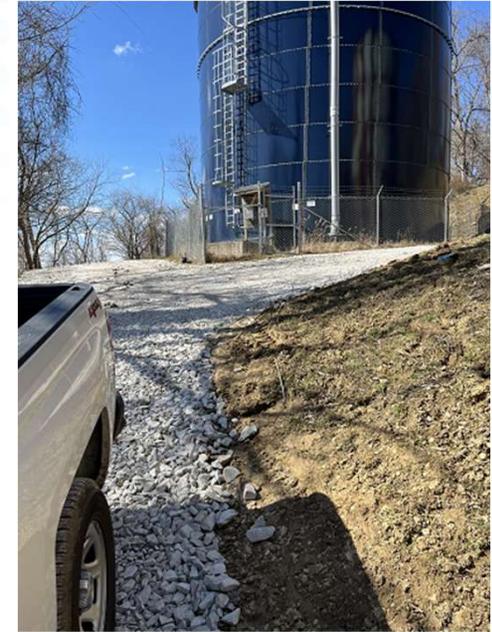
Photo 14 – Griffin Tank Access Road

Issue: Unimproved dirt road through pasture was unsafe and not suitable for vehicle passage to Griffin Tank (system's entry point for sampling).

Action Taken: Regraded roadway and installed new gravel surface for safe passage of vehicles.

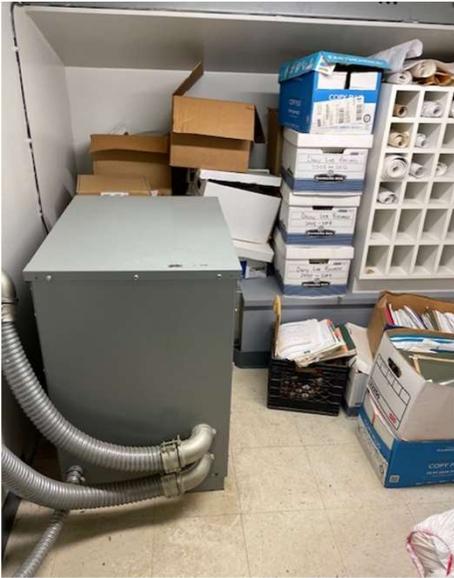
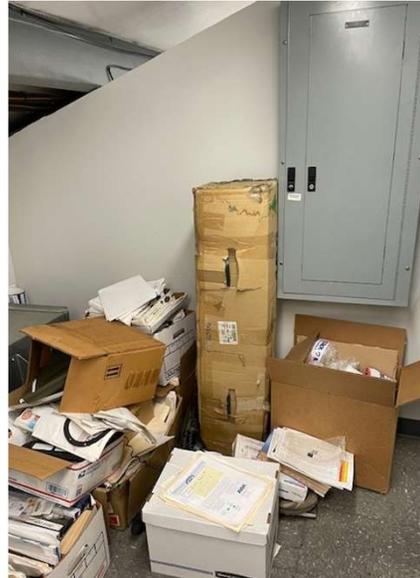
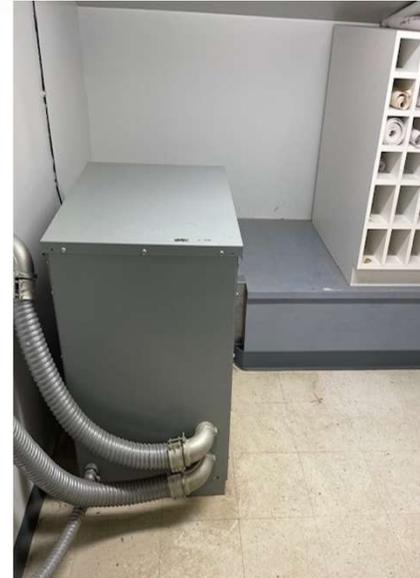
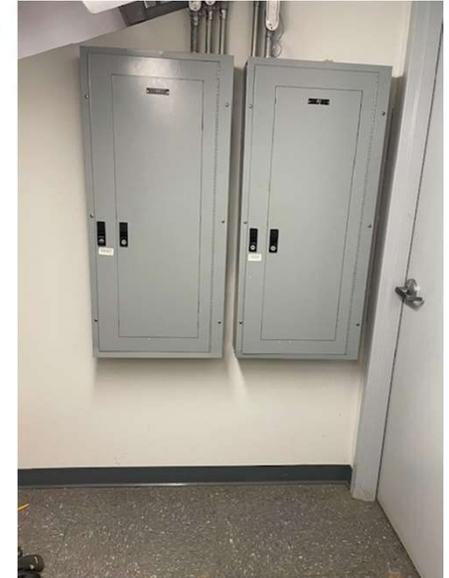
Photo 15 – Electrical Fire Hazards

1. Several overheated extension cords and inoperable electric outlets.
2. Boxes of paper stored next to transformer and breaker panel.
3. Missing guard on rotating part (clarifier mixer motor) presents pinch injury potential.
4. No electric shock protection mats in place near high risk electrical

Issue: Potential fire hazard due to paper/boxes stored next to transformer and breaker panel.

Action Taken: Material removed to eliminate potential fire hazard.

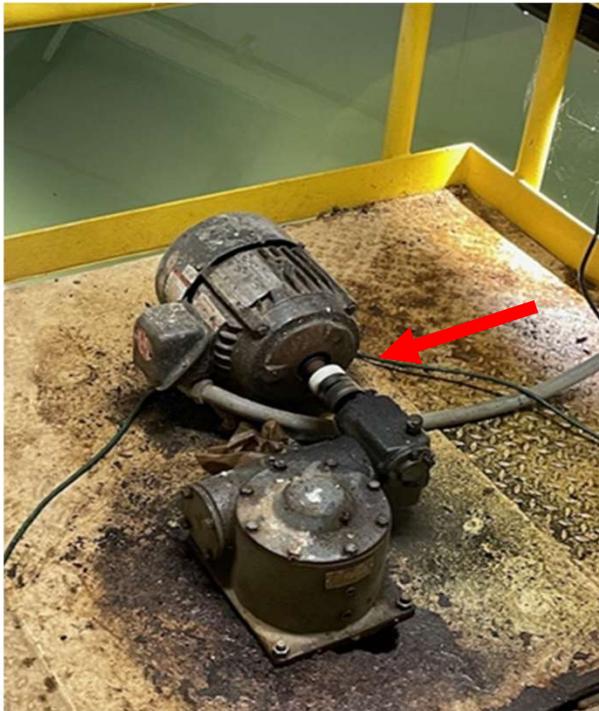
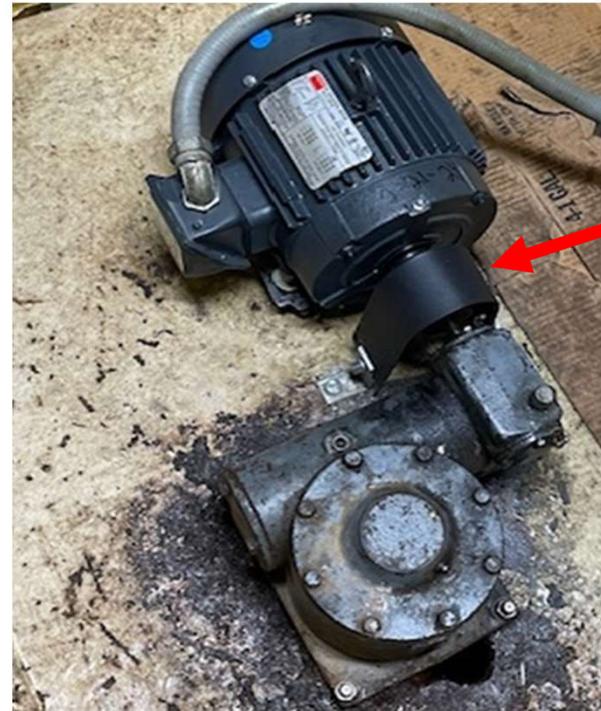
Photo 16 – Clarifier Mixer Motor Rotating Parts

Issue: Mixer motor missing guard on rotating part.

1. Initiated a steady state operation at lower production flow rate that has eliminated routine plant shutdowns entirely.
2. Replaced motor and controller on clarifier mixer (photo 16), purchased spare motor, ordered new gearbox, and reversed the rotation of the mixer to match manufacturer's specifications.

Action Taken: Initial protective guard installed.

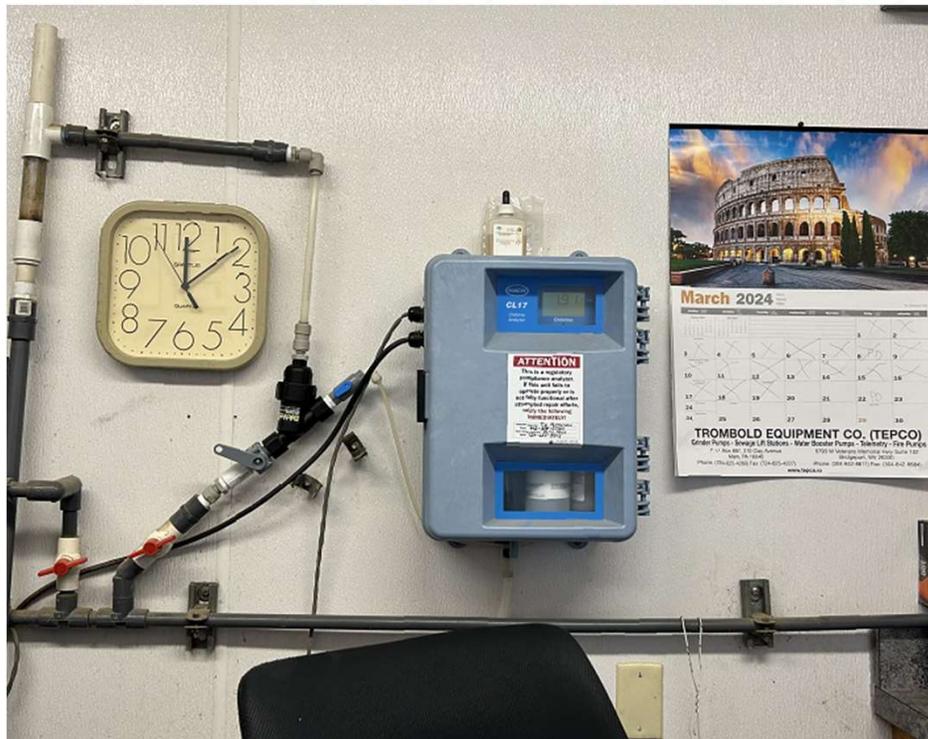
Photo 18 – Clearwell Chlorine Residual Analyzer

1. No real-time process monitoring in place for treated water (clearwell) quality.
2. One of two high service pumps was down and out for repair since October 2023, resulting in no redundancy on pumping operations to serve customers.
3. No backflow prevention or metering in place on finished water

Action Taken: Installed sample pump, turbidimeter and chlorine residual analyzer (shown) to monitor clearwell water quality.

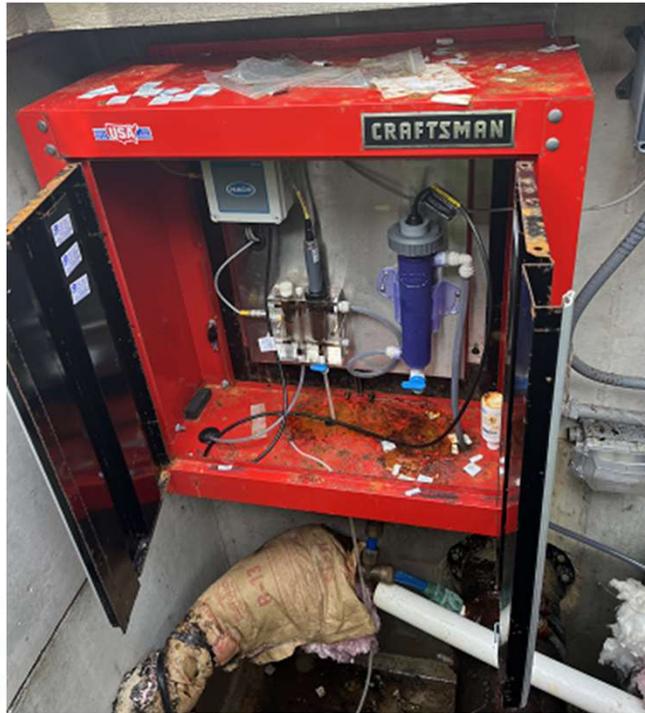
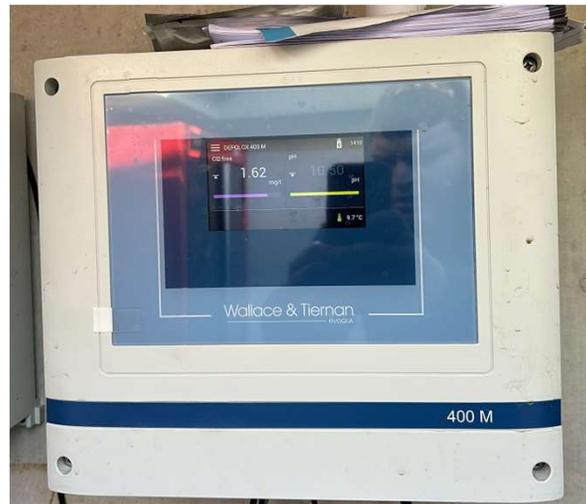
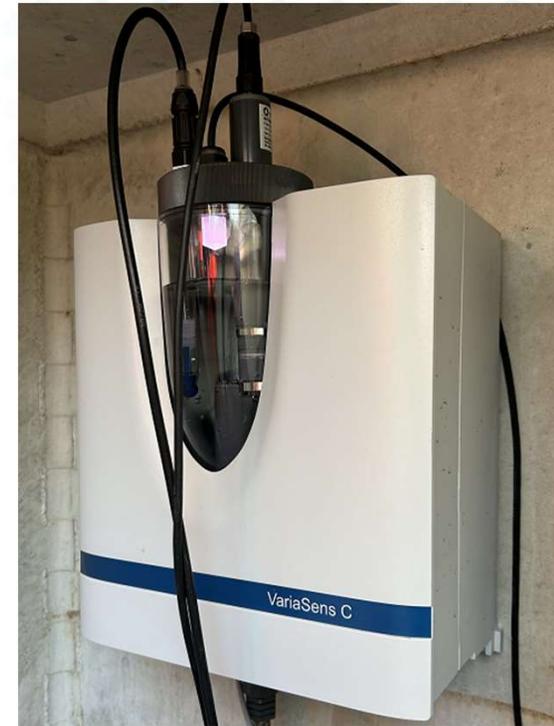
Photo 19 – New Entry Point Chlorine Residual Analyzer

4. Entry point sample location at vault on effluent line from Griffin Tank was producing poor quality water due to tap age, condition and location. The current Hach CL10 analyzer at entry point vault is in poor condition and needs to be replaced.

Issue: Entry point chlorine residual analyzer in poor condition and not reliable.

Action Taken: New Depolox chlorine residual analyzer installed on new sample tap.

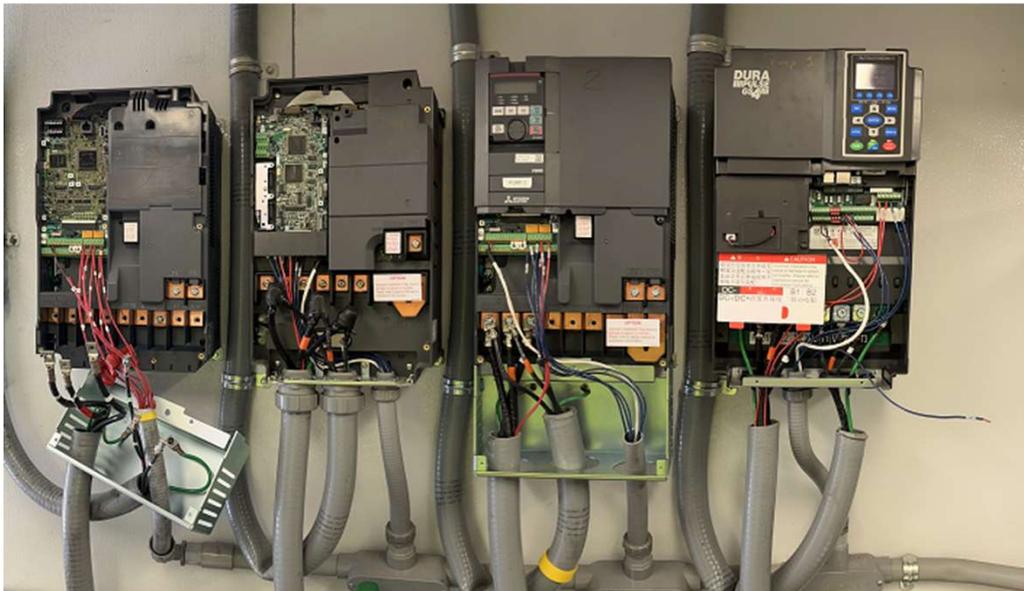
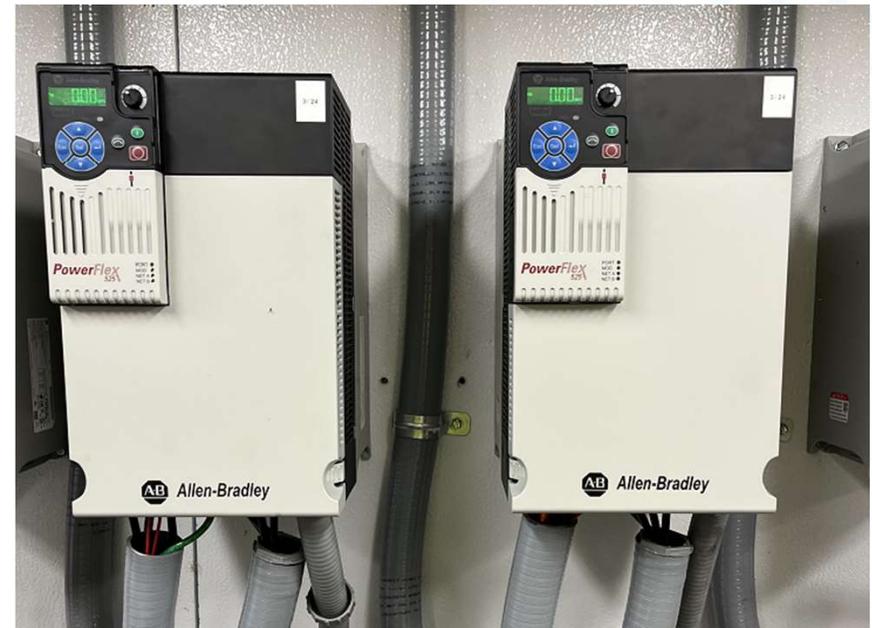
Photo 20 – Repairs to Willowtree Pump Station

1. Failed electrical equipment at Willowtree pump station is preventing it from operating as designed. Water is being purchased from Southwest Water Authority (“Southwest”) as a result.
2. One of the two 1994-vintage pumps at the Bald Hill pump station have failed and there is no redundancy.
3. Unknown accuracy of the storage tank level readings.

Issue: Station inoperable due to failed VFDs.

1. Rewired and replaced four failed variable frequency drives (“VFD”) and replaced two check valves (photo 20). Activated the pump station and made valve adjustments to eliminate the use of purchased water in the Clark Tank service area. Plans are being developed to discontinue the remainder of the purchased water from Southwest.
2. Applied for and received emergency permit from Department to replace two pumps at Bald Hill pump station. Ordered new pumps.
3. Performed field evaluation of all storage tanks to confirm water level reading accuracy. Alicia Tank levels are not accurate and need to be remedied. All others were accurate.

Action Taken: New VFDs installed and station is now operational. Purchased water expense is being reduced.

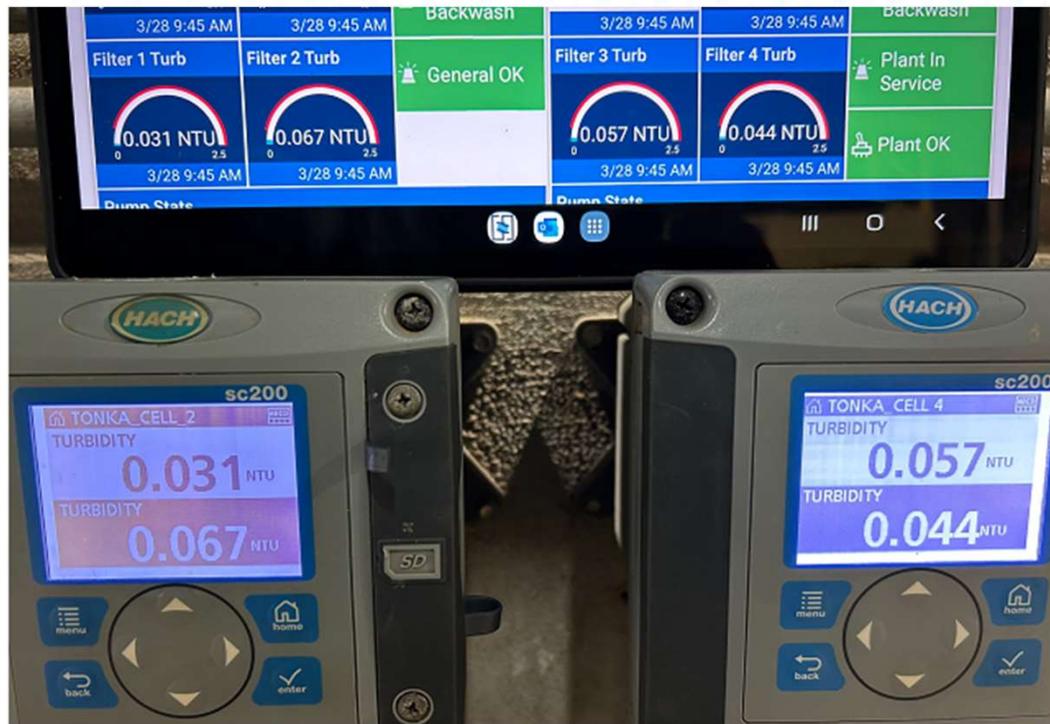
Photo 21 – Turbidimeter/SCADA Accuracy Verification

2. All four IFE turbidimeters had signal-averaging enabled in the instruments. Filter 1 was set to 30 seconds, filter 2 and 3 were 60 seconds, and filter 4 was 90 seconds. Signal averaging during periods of steady plant operation can cause readings in the SCADA systems to not update for long periods of time, unless and until there is a significant change in water quality.

Action Taken: Calibrated the analog output from the IFE turbidimeters and changed the spanning of analog turbidimeter signals in the SCADA system from 0-10 NTU to 0-2.5 NTU. Verified accuracy.

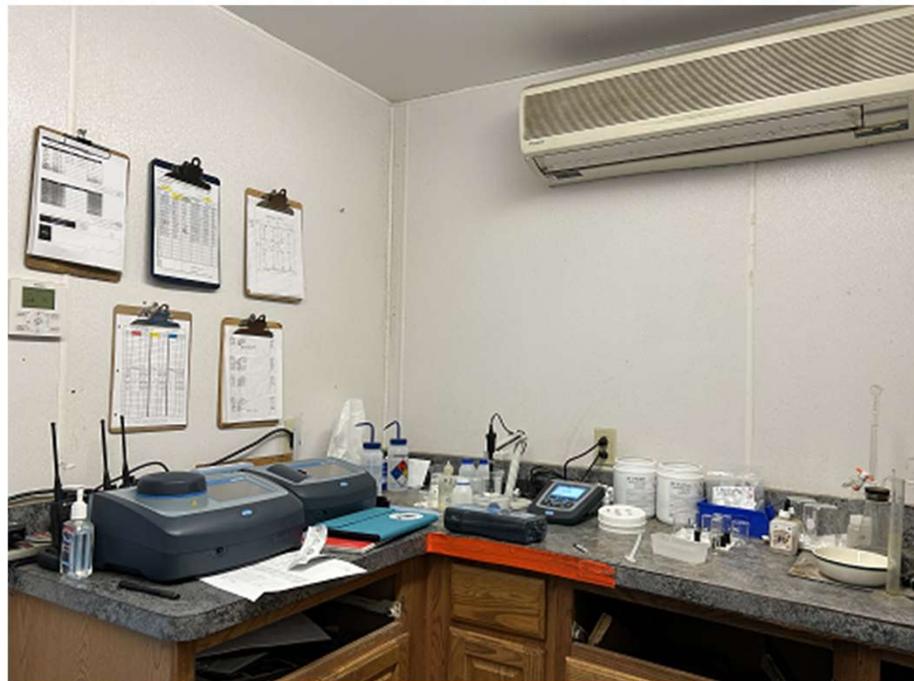
Photo 23 – New Lab Equipment & Calibration Logs

1. Not capable of performing process control tests for manganese due to off-gassing in lab area.
2. Low on lab supplies and reagents.
3. Bench pH meter and bench turbidimeter were in poor condition and not calibrated regularly.
4. No SOPs were in place for laboratory operations.

Action Taken: Purchased new bench turbidimeter, spectrometer and pH meter. Prepared and posted calibration log sheets for operator use.
