Re: Michael and Sharon Hartman v. PPL Electric Utilities Corporation
Docket No. C-2019-3008272

Subject: Summary Report - Stormwater Evaluation at
1650 Primrose Lane, Middle Paxton Township,
Dauphin County, Pennsylvania (the Site or Subject Property)

EXECUTIVE SUMMARY

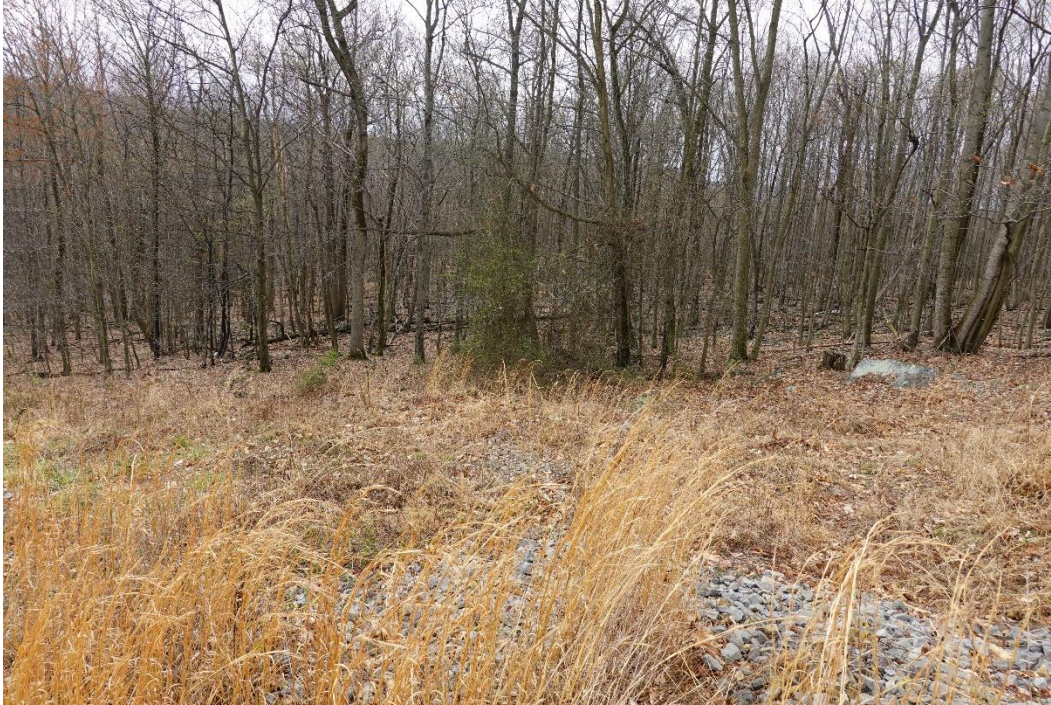
The erosion that was observed in this ROW is higher in elevation than the Subject Property but is located too far east of the Subject Property to have a contributing effect on runoff that makes its way to the Subject Property. This was observed in the field and confirmed with lidar-based topographic contours available for the area. There were no signs of significant migration of stone outside of the PPL EU ROW, but there was evidence of stone from the roadway along the access road within the PPL EU ROW.

Photo 1:
Signs of roadside
stone deposition from
500kv ROW

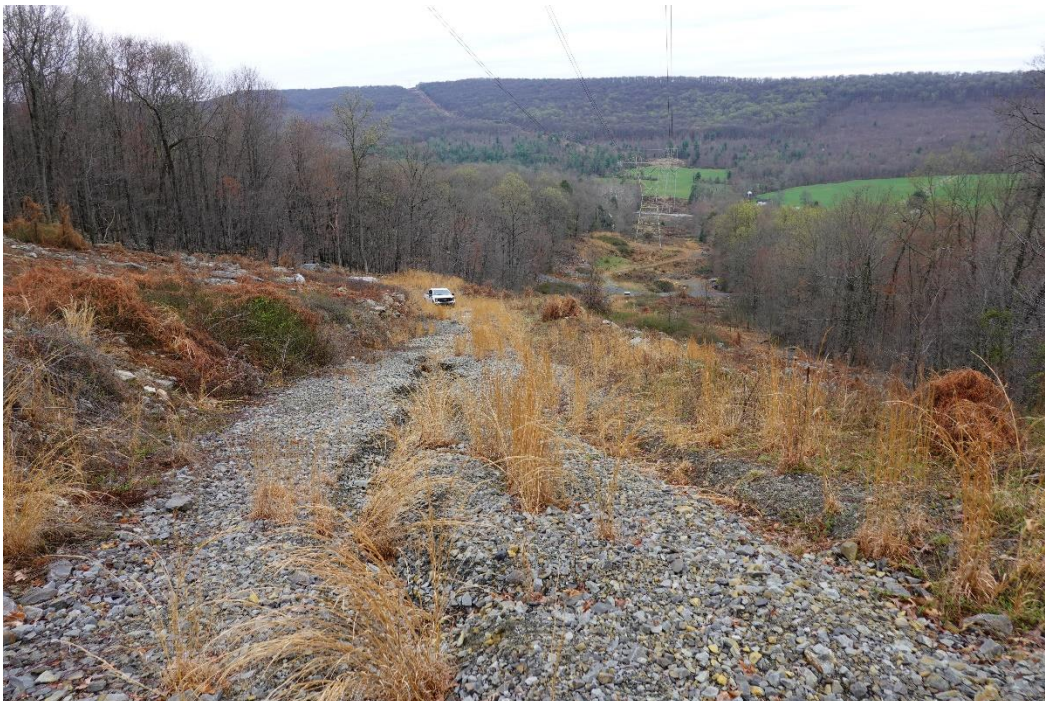
There were large erosion rills located down the middle of the access road to the 500kv structures at the top of the slope leading down to Linden Lane. There were the remnants of several mountable berms from work conducted along this right of way, but these berms were not adequately directing runoff away from the roadway. Instead, runoff is concentrated along the roadway and is scarifying away the road stone. This process has likely worsened over the years to the point where the road is not currently navigable with a standard off-road pickup truck.

Photo 2:
Significant road
erosion along the
center of the 500kv
ROW access route

Waterbars or mountable berms, spaced per the relevant PADEP Erosion and Sediment Control Manual details, could be installed along the former access road that traverses the 500kv ROW. To provide runoff that is dispersed and stabilized into sheet flow before hitting the stable forested area downslope of the ROW, appropriately sized riprap aprons or rock filters could be placed on the downslope side of the waterbars. A waterbar placed on the highest point of the access road that leads between the 500kv ROW and 69kv ROW could also increase the likelihood of runoff from this ROW staying close to the 500kv ROW. However, this road is cross sloped toward the bottom of the hillside, so it is unlikely that much, if any, runoff accumulates along this former access road. The cross slope of the road can also be increased as a more conservative solution to prevent runoff from the 500kv ROW from entering the 69kv ROW.

Penn E&R recommends that PPL EU stabilize and restore the eroded access road within the 500kv ROW with the solutions contained in this report. We recommend that no changes to the 69kv ROW be made, as they would have the potential to adversely affect high quality water features located downslope of this ROW.

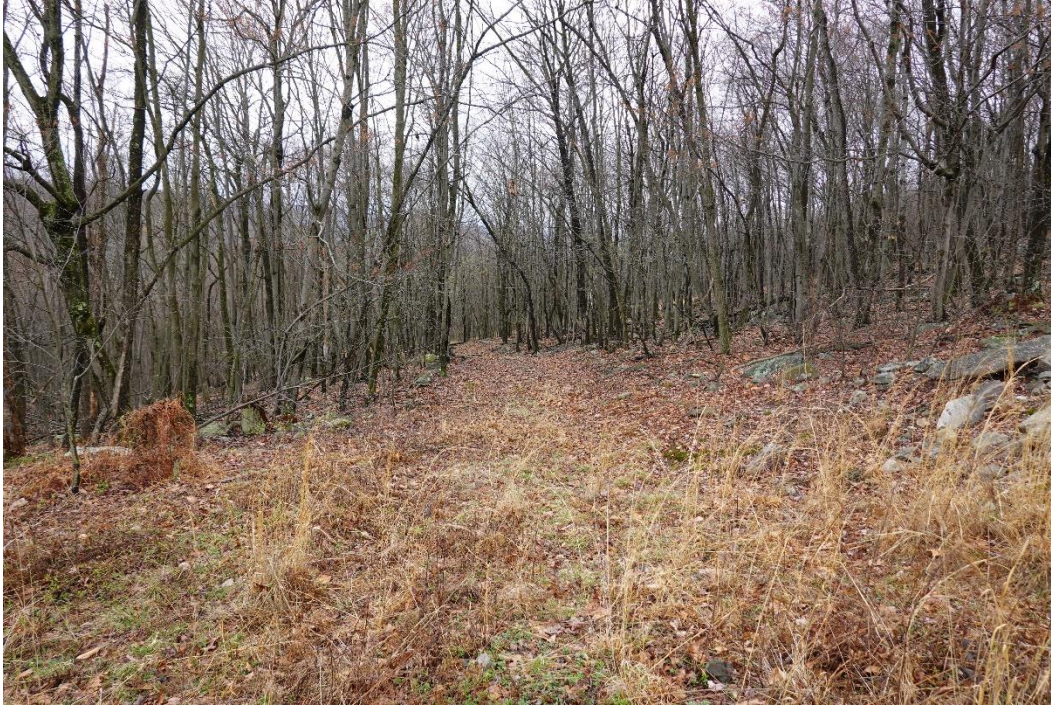
Photo 3:

There is a dirt roadway that formerly connected the 69kv ROW to the 500kv ROW. This roadway historically appeared to traverse what is now the pad for structure #76. The road is cross sloped downslope making it very unlikely for stormwater to concentrate along this corridor and make its way from the 500kv ROW to the 69kv ROW.

Existing access through 69kv ROW that existed before PPL EU rebuild. Road is cross sloped to the south.

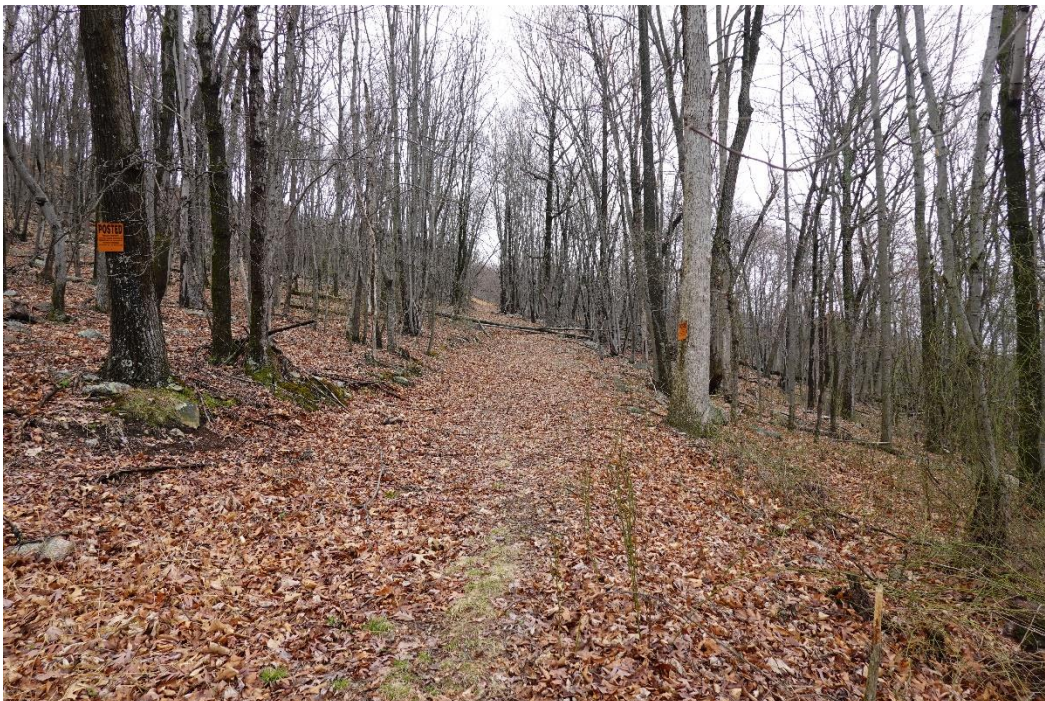
Photo 4:

Downslope side of existing access connecting the 500kv ROW to the 69kv ROW. No signs of erosion or sediment deposit

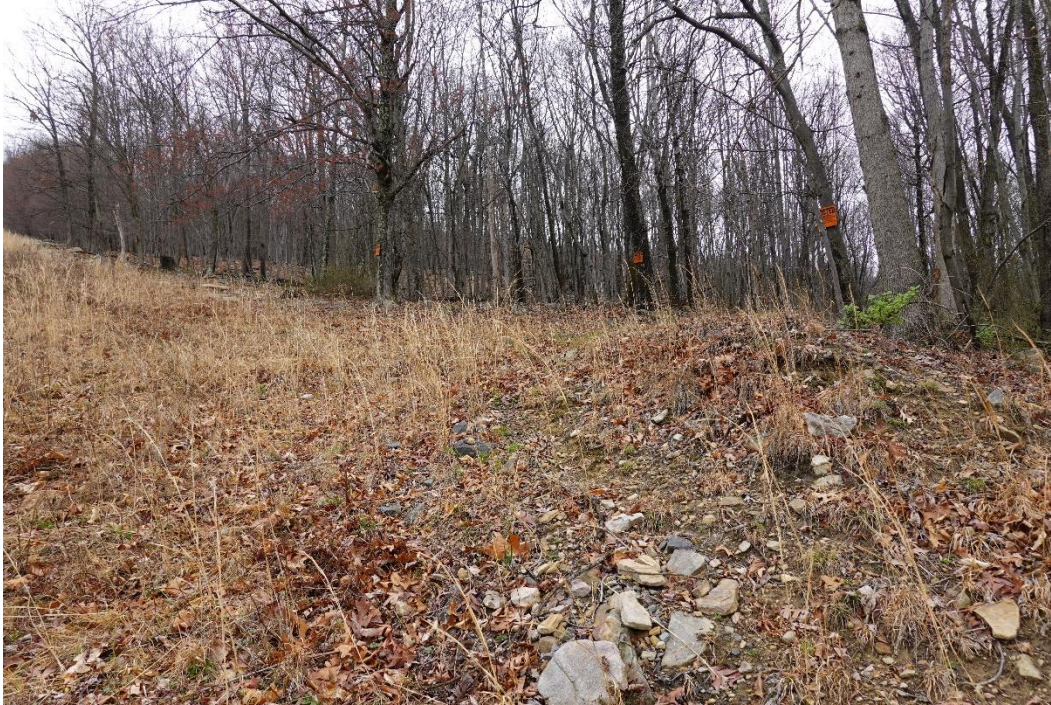
Photo 5:

Downslope side of existing access connecting the 500kv ROW to the 69kv ROW. No signs of erosion or sediment deposit

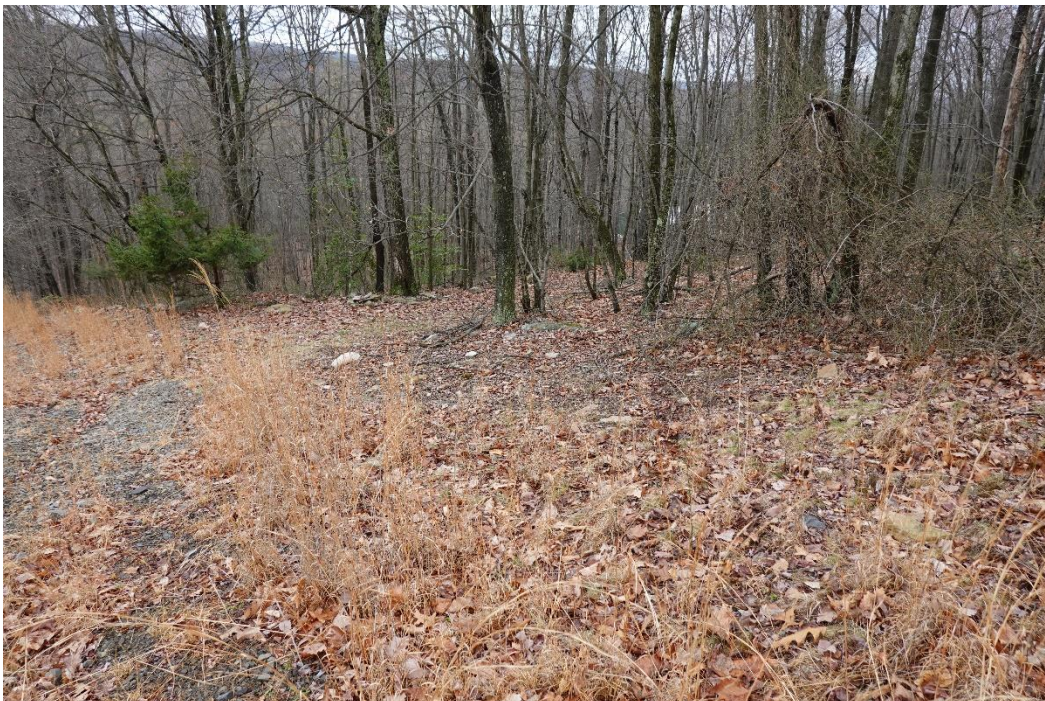
Photo 6:

Historic access road that continues to the subject property from the 69kv ROW. No observed signs of accelerated stormwater or erosion.

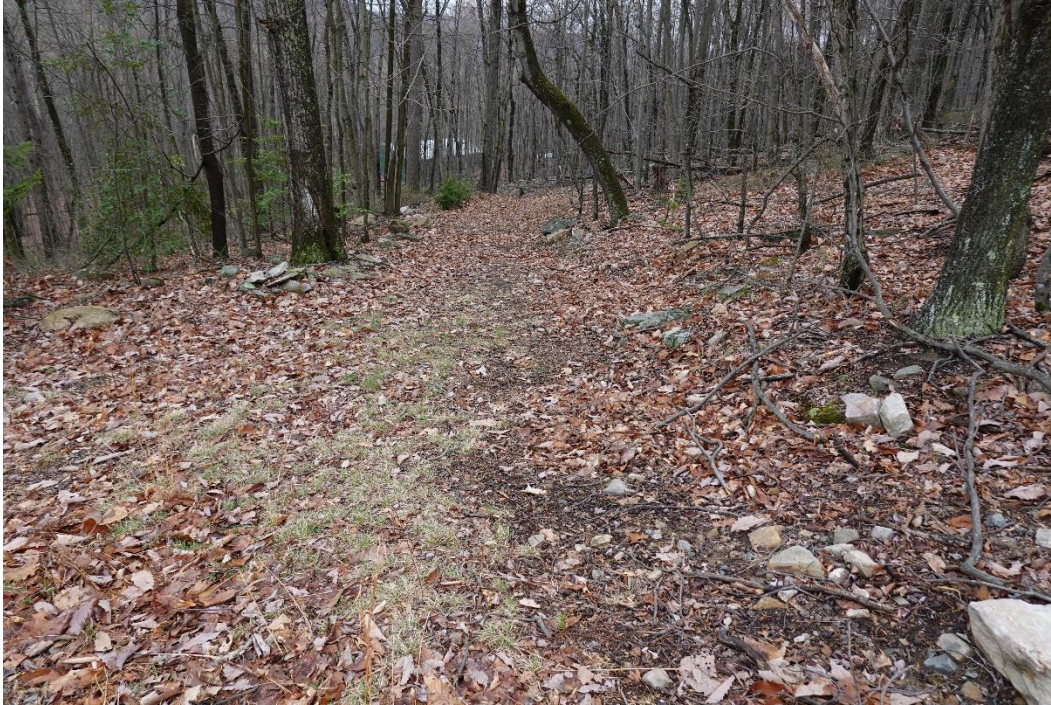
Photo 7:

Historic access road that continues to the subject property from the 69kv ROW. No observed signs of accelerated stormwater or erosion. Some signs of seasonal vegetative growth.

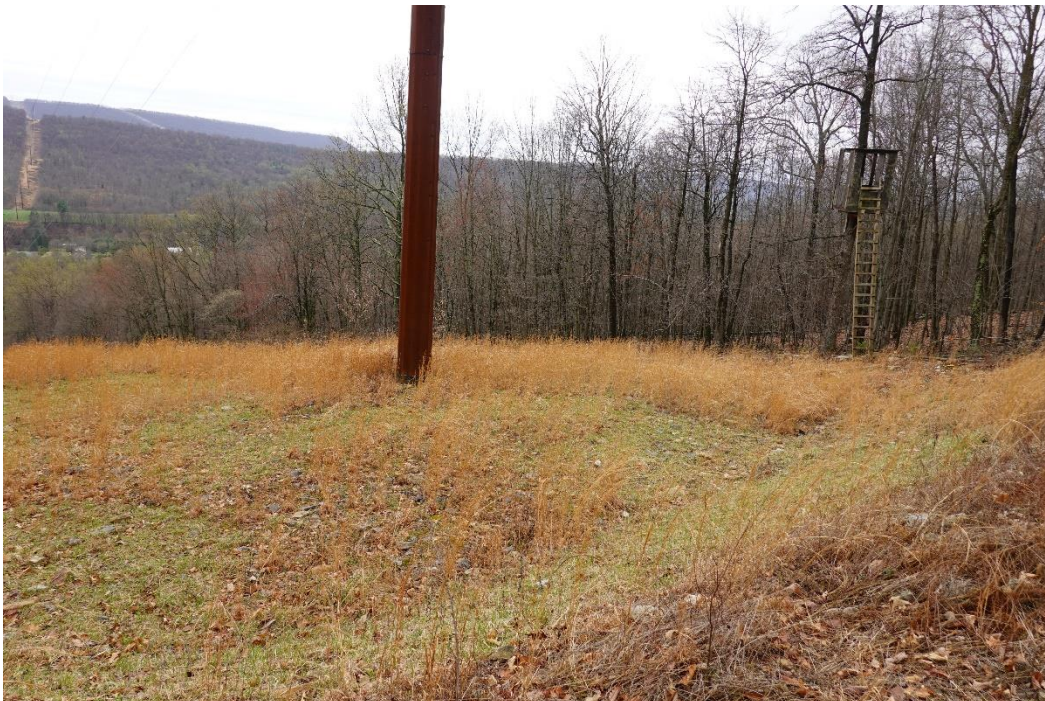
Photo 8:

Pad at structure 75 stabilized, with no apparent signs of erosion or sediment deposit.

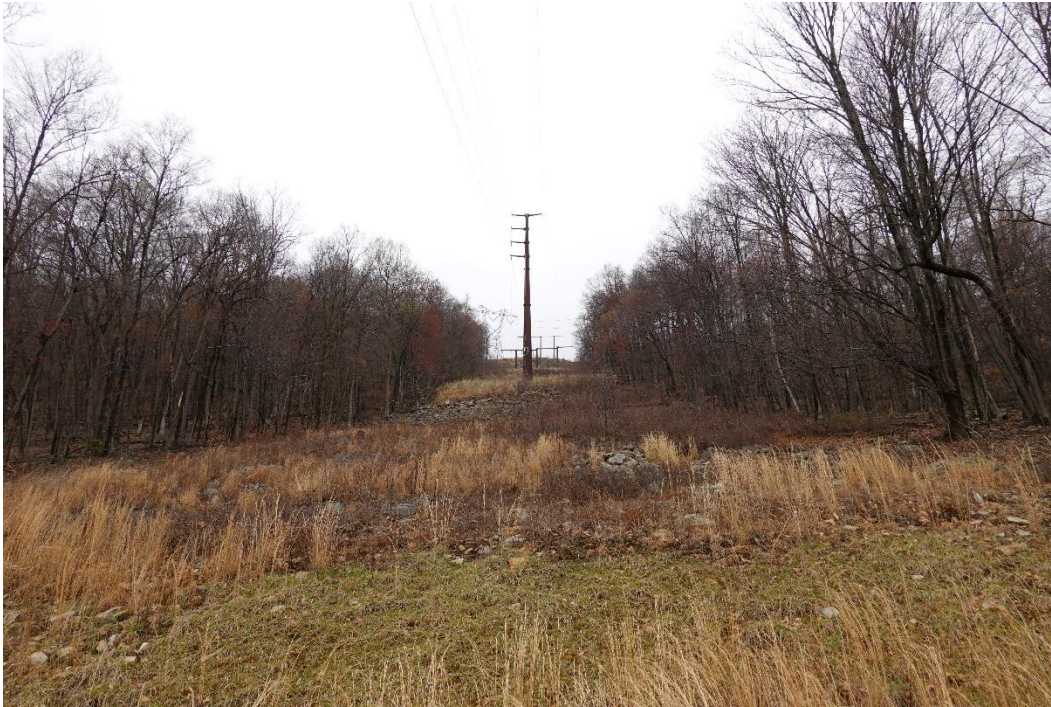
Photo 9:

Stabilized native rocky slope upslope of structure 75. No signs of erosion.

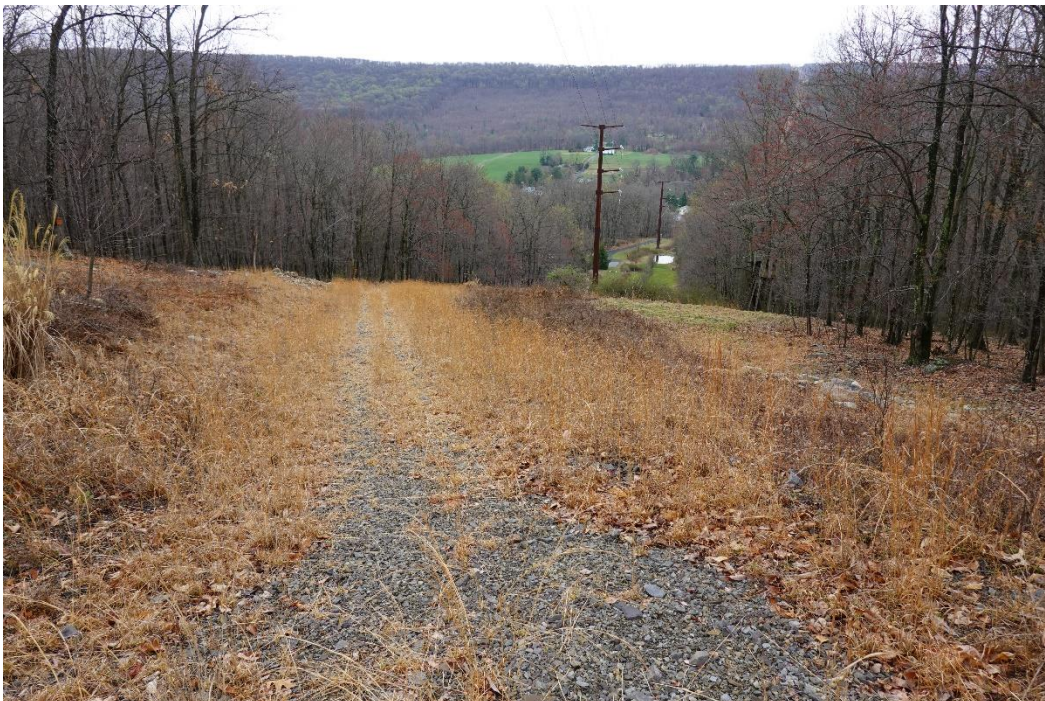
Photo 10:

Access between structures 75 and 76 is stone base with heavy vegetative growth. No signs of erosion or sediment deposit.

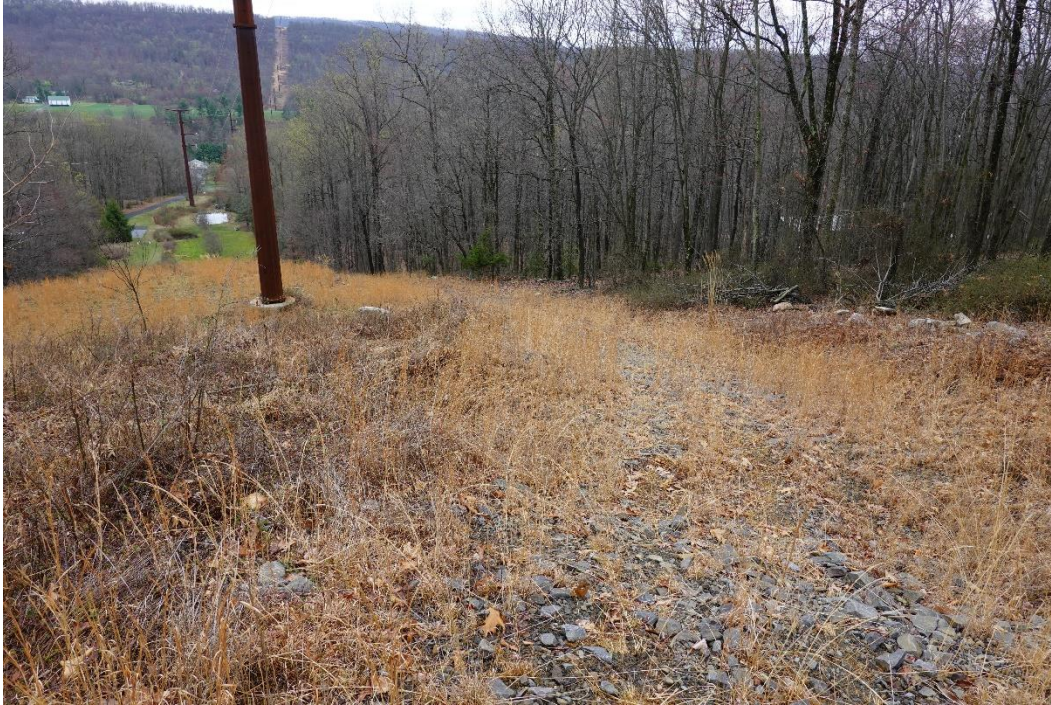
Photo 11:

Pad at structure 76 stabilized with no apparent signs of erosion or sediment deposit.

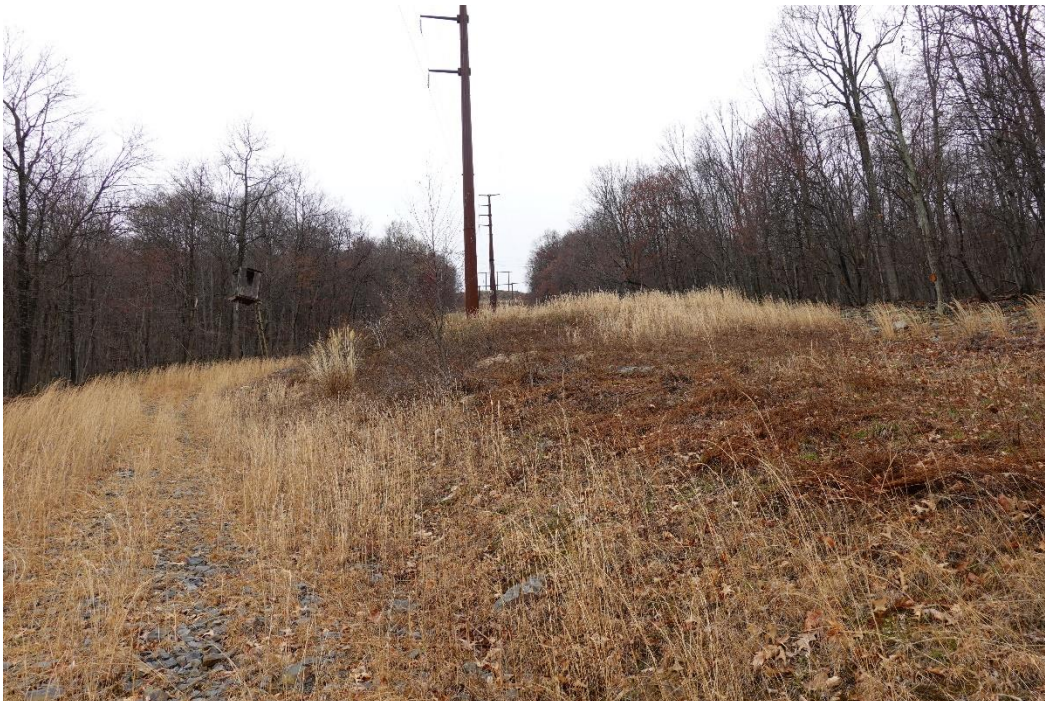
Photo 12:

Access and slope downslope of workpad is stone base with heavy vegetative growth. No signs of erosion or sediment deposit.

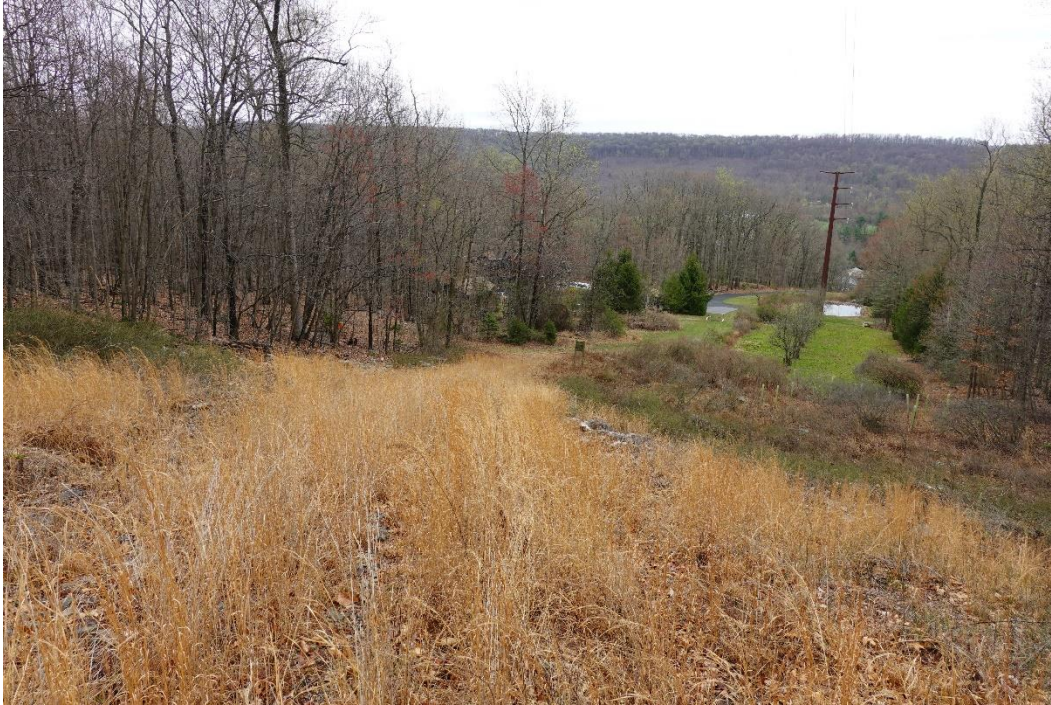
Photo 13:

Delineated wetlands depicted in pre-construction (2017) plans. Area saturated but stable during site visit. No signs of stone or sediment deposit.

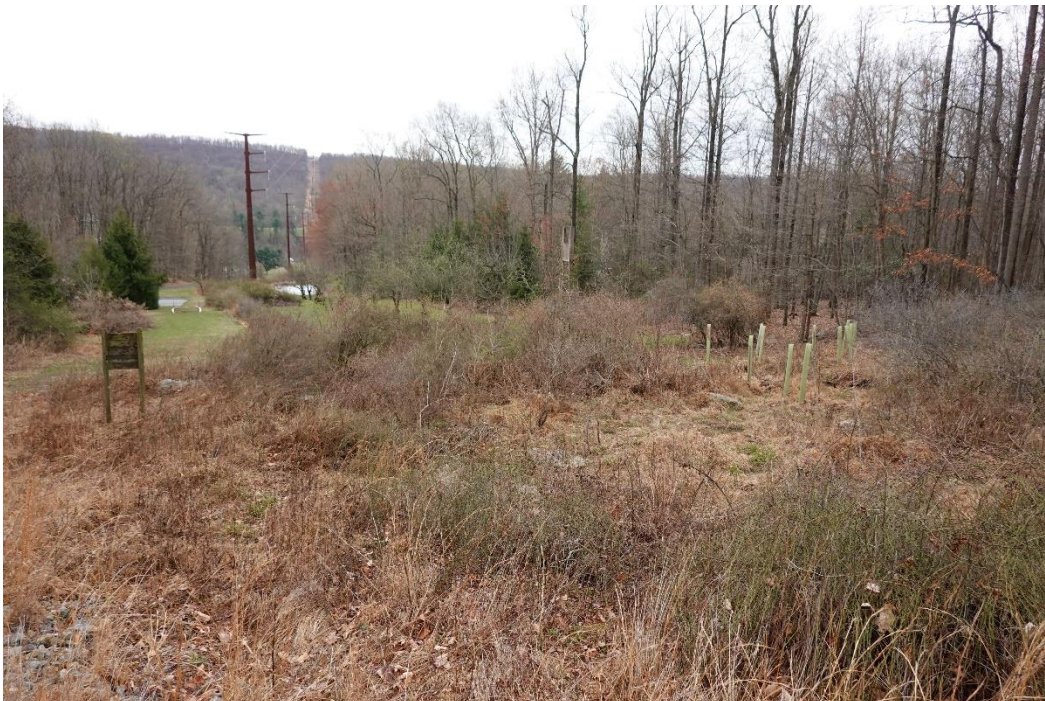
Photo 14:

Delineated wetlands depicted in pre-construction (2017) plans. Area saturated but stable during site visit. No signs of stone or sediment deposit.
