RE: Petition of the Borough of Royersford, Pennsylvania for Emergency Order  
Docket No. P-2025-XXXXXXX

PETITION OF THE BOROUGH OF  
ROYERSFORD, PENNSYLVANIA FOR  
EMERGENCY ORDER

3. This petition concerns two defective railroad crossings within the Borough that are part of the "Harrisburg Line" owned and operated by NS.

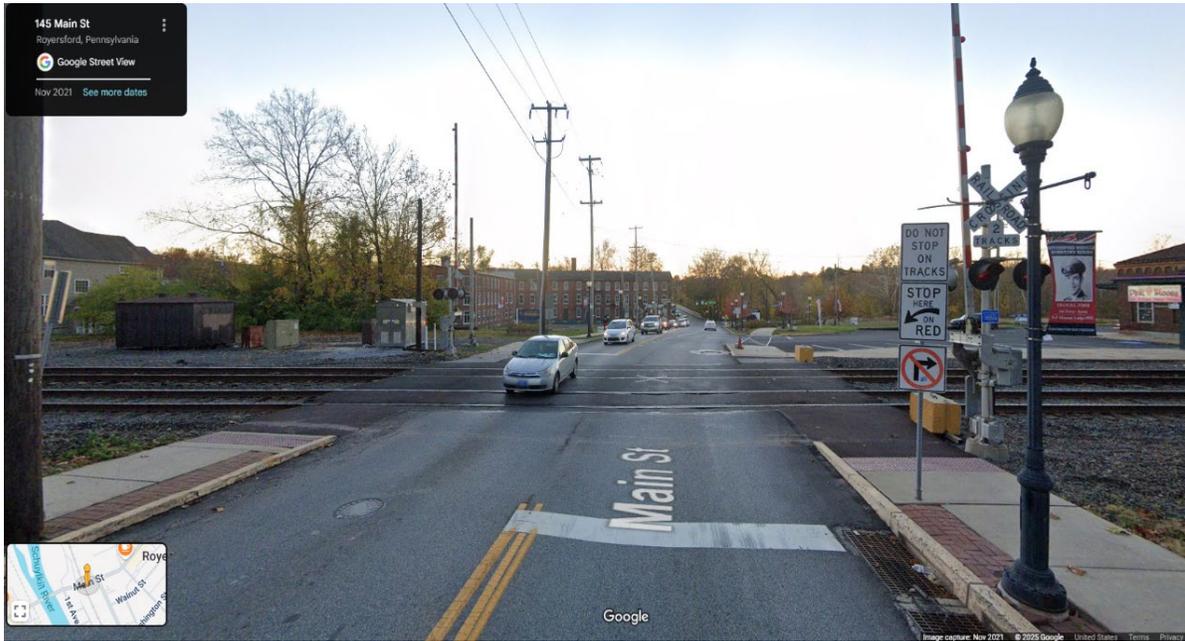
6. The first railroad crossing is located at Main Street, which is depicted in a Google Street View screen capture below:

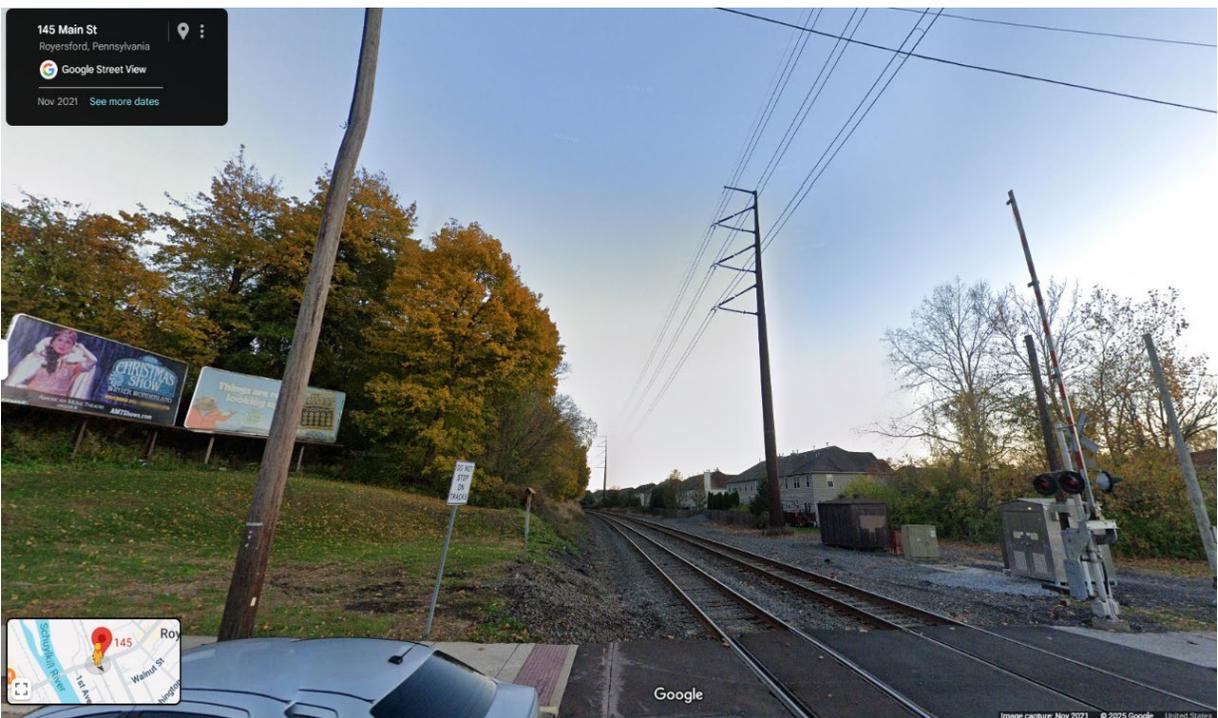
7. In an alternate view of the Main Street railroad crossing, the Transmission Line is visible in this same area:

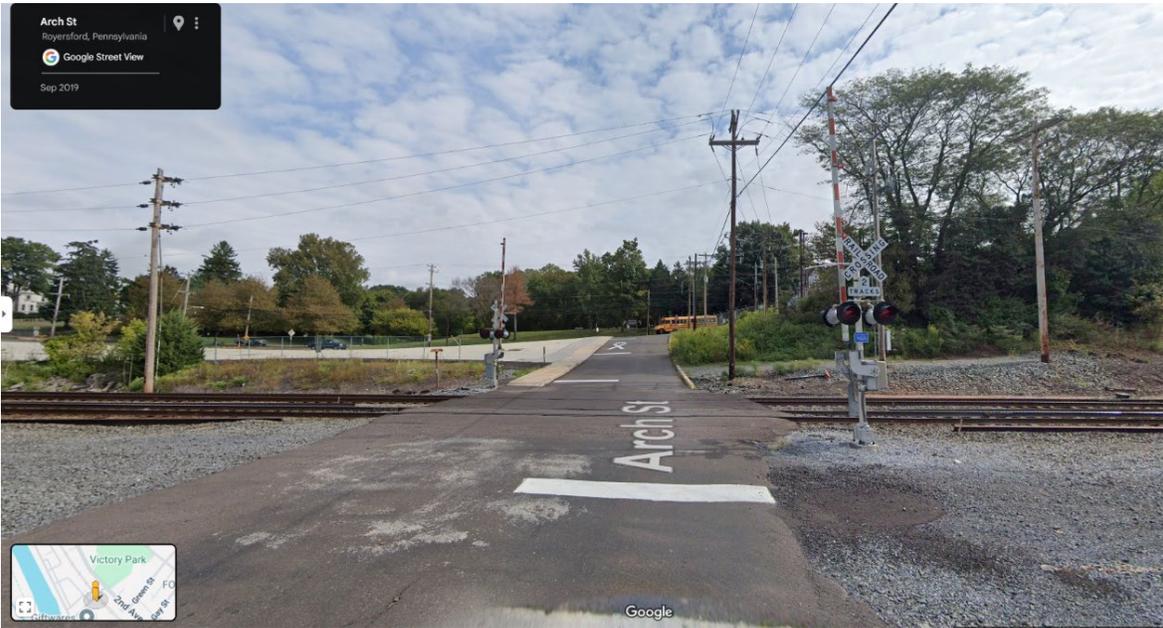
8. The second railroad crossing is located at Arch Street, which is depicted in a Google Street View screen capture below:

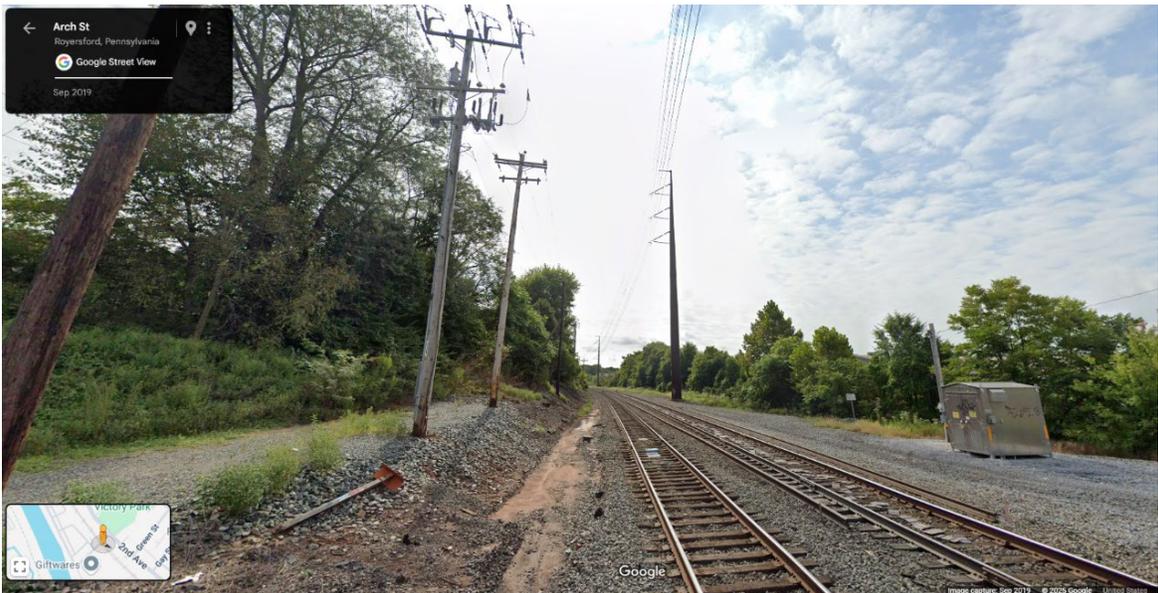
9. In an alternate view of the Arch Street railroad crossing, the Transmission Line is visible in this same area:

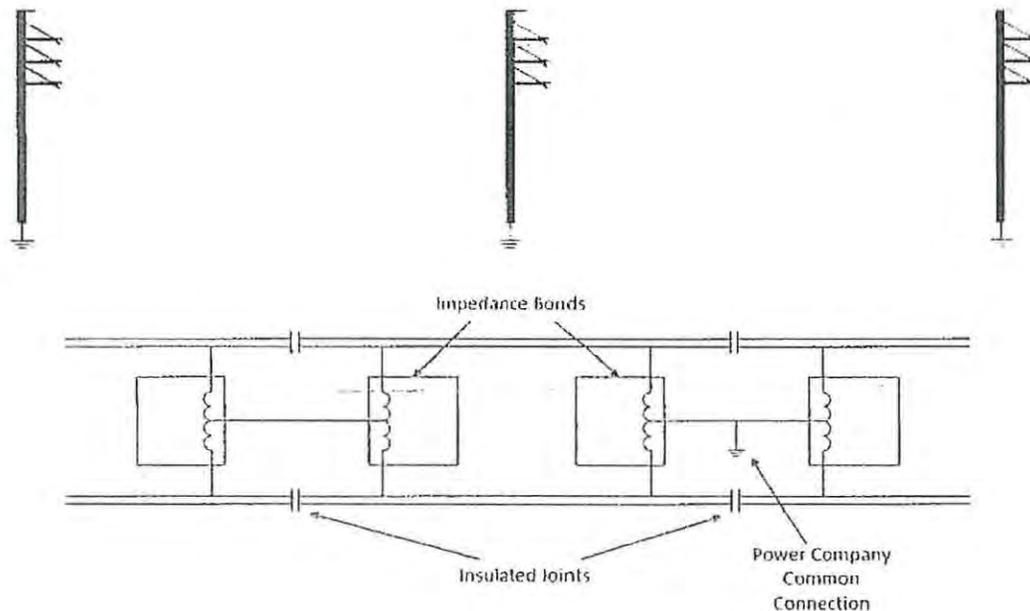
Figure 2: Impedance Bond Configuration

The impedance bonds were initially installed to resolve inductive issues that started at the commissioning of the 230kV line in the railroad right of way. This was confirmed by the inductive interference mitigation report [3] which was provided after the completion of testing. The impedance bonds were installed in a "drain bond" configuration as shown in Figure 2. The issue with this particular form of mitigation is that it trades induced voltage for conducted current. The trade-off to conducted current does not eliminate the hazard to railway workers or signaling equipment. Hazards exist with both conducted currents and induced voltage electrical energies on the railroad, and this was evidenced by the numerous equipment failures experienced over the years.

The observed state of the impedance bonds upon arrival indicated that various configurations were explored in an attempt to resolve issues with the signaling equipment in the area. Some impedance bonds had been completely disconnected. Some had been removed from their power company grounding connections. Others had new ground rods connected in parallel with the existing power company connections.

During the process of bond removal, several issues were uncovered that were masked by the presence of the impedance bonds. The first, and most critical, issue that was uncovered were several failed insulating joints. These failed insulating joints caused excessive rail-to-rail potentials in a steady state condition due to induced voltage effects on uneven lengths of rail. These levels were approximately 10V rail-to-rail in the affected blocks. However, when a train axle would either enter or exit the block, and a single axle was bridging two adjoining blocks together due to staggered insulated joints, this voltage could reach excessively high levels. These levels were calculated to be in excess of 80V. This high potential difference across the track circuit equipment caused the failure of crossing track cards in the area, and visible sparking could be seen from the train axle leaving the block. This issue was primarily mitigated through replacement of the failed insulating joints. However, the phenomena of the bridged track circuit was still present, albeit on a lower level of 50V<sub>RMS</sub>. In order to mitigate this hazard to the equipment, high power 60 Hz track filters were installed between the rails at both ends of each track section isolated by insulated joints. The addition of these filters resulted in the potential experienced by the track circuit equipment to be greatly reduced by balancing the induced voltage rail-to-rail. The level was measured to be a maximum of 7V rail-to-rail, and a current of 7A was dissipated through the track filter. The filters help prevent the large voltage spikes experienced when a train axle bridges two adjoining blocks when traversing an insulated joint.

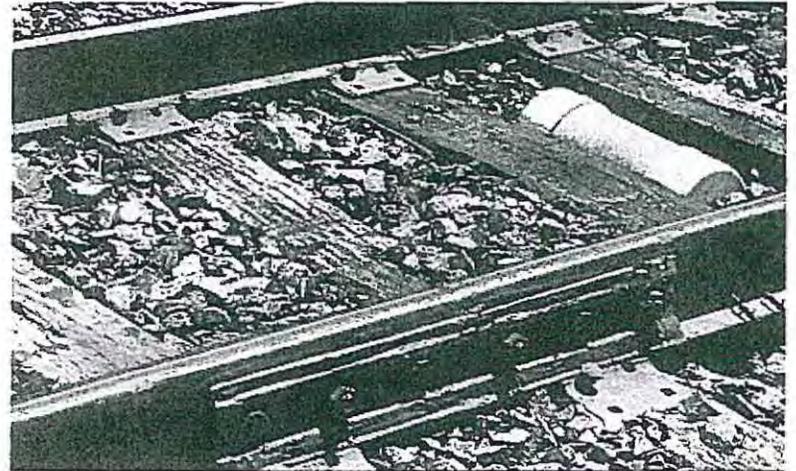
- At least four failed insulated joints were identified, which created a condition that caused damage to track control equipment.
  - 60 Hz high power track filters were also installed to mitigate an unsafe induction condition on the track rails (outside of signal equipment houses).

Isolated Joint near  
Arch Street Crossing  
and 60 Hz Shunt

- Evaluation of insulated joint conditions in the area.
  - Any failed insulated joints in the area need to be replaced in order to reduce the effect of induced magnetic fields from the overhead transmission lines.

- Insulated joints must be maintained in the area since a failure of a joint can lead to elevated potentials posing a hazard to both workers and signaling equipment.
