Pursuant to your request, the writer conducted a metallurgical evaluation on the submitted section of cast iron gas piping pertaining to the above referenced matter. On November 30, 2021, a gas explosion reportedly occurred at 815 Jackson Street, Philadelphia, Pennsylvania. Subsequently, Philadelphia Gas Works (PGW) launched an investigation for the source of a potential gas leak. As a result of the investigation, PGW's response team located a breach in a 4-inch diameter cast iron pipe located at/near the residence located at 815 Jackson Street (between S. 8th Street and S. Mildred Street) and attributed it to the gas leak (**Figure 1**). The breached section was excavated near the subject residence and stored at the facilities of PGW (**Figures 2 – 3**). It was understood that the Pennsylvania Public Utility Commission (PA PUC) is investigating the incident and, per Federal Pipeline Safety Regulations 49 CFR 192.617, requires that the incident pipe section be evaluated for the cause of failure. Upon which, the undersigned was retained to perform a metallurgical evaluation per the request of the PA PUC and PGW.

Re: Philadelphia Gas Works
July 15, 2022
Page 2 of 29

ITEM A – Extern

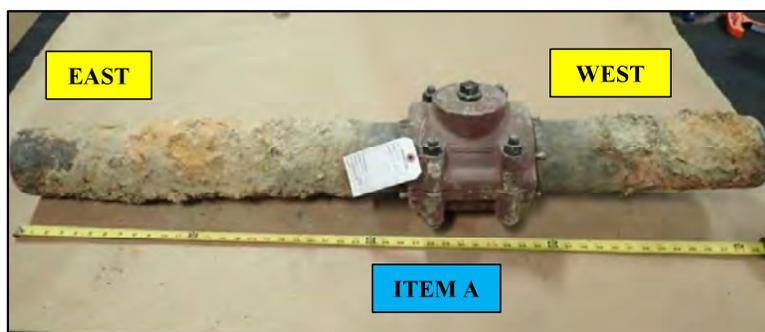
Photo No. 4 (W-6491-D-064.JPG – cropped)

ITEM A consisted of a 49-inch long, 4-inch diameter cast iron pipe with a metal pipe repair clamp (Dresser® Style 80 Repair Clamp) located in the approximate middle of the pipe section (**Photo Nos. 4 – 5**). A paper tag attached to the pipe section was marked “*DATE: 12/1/2021; LOCATION: 815 Jackson Street; DESCRIPTION: 4" CIOC gas main.*” Handwritten markings found on the surface of the clamp identified the TOP of the pipe and North (N), South (S), East (E), and West (W) directions denoting orientation as installed in the ground. It was understood that during the investigation process PGW workers installed a repair clamp across the breach, which was attributed to the reported incident, to secure the damaged region.

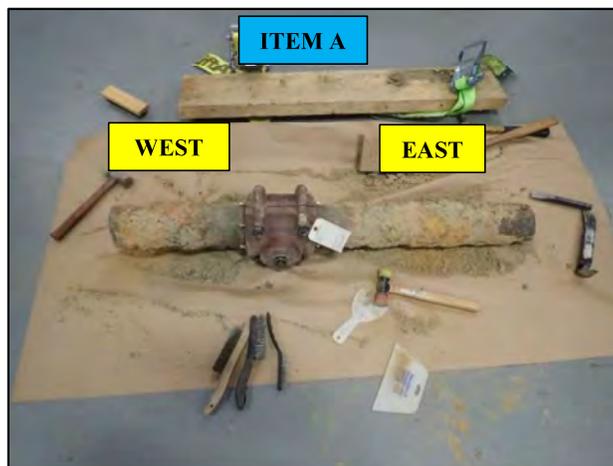
Photo No. 10 (W-6491-D-053.JPG)

The outside diameter (OD) surface of **ITEM A** exhibited a buildup of soil deposits and corrosion product. Some of the material adhering to the surface was carefully removed by mechanical scraping and chipping while most of it remained tightly adhering to the pipe, indicating that it bonded to the OD surface (**Photo No. 10**). The hard soil deposits, which consisted of hardened masses of scale product, were collected and sealed in a plastic bag. Since the deposits and scale did not contain any significant amount of actual soil or dirt, but rather, were comprised of corrosion scale mixed with soil deposits, no further testing was performed on the deposits. However, the sample was labeled **ITEM A-1** and was stored for subsequent testing if deemed necessary.

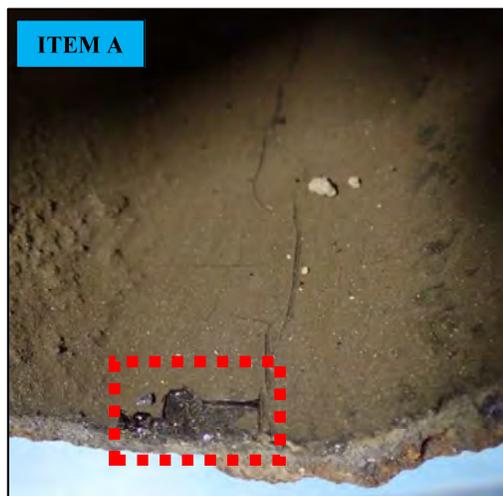
Photo No. 11 (W-6491-D-162.JPG)

The inside diameter (ID) surface of the pipe was coated with a shiny, black tar-like substance (**Photo No. 11**). The buildup along one radial axis of the pipe's diameter, formed by gravity, confirmed the orientation of the pipe, i.e. TOP and BOTTOM. The texture and softness of the coating was not consistent with any traditional means of lining the ID surface of a pipe. Rather, the material appeared to be a deposit or condensate. It was understood that PGW or its predecessor used to manufacture gas,

which is generally done by processing coke. This process produces a byproduct that can condense onto surfaces such as the ID of piping. A sample of the coating can be analyzed should it be deemed warranted.

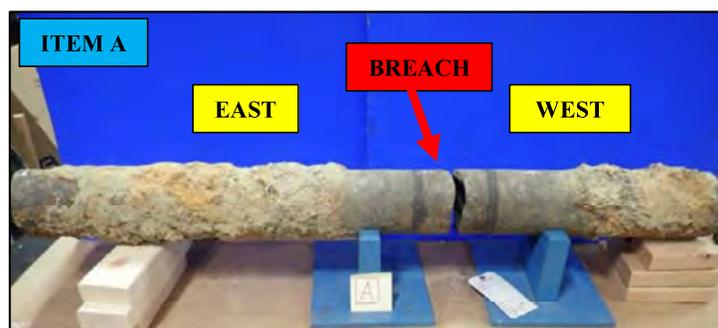
Photo No. 12 (W-6491-D-093.JPG - cropped)

After the repair clamp was removed, the breach location was exposed for further investigation (**Photo No. 12**). It was observed that the underlying pipe's OD surface was intentionally cleaned, which typically is performed in order to properly install a repair clamp. The surface must be cleaned and devoid of protrusions in order for the elastomeric gasket material to form an airtight seal around the circumference of the pipe. The breach was comprised of a single circumferential fracture that separated the cast iron main into two segments: 31-inch long EAST end and 18-inch long WEST end (approximately).

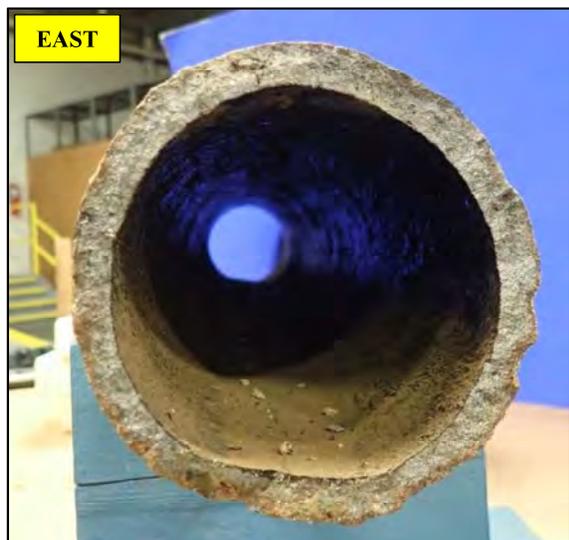
Photo No. 13 (W-6491-D-167.JPG – cropped)

Both mating fracture surfaces of **ITEM A** were visually examined in the as-received, or uncleaned, condition. The mating fracture surfaces were mirror images of each other (**Photo Nos. 13 – 14**). The **BOTTOM** of the cast iron main exhibited a darkened surface that spanned more than half the wall thickness. However, preliminary inspection of the mating fracture surfaces did not reveal the presence of a darkened region spanning the thickness of the wall, which would have suggested a pre-

existing leak prior to the reported incident. In order to further examine the fracture topography, microstructure, mechanical properties, and chemical composition, samples had to be cut/removed.

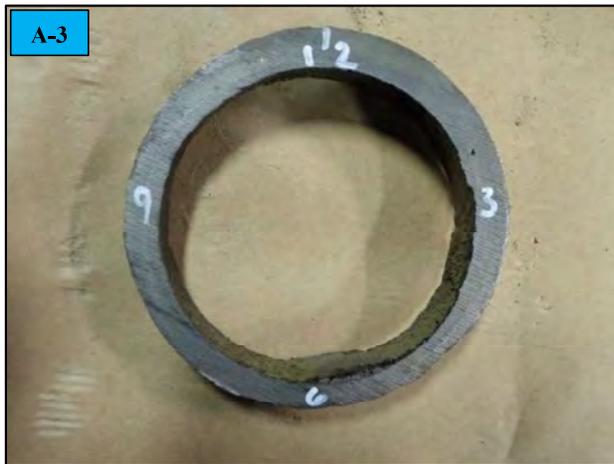
Photo No. 19 (W-6491-D-195.JPG)

Varying degrees of graphitization were observed on the cut edges of ring segments **ITEM A-3** and **ITEM A-4 (Photo Nos. 19 – 20)**. There was no indication of any through-wall penetrations formed by graphitization or any other type of corrosion or mechanical damage as intersected by the cuts. The effective wall thickness of the pipe in those two cross-sections was slightly reduced (up to 15%) as a result of graphitization (**TABLE A**). Notable casting voids were observed distributed along the cut edges of both rings, thereby further reducing the effective wall thickness (**Photo No. 21**).

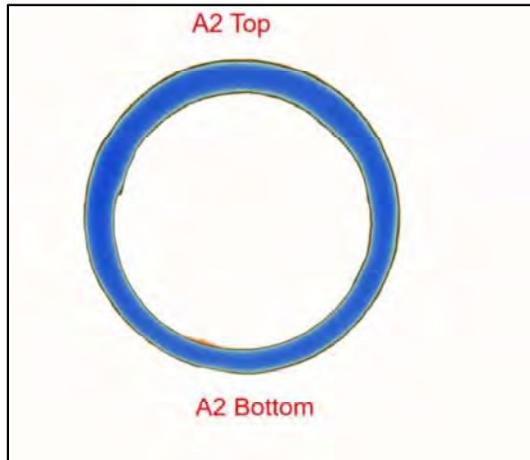
Photo No. 22 (Screenshot 2022-04-22 140045.jpg)

Radiographic views were taken at various angles for documentation purposes. Radiographic imaging showed the ring sections random, localized wall thickness losses (patchy distributions of graphitic corrosion) around the respective circumferences of **ITEM A-2**, **ITEM A-3**, and **ITEM A-4** (**Photo Nos. 22 – 27**). In addition, **ITEM A-3** exhibited an agglomeration of voids near its **BOTTOM** (5 to 6 o'clock positions) as well as some voids near its **TOP** (12 o'clock position).

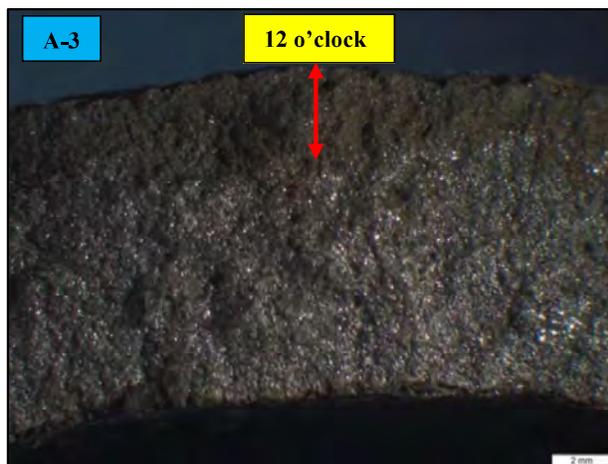
Photo No. 35 (W-6491-B-001.jpg)

The fracture surface was then examined via stereomicroscopy (**Photo Nos. 35 – 38**). Microscopic examination of the fracture surface showed brittle mode fracture of typical gray cast iron. Varying degrees of graphitization were noted along the OD surface. A notable amount of voids was observed near the 6 o'clock position.

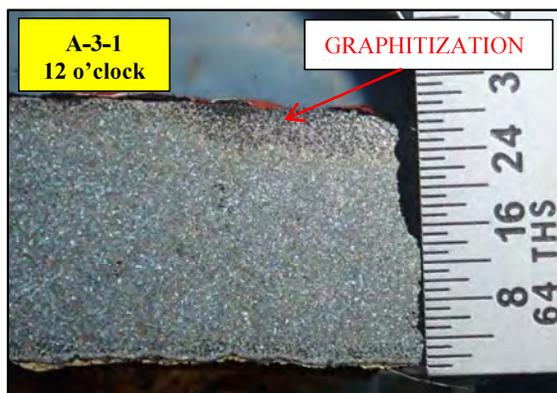
Photo No. 45 (W-6491-G-050.JPG – cropped)

Examination of the as-polished surfaces of the five microspecimens intersecting the fracture surface confirmed and documented the extent of graphitization that occurred over the 123 years of service (**Photo Nos. 45 – 49**). **TABLE B** contains the wall thickness measurements taken at the fracture. The 5 o'clock position (**A-3-5**) showed the most severe amount of corrosion damage resulting in an approximate 43% wall loss that reduced the effective wall thickness of the pipe to 57% of its original wall thickness at the fracture plane. Large-sized voids were also present in this region of the fracture, which further reduces the structural integrity of the gas main to approximately 30%. The 12 o'clock position (**A-3-1**) exhibited graphitization 20% (wall loss) of the original wall thickness while the 6 o'clock position (**A-3-6**) and 9 o'clock position (**A-3-8**) were both 13% (wall loss) at the fracture plane. The 3 o'clock position (**A-3-3**) was 11% wall loss. None of the microspecimens exhibited through-wall graphitic corrosion.

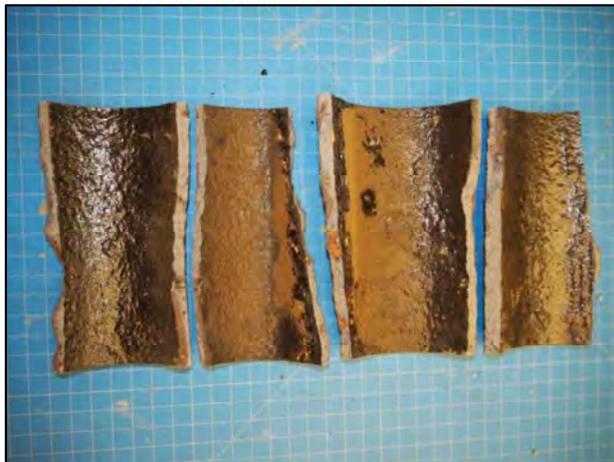
Photo No. 58 (W-6491-F-035.JPG)

Examination of the induced fracture surfaces of the Ring Test Sample revealed varying degrees of graphitization and casting voids, similar to that of previously examined and above described ring samples from the cast iron main (**Photo Nos. 58 – 65**).

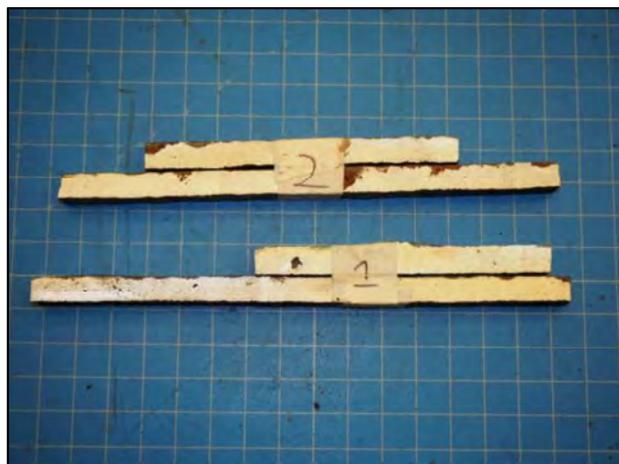
Photo No. 66 (W-6491-F-015.JPG)

Examination of the Talbot strip samples after testing revealed a reduction in effective wall thickness due to graphitization (**Photo Nos. 66 – 69**). In addition to the presence of graphitization in the cross-sections of the specimens, the low values may also be attributed to the presence of steadite phase in the microstructure, as observed in the microspecimens prepared from the cast iron main.

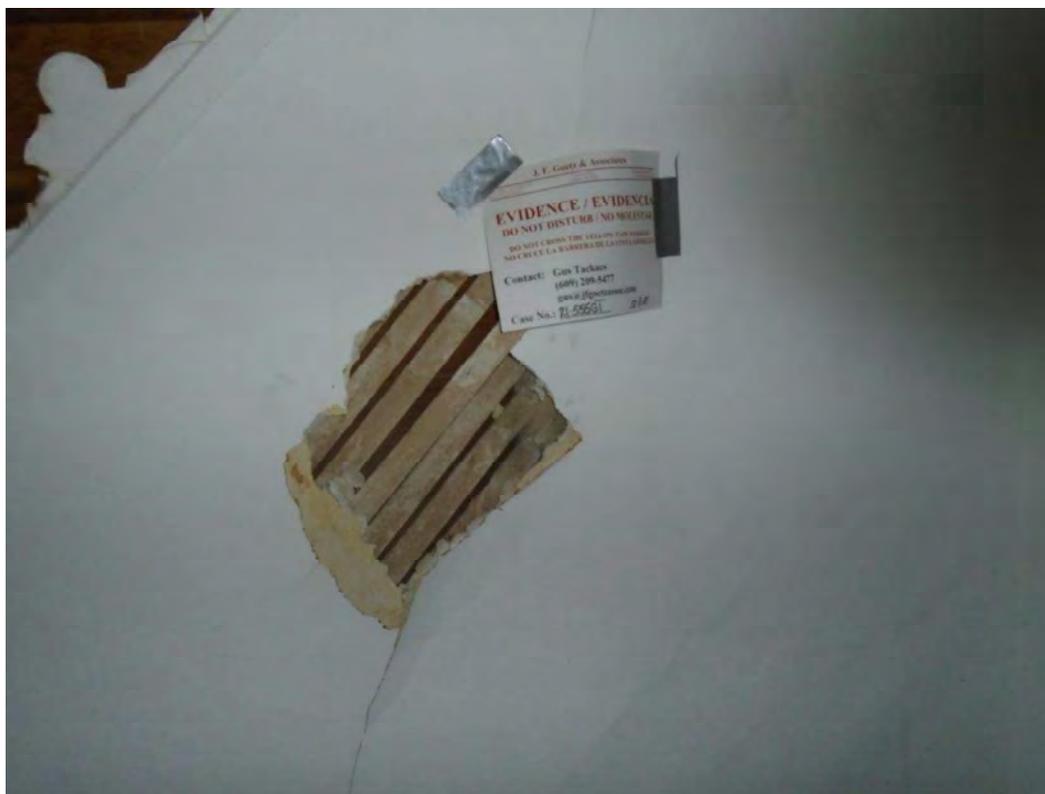
Photograph #11: Damaged living room wall at stairwell.

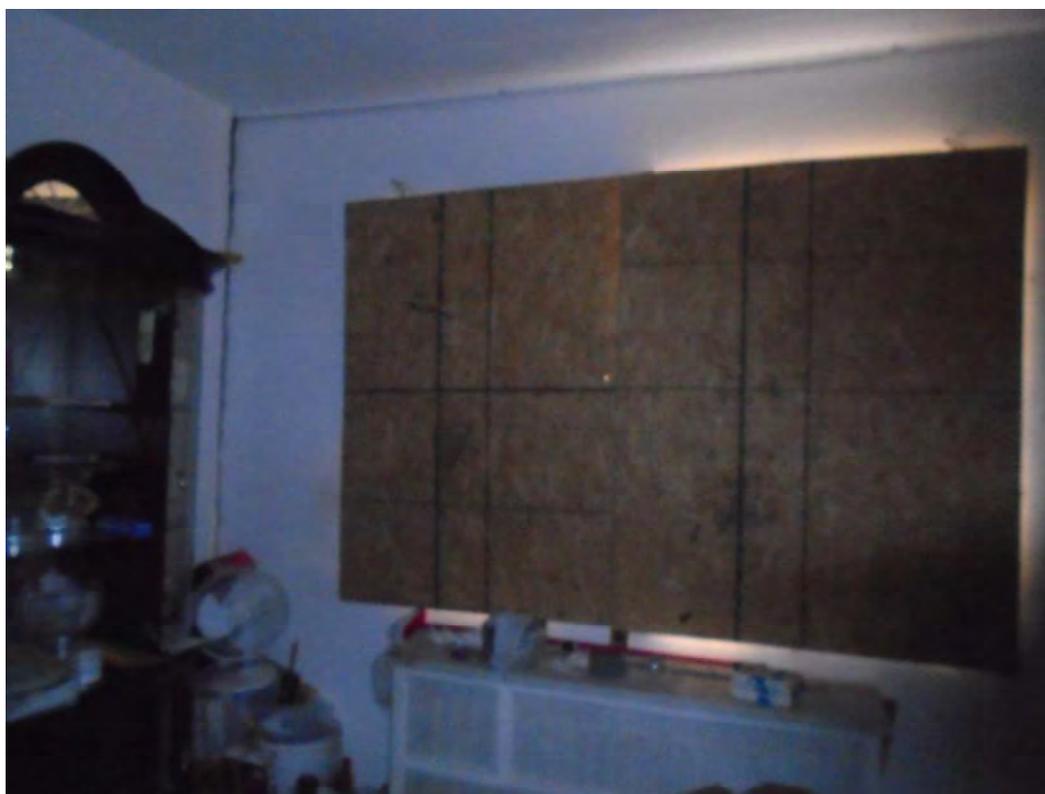
Photograph #12: Front window broken out in living room.

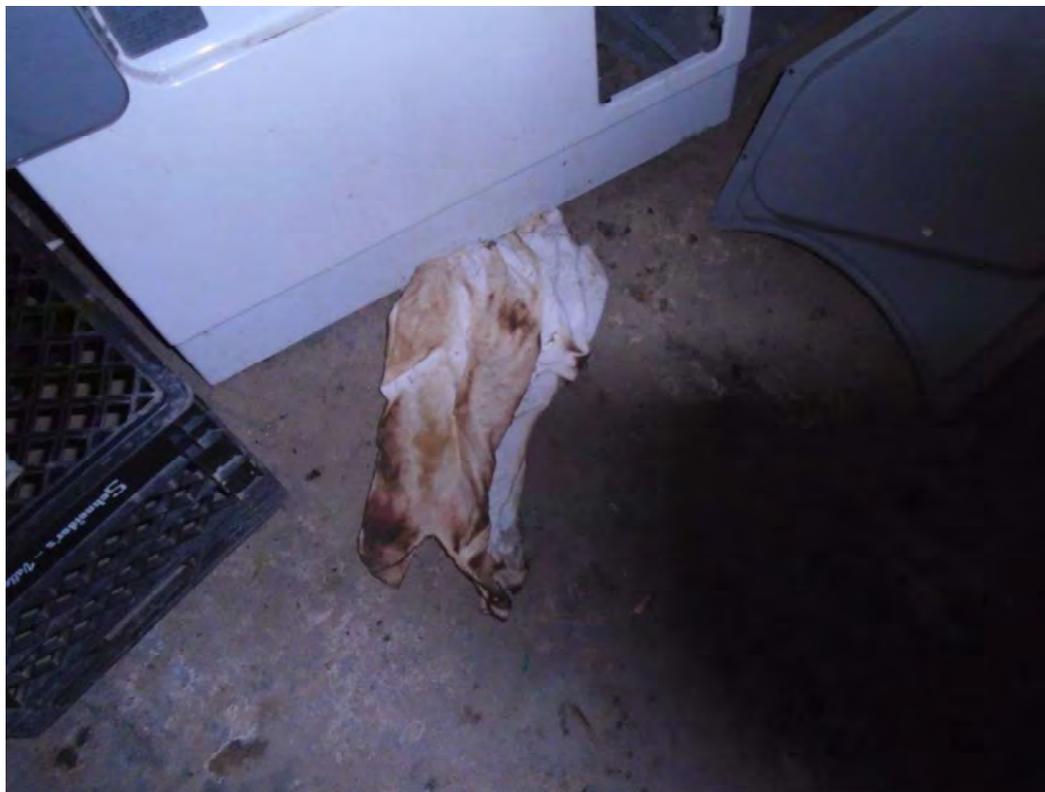
Photograph #15: Burned rags on basement floor.

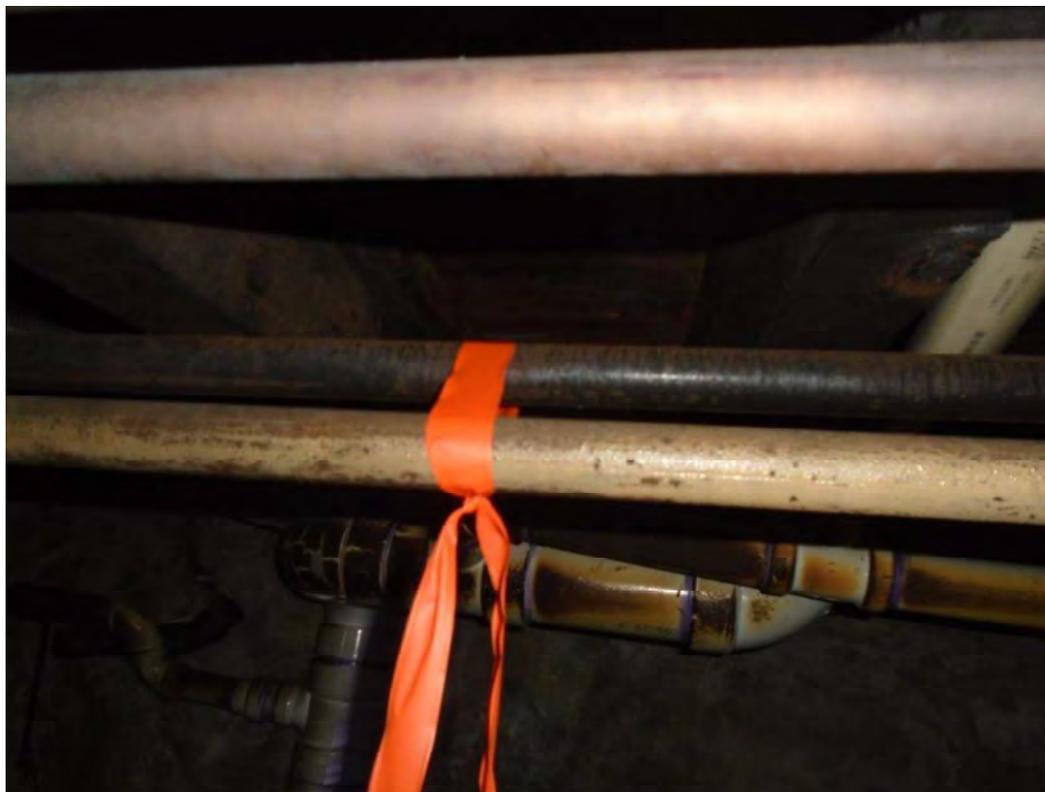
Photograph #25: Gas pipes in basement/heat stains on drainpipes.

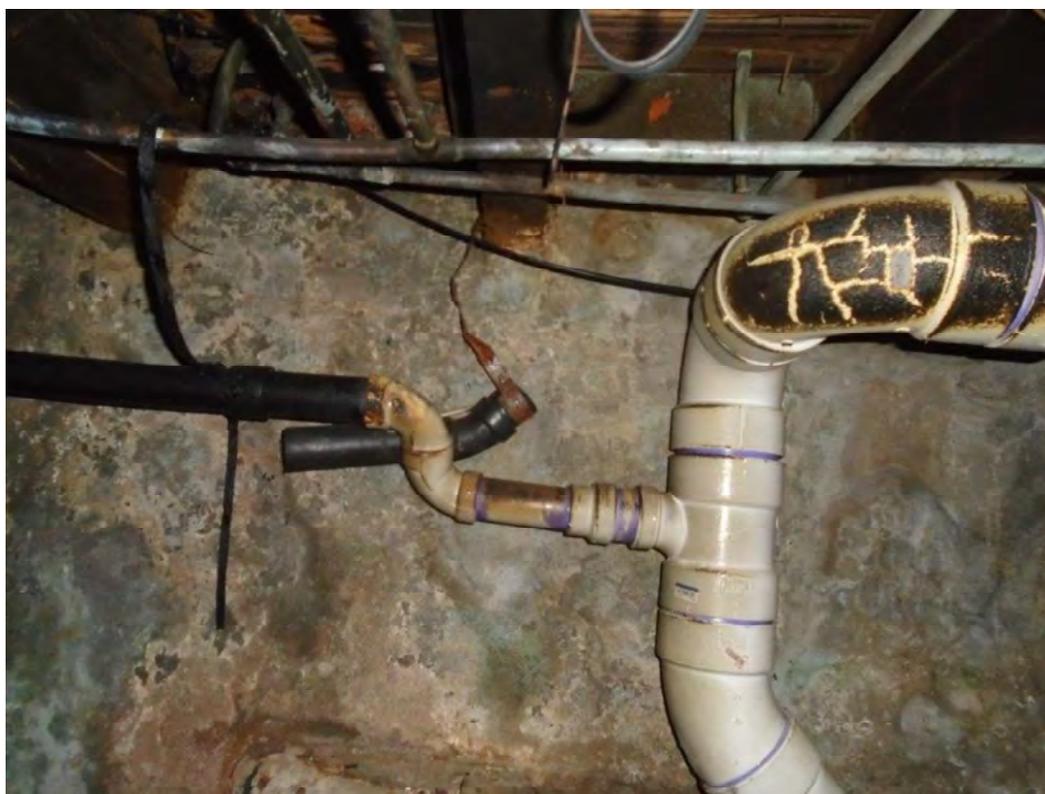
Photograph #26: Heat stains on drainpipes in basement.
