**BEFORE  
PENNSYLVANIA PUBLIC UTILITY COMMISSION**

**In re: (1) Application for the reopening of the Randall Avenue Bridge over (crossing AAR # - AAR 530 983 U) AMTRAK-owned railroad tracks located in Bristol Township in Bucks County, PA.**

Randall Avenue  
over  
AMTRAK

**Not for Public Record – Structure Safety Inspection Study**

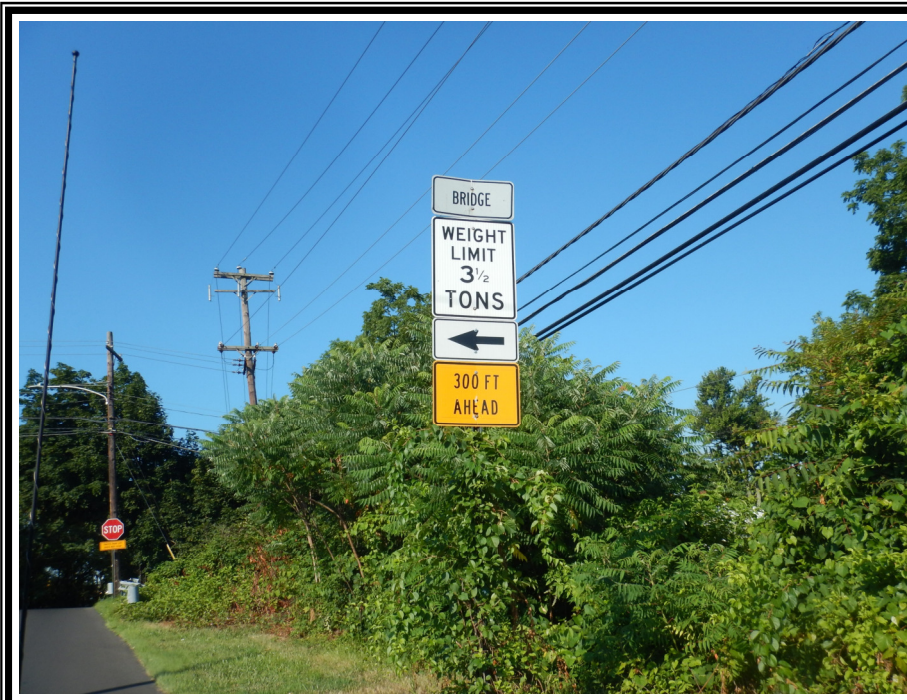
**NEAR ADVANCE POSTING**  
*West, At the Penn Avenue and Randall Avenue Intersection*

All required signs are in place and in good condition with no problems noted.

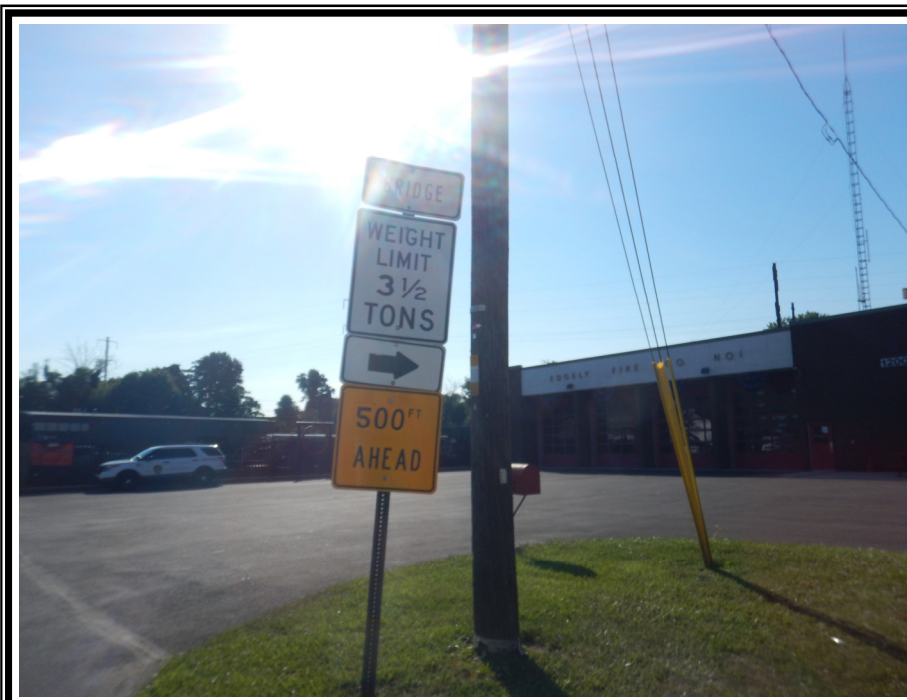
**NEAR ADVANCE POSTING**  
*West, At the Penn Avenue and Edgely Road Intersection*

All required signs are in place and in good condition with no problems noted.

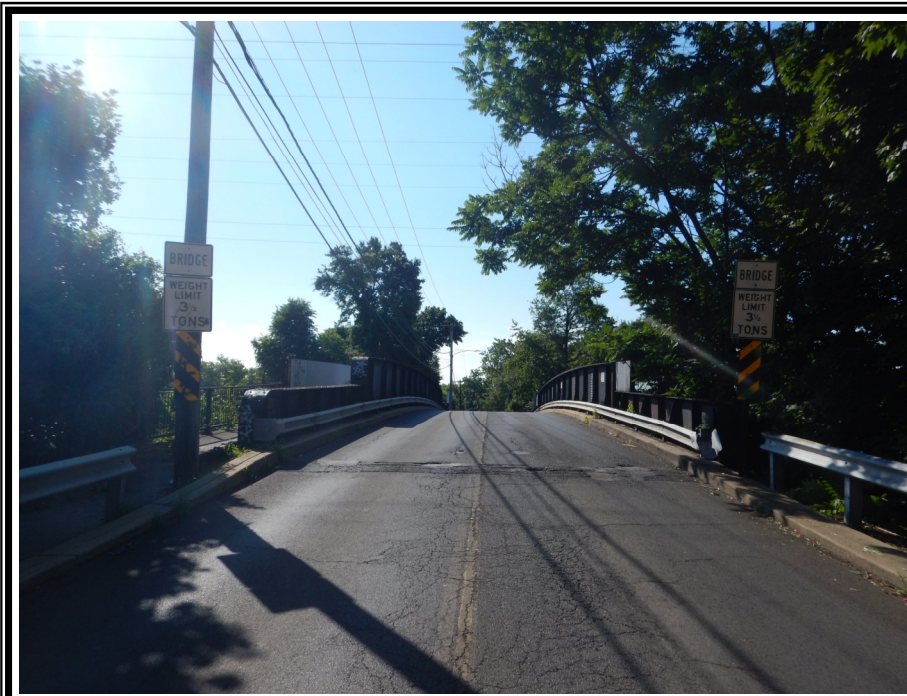
**NEAR APPROACH**

All required signs are in place and in good condition with no problems noted. A supplemental posting is in place at the near left corner.

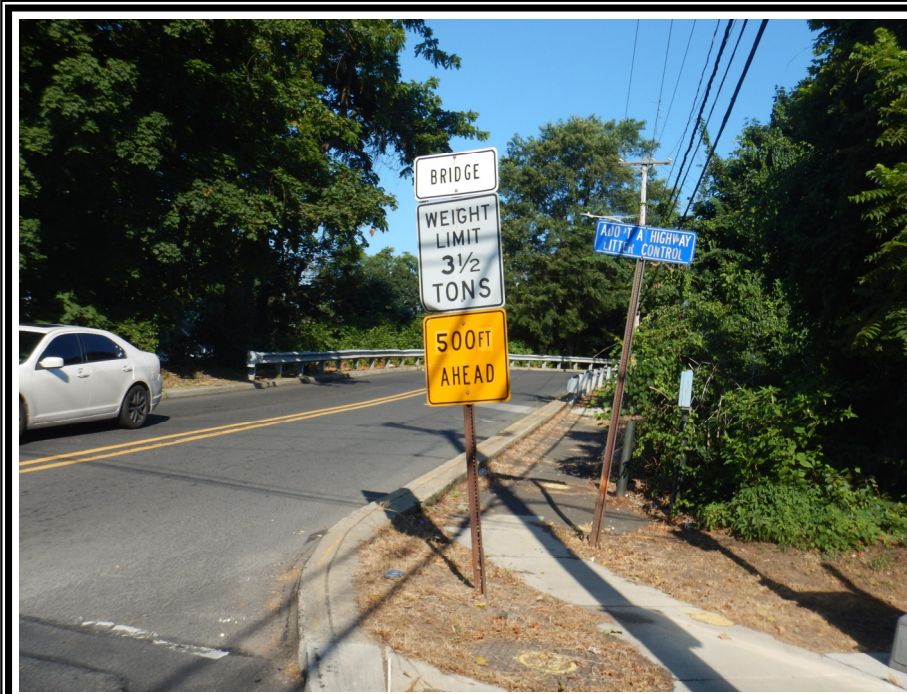
**FAR ADVANCE POSTING**  
*East, At the Radcliffe Street Intersection*

All required signs are in place and in good condition.

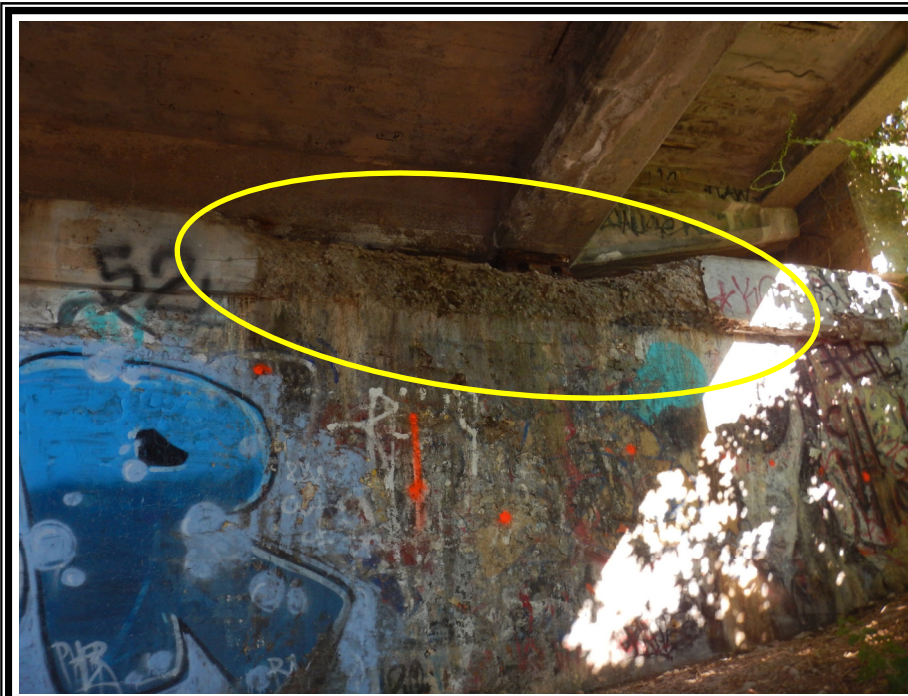
**NEAR ABUTMENT BRIDGE SEAT**  
*Left End*

The bridge seat has 10' long by 20" high by 20" deep spalling in front of the left bearing.

- Repair the severely spalled concrete abutments adjacent to the bearings at each corner. (12 CY)
- Repair the bituminous potholes exposing the joint steel at the near and far transitions. (2 SY)

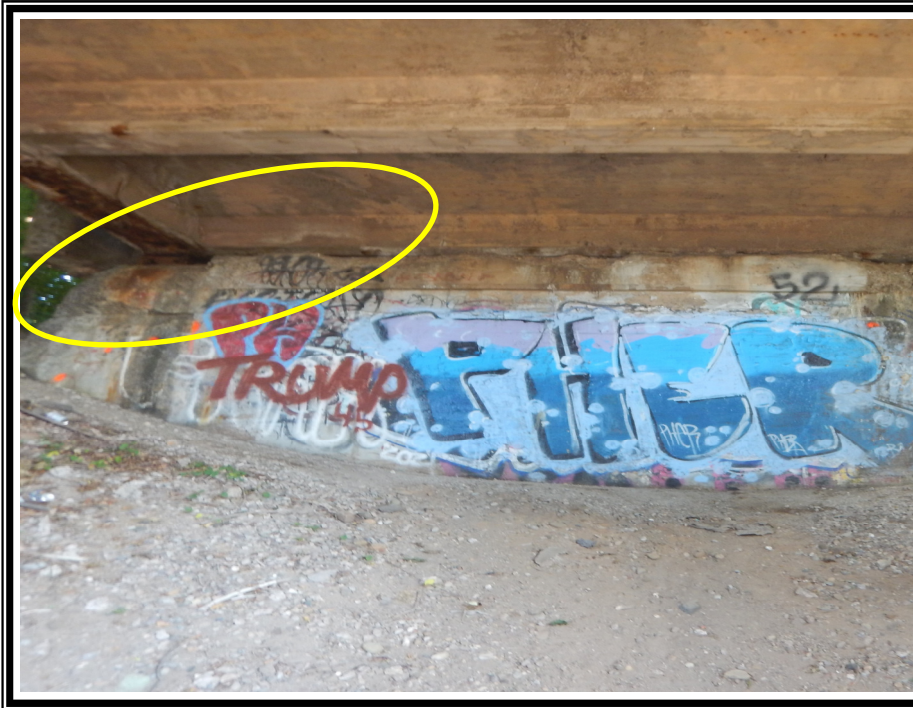
**NEAR ABUTMENT BRIDGE SEAT**  
*Right End*

The bridge seat has 8' long by 20" high by 16" deep spalling in front of the right bearing with very minor bearing loss.

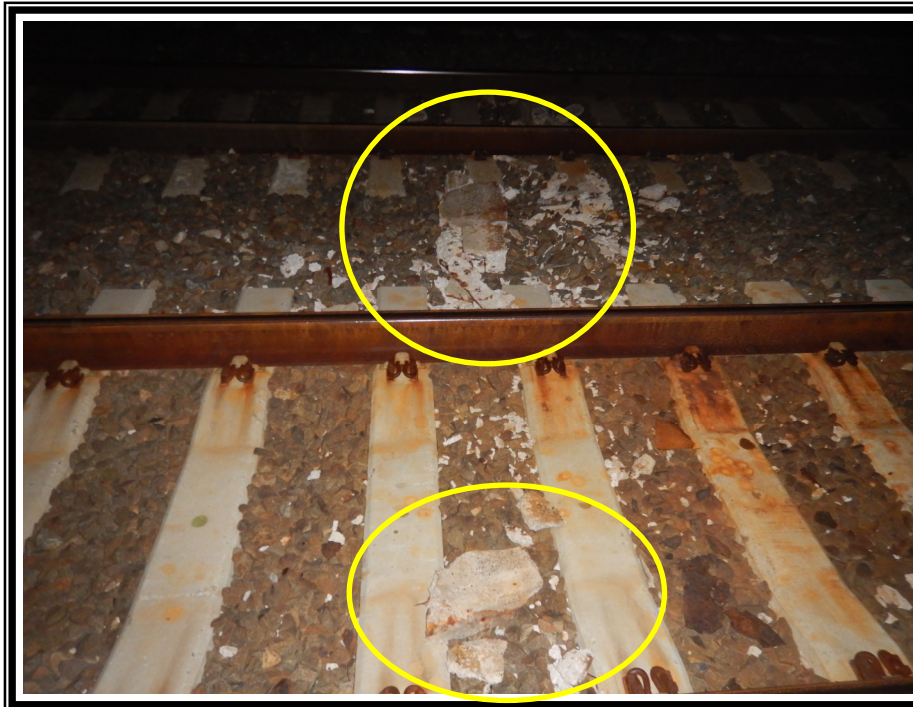
**SPAN 2, FALLEN CONCRETE,  
BELOW BAYS 11 AND 12**

Several areas of the right girder encasement concrete have fallen and landed on and adjacent to the railroad tracks.

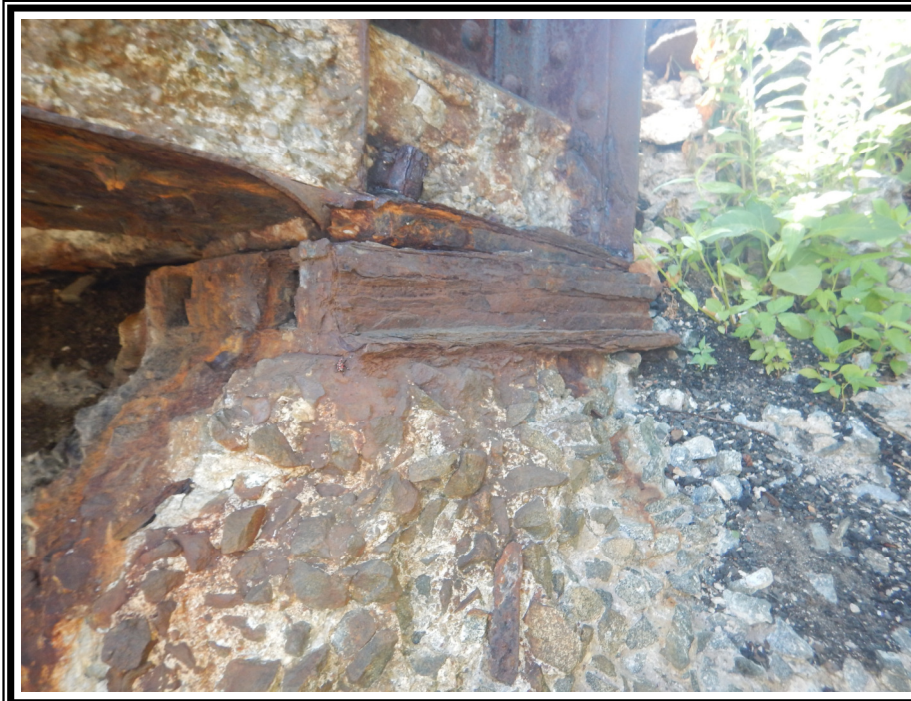
**FAR RIGHT BEARING**

*Bearings:* The sliding steel plate expansion bearings at the abutments are heavily corroded with moderate delamination, frozen, and inoperable. There is heavy bridge seat deterioration adjacent to the bearings at both abutments and a 22" long by up to  $1\frac{1}{2}$ " deep bearing loss along the right side at the far right bearing. The left fixed bearings at the piers have heavy delamination with minor section loss. The right fixed bearings have severe delamination, pitting, and moderate section loss.

There is 22" long (full length of plate) by up to 1.5" of bearing loss along the right side of the bearing.

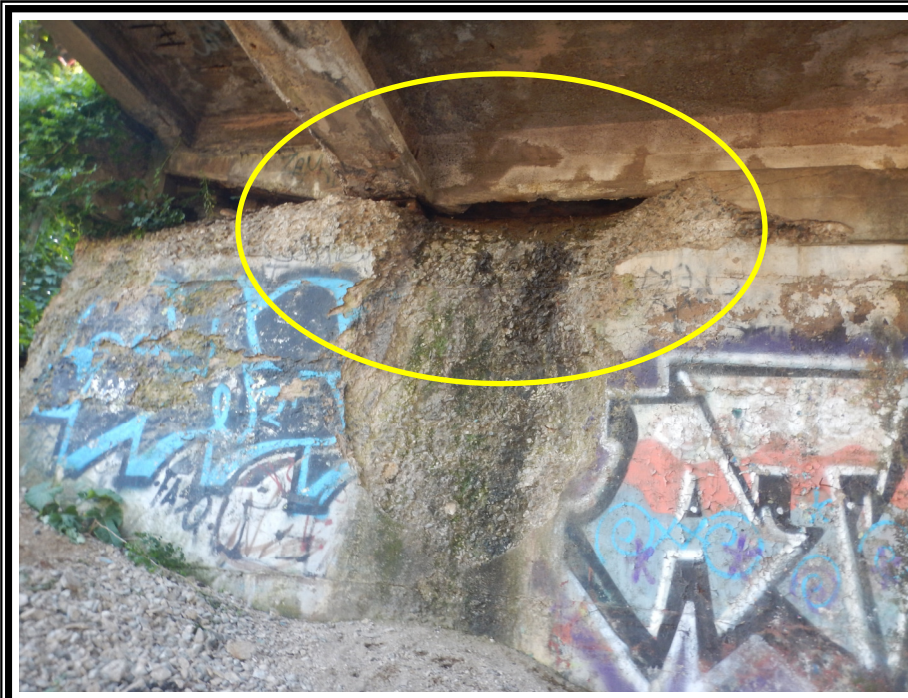
**FAR ABUTMENT BRIDGE SEAT**  
*Left End*

The spalling along the left side of the bridge seat measures 18'-4" wide by 20" high by 15" deep to the front face of the bearing.

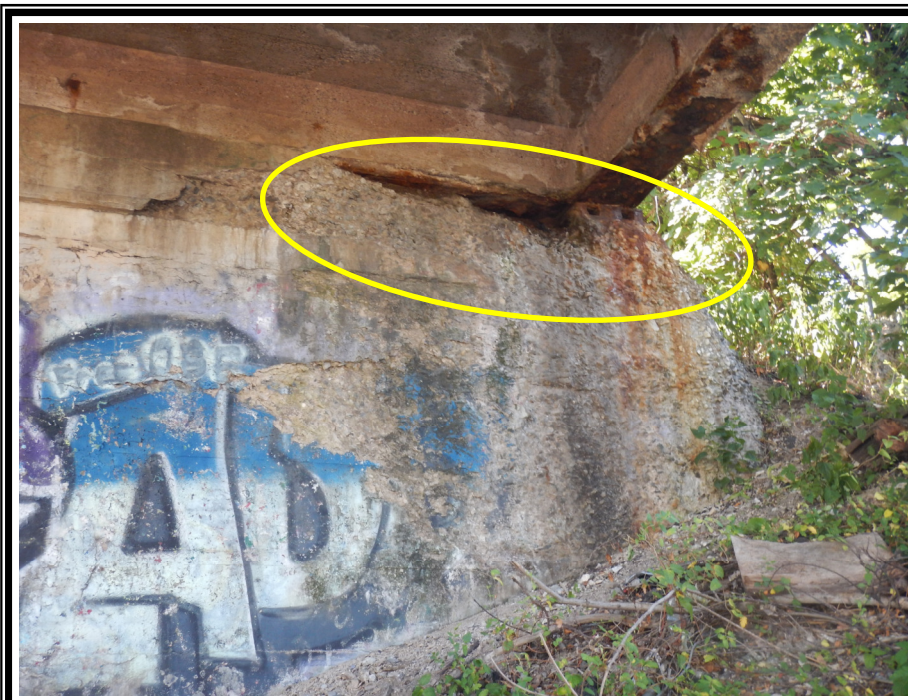
**FAR ABUTMENT BRIDGE SEAT**  
*Right End*

The bridge seat has 12' long by 20" high by 15" deep spalling in front of the far right bearing and spalling beneath the bearing continuing to the right end of the stem wall.

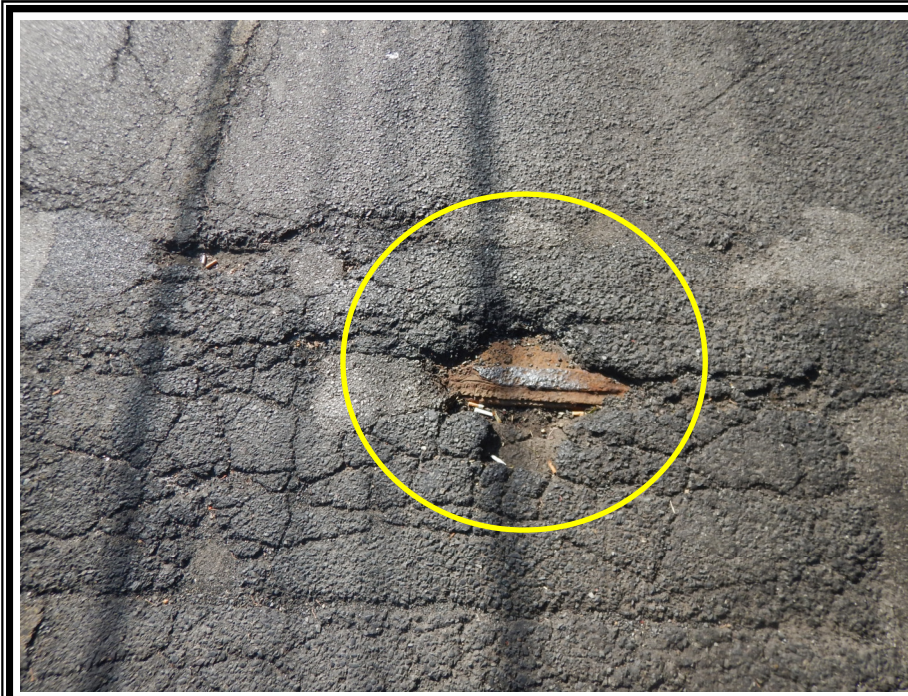
**NEAR TRANSITION POTHOLE**

There is a 16" long by 21" wide by 2" deep pothole exposing the steel joint at the center of the right lane.

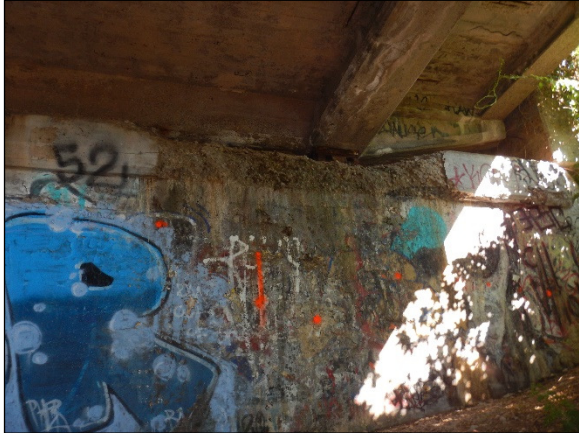
**LEFT:** The bridge seat has 10' long x 20" high x 20" deep spalling in front of the near left bearing.

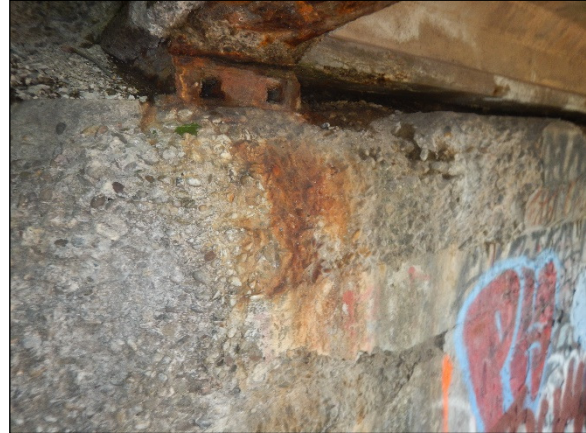
**RIGHT:** The bridge seat has 8' long x 20" high x 24" deep spalling in front of the near right bearing.

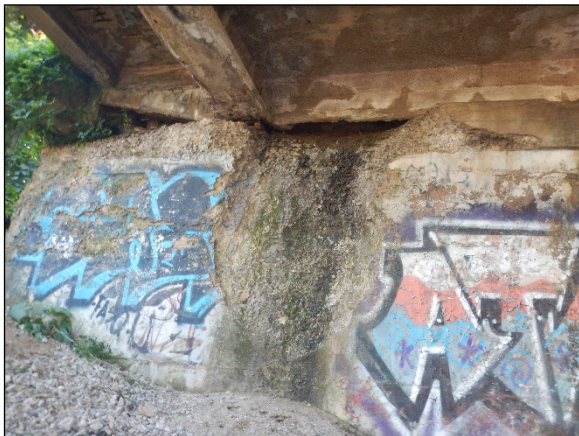
**LEFT:** The bridge seat has 18'-4" long x 20" high x 15" deep spalling in front of the far left bearing and up to 2' deep spalling to the right of the bearing.

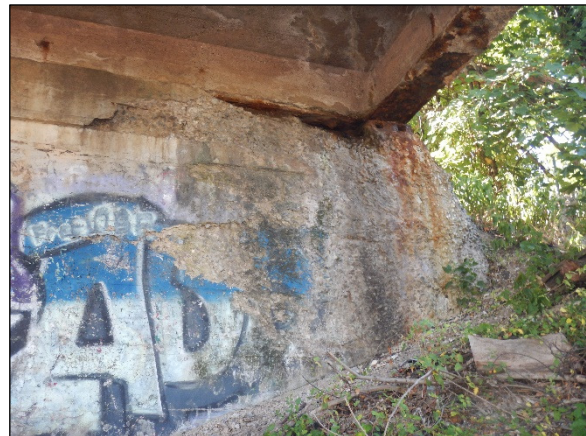
**RIGHT:** The bridge seat has 12' long x 20" high x 15" deep spalling in front of the far right bearing and spalling beneath the bearing continuing to the right end of the stem wall.

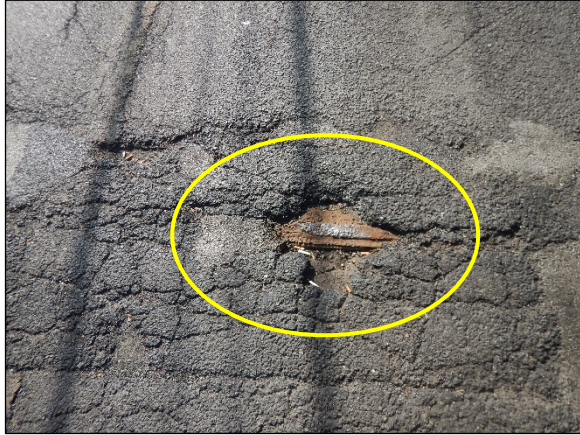
**LEFT:** The near transition has a 16" long by 21" wide by 2" deep pothole exposing the steel joint at the center of the right lane.

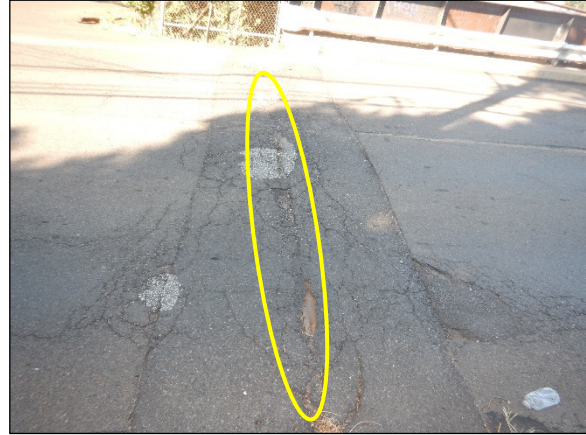
**RIGHT:** The far transition has three potholes, up to 6" long by 18" wide by 1.5" deep, exposing the steel joint along both wheel paths of the left lane and the center of the right lane.
