BUREAU OF
INVESTIGATION
&
ENFORCEMENT

March 18, 2026

Re: Pennsylvania Public Utility Commission,
Bureau of Investigation and Enforcement v.
UGI Utilities Inc. – Gas Division
Docket No. C-2026-
Formal Complaint (Non-Proprietary and Proprietary Version)

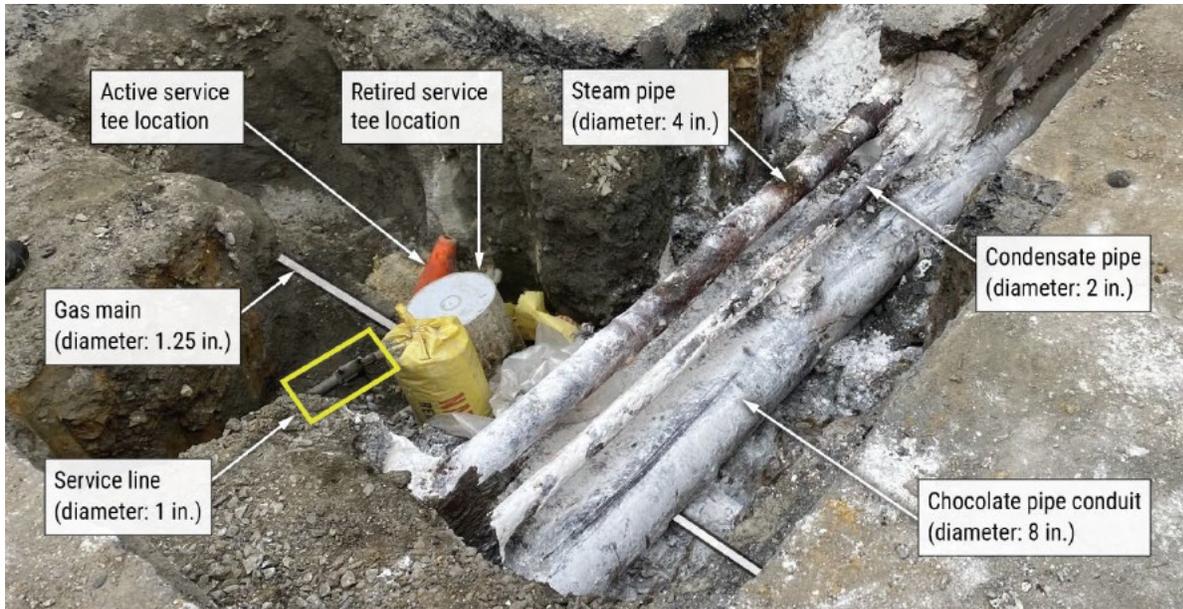
I&E Exhibit 3

98. The crack was located on the east side of the steam pipe, facing Respondent's retired Aldyl-A service tee for Building 2. See attached I&E Exhibit 3.

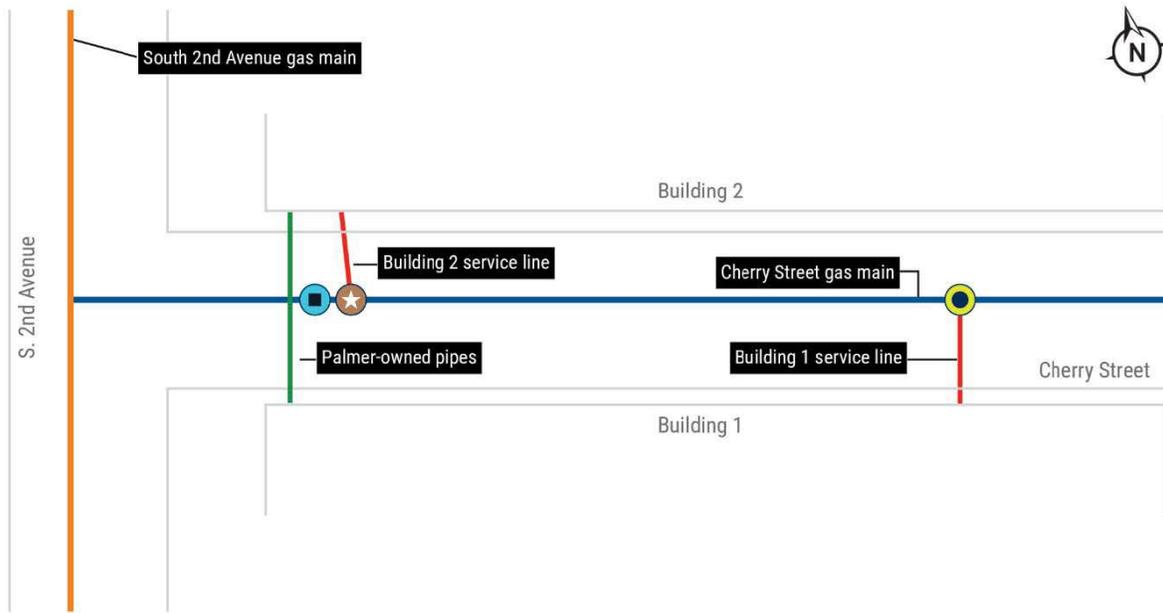
I&E Exhibit 4

- 1982 retired service tee, Building 2
- ★ 2021 active service tee, Building 2
- 1982 service tee, Building 1

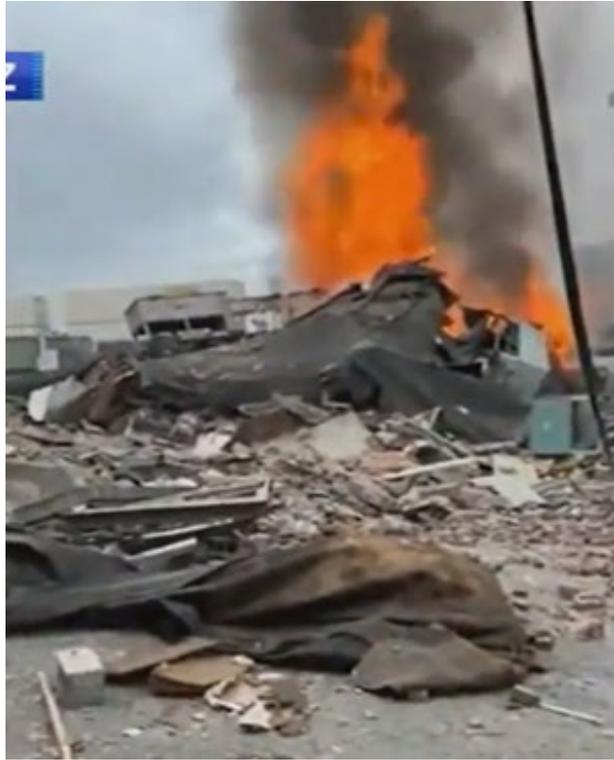
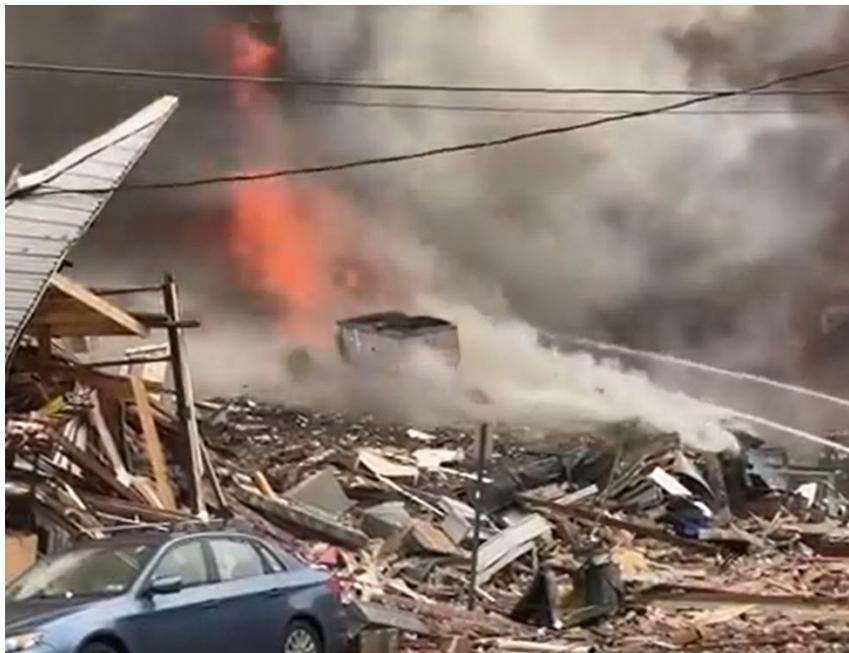
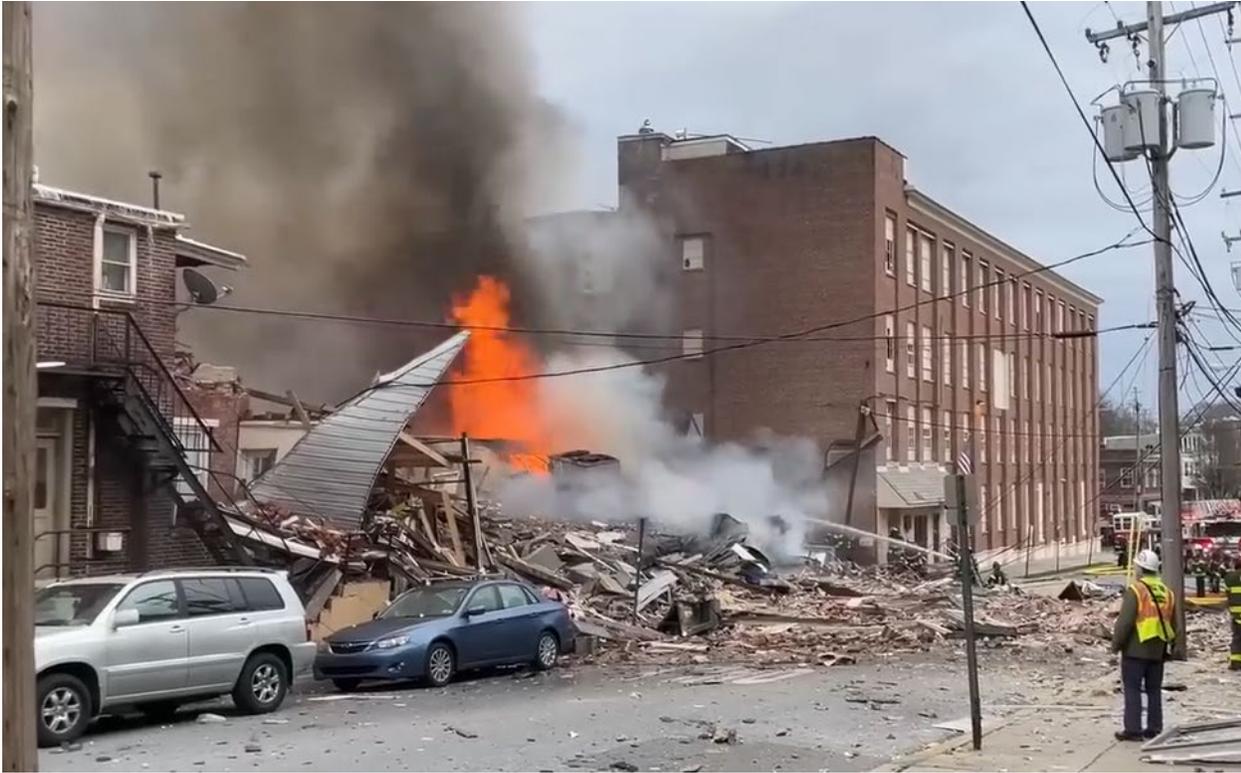
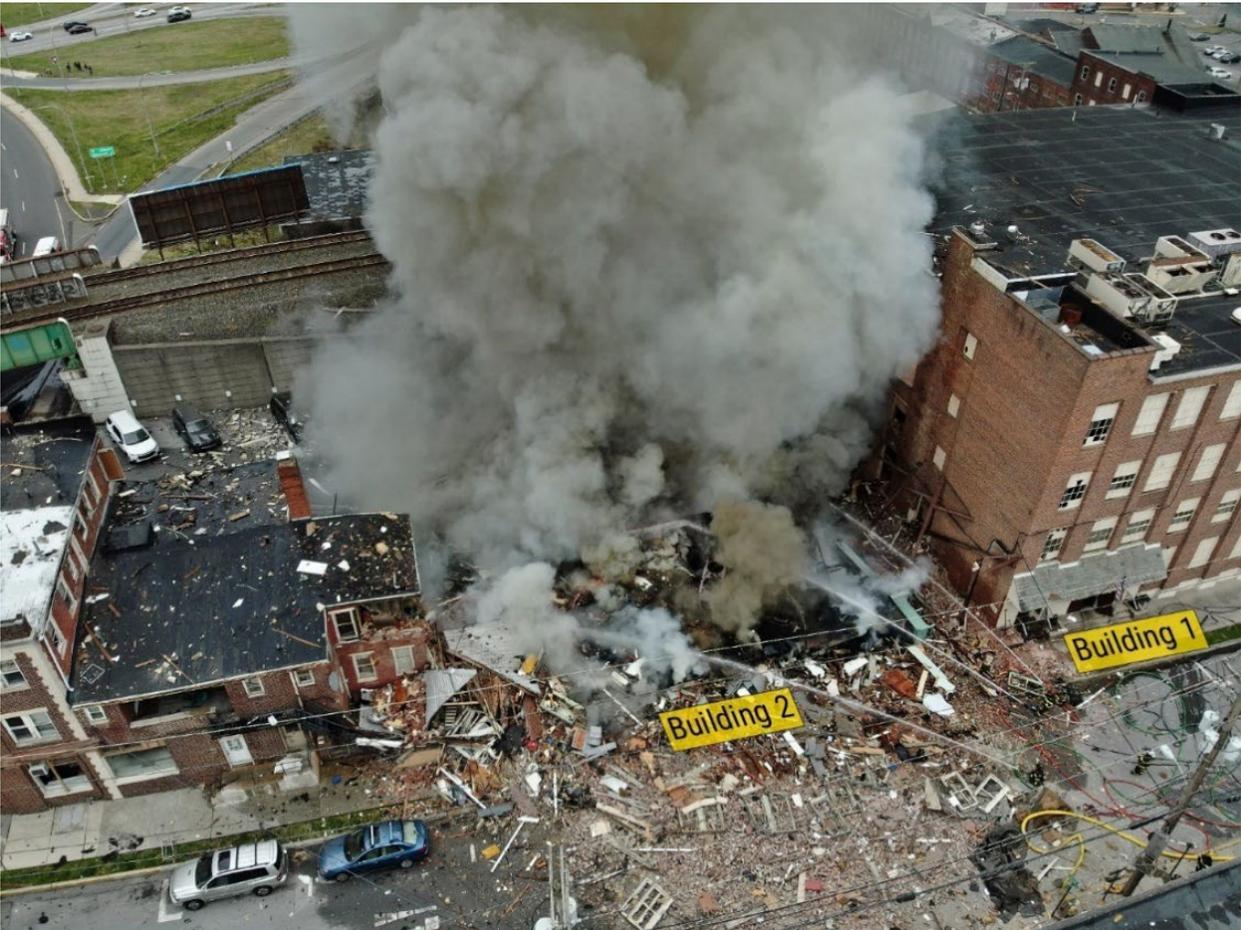
I&E Exhibit 5

59. The natural gas explosion and fire destroyed Building 2, caused significant structural damage to Building 1, and destroyed an adjacent apartment building, displacing three families. See attached I&E Exhibit 5.

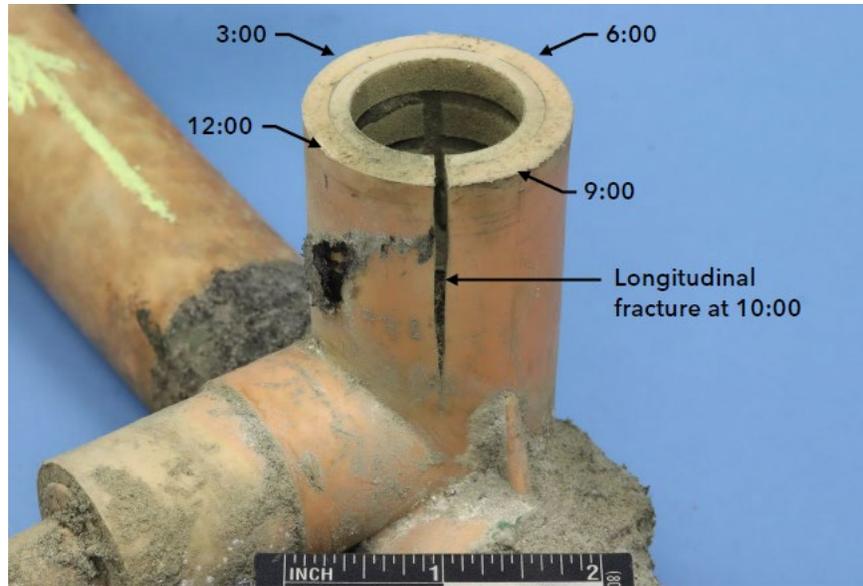
I&E Exhibit 10

- a. The tower assembly's outer shell exhibited a longitudinal fracture at the 10 o'clock position. See attached I&E Exhibit 10.
- b. The Delrin insert exhibited material degradation, dirt & debris, volume loss, a fracture origin point near 9 o'clock, a final fracture point near 3 o'clock (via jumping across a thread crest from the 9 o'clock position), and ratchet marks.⁵ See attached I&E Exhibit 11.
- c. The cutter head exhibited a transverse crack across the floor of the socket and multiple other cracks and fractures and the cutter barrel threads exhibited surface roughing and alteration. See attached I&E Exhibit 12.
- d. The cap was not recovered, but the cap's o-ring was recovered and exhibited a break. See attached I&E Exhibit 12.

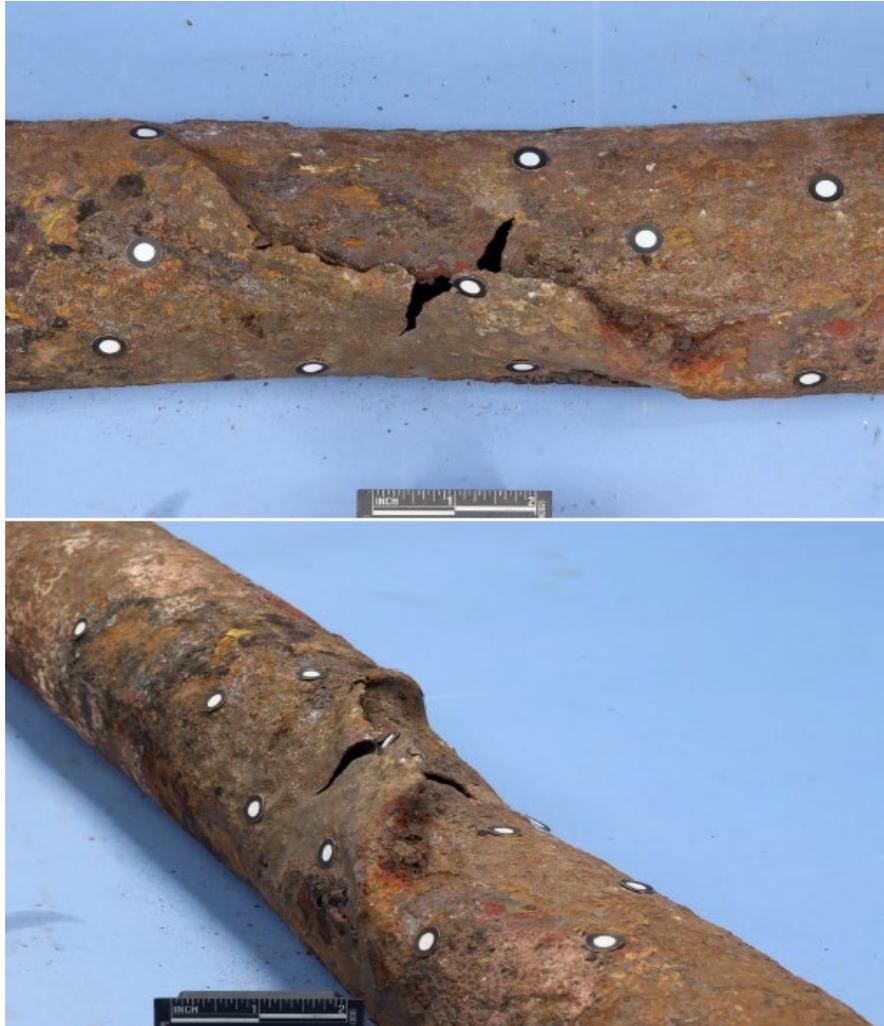
I&E Exhibit 13

97. Palmer's 4-inch steam line was found to be corroded, deformed by shear forces, and a 4-inch long crack with two smaller cracks branching off. See attached I&E Exhibit 13.

99. The crack in the steam pipe allowed steam to escape from the pipe and heat the soil around Respondent's facilities to temperatures far in excess of average soil temperatures.
