Re: American Transmission Systems, Incorporated, Application for the Acquisition of Certain Real Property from The Cleveland Illuminating Company - Docket Nos. A-2026-3061170, G-2026-3061176

FACILITY CONDITION ASSESSMENT

FACILITY CONDITION ASSESSMENT OF NORTHERN REGION HEADQUARTERS

6896 Miller Road
Brecksville, Ohio 44141

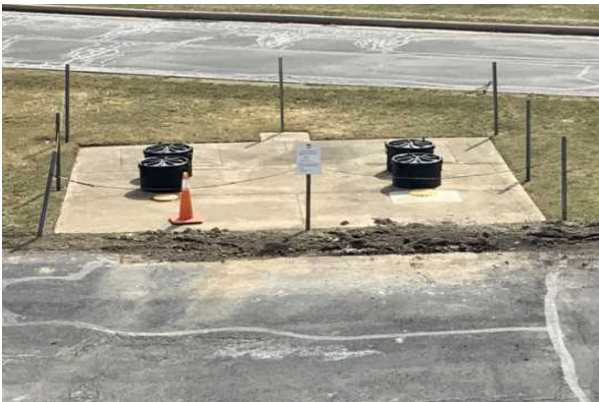
11	UST
----	-----

The two 1,860-gallon underground fuel-oil storage tanks will be replaced.

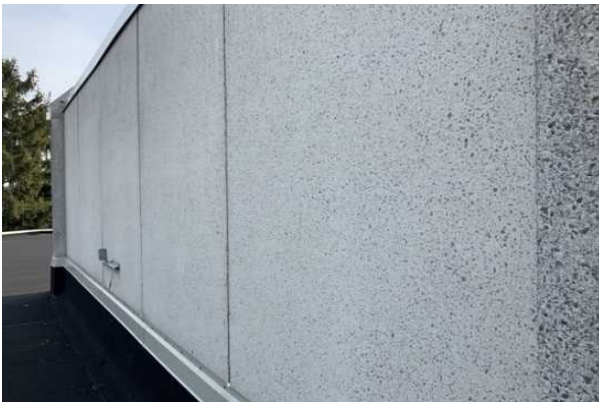
41	EXTERIOR WALLS
----	----------------

- The precast concrete wall panels have slight depressions in the upper edge of the panels that allow the collection of moisture. The moisture then evaporates leaving a black microbial growth substance that then is washed down the walls during the next rainstorm creating an ugly black stain streak on the exterior walls around the perimeter of the building. These depressions need to be cleaned and the depression filled to prevent the future accumulation of moisture. See discussion in Section 6.3.

Exterior mold occurs along the perimeter of the building under the windows where a depression in the top of the precast concrete wall panels underneath the windows tends to catch and hold rain which then evaporates and leaves a black substance that resides in the depression and tends to run down the exterior walls leaving black stain streaks down the sides of the wall panels. The discolored areas under the windows include approximately 1,500-2,000 square feet of wall area. See discussion in Section 6.3.
