| Denise Mitchell, | |
| PECO Energy Company | |

Docket No. C-2024-3052605

**Exhibit #1 Exterior Photographic Evidence.**

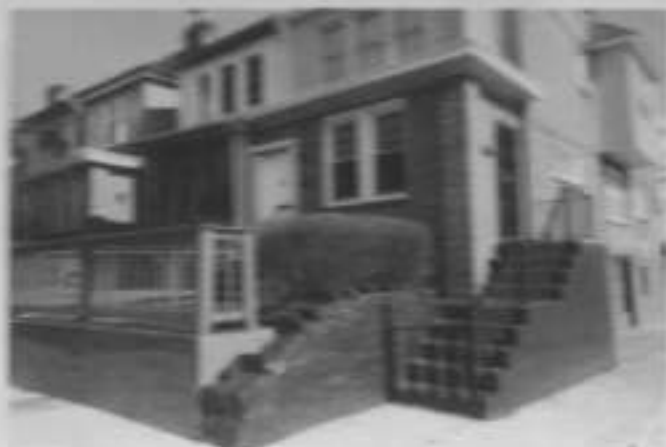
Photo #1 - Taken 04/16/2021 Property in Good Condition

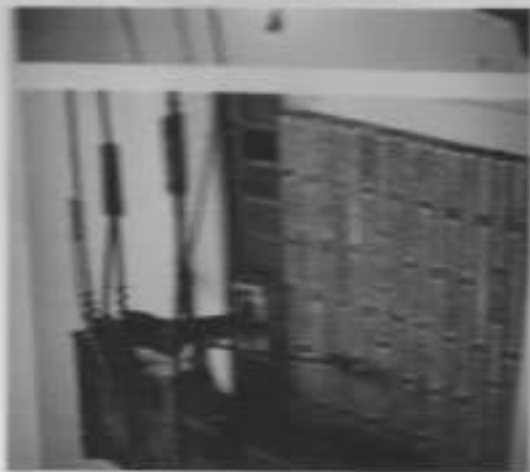
Photo #2 - Taken 03/23/2023 PECO Bracket & Aerial Lines Located Near Porch Roof

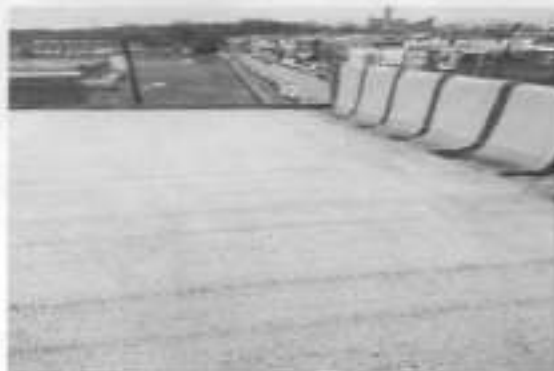
Photo #3 - Taken 04/21/2023 Roof Top & Rear Section Of Property Facing Open Park Area - Weather Impact

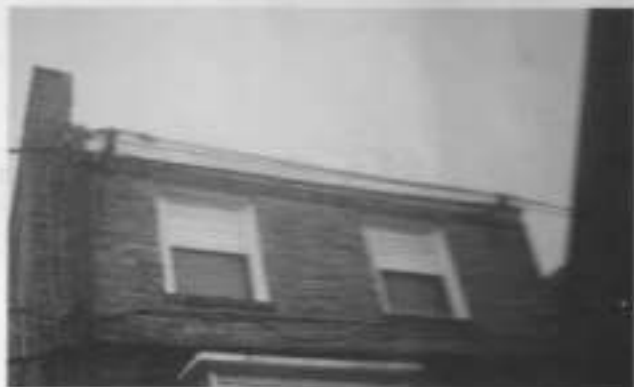
Photo #4 - Taken 07/19/2022 PECO's Bracket North End - 32 of its customer attached

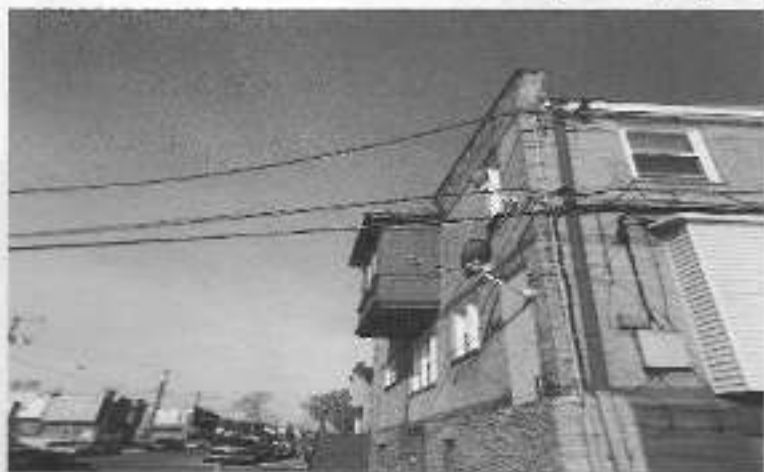
Photo #5 - Taken 04/16/2021 Downspout Properly Aligned

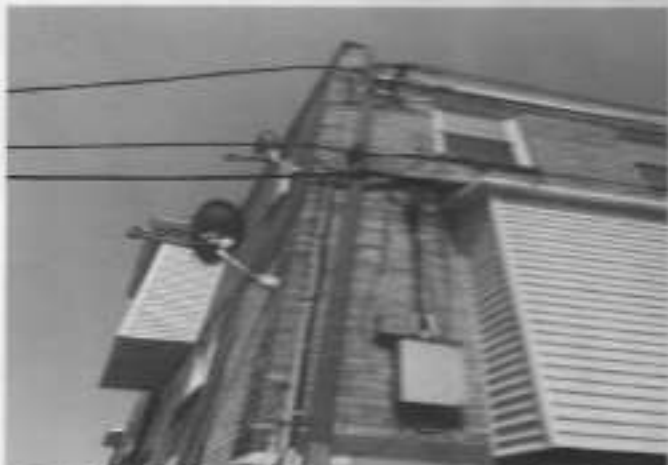
Photo #6 - Taken 06/21/2023 Downspout out of alignment

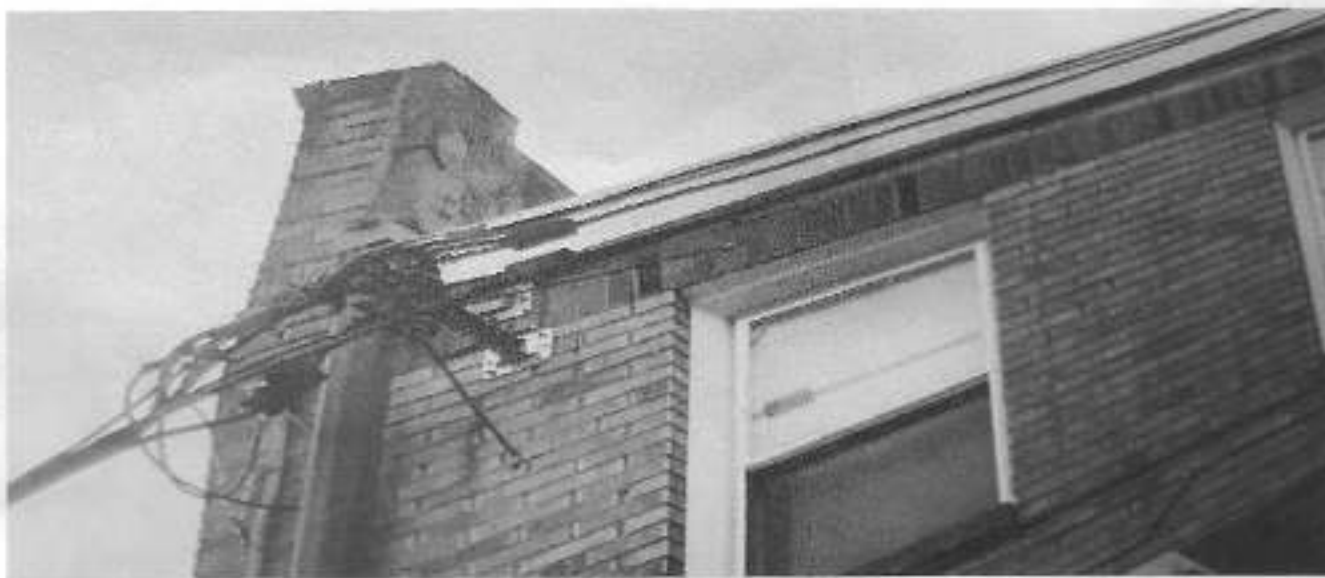
**Photo #7** Taken 12/07/2023. PECO's Bracket repaired, Aerial Line attachments modified & downspout realigned. Visible Parapet Roof Damage. Did PECO apply pointing to all bricks areas around it's old bracket? See Exhibit #15 Claimant's 06/15/2025 Additional Damage Reported to PECO. Water Continues To Enter 2<sup>nd</sup> Floor Unit.

**Exhibit 17 — Response to Judge Nause’s Request Regarding Exhibit 1, Photo #7 (Taken 12/07/2023)** documenting the current condition of the Claimant’s rear wall. During the repair work, PECO modified the aerial line attachments and realigned the downspout. **PECO did not apply pointing to all brick areas surrounding its old bracket**, leaving the wall vulnerable to continued water intrusion. Subsequent deterioration is documented in:

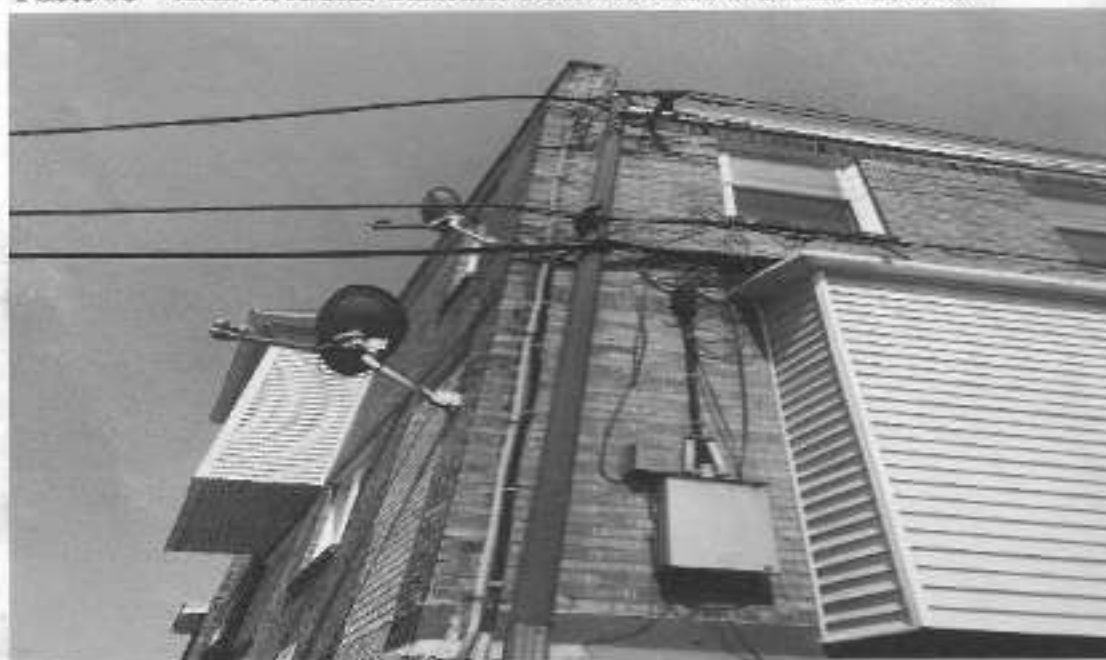
**Photo #8** – Taken 06/01/2023 Customer's Service Head & Bracket Location

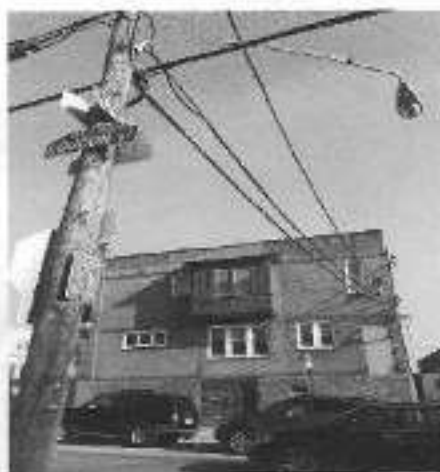
**(a) Parapet Roof in '2011**

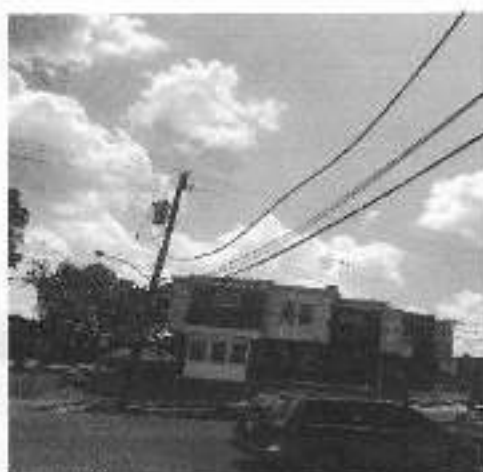
**(b) Taken 04/21/2023 PECO Drooping Wires**

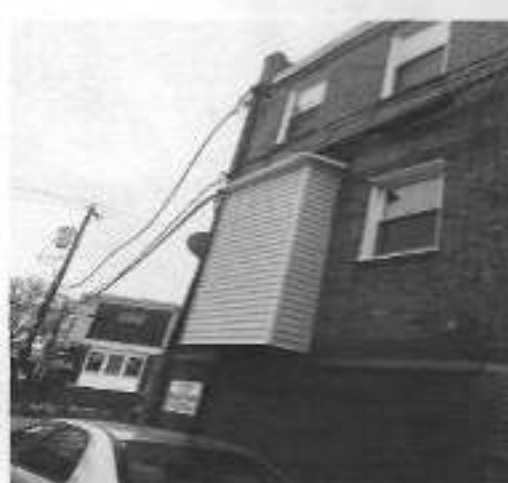
**(c) Taken 01/31/2022 Wires Pulling wall**

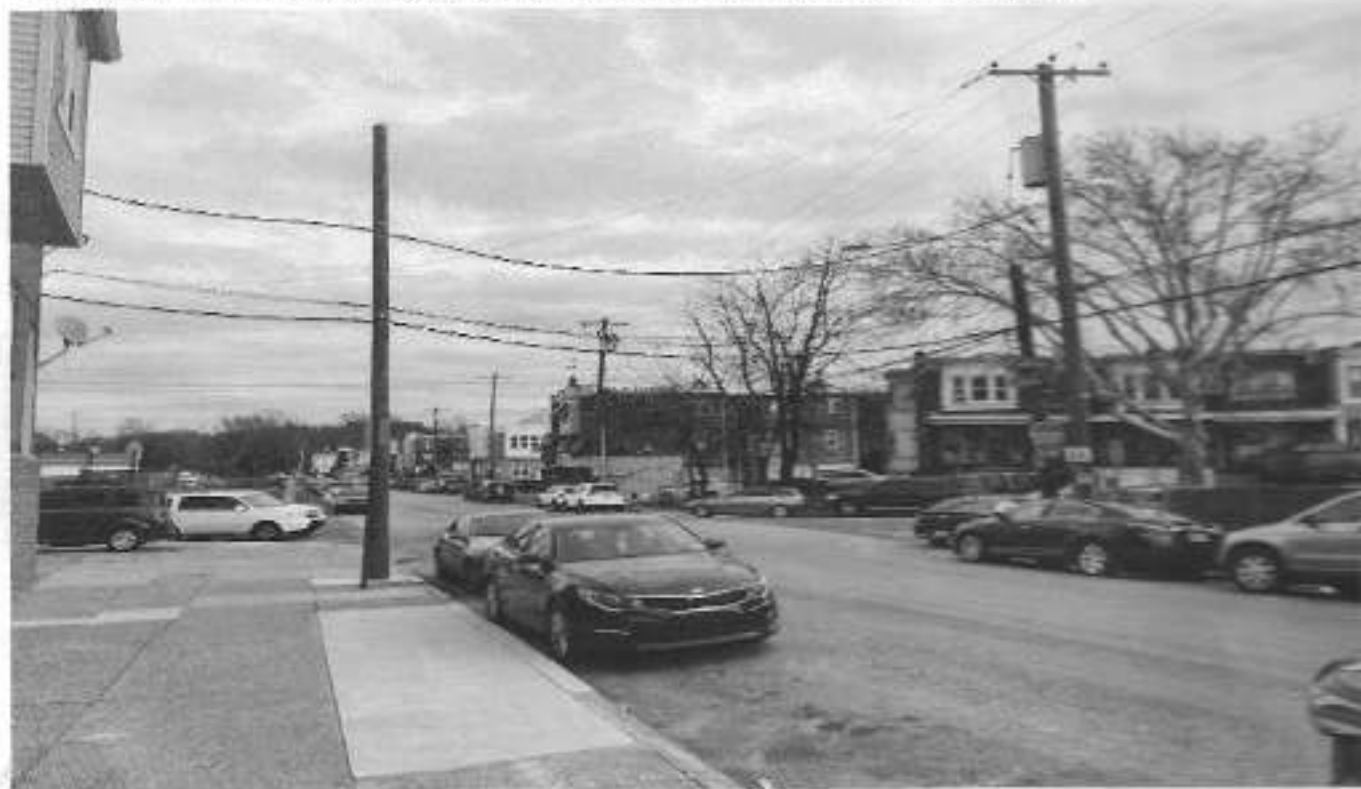
**Photo #10** – PECO's Completed Repairs Per Work Order #19203009-04, see Exhibit #11

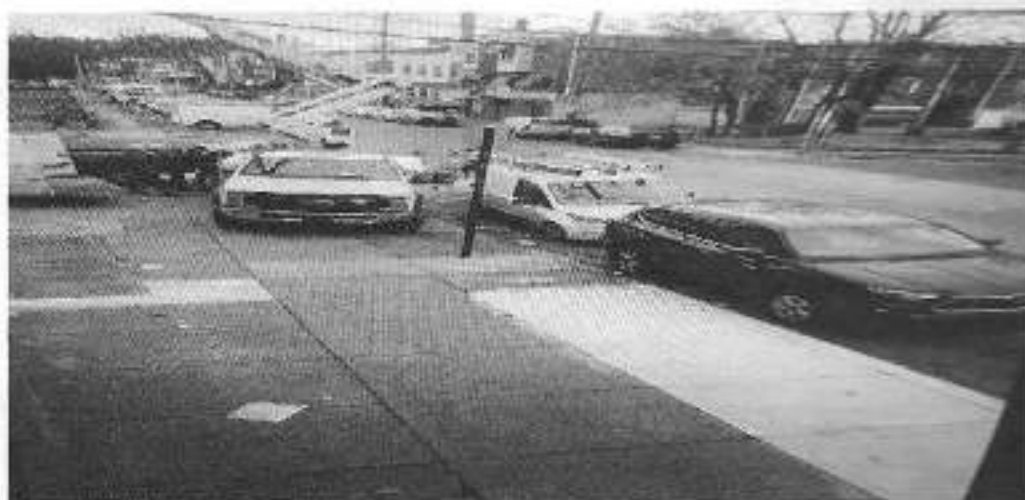
**Photo # 11 – Taken 11/21/2023 - PECO's Technicians Performing Bracket Inspection.** PECO Senior Claims Manager withheld this report from Claimant until 04/22/2025 after denying it didn't exist. See **Exhibit #11**

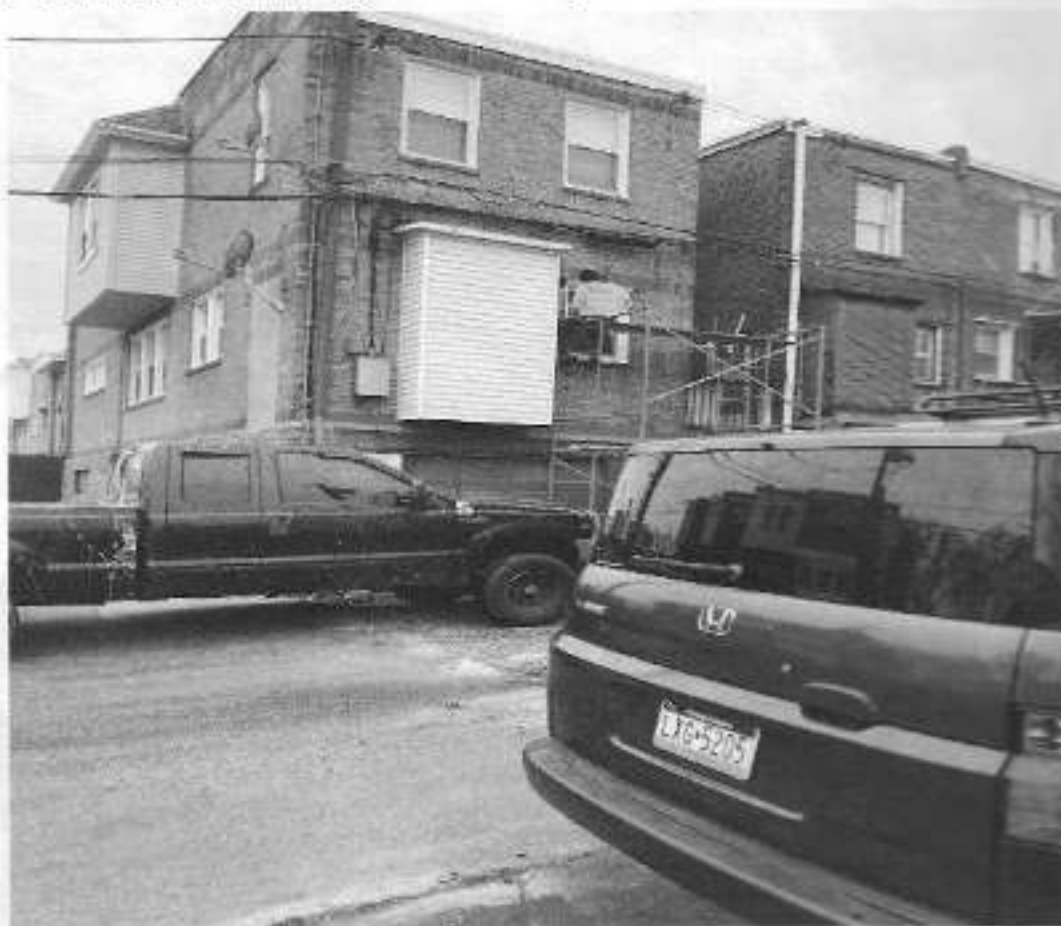
**Photo # 12 - Taken 11/22/2025 Lintel Repair – Claimant Replaced 1<sup>st</sup> Floor Rear Window Lintel**

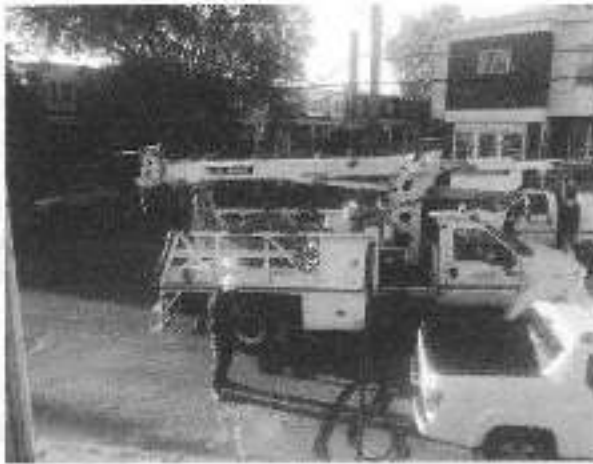
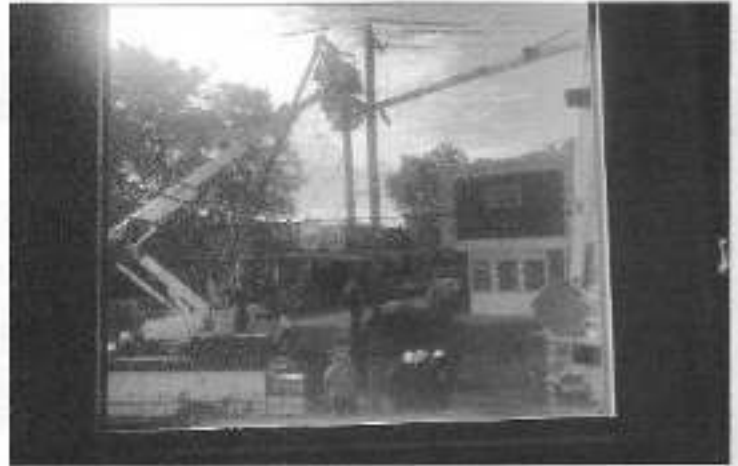
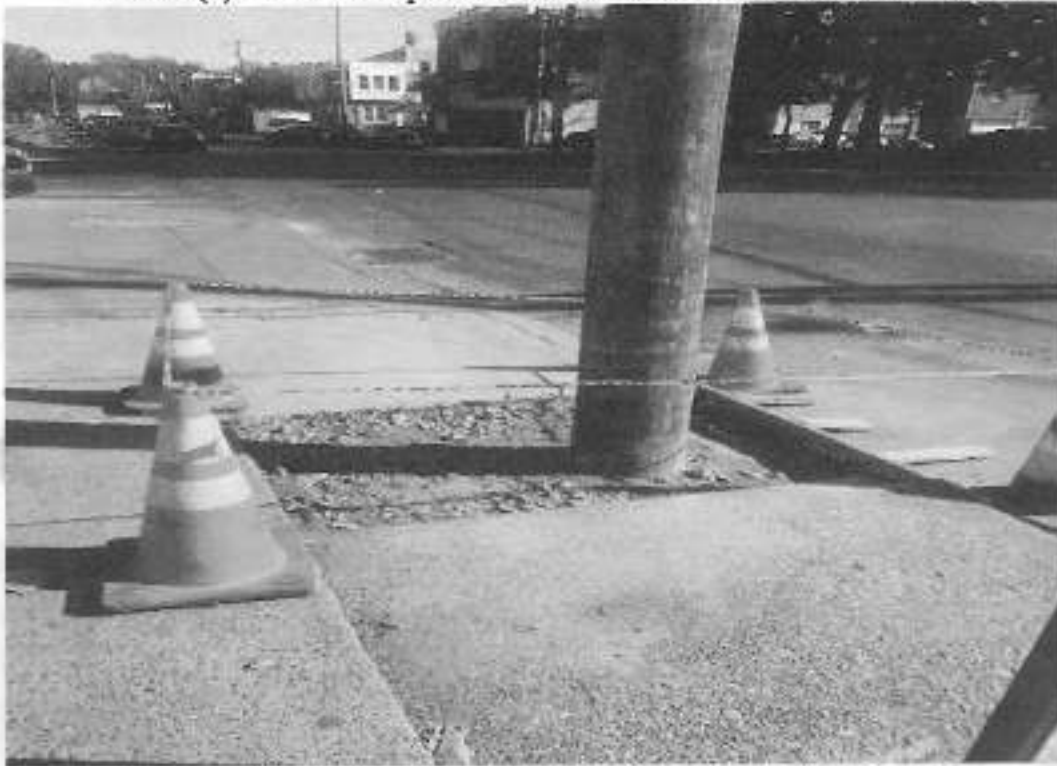
**Photos #13 – Taken 10/16/2024. PECO's Installed - Pole #50866D on Claimant's property without structural engineer's prior approval.**

**Photo (c) – PECO Completed Installation Of Pole #50866D on 10/16/2024**

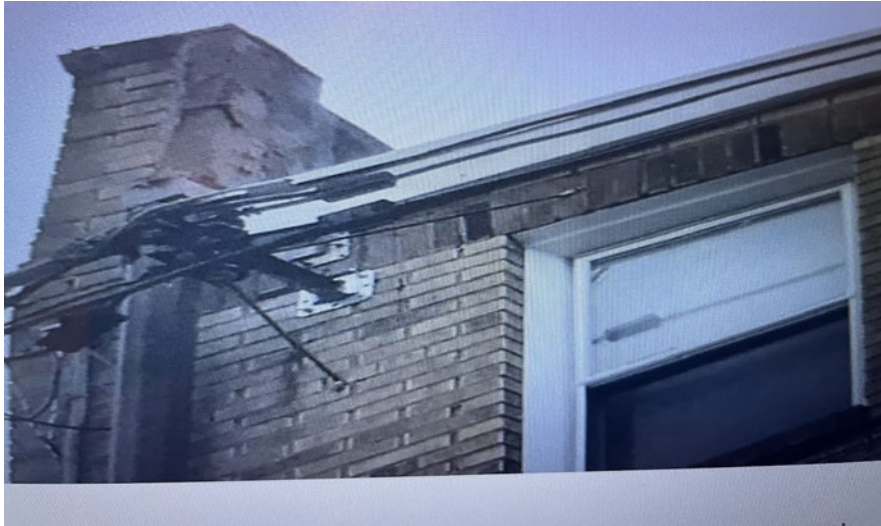
**Photo #2** Taken January 4, 2025 - Shows progression of cracking and mortar loss around the old bracket location.

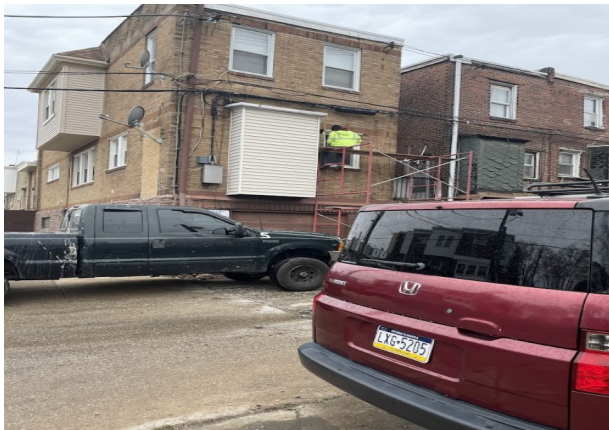
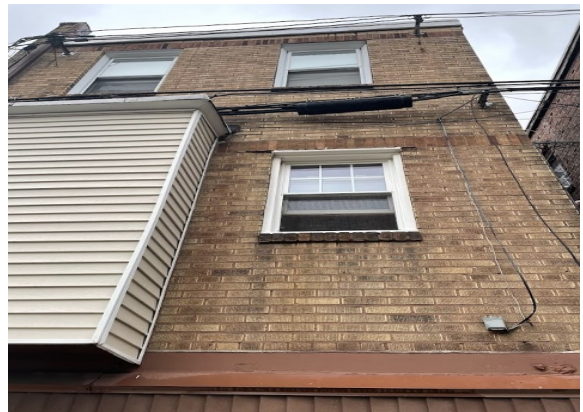
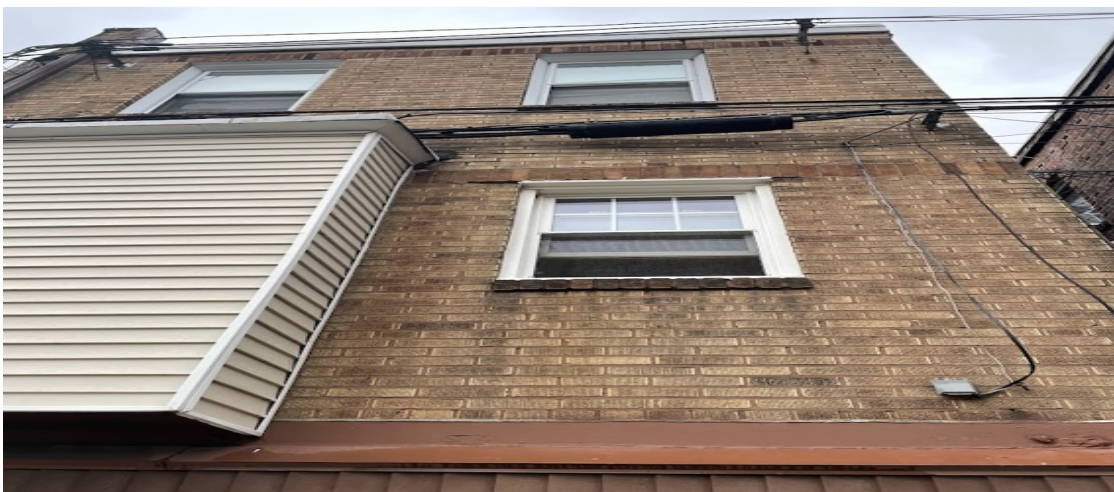
**Photos #3** Taken 11/22/2025 – Claimant's 1<sup>st</sup> Floor Rear Window Lentil Repair

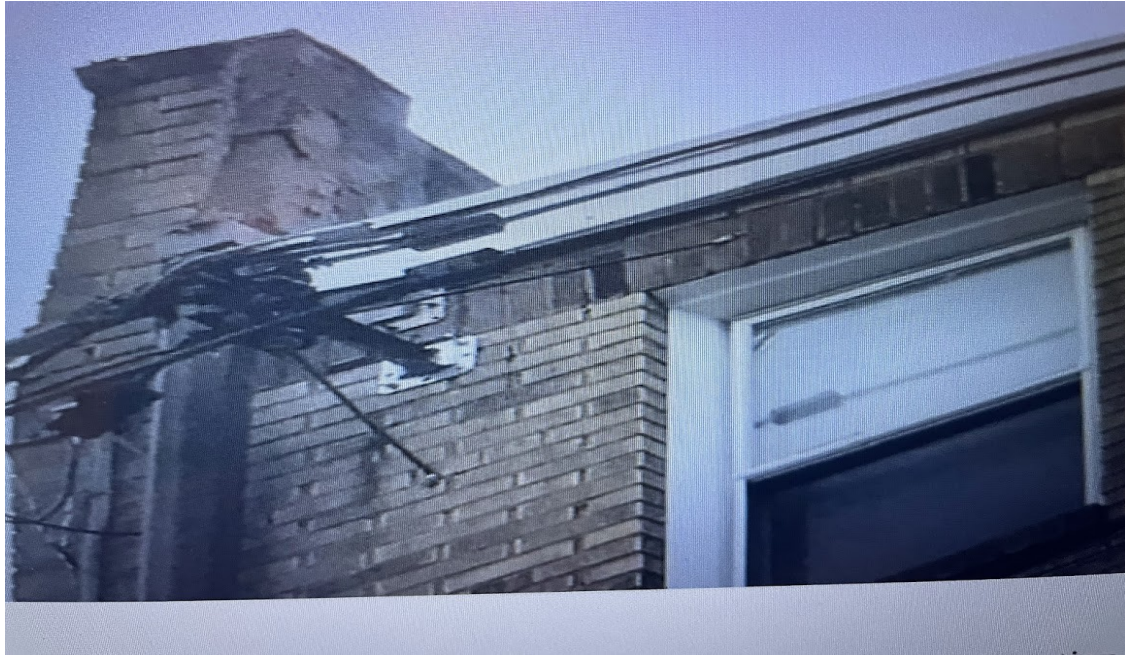
**Photo #4** Taken 11/28/2025 - Shows continued cracking and displacement around the original bracket area.

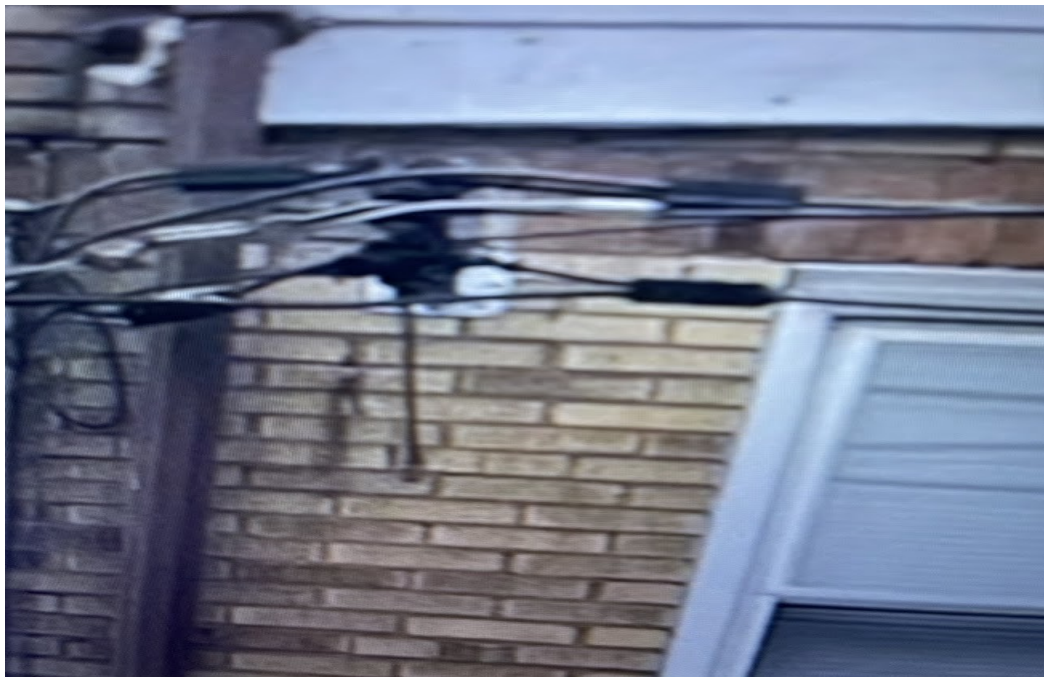
**Photo #5** Taken 04/26/2026 - “Visible impression of the original bracket above the current bracket. The outline is clean and sharply defined, indicating the original bracket has recently detached.”

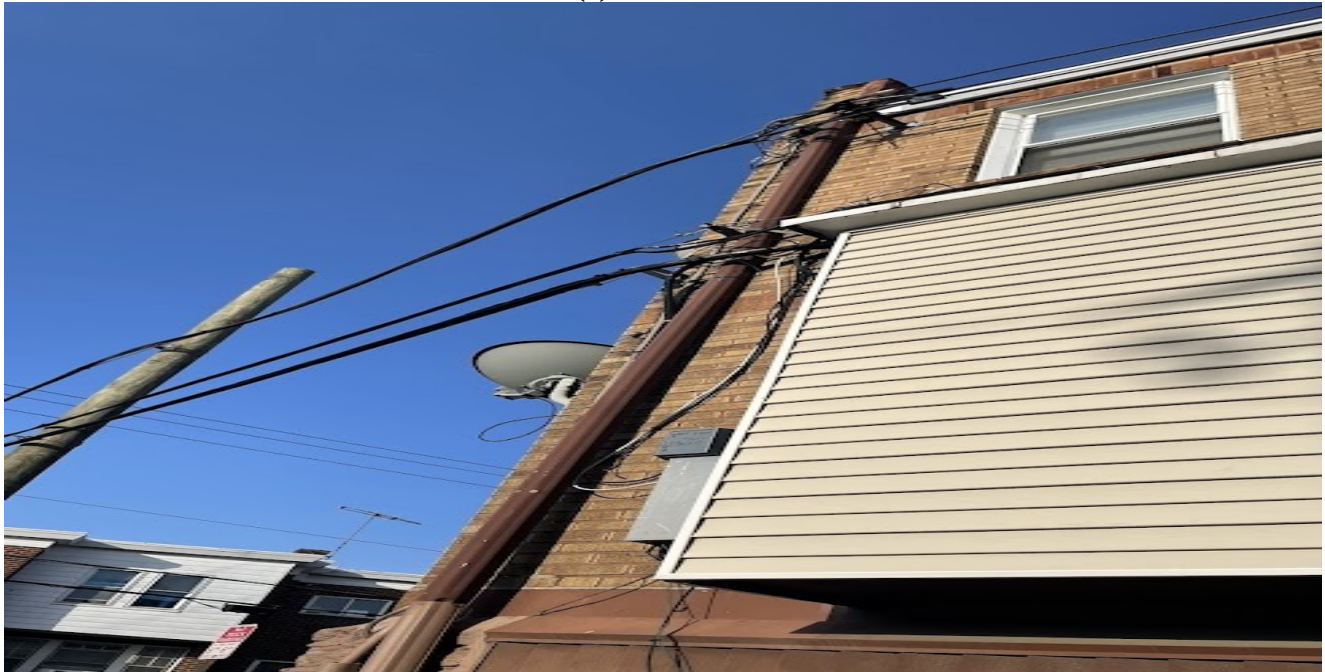
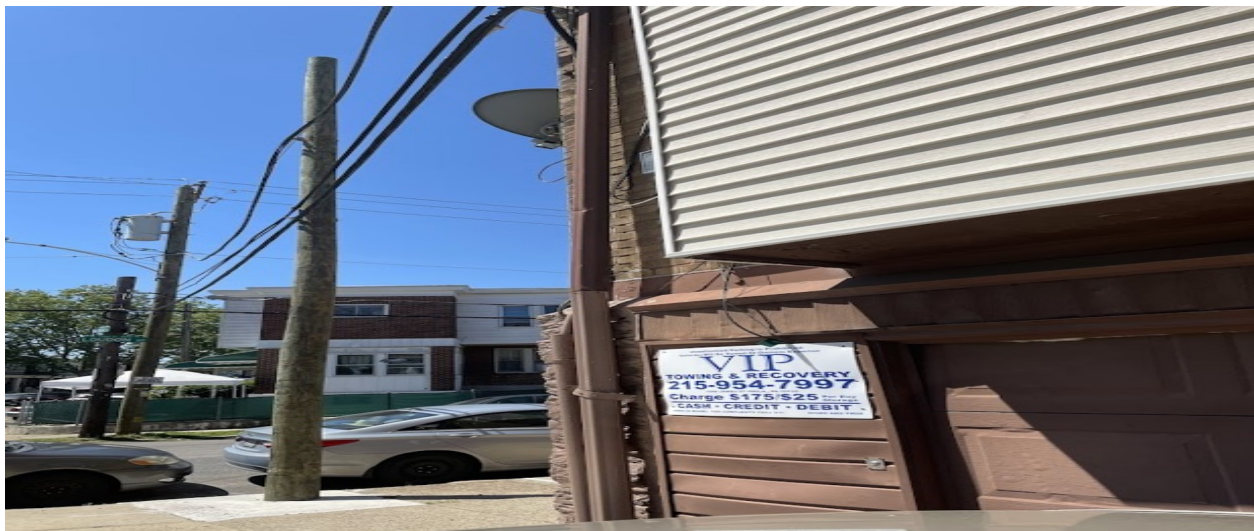
**Photos #7** - Taken 05/27/2026 - **Exterior View — Aerial Line From Pole Across Street to PECO Bracket.** **Description:** This photo shows the PECO aerial service line extending from the pole located across the street at E. Loudon & Bingham directly attached to the Claimant's rear wall. The angle and tautness of the line demonstrate the direction of tension applied to the structure. This image visually confirms the load path described in PECO Work Order 19203009 ("job to put additional pole... to reduce load on rear bracket").

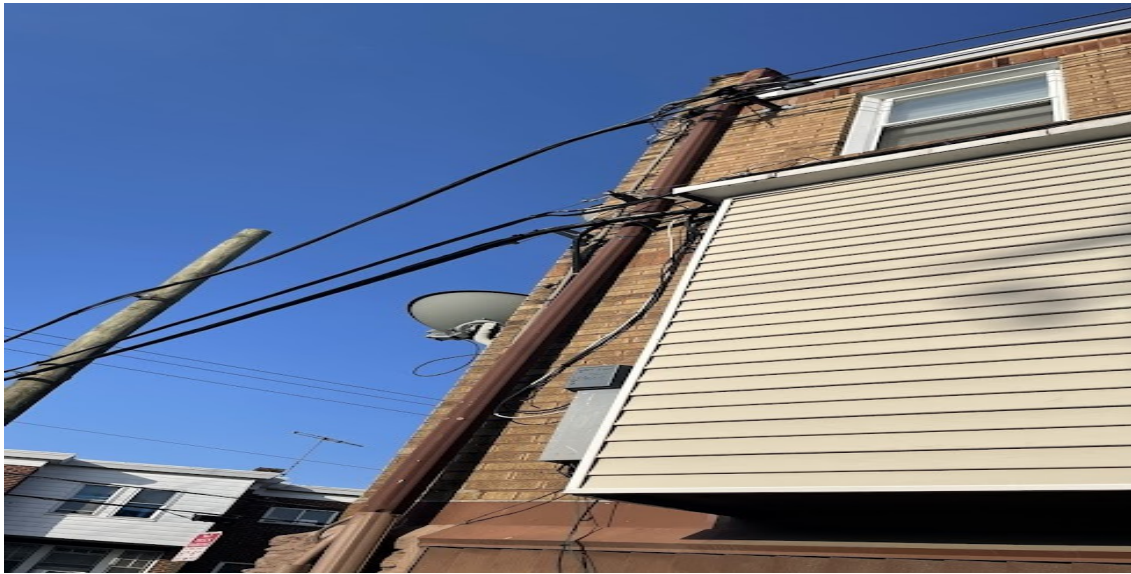
**Photo #1** – Taken 04/27//2026 Misaligned Downspout

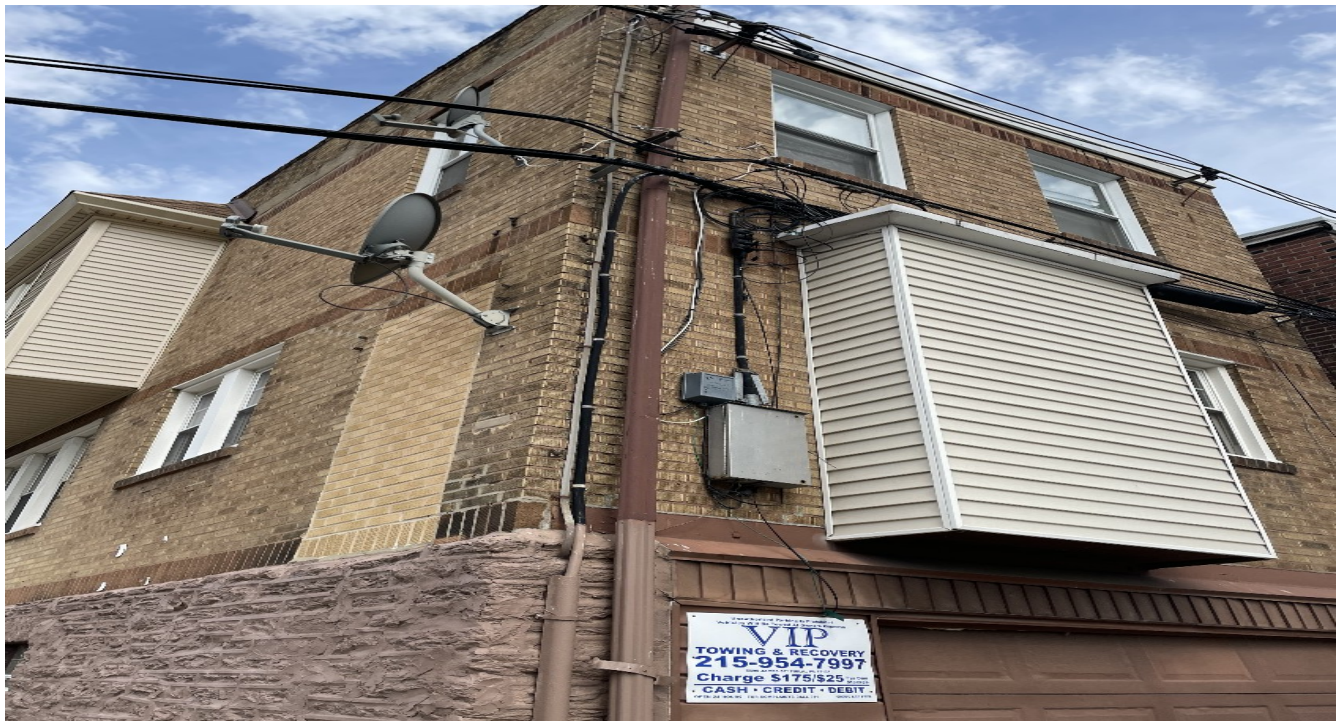
**Photo #2** – Taken 05/13/2026 After PECO’s Attempt To Realign Claimant’s Downspout

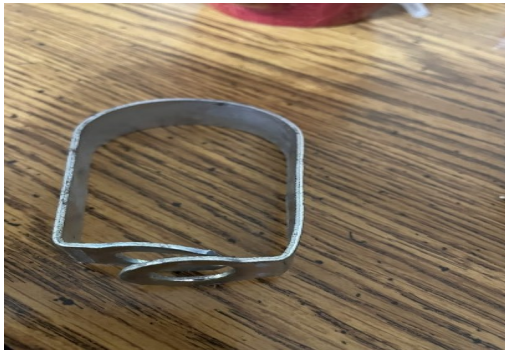
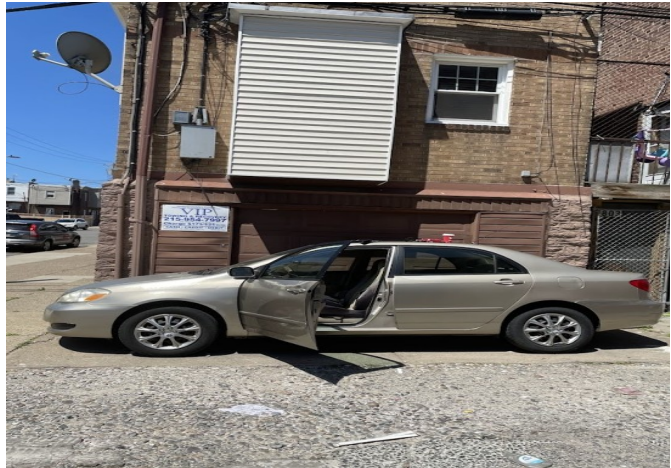
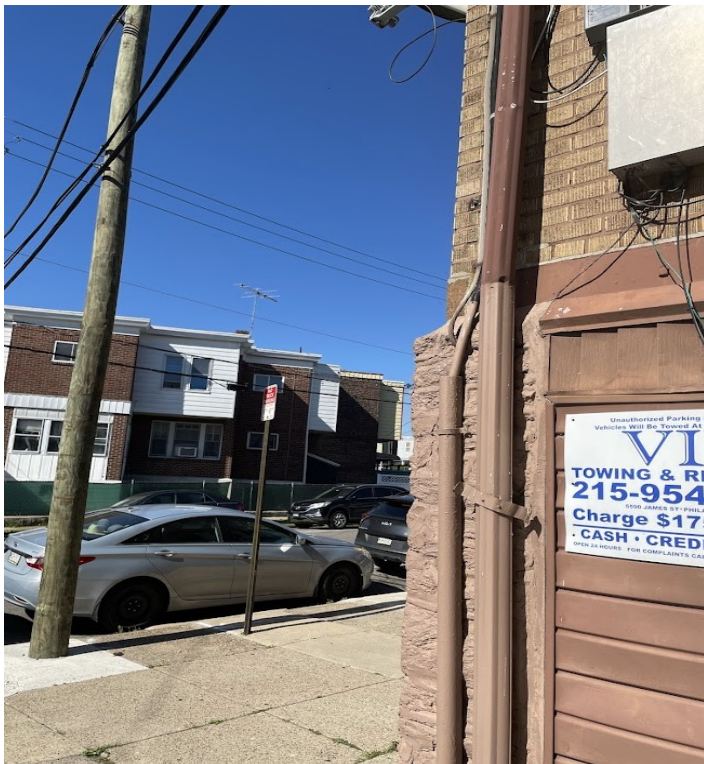
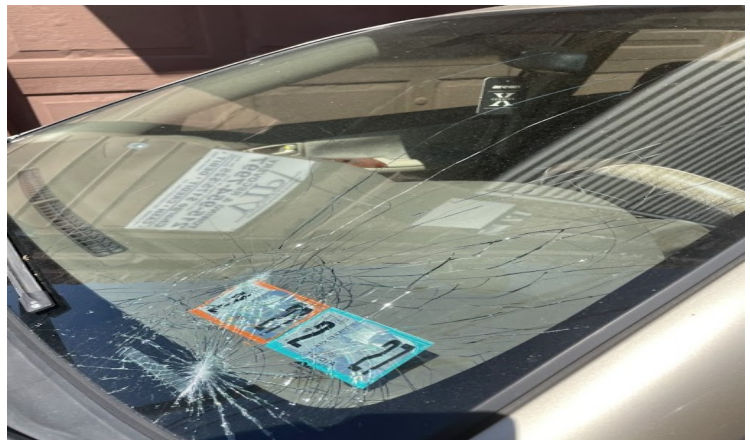
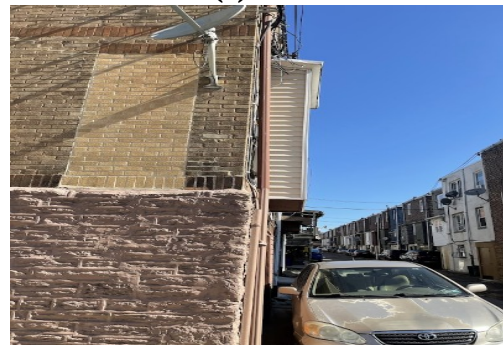
**Photos #3** – Document the resulting damage from the structural conditions shown in Exhibit 17, including PECO’s metal fastener found on the ground beneath the utility mounting area and the Claimant’s shattered windshield caused by a vertical falling-object impact. The fall zone aligns directly with the location of the missing fastener shown in **photo 3(a) below**. The impact pattern on the windshield is consistent with a dense metal object falling from the height above the vehicle, supporting the conclusion that PECO-related hardware caused the hazard. See photo **3(a) and 3(d) below**.
