-----  
Bureau of Investigation |  
and Enforcement |  
v. |  
Philadelphia Gas Works, |  
In Person Evidentiary |  
-----

Docket No.:  
C-2024-3052277

Thursday, October 16, 2025  
Commencing at 9:59 a.m.

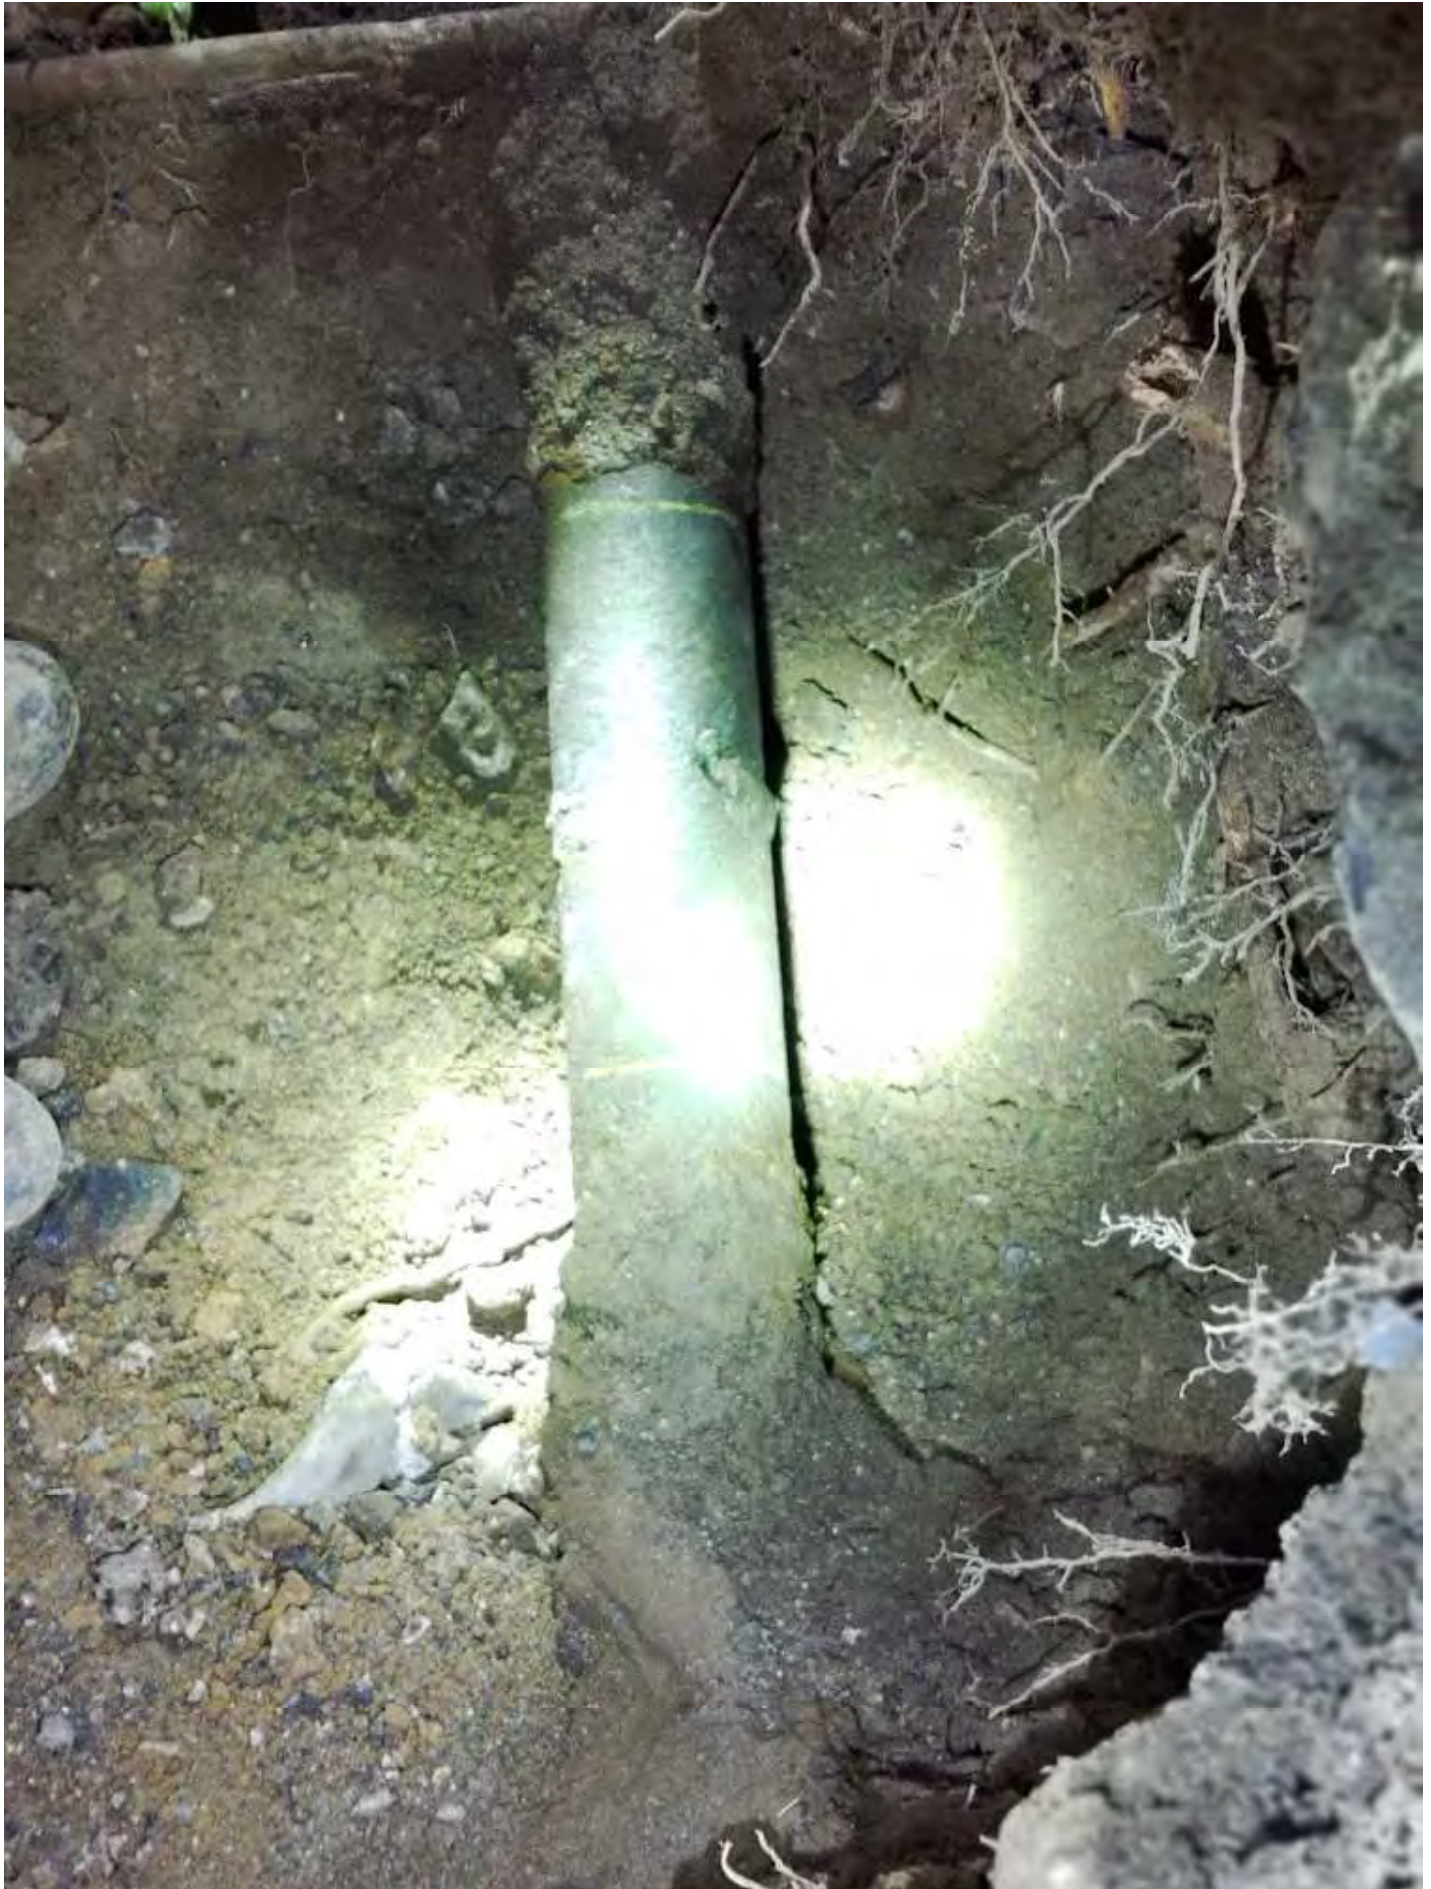
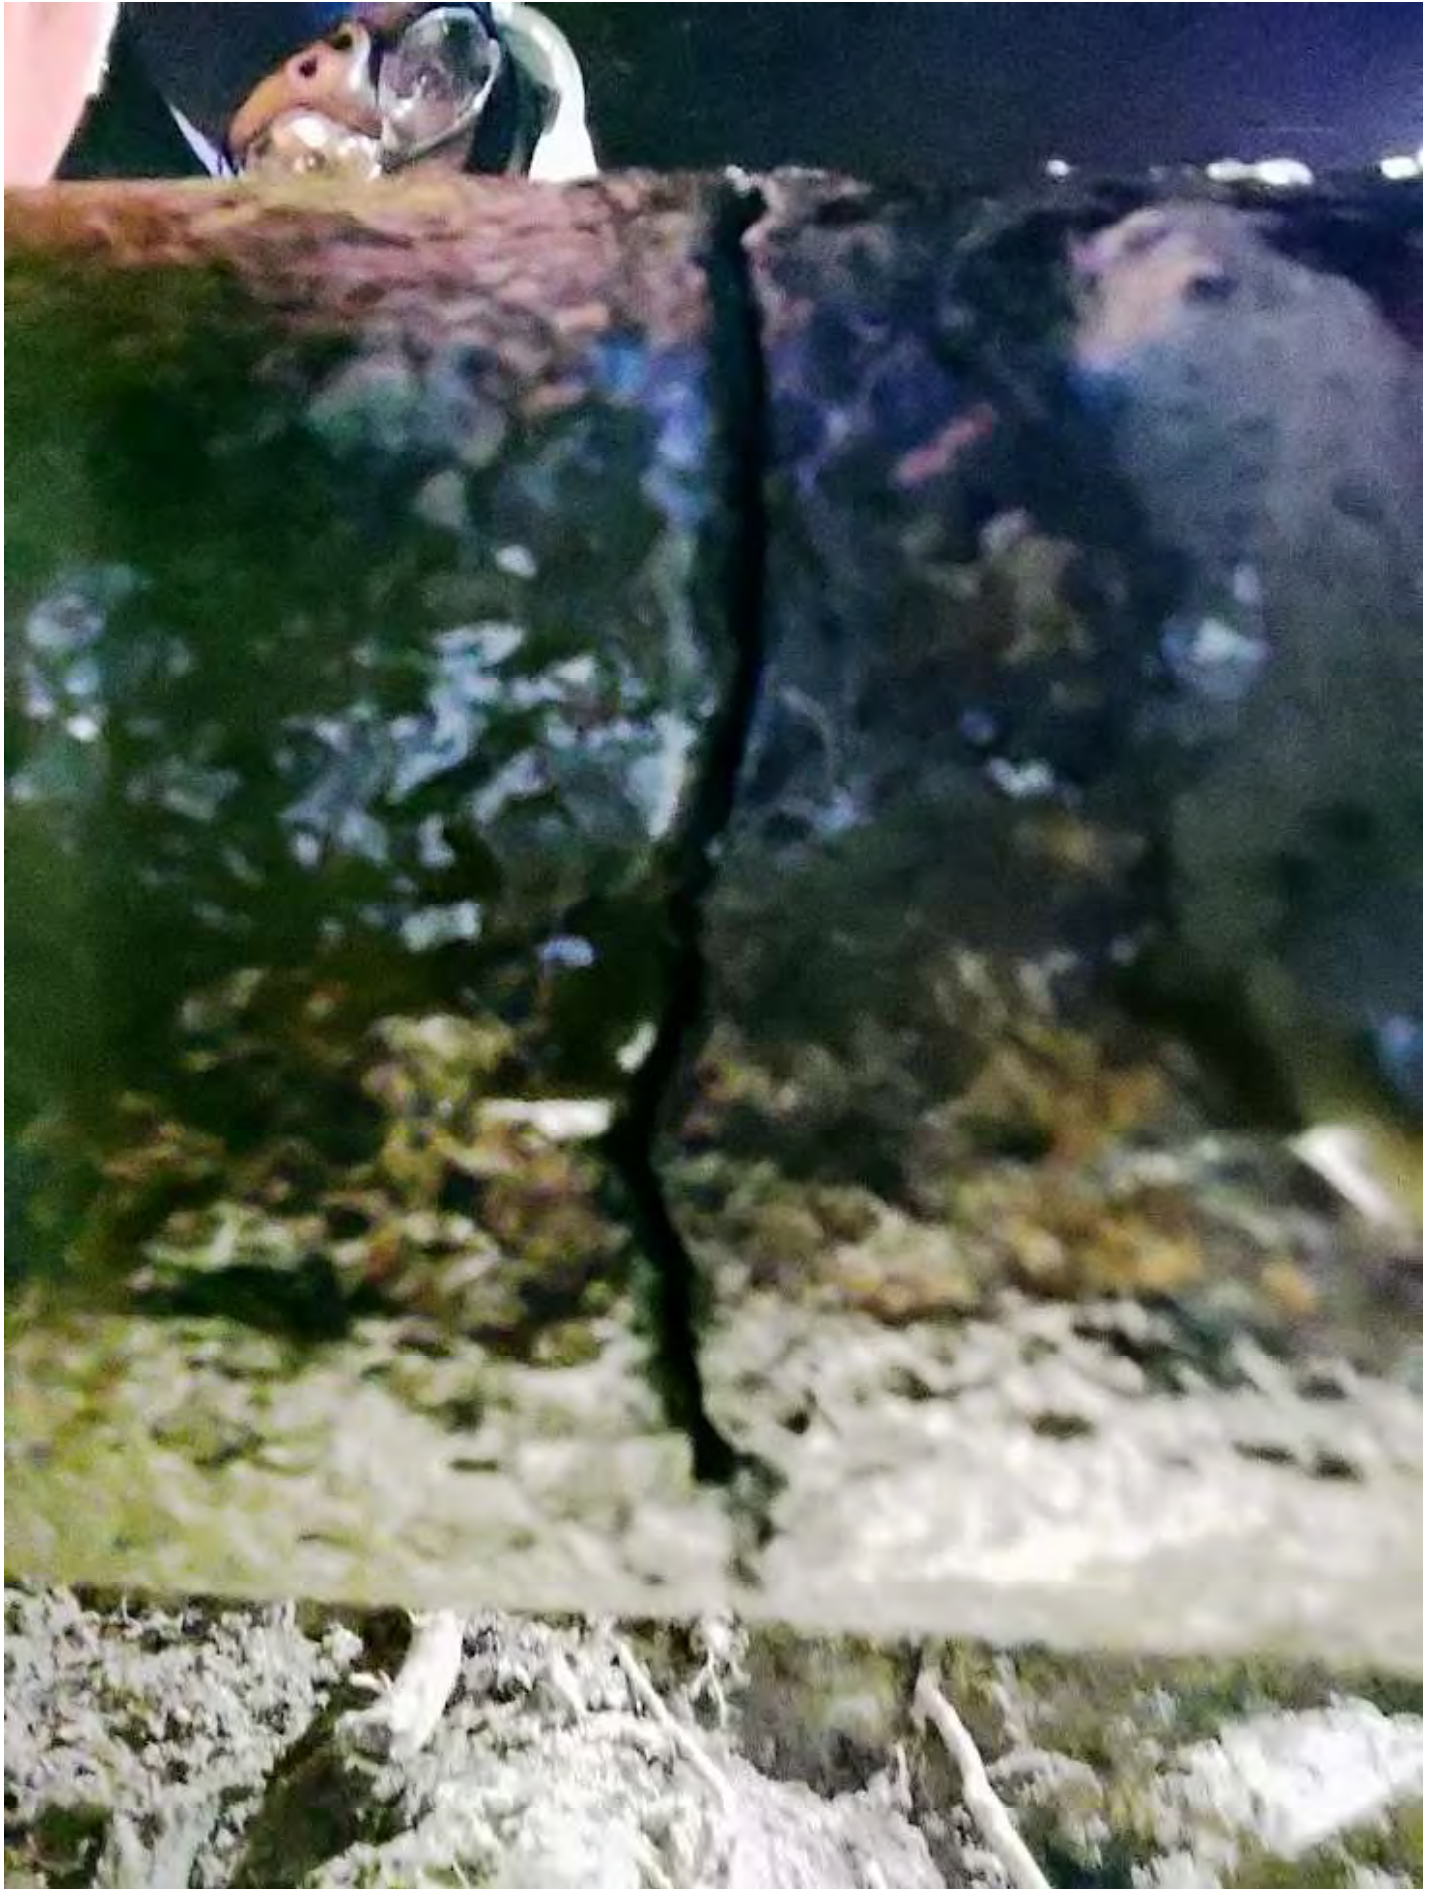
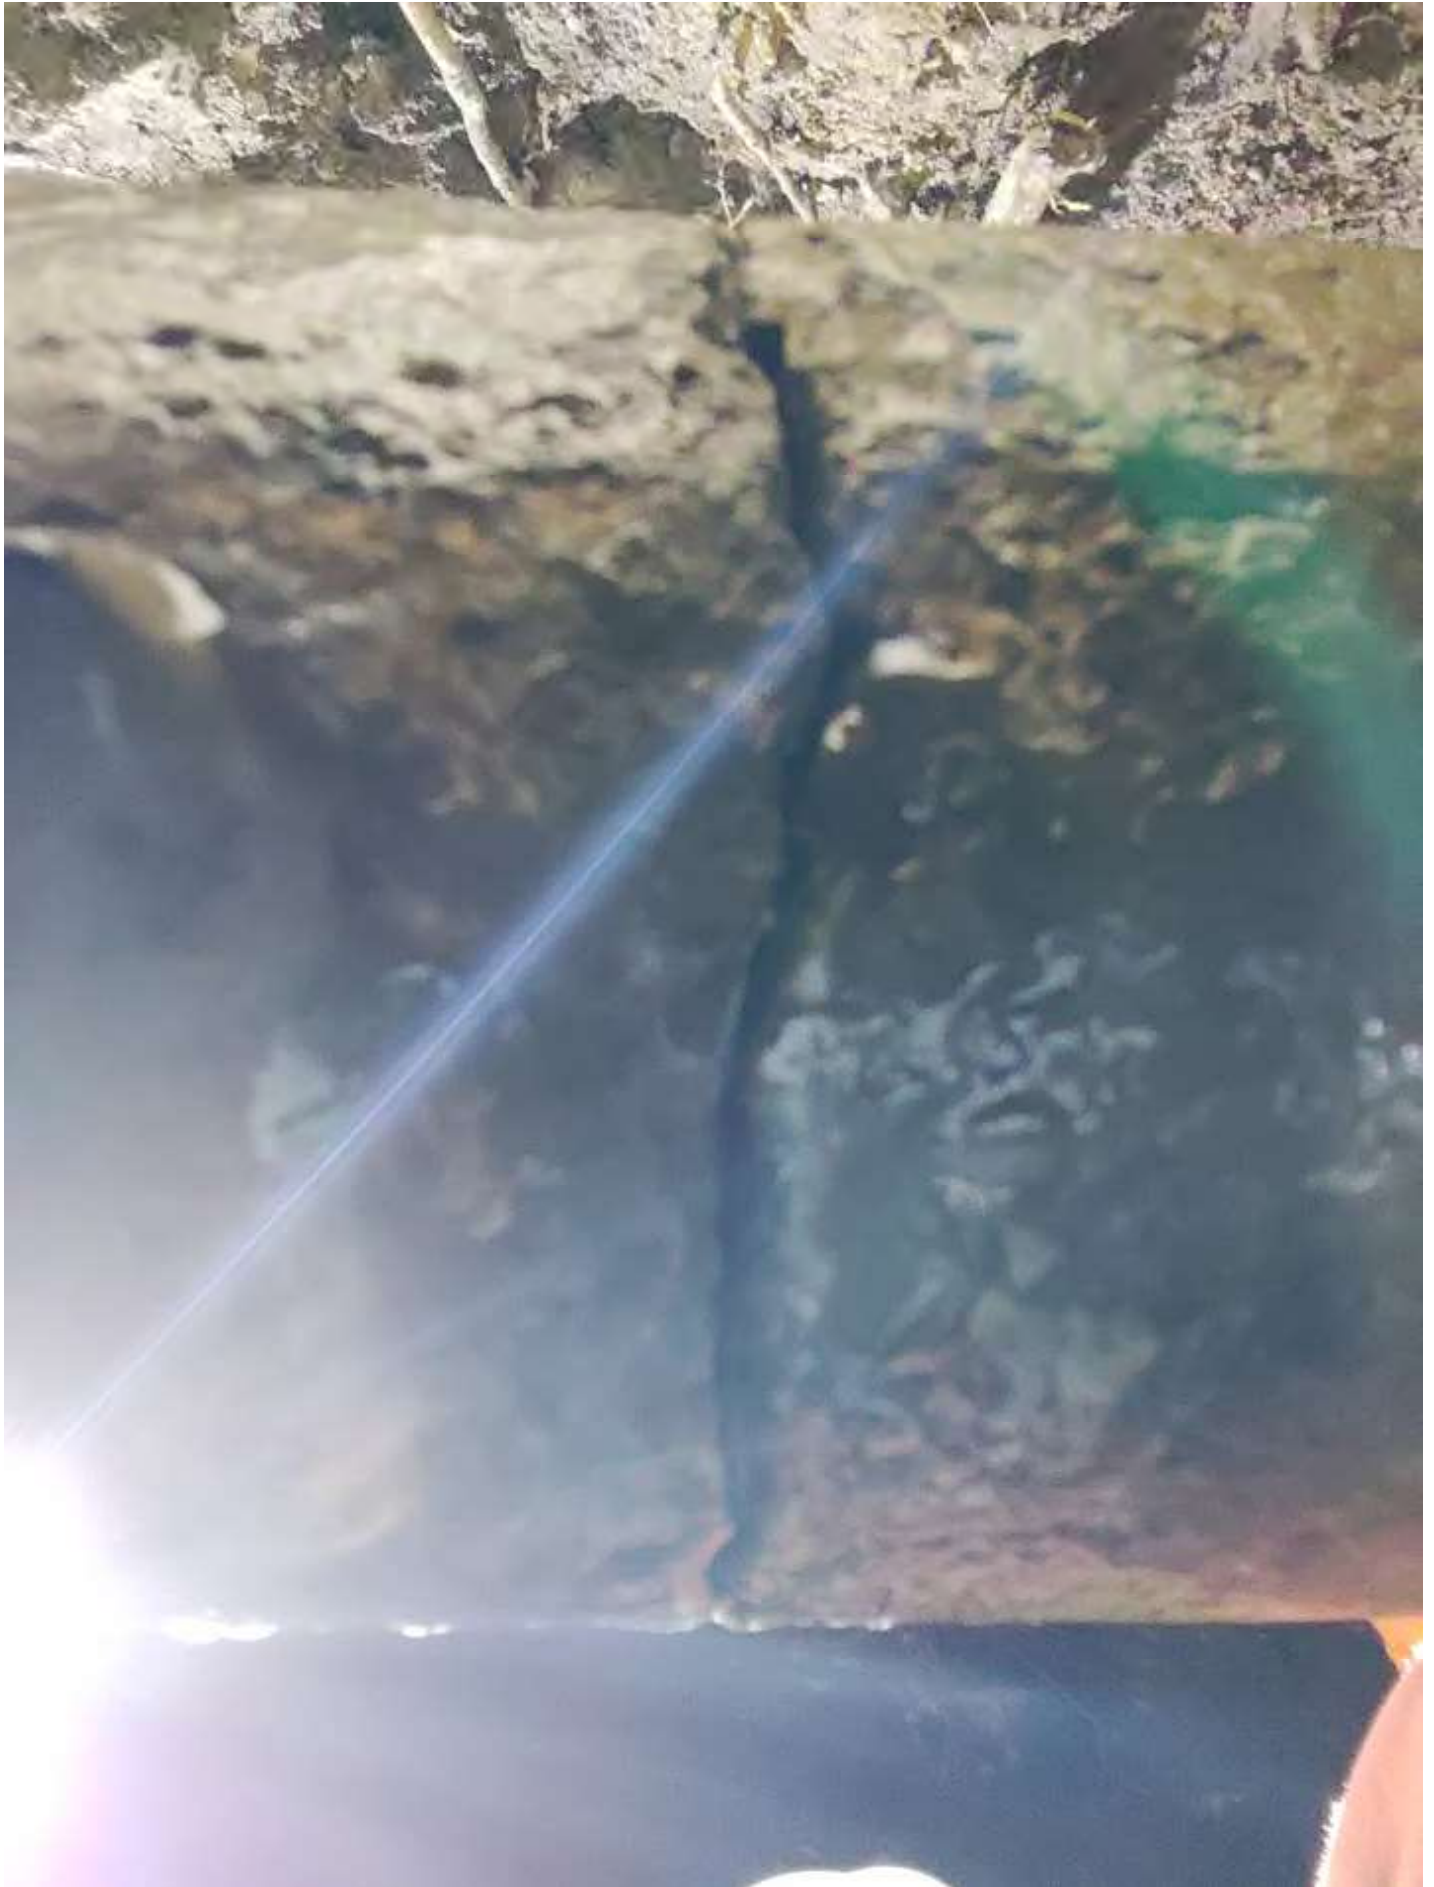
# **I&E Exhibit 4**

3 I&E Exhibit 4 consists of four photographs. The first three photographs show the  
4 broken cast iron main at the scene of the explosion. The last photograph shows the  
5 broken cast iron main after it had been removed and sent for testing.

8   A:    The metallurgical evaluation revealed that the effective wall thickness of the pipe  
9       was reduced to 13-15% as a result of graphitization and a circumferential crack  
10       that initiated along the bottom of the pipe. The cast iron pipe exhibited graphic  
11       corrosion around its circumference whereby the strength of the wall was  
12       compromised. There was no evidence of a pre-existing breach or leak location  
13       observed on the fracture surface.

1 material around and below a pipeline can lead to undermining of pipelines. The  
2 lab report concluded that external stresses applied to a graphitized gas main  
3 induced a circumferential crack whereby gas could escape.

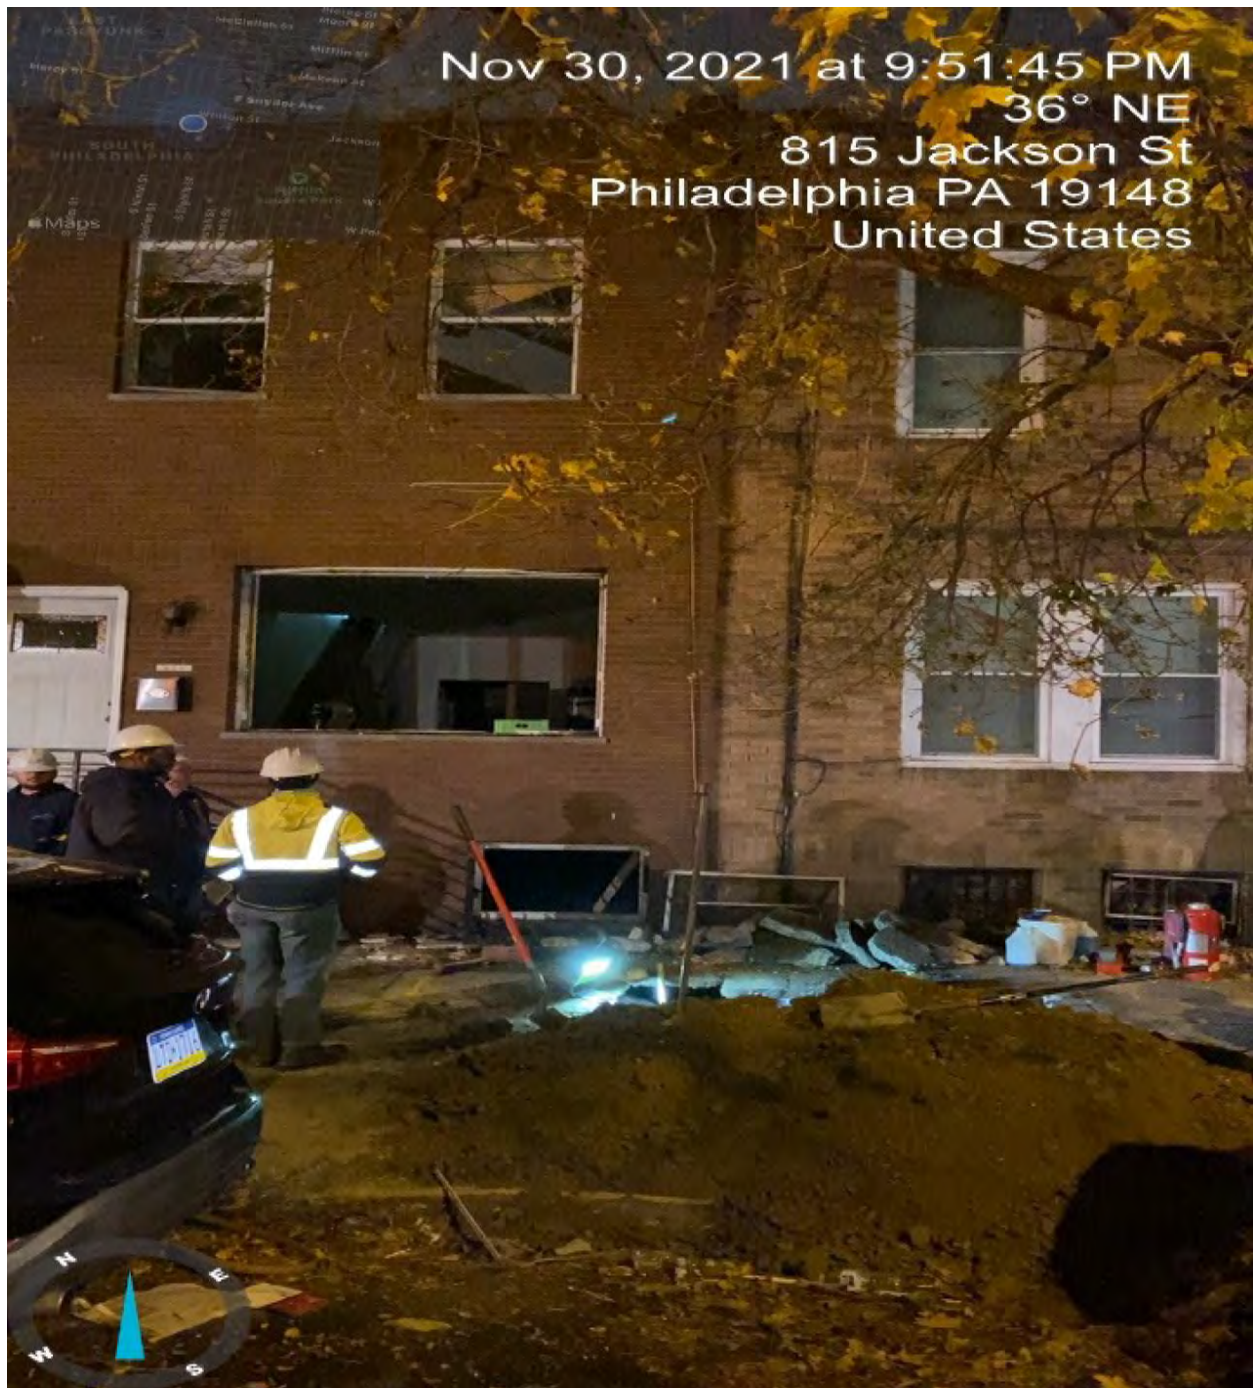
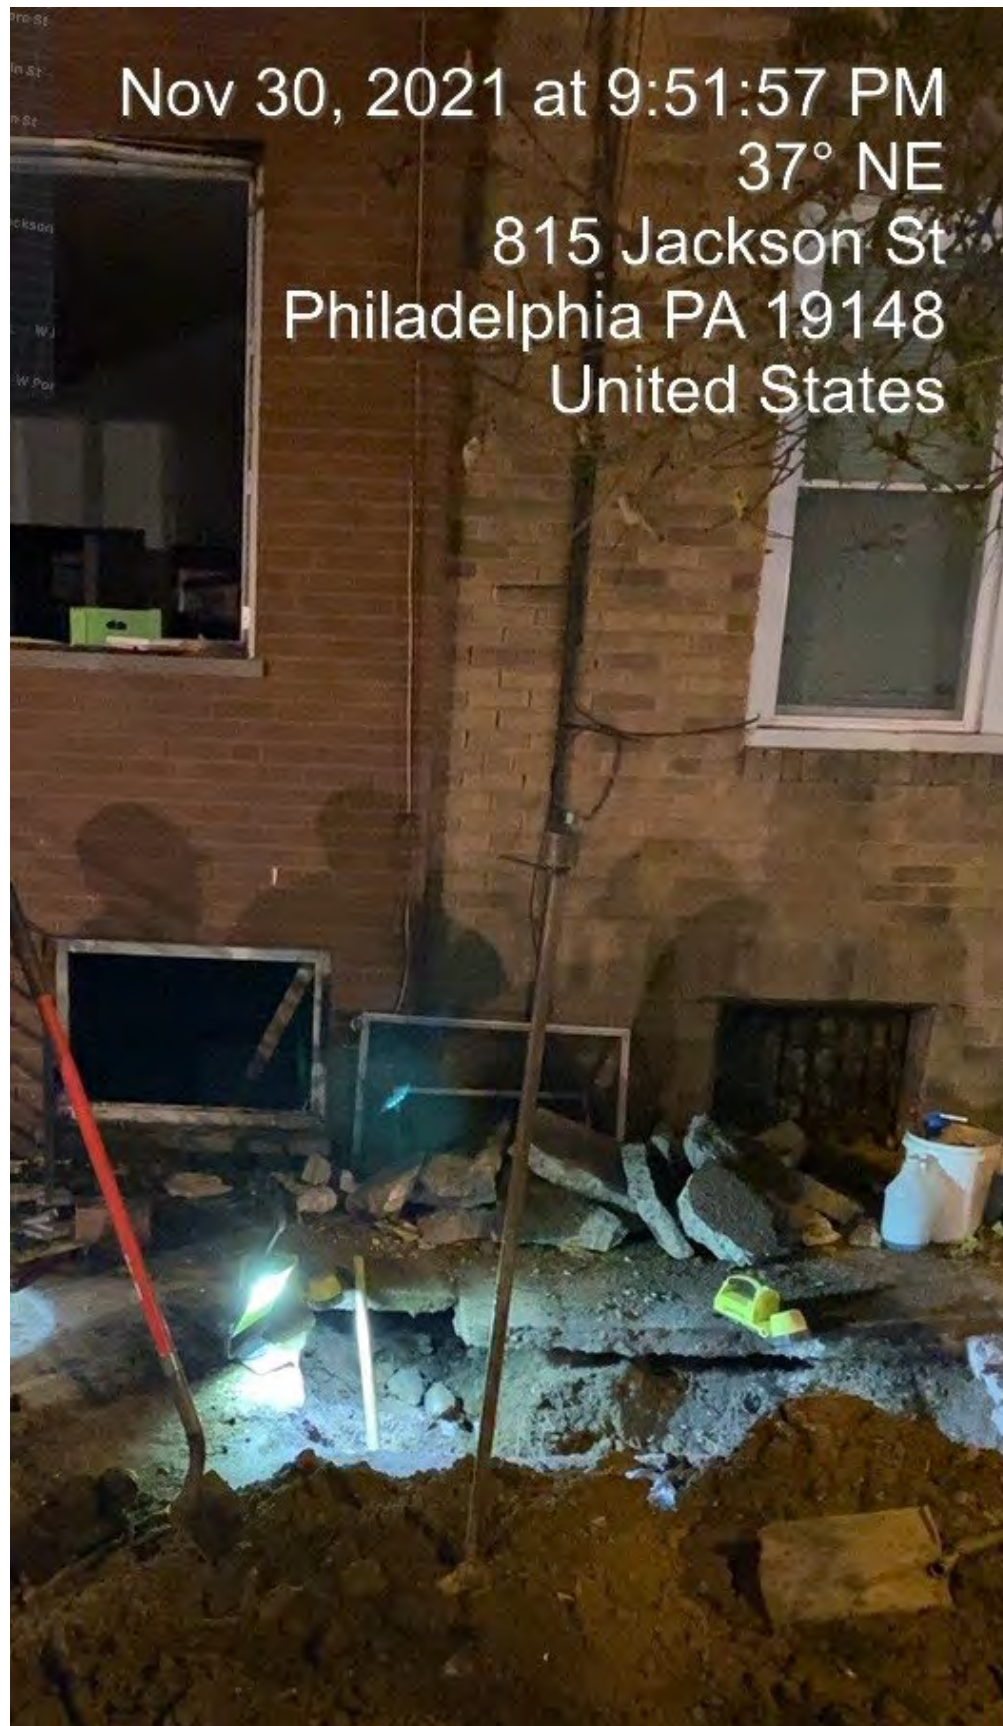
# **I&E Exhibit 5**

6   A:    At the time of excavation, it was found that there were newer sections of sidewalk  
7       directly adjacent to the cracked main. The newer sections were sunken down with  
8       a depression in the center. When the excavation above the broken main began the  
9       sidewalk crumbled downward. The excavation uncovered a void under the  
10      sidewalk that measured approximately 50-inches wide by 16 inches deep.

6 I&E Exhibit 5 consists of two photographs showing the excavation at the site of  
7 the broken cast iron main. These photographs give perspective as to the location of  
8 the break as it relates to 815 Jackson Street, the home on the left with the broken  
9 windows, and 813 Jackson Street, the home on the right.

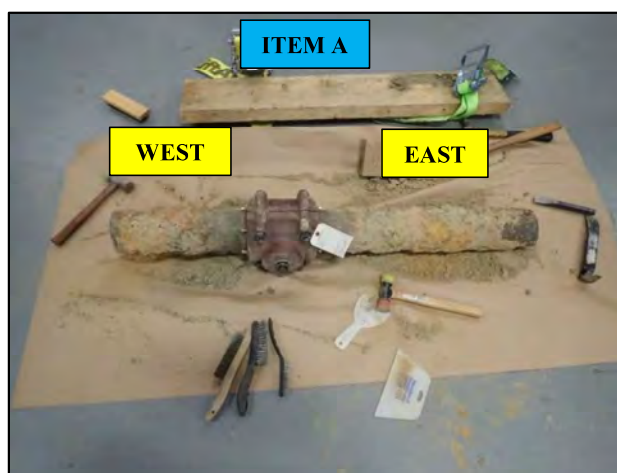
Photo No. 10 (W-6491-D-053.JPG)

The outside diameter (OD) surface of **ITEM A** exhibited a buildup of soil deposits and corrosion product. Some of the material adhering to the surface was carefully removed by mechanical scraping and chipping while most of it remained tightly adhering to the pipe, indicating that it bonded to the OD surface (**Photo No. 10**). The hard soil deposits, which consisted of hardened masses of scale product, were collected and sealed in a plastic bag. Since the deposits and scale did not contain any significant amount of actual soil or dirt, but rather, were comprised of corrosion scale mixed with soil deposits, no further testing was performed on the deposits. However, the sample was labeled **ITEM A-1** and was stored for subsequent testing if deemed necessary.

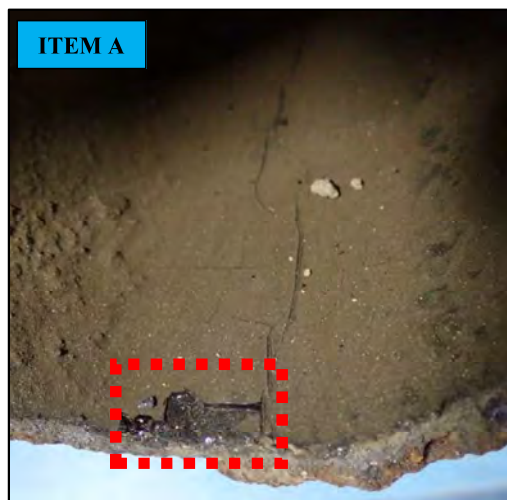
Photo No. 11 (W-6491-D-162.JPG)

The inside diameter (ID) surface of the pipe was coated with a shiny, black tar-like substance (**Photo No. 11**). The buildup along one radial axis of the pipe's diameter, formed by gravity, confirmed the orientation of the pipe, i.e. TOP and BOTTOM. The texture and softness of the coating was not consistent with any traditional means of lining the ID surface of a pipe. Rather, the material appeared to be a deposit or condensate. It was understood that PGW or its predecessor used to manufacture gas,

which is generally done by processing coke. This process produces a byproduct that can condense onto surfaces such as the ID of piping. A sample of the coating can be analyzed should it be deemed warranted.

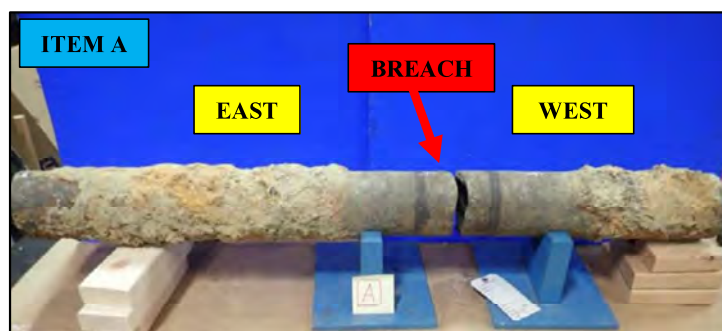
Photo No. 12 (W-6491-D-093.JPG – cropped)

After the repair clamp was removed, the breach location was exposed for further investigation (**Photo No. 12**). It was observed that the underlying pipe's OD surface was intentionally cleaned, which typically is performed in order to properly install a repair clamp. The surface must be cleaned and devoid of protrusions in order for the elastomeric gasket material to form an airtight seal around the circumference of the pipe. The breach was comprised of a single circumferential fracture that separated the cast iron main into two segments: 31-inch long EAST end and 18-inch long WEST end (approximately).

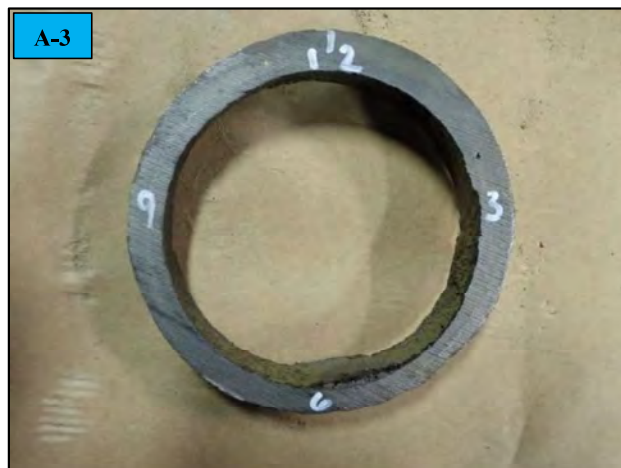
Photo No. 19 (W-6491-D-195.JPG)

Varying degrees of graphitization were observed on the cut edges of ring segments **ITEM A-3** and **ITEM A-4 (Photo Nos. 19 – 20)**. There was no indication of any through-wall penetrations formed by graphitization or any other type of corrosion or mechanical damage as intersected by the cuts. The effective wall thickness of the pipe in those two cross-sections was slightly reduced (up to 15%) as a result of graphitization (**TABLE A**). Notable casting voids were observed distributed along the cut edges of both rings, thereby further reducing the effective wall thickness (**Photo No. 21**).

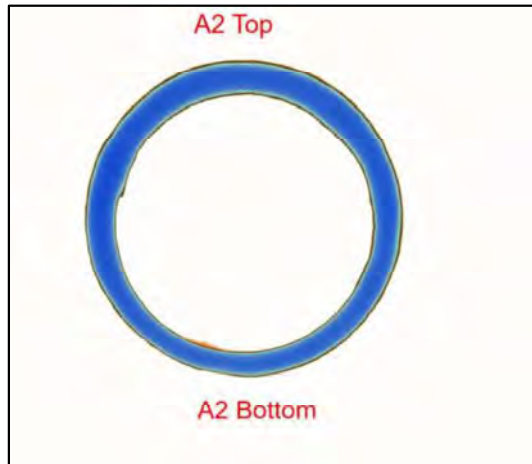
Photo No. 22 (Screenshot 2022-04-22 140045.jpg)

Radiographic views were taken at various angles for documentation purposes. Radiographic imaging showed the ring sections random, localized wall thickness losses (patchy distributions of graphitic corrosion) around the respective circumferences of **ITEM A-2**, **ITEM A-3**, and **ITEM A-4** (**Photo Nos. 22 – 27**). In addition, **ITEM A-3** exhibited an agglomeration of voids near its **BOTTOM** (5 to 6 o'clock positions) as well as some voids near its **TOP** (12 o'clock position).

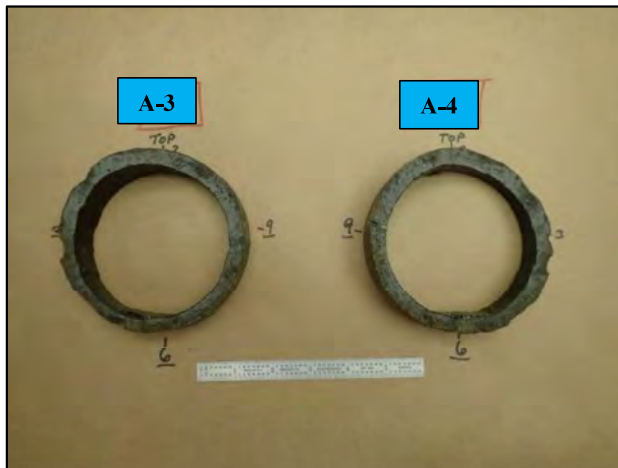
Photo No. 28 (W-6491-D-245.JPG)

There was no evidence of plastic deformation, which is typical for gray cast iron with the application of a tensile or bending overloading condition. The topography was found to be relatively devoid of any corrosion product, aside from uniform light rusting, or a pattern of oxidation that would suggest that a crack propagated to the OD surface and caused a notable through-wall penetration for an extended period of time (**Photo Nos. 28 – 33**). There was no indication of a pre-existing leak location along the fracture surface, as evident by the uniformly colored topography. While varying degrees of graphitization (darkened regions initiating on the OD surface) were observed along the circumference of the mating fracture surfaces, the most notable graphitized region was observed near the BOTTOM of the pipe (**Photo No. 34**). As noted above, this region of the cross-section also exhibited a notable agglomeration of casting voids.

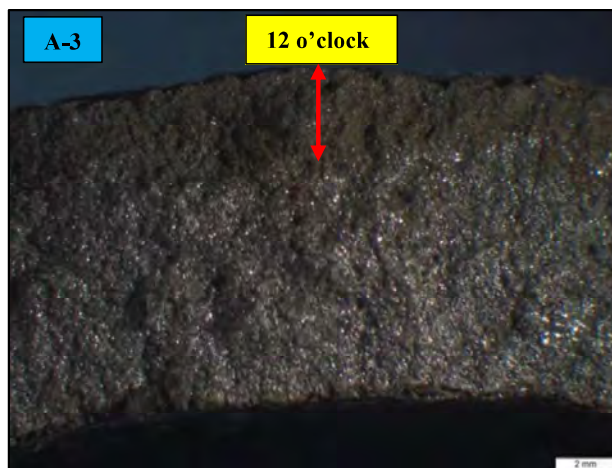
Photo No. 35 (W-6491-B-001.jpg)

The fracture surface was then examined via stereomicroscopy (**Photo Nos. 35 – 38**). Microscopic examination of the fracture surface showed brittle mode fracture of typical gray cast iron. Varying degrees of graphitization were noted along the OD surface. A notable amount of voids was observed near the 6 o'clock position.

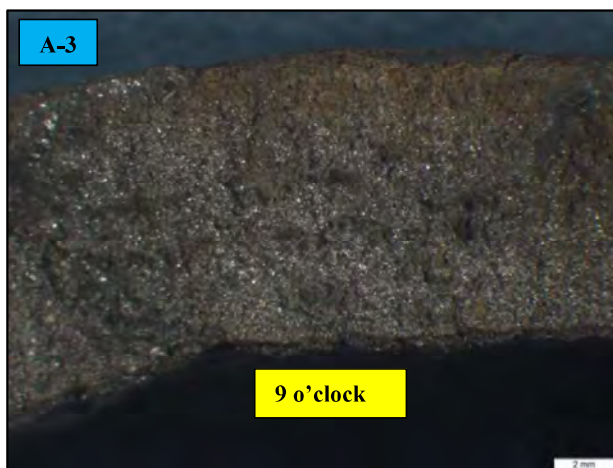
Photo No. 38 (W-6491-B-021.jpg)

Based on the as-failed conditions of the mating fracture surfaces, it was evident that a crack developed at/near the bottom of the pipe and propagated along in both the clockwise and counter-clockwise directions along its circumference until the two crack fronts arrested near the TOP. Examination of the cross-sections at the fracture as well as along cut edges revealed material loss via graphitization, which can serve as a stress riser(s) under the application of external force. Judging from the topography, the fracture resulted from a one-time overload condition. Based on the fracture profile, the fracture appeared to have initiated near the BOTTOM of the pipe where the graphitization was deepest and propagated along its circumference towards the TOP. As noted above, this region of the cross-section also exhibited a notable agglomeration of casting voids.

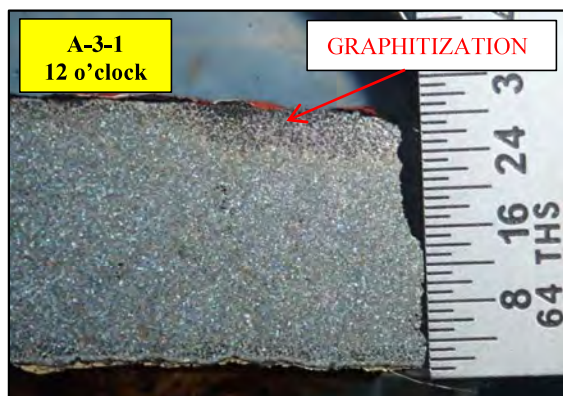
Photo No. 45 (W-6491-G-050.JPG – cropped)

Examination of the as-polished surfaces of the five microspecimens intersecting the fracture surface confirmed and documented the extent of graphitization that occurred over the 123 years of service (**Photo Nos. 45 – 49**). **TABLE B** contains the wall thickness measurements taken at the fracture. The 5 o'clock position (**A-3-5**) showed the most severe amount of corrosion damage resulting in an approximate 43% wall loss that reduced the effective wall thickness of the pipe to 57% of its original wall thickness at the fracture plane. Large-sized voids were also present in this region of the fracture, which further reduces the structural integrity of the gas main to approximately 30%. The 12 o'clock position (**A-3-1**) exhibited graphitization 20% (wall loss) of the original wall thickness while the 6 o'clock position (**A-3-6**) and 9 o'clock position (**A-3-8**) were both 13% (wall loss) at the fracture plane. The 3 o'clock position (**A-3-3**) was 11% wall loss. None of the microspecimens exhibited through-wall graphitic corrosion.

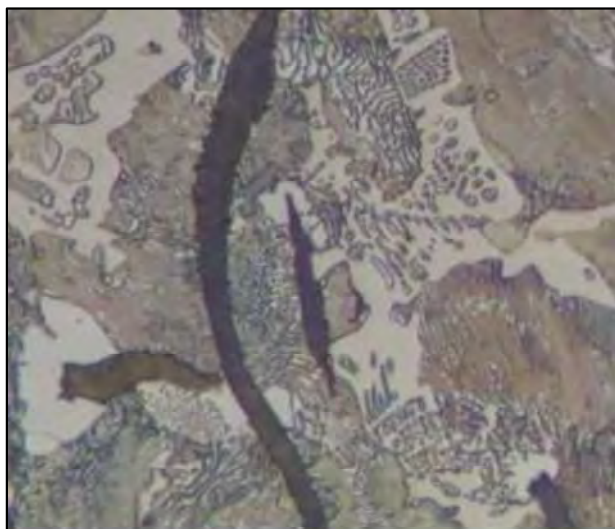
Photo No. 54 (W-6491-H-IMG\_101.jpg – cropped)

Random distributions of iron-phosphide eutectic (Fe-P), also known as steadite phase, within a predominately Pearlite phase with some ferrite were also observed throughout the microstructure of all the specimens (**Photo No. 54 / Figure 4**). Steadite has a low melting point (1705°F) and is typically the last microstructural constituent to form upon solidification, which generally occurs at the grain boundaries.

The microstructure, comprised mostly of Pearlite phase with some residual ferrite, was consistent with Class 60 type gray cast iron. However, the presence of steadite phase is a hard constituent that makes the cast iron more brittle and can decrease the mechanical properties of the casting.

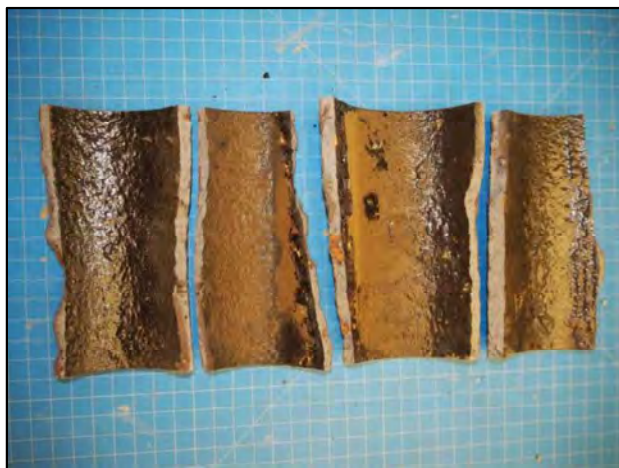
Photo No. 58 (W-6491-F-035.JPG)

Examination of the induced fracture surfaces of the Ring Test Sample revealed varying degrees of graphitization and casting voids, similar to that of previously examined and above described ring samples from the cast iron main (**Photo Nos. 58 – 65**).

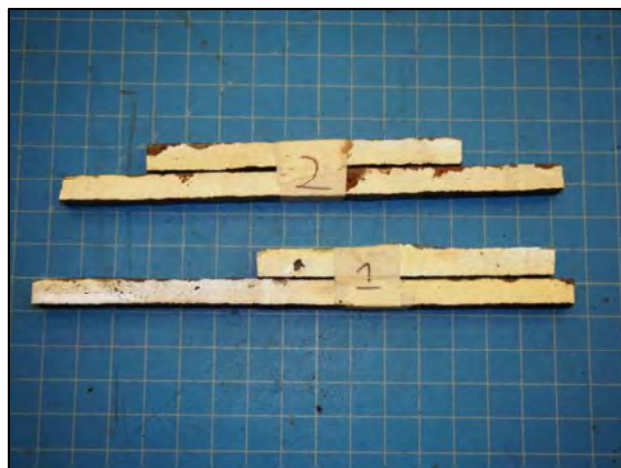
Photo No. 66 (W-6491-F-015.JPG)

Examination of the Talbot strip samples after testing revealed a reduction in effective wall thickness due to graphitization (**Photo Nos. 66 – 69**). In addition to the presence of graphitization in the cross-sections of the specimens, the low values may also be attributed to the presence of steadite phase in the microstructure, as observed in the microspecimens prepared from the cast iron main.

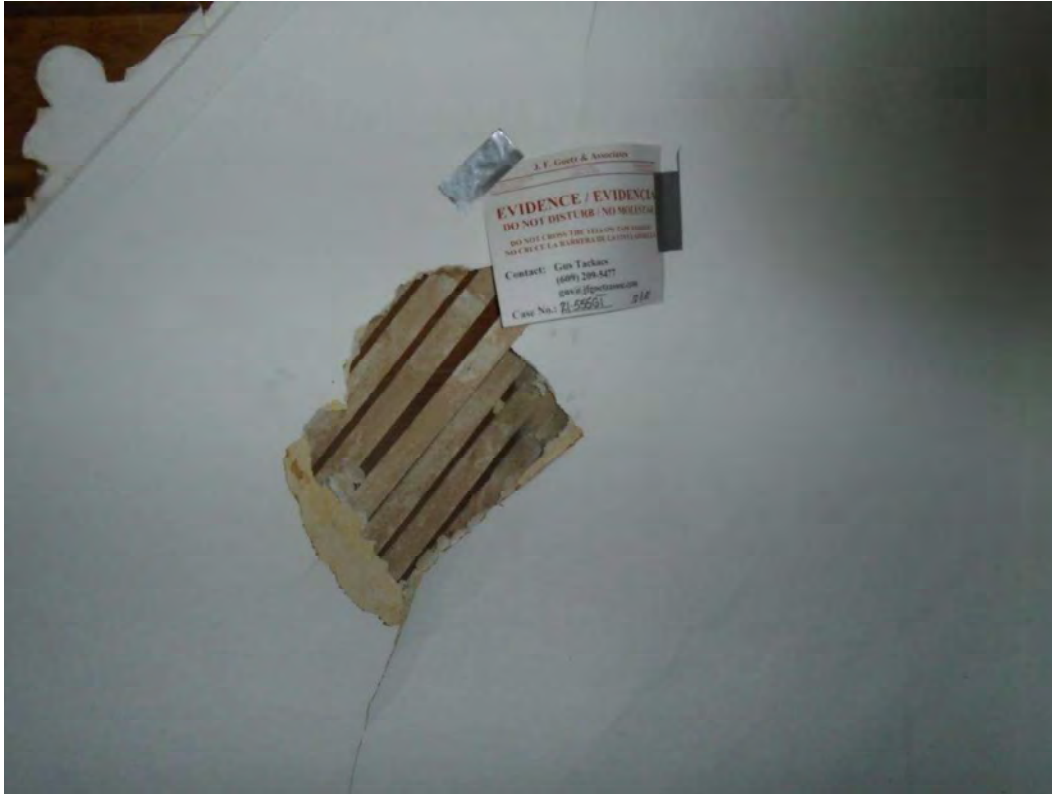
Photograph #11: Damaged living room wall at stairwell.

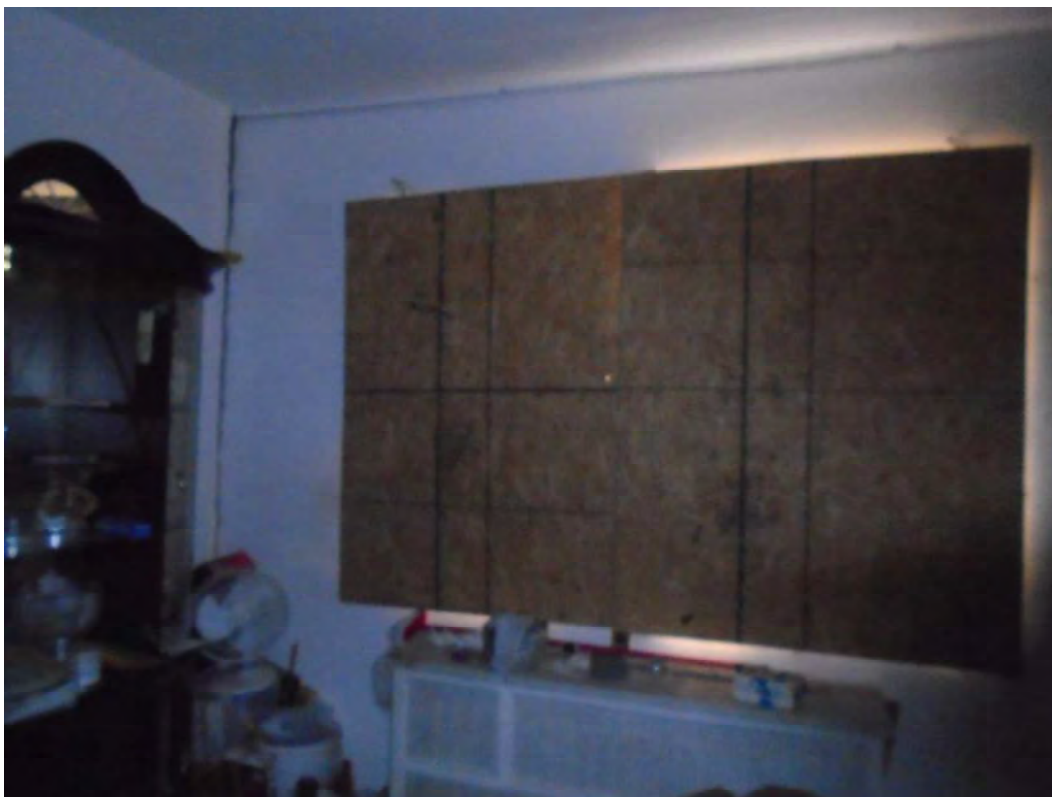
Photograph #12: Front window broken out in living room.

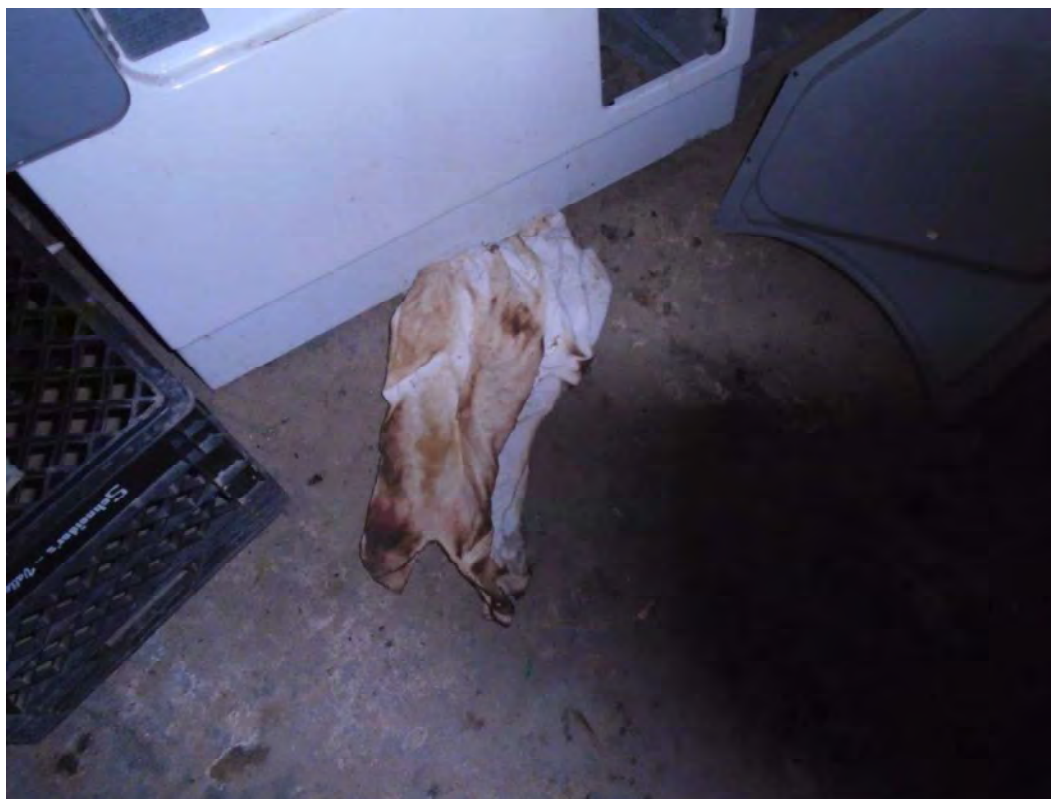
Photograph #15: Burned rags on basement floor.

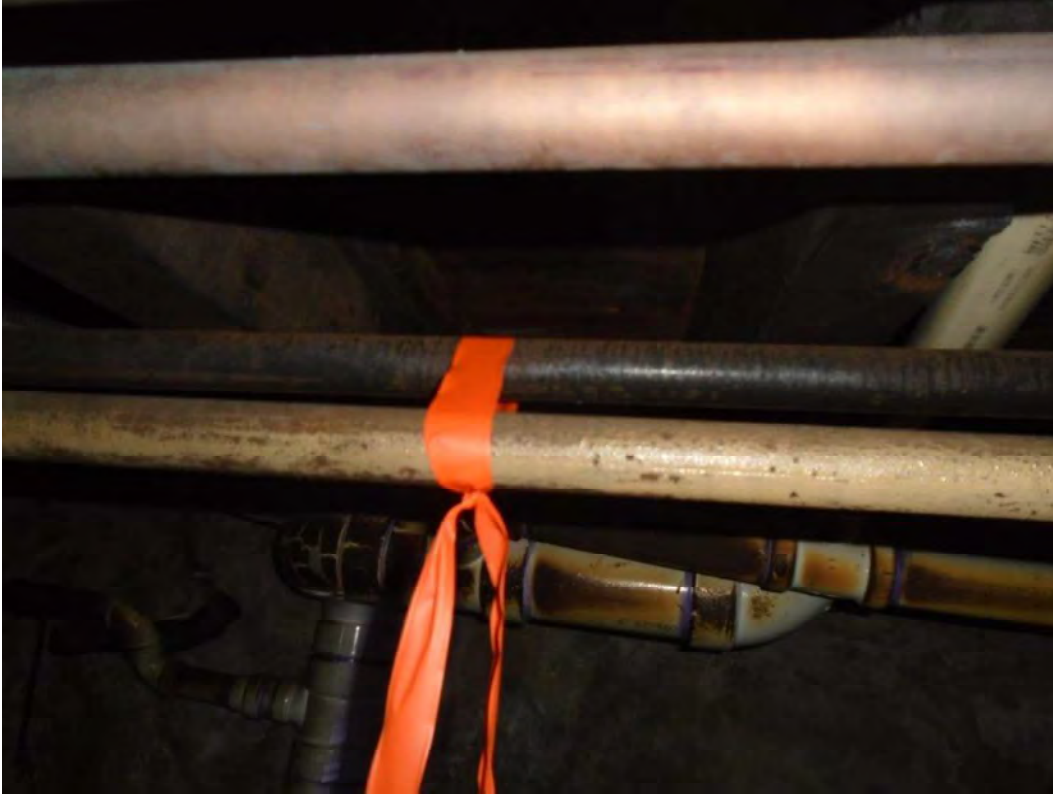
Photograph #25: Gas pipes in basement/heat stains on drainpipes.

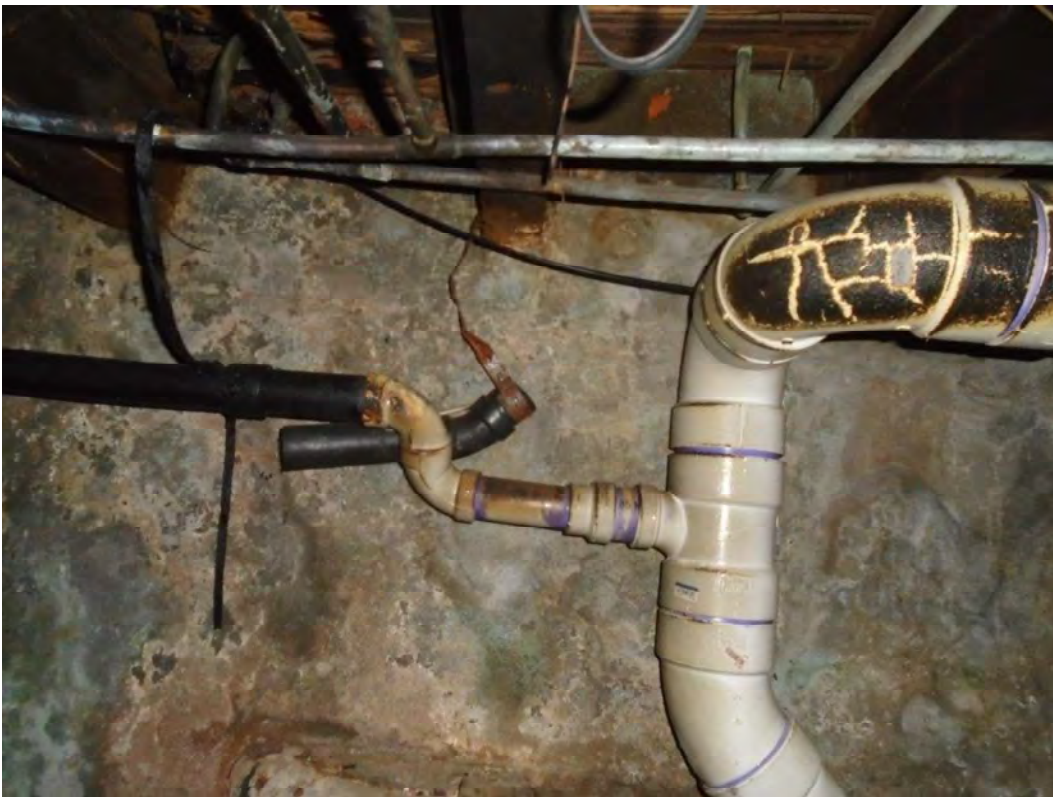
Photograph #26: Heat stains on drainpipes in basement.
