REBUTTAL RESPONSE

FILED BY DAWNE SOHN AND
DIANE SOHN THROUGH THE
PENNSYLVANIA PUBLIC UTILITY COMMISSION

DOCKET NUMBER C-2016-2532799

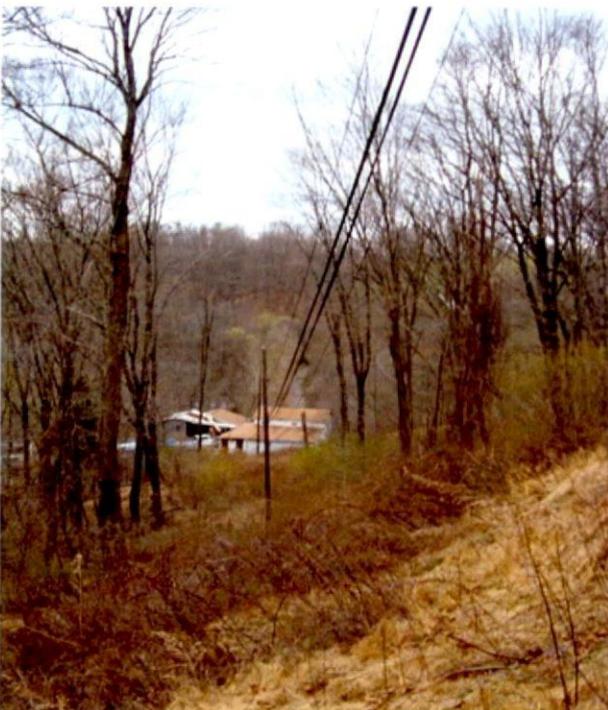
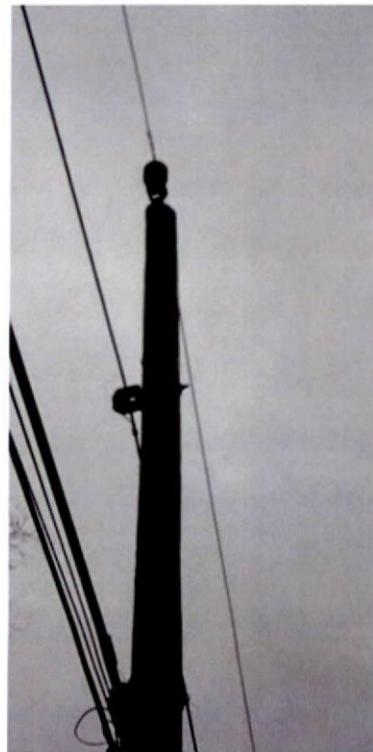
RESPONSE: This line is a regular, general, residential power line that services the following: three houses at the top of the property, a barn in the middle, and two houses at the bottom of the line.

Electrical Line. Barn and corral to right of photograph.

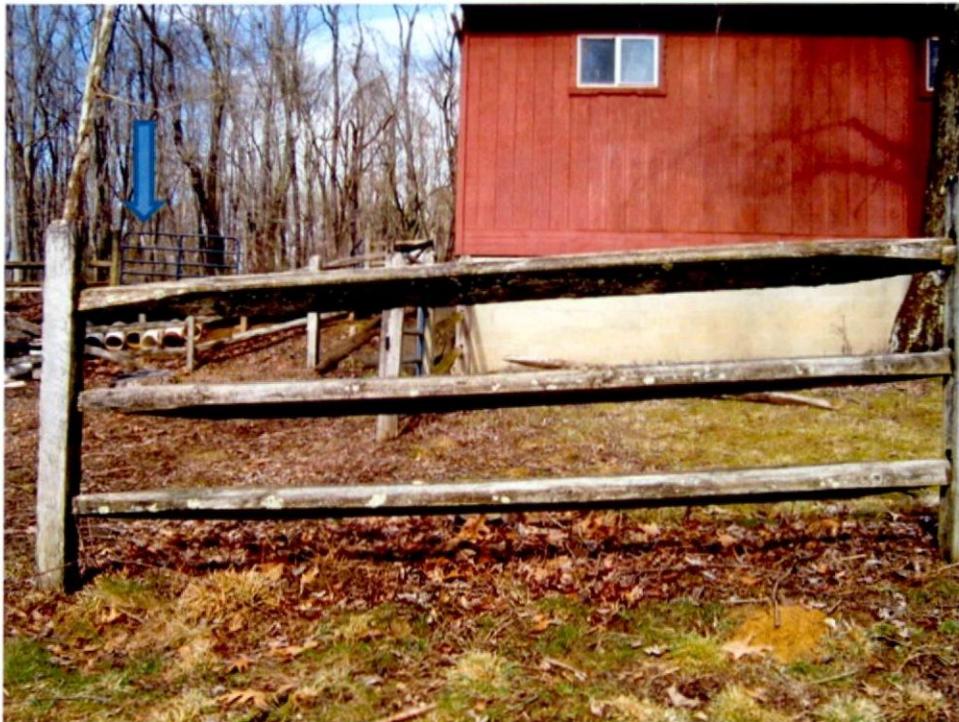
The ash tree in question was 31 feet from the electrical line. Not only was it 31 feet from the line, it was inside a fenced horse corral and beside a barn. It posed zero "threat to Duquesne Light's facilities". There was no need for them to be within the fence line. Pictures in subsequent responses will show this visually, including this photograph taken standing under lines. Arrow is tree location:

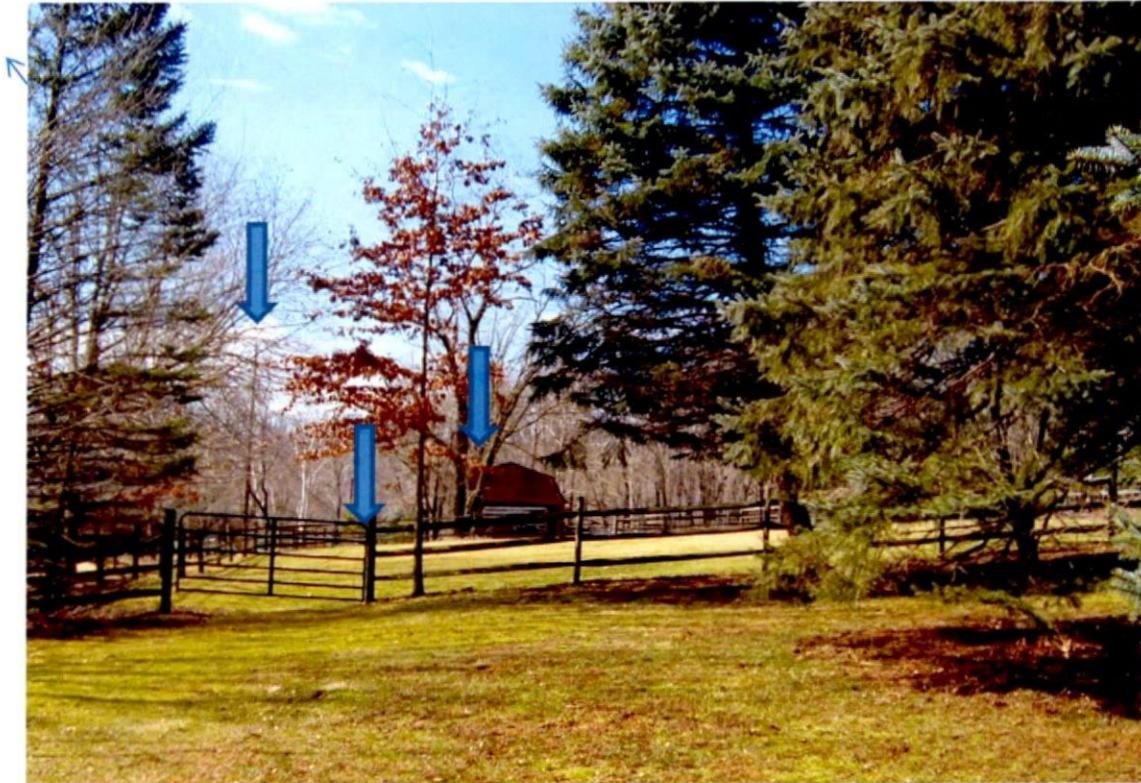
Barn and Pastureland. Far left blue arrow is electrical wire location (pole visible). Middle arrow is where the maple tree was located and the right arrow is the ash tree location behind the barn.

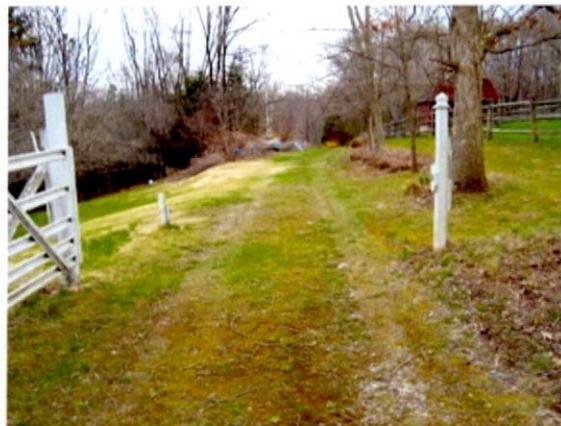
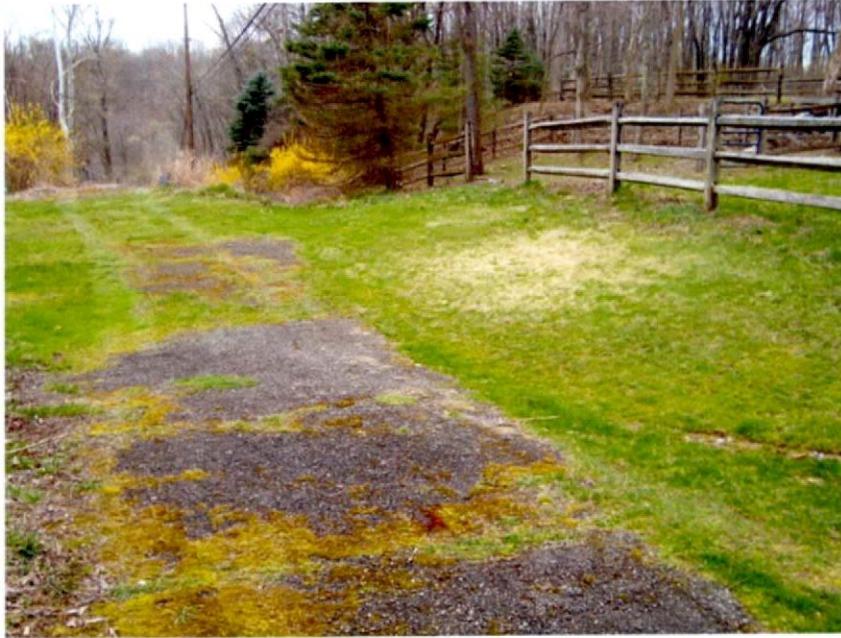
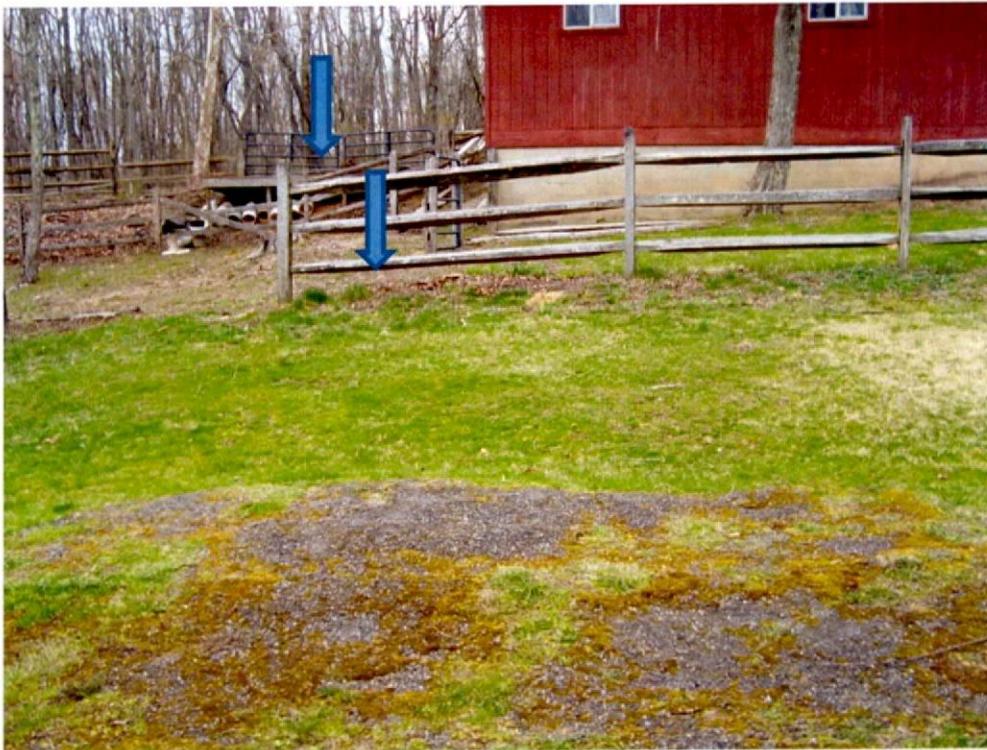
Left arrow is the ash tree location behind fence and barn.

Right arrow is the maple tree location behind the fence.

The ground is blacktop and rocks along this drive.

Development of back property and barn also shown.

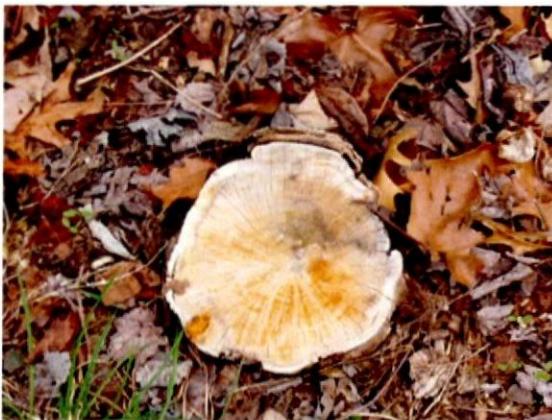
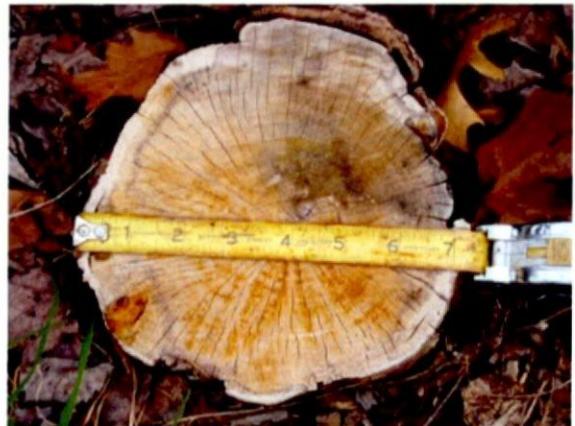
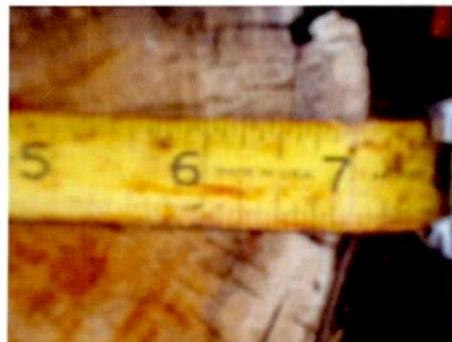
Maple Tree
Stump
and Maple
Tree Stump
Measurement.
7 inches.

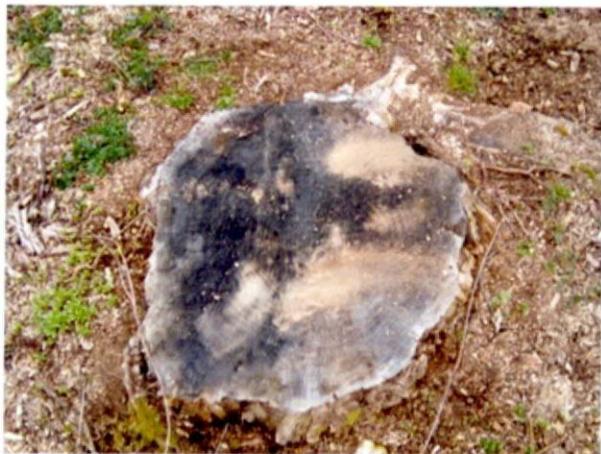
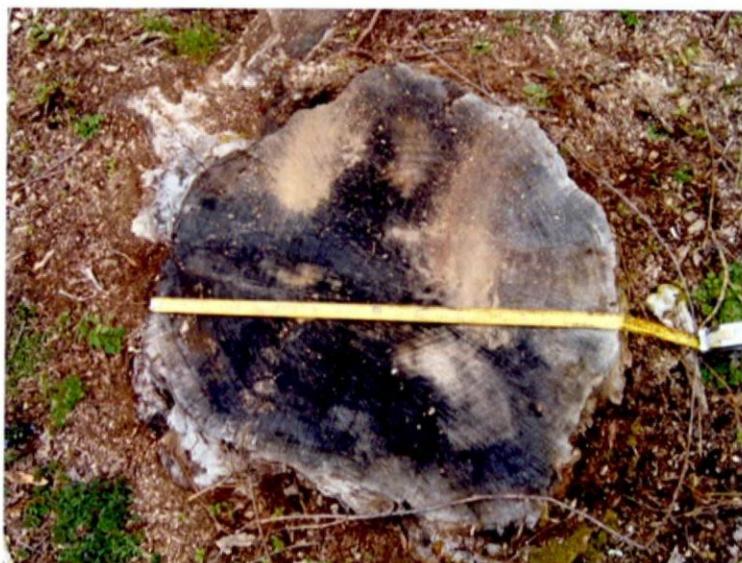
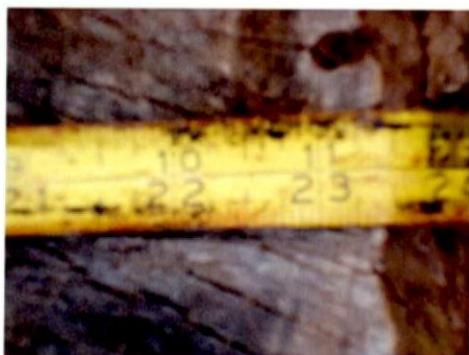
Ash tree stump and ash tree stump measurement.
23 inches.

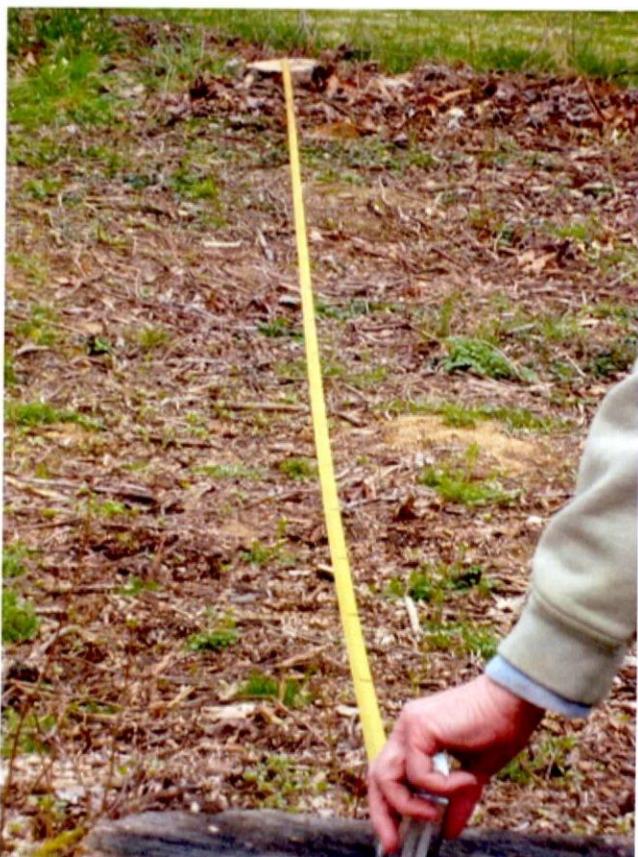
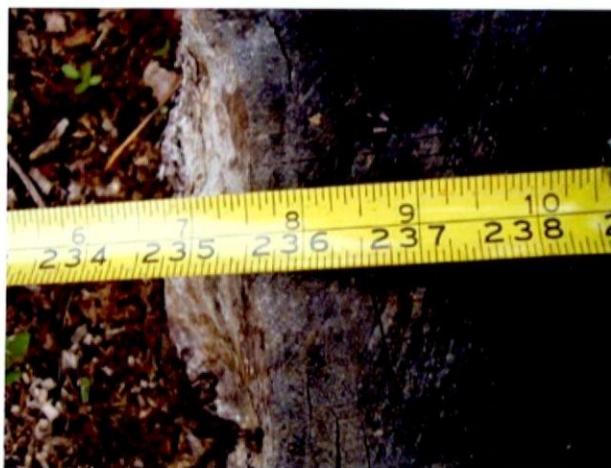
Distance from maple tree to ash tree:
20 feet.

There was also a fence between the two trees, which was knocked down when the ash tree limbs were cut. The maple tree was the smaller tree. The ash tree was significantly taller and above the barn roof. Therefore, to “manually climbed an adjacent maple tree to perform the work”, the contractor had to literally leap over 20 feet backwards into the air from a little maple tree, navigate this leap over a fence, flip facing front from a backwards position in the maple tree, and land high up in the ash tree—all while carrying a chain saw. Here is a diagram of the only way that could have happened. Since both trees and the damaged rails are gone, no photographs can be provided:

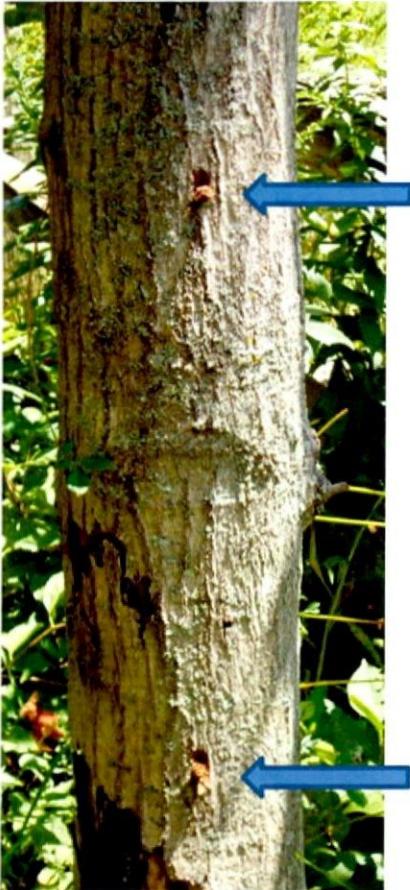
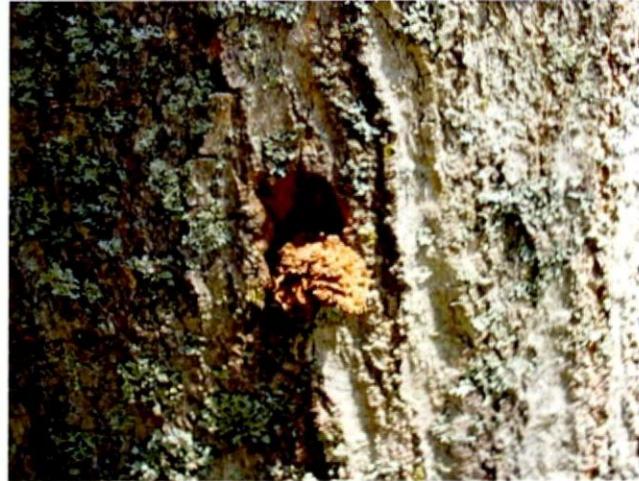
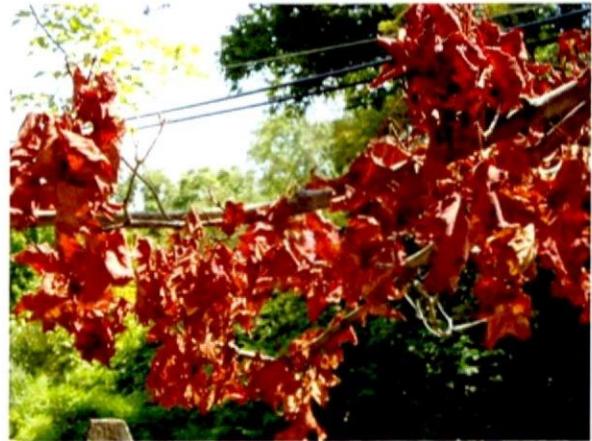
RESPONSE: There is no conceivable reason anyone was in or near this tree, let alone spiking and killing it. As stated above, we have no actual sighting of anyone from Duquesne Light’s contractors being in this tree. This is what we do know: The top of this maple was cut off during Duquesne Light’s contractors being on our property. This tree was not within Duquesne’s Light right-of-way, it was not near any electrical wire, and it was within our fence line. Within days it was visibly wilting. Within a few weeks it was dying. When an expert from another tree service company visited the

property to review for clean-up, he was asked what was wrong with the tree. He said within seconds: It was spiked. Spiking kills a tree.

Spike marks and
dead leaves
on maple tree.

This is ultimately the only point of our Formal Complaint to the Pennsylvania Public Utility Commission: We want reimbursed for the unnecessary spiking and killing of this maple tree. This would include payment for a new tree of equal size and quality of the one spiked and payment for the planting of the tree by a nursery of our choice.

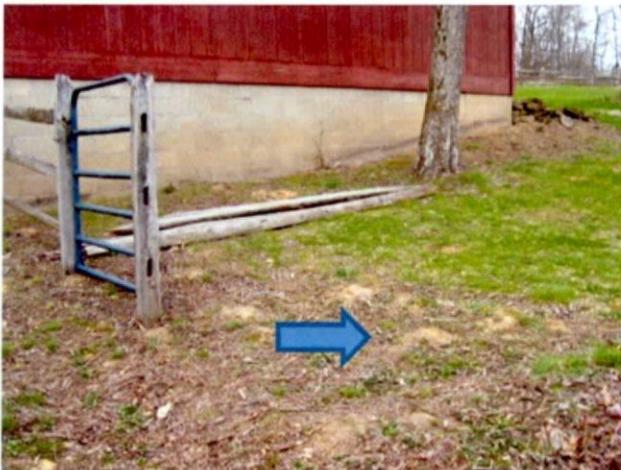
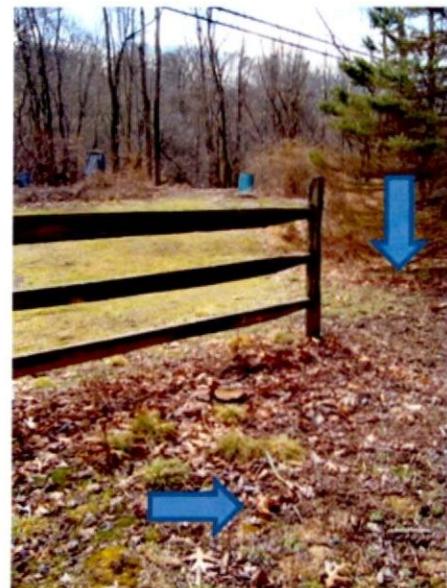
RESPONSE: This simply is not true. The limbs from the ash tree landed on two separate sections of the split rail fence and knocked out the rails. Most were intact, but a few of the rails were broken. This is not part of our Formal Complaint. The rails are scheduled to be replaced at the homeowner's personal expense. Arrows show sections in the fence where rails were hit by ash tree limbs.

The photograph above is the same section as the lower arrow in the right photograph.
