Subject: TS&L Submission
South Lehigh Avenue and SR 1004 (Race St.) Retaining Wall Rehabilitation
Whitehall Township, Lehigh County
MKA Job No. 01035-01

South Lehigh Avenue Retaining Wall
Whitehall Township, Lehigh County

Type, Size and Location Report

December 10, 2008

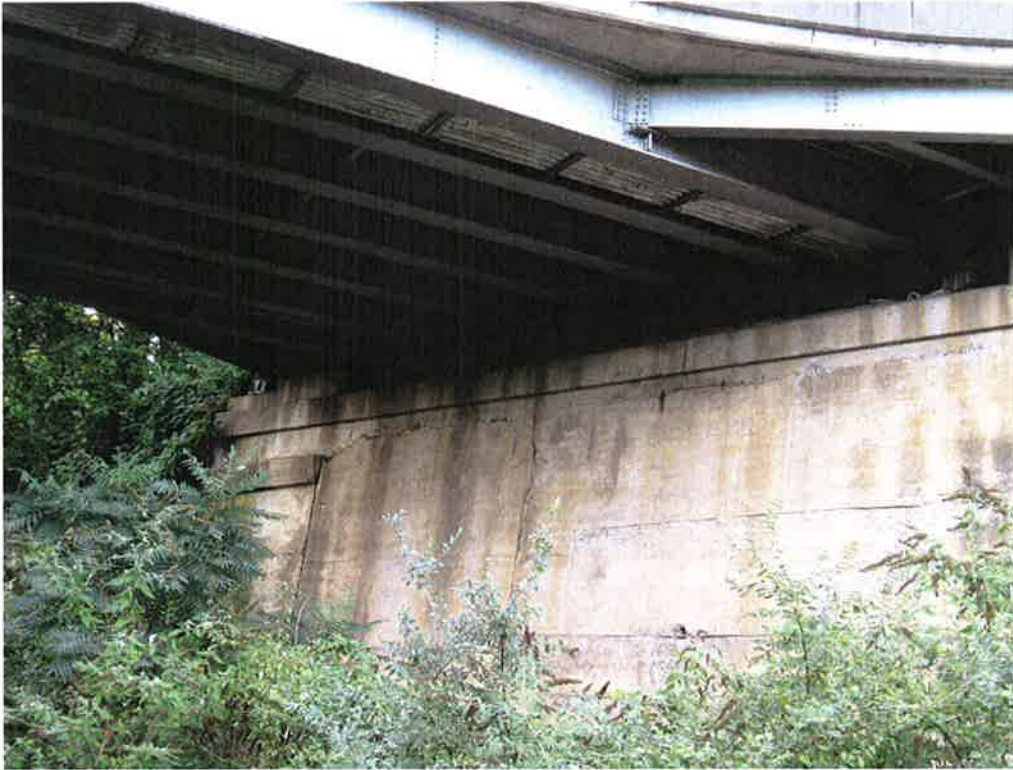
PHOTO 1 Below Race Street Bridge.

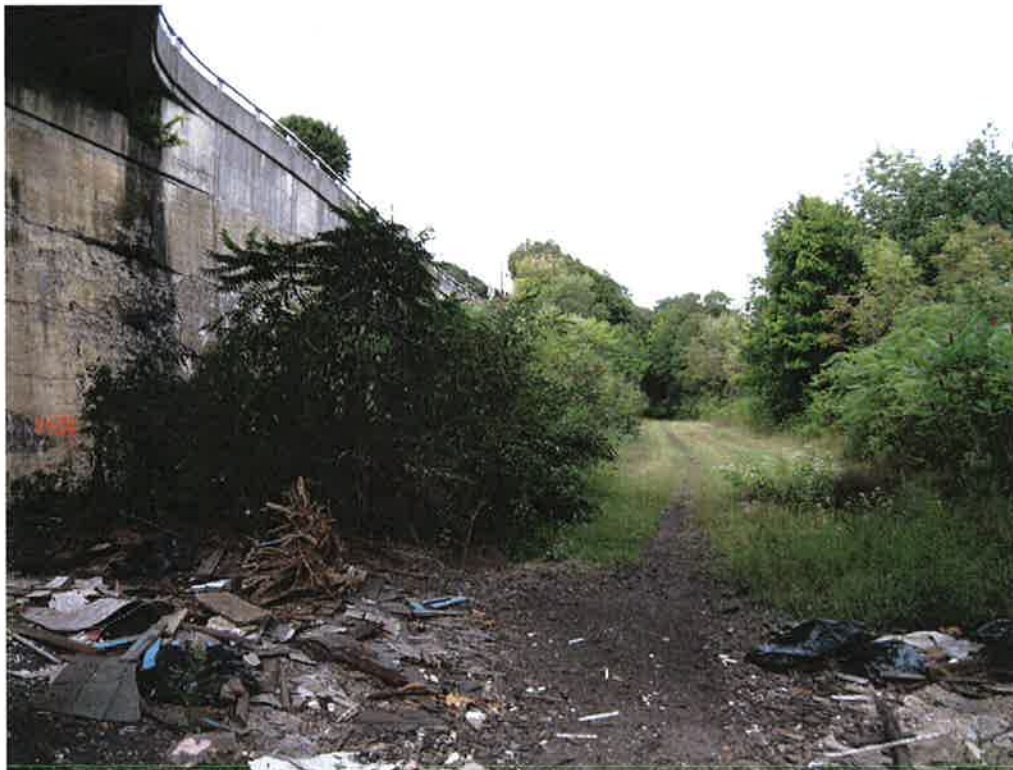
PHOTO 2 Looking north on old railroad bed.
