BEFORE THE PENNSYLVANIA PUBLIC UTILITY COMMISSION

DOCKET NO. C-2024-3052605

RE: Denise Mitchell v. PECO Energy Company (PECO) Docket No. C-2024-3052605.
Exhibit 17 — Response to Judge Nause’s Request For Documentation Of Current Condition of Claimant’s Property. Parapet-wall deterioration, downspout displacement, and water infiltration continues at the time of this filing.

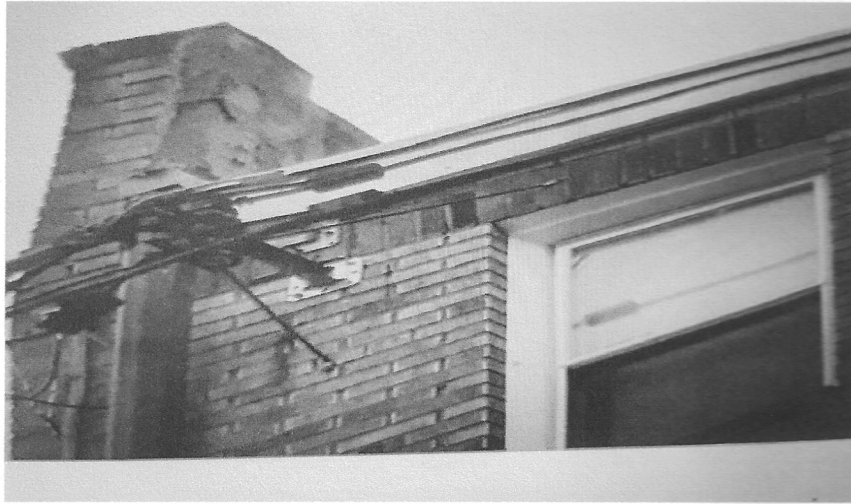
Photo #2 Taken January 4, 2025 - Shows progression of cracking and mortar loss around the old bracket location.

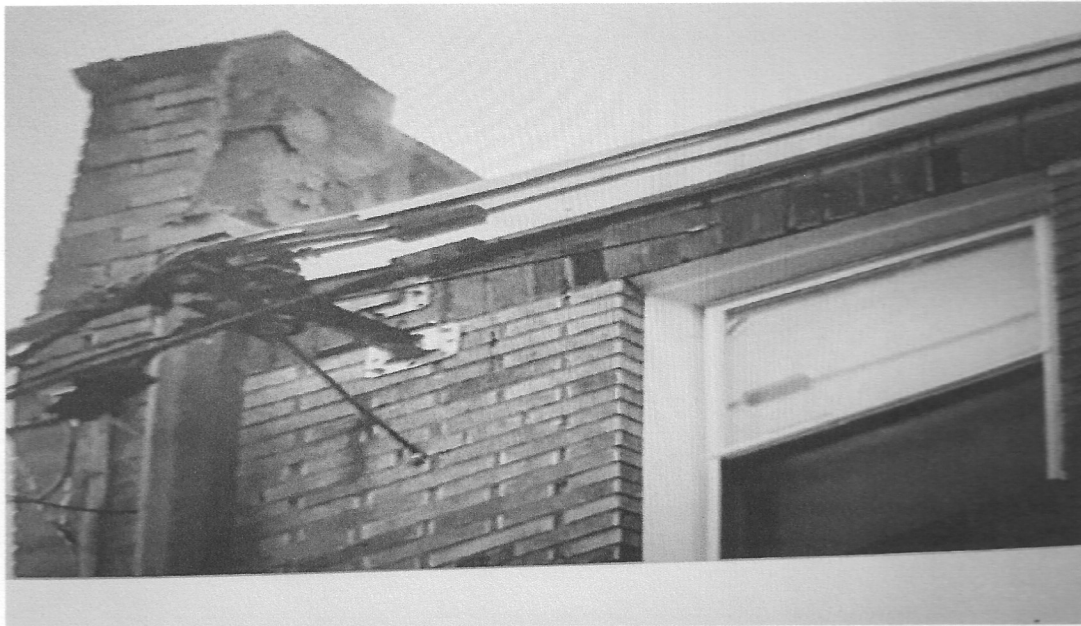
Photo #4 Taken 11/28/2025 - Shows continued cracking and displacement around the original bracket area.

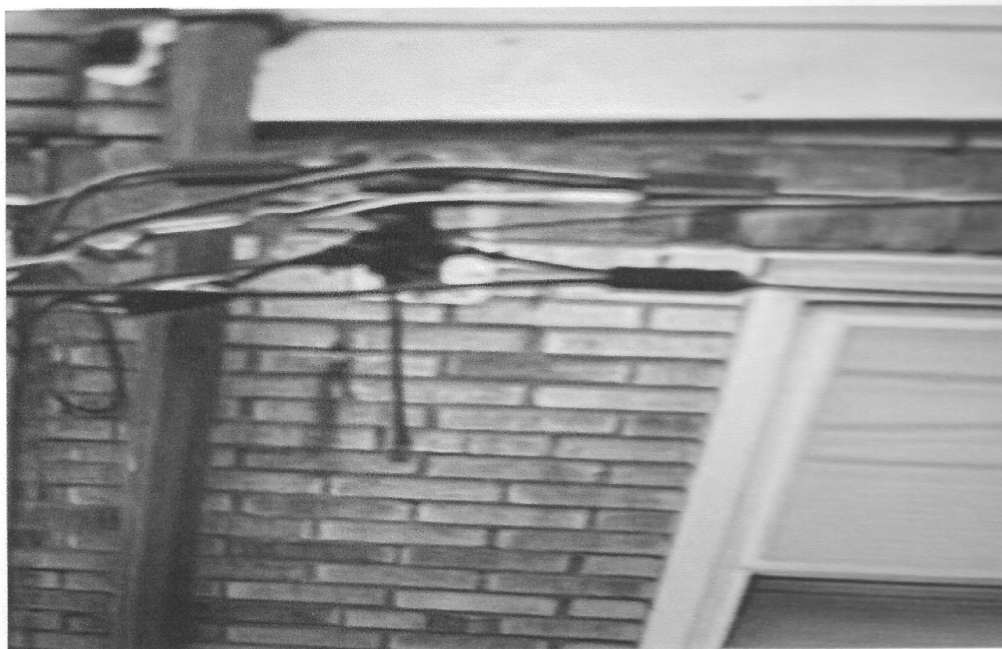
1. Visible Bracket Impression - The clean outline of the original bracket above the new bracket indicates the surface behind it was recently covered. This is consistent with recent detachment.

Photo #5 Taken 04/26/2026 - "Visible impression of the original bracket above the current bracket. The outline is clean and sharply defined, indicating the original bracket has recently detached having causing severe Wall Damage prior to dislodging.

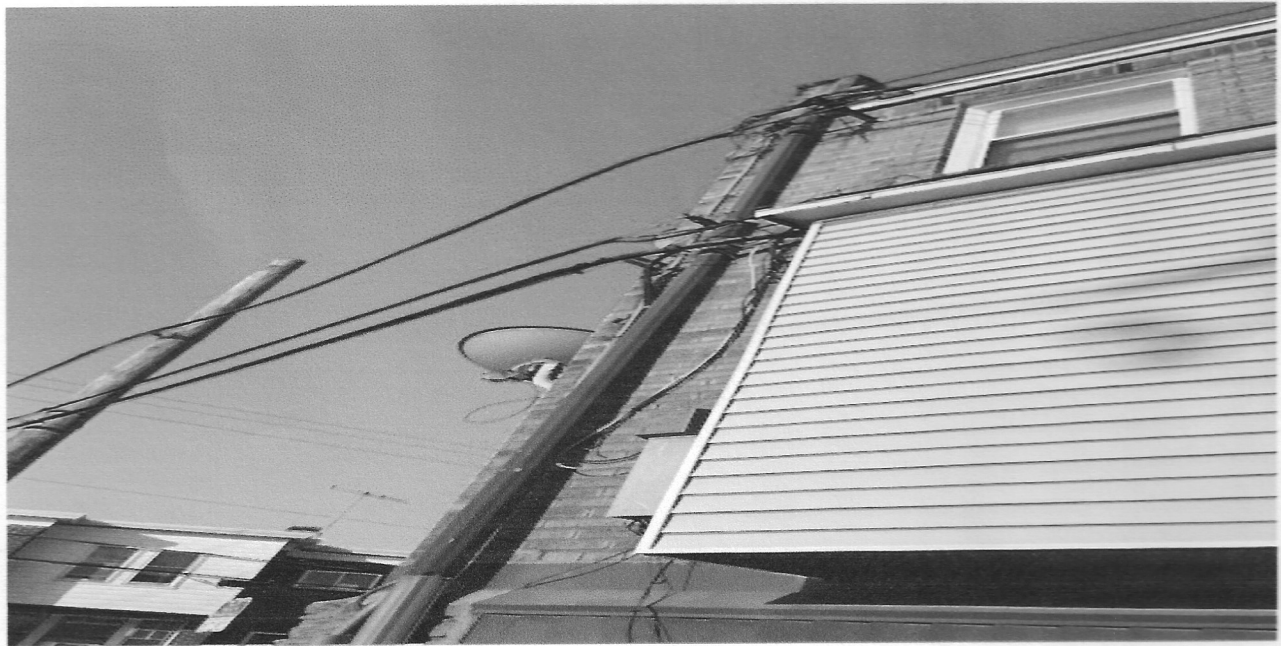
2. Downspout displacement - The downspout is pulled outward in the same direction as the wall movement. This is consistent with tension redistribution when a bracket loosens or detaches. The downspout misalignment is a symptom of structural wall movement caused by PECO’s bracket detachment. Realigning the downspout does not stop the wall from shifting, does not repair the mortar loss, and does not correct the brick separation documented in Exhibit 17. The misalignment of the downspout returned because the wall continues to move. PECO’s readjustment of the downspout in 05/2026 was cosmetic only and did not address the underlying structural condition. Exhibit 18, photo 2 and 3 (c) as opposed to Exhibit 1, photo 5

Photo #6 - Taken 04/27/2026 - Downspout displacement. The downspout is visibly pulled outward in the same direction as the wall movement documented in prior photos.

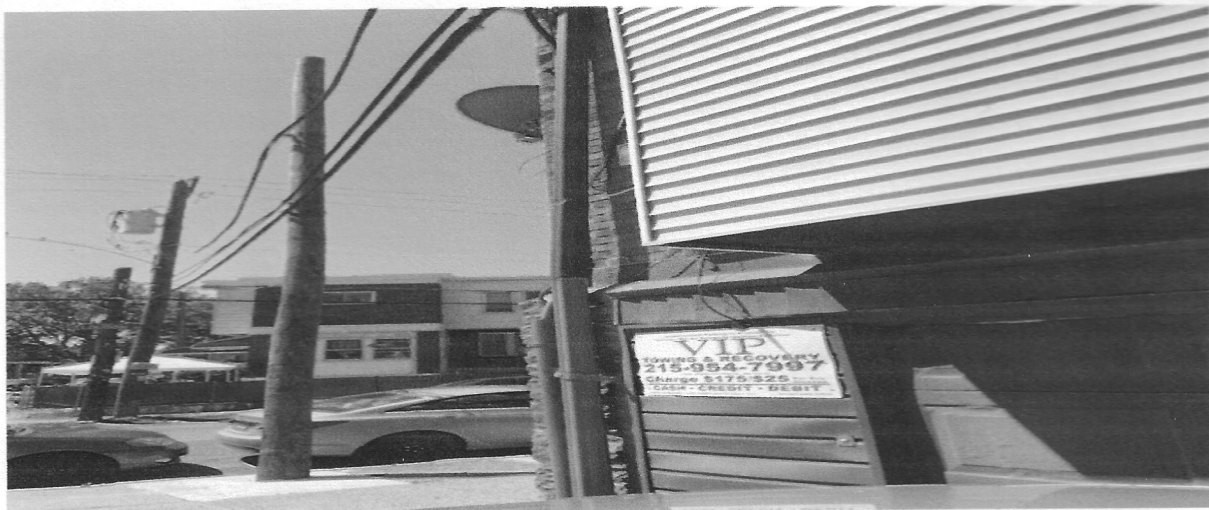
- (d) aerial line from pole across Street connected to bracket on Claimant’s rear wall contributes to the tension. (Photo 6 and 7)
 - (e) worsening parapet damage

Photo #7 - Taken 05/27/2026 - **Exterior View — Aerial Line From Pole Across Street is connected to PECO Bracket located on Claimant’s rear wall.** Description: This photo shows the PECO aerial service line extending from the pole located across the street at E. Loudon & Bingham directly attached to the Claimant’s rear wall. The angle and tautness of the line demonstrate the direction of tension applied to the structure. This image visually confirms the load path described in PECO Work Order 19203009 (“job to put additional pole... to reduce load on rear bracket”).
