## 2023 Safety Seminar

# 2023 High Profile Investigations/Tragic Events:

# West Reading RM Palmer Chocolate Factor

# Rustic Ridge –Plum Borough

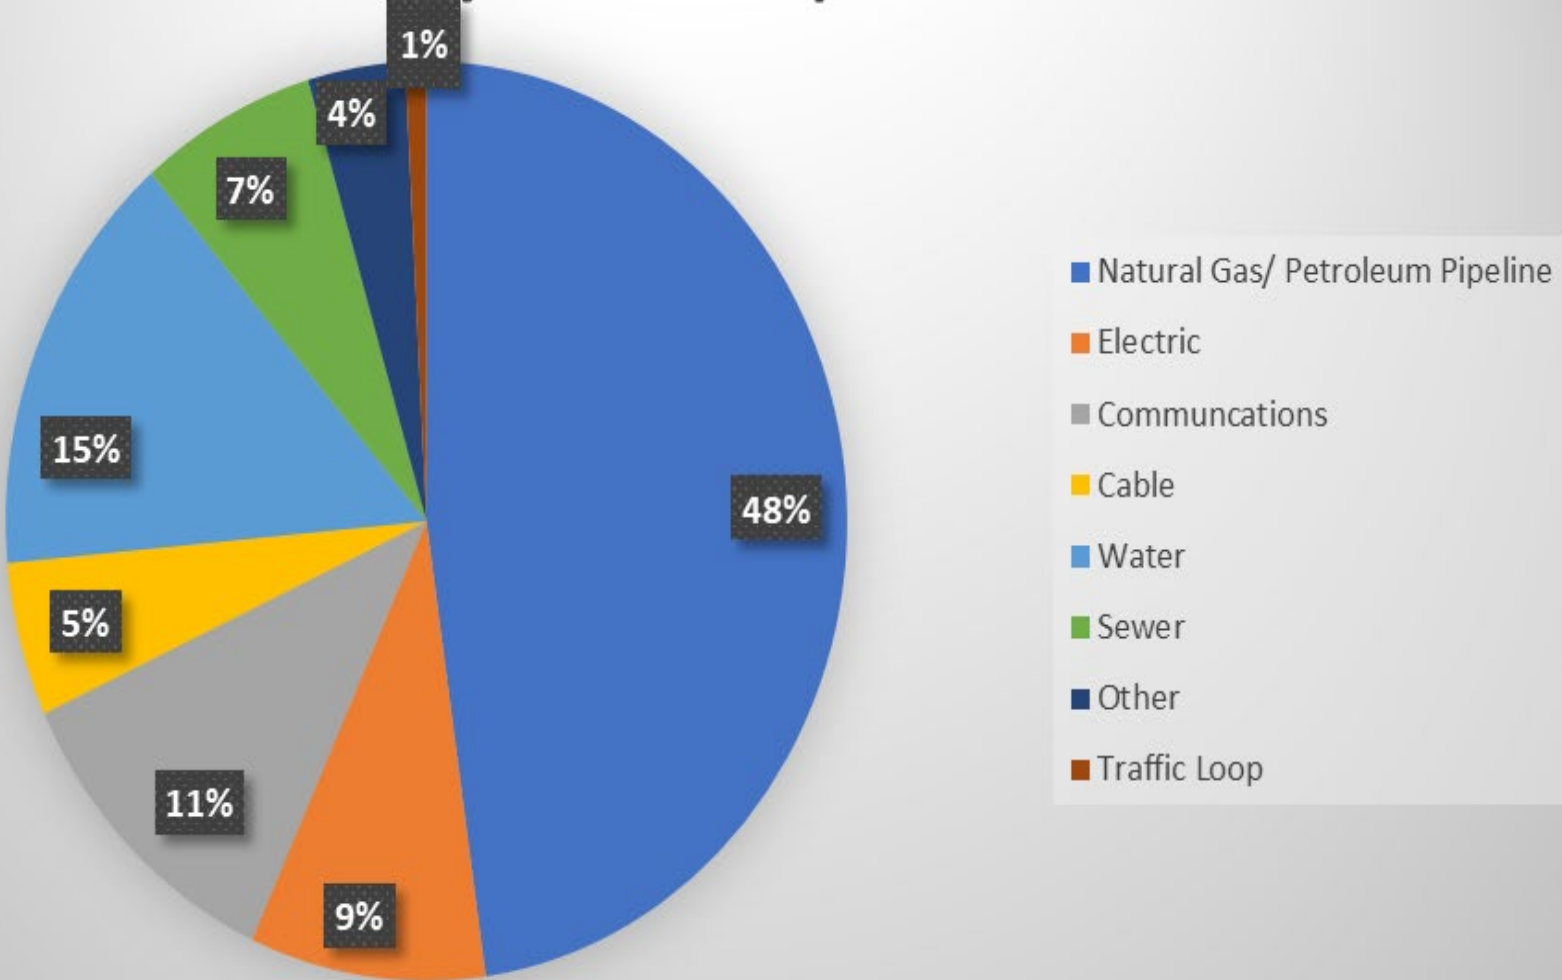
# AVRs Sent by Affected Operation in 2022

- 495 Cases through the DPC in 11 meeting in 2022
- ~\$844,000 in fines levied in 2022
- ~\$1.46 million levied so far in 2023 (through August)
- Over \$3.9 million levied since inception
- 175 stakeholders with educational requirements
- While peaks are in the summer, AVR #s remain relatively close in each month.
- In 2022, 48 % of AVRs involved gas facilities followed by water with 15%.

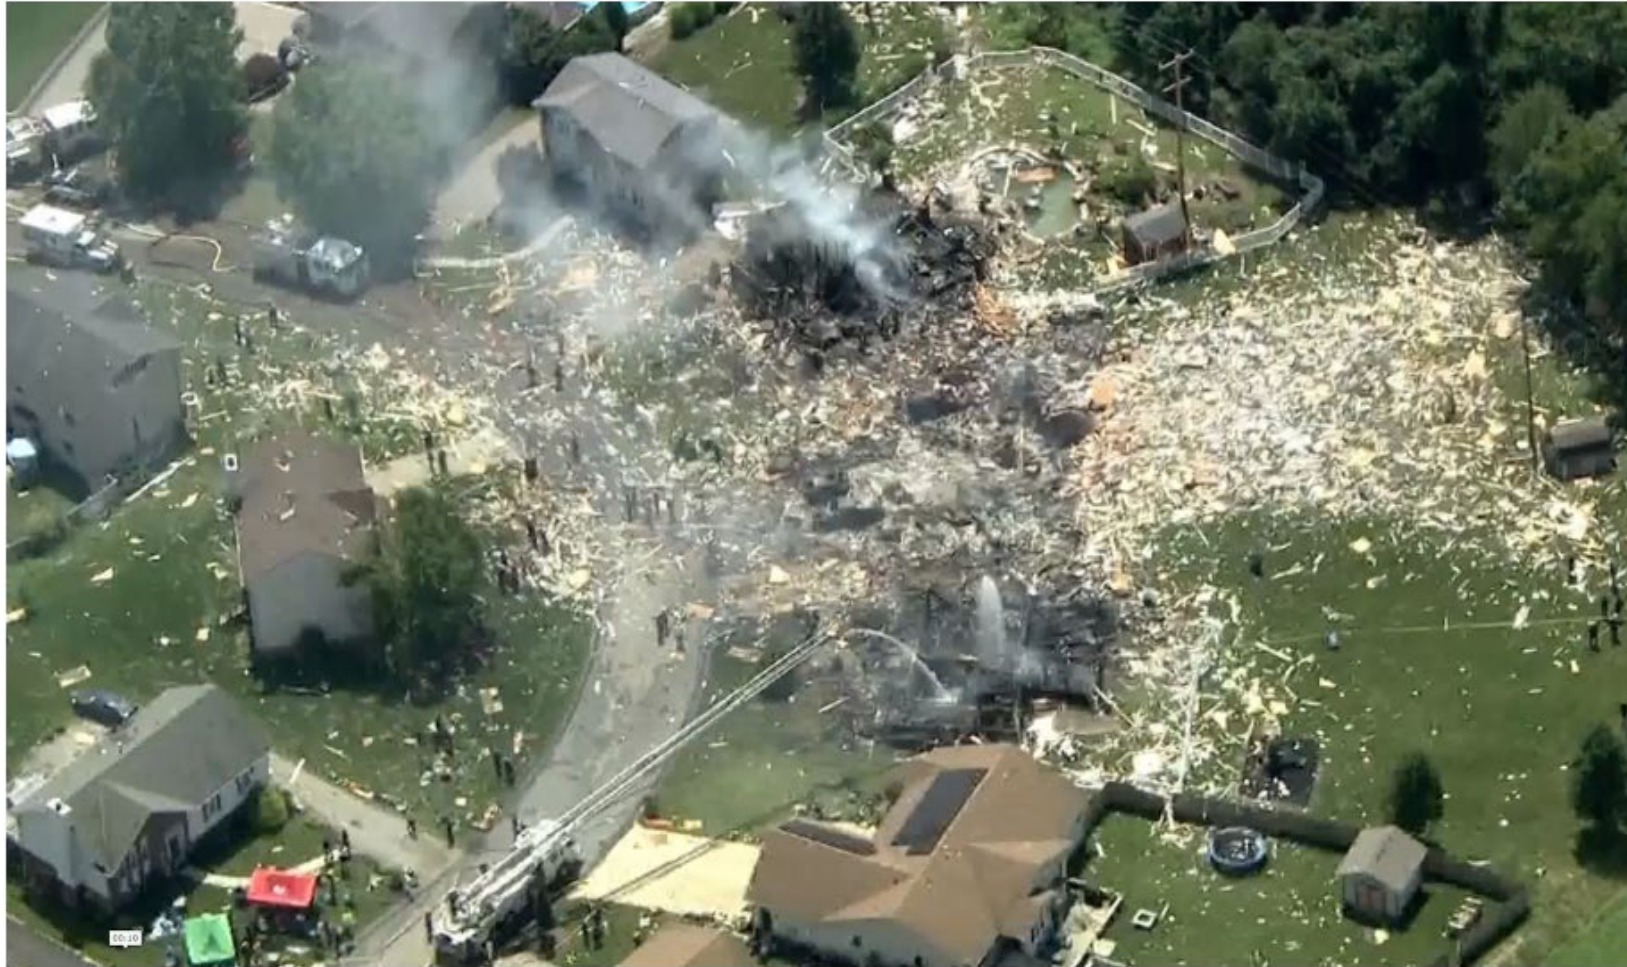
In this screen grab from a video, widespread damage is shown after a house explosion in Plum, Pa., on Aug. 12, 2023.
