# Carbon Dioxide The Other Silent Killer

George Lomax

Heath Consultants Incorporated

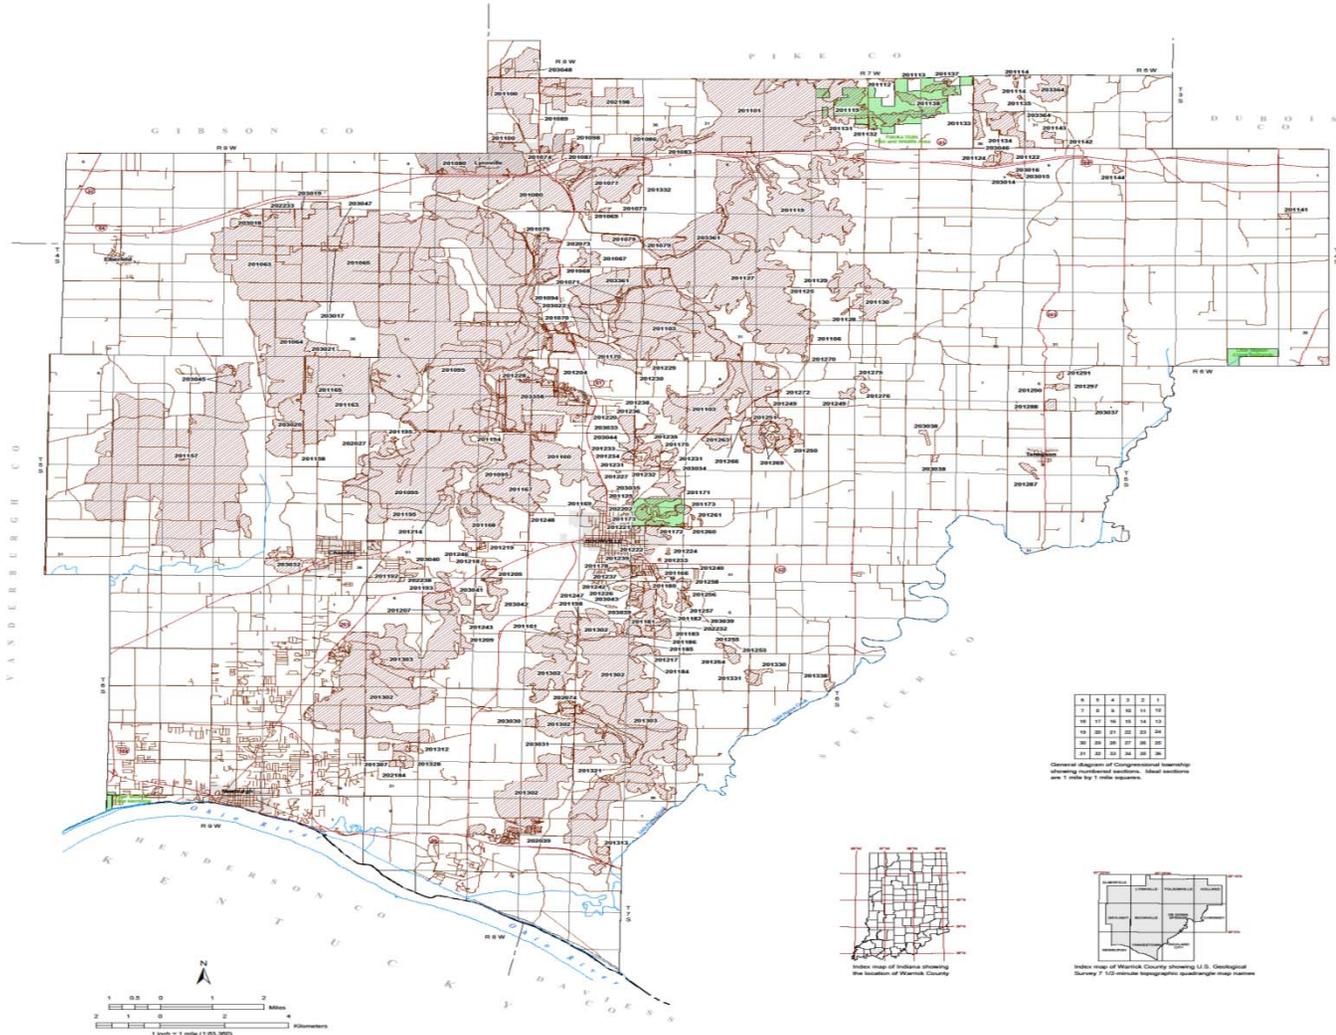
# Map Showing Surface Coal Mines in Warrick County, Indiana

This map shows the location and extent of surface coal mines in Warrick County, Indiana, which includes updated mine maps as published annually from the Indiana Department of Natural Resources, Division of Reclamation and the Indiana Bureau of Mines.

- Warrick County Indiana is one of the largest strip mining areas in the State of Indiana.
- Thousands of acres were disturbed over the last 80 years in the process of removing the coal.
- The State of Indiana put in place a program to reclaim and repurpose much of this land.

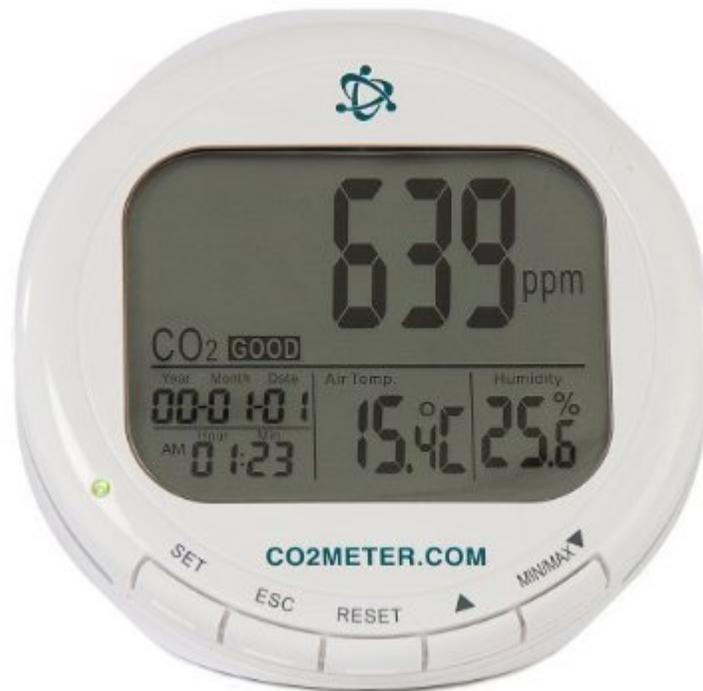
- The gas company personal also recommended, and the home owner agreed, that they install a CO<sub>2</sub>/O<sub>2</sub> monitor in the basement.
