Catasrophic Failure of Aging Underground Pipelines Is Inevitable Under Certain Corrosion Conditions

**M. ZEE, PHD
FELLOW OF NACE, FELLOW OF ASM
Zee@exova.com
(412)952-9441**

Exova Pittsburgh

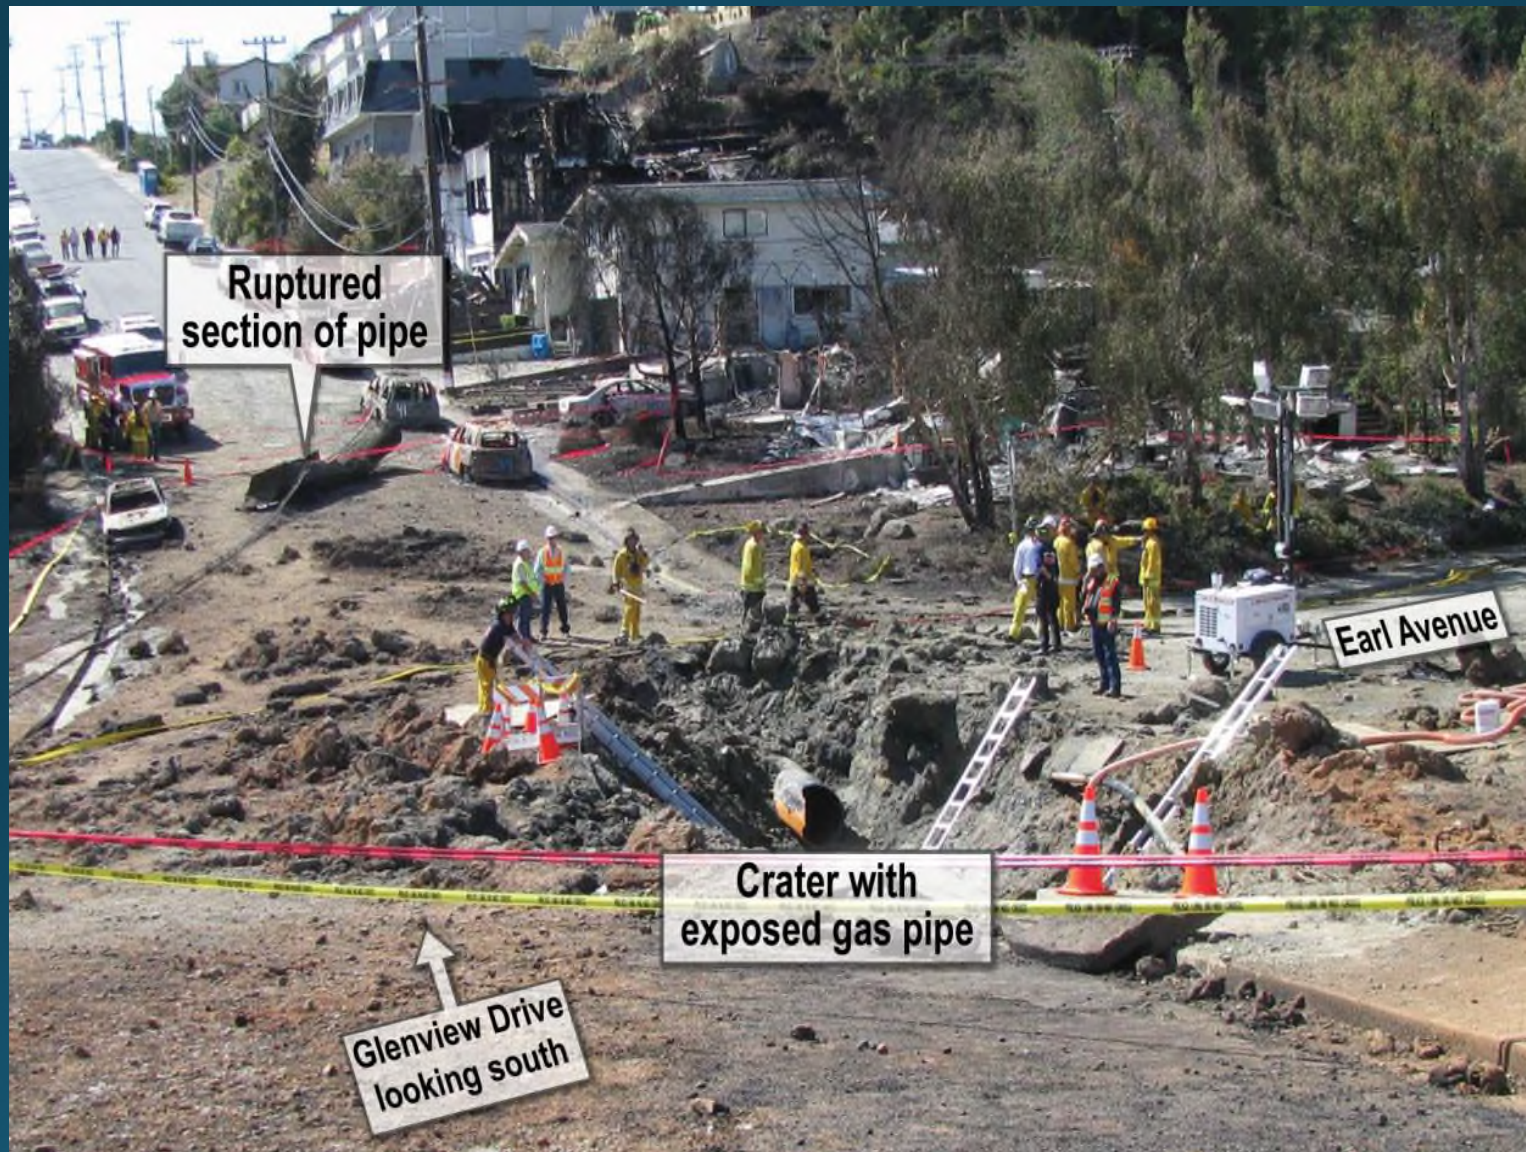
Pipeline Accident

- On September 9, 2010 a 30 inch diameter segment of gas line ruptured in a residential area in San Bruno California. The rupture produced a crater about 72 ft long by 26 ft wide.
- The natural gas ignited resulting in destruction of 38 homes and damaged 70. Eight people were killed and many were injured.

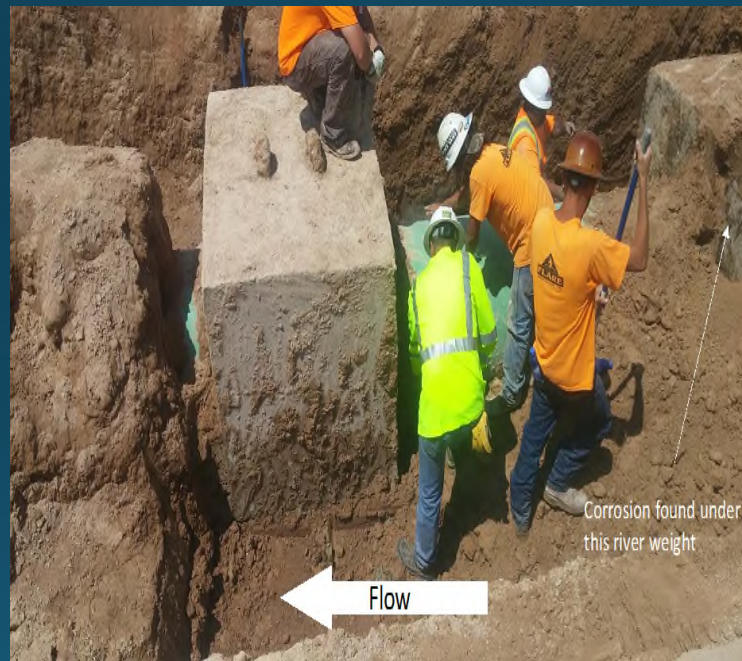
CP Shielding

Shielding Cathodic Protection

1-External Barriers (river weights, Shields, Rocks...

2-Coating (FBE, Polyurethane, liquid epoxy, wax, and shrink sleeve)

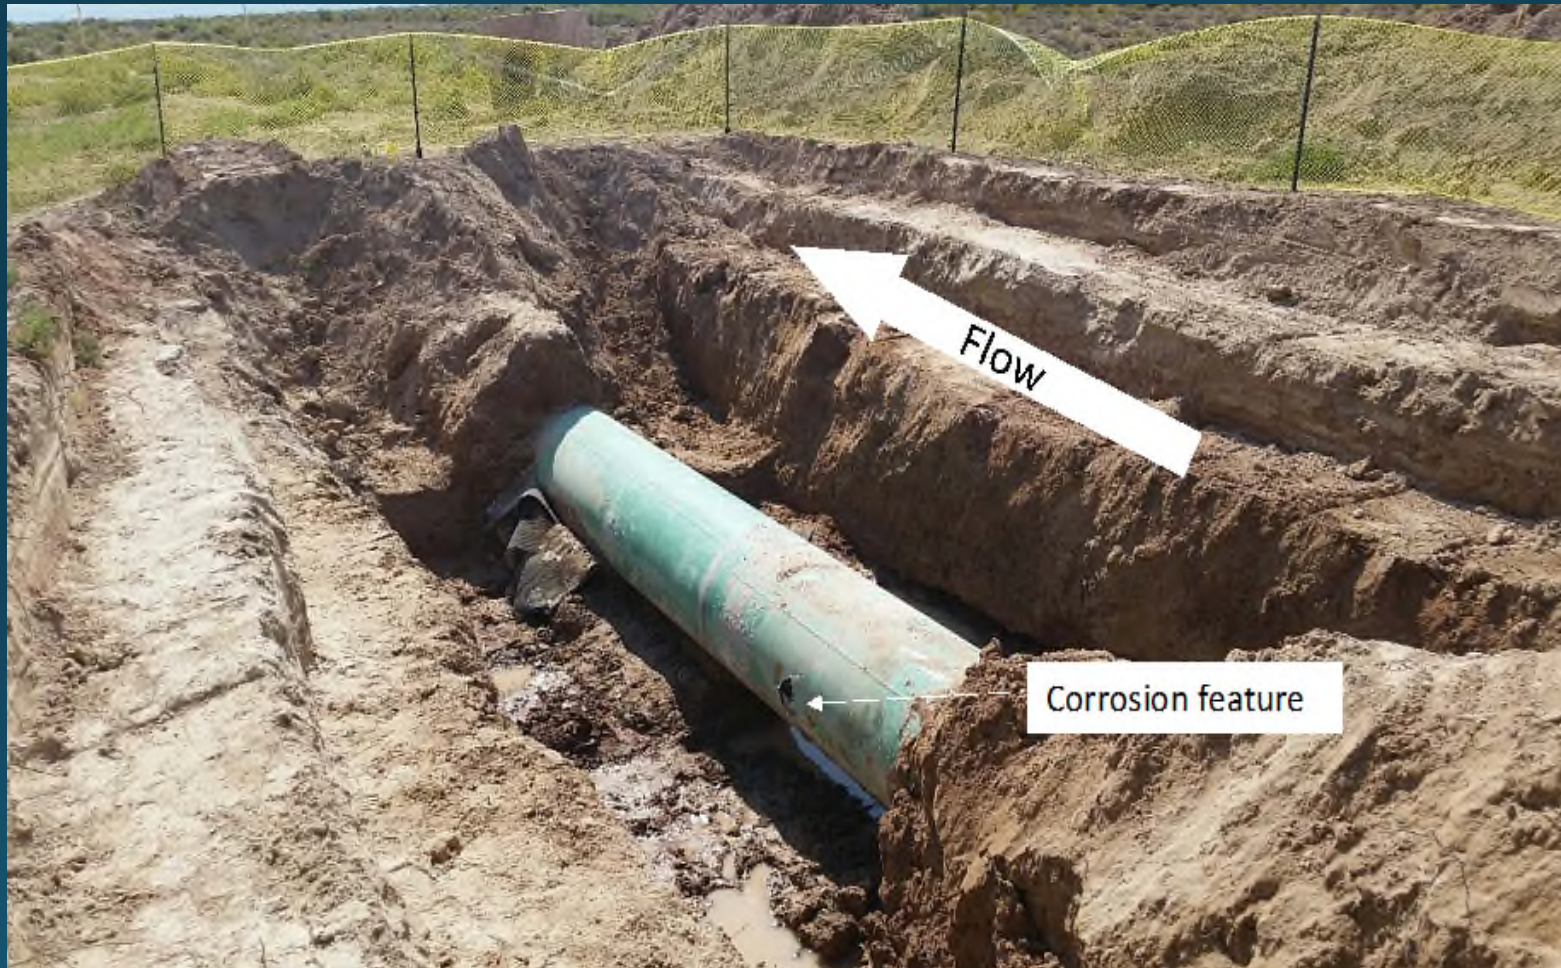
Corroded FBE Pipe

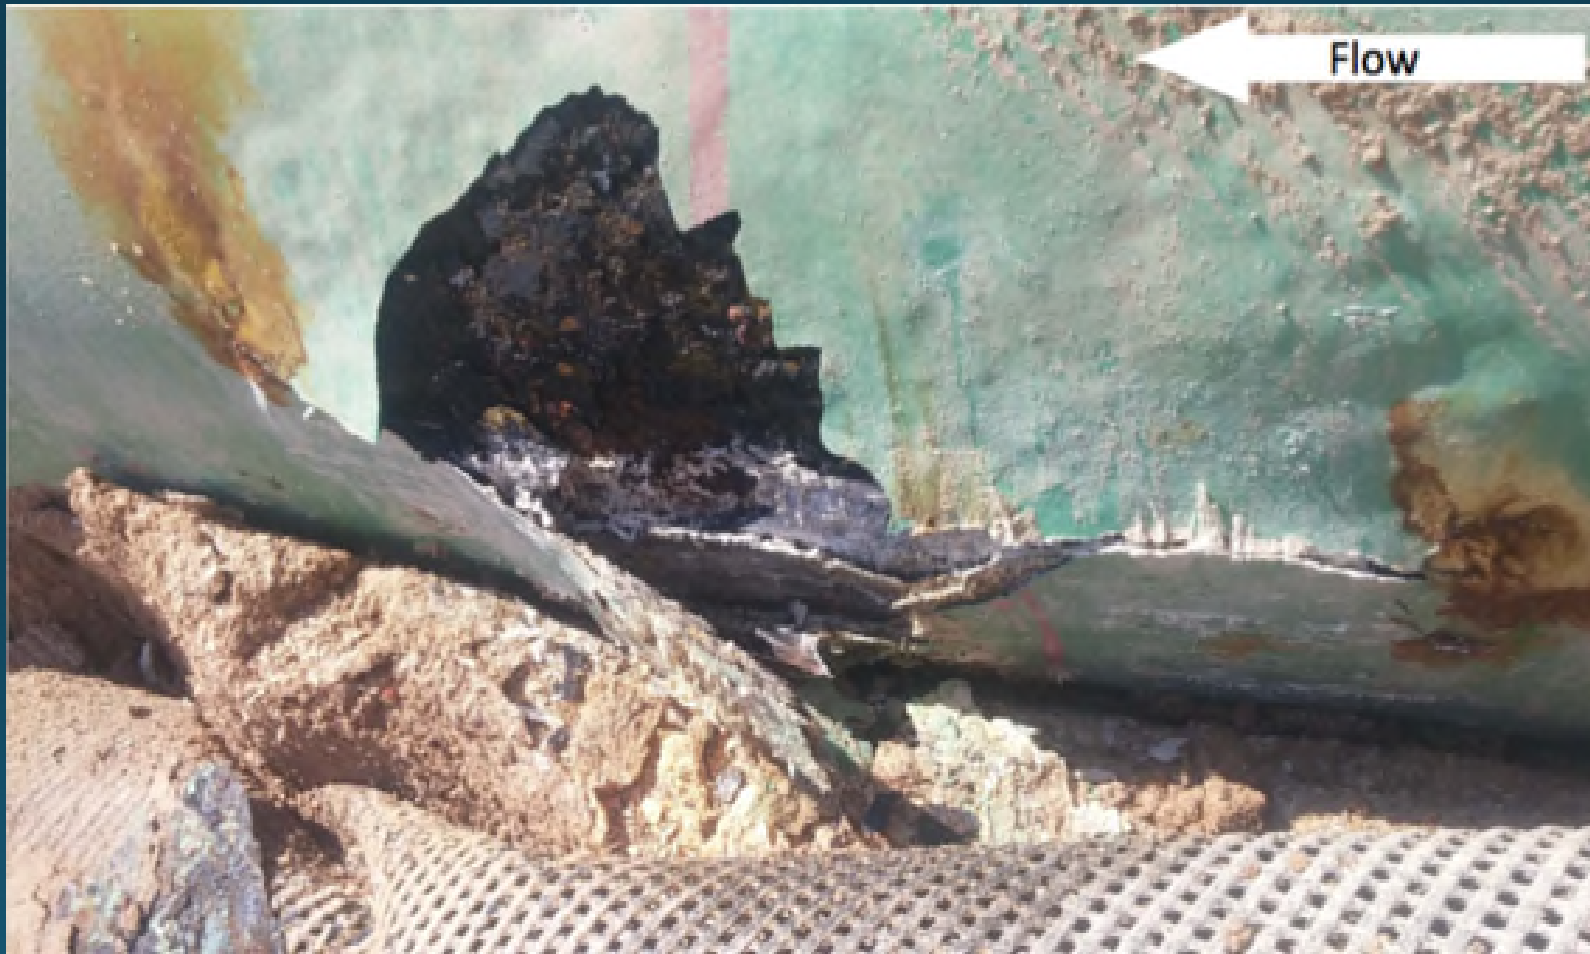
Localized Corrosion and Magnetite

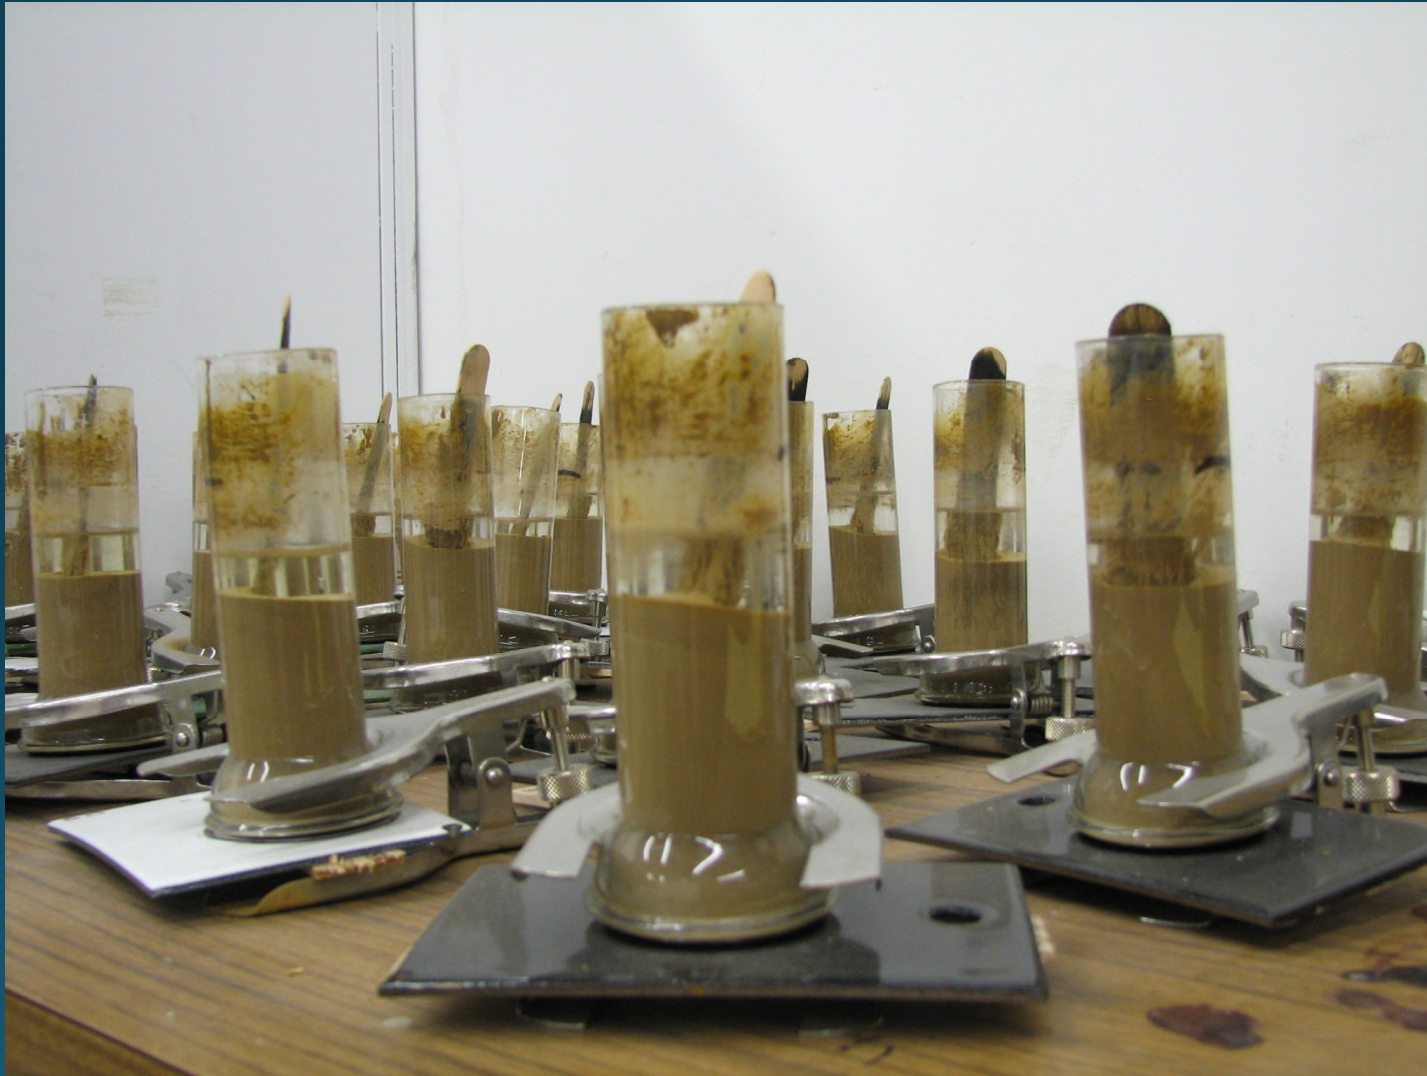
Soil Testing

Key Risk Factors in Soil Corrosivity

- **Soil chemistry**
- **Soil resistivity (soil conductivity)**
 - Chlorides, sulfates, sulfides
 - Low soil resistivity (high conductivity)
 - Acidity (low pH)
 - Wet-dry fluctuations
 - Differential aeration

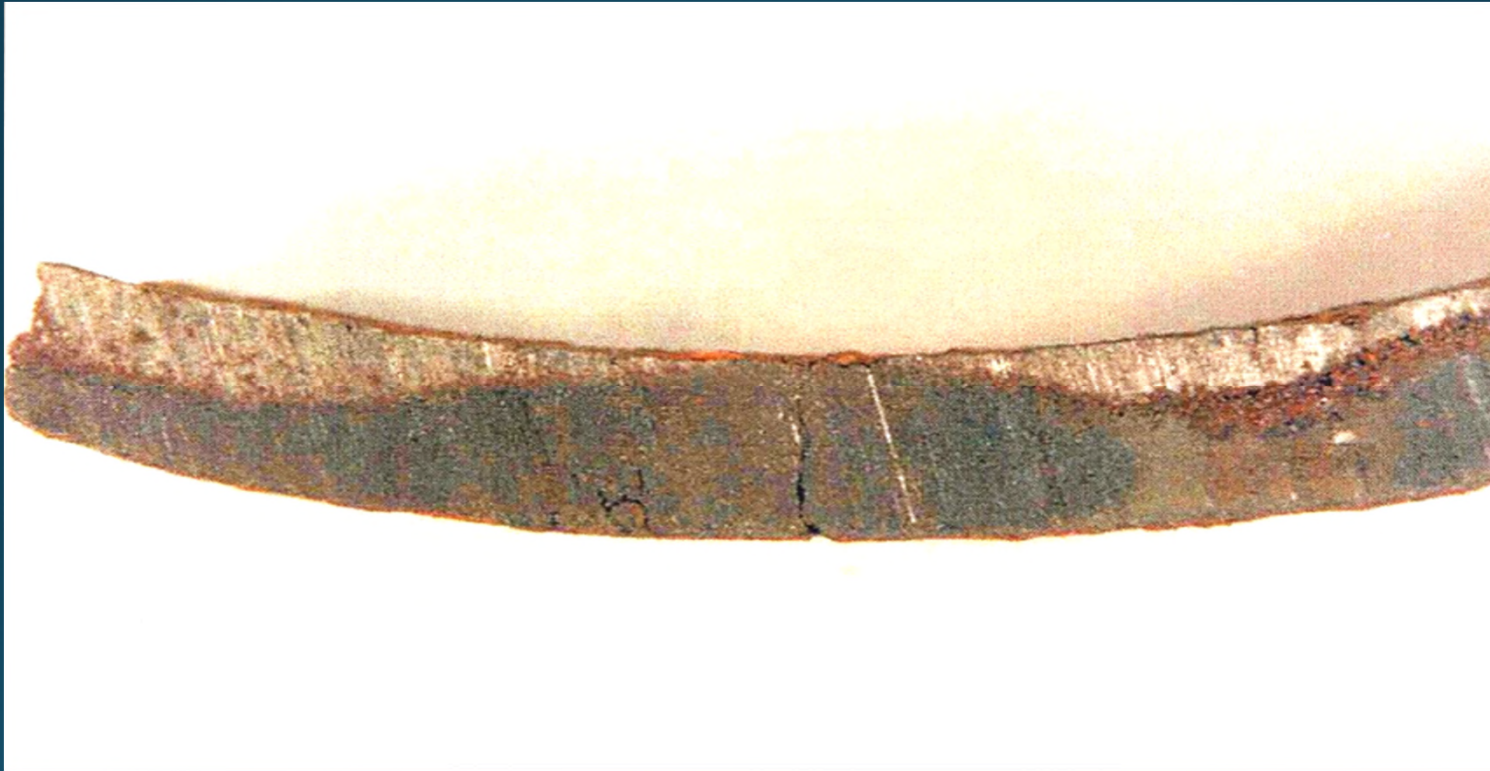
Cast Iron Graphitization

- The utilities replaced about 10,000 miles of the most vulnerable cast-iron pipe from 2004 through 2013, **leaving 30,000 miles to go**. They replaced an additional 17,000 miles of bare-steel mains during the same period, leaving about 56,000 miles still in operation.
- To unearth, remove and replace an old cast-iron gas main can cost more than \$1 million a mile. It means cutting into streets, navigating a rat's nest of other pipes and underground infrastructure, shutting down roads and sidewalks. The cost can be **several million dollars a mile** in major cities, where those disruptions are amplified by the presence of more people, buildings and cars.

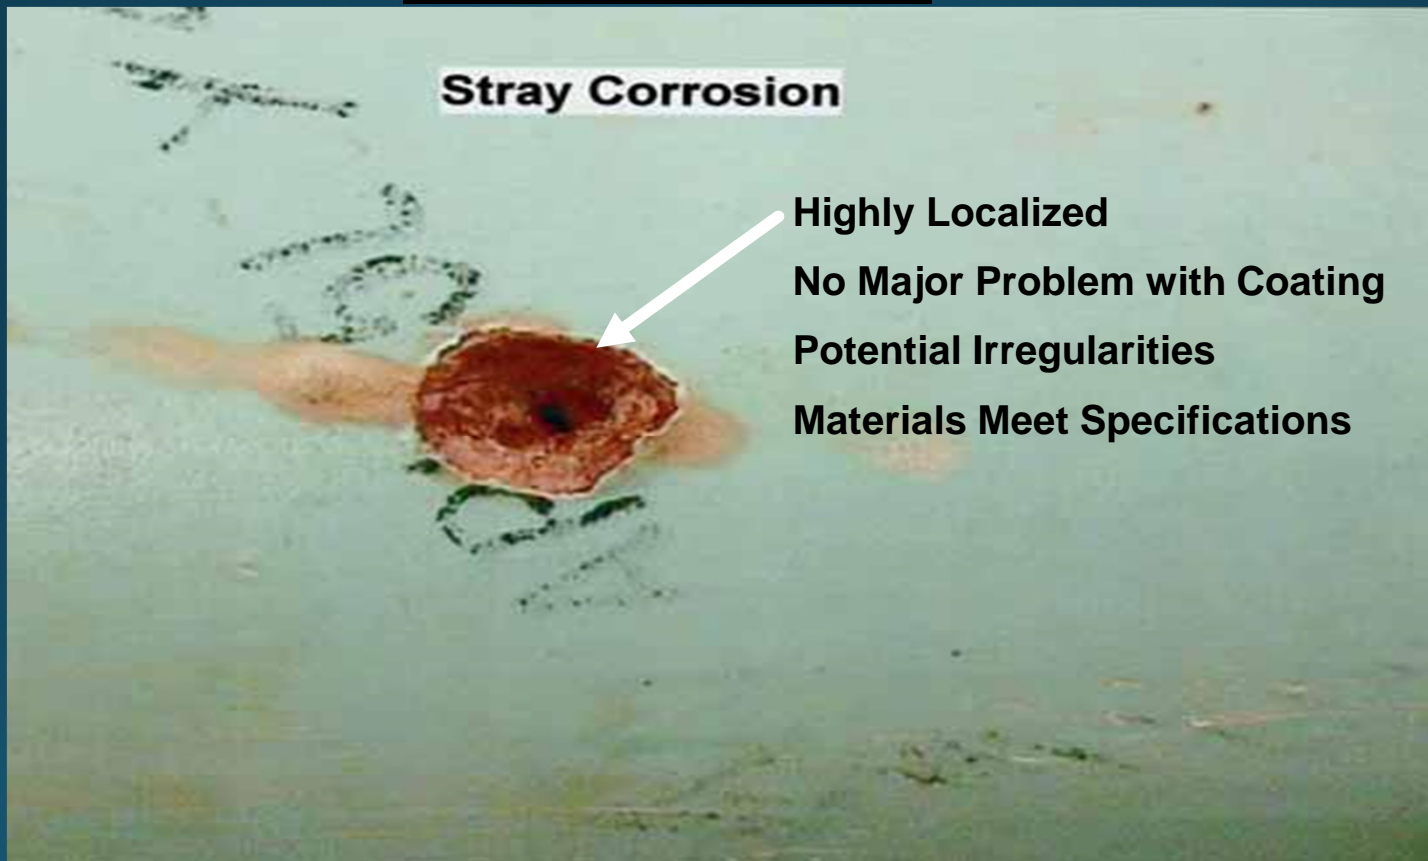
Stray Current Corrosion
(6 months only)

1. Corrosion Potential Measurements

Noble potential at point of discharge

Negative potentials at point of entry

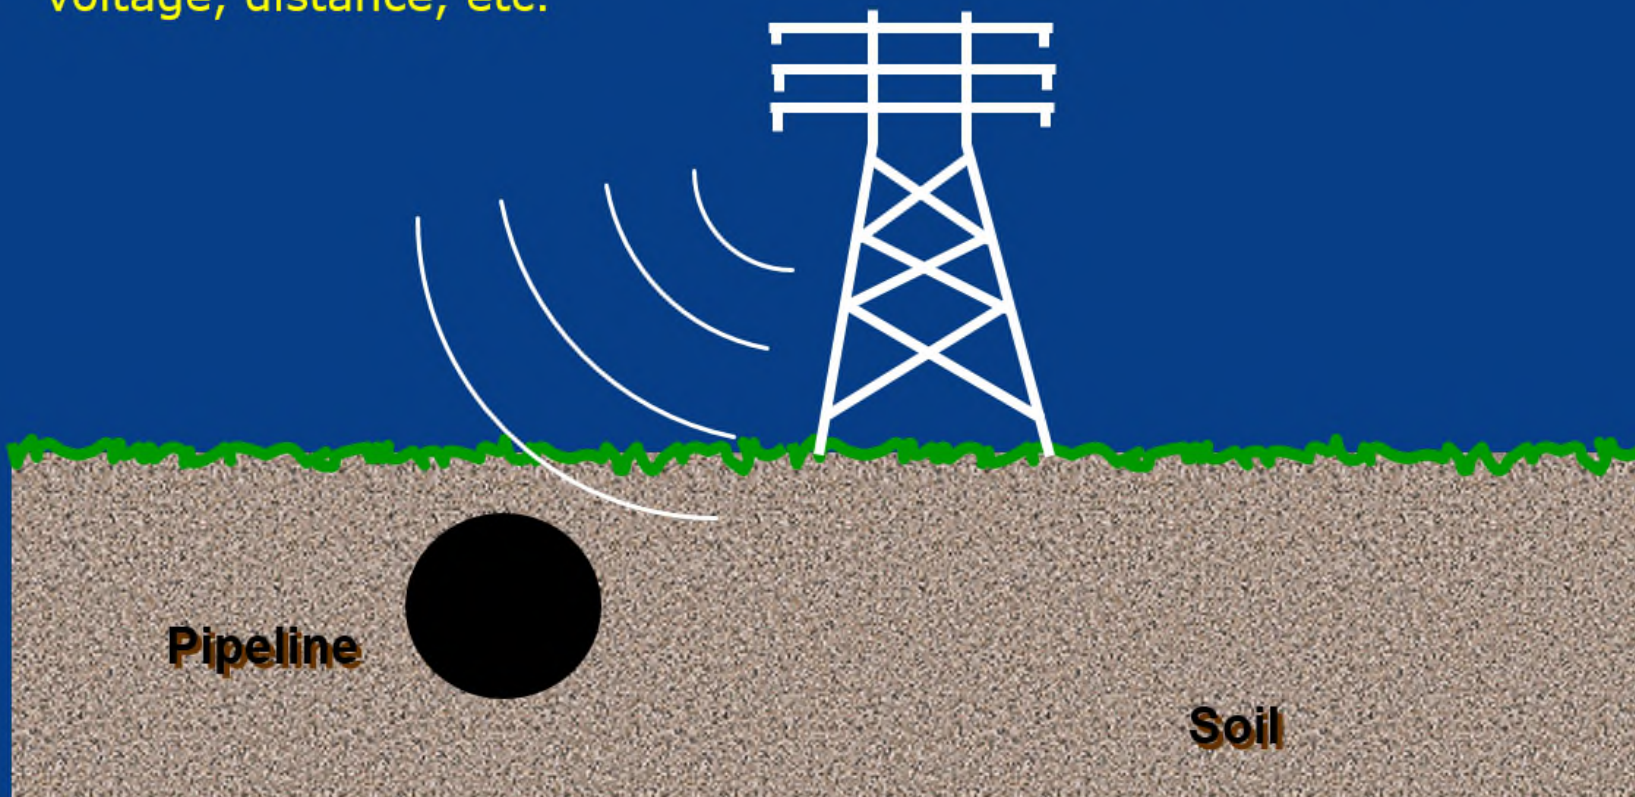
AC Interference

The magnetic field generated by the overhead power lines induces an AC voltage onto the pipeline (which creates AC currents). The magnitude of such currents depend on many factors such as coating condition, soil composition, power line voltage, distance, etc.

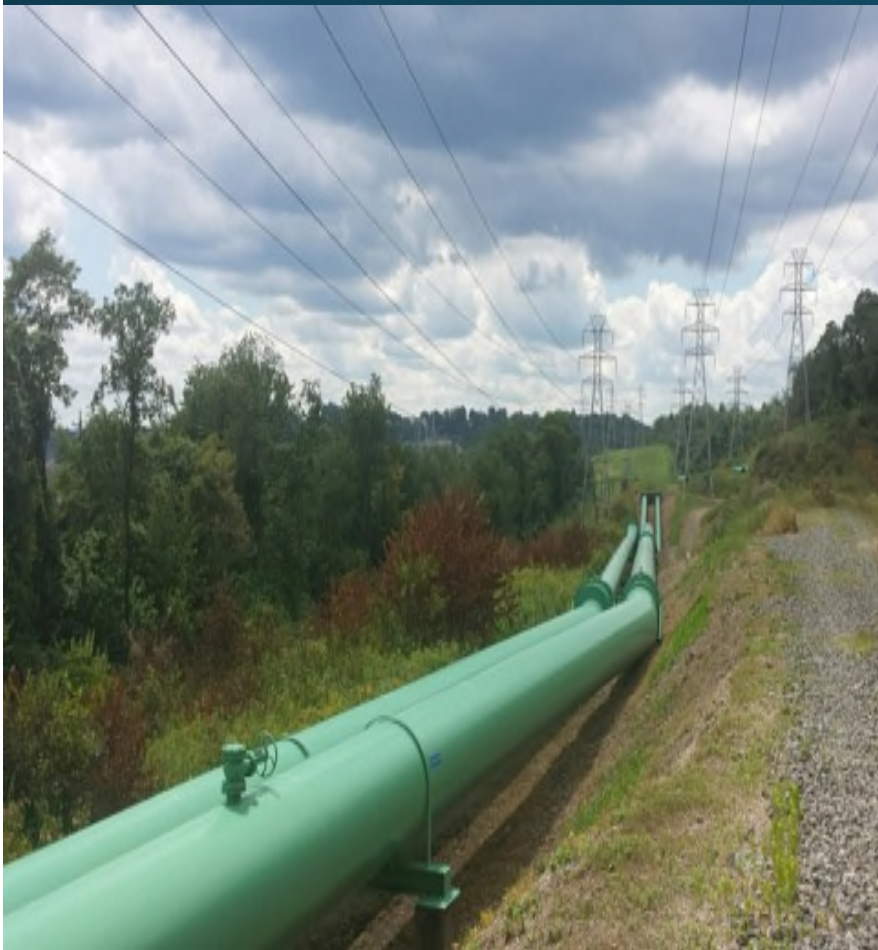
AC Interference

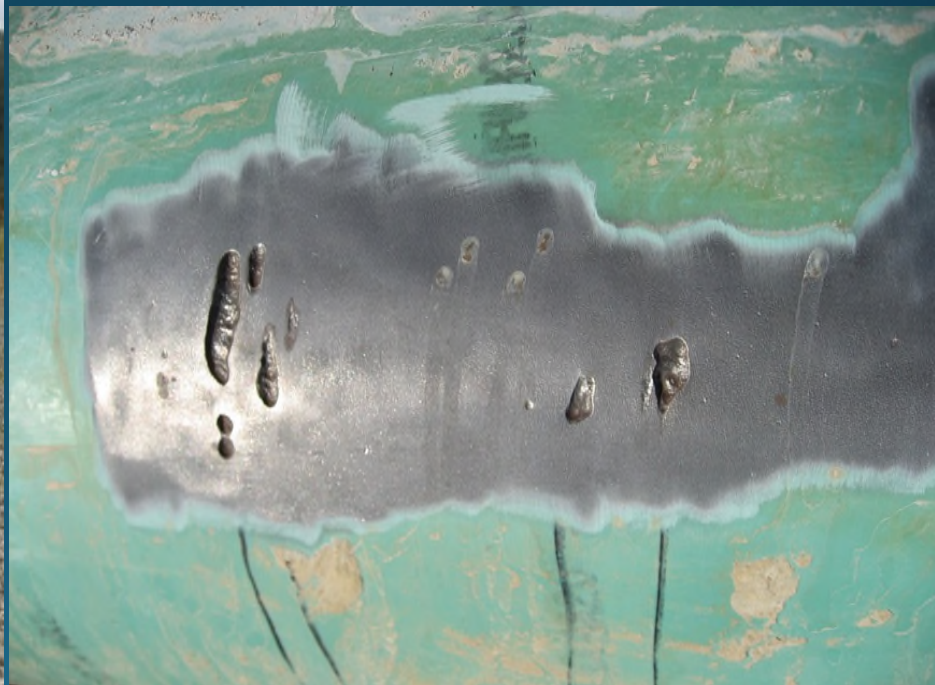
Fusion bonded epoxy
(FBE) coating

- AC Interference
 - >100A/m²
 - >4.8 AC Voltage
 - Low soil resistivity
 - High pH

Smooth round pit?

Hard corrosion product: Magnetite

Likely hood increase with decreasing AC frequency and decreasing holiday surface area.

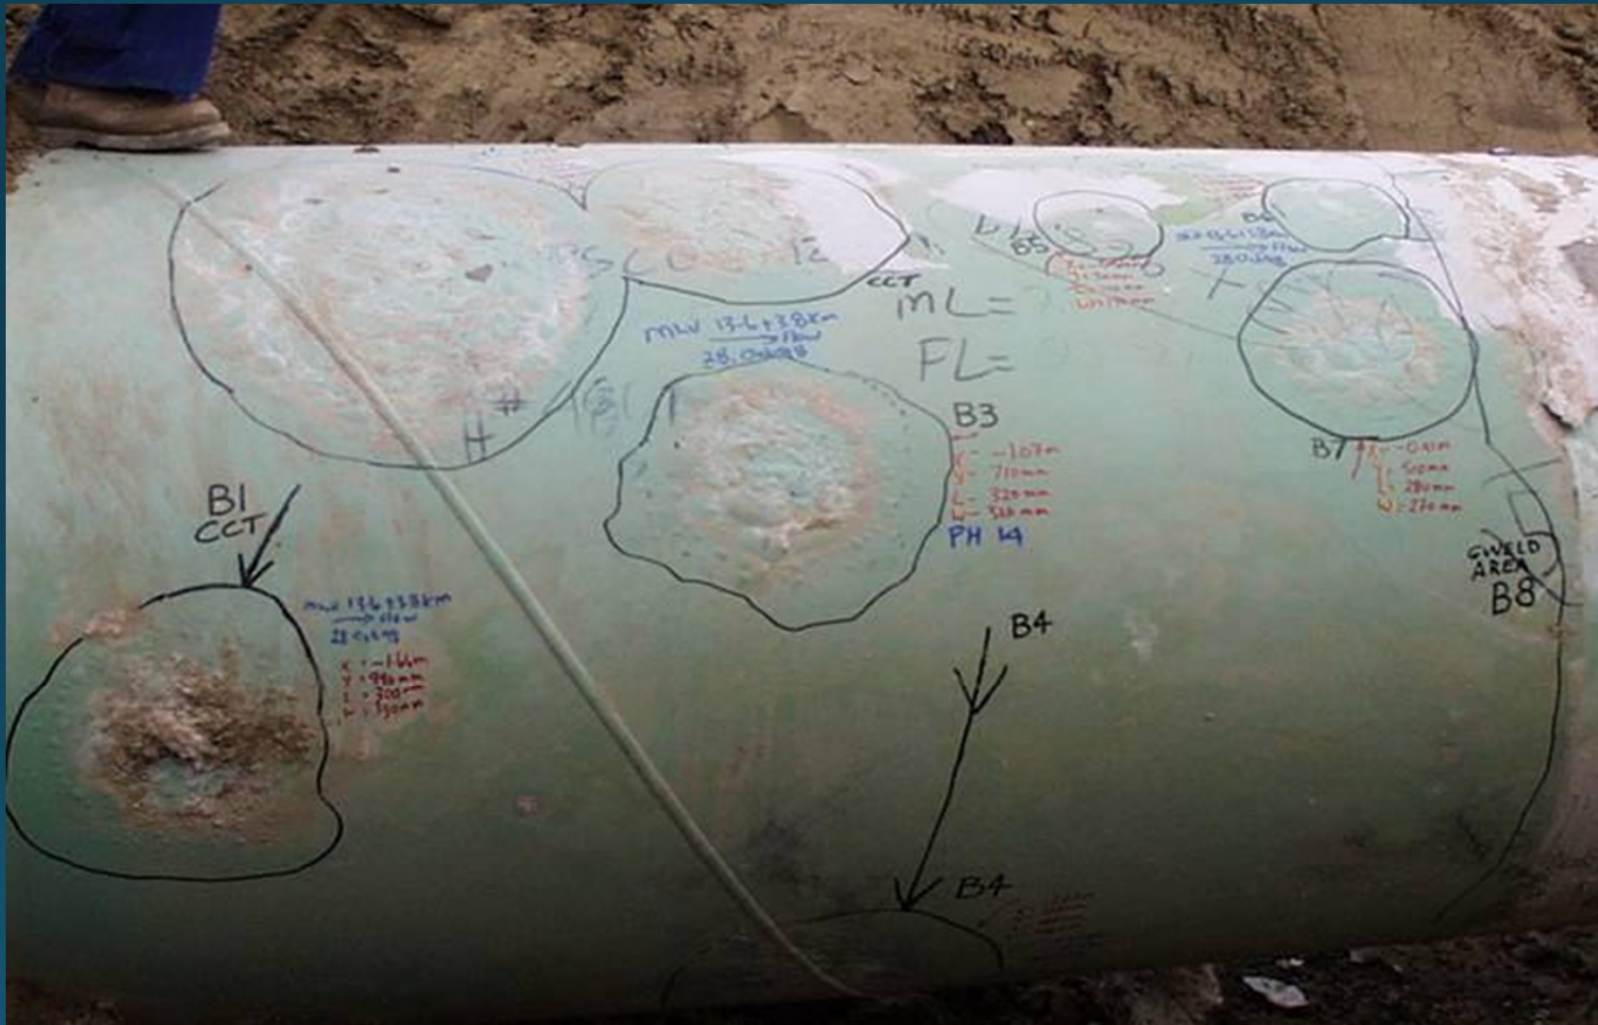
Disbondment

Root Cause

- 1-Extensive disbondment after 15 years

- 6-Root Cause –Inadequate QC/QA prior and during coating process

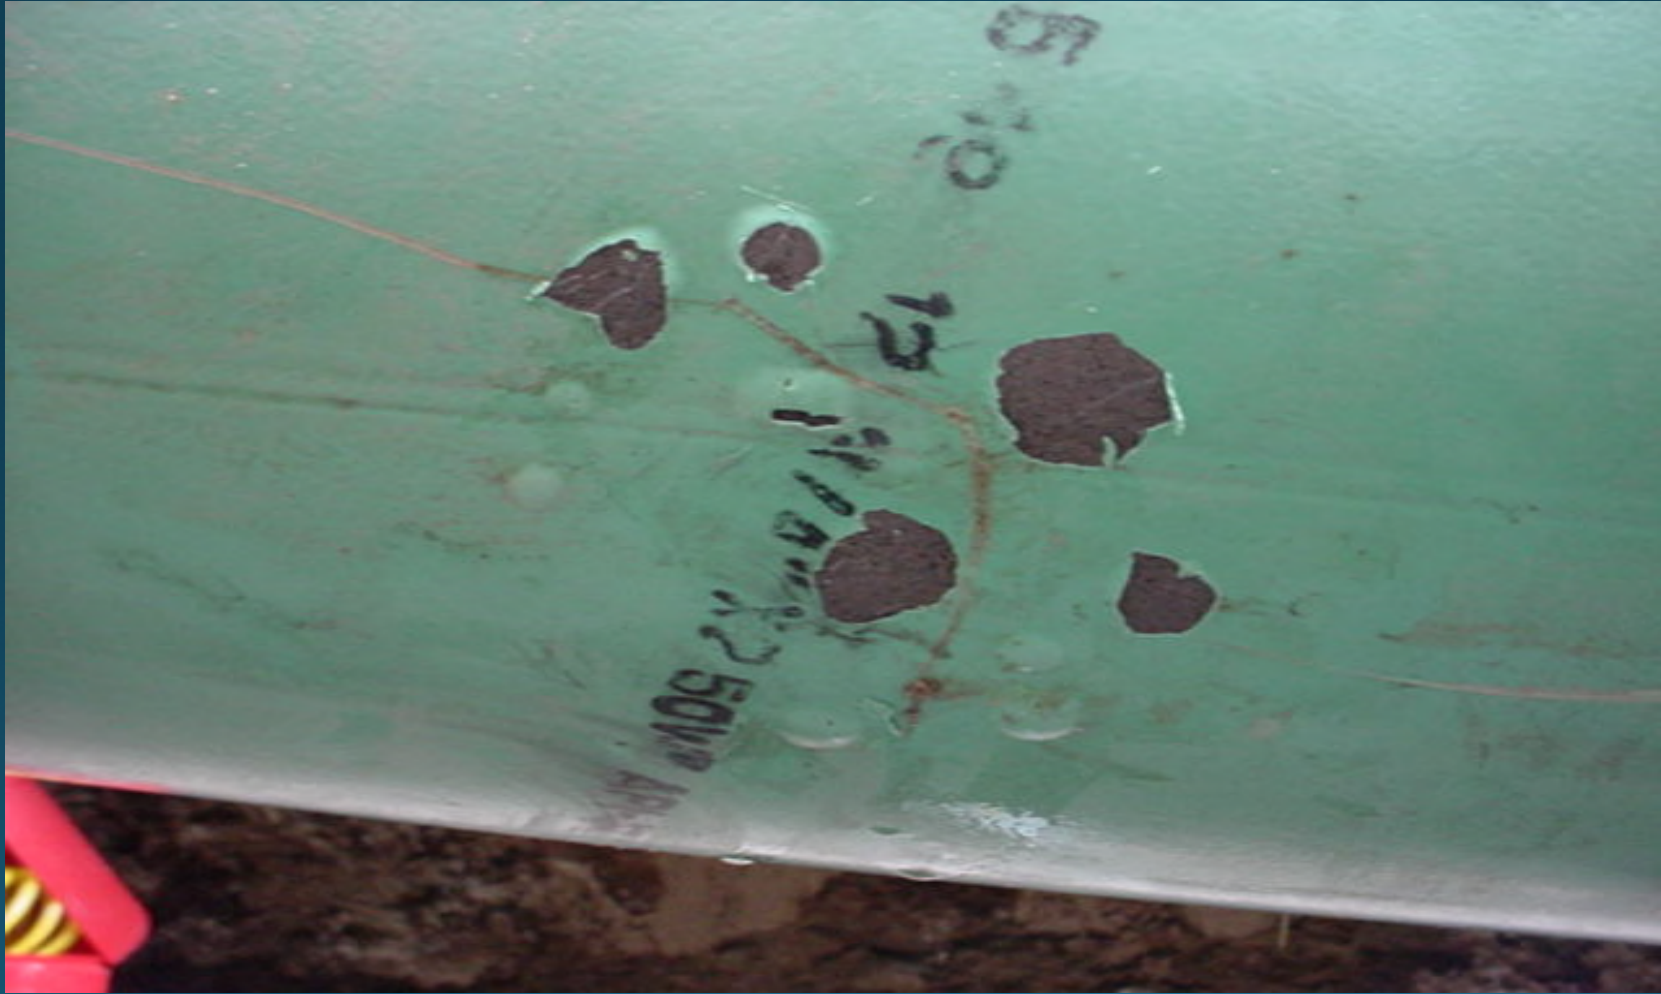
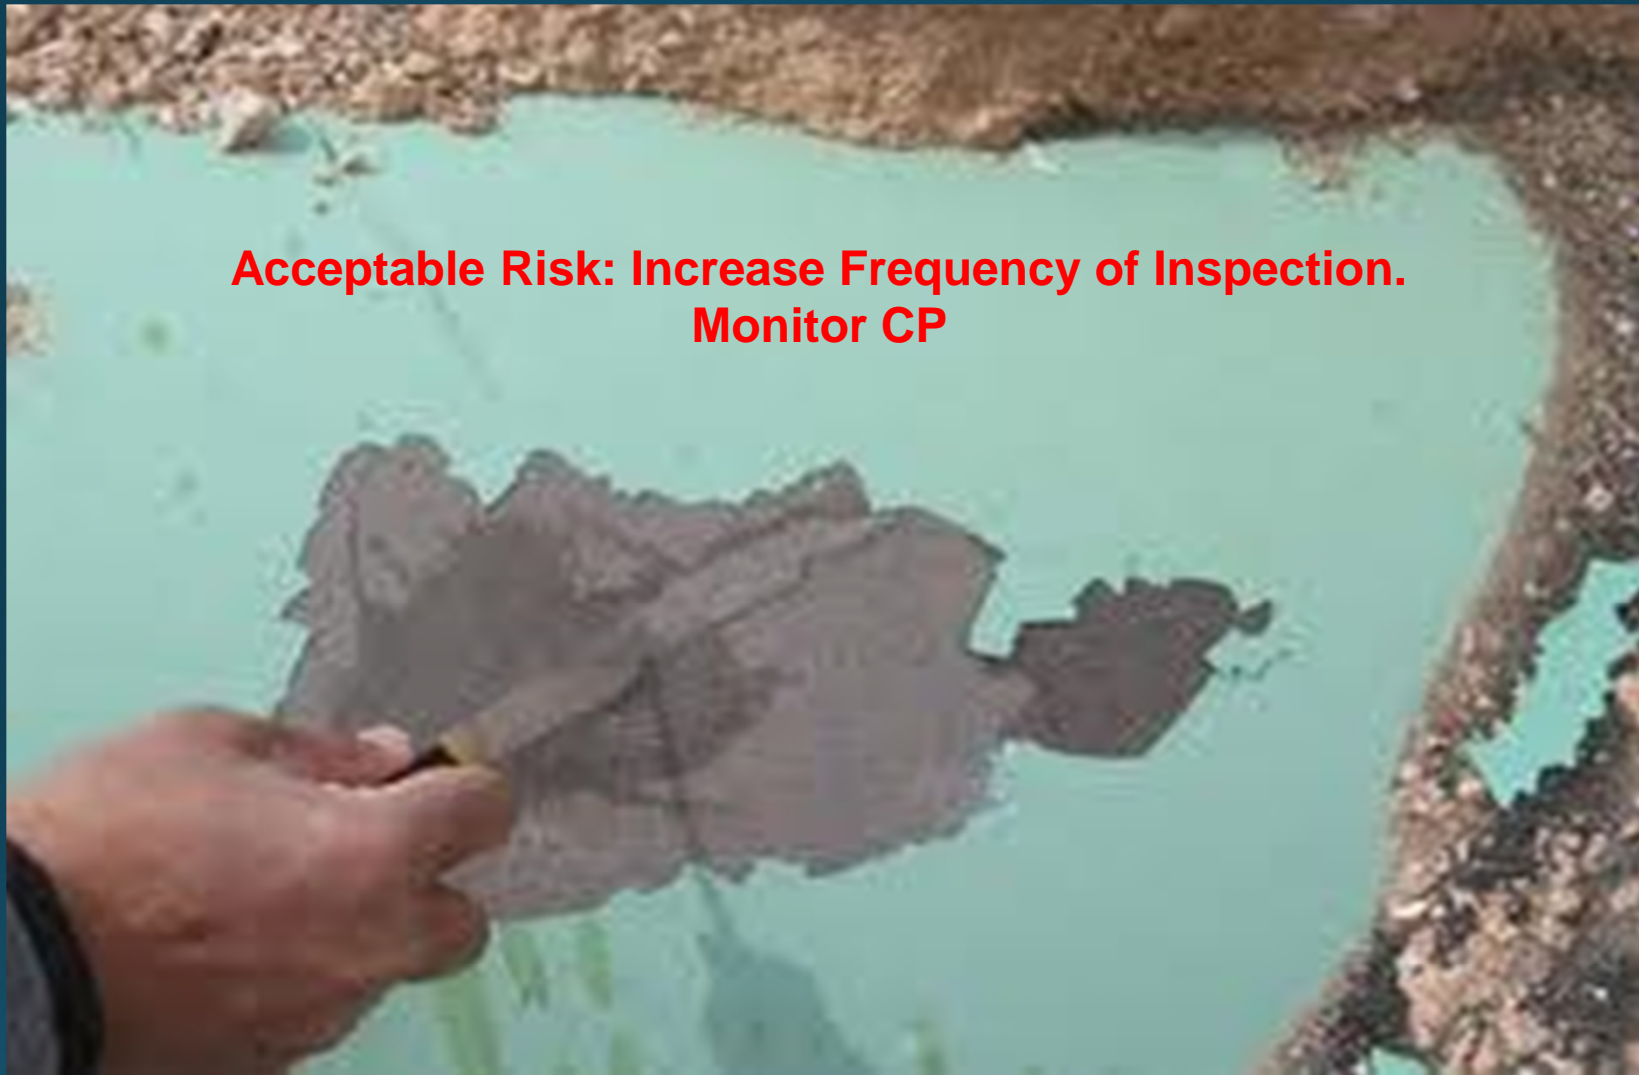
Blistering

**FBE Coated Gas Line Exhibiting Blisters, Adhesion Problems
and Delamination**

**Acceptable Risk: Increase Frequency of Inspection.
Monitor CP**

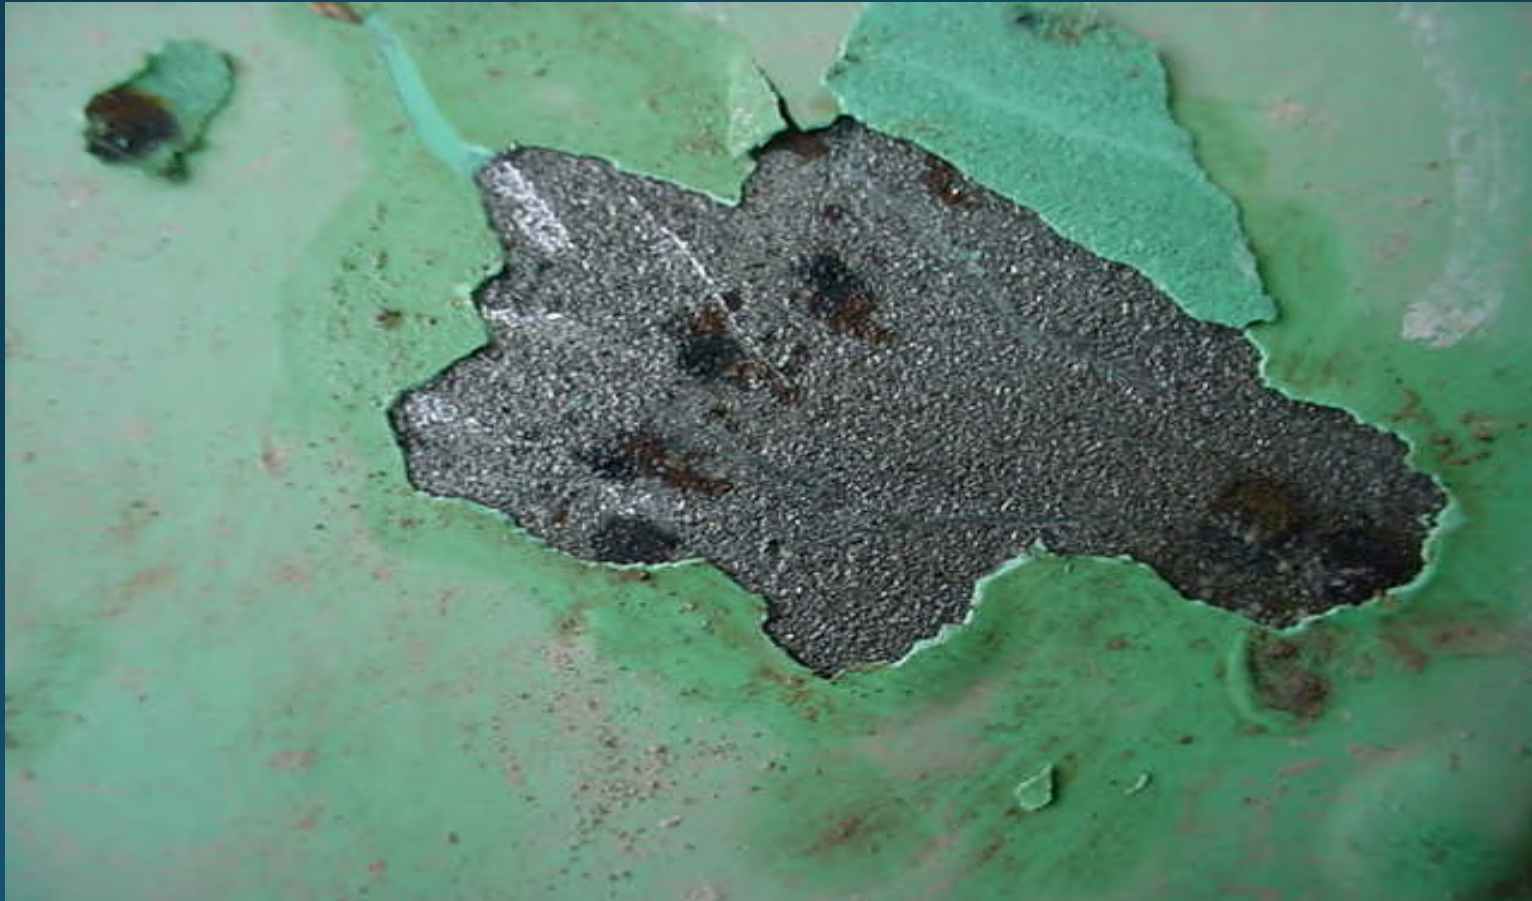
FBE Disbondment

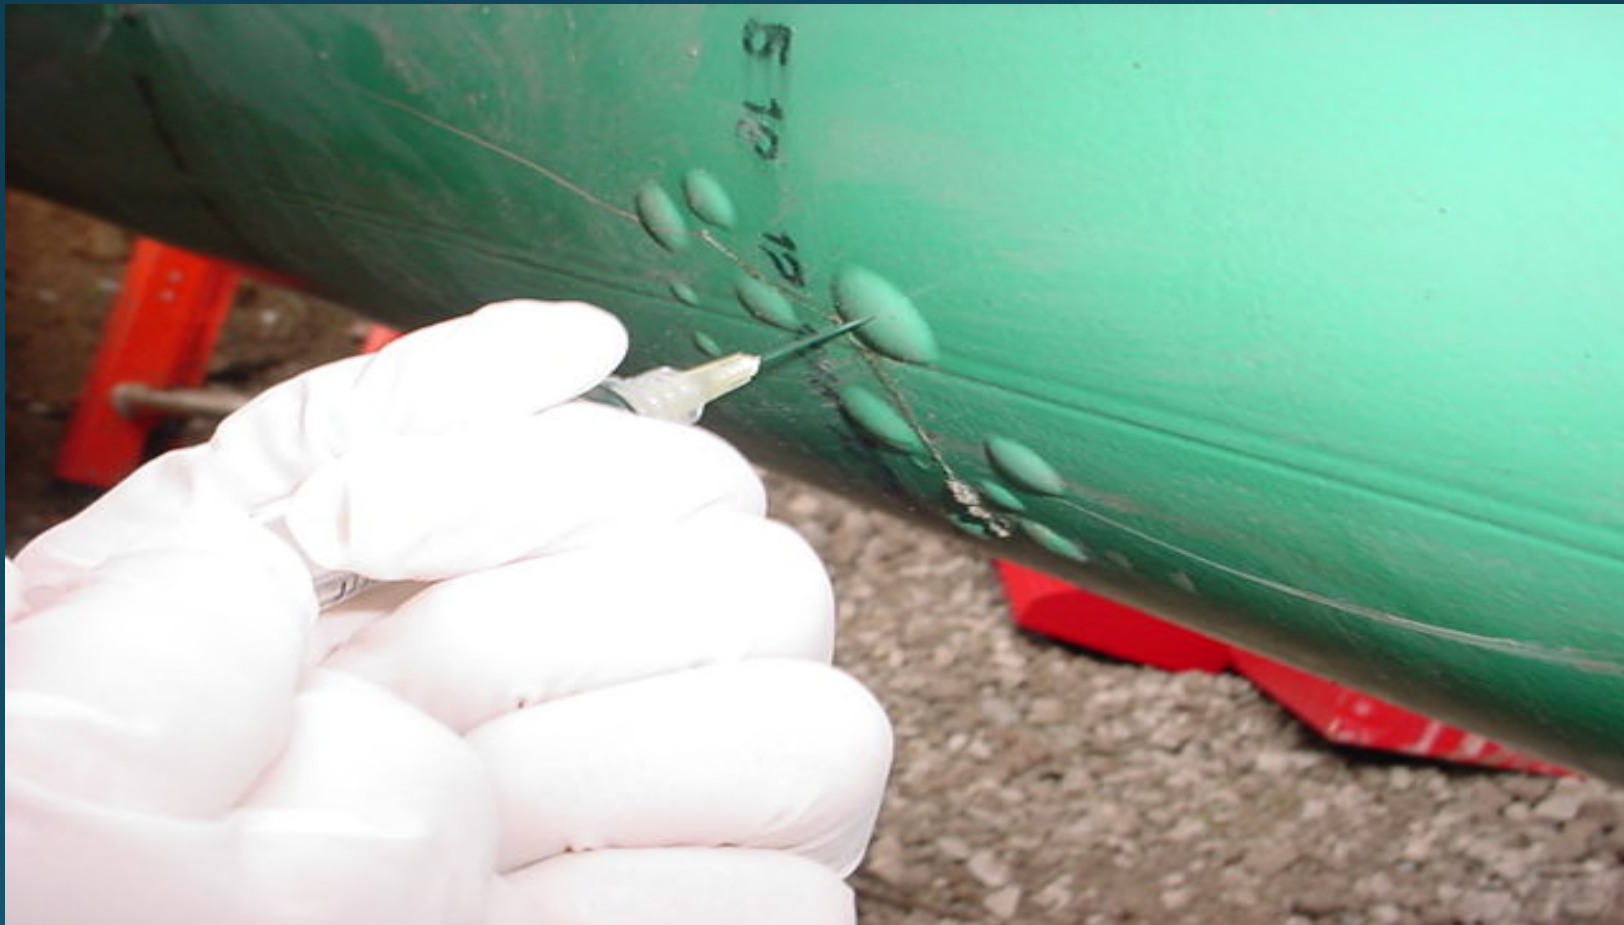
Blister Solution Sample Collection

- 4-Presence of high amounts of negatively charged ions, Cl^- , NO_3^-
