2019 Safety Conference
State College, PA

PA PUC - Safety Division
Rob Horensky

Safety Division – Program Overview

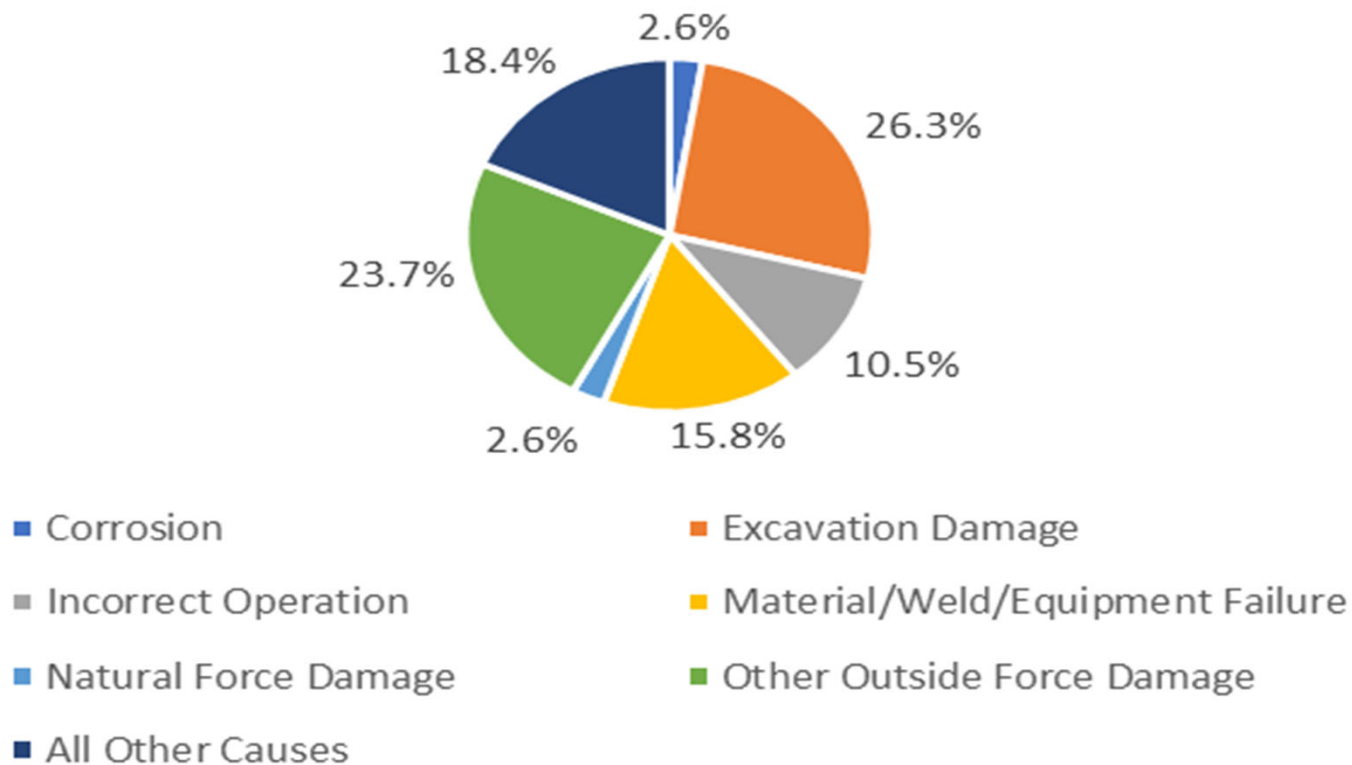
Serious Incident Cause Breakdown in 2018

2018 Serious Incidents By Cause – Across USA

Serious Incidents include a fatality or injury requiring in-patient hospitalization

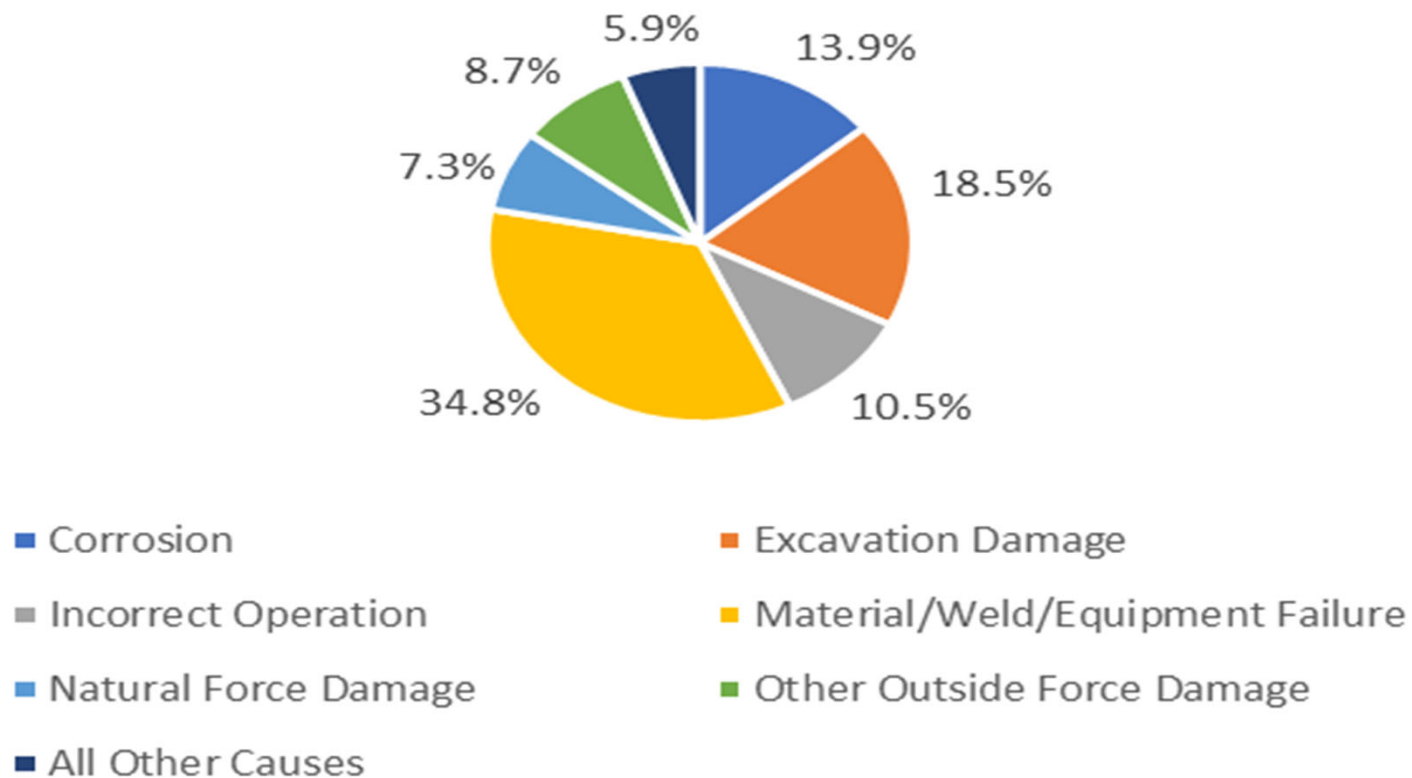
Significant Incident Cause Breakdown in 2018

2018 Serious Incidents By Cause – Across USA

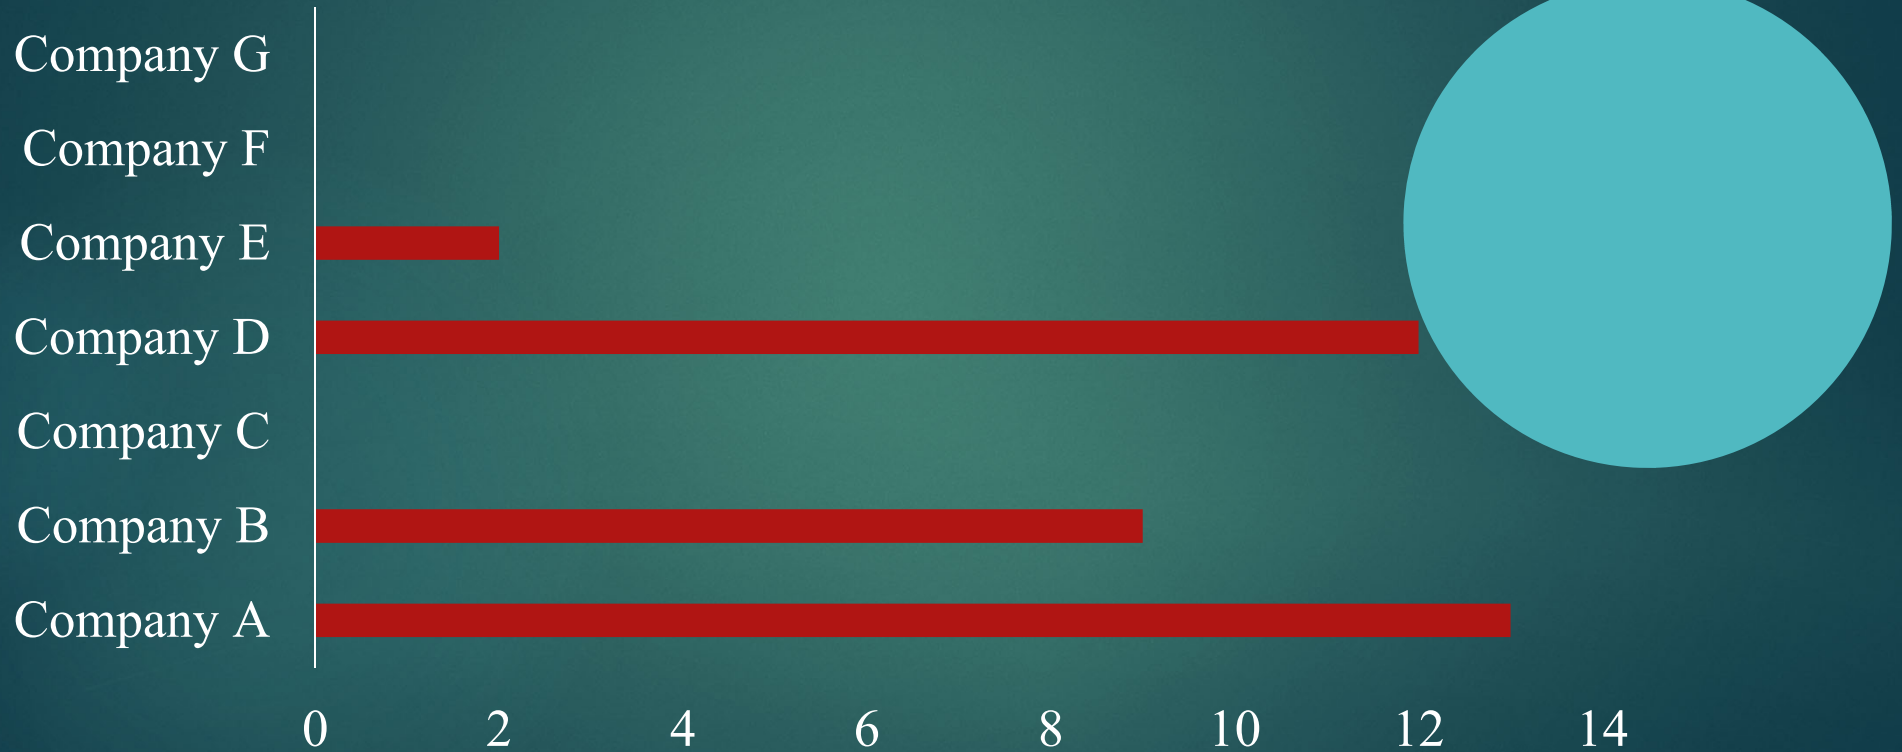
Total Leaks Associated with Master Meters in 2018

Some Companies Don't Track Master Meter Leaks
