## AUTOMATIC SPLICES – THE INSIDE STORY

Carl R. Tamm  
September - 2013

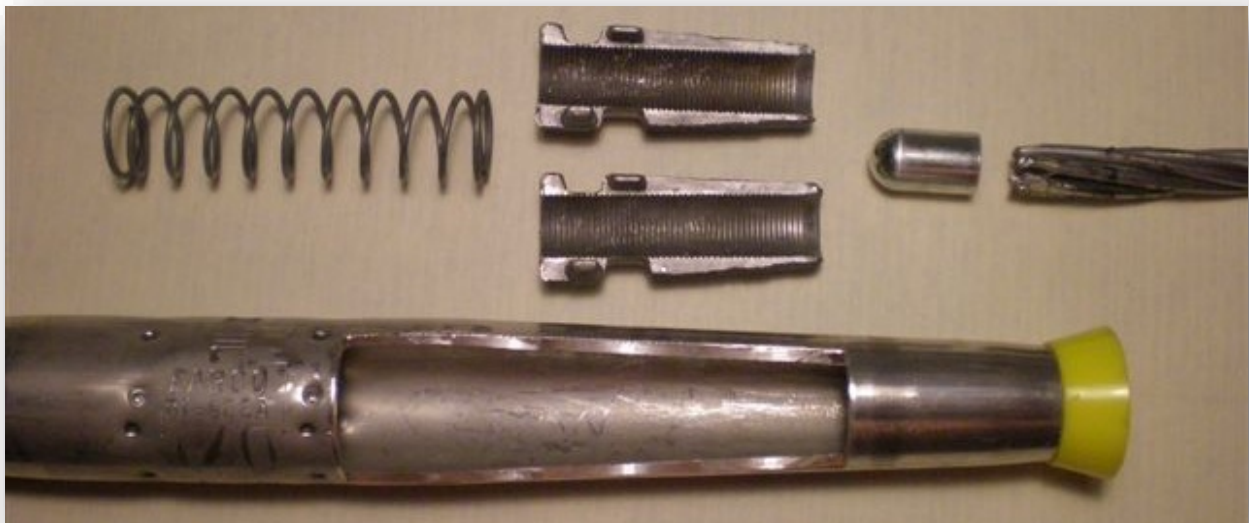
The following is a picture of the “guts” of one side of an automatic – the other side is the same.

Beginning at the upper left and moving clockwise, we have (a) the spring, which provides a forward thrust to the jaw assembly during installation, (b) two jaws which interlock and make up the “jaw assembly”, (c) the pilot cup, which captures the ends of the conductor strands, and maintains their position (keeps them together) during the installation, and at the bottom, the yellow component is the “funnel guide” which serves to hold the pilot cup inside the assembly and guide the individual strand ends of the conductor into the pilot cup – all within the tapered body of the splice.

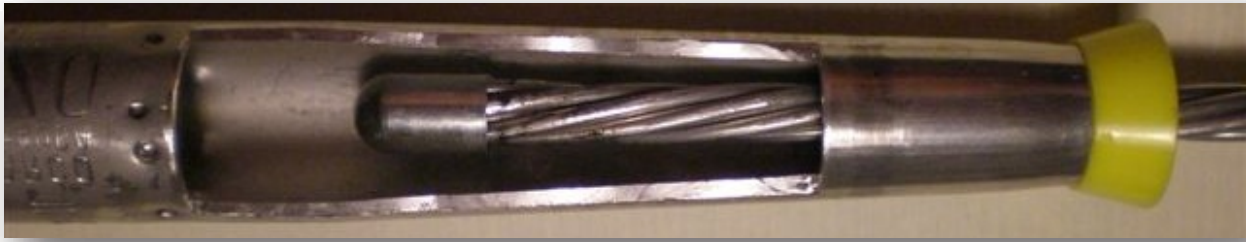
To illustrate the action of the pilot cup, the following photo shows how the conductor, once inserted through the funnel guide, fits within the confines of the pilot cup. As will be discussed in detail later, the function of this pilot cup is critical to a successful installation of an automatic splice.

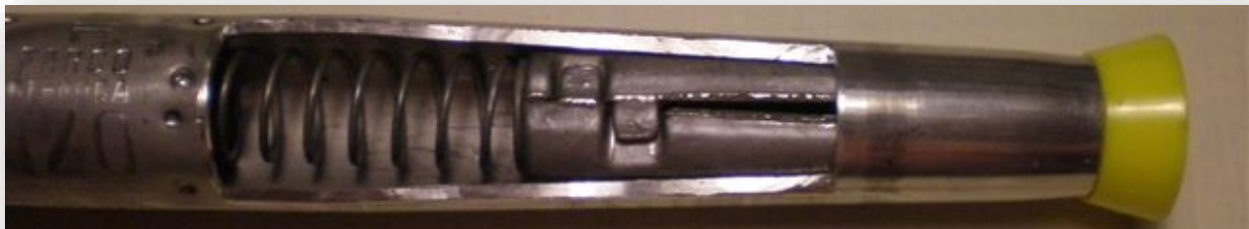
Prior to insertion, having this side cut out from the splice, one can see the position of the jaws, urged forward by the force of the spring, awaiting insertion of the conductor.

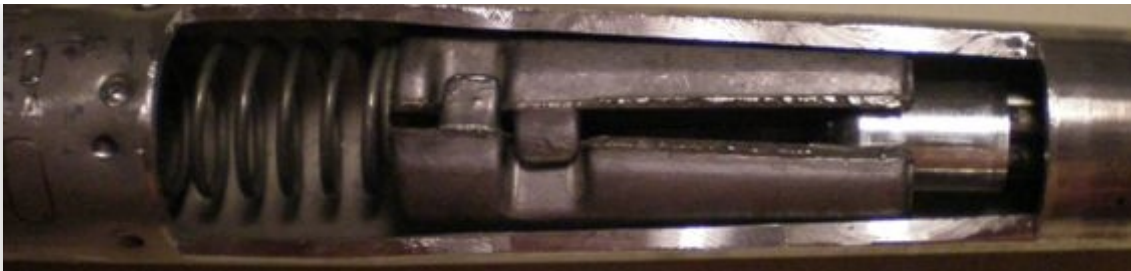
Upon insertion of the conductor, having picked up the pilot cup as it passes through the funnel guide, the "resistance" that is felt during installation is the force required to push the jaw assembly backward against the spring.

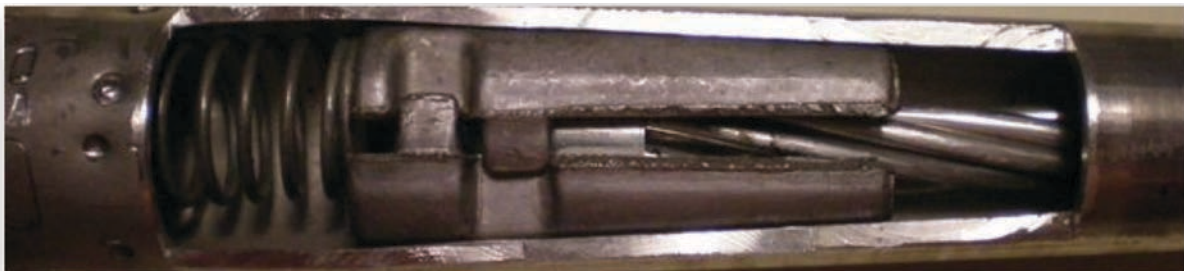
As can be seen, the pilot cup serves to maintain the conductor's position, centered within the jaws as it is pushed toward the center of the splice.

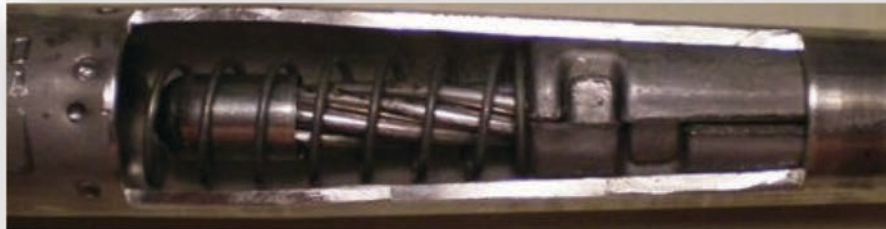
Properly installed, the conductor will push the pilot cup completely through the jaws, to the center of the splice. Because the pilot cup must contain the entire conductor, it is obviously of larger diameter than the conductor, and as can be seen in the following photo, upon passing the pilot cup completely through the jaws, the jaw assembly will “spring” forward, and the taper of the body will force the jaws into intimate contact with the conductor! Additional tension on the device will serve to further “seat the jaws” and urge them into increased forced contact with the conductor.

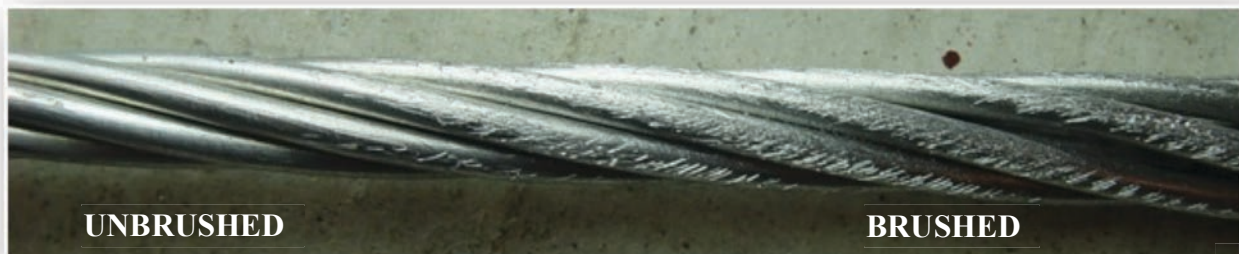
This is the first step in properly installing **any splice or connector**, but this critical step seems to be skipped or neglected more often with automatics than with other connectors. Perhaps it is because so many automatics are installed during storm restoration events, when there is tremendous pressure on the linemen to “get the lines up and power restored” and the job is rushed. There are numerous reports and tests available to assert the importance of this step, so this paper will not go into detail on this, other than to state, that the key result of this operation is not, as many misunderstand, to remove oxides, but rather to “roughen the surface of the conductor” which results in significant improvement of electrical contact at the interface. The difference is EASY to see with the naked eye.

- ***Failure to PREPARE & BRUSH the Conductor***

Other than physically removing the splice, one cannot determine, even with an X-Ray, whether or not the conductor has been properly brushed and prepared. A recent event, where an automatic splice, installed for only 5 years, let go and dropped a line on a woman, ultimately resulting in her tragic death. The lawsuit resulted in an award of \$105 Million. The manufacturer walked away untouched – because it was EVIDENT that the conductor had NOT BEEN BRUSHED, as per the instruction on the package! The only person who knows that any splice is properly installed is the person who did the installation – because the part of the conductor that must be brushed is INSIDE the connector and IS NOT visible!

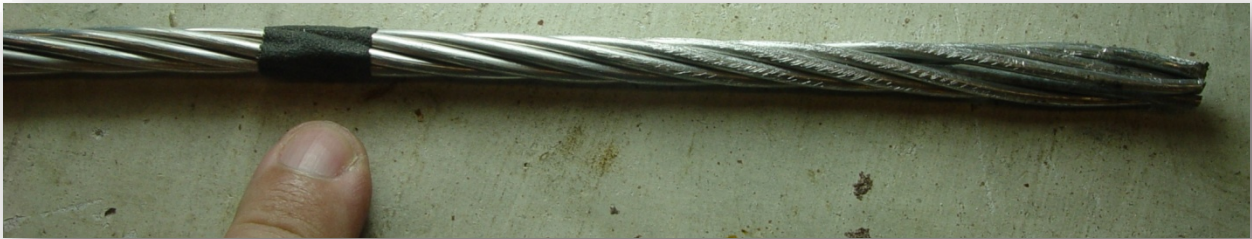
Also a critical step in any connector, to assure proper insertion depth is achieved, it is perhaps more critical with automatics than with other splices. The reasons for which this paper will explain in more detail! Perhaps it is again, storm restoration and hurried workmanship, or perhaps it is too easy to put ones thumb at the insertion depth... but then something happens, it does not go in as it should, the thumb slips, and the mark is lost. A permanent marker works, but best of all, is a simple piece of tape. Whatever the reason, too many automatics fail due to improper insertion issues.

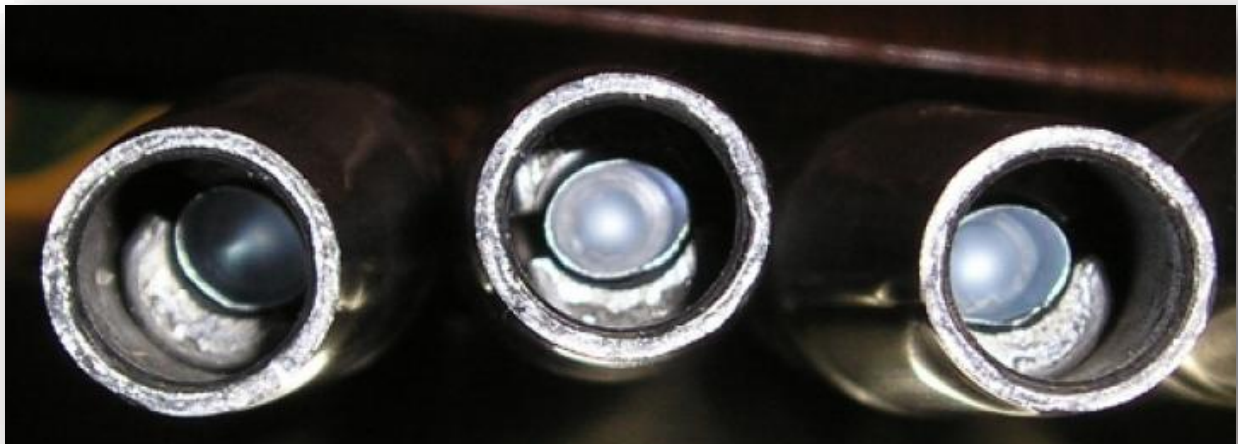
The result is that of the following photos. In the instance of the first photo, insufficient force was provided to drive the pilot cups into the jaws, and the conductor was simply not gripped. If this occurs, the lineman will immediately recognize there is a problem, and take action to correct that, by installing another splice.

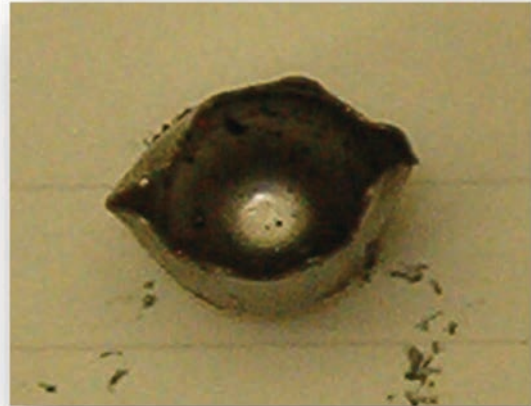
However, in the instance that follows, the pilot cup has passed almost to the end of the jaws, which is the most dangerous situation, as the tips of the jaws may capture the conductor, leading the installer to believe that the splice is made adequately, and the conductor may withstand the initial tension of the line, but the jaws are prevented from closing completely on the conductor by the invading pilot cup! In such instances, the splice may be left in service for days, weeks, or even years, before some event jostles the line sufficiently or components of corrosion build up, thus allowing the conductor to slip out! This condition may be impossible to detect with infrared techniques or direct resistance measurements, depending on the current load on the line.

- ***Partial Insertion Errors – Incomplete Insertion***

The only means of detecting this condition during inspection is with X-Ray. It is highly unlikely, unless the connector is actually within hours or days of failure, that the resistance measurements or thermal imaging will indicate this condition unless the line is really heavily loaded.

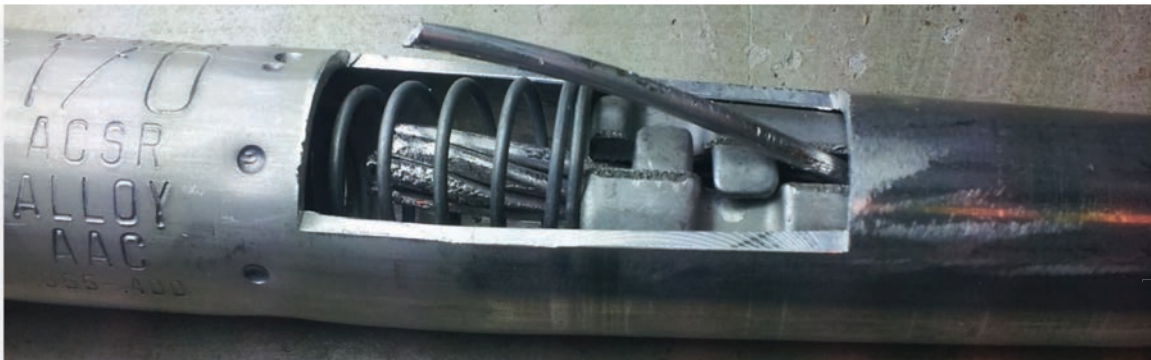
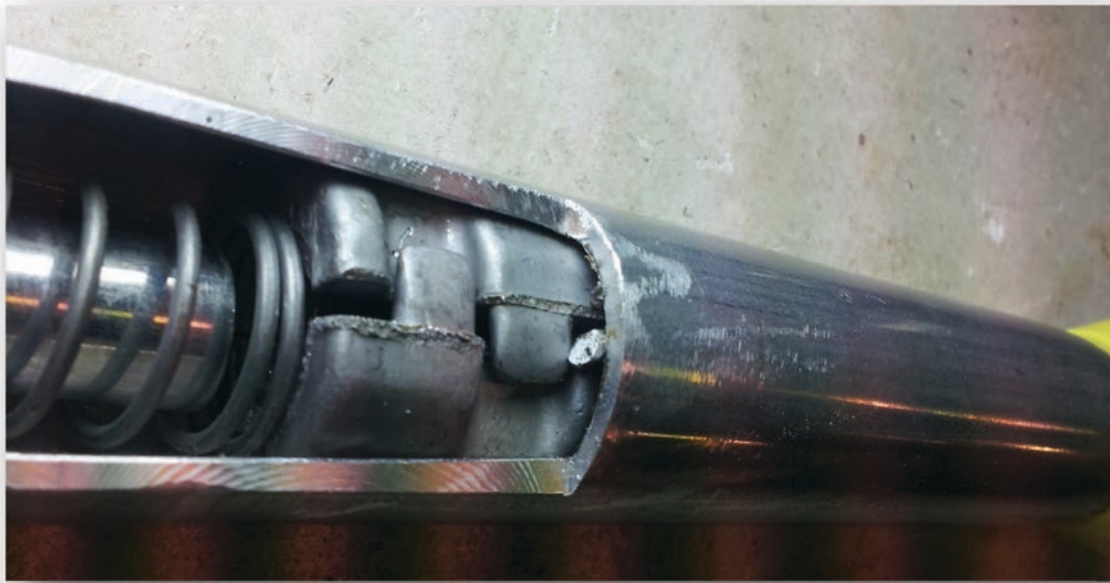
(b) Errant Strand – Partial Insertion Error

A second type of insertion error occurs from time to time, when upon inserting the conductor, the lineman pulls it back a bit (possibly to get a better grip because it was obvious that the conductor did not go in far enough – such as the condition in the previous photo – BUT when that occurs, the pilot cup does not come back, as it is held in the jaws. The purpose of the pilot cup is to keep the ends of the strands together, and assure that they all pass completely through the jaws. In the scenario where the conductor is retracted as much as  $\frac{1}{2}$  inch, the strands can escape from the pilot cup, and one may erroneously slip through the side between the jaws. In this instance, although the conductor may be fully inserted, the errant strand between the jaws prevents them from closing completely, and because it is not within the bundle, the overall diameter is reduced and again, the conductor can slip from the grasp of the jaws.

The following two photos illustrate the above described scenario. More typically, the strand will only be between the jaws, but the result is the same.

The critical concern is that neither of these situations are visible or otherwise readily detectable, and while the splice may hold the line under the stringing tension of a few hundred pounds, additional tension or other disturbance during work on the line may be enough to allow it to slip.

- ***Partial Insertion Errors – Errant Strand***

The only means of detecting this condition during inspection is with X-Ray, and more particularly, only if the orientation of the splice/jaws and the camera is at an acceptable angle to “see” the condition. Also, this too is highly unlikely that this condition could be detected by resistance measurements or thermal imaging.

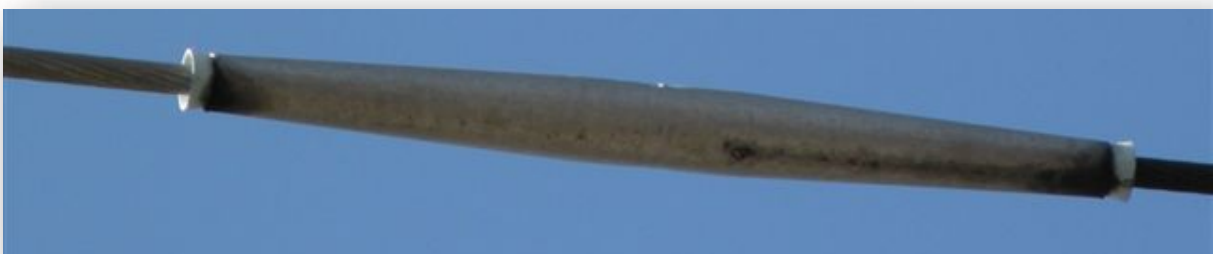
Placing a ClampStar on the line in a gentle fashion allows both the electrical and mechanical safety to be applied at the same time, and is faster and safer to install. If the splice appears bad, i.e., has burnt funnel guides or has evidence of obvious expulsion of contaminants (looks like black grease) running out of it, perhaps it would be wise to simply leave the ClampStar in place!

However, if there is sufficient confidence in the integrity of the splice, the ClampStar can be removed, and used again.

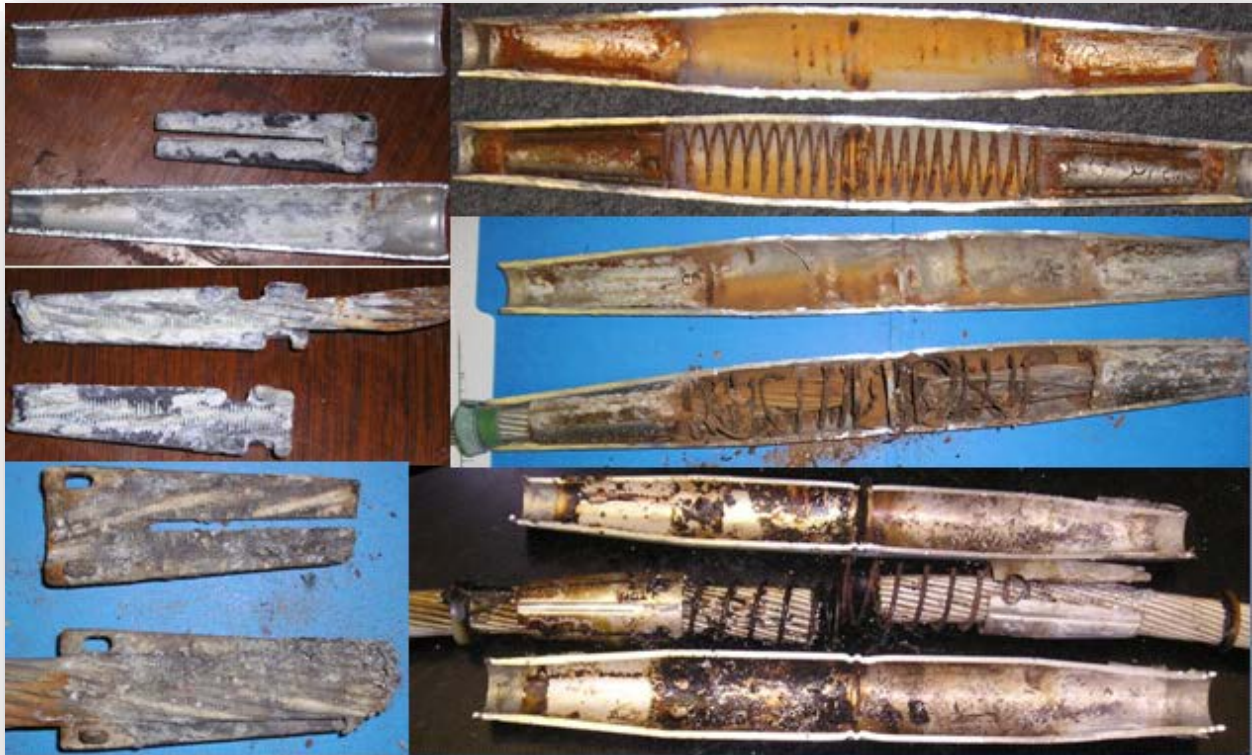
ALL connectors used on aluminum conductor should have a high quality inhibitor used in the electrical interface. Those that don't will result in a premature failure. Automatics are no exception. While the installer has no options on the interfaces between the jaws and the body, the conductor, should be cleaned and prepared properly, which includes wire brushing and applying inhibitor. Manufacturers have long touted the effectiveness of their "wax" inhibitors. The actual purpose of the wax is a lubricant, and because it does coat the surface, is better than nothing. But, if it is so good, why are manufacturers now coming out with "Corrosion Proof" or "Corrosion Resistant" automatics? I assure you they are not doing it to save money! They are doing it because of the large number of automatics "letting go" and finding, post mortem, that they are severely corroded inside.

Again, we must stress, that the installers of the automatics over the past 40 years, who have installed something on the order of 300 Million automatic splices, could have had no effect on the electrical interface between the jaws and the shell. One of the weak points of the automatic is that it has 8 electrical interfaces instead of two like that of the compression splice. The failure point of all connectors is the electrical interface.

An automatic, unless it is located on top of an insulator (which of course it never will be) always has a portion of conductor above it. The airborne contaminants, exhaust, fertilizers, road salt, etc., that settle on that conductor are washed right into the connector when it rains. The water evaporates leaving the contaminants trapped inside! Do you wonder why automatic splices are more prone to corrosion issues than compression? A properly made compression splice is filled with inhibitor – and therefore prevents the ingress of water.

By its very name, "inhibitor" is critical to the prevention of corrosion in ANY connector, but especially in aluminum automatic splices with aluminum conductor!

- ***Lack of Inhibitor***

If corrosive conditions are well established, and the line is heavily loaded electrically, this condition may possibly be detected with IR or resistance measurements, but actual field practice has shown mixed results with both false positives and false negatives.

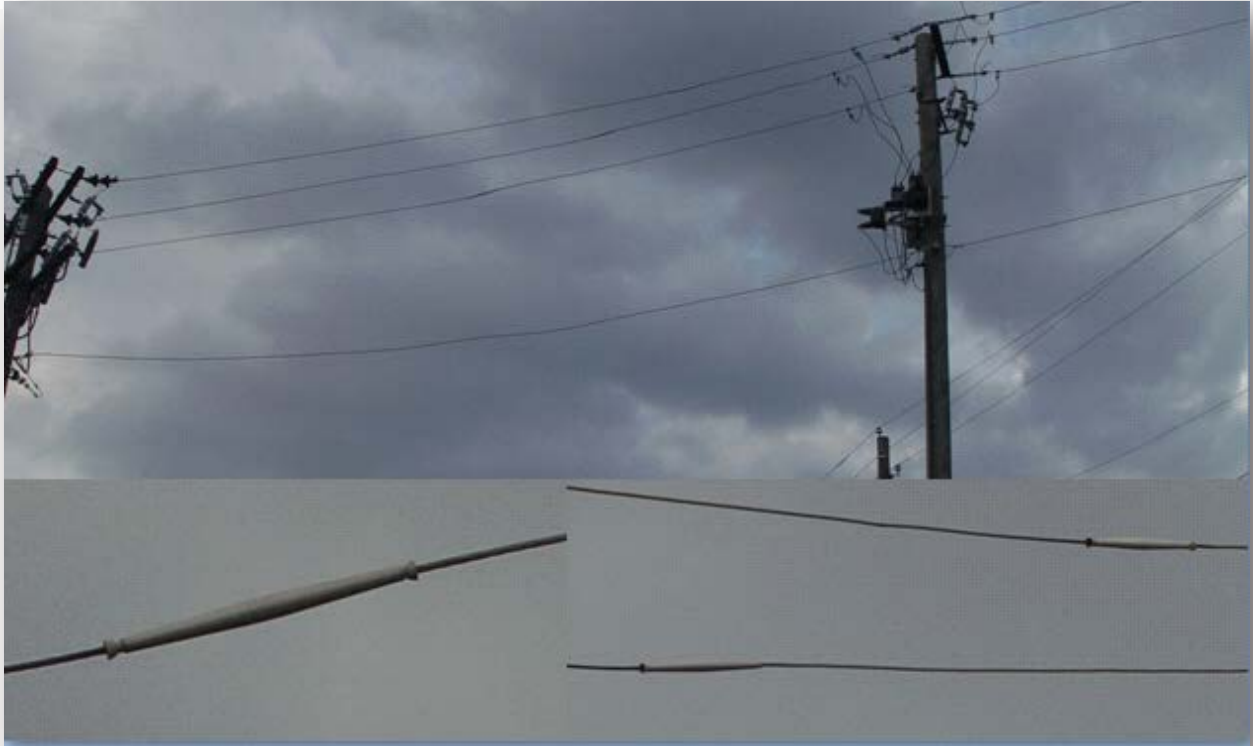
One does not need much imagination to recognize that the force to create the electrical interface with the tapered jaws of an automatic is derived from the tension of the suspended conductor. Manufacturers warn not to use automatics in slack spans, but driving around most any town, one will see many installations where there is not even enough tension in the span to pull the conductor straight.

These are definitely “installation errors” or more appropriately “application errors” where the wrong device, in these examples an automatic splice, should never have been installed.

And, it is obvious if an automatic is installed in a slack span, that’s a no-brainer.

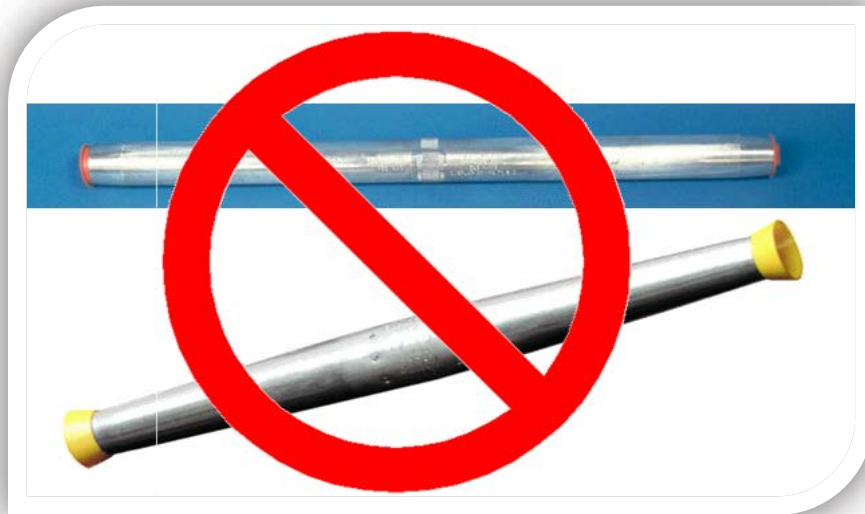
ANSI C119.4 Class A rating is for connectors intended for use on new, un-weathered conductor, operating at temperatures below 93°C! This applies to automatics especially, because their tension capacity is derived from a tempered aluminum barrel which, when subjected to temperatures above 93°C will begin to anneal, resulting in as much as a 70% loss of strength!

**DO NOT ALLOW THESE TYPES OF ALUMINUM BODIED CONNECTORS TO EXCEED 93°C**

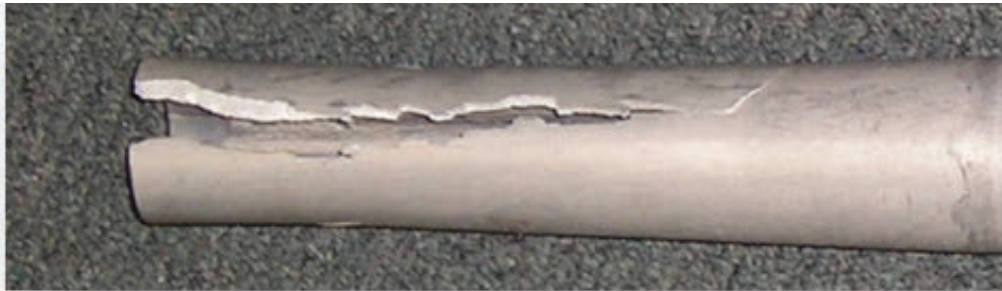
The result of the softening of the connector body may result in the body parting in the center, or splitting along the tapered section.

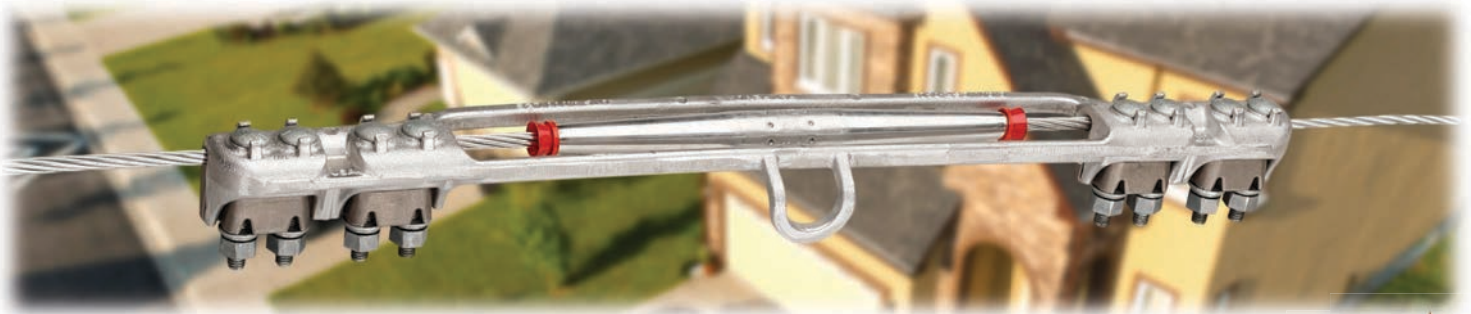
CORRECTING automatic splices or any overhead connectors with ClampStar® is faster, much less expensive, and results in a connection of significantly higher integrity than even that of an original, properly installed connector! The installation can be performed without a power interruption, and the result is a thermally uprated connection, and a visible indication that your utility has taken the steps to protect the general public against the possibility of yet another power line on the ground that occurred as the result of a failed connector.

Have you ever looked up as you were driving, and noting a splice in the conductor passing over the road, wondered if that splice was one of many that, although it is there today, may have been improperly installed, and could “let go” at any moment with no warning? Perhaps one might sleep a little better if they saw a ClampStar covering that splice, knowing that one connector had been “corrected”!
