**INITIAL STATUS REPORT TO THE
PENNSYLVANIA PUBLIC UTILITY COMMISSION**

**NORTH HEIDELBERG SEWER COMPANY
AQUA PENNSYLVANIA WASTEWATER, INC. RECEIVERSHIP**

DOCKET NO. M-2018-2645983

DOCKET NO. I-2018-3001161

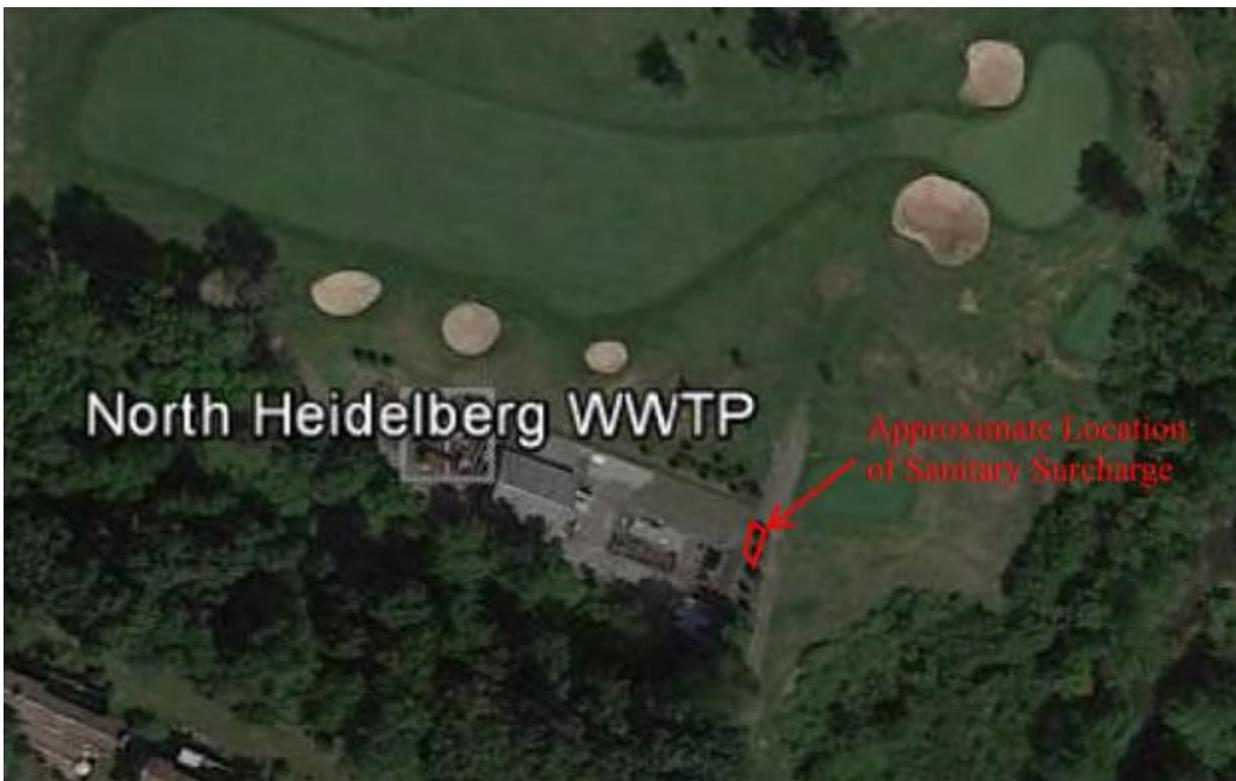
Image 1 SSO Location

The following report documents the suspected sanitary sewer overflow that was discovered on April 11, 2018 following notification by the North Heidelberg Country Club of evidence of sanitary residuals in the vicinity of NHSC's manhole located just outside the NHSC WWTP's east fence line (opposite side of the plant from the driveway entrance).

Image 1 above indicates the approximate location of the manhole suspected of surcharging.

The area around the manhole was cleaned up by EEMA and lime was applied to the affected area. EEMA then contacted a local contractor that day, 4/11/2018, and the sewer mains in the vicinity of the manhole were cleaned with a water jet to clear residuals in the pipe. The next day, 4/12/2018, Liquid Motion was dispatched to remove residuals from the sewer main utilizing a vacuum truck. Having cleared the main and removing the residuals, the main was clear and conveying flow unimpeded.

Aqua will have EEMA monitor this area of sewer main in particular going forward and will perform sewer cleaning as deemed necessary to ensure that no further blockages can occur.

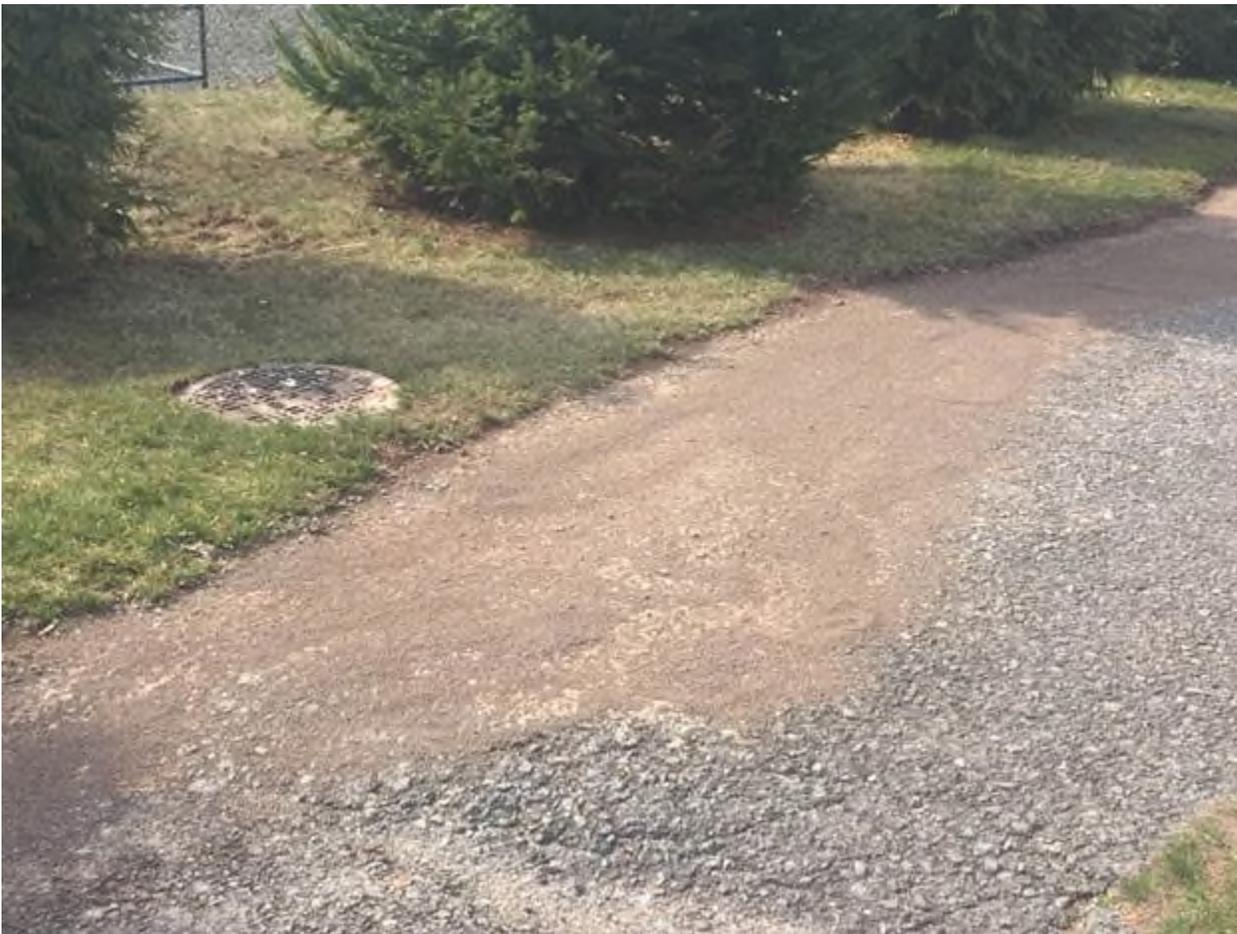
Image 2 below captures the manhole suspected of surcharging and the adjacent golf cart path. The WWTP fence can be seen in the background.

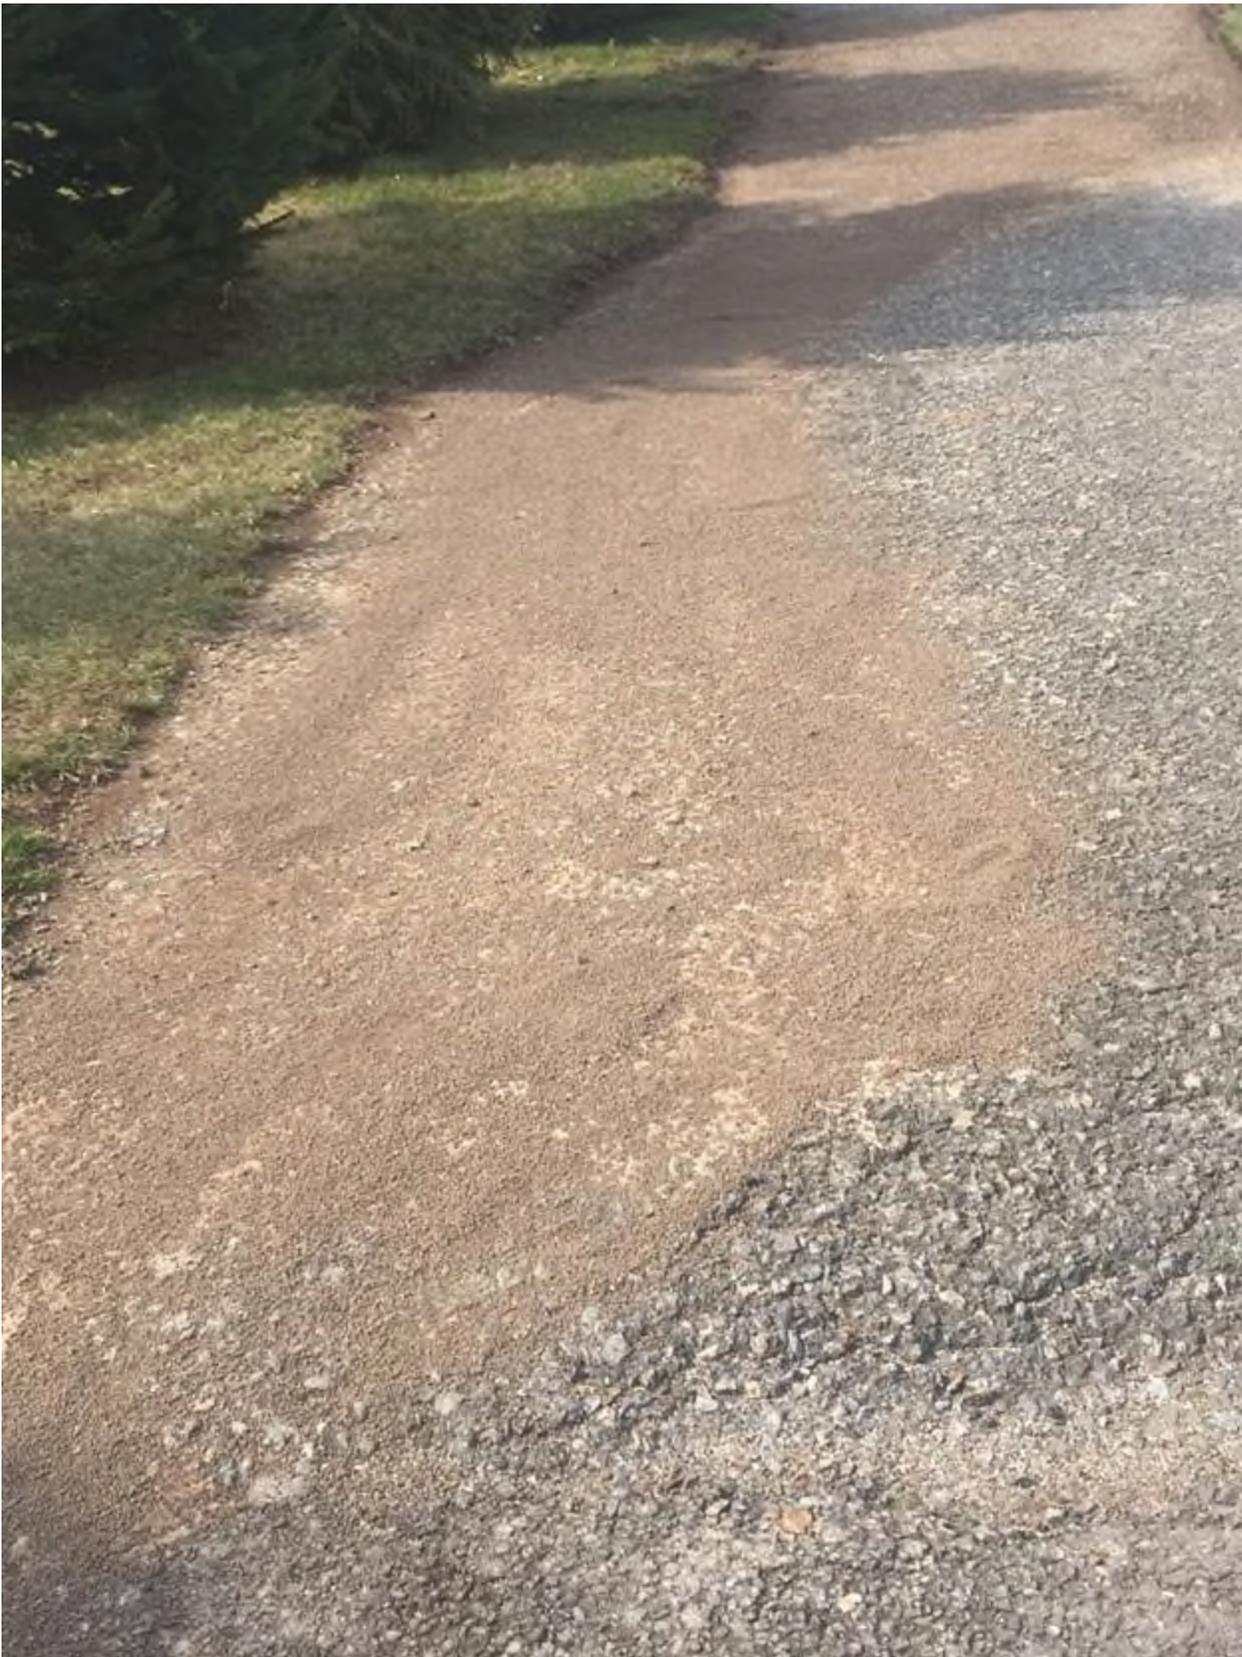
Image 3 below shows the cleaned golf cart path in further detail. The manhole is just out of view of this photograph.

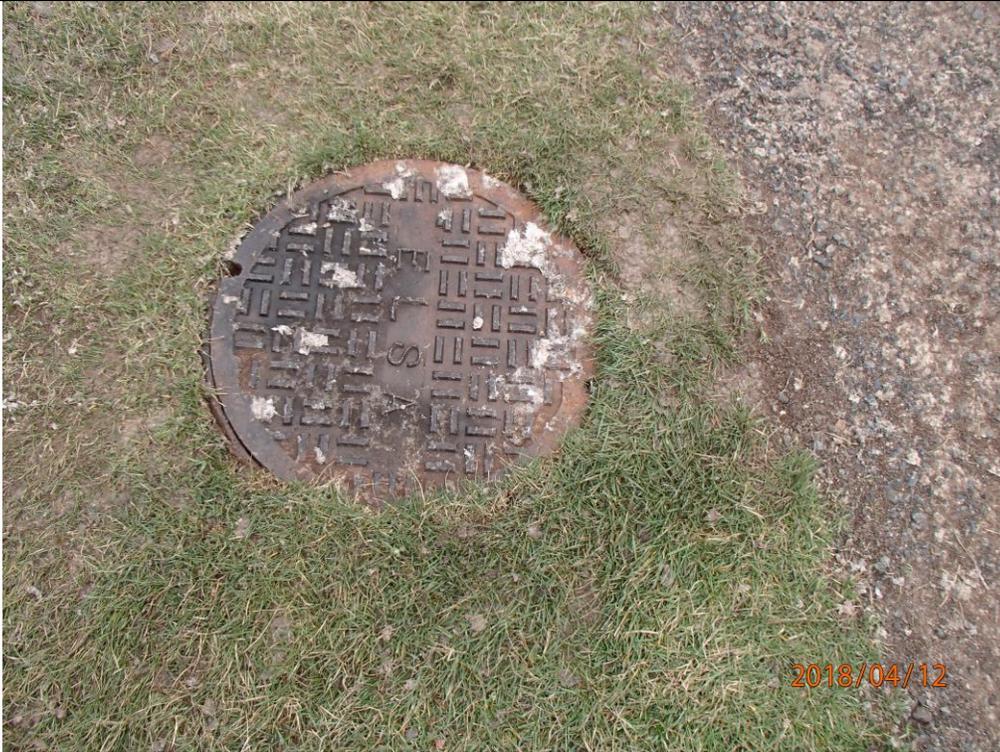
There is debris on the manhole and on the cart path. No apparent discharge to the stream observed. The affected area appears to be limited to within ~15 M of the overflow manhole.

Figure 1- photo taken by Kevin Buss, shows overflow manhole.

I spoke to Mr. Grassley over the phone at 11:46 and recommended removing debris and applying lime to the affect area.

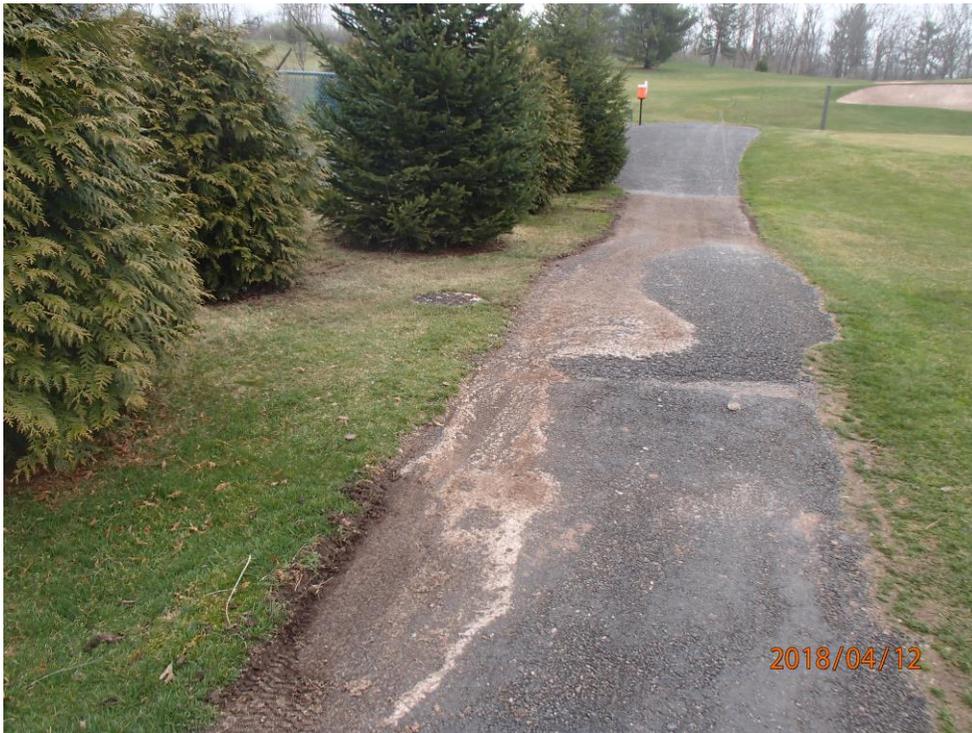
Figure 2- photo taken by Kevin Buss, shows area of sewer overflow
