COMMONWEALTH OF PENNSYLVANIA  
PENNSYLVANIA PUBLIC UTILITY COMMISSION  
P. O. BOX 3265, HARRISBURG, Pa. 17120  
February 10, 1986

Pennsylvania Department of Transportation  
v.  
Consolidated Rail Corporation, Snyder Township, Blair County,  
and The Bell Telephone Company of Pennsylvania

CONDITION SURVEY REPORT  
FOR  
L.R. 55 (S.R. 4027), Station 931+54  
SNYDER TOWNSHIP, BLAIR COUNTY  
PUG. C. 844440

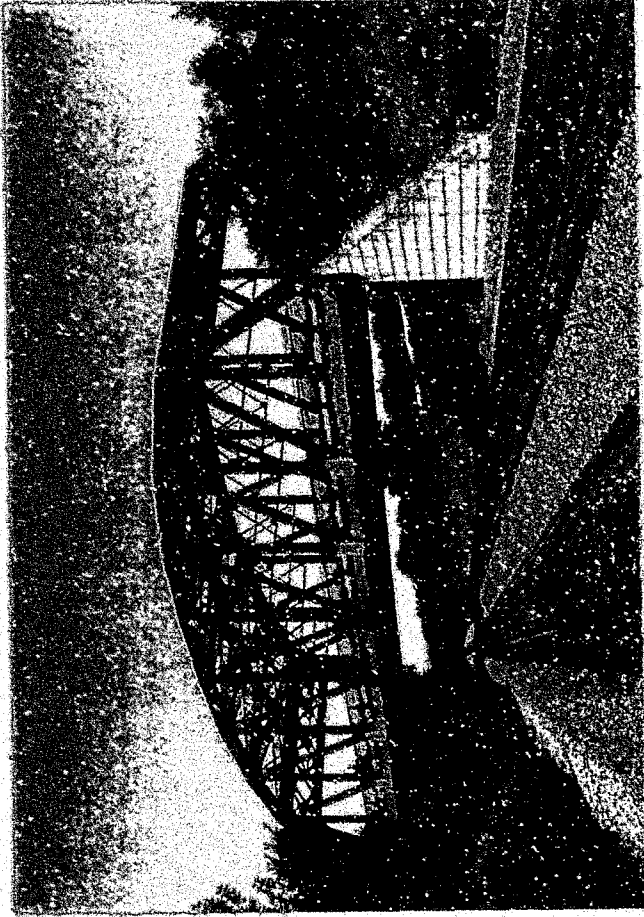
Photo 4  
View of Deck,  
North End

The bridge traffic wearing surface is in generally good condition. (Photos 4,5 and 6) However, there are transverse pavement cracks at the north and south ends of the bridge at the deck joints. (Photo 7)

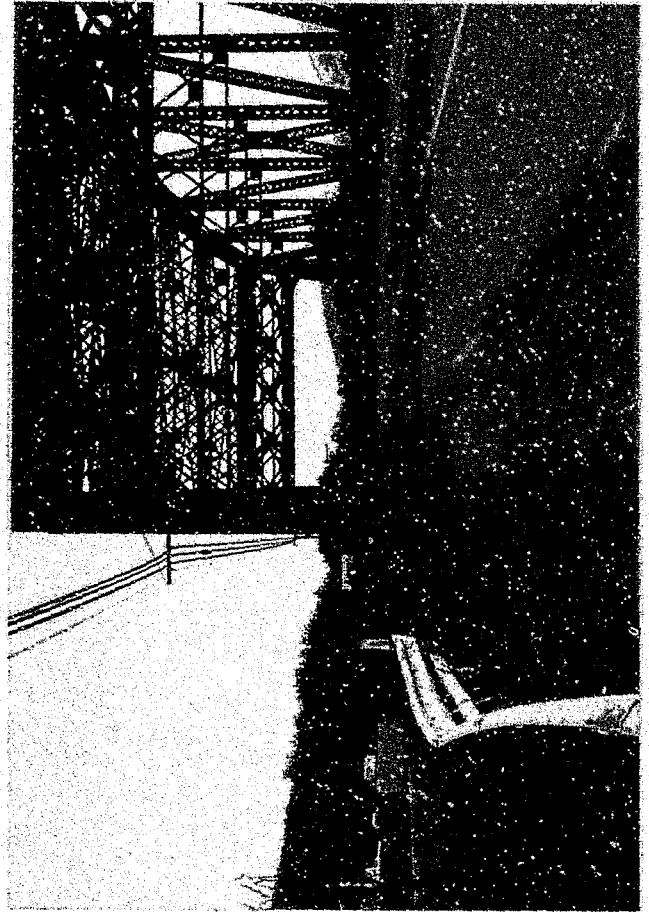
Photo 8  
Sidewalk, Looking North

The sidewalk and curbs are in poor condition. The curbs are spalled and broken away to almost the level of the traffic wearing surface. The sidewalk surface is severely scaled and large spalls exist where the railing is anchored. For sidewalk location see Photo 8.

- (b) The curbs and sidewalk are in poor condition as presented in Article 3, "Visual Inspection". We recommend that new curbs and sidewalk be constructed.

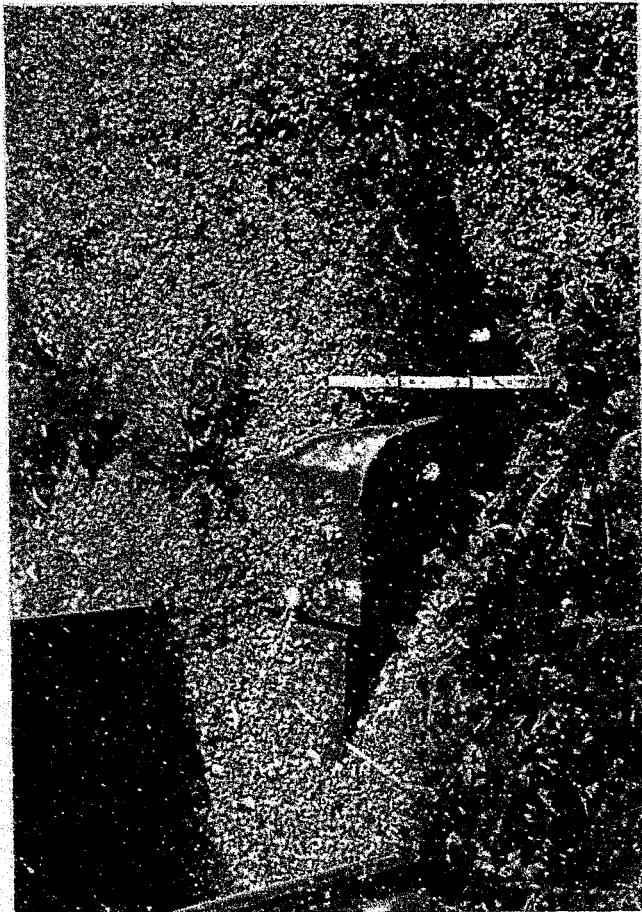
Photo 10  
Deck Deterioration,  
Southwest Corner

- Southwest corner of the bridge (Photo 9).
- Along west curb near south end of the bridge (Photo 10).
- Along west curb near north end of the bridge (Photo 11).
- Northwest corner of the bridge at the start of the sidewalk (Photo 12).
- Along east edge of the bridge near north end (Photo 13).
