**Re: Letter Of Notification Of PECO Energy Company, Filed Pursuant To 52 Pa. Code Chapter 57 Subchapter G, For Approval To Site And Construct 0.5 Miles Of Transmission Lines In Lower Chanceford Township, York County, Pennsylvania To Interconnect To The Transmission Grid The New 500-230 kV Furnace Run Substation Proposed By Transource Pennsylvania, LLC
Docket No. A-2020**

LETTER OF NOTIFICATION

**PECO ENERGY COMPANY,
FURNACE RUN INTERCONNECTION 500KV TRANSMISSION LINE PROJECT
WATERS OF THE US DELINEATION REPORT**

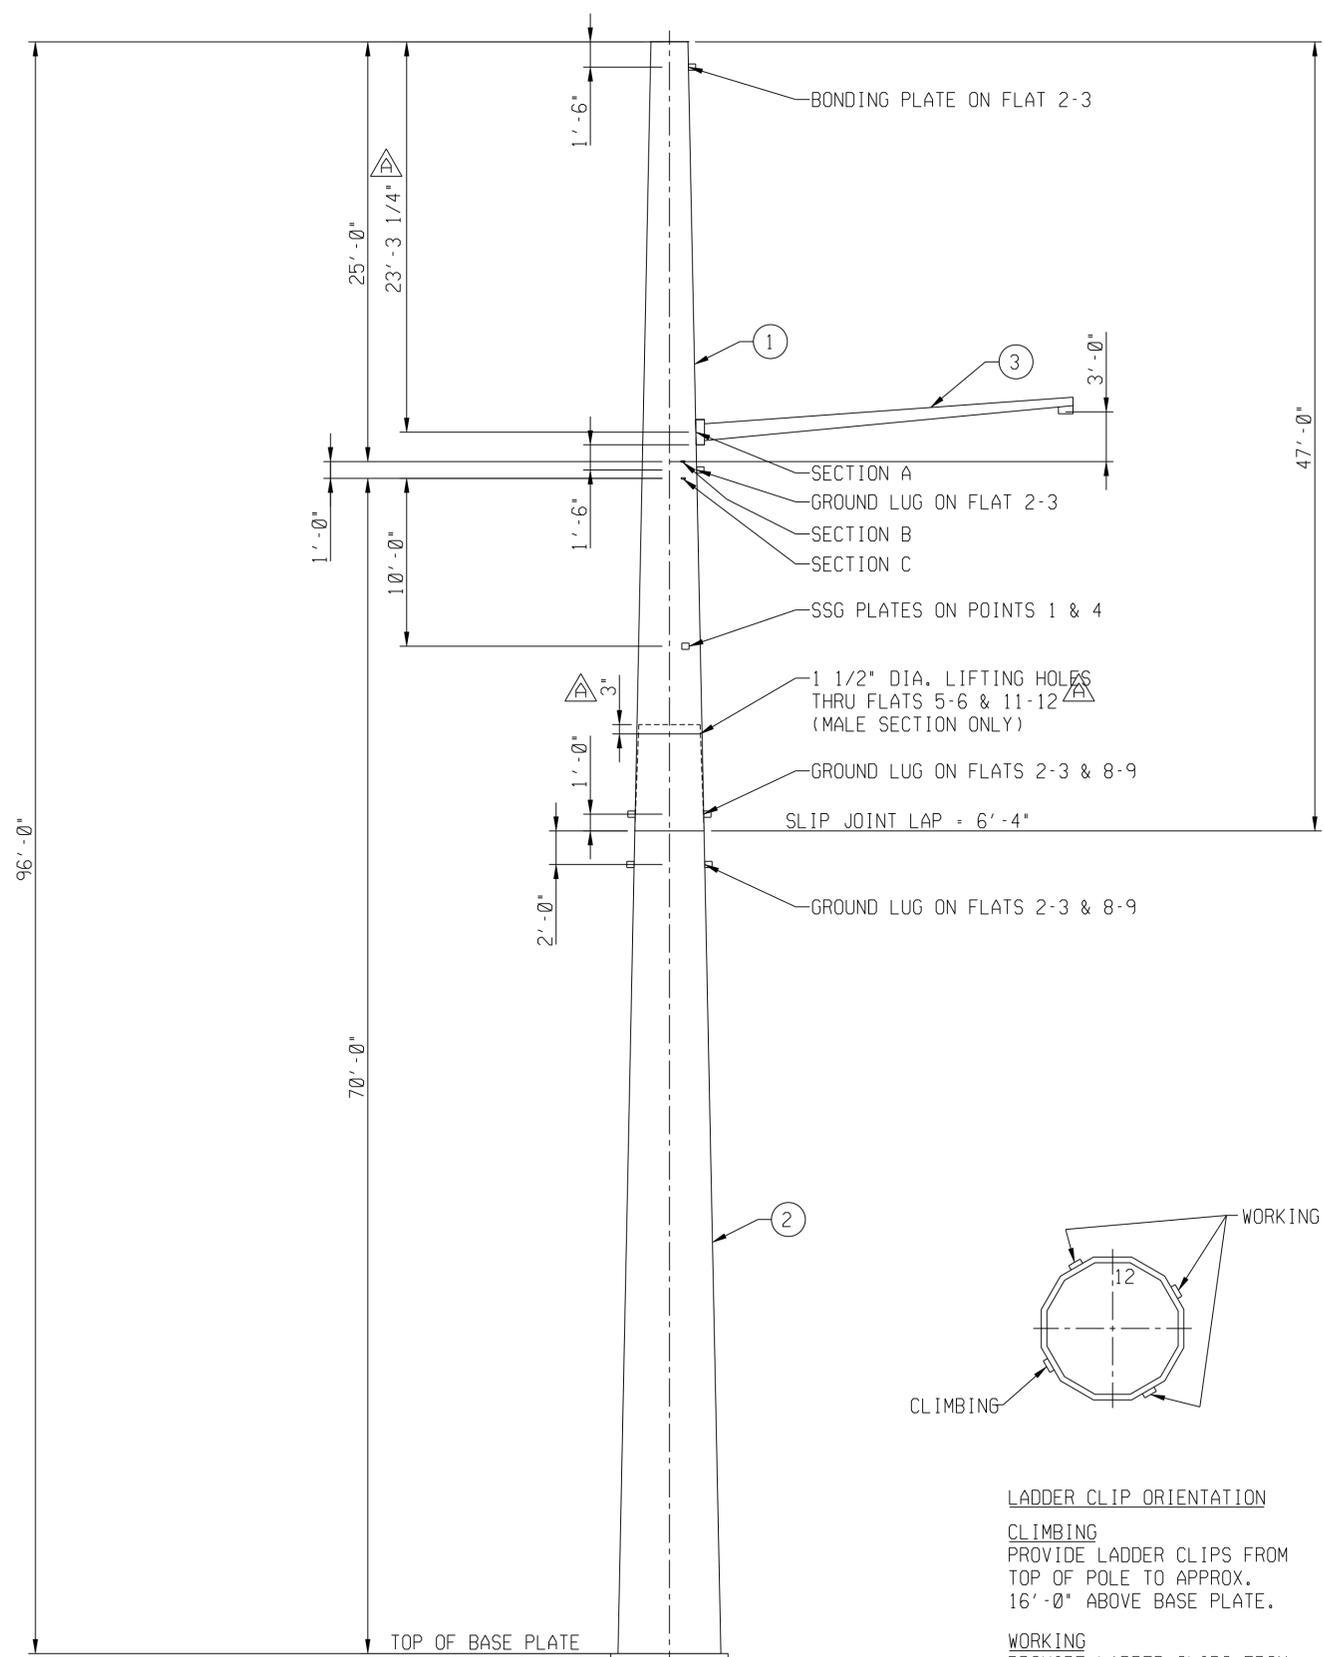
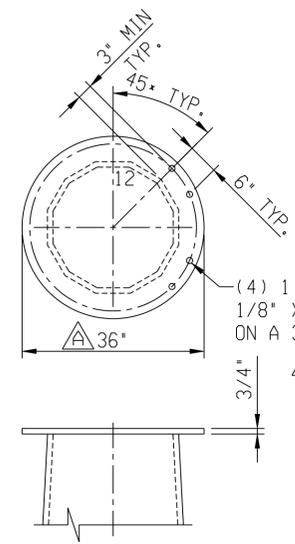
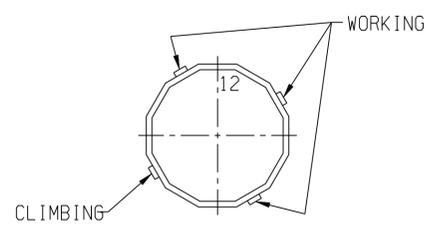
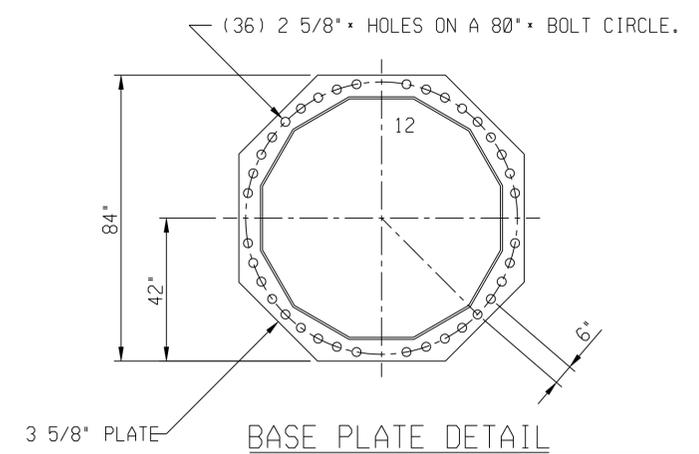
ATTACHMENT 3

MAJOR COMPONENT INFORMATION				
ITEM	MARK	QTY.	DESCRIPTION	WT. EACH
1	3004	1	SHAFT ASSEMBLY, 47'-0" LONG	8,500
2	3005	1	SHAFT ASSEMBLY, 55'-4" LONG	27,200
3	A D	1	ARM ASSEMBLY	650
TOTAL WEIGHT				36,350

STRUCTURE INFORMATION	
BILLABLE	REV73AAT
POLE NO.	7-3A, 7-4C
HGT. ABOVE GRND. LINE	96'-0"
TOP DIA.	26 7/16"
GRND. LINE DIA.	73 25/32"
TAPER	0.50000 IN./FT.

SHAFT INFORMATION	
ITEM 1, SHAFT ASSEMBLY	
TUBE SECTION 1:	
LENGTH @ THICKNESS	27'-0" @ 11/32"
TOP DIA / BOTTOM DIA	26 7/16" / 39 15/16"
TUBE SECTION 2:	
LENGTH @ THICKNESS	20'-0" @ 15/32"
TOP DIA / BOTTOM DIA	40 7/32" / 50 7/32"
ITEM 2, SHAFT ASSEMBLY	
TUBE SECTION 3:	
LENGTH @ THICKNESS	20'-0" @ 9/16"
TOP DIA / BOTTOM DIA	45 31/32" / 55 31/32"
TUBE SECTION 4:	
LENGTH @ THICKNESS	20'-0" @ 5/8"
TOP DIA / BOTTOM DIA	56 1/8" / 66 1/8"
TUBE SECTION 5:	
LENGTH @ THICKNESS	15'-4" @ 5/8"
TOP DIA / BOTTOM DIA	66 1/8" / 73 25/32"
ITEM 3, ARM ASSEMBLY	
LENGTH @ THICKNESS	22'-3" @ 7/32"
SMALL DIA / LARGE DIA	6" / 12"

CAP PLATE DETAIL

LADDER CLIP ORIENTATION
CLIMBING
 PROVIDE LADDER CLIPS FROM TOP OF POLE TO APPROX. 16'-0" ABOVE BASE PLATE.
WORKING
 PROVIDE LADDER CLIPS FROM TOP OF POLE TO APPROX. 10'-0" BELOW TOP OF POLE AND FROM APPROX. 20'-0" BELOW TOP OF POLE TO 35'-0" BELOW TOP OF POLE.

BASE PLATE DETAIL

18. The new 500 kV transmission lines will consist of two tubular steel H-frame dead end structures with a height of approximately 90 feet, two 3-pole dead end structures, high capacity conductors, and two overhead ground wires. The new dead end structures are expected to range between 80 and 140 feet and will be installed on concrete caisson foundations. A typical H-frame and dead end structure are shown in Attachment 3.

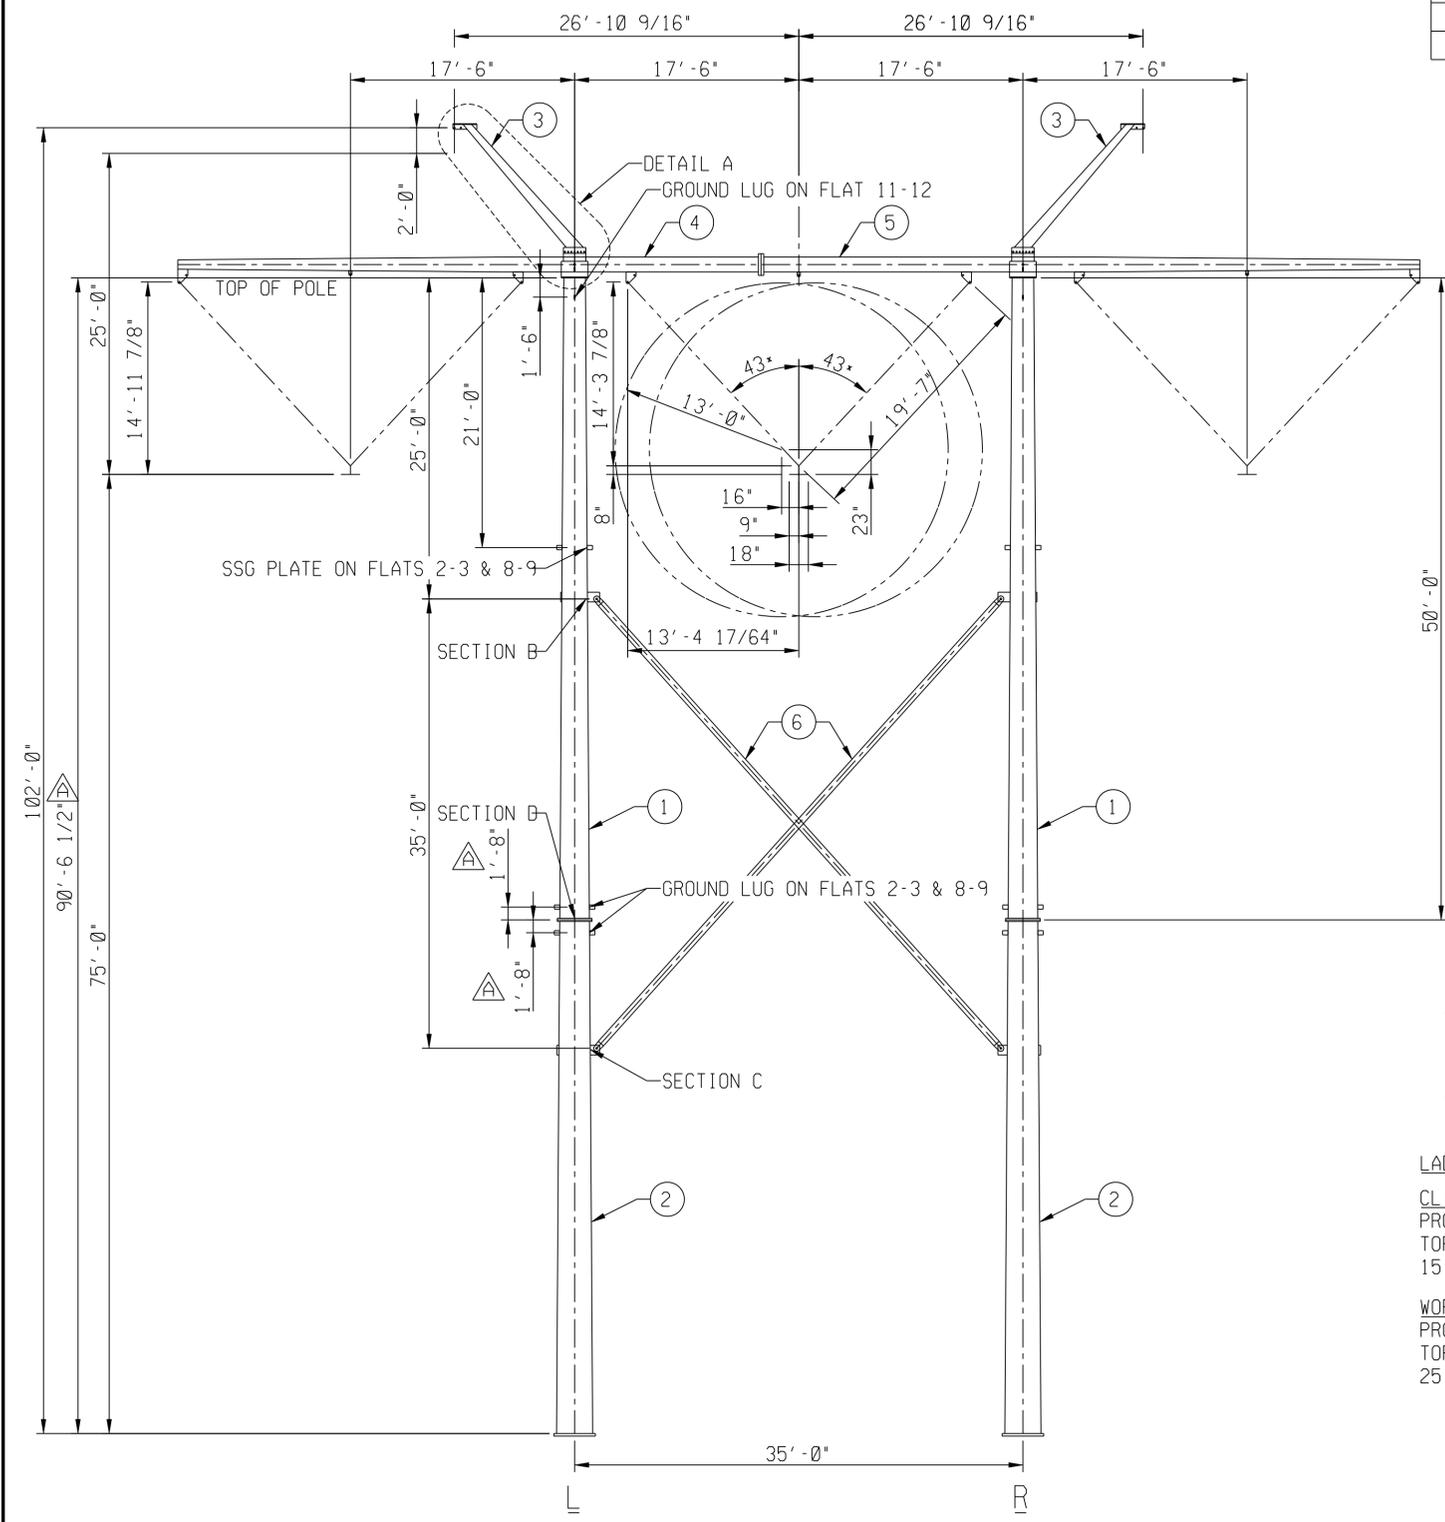
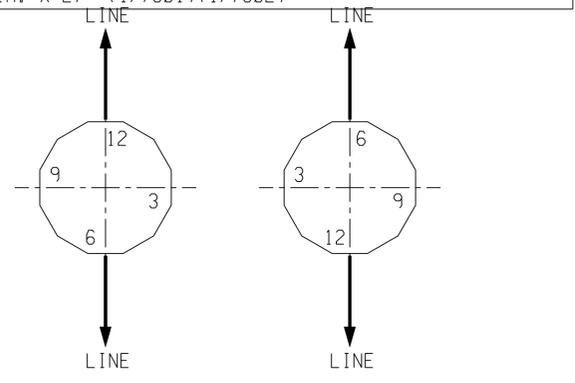
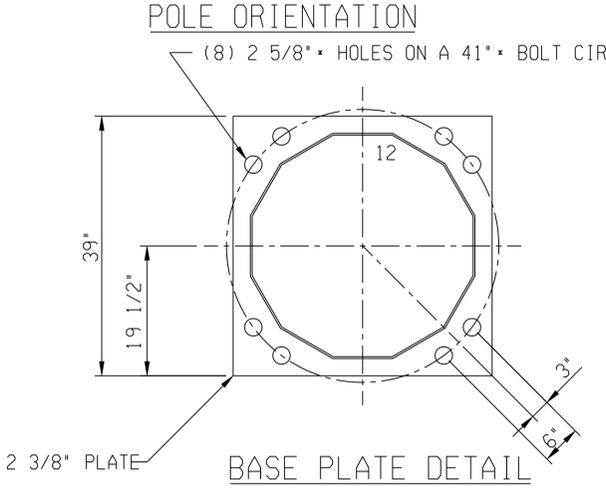
ITEM 6, CROSSBRACING ASSEMBLY	
LENGTH @ THICKNESS	46'-1 1/2" @ 3/16"
SMALL DIA / LARGE DIA	7" / 7"

FASTENER INFORMATION		
MARK	QTY.	DESCRIPTION
70678	4	NUT, 1 1/2" DIA.
70860	26	STEPBOLT, 3/4" DIA. X 6 3/4"
72938	2	NUT, 1 3/4" DIA.
72940	75	NUT, 1" DIA.
74269	2	FLATWASHER, 1" DIA. (2/74936)
74936	1	BOLT, 1" DIA. X 15", (1/CENTER 3201)
74937	14	BOLT, 1" DIA. X 19, (7/ARM A)
76571	4	BOLT, 1 1/2" DIA. X 4" (2/3201)
78271	40	BOLT, 1" DIA. X 5 1/4" (20/POLE FLANGE CONNECTION)
78274	20	BOLT, 1" DIA. X 6" (20/CROSSARM FLANGE CONNECTION)
74567	2	BOLT, 1 3/4" DIA. X 27" (1/7601)(1/7602)

LADDER CLIP ORIENTATION
CLIMBING
 PROVIDE LADDER CLIPS FROM TOP OF POLE TO APPROX. 15'-0" ABOVE BASE PLATE.
WORKING
 PROVIDE LADDER CLIPS FROM TOP OF POLE TO APPROX. 25'-0" BELOW TOP OF POLE.

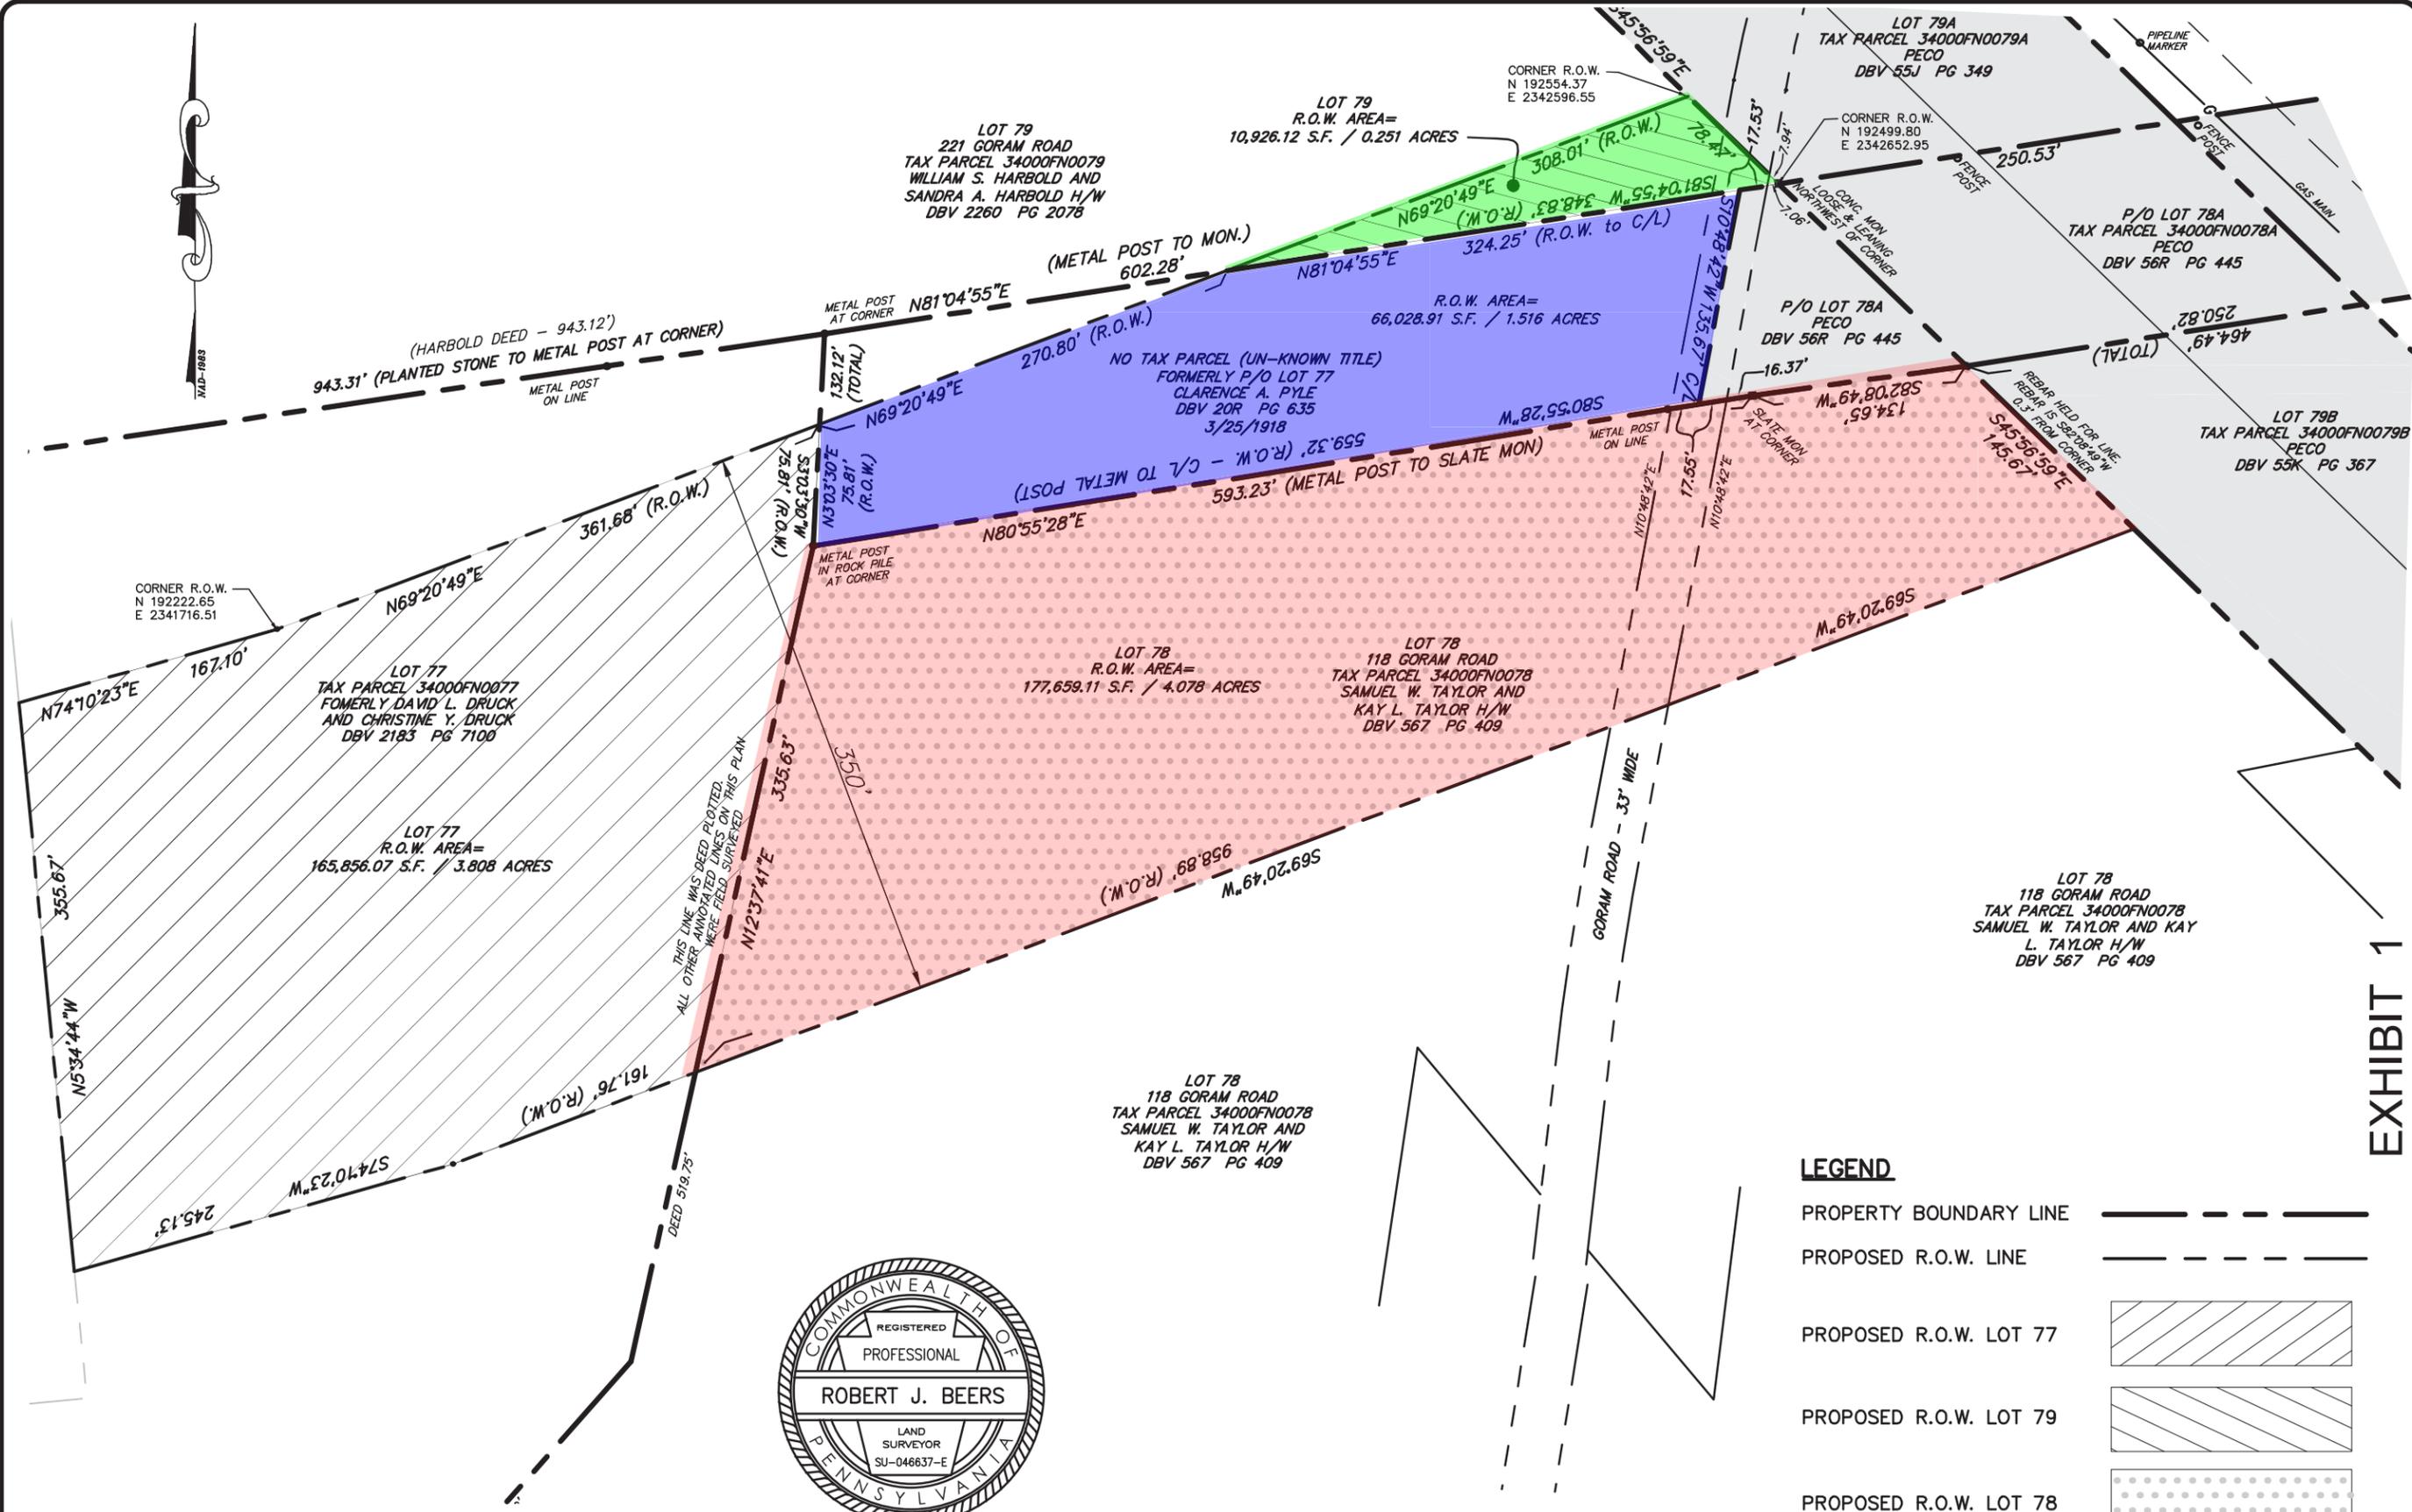
ATTACHMENT 4

CORNER R.O.W.
N 192222.65
E 2341716.51

LOT 78
118 GORAM ROAD
TAX PARCEL 34000FN0078
SAMUEL W. TAYLOR AND
KAY L. TAYLOR H/W
DBV 567 PG 409

⁵ The Pyle Parcel, the Taylor Parcel, and the Harbold Parcel are shown in blue, red and green, respectively, on the map set forth in Attachment 4. The York County Tax Maps purport to show that the Pyle Parcel is part of the Taylor Parcel. However, when PECO’s surveyor plotted the legal description of the Taylor Parcel, he discovered that it does not in fact include the Pyle Parcel. PECO then engaged in a thorough search for the owner of the Pyle Parcel. PECO engaged a York County law firm to do a title abstract of the Pyle Parcel. Ultimately, PECO found no evidence that the Pyle Parcel has been conveyed to anyone since it was acquired by Clarence A. Pyle in 1918. After further extensive research, PECO identified eleven known heirs of Clarence A. Pyle, who inherited the Pyle Parcel. PECO has sent letters to each of these individuals for whom it was able to find an address. The letter offered to pay fair market value to the rightful owners of the Pyle Parcel as their interest may appear. The Company also published a notice in the York Daily Record and the York Legal Record requesting that any person with an interest in the Pyle Parcel contact PECO.

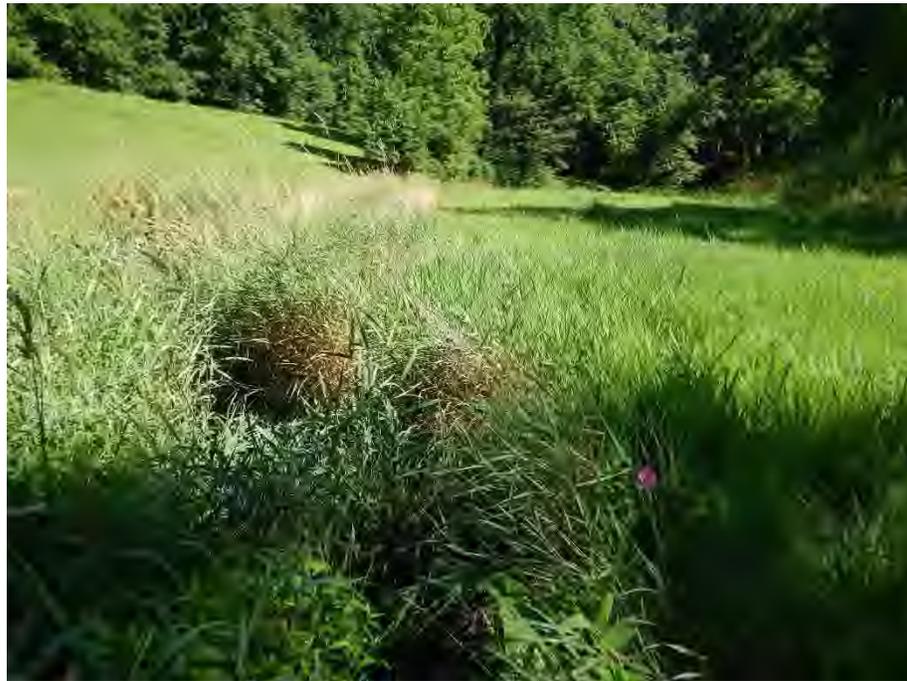
PHOTO 1

View facing north from the edge of the 300-foot buffer of the Project area of Furnace Run and the reed canary dominated meadow.

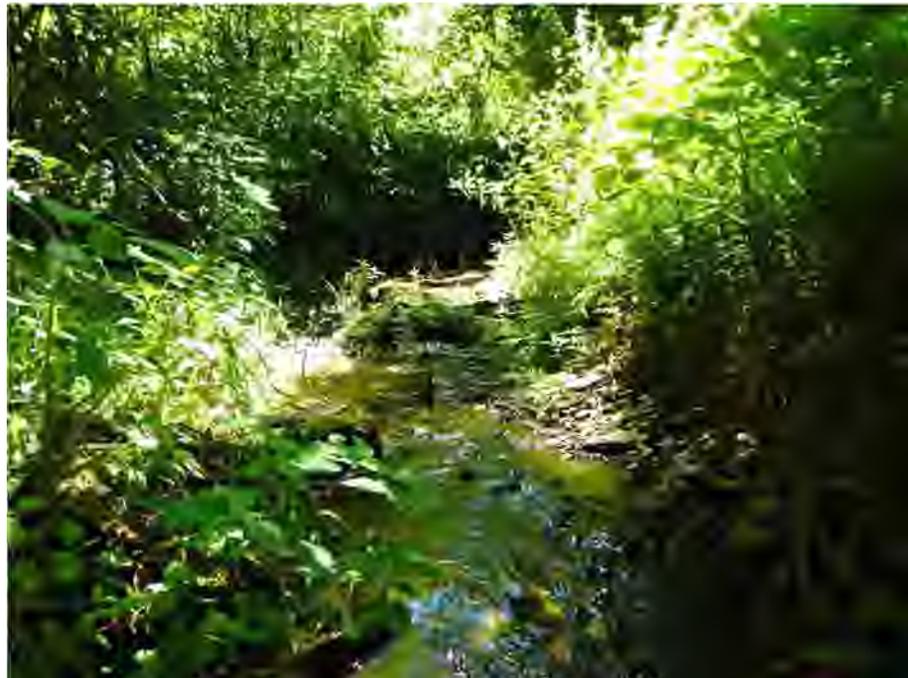
PHOTO 2

View facing north of Furnace Run within the proposed ROW.

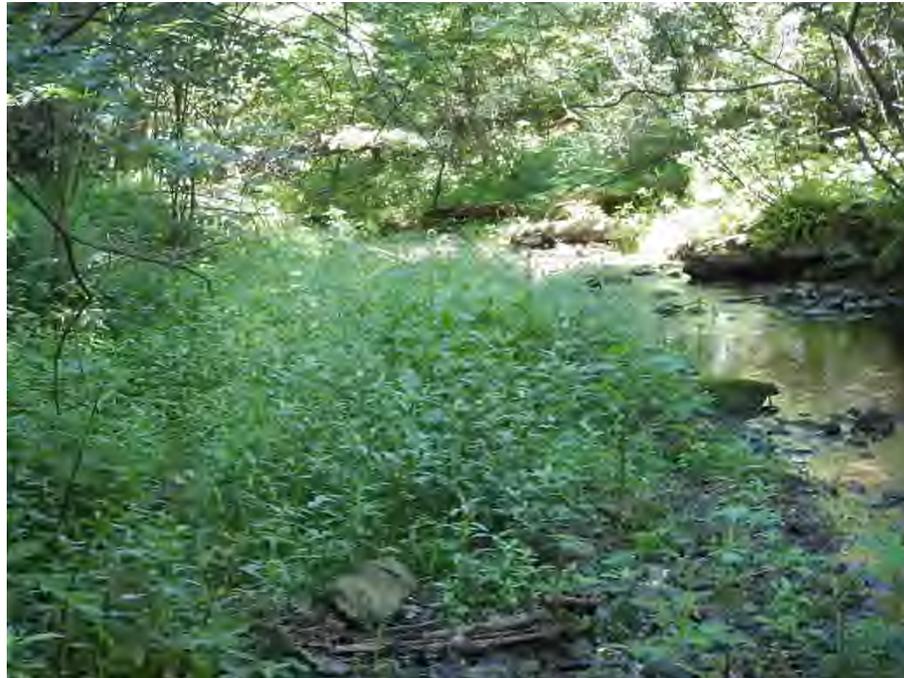
PHOTO 3

View facing north of identified Wetland 3 formed on a sand/gravel bar of Furnace Run. Wetland is dominated with Pennsylvania smartweed (*Polygonum pensylvanicum*).

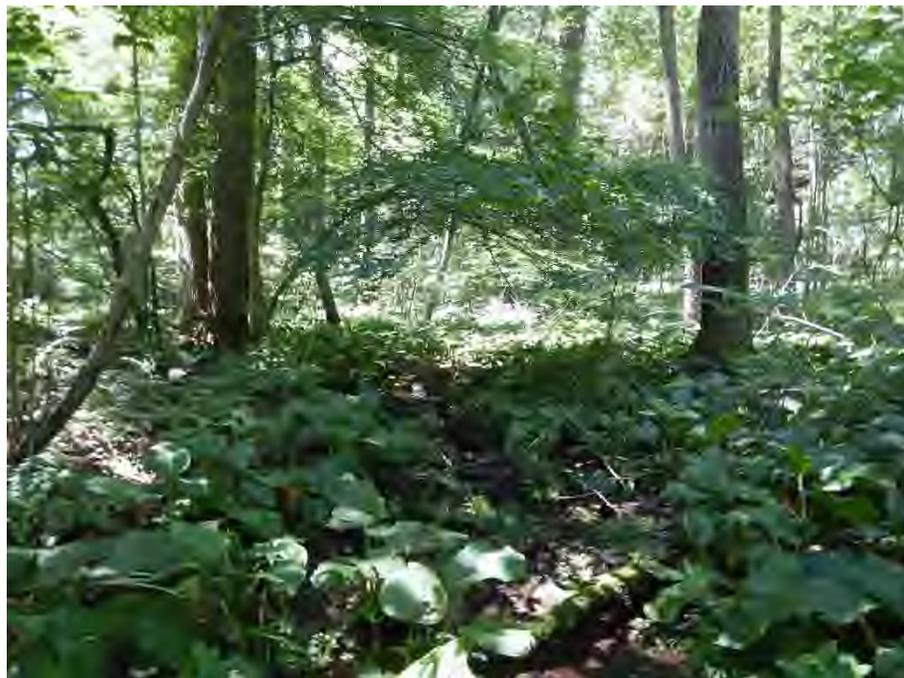
PHOTO 4

View facing west of the identified Wetland 4. Wetland is dominated with skunk cabbage (*Symplocarpus foetidus*), tulip poplar (*Liriodendron tulipifera*, FACU), and northern spicebush (*Lindera benzoin*, FAC).

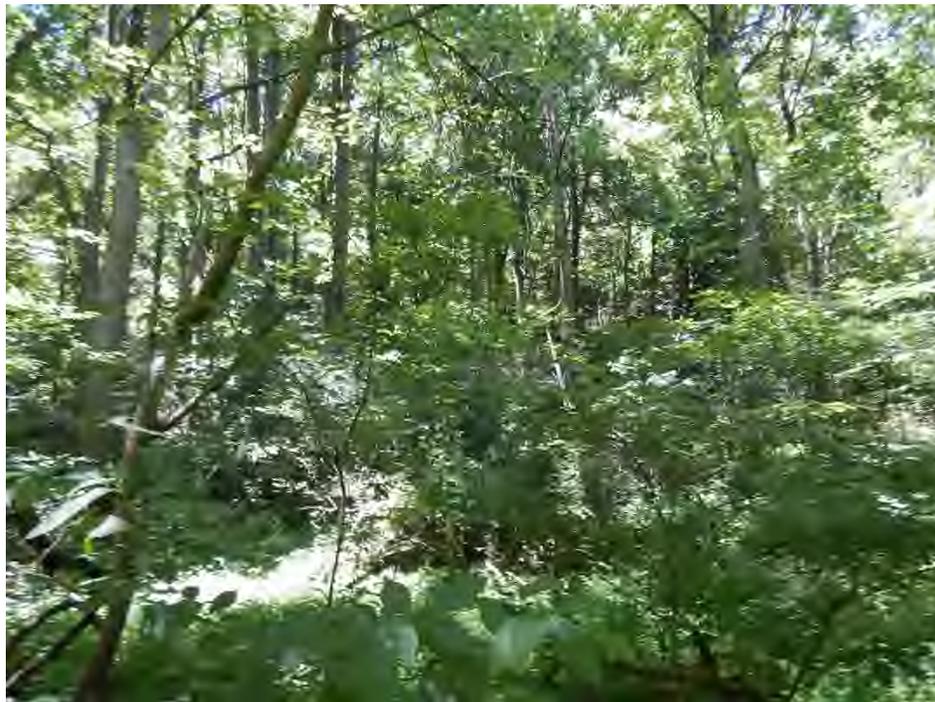
PHOTO 5

View facing west of the upland forest. Upland forest is dominated with tulip poplar (*Liriodendron tulipifera*), spicebush (*Lindera benzoin*) and witchhazel (*Hamamelis virginiana*).

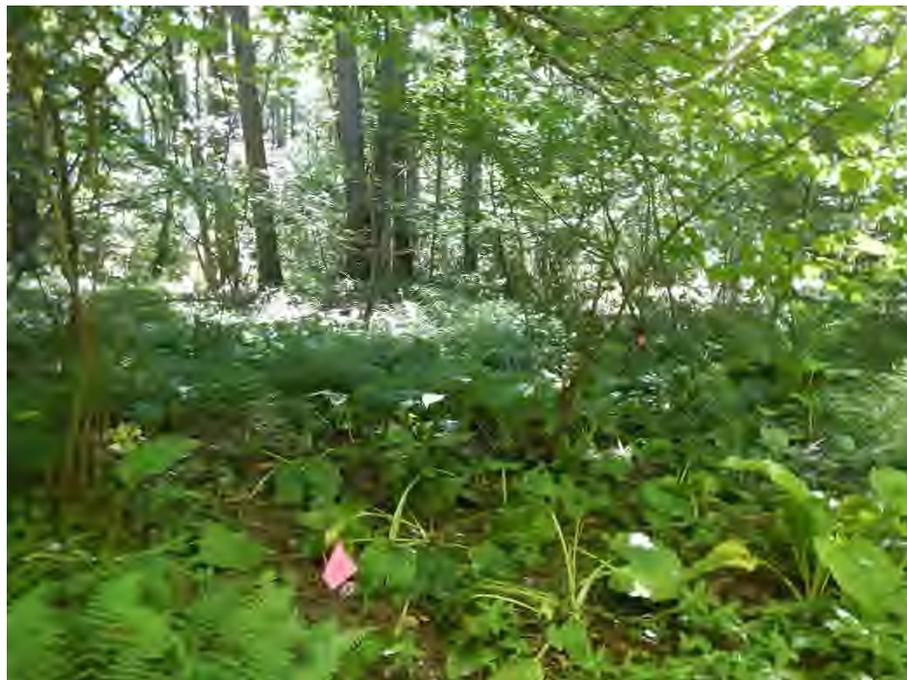
PHOTO 8

View facing of south of identified Wetland 7. Wetland is dominated with skunk cabbage (*Symplocarpus foetidus*), tulip poplar (*Liriodendron tulipifera*, FACU), and northern spicebush (*Lindera benzoin*, FAC).

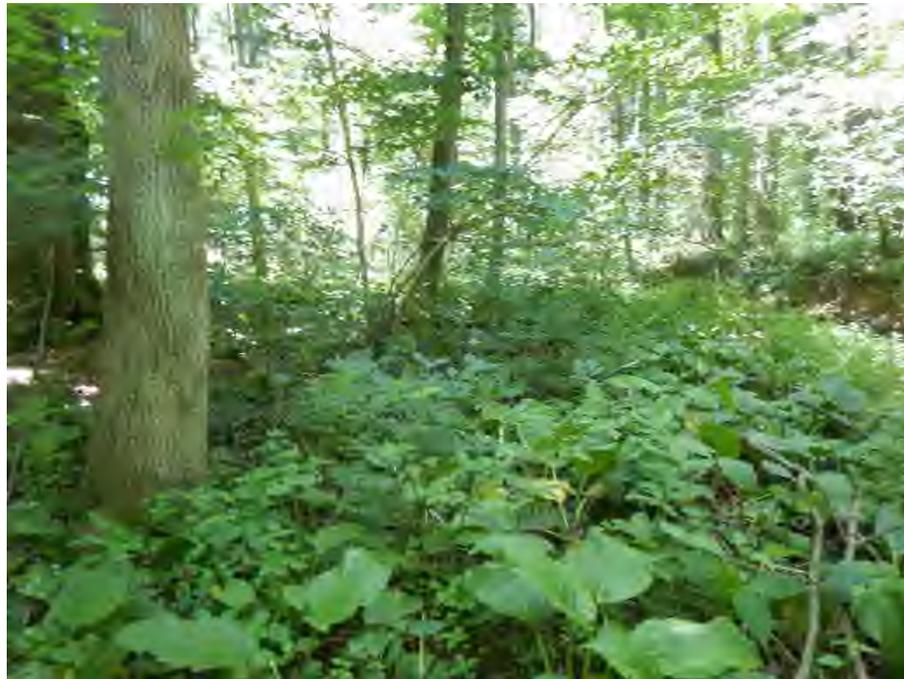
PHOTO 9

View facing north of Wetland 6. Wetland is dominated with skunk cabbage (*Symplocarpus foetidus*), tulip poplar (*Liriodendron tulipifera*, FACU), and northern spicebush (*Lindera benzoin*, FAC).

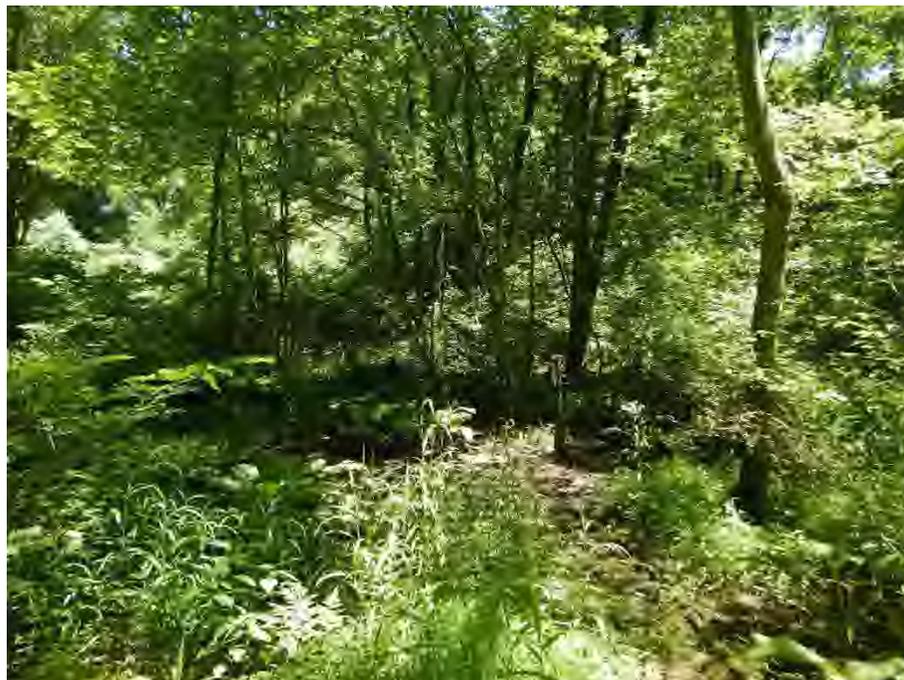
PHOTO 10

View facing east of saturated bare ground within Wetland 6.

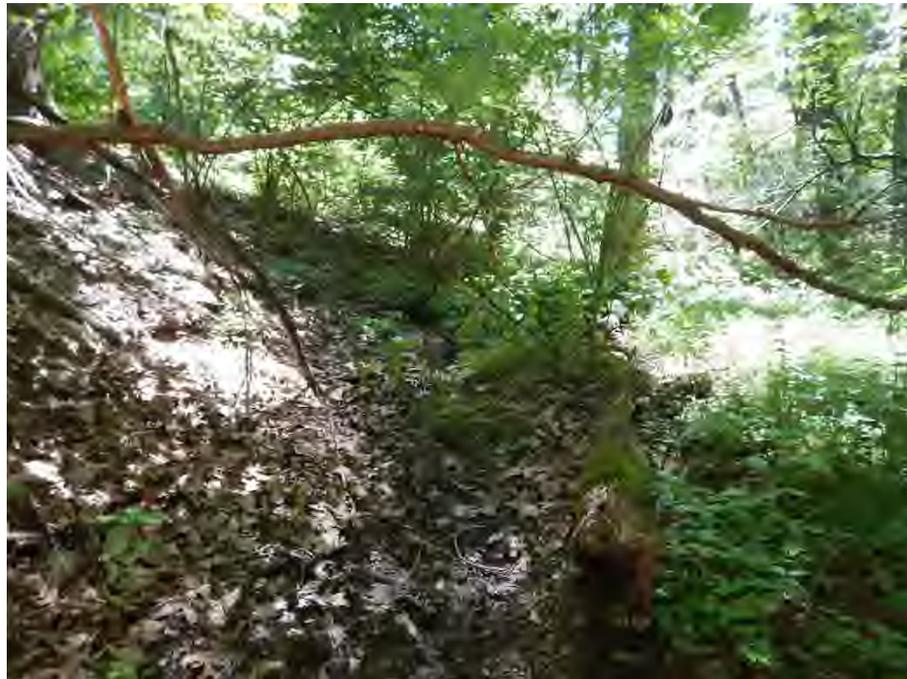
PHOTO 11

View facing south of Wetland 8. Wetland is at base from Goram Road and Furnace Run.

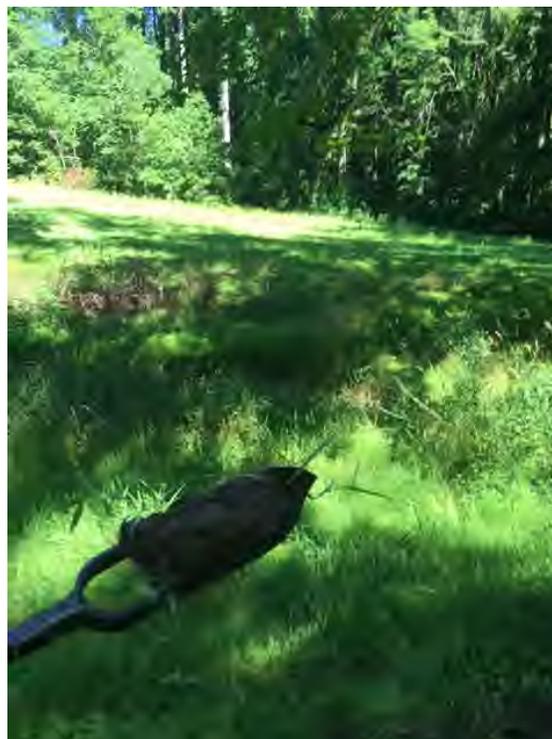
Photo 2: Representative view of the mineral, non-mucky soils in the palustrine emergent wetlands.
