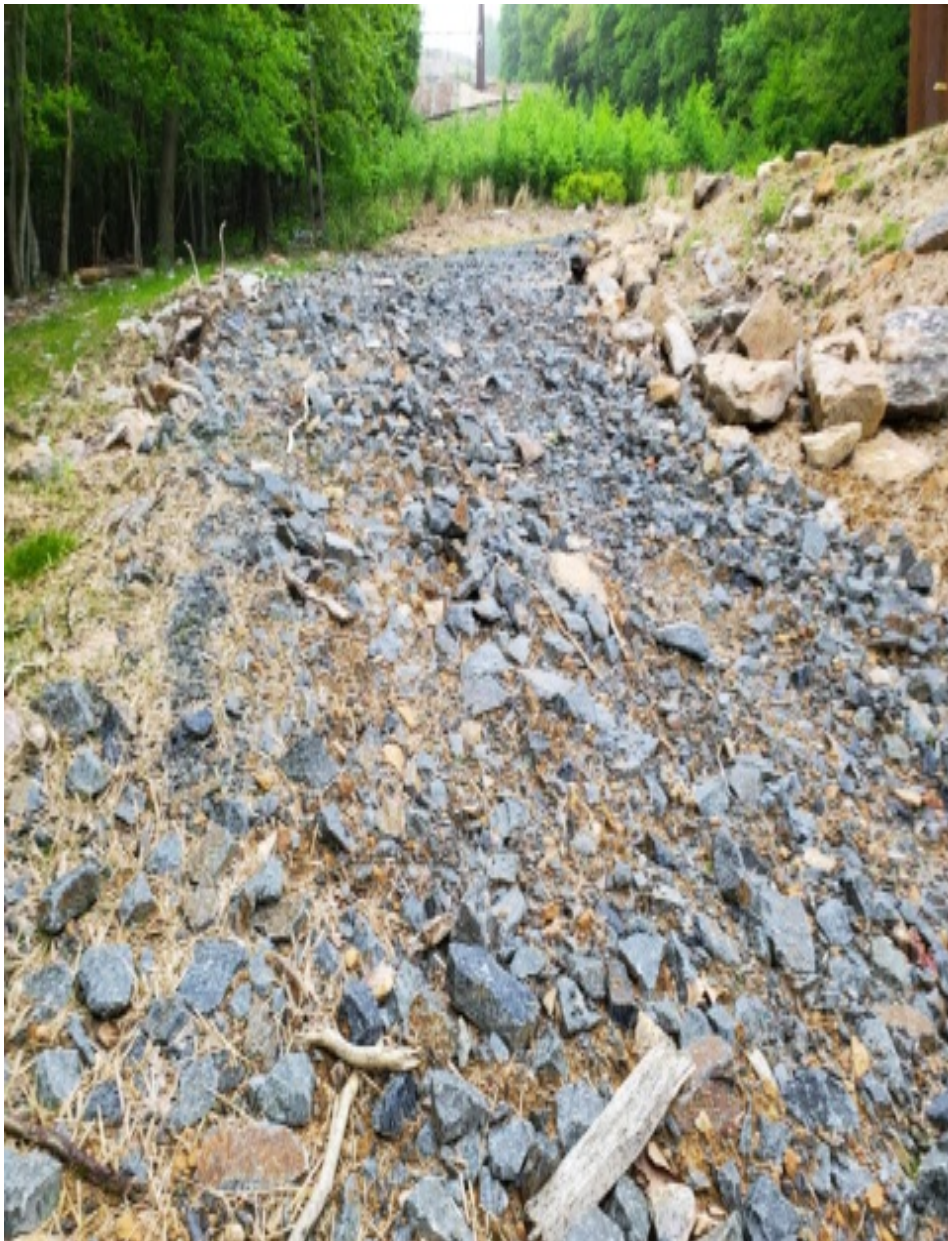
**Photograph 1** - Remnants of access road and scattered boulders on Hartman property on the west side of Crane Pad 75. Per the PPL E & S Plans filed with DCCD, the access road should have been constructed on the east (opposite) side of Crane Pad 75 on Wech property, and removed and vegetated at the landowner's preference.

1. All blue commercial rock must be removed from our property. Presently, the commercial rock can be found on the access road and scattered the entire width of the ROW. Photograph 1, below, is an example of the commercial rock presently located adjacent to Pole 75, E & S -114 of the PPL/DCCD Erosion and Sediment Control/Restoration Plan. The eroded access road depicted in Photograph 1 is an eyesore, impedes access to our remaining property and is a danger to humans and wildlife. This portion of our property was reportedly outside of the planned area of disturbance in the PPL E & S Plan filed with Dauphin County.

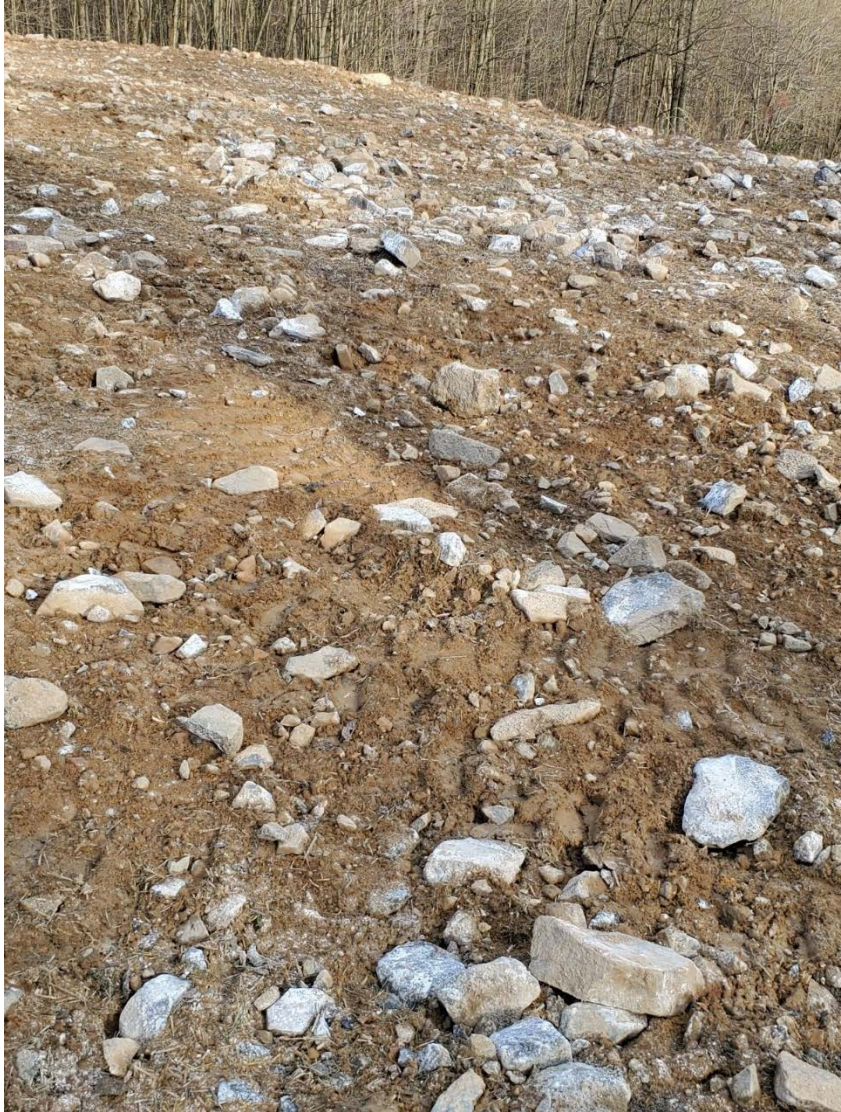
**Photograph 2** - Commercial Stone rising above sub-soil cover on Crane Pad 75 following second restoration and just prior to re-seeding. Similar erosion is evident on Crane Pad 76. Per the DCCD, PPL has to achieve 70% cover, re-vegetation, of all excavated land. On NPS lands, the commercial stone was removed from the Crane Pads, and covered with trucked-in topsoil before seeding.

3. After commercial stone has been removed, all excavated areas on our property must be returned to their original elevation and covered by 4 inches (after settling) of trucked-in topsoil. In contradiction of the E & S Plan, PPL excavated our property on the west side of the access road to harvest soil to construct crane pads for the installation of poles 76 and 75, E & S Plans 114 and 115.

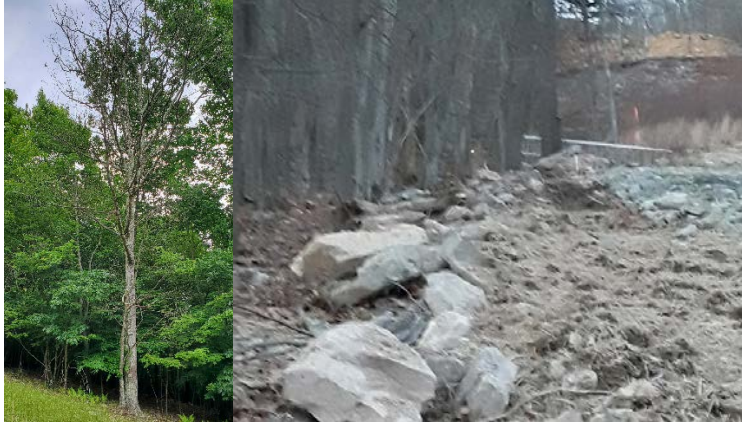
**Photograph 3** - Excavation and damage off the ROW adjacent to access road and Pole 75 caused root damage to a row of hardwoods situated off the ROW. One mature oak tree has already succumbed to the unauthorized and unwarranted excavation activity to harvest fill for road and crane pad construction.

1. During April 2019, Jonathan Scott and I measured the width of the PPL excavation activity at Pole 75. The excavation area measured 110 feet, 60 feet on Hartman property. The entire ROW is 100 feet, 50 feet Hartman and 50 feet Wech. Remarkably, during PPL's first restoration effort following the April 2019 meeting PPL disturbed additional property beyond the ROW. The width of disturbance at Poles 75 and 76 now measures 120 feet and 117 feet, respectively. Accordingly, PPL must compensate us for trespassing and further disturbing our property and native vegetation. The operation of PPL heavy equipment off the ROW, and far from the access road, threatened the root structure and stressed mature hardwood trees on Hartman property west of the access road between Poles 76 and 75. One mature oak tree has already succumbed to the unauthorized trespass. Third photograph below.

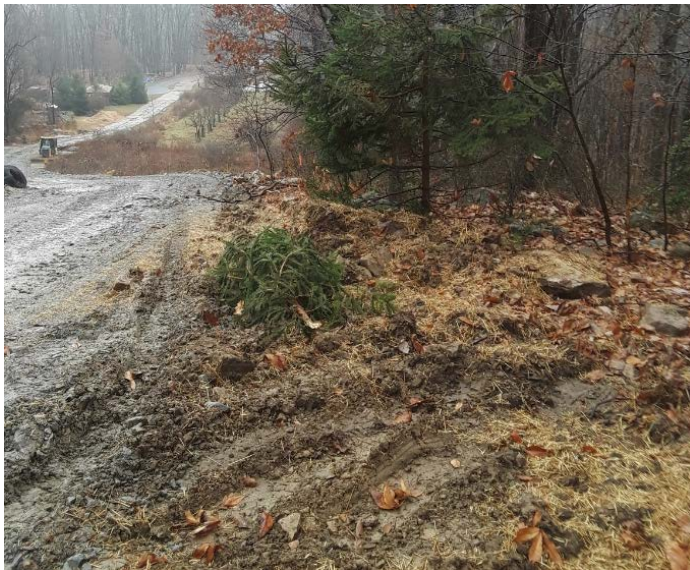
**Photograph 4** - Decapitated 15 year old retail Norway Spruce and excavation beyond ROW adjacent to access road and Pole 76.

2. PPL also excavated our property beyond the ROW at pole 76 as evidenced by the decapitated Norway Spruce tree and tread marks off the ROW. Fourth photograph below.
