Pictorial for Verizon Owned Poles

Part III. VZPA is Jeopardizing the Safety of its Employees and the Public by Failing to Maintain Safe Facilities

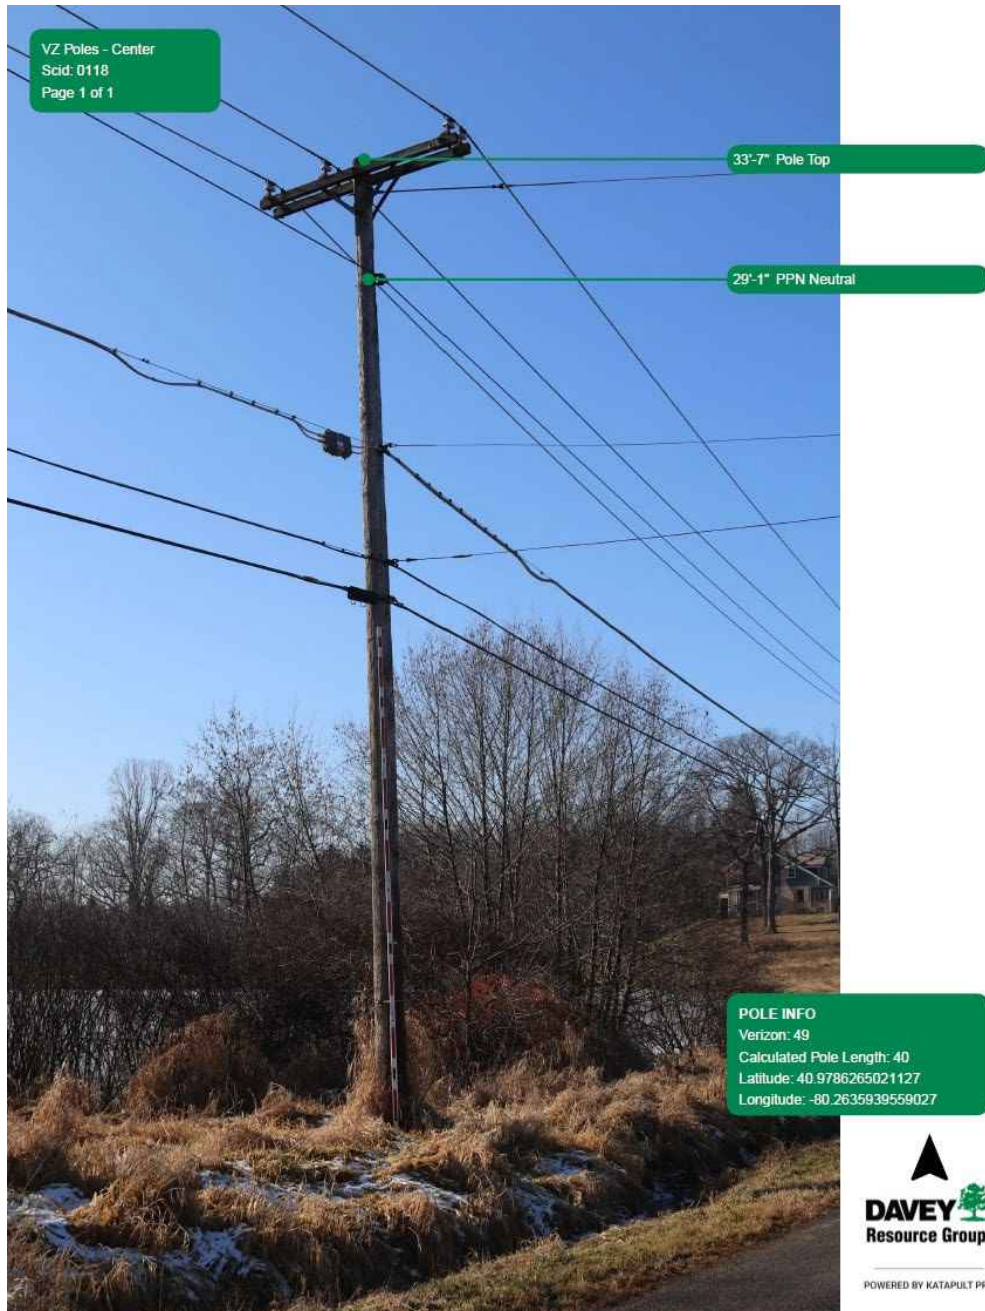
Data Note: Verizon Owned Pole, VZ Center Area, SCID 0118, Pole Top 33'-7", PPN Neutral 29'-1", Verizon Tag 49, Calculated Pole Length of 40', latitude of 40.97862, longitude of -80.26359

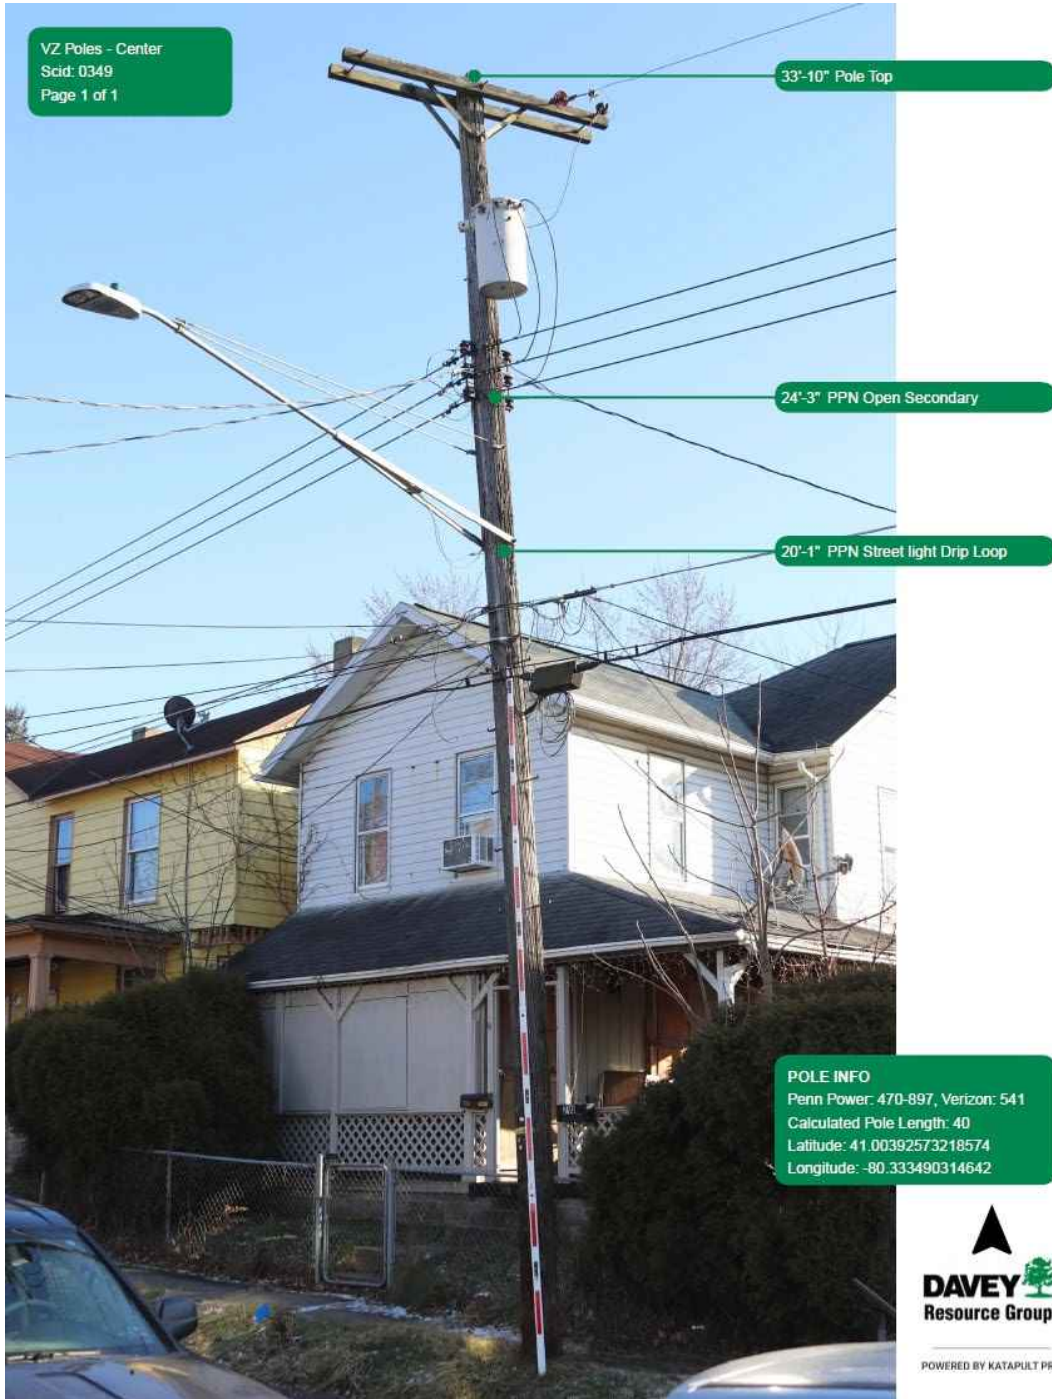
For locations with a streetlight, the lowest power attachment will be captured (which includes the power neutral, secondary attachments, and transformer drip loops.), and the lowest streetlight attachment will be recorded at the lowest physical point of the streetlight. If the Street Light is below the required 40" of worker safety space from the lowest power attachment, then the Clearance Space Required (Column S) will be calculated as 12" from the lowest streetlight attachment.

Data Note: Verizon Owned Pole, VZ Center Area, SCID 0349, Pole Top 33'-10", PPN Open Secondary 24'-3", PPN Street light Drip Loop 20'-1", Penn Power Tag 470-897, Verizon Tag 541, Calculated Pole Length of 40', latitude of 41.003925, longitude of -80.333490

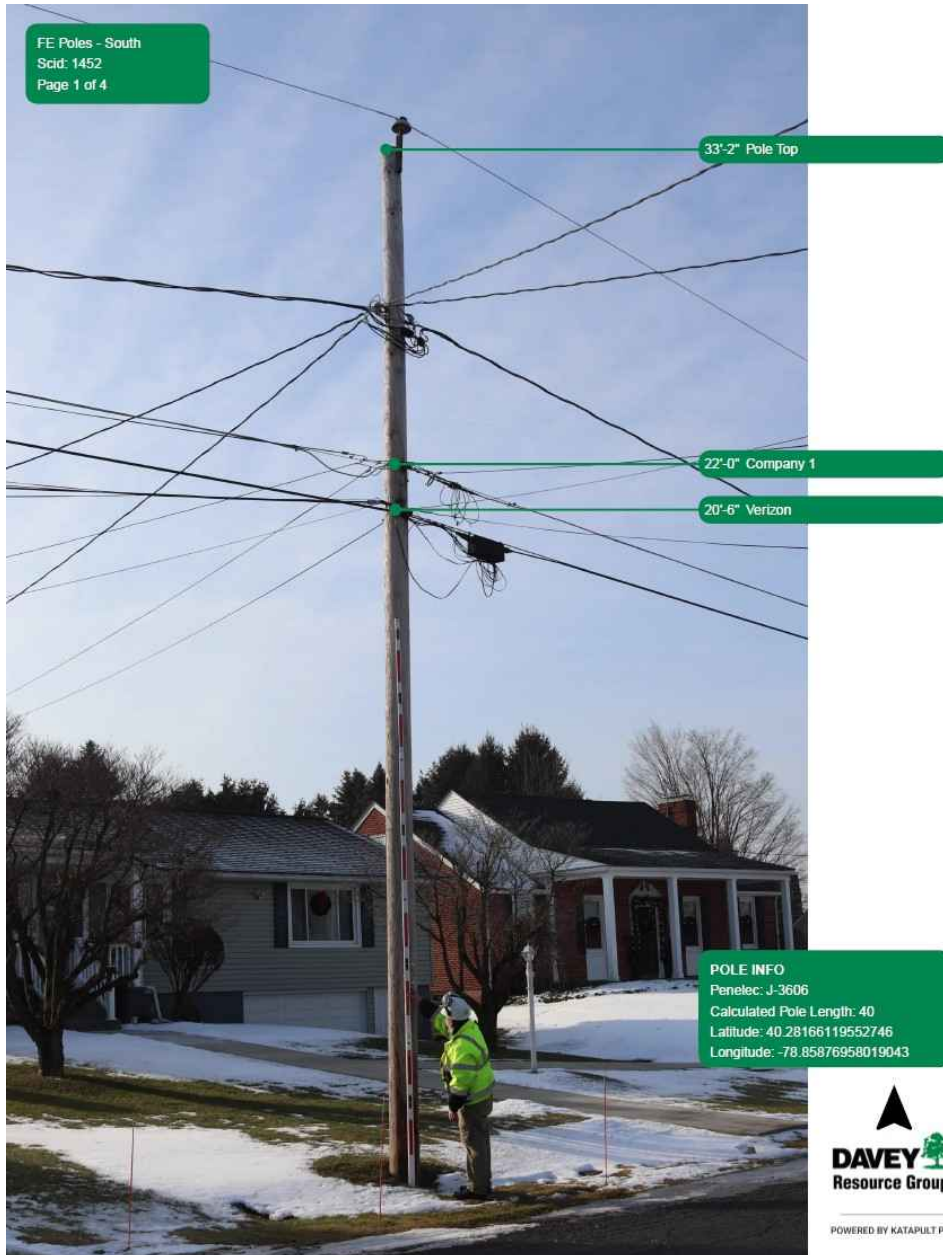
Data Note Source Pole: FirstEnergy Owned Pole, FE South Area, SCID 1452, Pole Top 33'- 2", Company 1 22'-0", Verizon 20'-6", Penelec Tag J-3606, Calculated Pole Length of 40', latitude of 40.281661, longitude of -78.858769

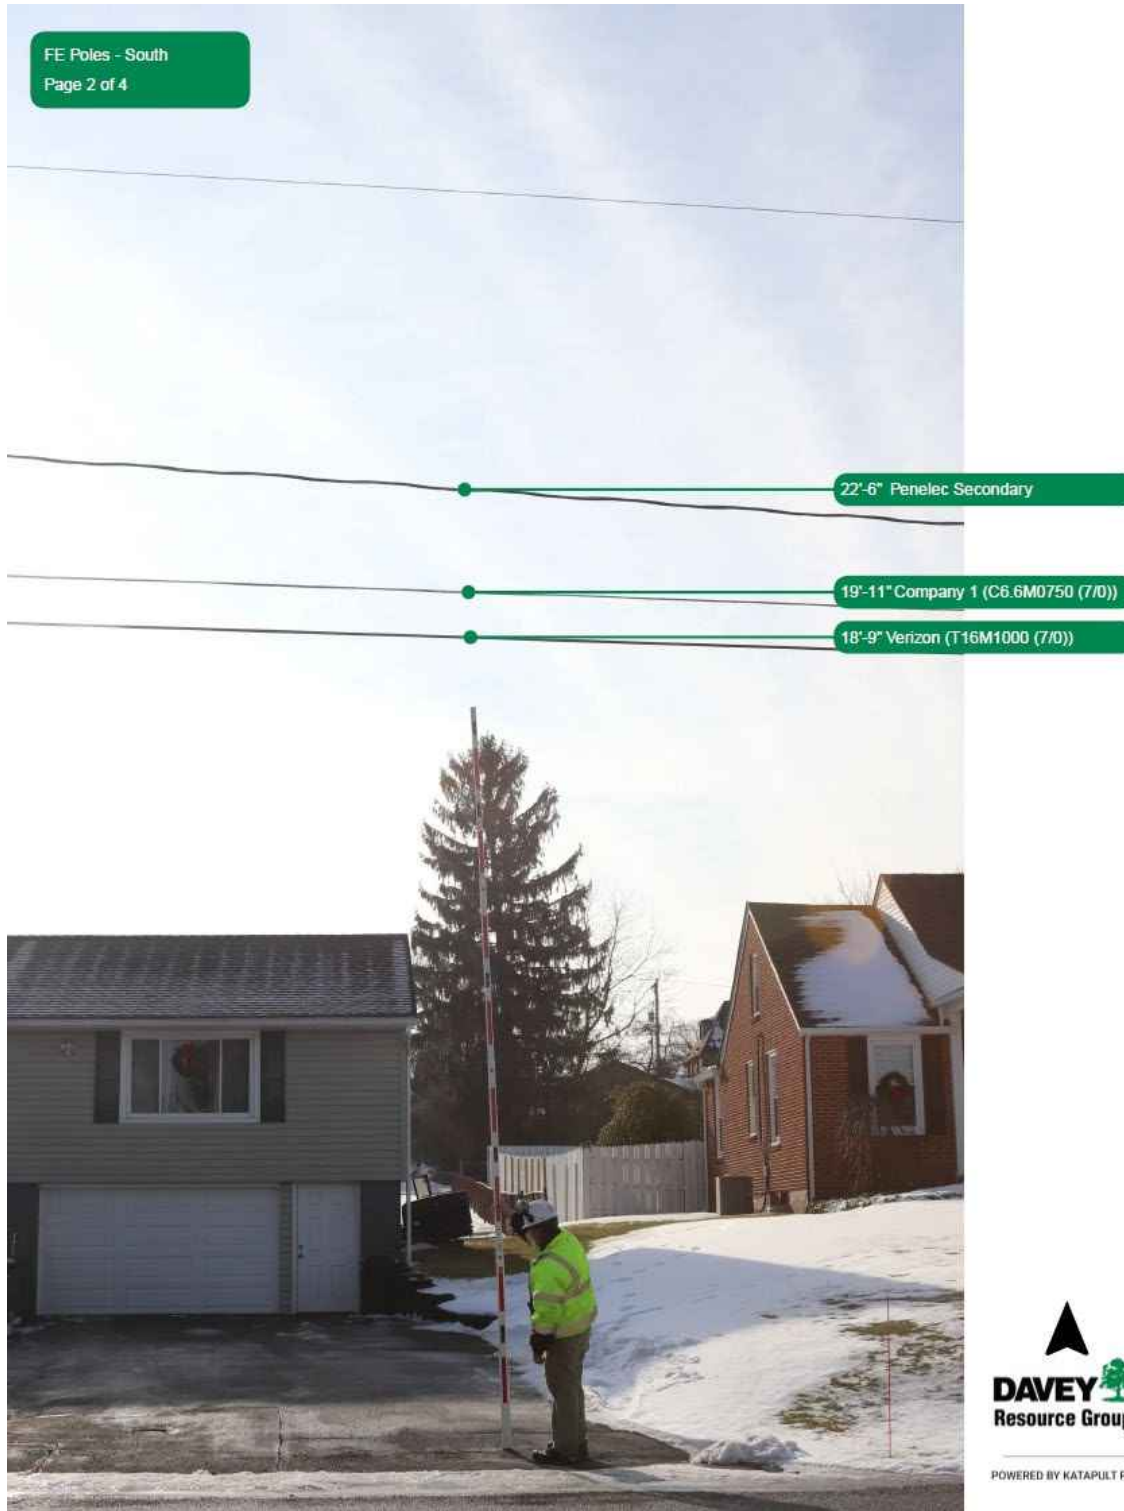
On the Midspan Photo in the upper left, the name of the group the location has been associated with in the data collection system; from top to bottom, along the right side of the photograph, the midspan measurements of the lowest power measurement and the communications attachers will be annotated, with their wire size, and identified as Company 1, Company 2 etc. and Verizon.

Data Note Midspan Pole: FirstEnergy Owned Midspan, FE South Area, Penelec Secondary 22'-6", Company 1 19'-11" C6.6M0750, Verizon 18'-9" T16M1000

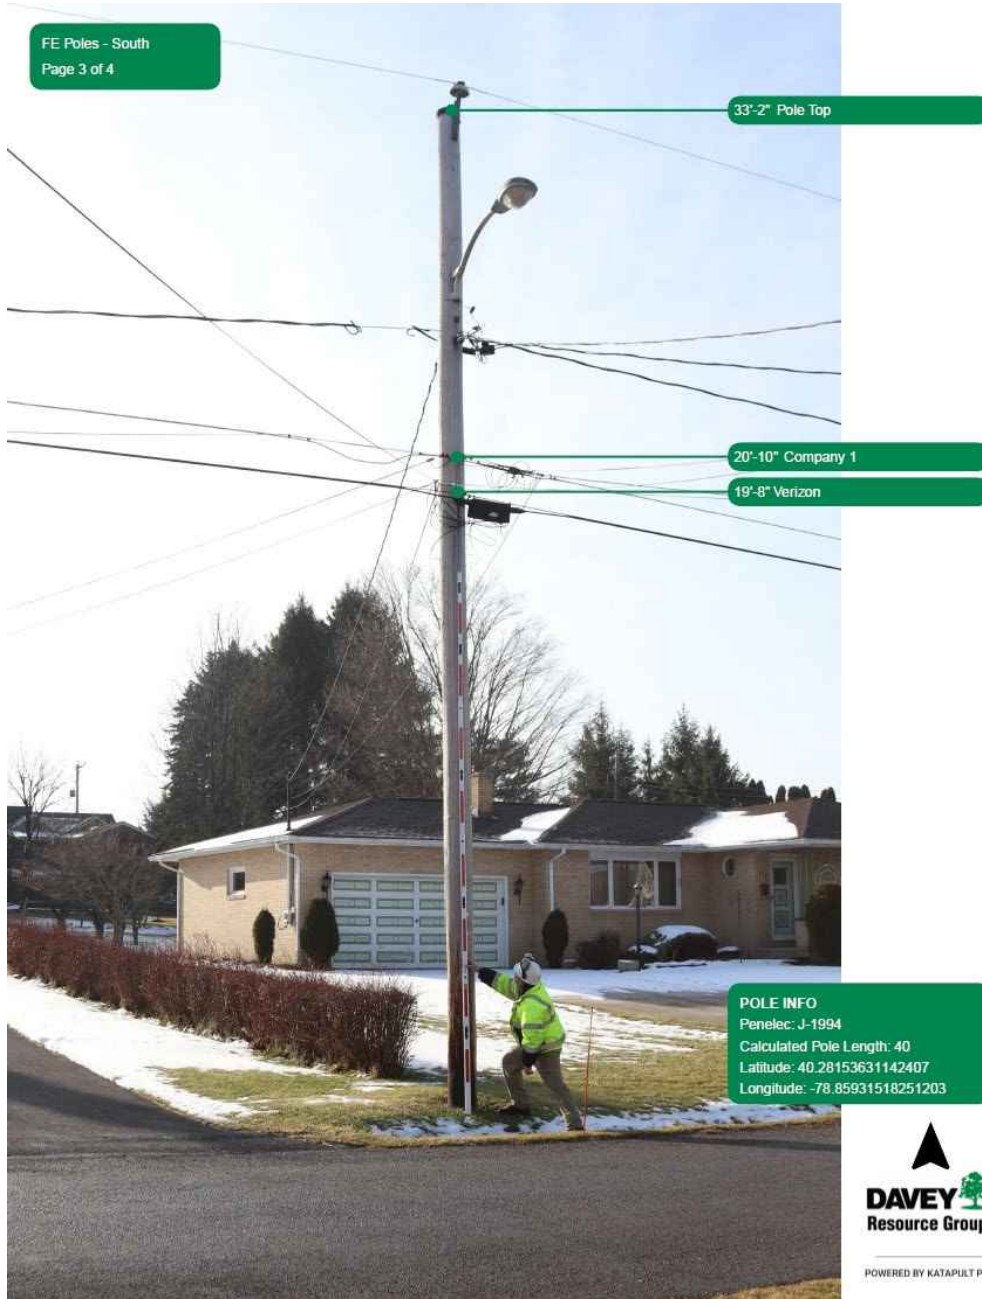
On the Reference Pole Height annotated photo the following information will be displayed: in the upper left, the name of the group the location has been associated with in the data collection system; from top to bottom, along the right side of the photograph, the pole top measurement and all attachments of communication wires, and they will be annotated as Company 1, Company 2 Etc. and Verizon; in the lower right, pole tags information, pole length calculation, and latitude / longitude will be documented.

Data Note Reference Pole: FirstEnergy Owned Pole, FE South Area, Penelec Tag J-1994, Pole Top 33'-2", Company 1 20'-10", Verizon 19'-8", Calculated Pole Length of 40', latitude of 40.281536, longitude of -78.859315

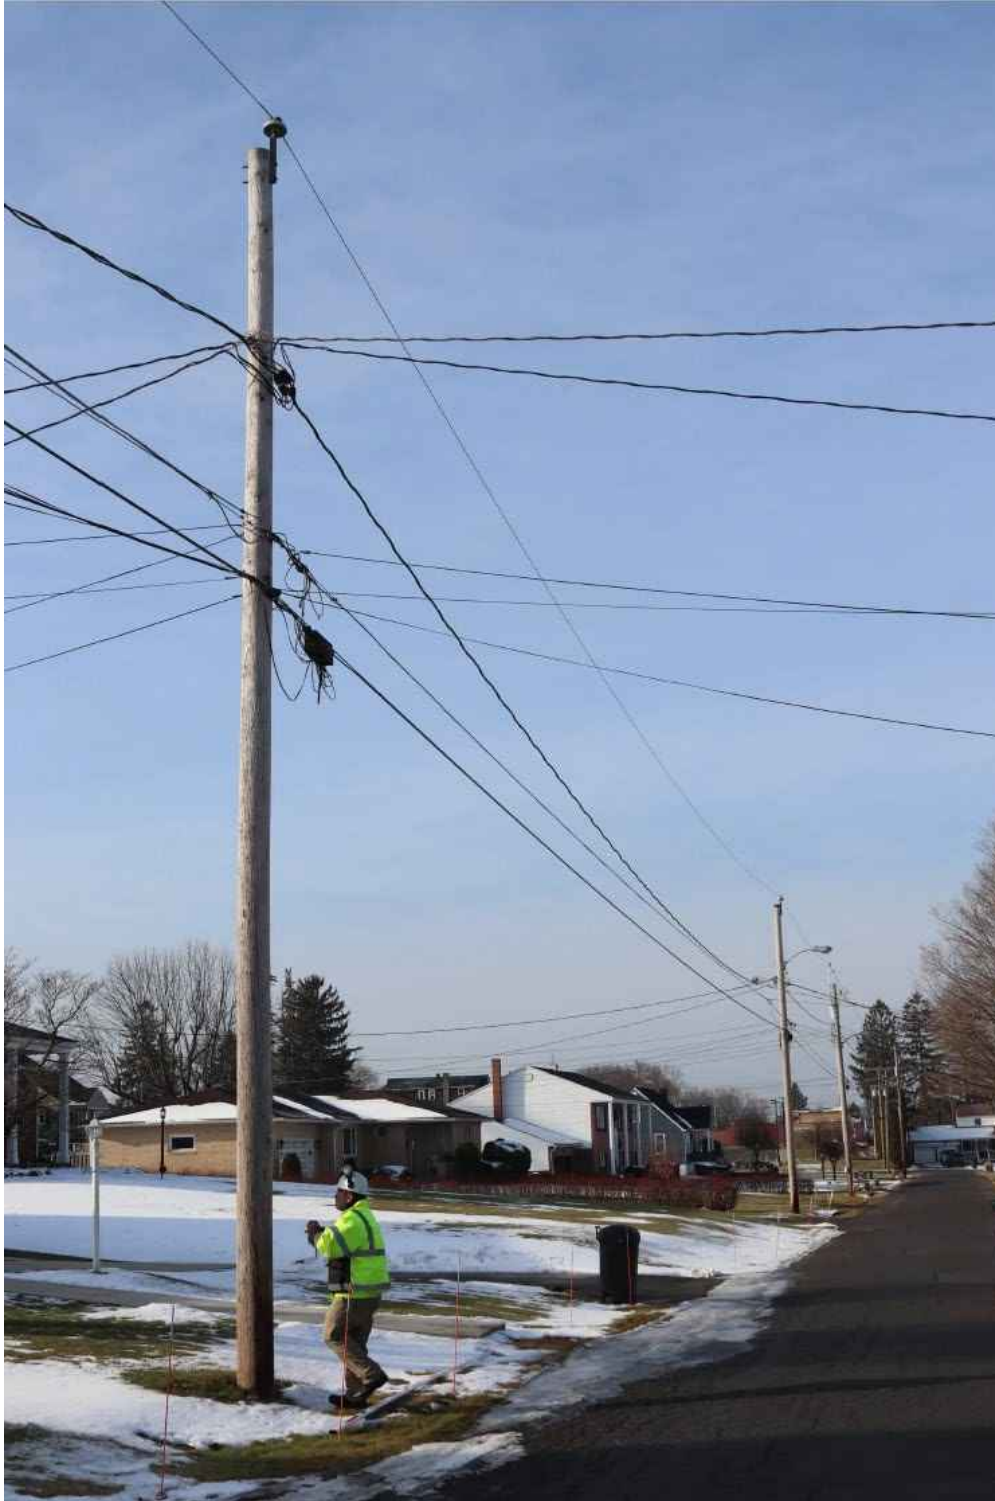
The Hallway shot is the fielded photo of the source pole and reference pole in line that captures both the pole top and bottom of each pole and the ground between

Data Note: Hallway Photo - photograph used to see the surrounding area of source pole, midspan, and reference pole.

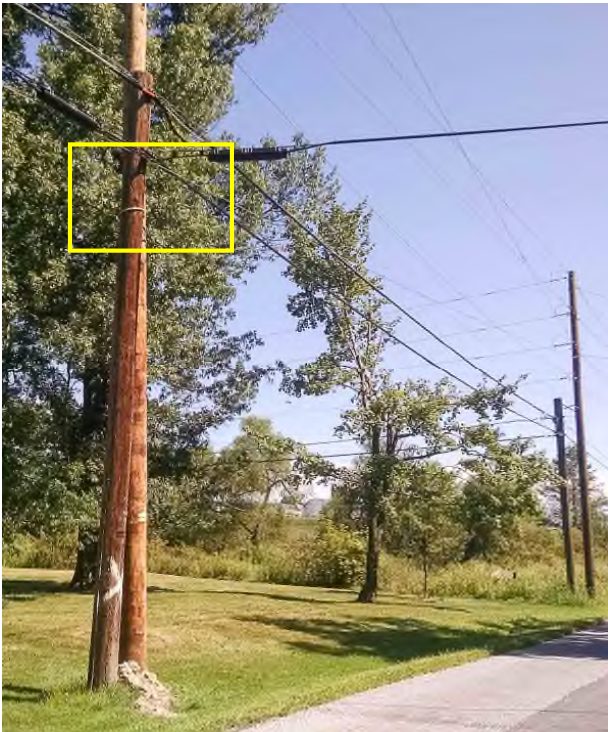
A. **Dangerous Double Poles.** The picture at left from Chester County shows two sets of double poles (one in the foreground and one in the background). The old pole in the foreground is clearly marked with an "X" indicating it is to be removed. This pole is so bent that it is tied to the new pole at the top to keep it from falling over (see blow-up below of area outlined in yellow). It appears that VZPA's facilities are the only ones still attached to the old poles.

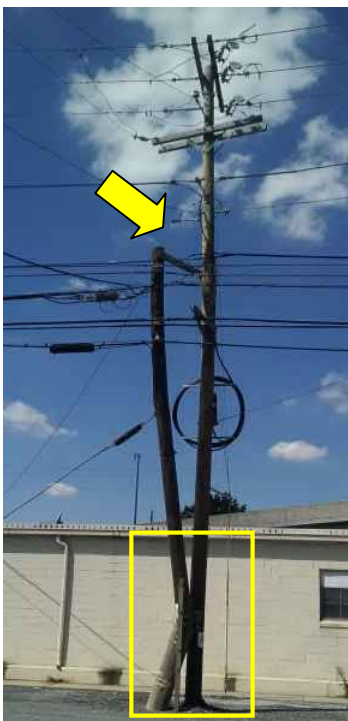
D. In the picture below left, an old double pole in Cumberland County has broken. The blow up shows that the base of the pole is being held together by a wooden post. The top of the old pole apparently is kept upright by a single brace to the newer pole (yellow arrow).

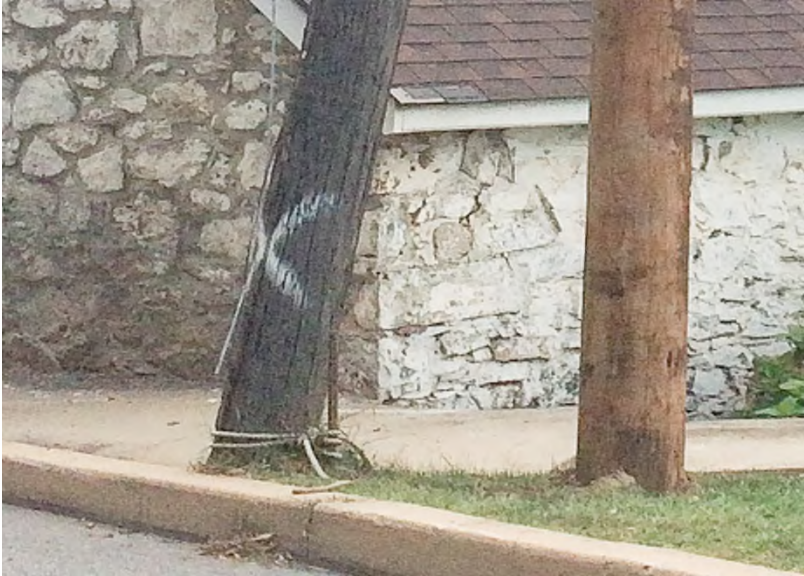
E. Old double poles can become so bent that they require supports to try to keep them upright. The picture at right from Berks County shows a seriously bent old double pole. A blow-up of the base of the pole (below) shows a metal bar has been sunk into the ground and tied to the old pole to try to keep it from falling over. Once again, VZPA's facilities are the only ones still attached to the old pole. The blow-up also shows grass growing right up to the base of the newer pole, indicating that the newer pole has been in place for quite some time.

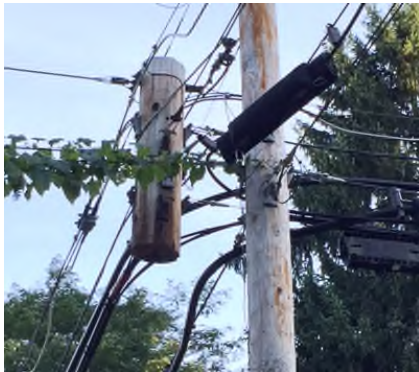
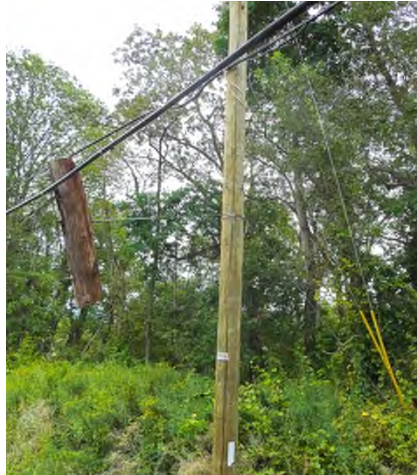
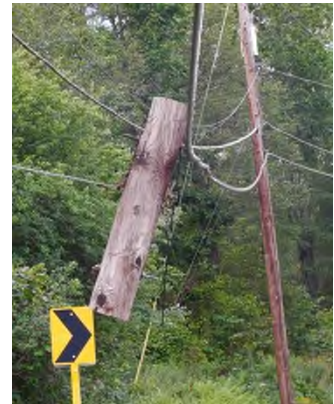
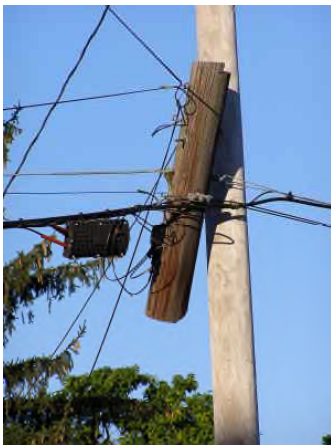
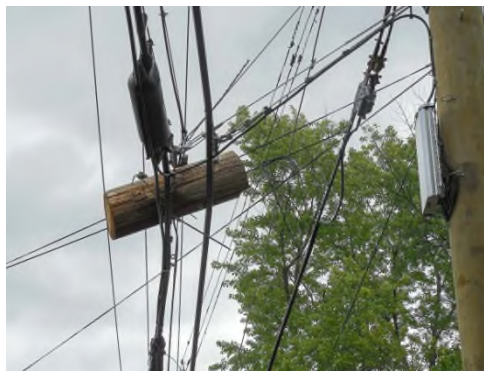
F. **Dangling Pieces of Old Poles.** There are times, of course, when there simply is no room for the old pole. Even in those situations, VZPA does everything it can to avoid the expense of moving its facilities to the new pole. When VZPA does nothing, and the electric utility must remove the pole from the base, it may leave the portion of the old pole containing VZPA facilities just dangling over the right of way, tied to the new pole by a single cable or a make-shift wooden support. The pictures on this page come from throughout the Commonwealth (Cumberland, Luzerne, Monroe, and Washington counties) and show a few of the many examples of this incredibly dangerous practice.

G. Leaving a portion of the old pole hanging is not only dangerous to the public (for obvious reasons if the support were to break), but also poses a serious hazard to utility workers who must navigate this heavy foreign object and try to find a safe and secure way to work on the facilities attached to the old bit of pole (you certainly cannot prop up a ladder against it). Note how some of these dangling bits of pole are perilously close to the ground.

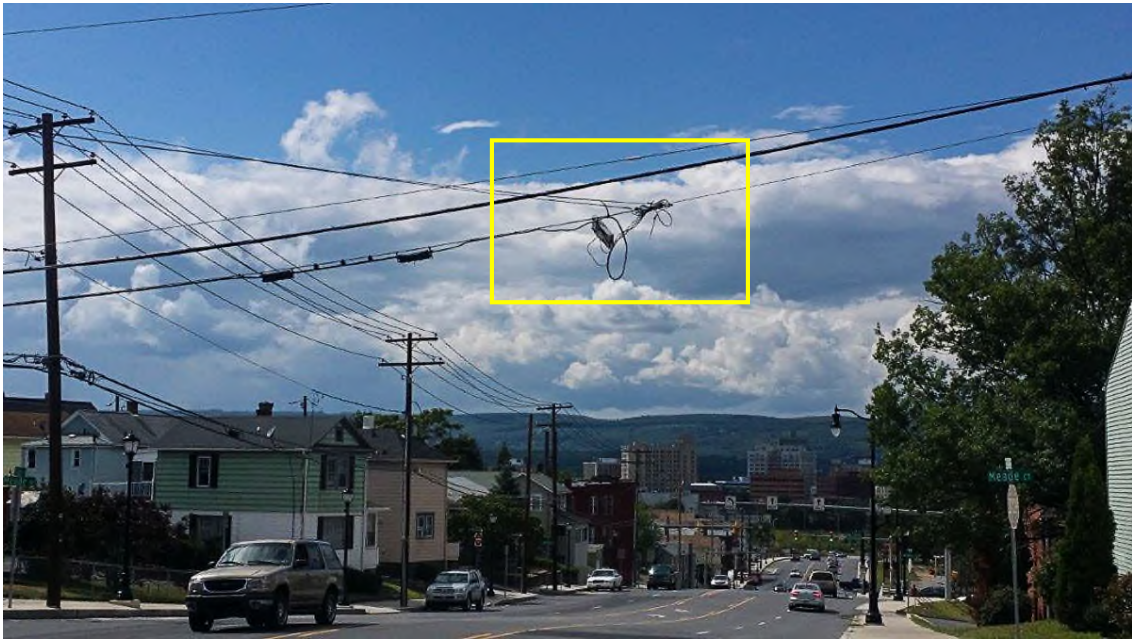
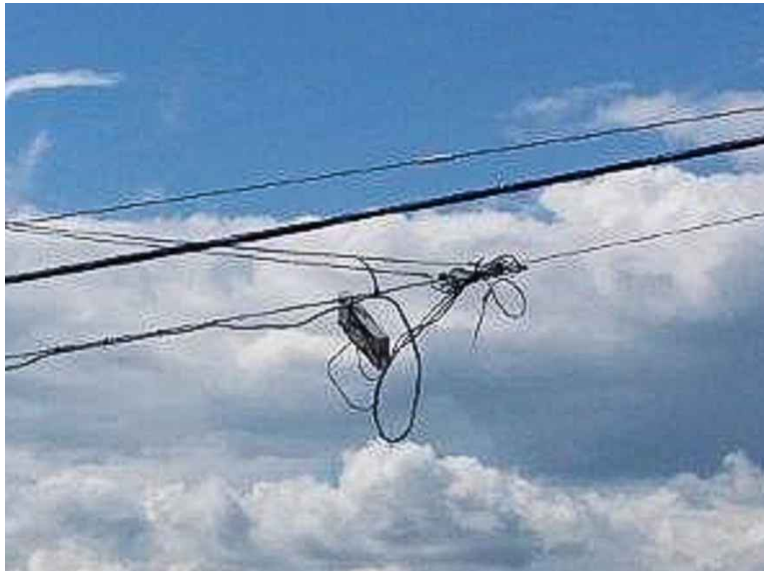
H. **Unattached Facilities.** In other circumstances, it is simply impossible to leave the old pole hanging. For example, a highway widening project in Monroe County required the complete removal and relocation of poles. VZPA had to remove its facilities from the old pole, but instead of spending the money to run new, longer cable to attach to the new pole, VZPA simply left its old facilities dangling over the highway, as shown in the picture below. This includes a terminal that is supposed to be attached to a pole to secure the conductor inside -- conductor that directly serves individual customers along the highway -- as shown in the blow-up below the main picture.

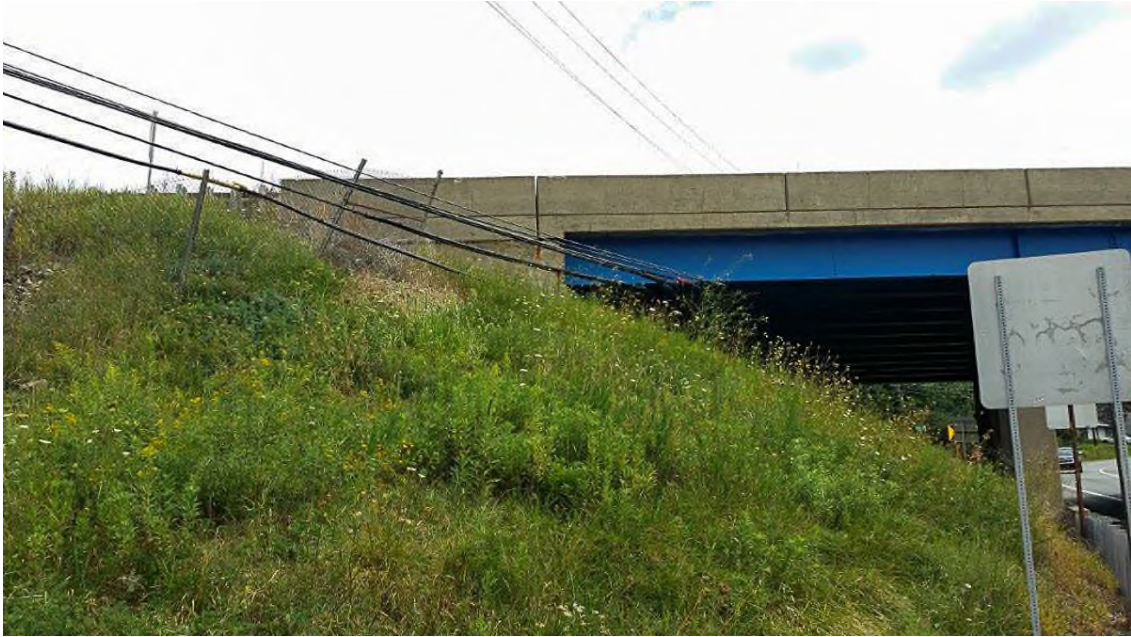
I. Incredibly, there are even circumstances where VZPA's failure to spend money to maintain its non-FiOS network has resulted in cables being unattached to any pole at all. The picture below from Luzerne County shows VZPA's cables attached to a fence, so the cables run underneath a bridge instead of over the top (as the electricity cables do). Needless to say, this condition, which has cables just a foot or two above ground level, is extremely hazardous to the integrity of the cable (animal infestation, unauthorized human contact, etc.), the public who may pass within inches of the cable, and utility workers who are somehow supposed to work safely on cable attached in this manner.

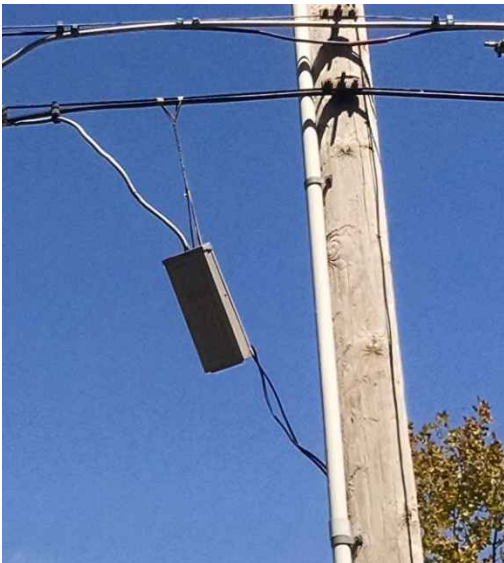
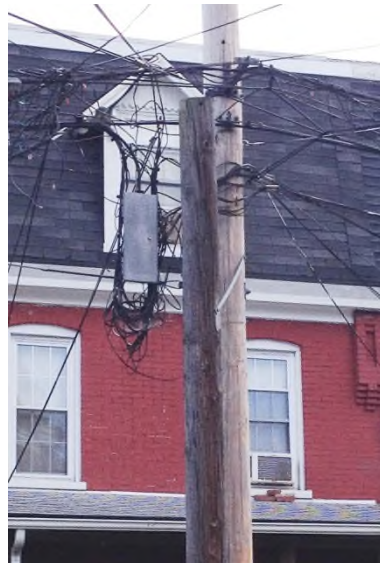
J. Symptoms of the same problem occur in the accompanying pictures from Chester and Lancaster Counties. VZPA has simply left terminals and other facilities dangling over the road or sidewalk, rather than spending the money to properly attach them to the new pole.

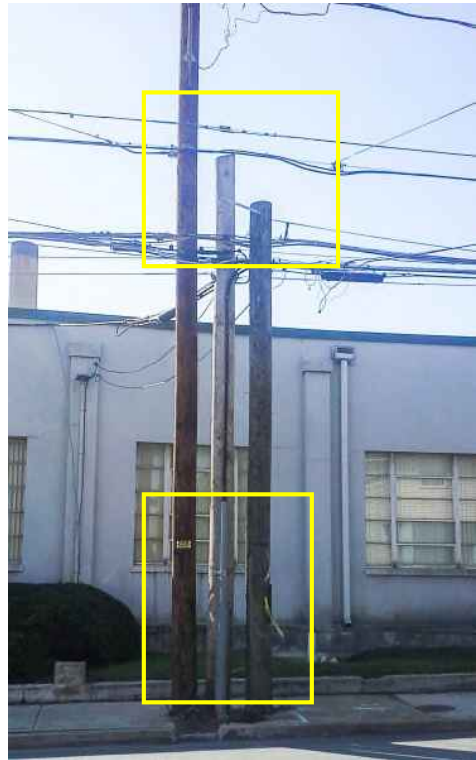
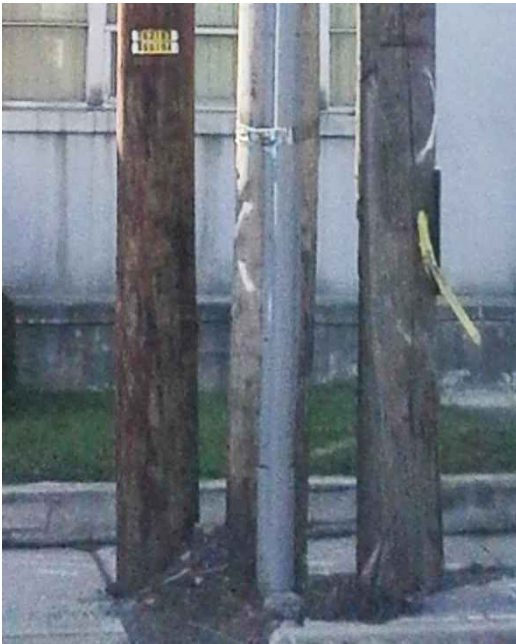
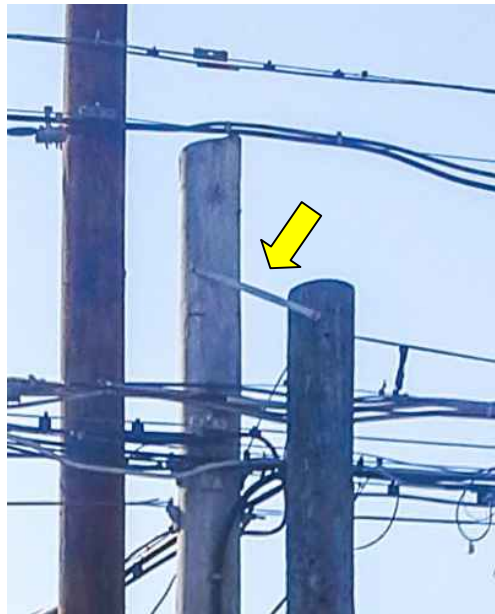
K. Further, VZPA's failure to spend the money to move its facilities and remove double poles has been an ongoing practice for many years. An astounding example of this is the picture at right from Berks County showing a triple pole. This represents two generations of poles that VZPA has allowed to remain in place without regard to the safety of line workers and the public. VZPA's facilities remain attached to the oldest (right) pole. In the blow-up below left, it can be seen that the right and center poles are each marked with an "X" indicating that the poles are to be removed. It also appears that the center pole has split causing a metal support and band to be installed to try to keep the pole together. Incredibly, despite this defect in the center pole, the right pole remains attached to the center pole for support, as shown in the blow-up below right (yellow arrow).

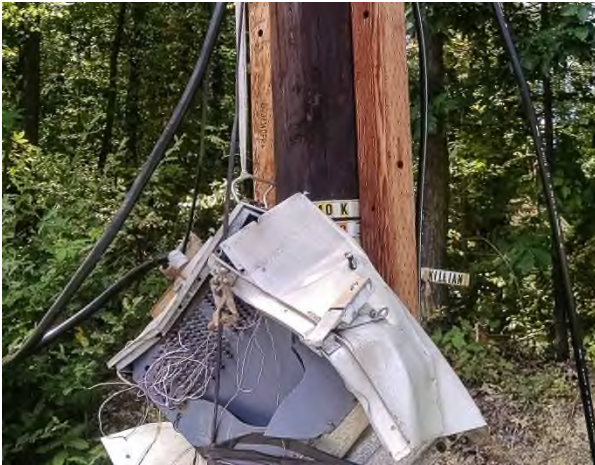
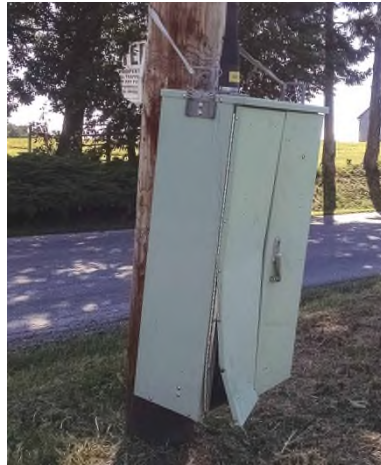
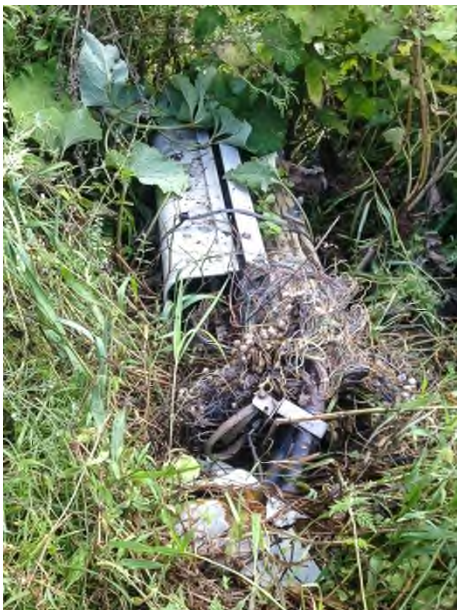
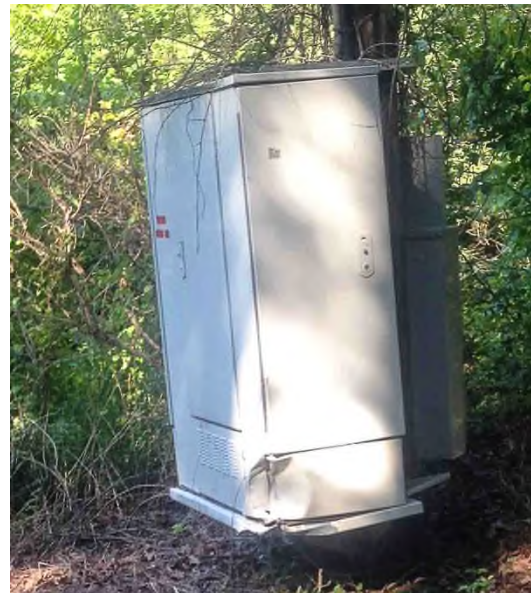
M. **Damaged Cross-Connect Cabinets and Remote Terminals.** Cross-connect cabinets are vitally important facilities on the non-FiOS network. Large cables (containing hundreds of pairs of the individual conductors that serve customers) enter the cabinet and are then split into their individual circuits. A remote terminal ("RT") serves as a miniature central office, providing dial tone and data services to customers who are distant from a central office. Damaged cross-connect boxes and RTs have a direct impact on the reliability of service to customers as wires get damaged, rained on, chewed by animals, or disconnected. Damaged cabinets (even seemingly small openings) also are subject to infestation by insects and animals creating a significant safety hazard to utility workers who must access the cabinet, as well as a potential public health problem.

N. VZPA does not replace damaged cross-connect cabinets and RTs and allows these types of hazards (and resulting poor service quality) to proliferate. Following are a few examples of damaged cross-connect cabinets from two areas in Chester County (top row) and Lycoming County, and a damaged RT from Centre County (below right).

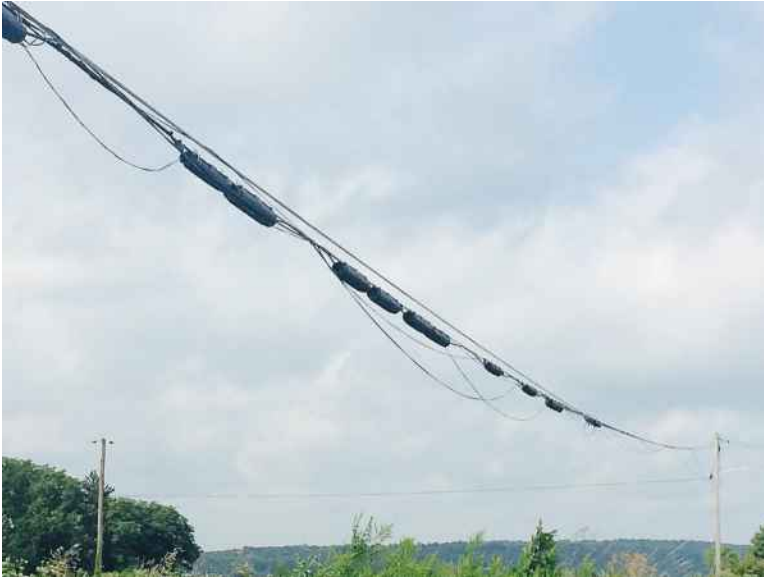
P. The picture at left from Monroe County shows a single cable that has become so damaged there are at least 10 splice boxes on a single span of a few hundred feet. Each splice box covers a portion of damaged or defective cable. Each of the numerous thin wires would have been installed in response to a separate customer complaint of either no dial tone or static on the line. Rather than replacing this

span of cable, which almost certainly has deteriorated to the point where conductors are damaged or exposed to weather (rain, ice, snow), VZPA has directed a series of make-shift fixes that do not address the long-term problem.

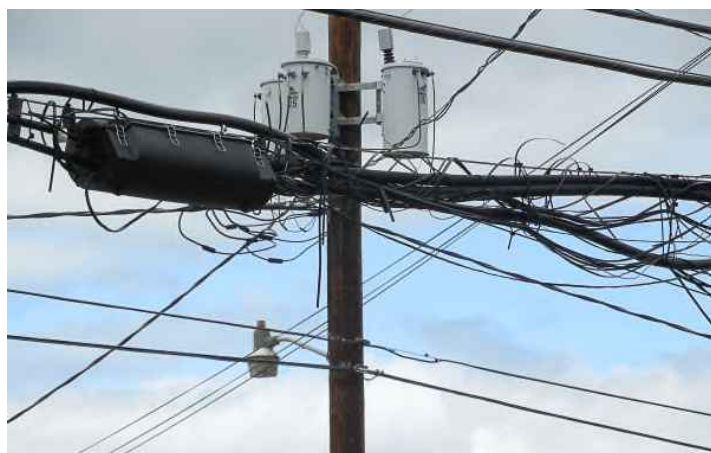
Q. The picture at right from Luzerne County exhibits the same problem (defective cable that should be replaced). The number of work-arounds on this portion of cable are astounding. Each small wire represents a response to a different customer's service complaint, and likely represents a separate service call and trip up the pole for a VZPA field worker. Obviously, it will become increasingly difficult to apply these "band aids" to this cable, as there is little ability to work safely to install yet another patch within this limited space.

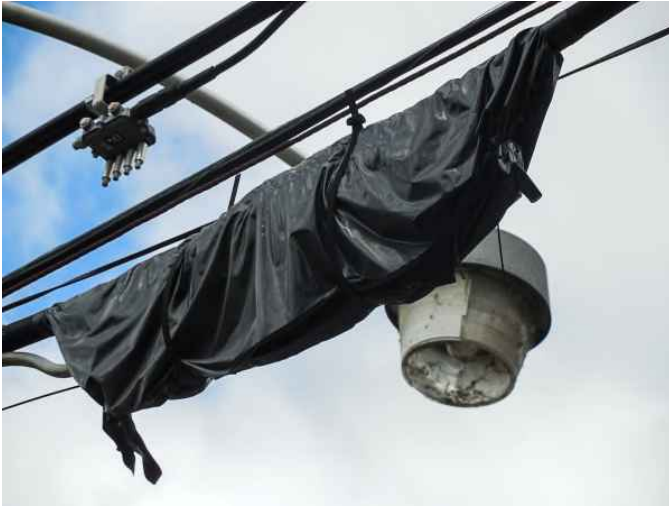
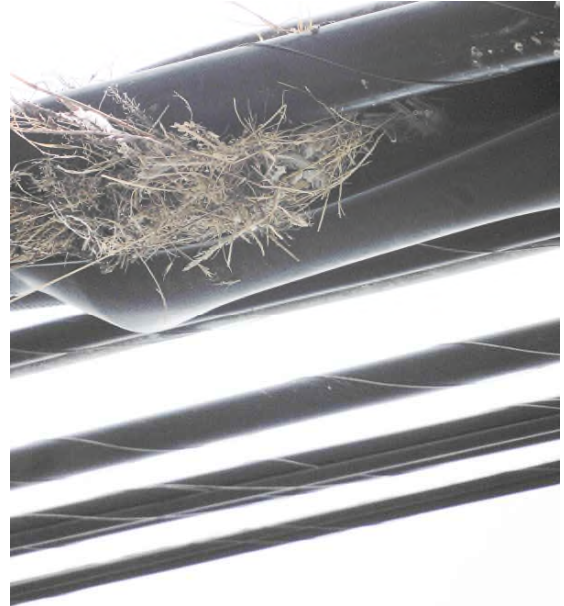
R. At other times, cable becomes so deteriorated that VZPA simply directs that it be covered with plastic to try to keep out the weather. These plastic coverings, which resemble heavy-duty plastic trash bags, themselves deteriorate as animals chew through them. The result can be animals and insects nesting inside which poses a serious hazard to utility workers if they must work near and inside the coverings. This problem can be seen in the following pictures. The picture below left from Lehigh County shows early signs of deterioration in a plastic covering (tearing on the left). The picture below right from Luzerne County shows significantly advanced deterioration of what is supposed to be a protective covering. Here the covering is split open and some type of animal has built a nest inside.

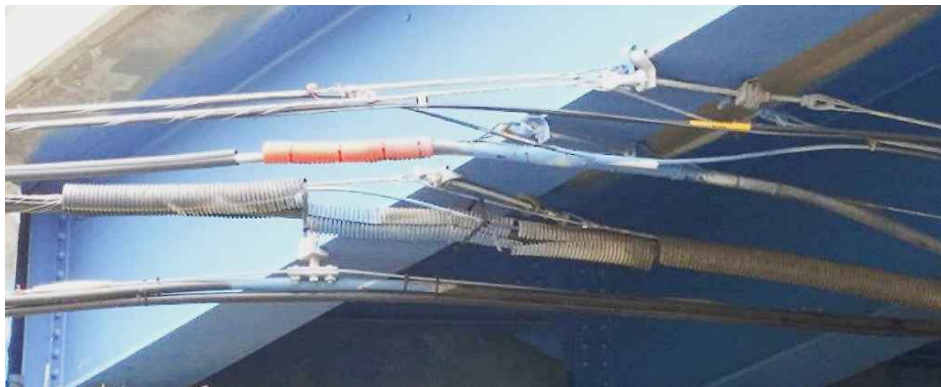
S. As seen in the picture below from Luzerne County, there are, unfortunately, times when VZPA is not even willing to put this level of effort into a repair. The picture below shows deteriorated cable that has not been repaired in any manner (or perhaps its plastic covering has completely deteriorated). The contents of the cable are simply exposed to the elements, allowing the cable, and service to customers, to further deteriorate. (This is a close-up of the cable at ground level running under the bridge in paragraph I, above.)

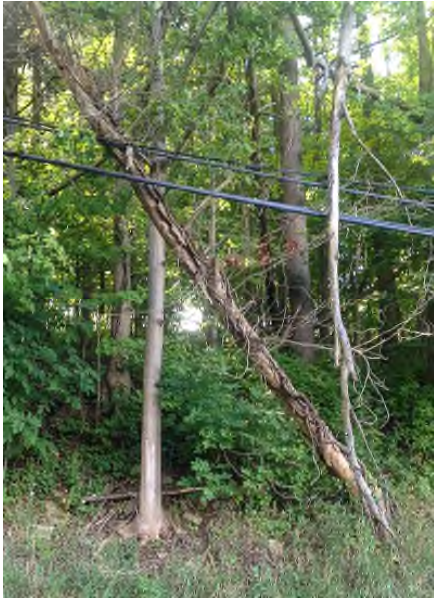
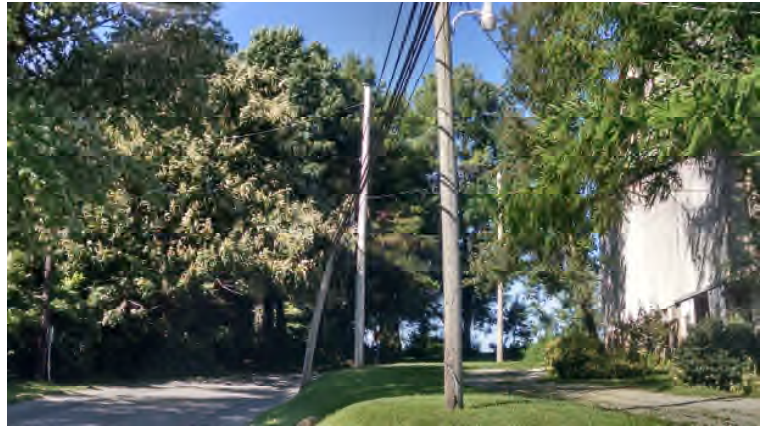
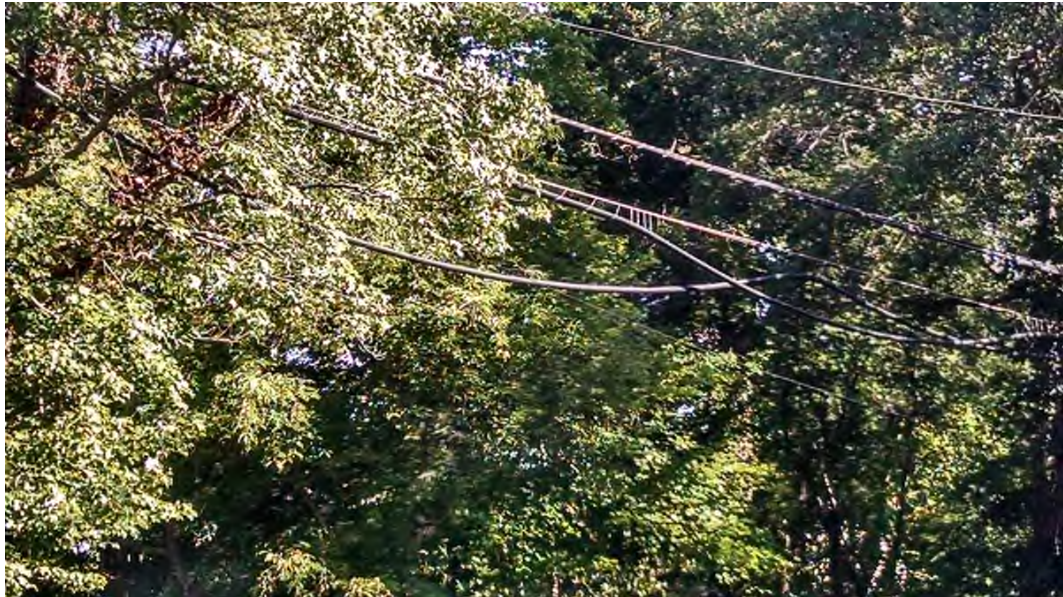
T. **Falling Trees and Poor Vegetation Control.** VZPA also is failing in its obligation to control vegetation near its facilities. The failure to control vegetation damages facilities and poses a significant safety hazard to utility workers who must try to access facilities in need of repair while maintaining sufficient maneuverability and clearances to

work in a safe manner. The following pictures from Centre and Chester counties provide just a few examples of VZPA facilities that are covered by fallen trees or almost completely overgrown by vegetation.

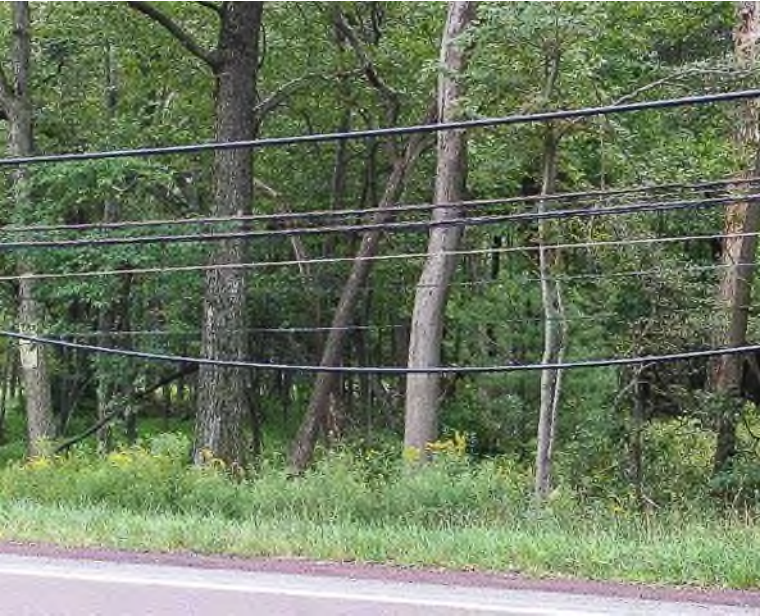
U. **Dangerously Sagging Cables.** Further evidence of VZPA's neglect of its non-FiOS network is apparent in the prevalence of cables sagging below their normal space on the pole, and in some cases sagging just a few feet off the ground. Sagging cables usually occur because lashing wire has broken and, at VZPA's direction to save money, not been replaced. Sagging cables create a safety hazard to utility workers, as the cables become too close to other cables on the pole (restricting line worker maneuverability). When cables sag too close to the ground, they also pose a hazard to the public, placing the cable

C. NESC 232 requires a utility to maintain minimum vertical clearances for communications conductors of at least 4.7 meters (approximately 15.4 feet) above any land or road subject to vehicular traffic, and at least 2.9 meters (approximately 9.5 feet) above pedestrian-only areas. Unfortunately, there are numerous areas in Pennsylvania where Verizon has failed to repair broken lashings or install replacement poles, allowing its cables to sag perilously close to the ground, and well below the minimum clearances required by the NESC.

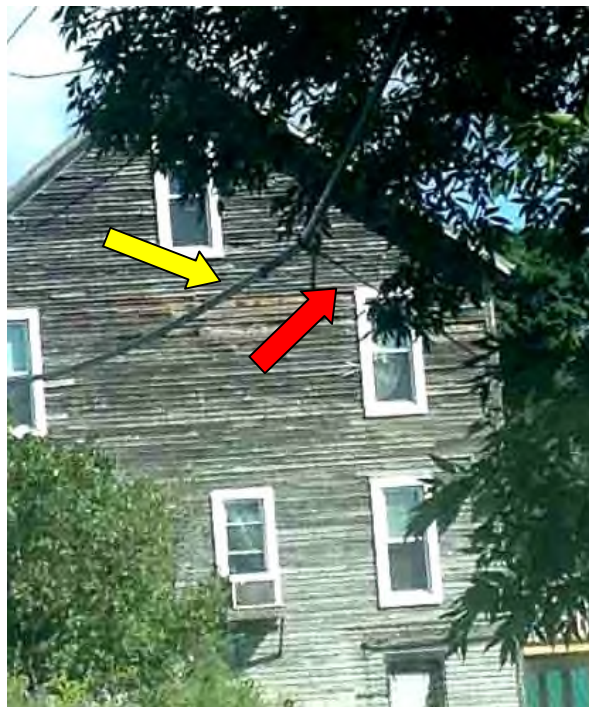
within easy reach of pedestrians, vehicles, and even children. Sagging cables also threaten the integrity of the conductor inside the cables, as strain is placed on the thin conductor which is improperly bearing the weight of the cable. The accompanying pictures show VZPA cables that are sagging perilously close to the ground. The picture at left from Luzerne County shows a VZPA cable that is only 3 or 4 feet above the ground. The picture below from Centre County shows a

VZPA cable (yellow arrow) that is sagging so badly the homeowner apparently tied it to a tree to try to keep it out of the road (red arrow).
